EVALUATION OF BOSCHUNG ICE
EARLY WARNING SYSTEM

Frank Spica

Research Laboratory Section
Materials and Technology Division
Research Project 82 G-257
Research Report No. R-1289

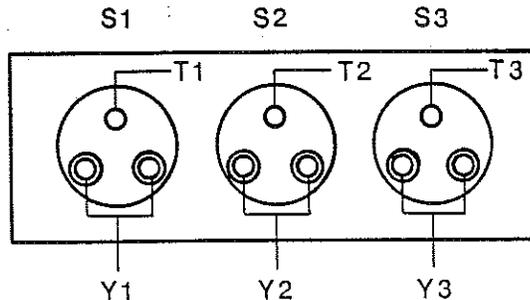
The ground probes of the Boshung black ice early warning system

Sensor S1 measures T1, which is the actual temperature of the surface, and the electrical conduction Y1, to determine if there is moisture present on the roadway. Sensor S2 measures temperature T2. This sensor is heated or cooled relative to T1. It also measures conductance Y2 to further indicate the presence of moisture. Sensor S3 can only be heated with respect to T1. It also can measure conductance Y3 for a third indication of the presence of moisture.

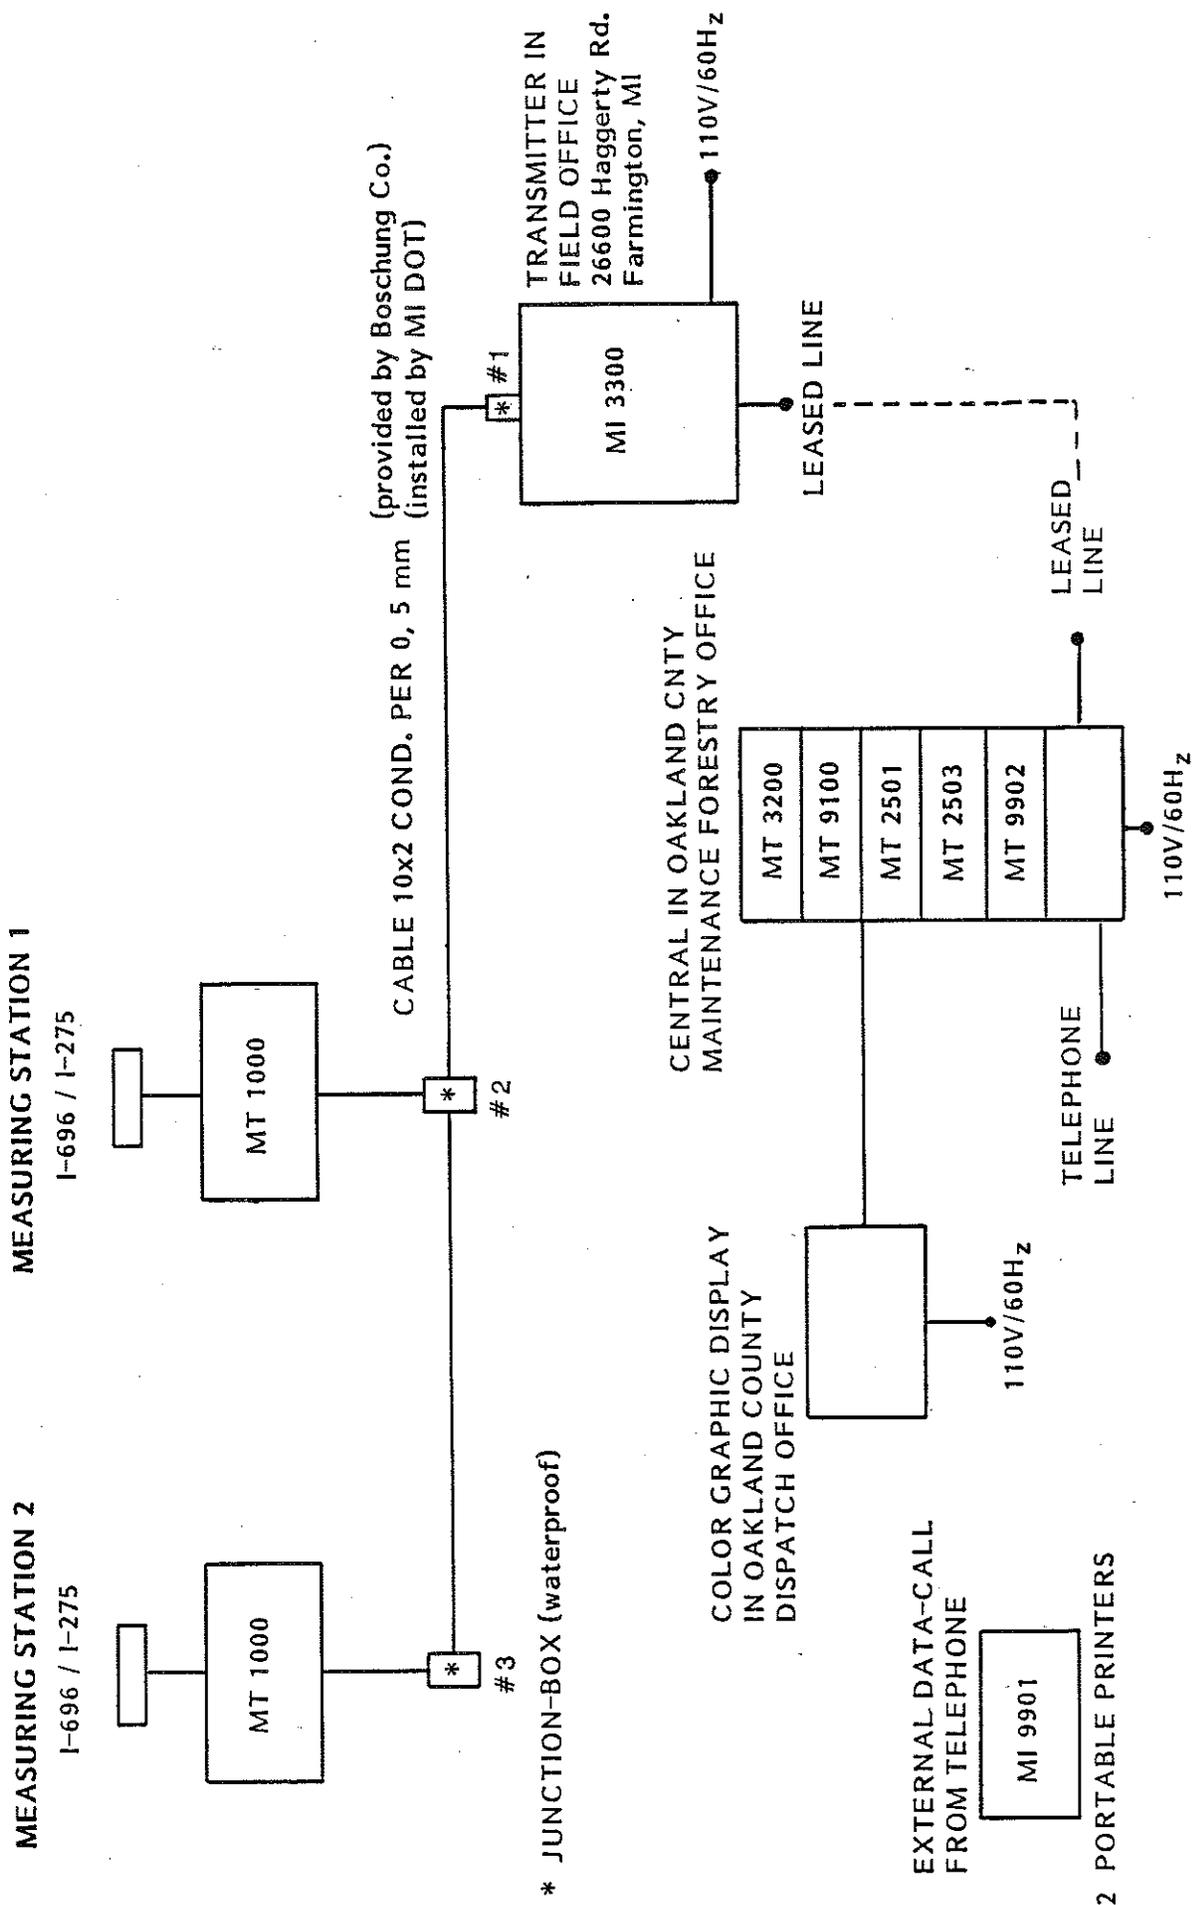
Figure A

The installation consisted of a separate measuring station for each of the two structures. The output of these measuring stations was connected by cable to a telephone modem located at the MDOT field office on Haggerty Rd in Farmington Hills. From this point the data were transmitted over a leased telephone line to a central computer located in the Oakland County Road Commission building in Pontiac. The data were processed by a personal computer (PC) and displayed on a high resolution color graphics terminal.

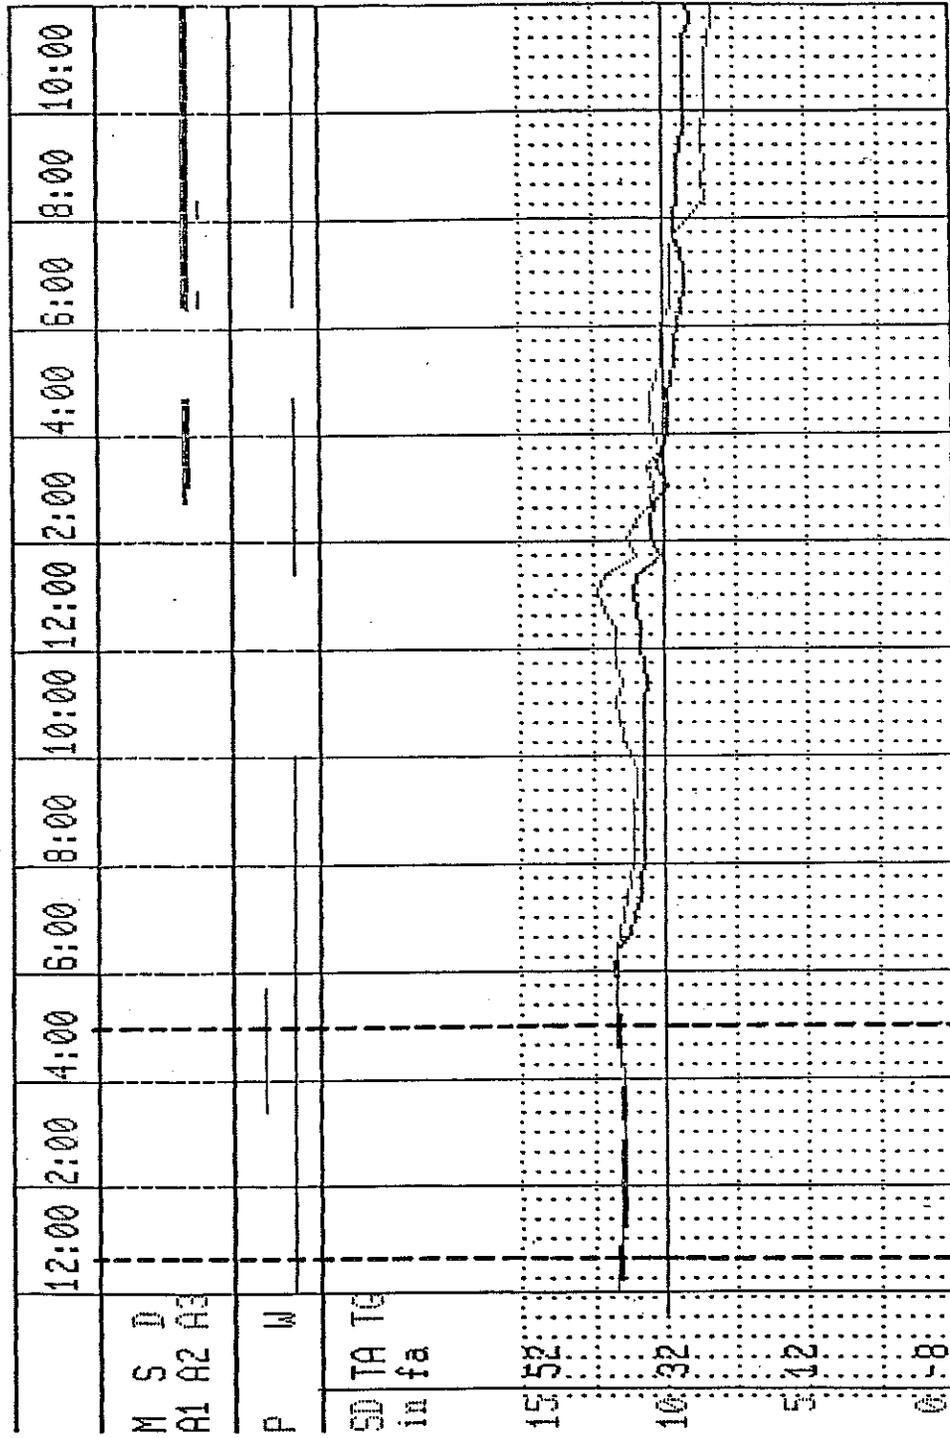
Figure F1

TIME OF 5:00 A.M. OBSERVATION ON TOP DECK

TIME OF 12:40 A.M. OBSERVATION ON TOP DECK
