2021 Communication Meeting

Michigan Public Service Commission
Energy Operations Division

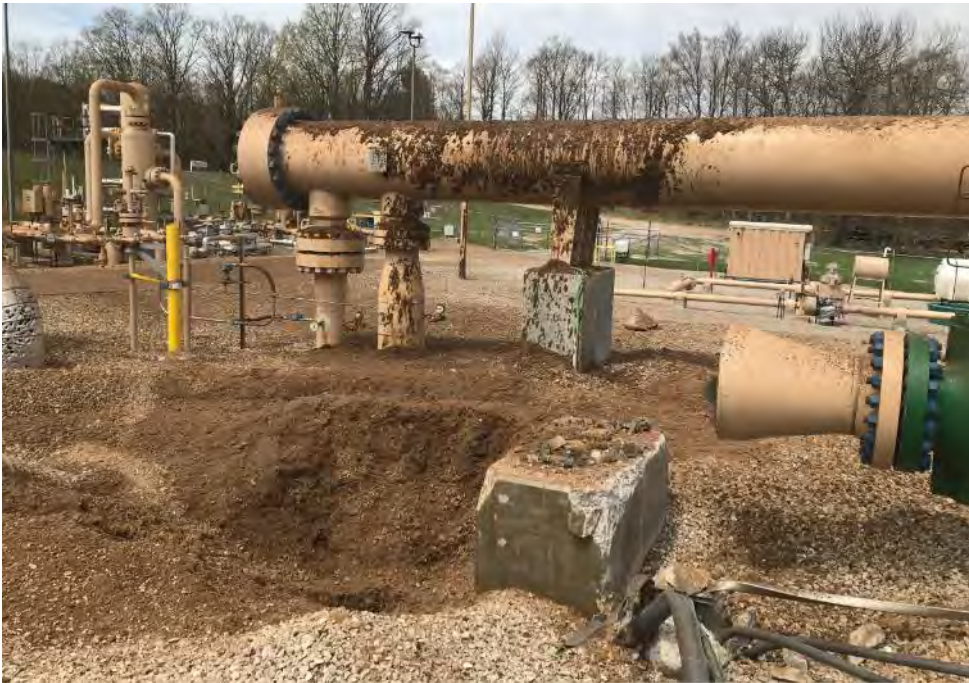
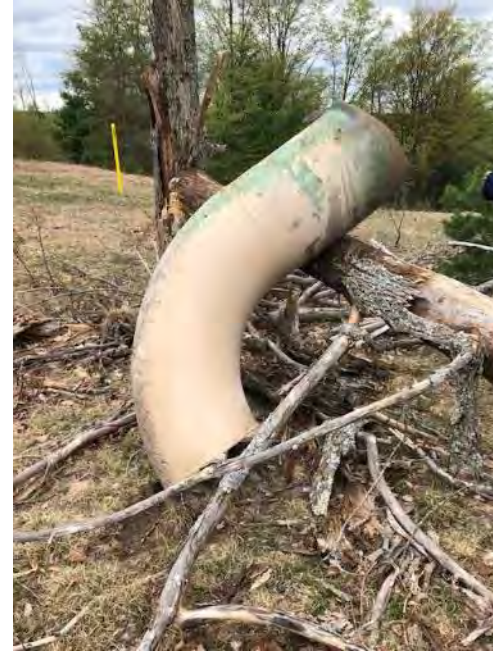
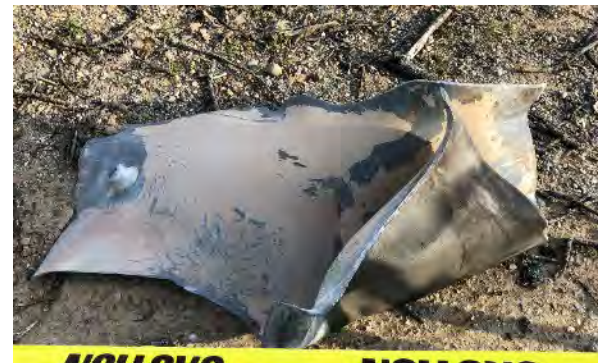
Significant Incident – 4515 (Cont.)

Significant Incident – 4515

- Equipment Failure / Overpressure with rupture
- Characteristics
 - Compressor station facility
 - Injection pipeline MAOP 4000
 - Withdrawal pipeline MAOP 1050
 - \$400k in damages
 - 26.5 mcf gas lost
- Description
 - Debris caused damage to isolation valve ball and seats, combined with ineffective maintenance, leading to leaky valve.
 - Leaky valve was between injection and withdrawal pipelines.
 - Overpressure Protection inadvertently isolated, causing portion of MAOP 1050 pipe to be unprotected.
 - Pressure within the MAOP 1050 pipe rose and rupture occurred on above ground section of piping.
 - No injuries or ignition.
 - Under investigation.

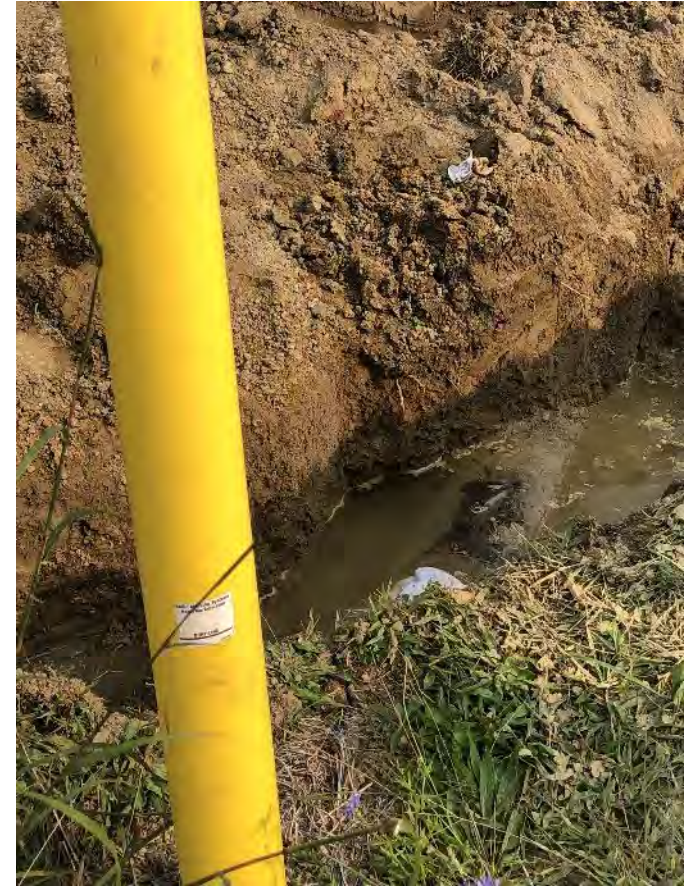
Significant Incident – 4988

- Third Party Damage
- Characteristics
 - 20-inch steel transmission
 - Directional drilling
- Description
 - Not marked
 - Violations: 192.614(c)(5) – Failure to provide temporary marking of buried pipelines.
 - Excavator Violations: MCL 460.725(9) – Failure to stop excavation when positive response indicates presence of a facility with no marks visible.

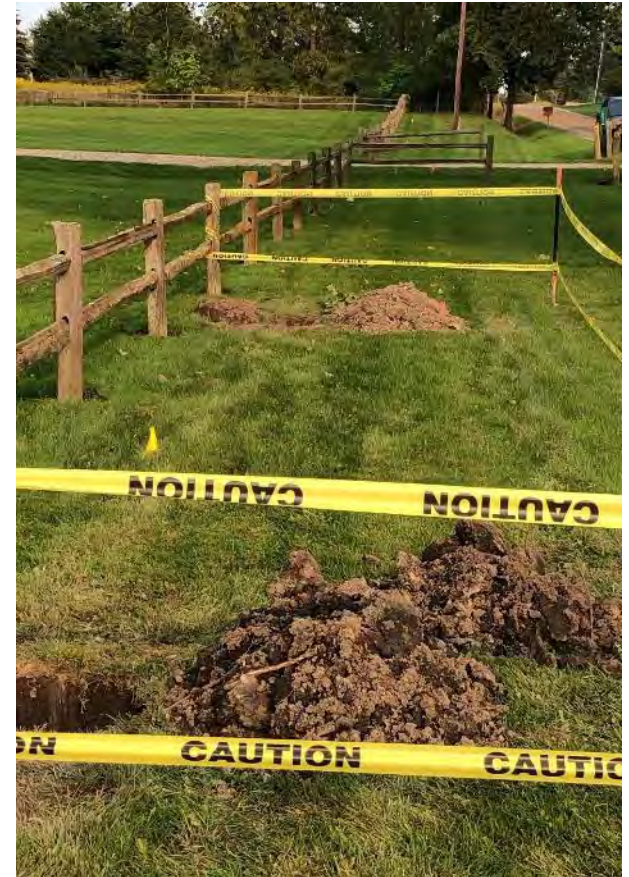
Significant Incident – 4988 (Cont.)

- No Damage
- Characteristics
 - Distribution main
- Description
 - Recommendation: Establish a set interval to hand expose.
 - MCL 460.725(5): “For excavations in a caution zone parallel to a facility, an excavator shall use soft excavation at intervals as often as reasonably necessary...”

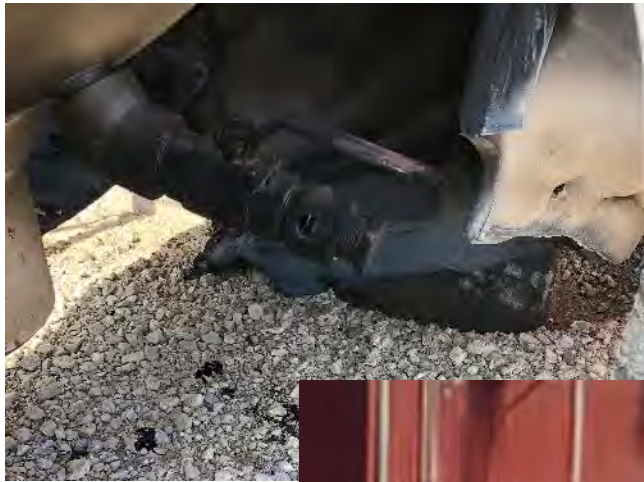
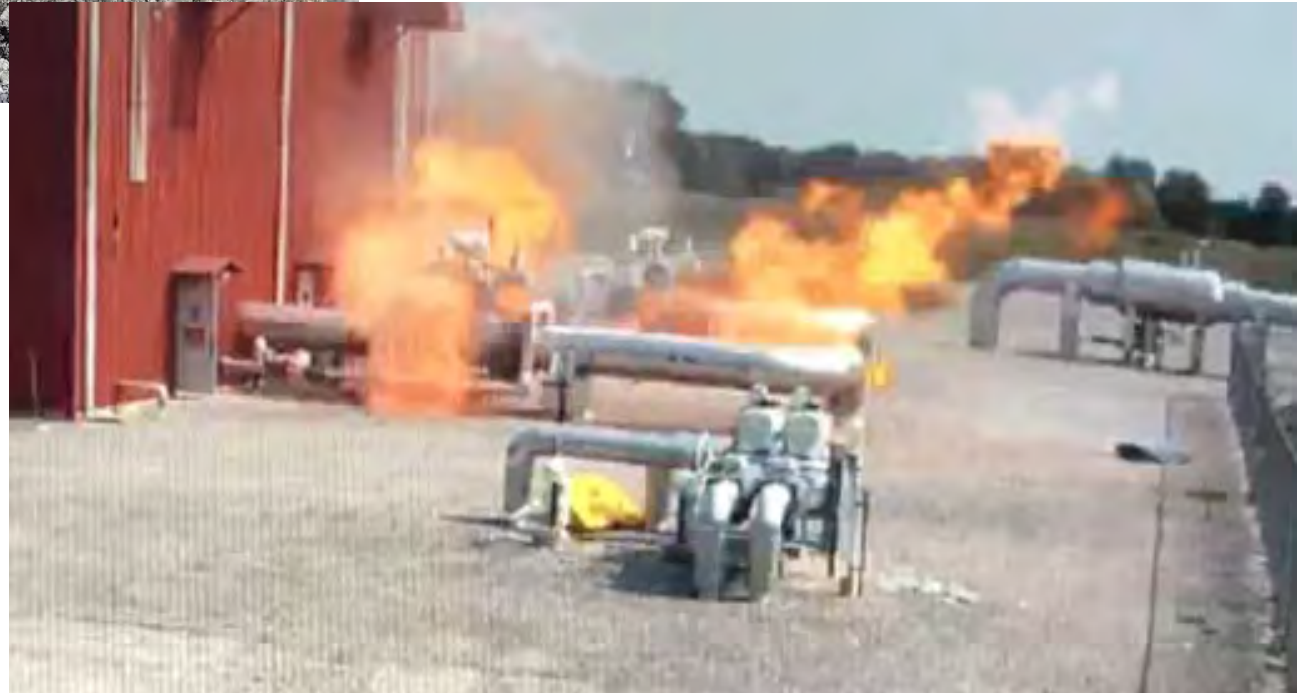
Significant Incident – 5004 (Cont.)

Significant Incident – 5004

- Compressor Station Fire
- Characteristics
 - Compressor Station Facility
 - Operating pressure: 748 psig
 - \$72,599 in damages
- Description
 - During routine compressor maintenance, body bleed valves were opened but not documented on lock out / tag out procedure. They were not locked or tagged.
 - No injuries or fatalities
 - Under investigation

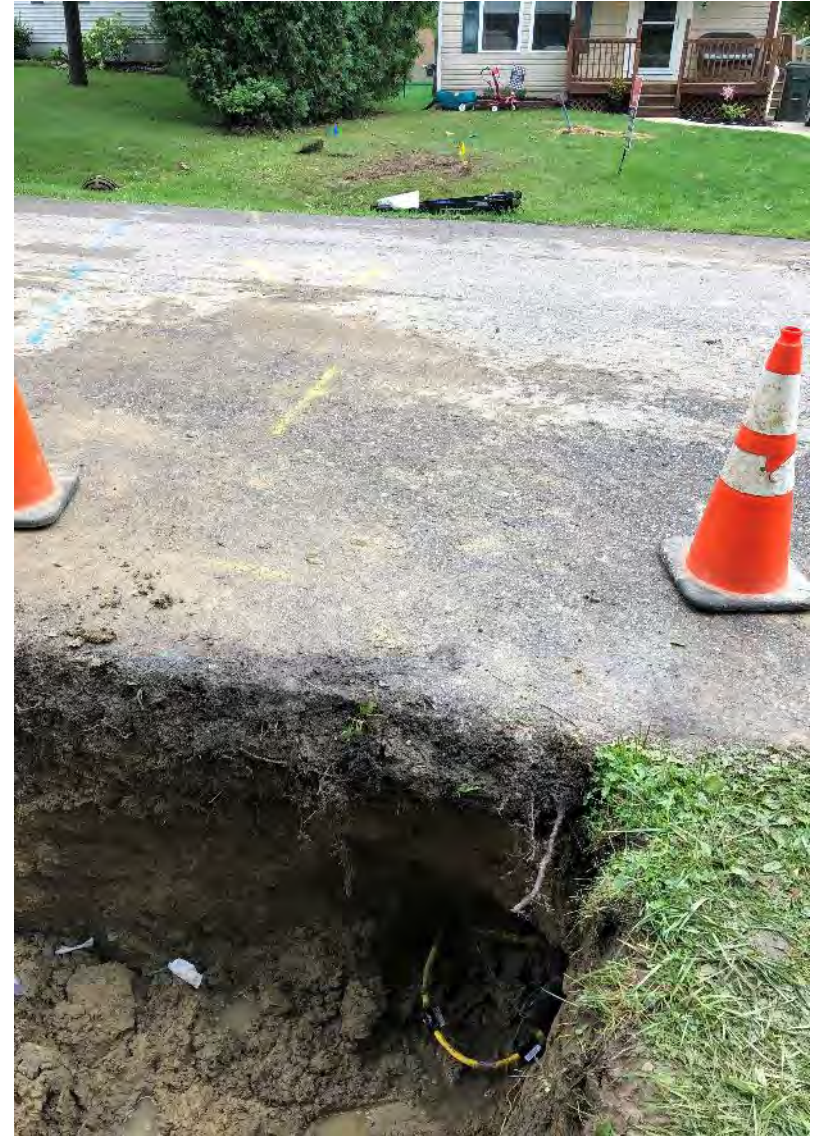
- 192.614(c)(5) – Failure to provide temporary marking of buried service line.
- R460.20501(2)(a) – Failure to maintain map showing location of ‘looped’ service line.

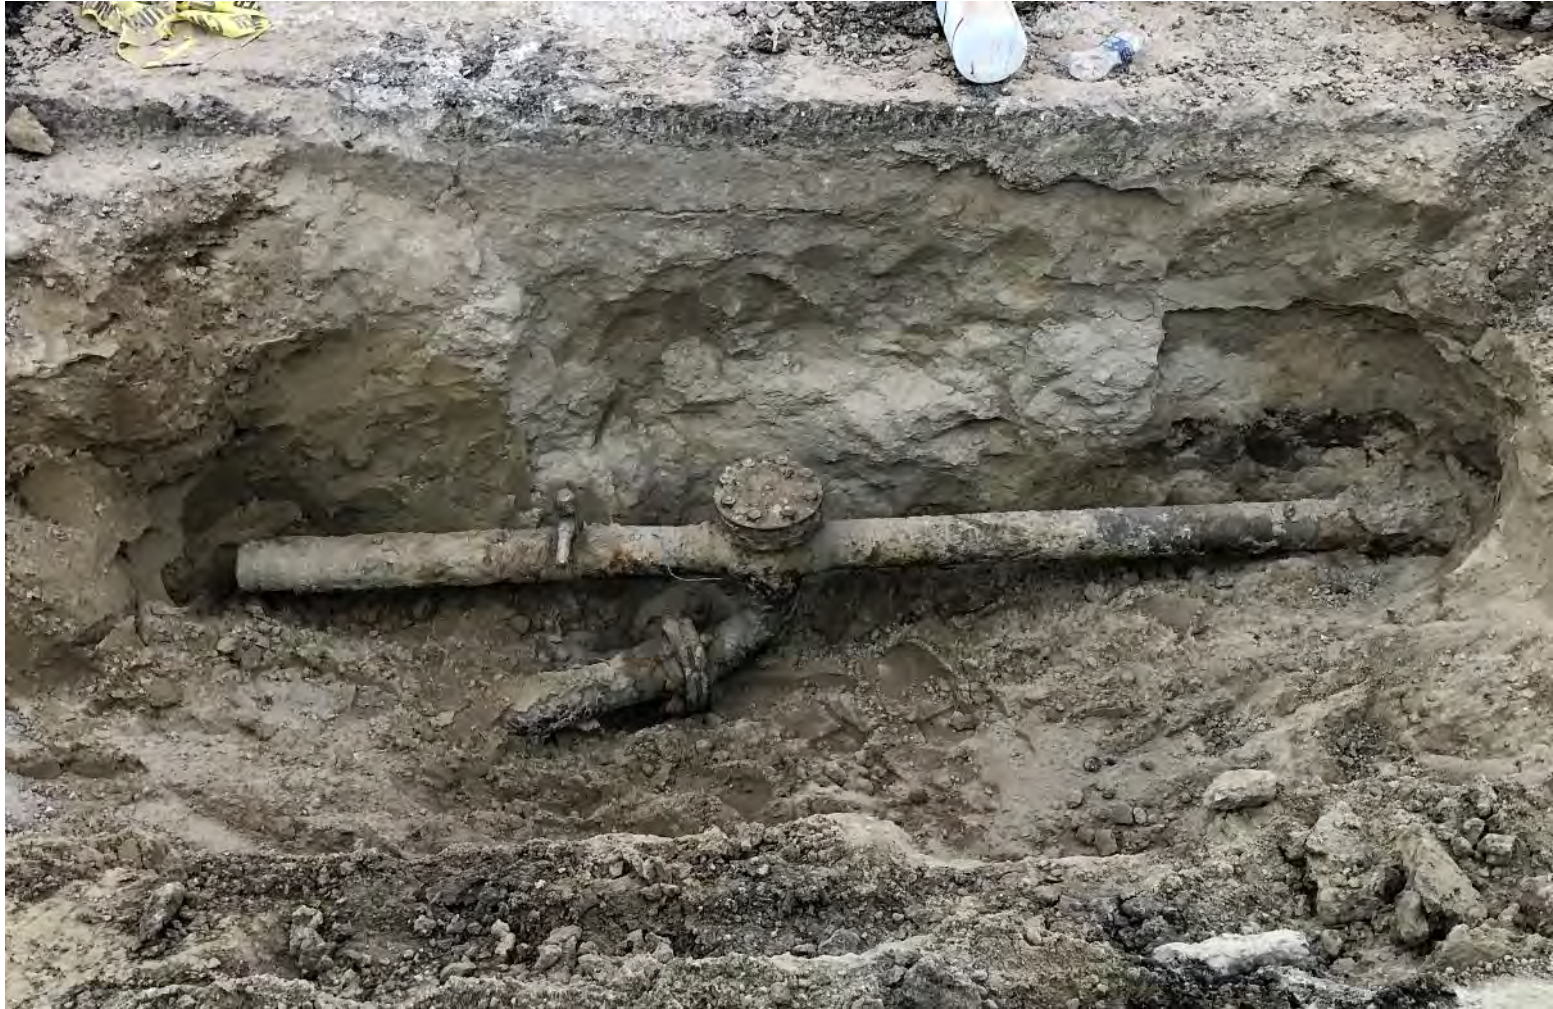
Significant Incident – 4956 (Cont.)

Significant Incident – 4956

- Equipment Failure / Leak
- Characteristics
 - 4-6-inch Steel Main
 - MAOP 400 psig
 - 1957 vintage control fitting gasket
 - \$618k in damages
- Description
 - Leak found during leak survey.
 - Two new control fittings were required to stop leak.
 - Installation of 884 feet of new 6-inch steel.

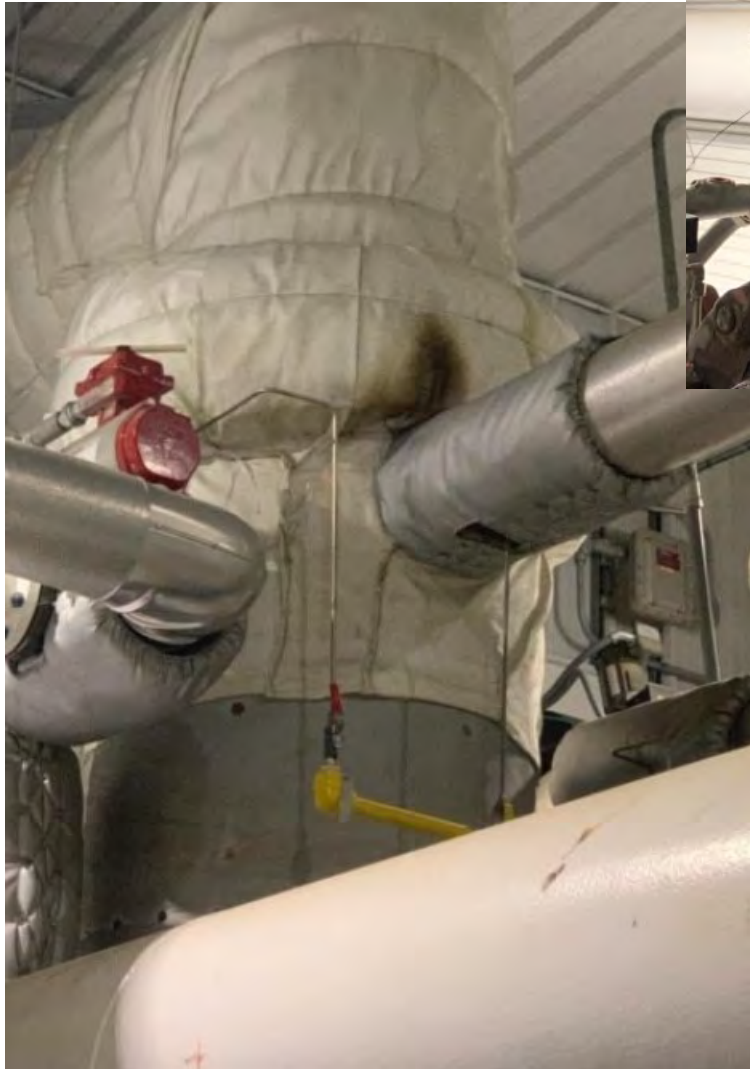
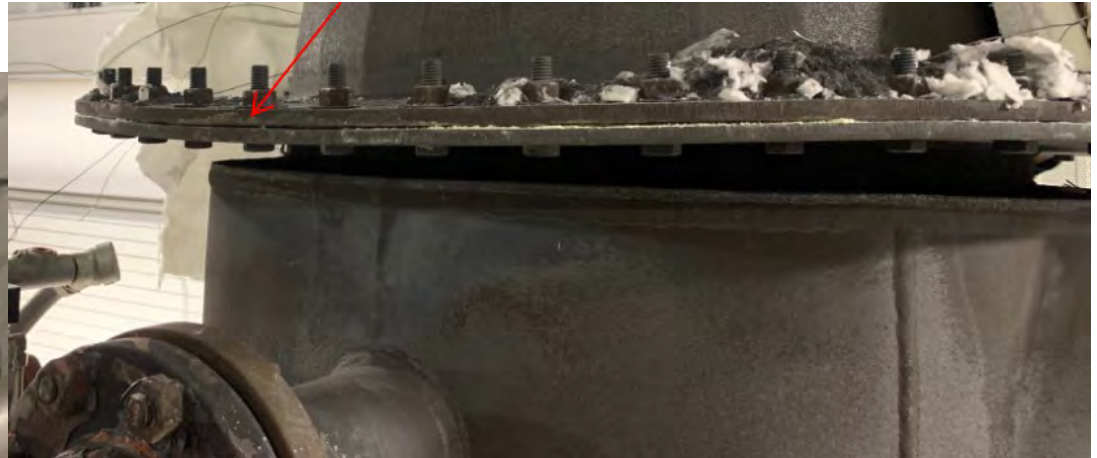
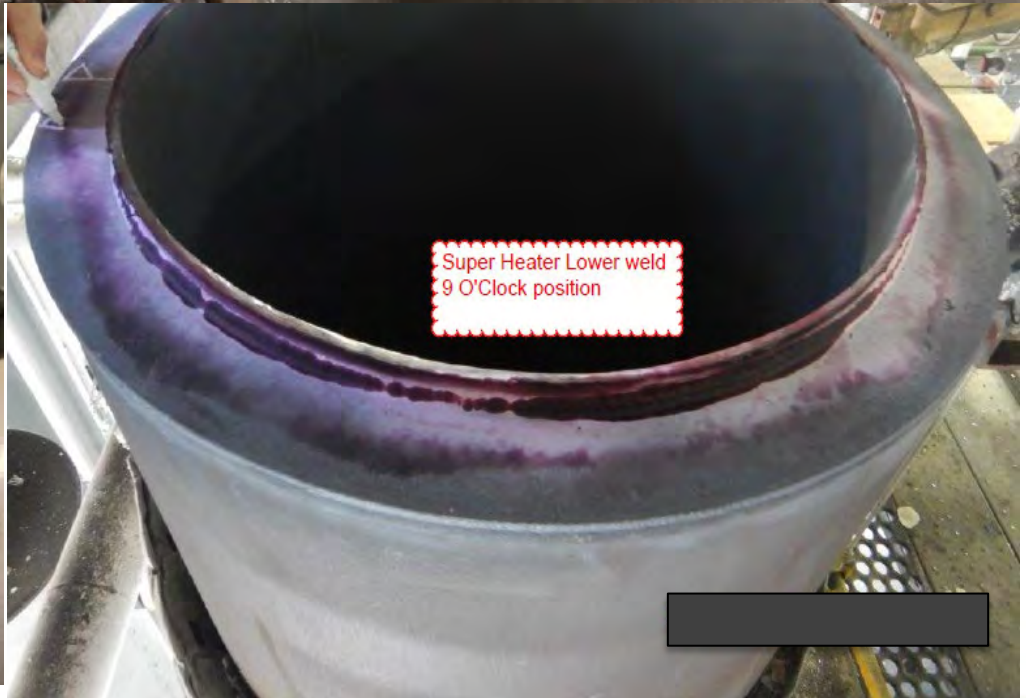
Significant Incident – 5250 (Cont.)

Significant Incident – 5250

- Equipment Failure / ESD
- Characteristics
 - Indoor Compressor Station Dehydration System
 - \$200k in damages
- Description
 - Thermal exhaust stack weld cracked allowing high-temp exhaust to leak into building.
 - Heat signature triggered fire eye resulting in an ESD.
 - Recurring issue due to thermal stresses of superheater incorporated into stack.

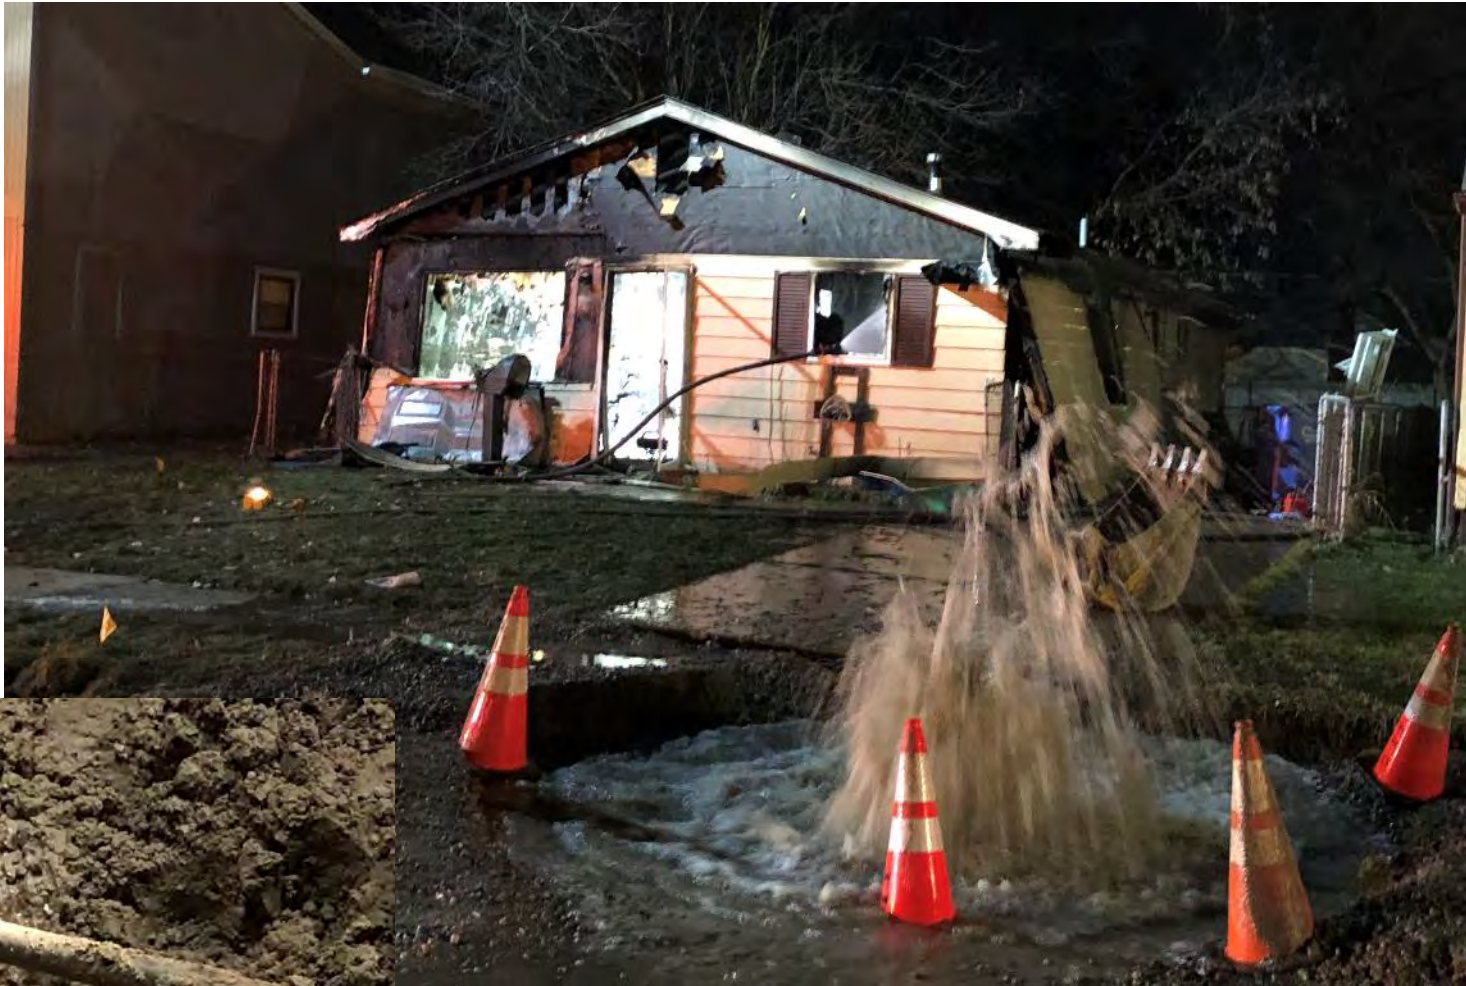
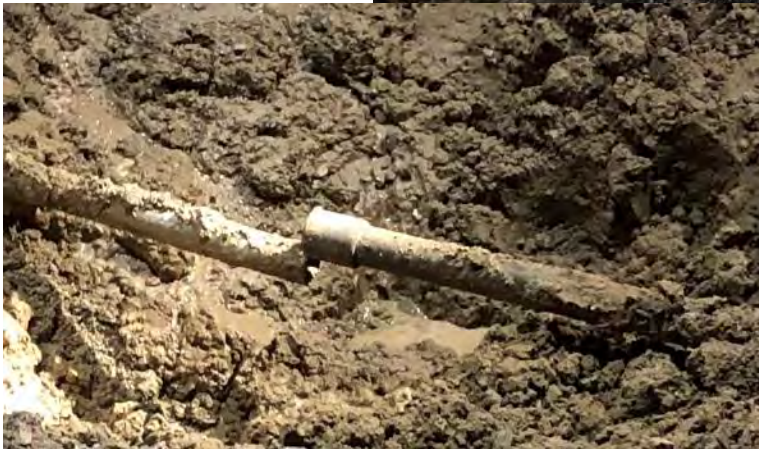
Significant Incident – 5285 (Cont.)

Significant Incident – 5285

- Third-Party Damage / House Explosion
- Characteristics
 - Threaded/Coupled Dist. Main
 - 28' from residence
- Description
 - City working on sewer lateral repair.
 - Gas main separated during backfill/compacting.
 - Operator onsite and in process of leak investigation when explosion occurred.
 - Under investigation.

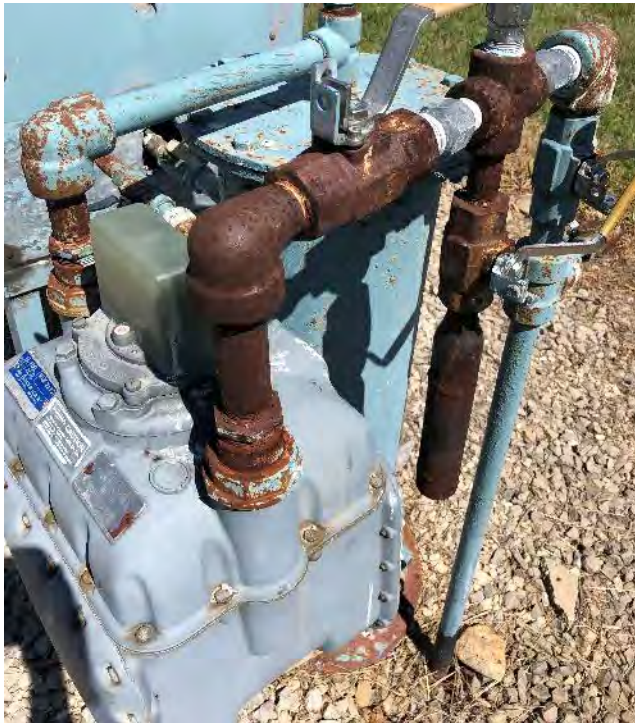
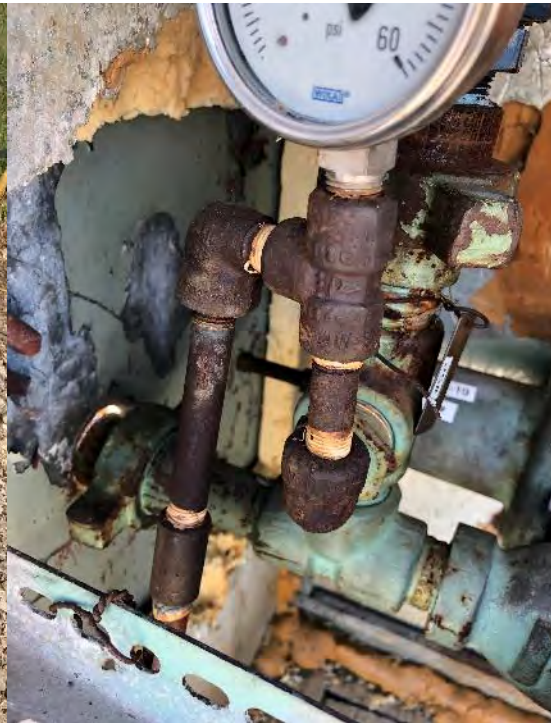
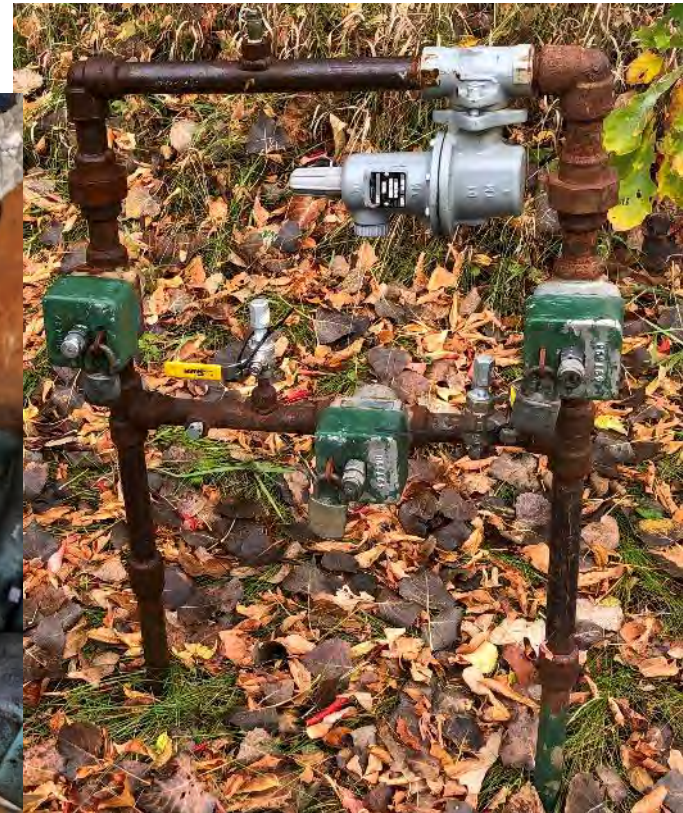
- 192.245(b) – Failure to remove defect while making service tee weld repair.
- 192.479(a) – Failure to coat new pipe in a reasonable timeframe.

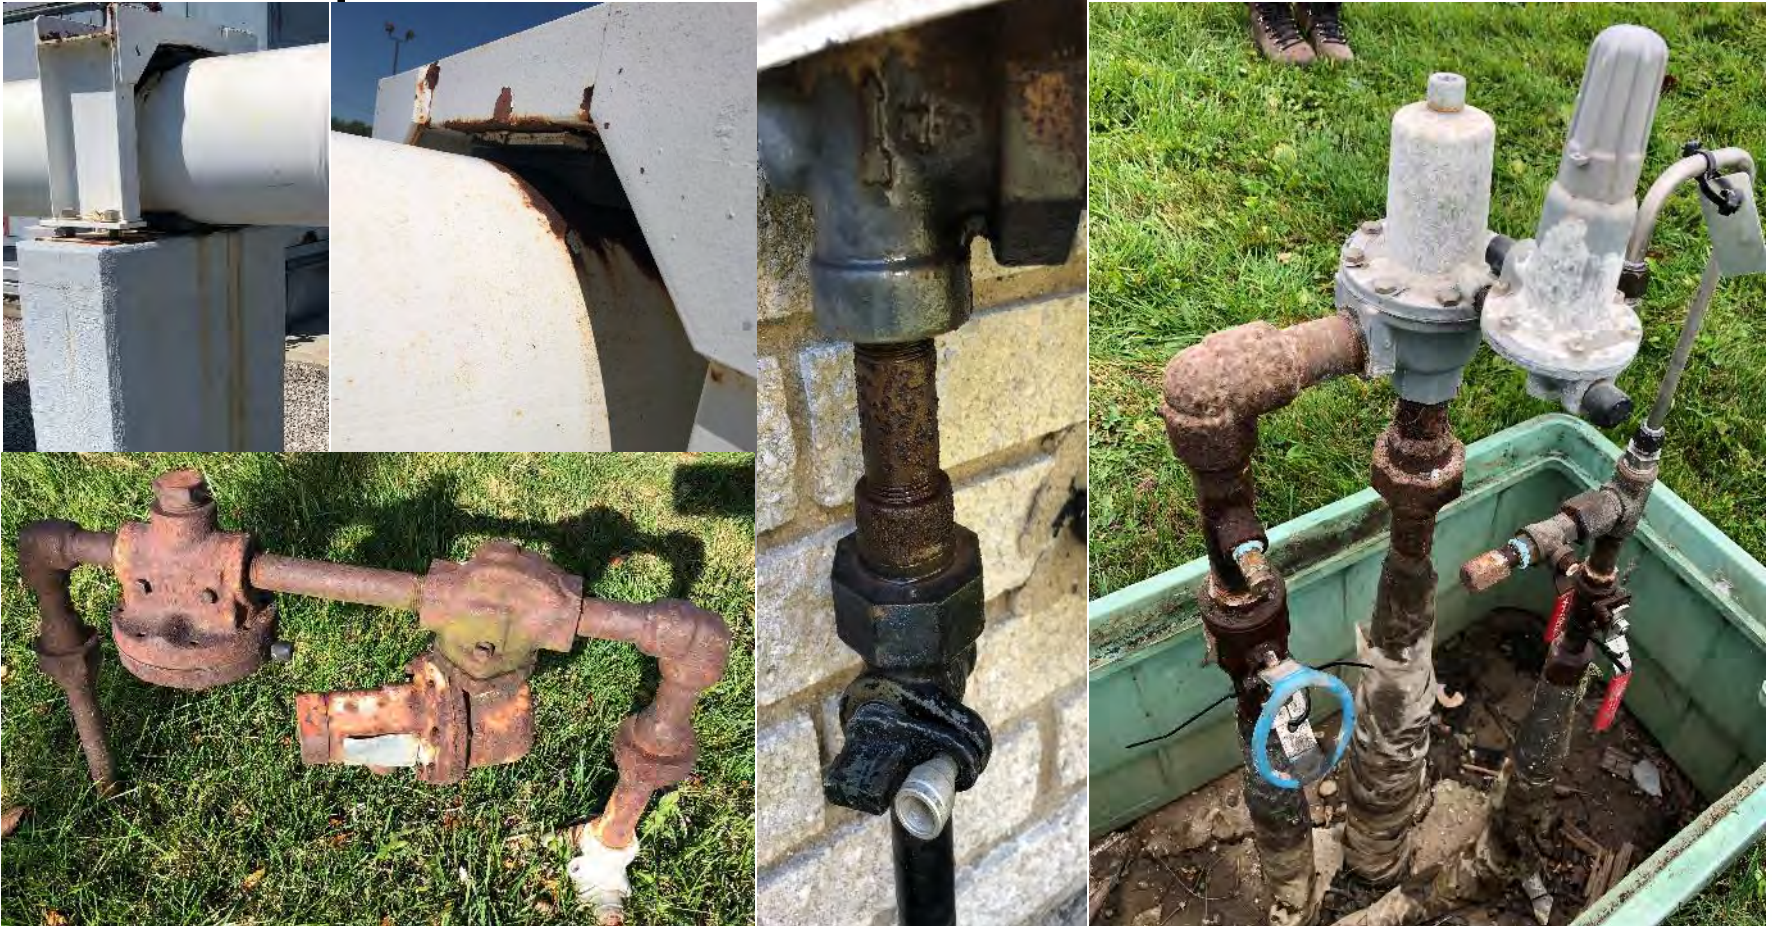
- 192.481(a)– Failure to adequately perform atmospheric corrosion inspections.

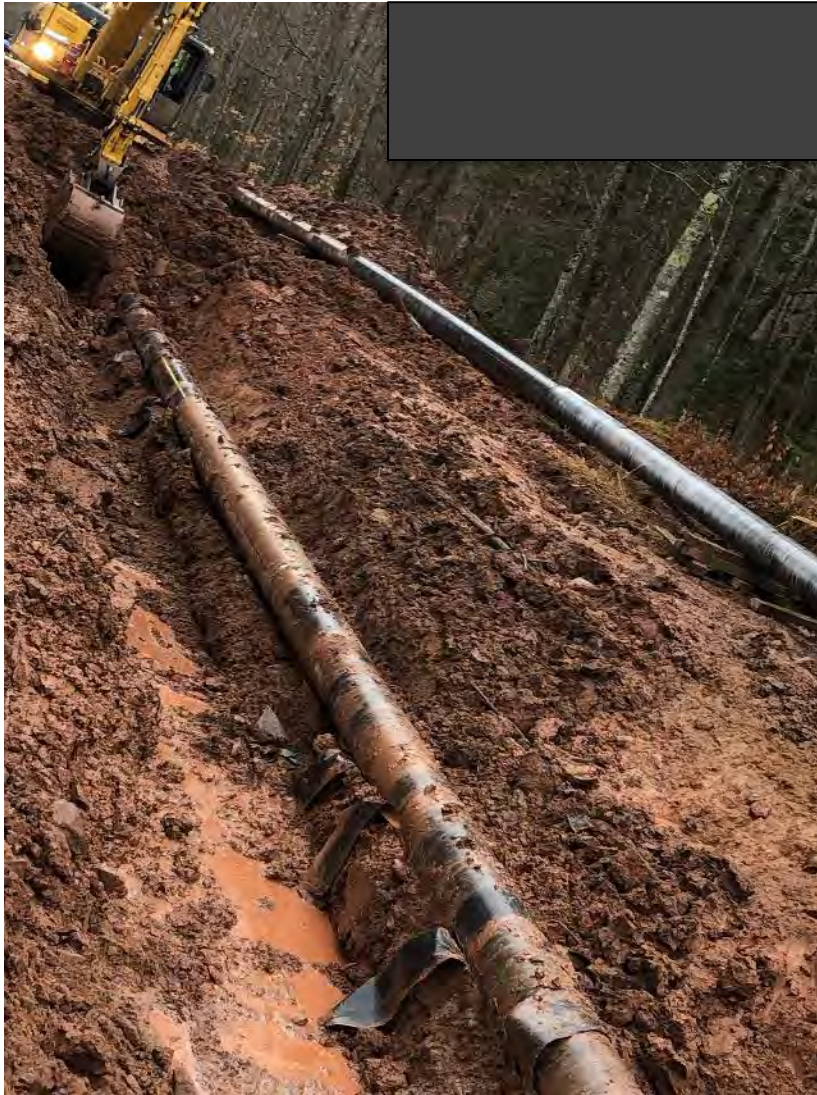
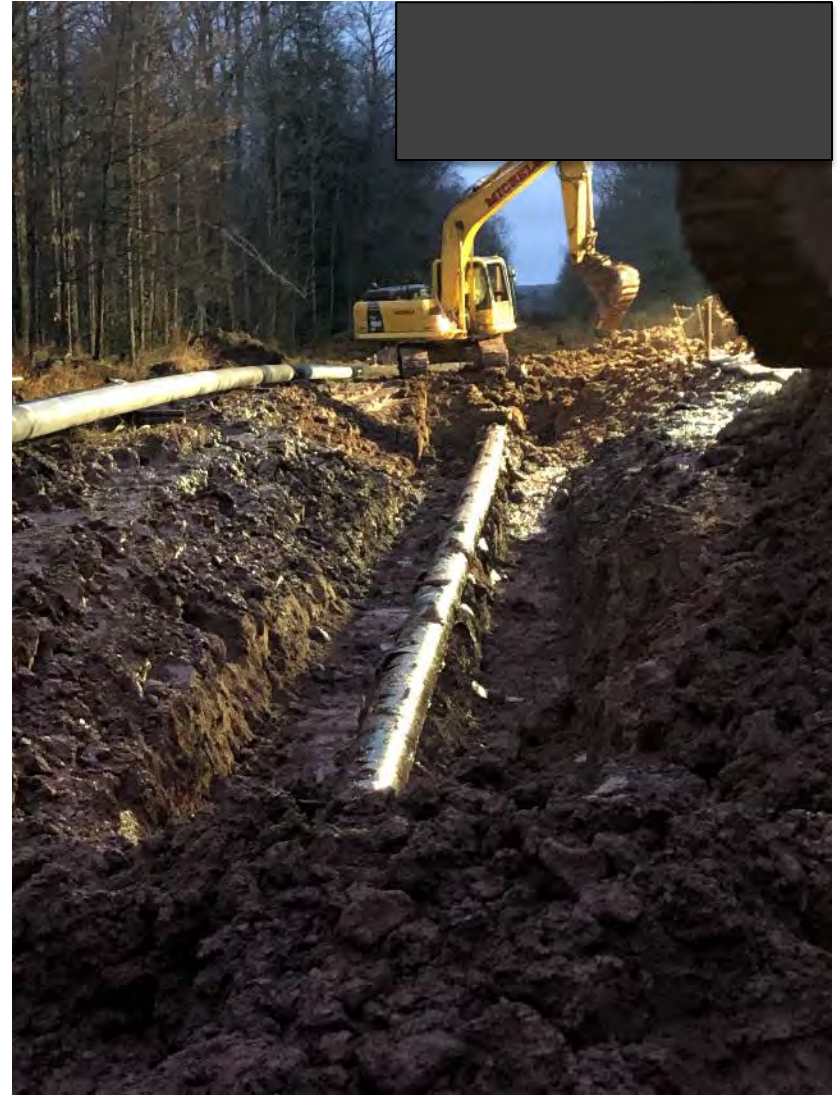
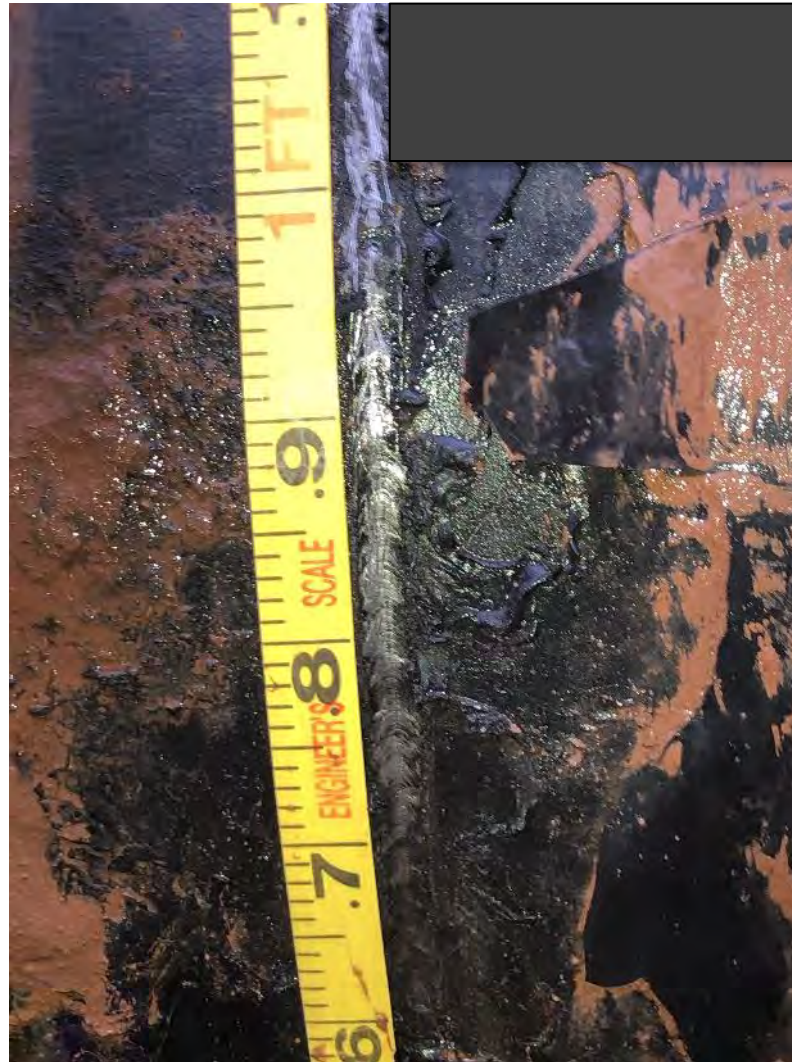
Significant Incident – 5173 (Cont.)

Significant Incident – 5173

- Leak – Material Failure of Pipe (Weld)
- Characteristics
 - 16” Steel Transmission
 - Installed in 1965
 - \$895k in damages
- Description
 - Contractor observed leak indication prior to performing integrity repairs.
 - Crack discovered in the vicinity of the planned integrity repair.
 - Remote location of leak, nature of pipeline, and repair method impacted the repair costs.
 - Under investigation.

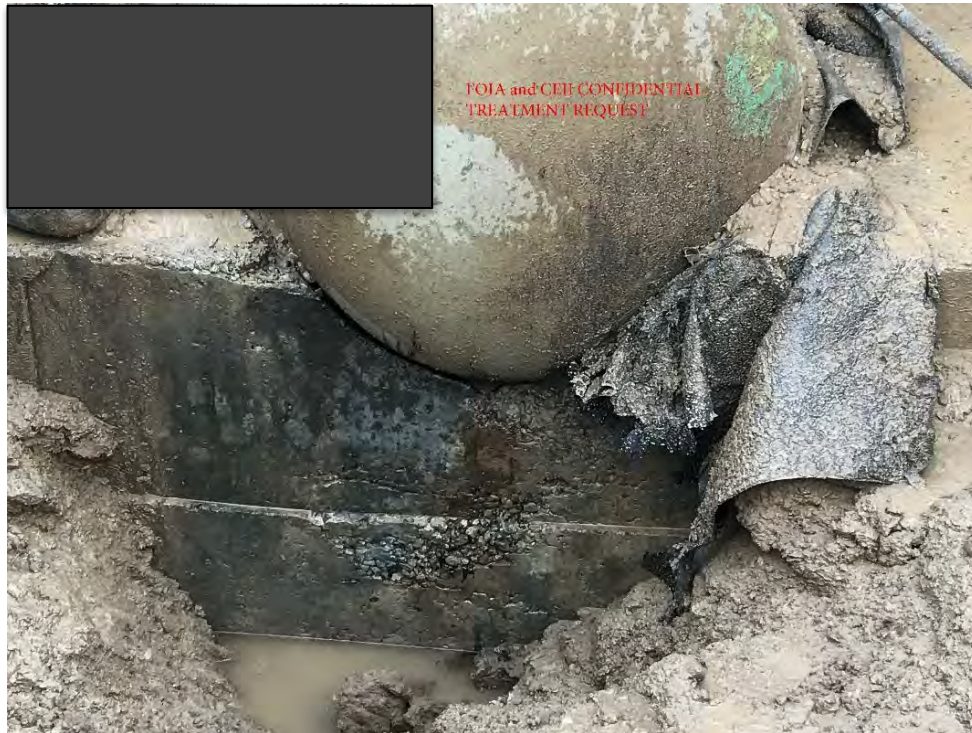
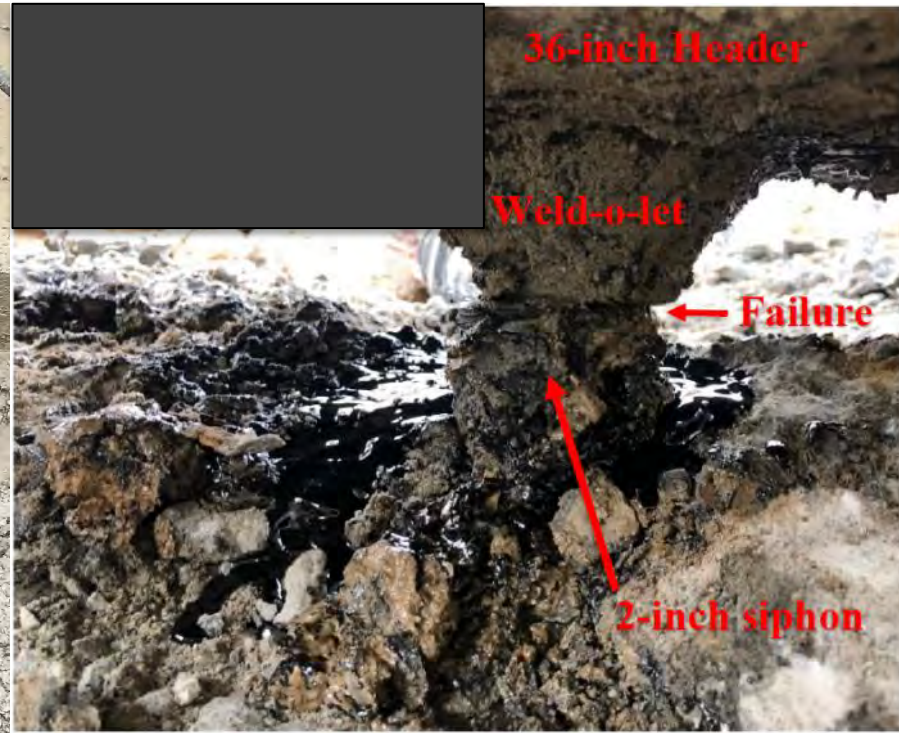
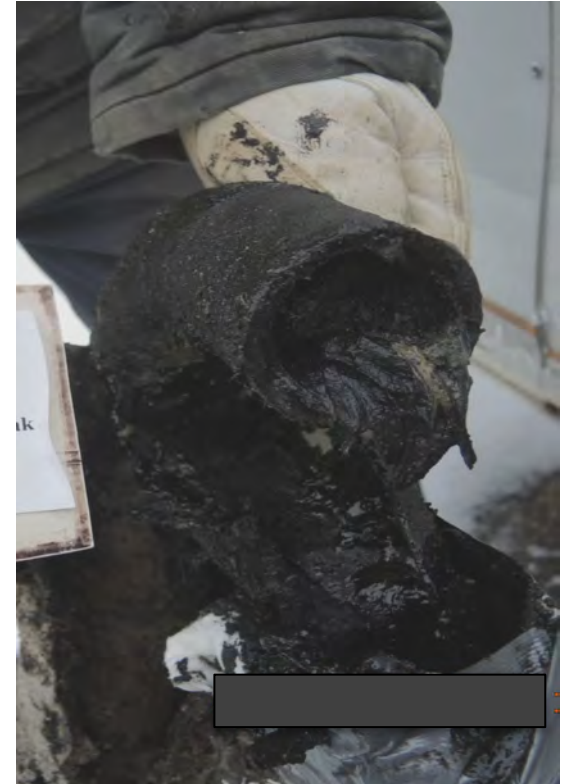
Significant Incident – 4155 (Cont.)

Significant Incident – 4155

- Compressor Rupture
- Characteristics
 - MAOP 974 psig
 - 36-inch header piping
 - \$563,327 damages
- Description
 - Modifications in 1998 included a concrete foundation that restrained vertically, but not laterally.
 - Failure occurred at a girth weld on a 2" siphon.
 - Caused by reversed bending fatigue – thermal expansion and contraction of a 36-inch header.

- 192.161(a)(1) – Failure to design the pipeline and its associated equipment with sufficient anchors or supports to prevent undue strain on connected equipment.
- Recommendation: Utilize siphon to remove liquids where liquids could collect.
- Recommendation: Conduct a review of other facilities for similar design to prevent reoccurrence.

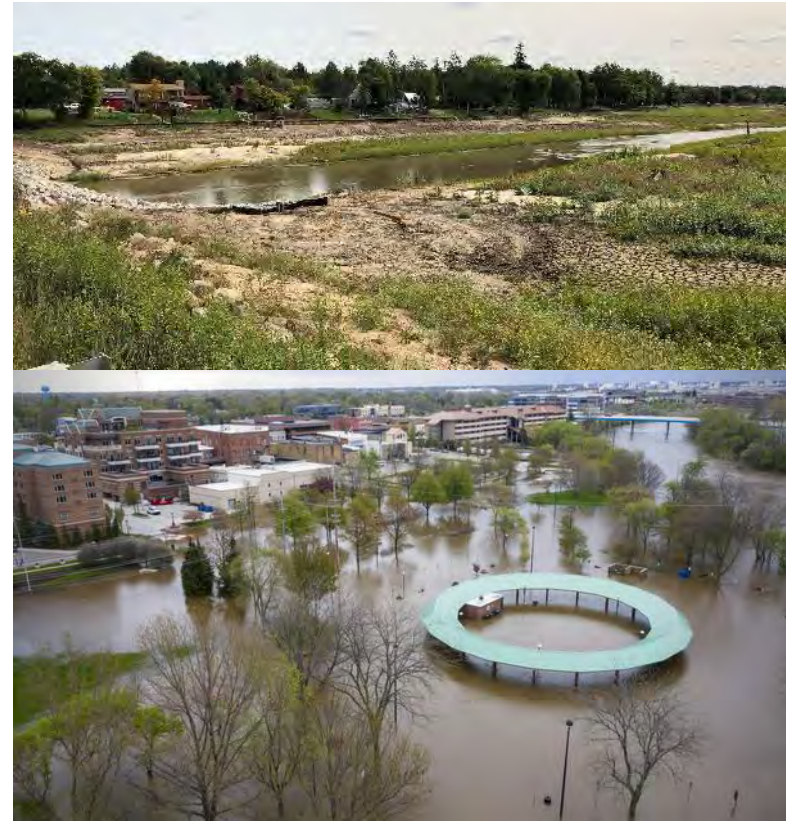
Significant Incident – 4518

- Natural Force Damage
- Characteristics
 - 4" steel main
 - MAOP 60 psig
 - \$3,966,248 damages
- Description
 - Roadway washout caused severed main.
 - One-way feed: 476 outages.
 - CNG provided temporary service for several weeks.
 - 6.25 miles of new main.

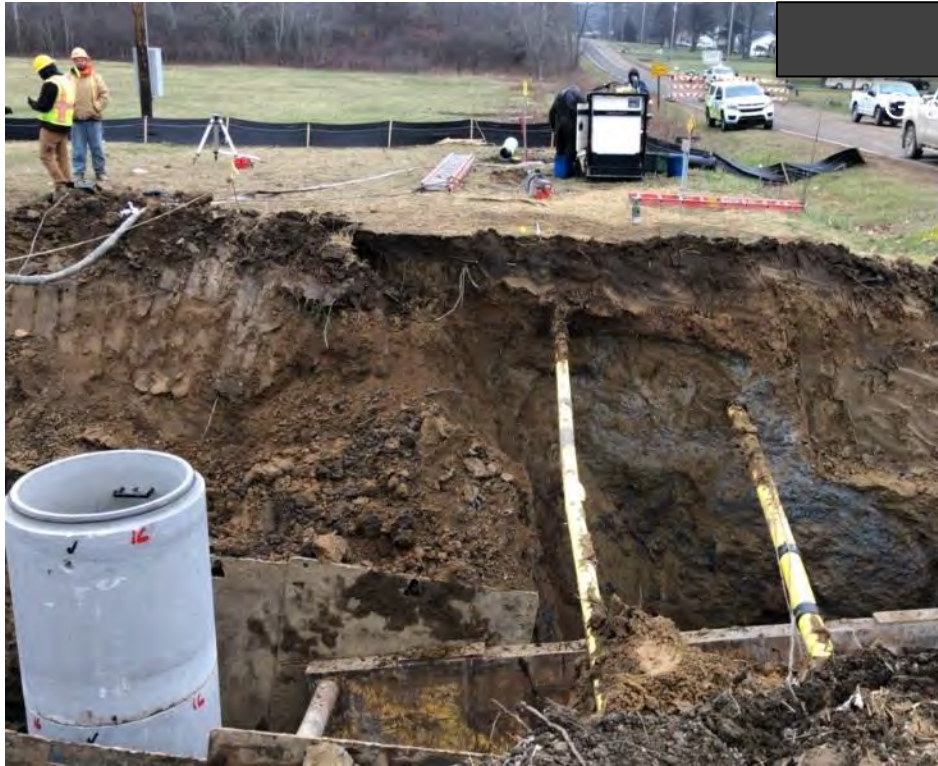
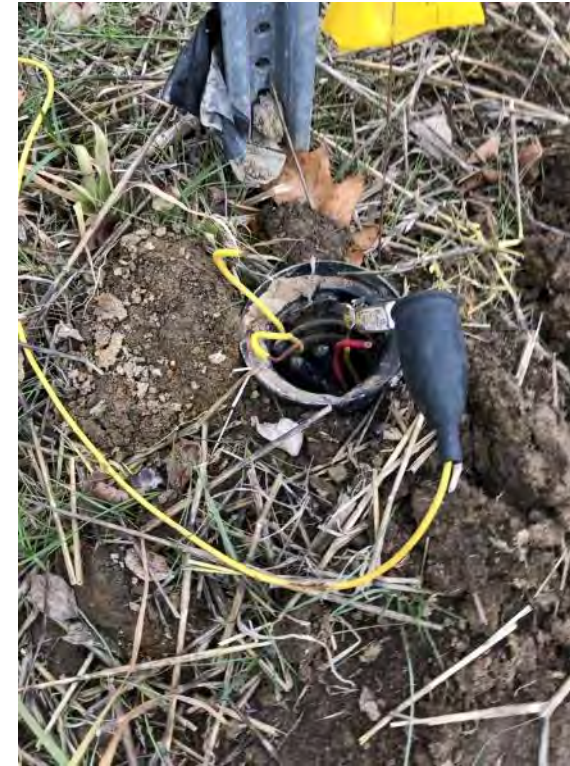
Significant Incident – 5261 (Cont.)

Significant Incident – 5261

- Third-party Damage
- Characteristics
 - 6" plastic main newly installed
 - MAOP 60 psig
 - 1314 outages due to loosing a primary feed.
 - 2.7 Mmcf gas loss
 - \$213,274 damages
- Description
 - 192.614(a) – Inaccurate staking. Staking contractor marked an abandoned main 7 feet away from new main.
 - Recommendation: Formal process to provide redline as-builts to staking contractor until redlines are incorporated into mapping.
 - Recommendation: Staking contractor be given access to abandoned pipeline maps.
 - Recommendation: Label locating wires inside test stations.

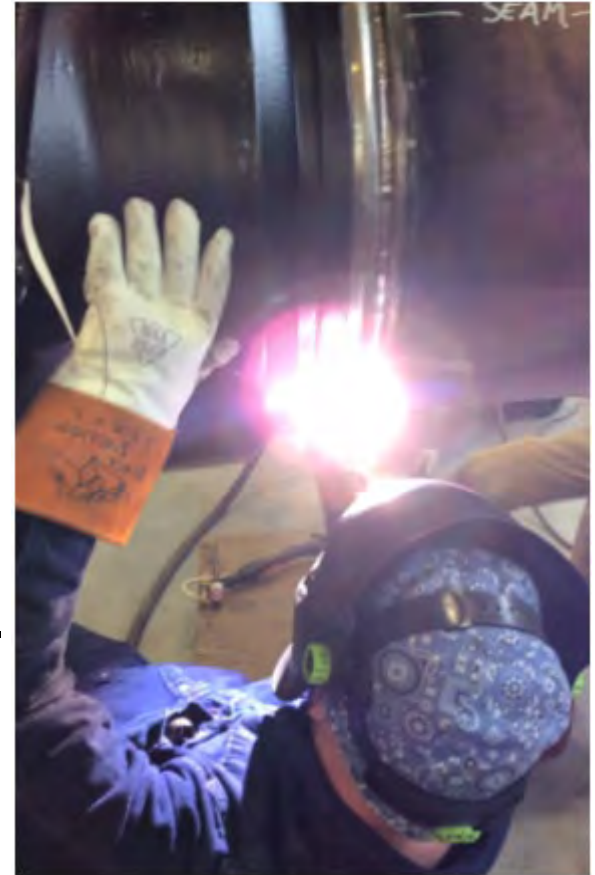
- 192.225(a) – Welder failed to follow welding procedure
 - Outside amperage range.
- 192.241(a)(1) – CWI failed to verify welding was performed in accordance with the welding procedure.
- 192.227(a) – Welder failed to follow welding procedure during qualifications.
 - Did not maintain minimum root opening.
 - CWI did not identify.
