Hager Creek Restoration

August 1, 2001 through December 31, 2004

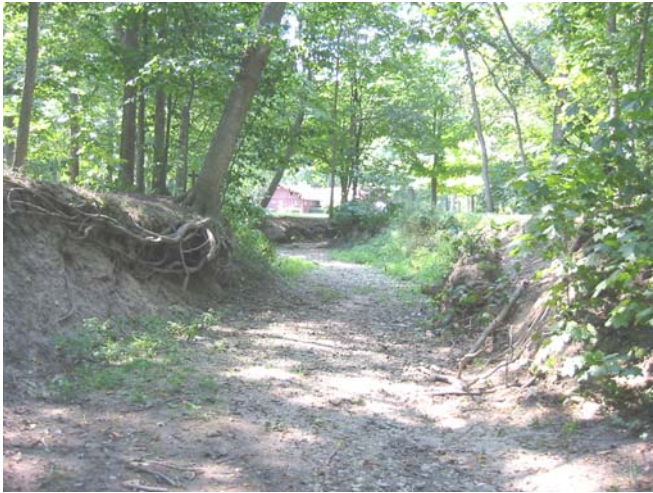
Before: Hager Creek east of Park Drive prior to implementation of management practices.

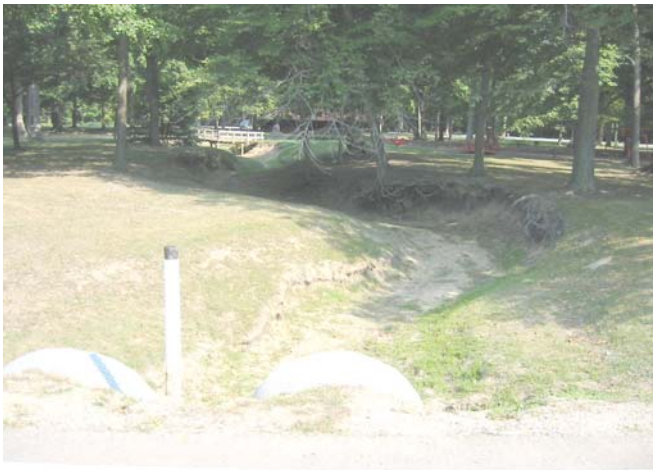
Before: Hager Creek at 28th Avenue prior to implementation of management practices.
