Title: Partridge Creek Channel Diversion Project

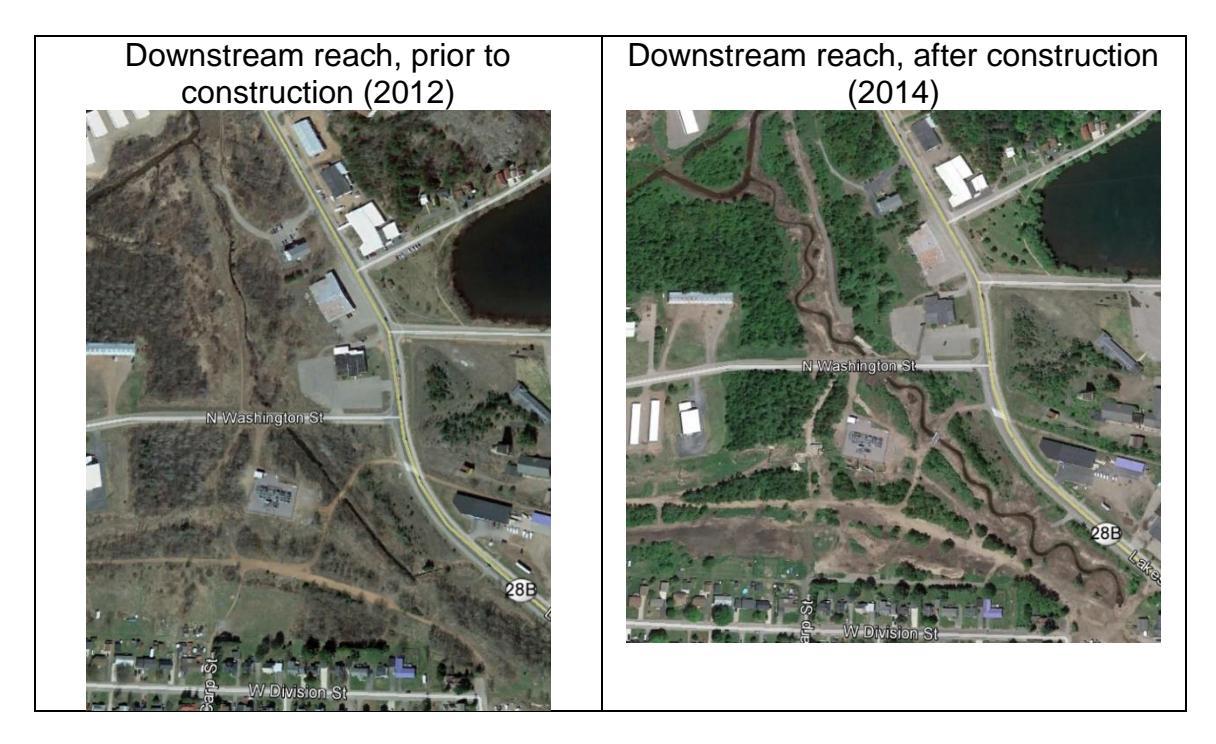
Metrics of channel stability improved substantially after the stream was reconstructed. The post-construction channel is more sinuous and less confined than the pre-construction channel (Figures 1 and 3). Floodplain width (defined as valley width at twice the bankfull depth) increased by over a factor of 10 at the upstream reach and by factors of 3 to 6 in the downstream reach (Tables 3 and 4 and Graphs 1 and 2). Floodplain connectivity also improved; channel entrenchment ratio (an expression of floodplain access) increased, and bank height ratio (an expression of channel incision) decreased after construction (Tables 5 and 6). Using EPA's stream function assessment protocol, entrenchment ratios and bank height ratios were "Not functioning" prior to channel construction, and "Functioning" after construction.

Figure 1. Aerial photos of the downstream reach. (Courtesy of Google Earth)

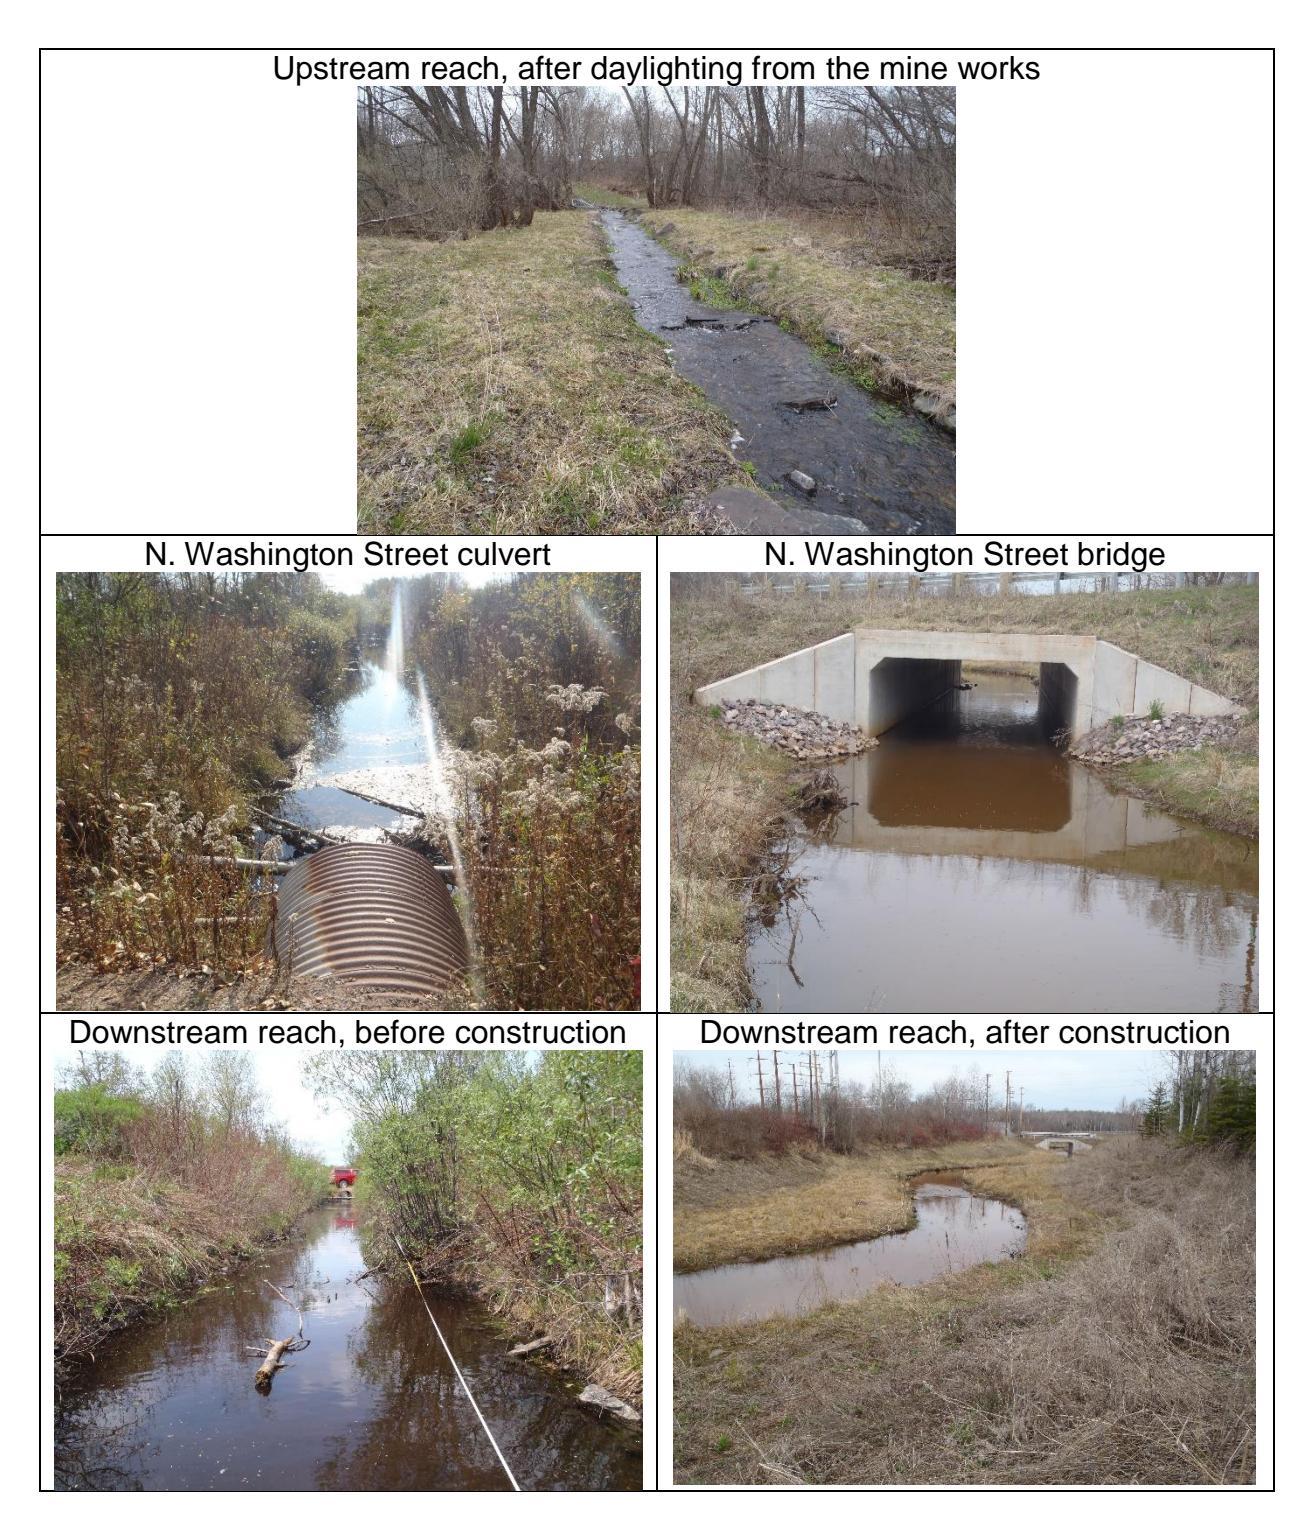
Figure 3. Pre- and post-construction photographs.

<u>Project Highlights:</u> In 2013 the upstream channel was removed from the mine workings and returned to a constructed channel that overflows into the New York Pit at high discharges. The downstream channel was reconfigured and floodplain benches were constructed. The constructed channels are more sinuous, have more riffles and pools, and are better connected to their floodplain than the original channel (Figure 1). DO improved substantially although it does not meet the water quality standard for coldwater streams. Macroinvertebrates did not improve, perhaps due to colonization lag time.
