Expected Service Life of Michigan Department of Transportation Reinforced Concrete Bridge Decks

Prepared for Michigan Department of Transportation Bureau of Development, Design Division, Bridge Development Section

By Stacey Valentine, Undergraduate Student University of Michigan

August 28, 2015

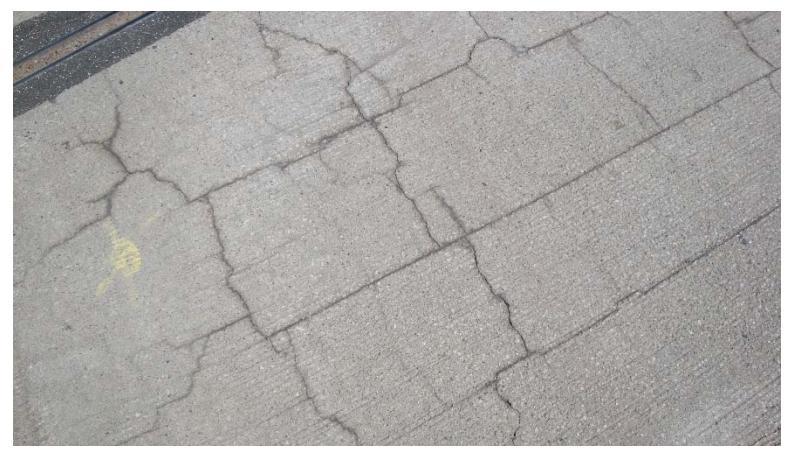
Figure 2-4: Cracking on north span of Bridge Street Bridge

Extensive deck cracking was also observed in the local agency owned CFRP bridge deck carrying Bridge Street, as shown in Figure 2-4. The bridge deck has a 1¹/₂ inch concrete overlay, so it believed that the cracking is mostly influenced by delamination of the concrete overlay from the structural deck.

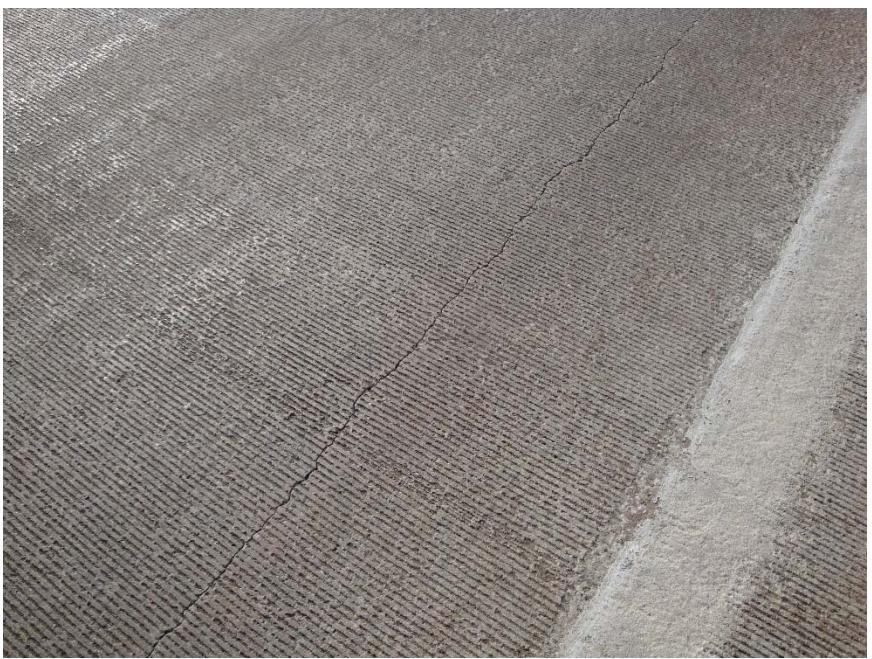
The Goodings Creek Bridge was built in 2000 and used AFRP rebar. The superstructure is spread box beams and the deck is nine inch with two mats of AFRP rebar. As of 2015, the deck surface has a rating of 6 (satisfactory). This deck has been rated a 6 (satisfactory) since four years after it was constructed. The southbound lane has two longitudinal cracks visible in the wheel patches and the northbound lane has two longitudinal cracks visible in the center of the lane. The width of the

four longitudinal cracks range from 1/32 inch to 1/16 inch, which are defined as moderate and wide cracks respectively in the Michigan Bridge Element Inspection Manual².

Figure 2-6: Longitudinal crack on southbound lane

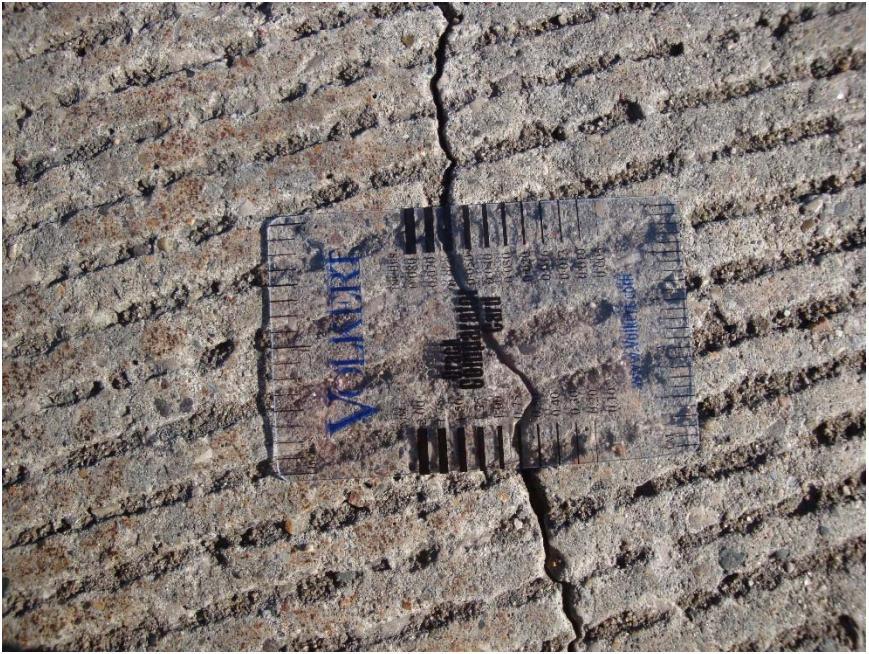
Figure 2-7: Longitudinal crack with a width of 1/16 in at the top

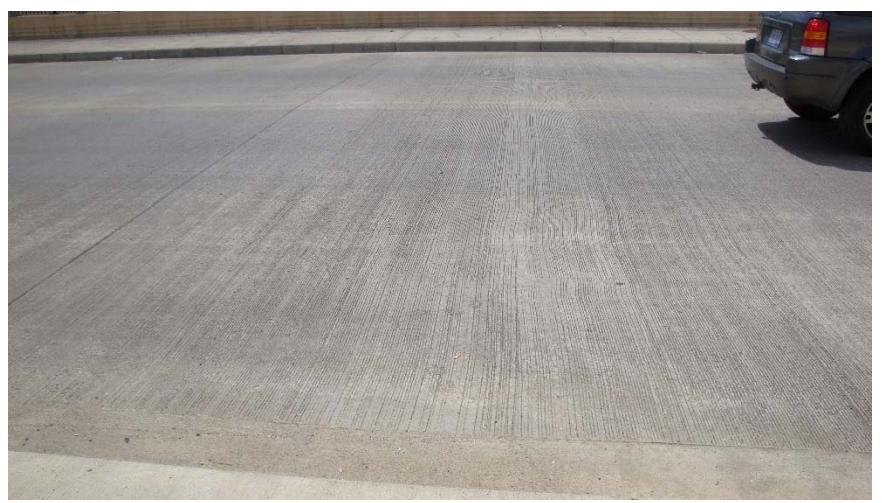
contributes to the good performance. As of 2015 it is still rated a 9 (excellent). There are no cracks observed on this deck.

Figure 2-8: Pembroke Ave in excellent condition (Rated 9)
