Repair of Bridge Deck Fascias OR22-002

Final Report

09/30/2023

> **Prepared By:** Furkan Cakmak Fatmir Menkulasi Christopher Eamon Hwai-Chung Wu

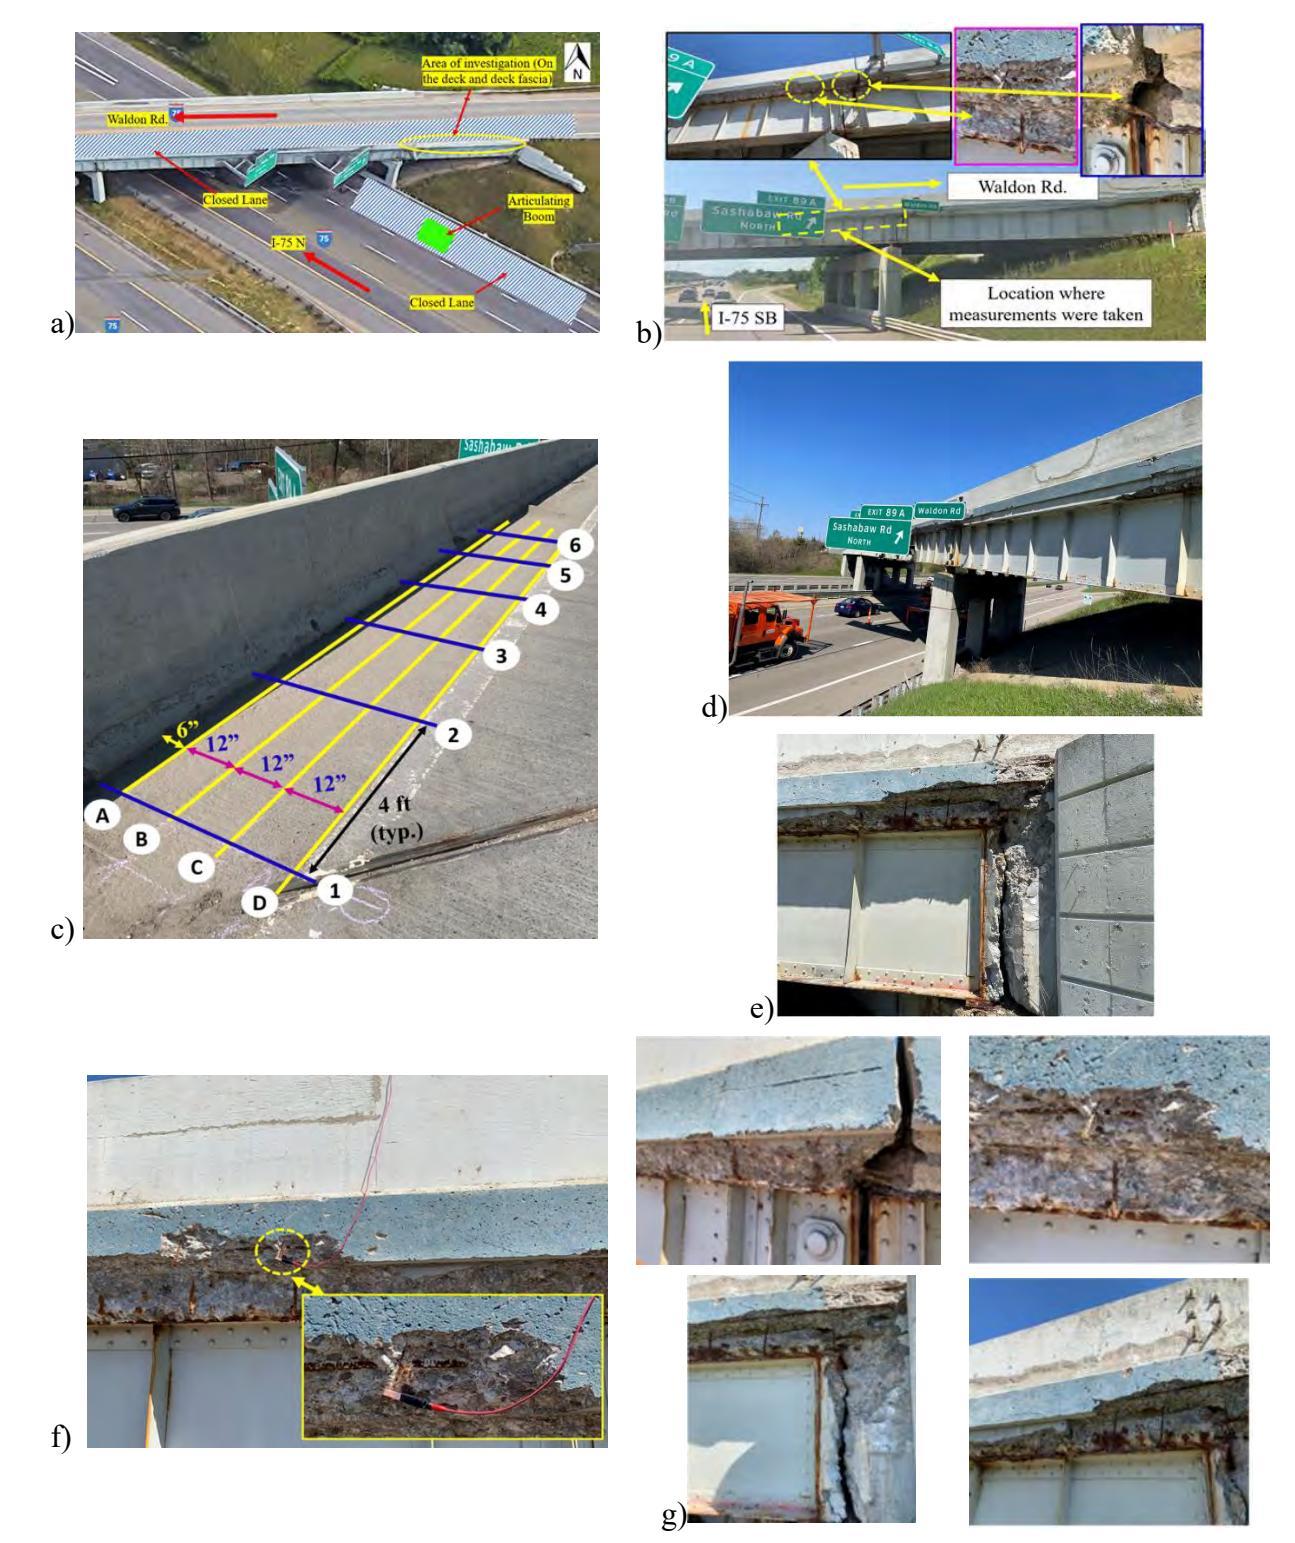
Fig. 3.7 Bridge on Waldon Road over I-75: a) closed lanes and location of bucket truck, b-c) location where measurements were taken and illustration of deteriorated deck fascia near the expansion joint, d-e) illustration of deteriorated deck fascia near the abutment, f) location where electrode was connected to existing bars for half-cell potential measurements, g) further illustration of deck fascia deterioration near the expansion joint and abutment

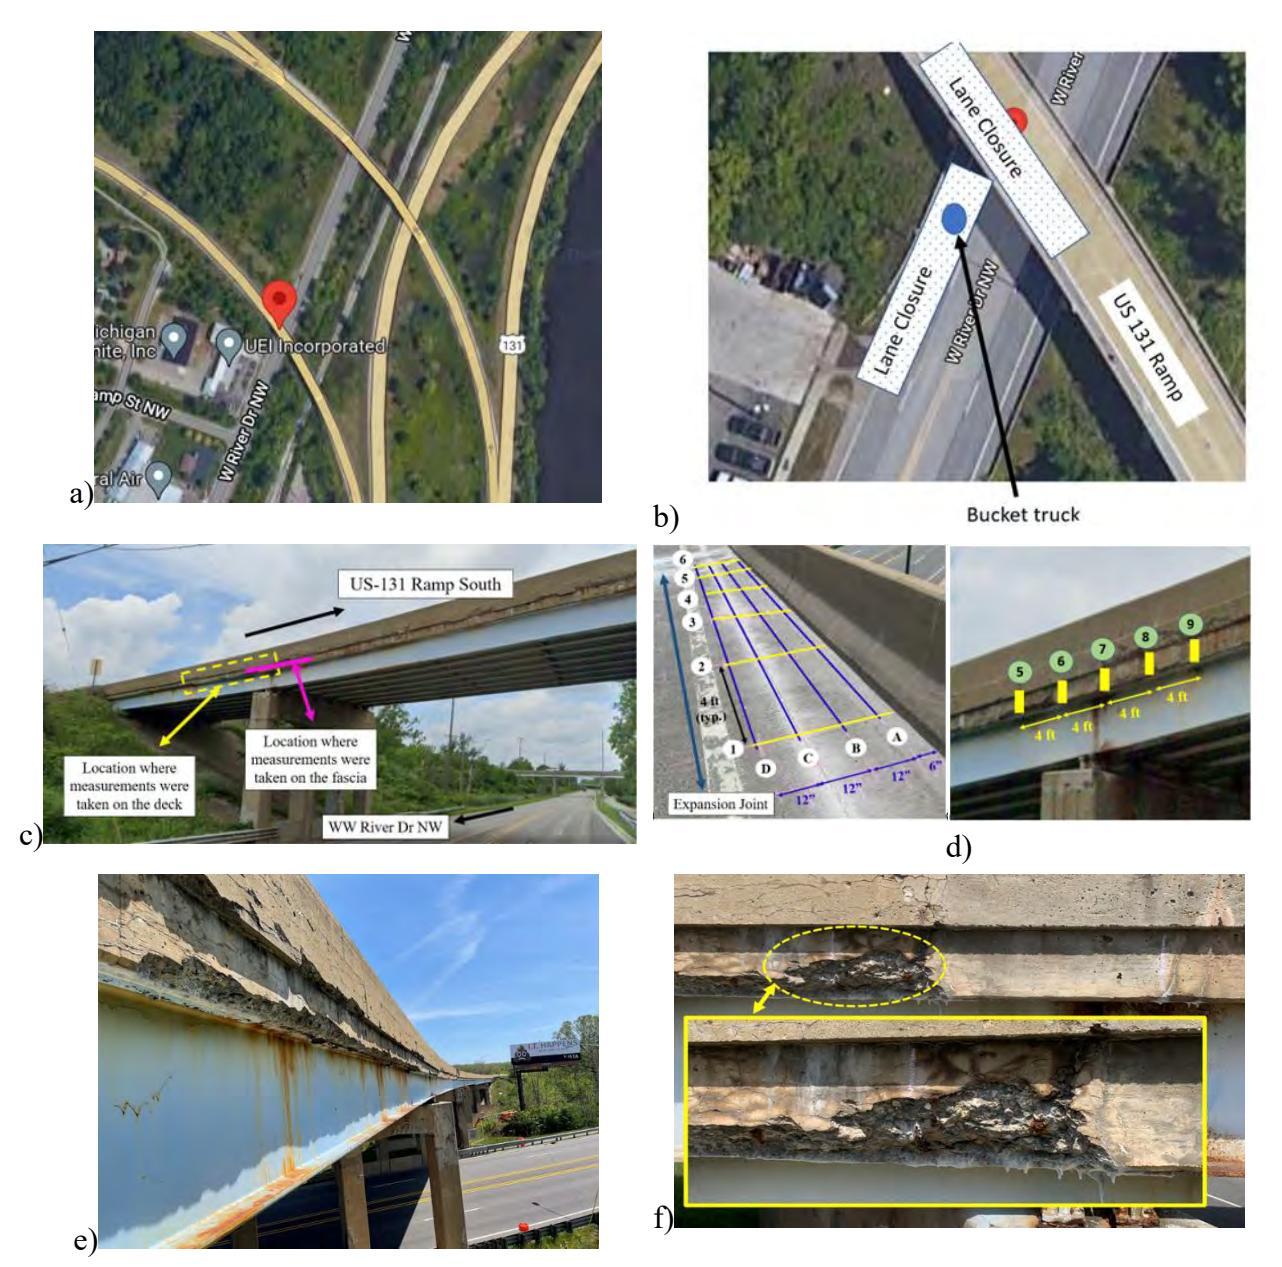
Fig. 3.8 Bridge on US 131 Ramp South over W River Drive NW: a) general location of the bridge, b) closed ramp and lanes and position of bucket truck, c-d) locations where measurements were taken on deck and fascia, e-f) deteriorated fascia

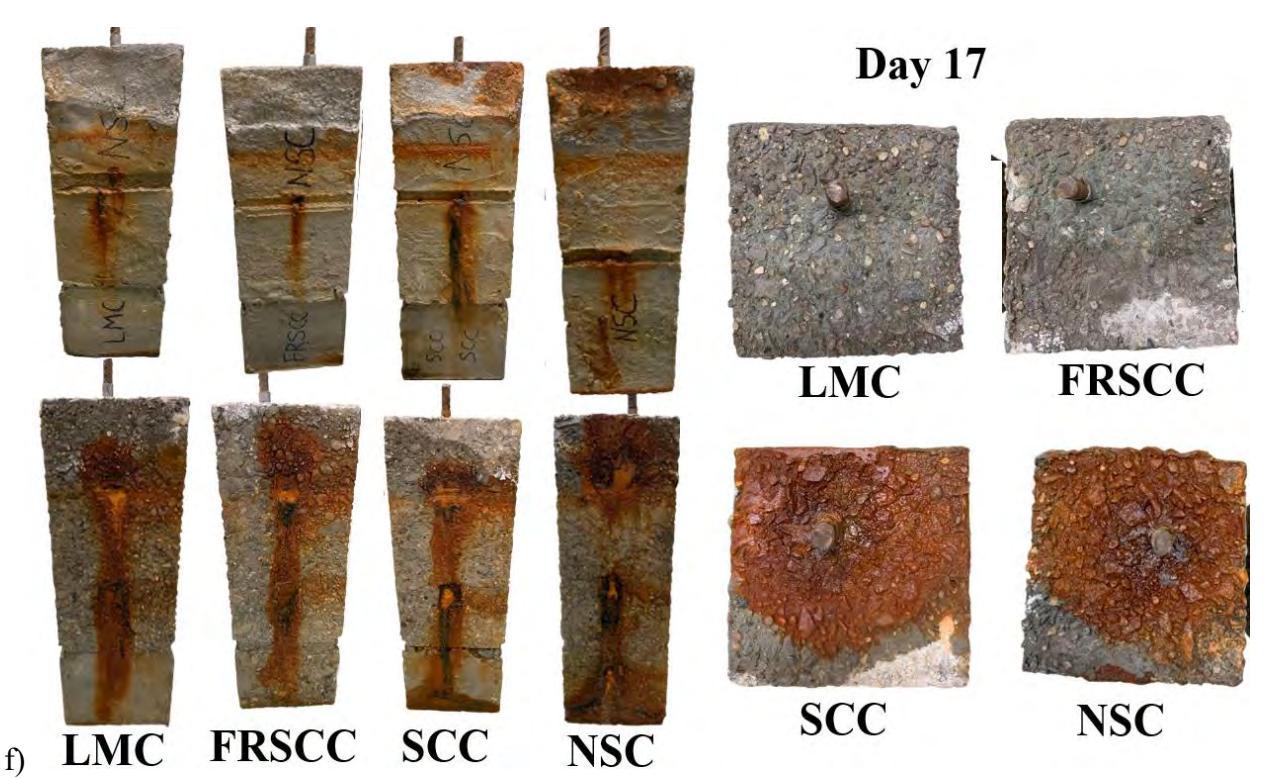
Fig. 5.25 a) Illustration of debris accumulation in the container during corrosion test; b-f) Conditions of the specimen throughout the corrosion test

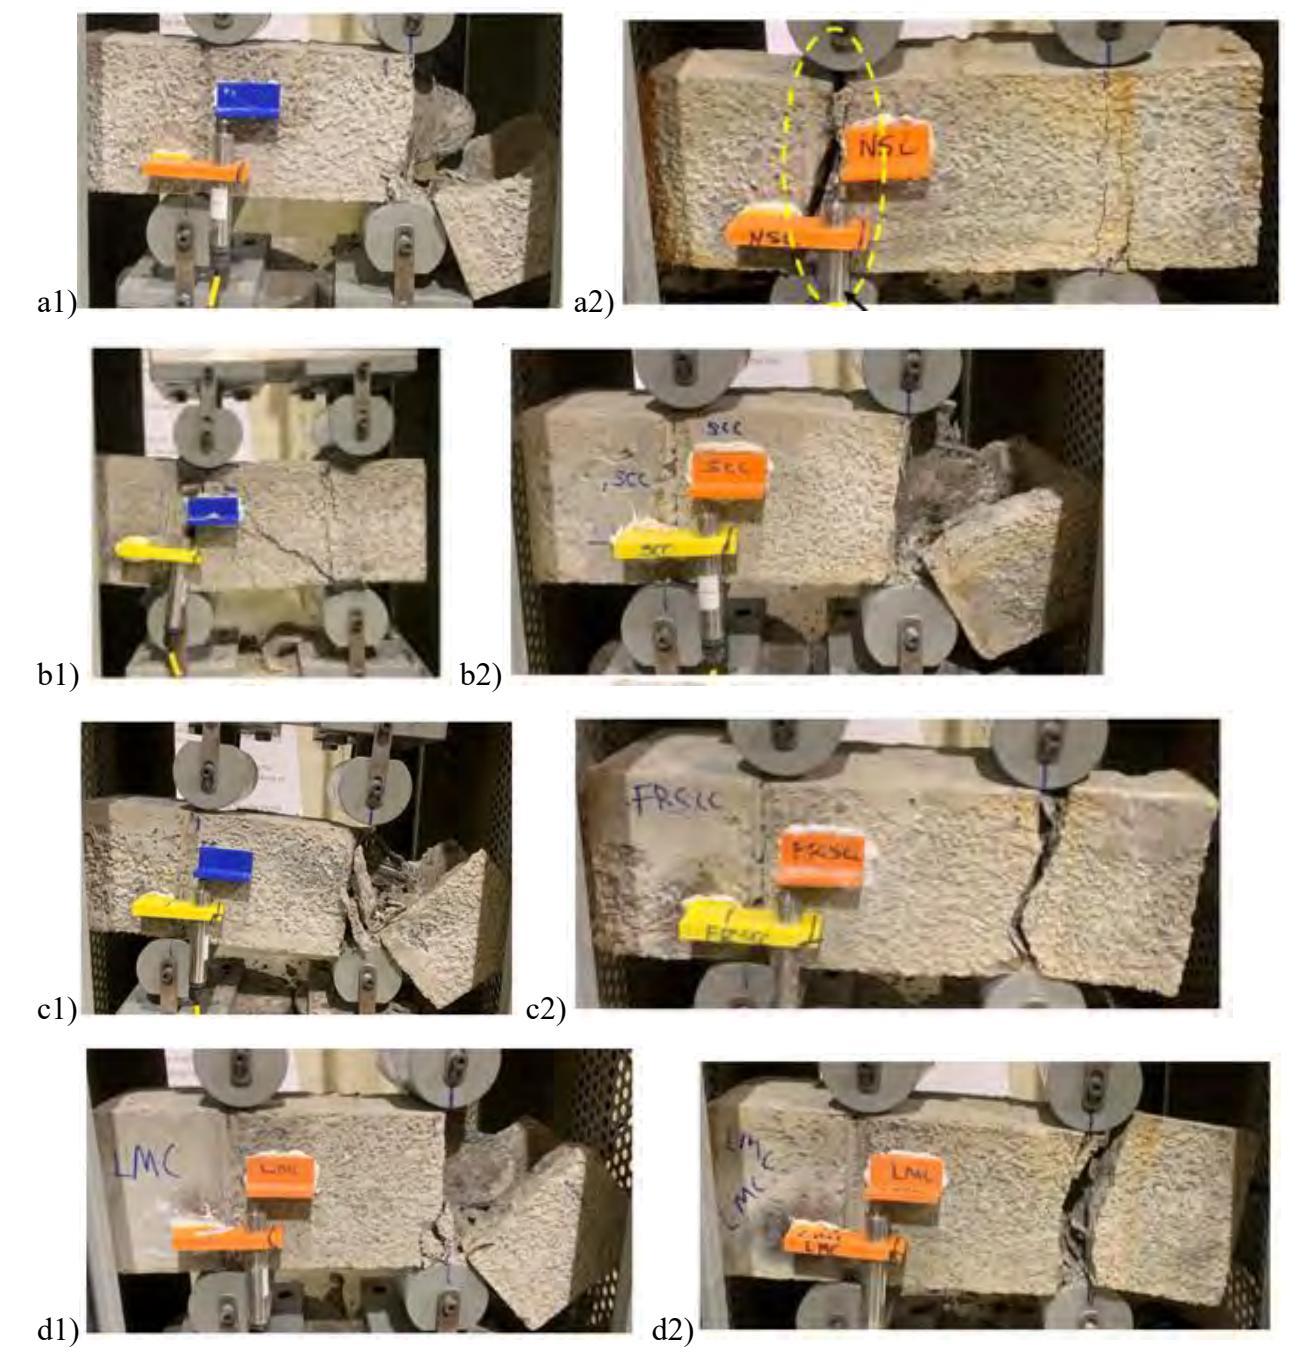
Fig. 5.28 Failure mode: a) Control NSC specimens: shear failure at the right support in unweathered specimen (a1), shear failure in the left support in weathered specimen (a2); b) Repaired SCC specimen: shear failure near left support in un-weathered specimen (b1), splitting failure at right support in weathered specimen (b2); c) Repaired FRSCC specimen: splitting failure at right support with interface crack at left support in un-weathered specimen (c1), splitting failure at right support in weathered specimen (c2); d) Repaired LMC specimen: splitting failure at right support in un-weathered specimen (d1), splitting failure at right support in weathered specimen (d1), splitting failure at right support in weathered specimen (d2).

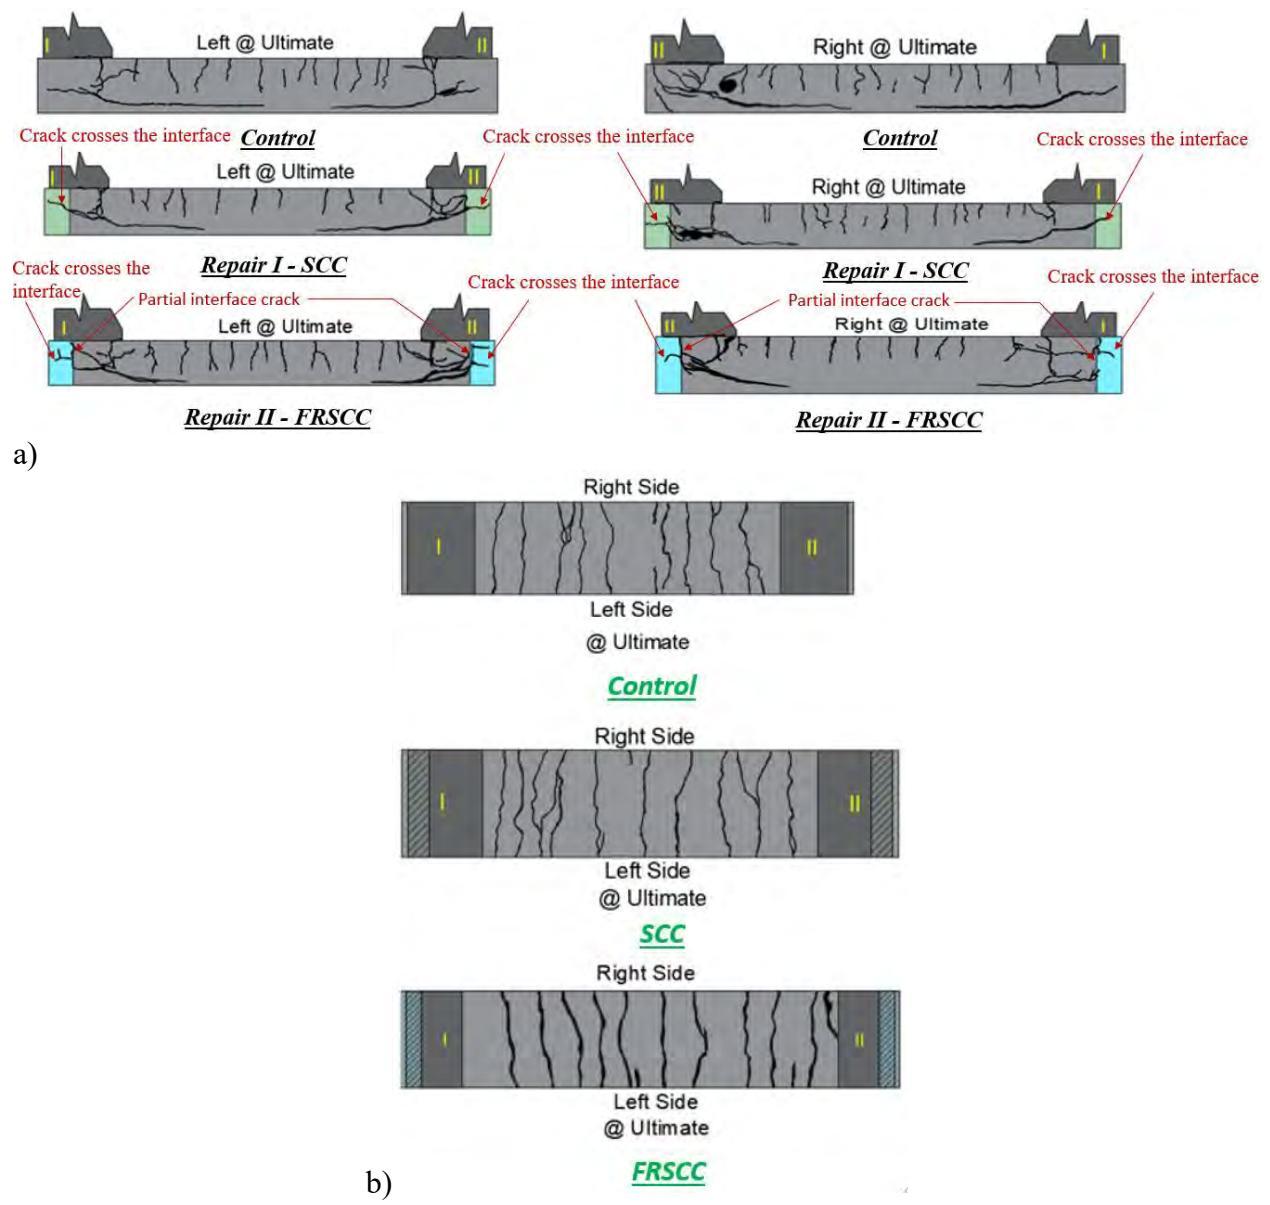
Fig. 6.28 Crack pattern on: a) left and right sides at the ultimate condition for all tested specimens, b) top of deck
