Re: 2012 Straits of Mackinac Pipeline Inspection & Repair Project

## **Project Overview**

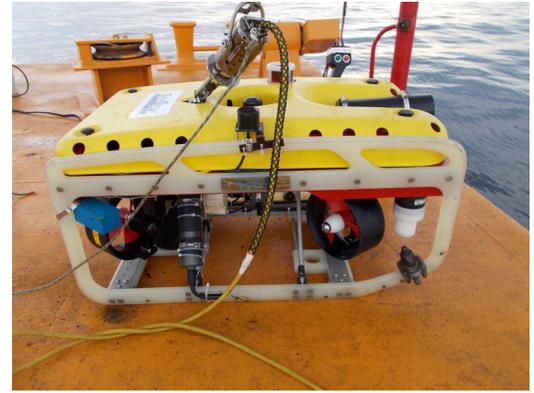
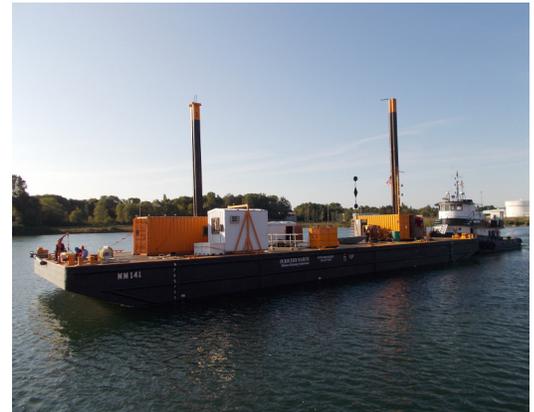
The “Falcon”, a Remotely Operated Vehicle (ROV) system, is extremely versatile and can be employed to carry out a variety of tasks including surveying, searching and inspections. A pilot on the surface controls the vehicle remotely by sending commands to the vehicle tether. The vehicle can be moved in any direction or by using the autopilot facility remain accurately on course and depth to provide a stable platform. The pilot can also control the vehicle’s video system, lighting and any other equipment fitted to the unit.

For this inspection, the vehicle was fitted with a Linkquest USBL tracking system in concert with an RTK GPS system and Hypack software. In use, the ROV was fitted with a Linkquest acoustic transponder, which sends out a sound signal to be picked up by a hydrophone mounted on the side of the surface support barge. The offsets of the vehicle as calculated by Hypack, is fed to the navigation computer that plots a corresponding XY position based on Real Time Kinematics (RTK) information from the GPS. Video from the on-board camera is recorded in a digital format, with the surveyor following position information from the Hypack navigational software. Once data has been gathered as acoustic records, video documentation is encouraged in order to provide definitive ground truthing of the indications on the sonar record.

In operation, the tug and barge is positioned over the pipeline using a live boat operation for the survey. With evidence of a strong fixed RTK lock as well as a solid return from the vehicle tracking system, the vehicle is launched from the surface to begin its descent to the bottom. Once on bottom, the operator utilizes the navigation system to guide the vehicle to the pipeline. With the pilot free to fly the vehicle, the survey supervisor takes notes with further direction given by the client representative on site. “Parking” the vehicle at the desired location attains accurate location of anomalies, while the Linkquest tracking and RTK stabilize and update the position. This position is noted in the inspection log for future reference. After taking a fix on the span location, anchor or other items of interest the ROV, tug and barge would proceed along the pipeline to the location. With the survey running a live boat operation, Veolia was able to survey more efficiently.

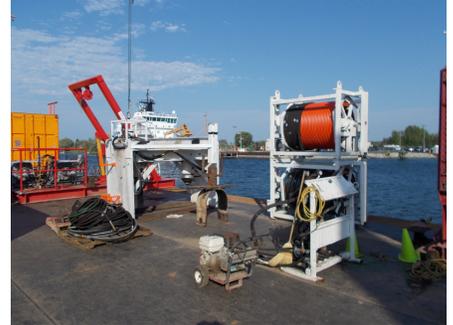
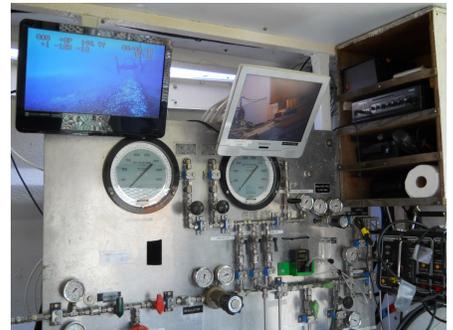
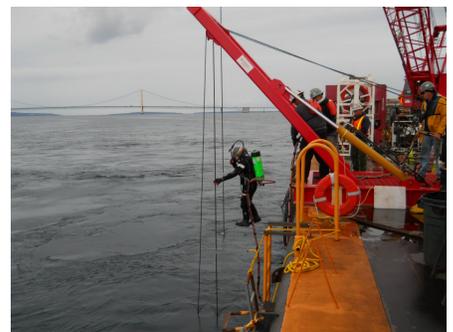
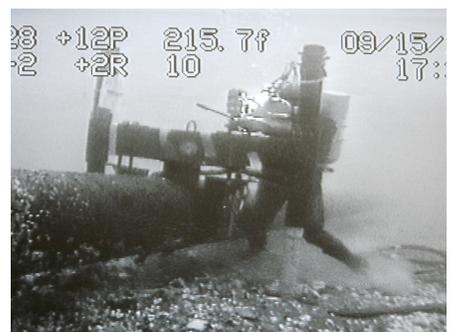
The screw anchor and saddle support, which is a prefabricated design, is designed to drill along both sides of the pipeline. Extensions can be added, for adjustment with sub-bottom material or span height. When drilling into the sub-bottom, a specified hydraulic pressure must be met. At that time, the upper and lower saddle supports were installed. Placing the support over and under the pipeline and then all-thread bolts bring all the support saddles together.

Dive operation begins and bottom time starts when the diver leaves the surface. Once on bottom, the diver brings the drilling tool over the pipeline and lowers the drilling tool into place. Once in place, drilling proceeded. The Diver monitored the drilling process until completion. When drilling is complete, the 3-pin assembly is disconnected and the hydraulic tool is lifted off the screw assembly and safely placed off the East Side of the pipeline to prevent dragging back into the pipe. The Diver then assembled the anchor and saddle into place. A repair (as detailed in above) is completed.

The final inspection and position of the pipeline repair was recorded from the ROV and the diver was brought to the surface and decompressed. This process usually entailed multiple dives to complete. The same ROV and equipment detailed above for video survey operations was utilized for dive support.
