Former Performance Paper Mill Property: From Demolition to Revitalization

Michigan Department of Environmental Quality

City of Kalamazoo

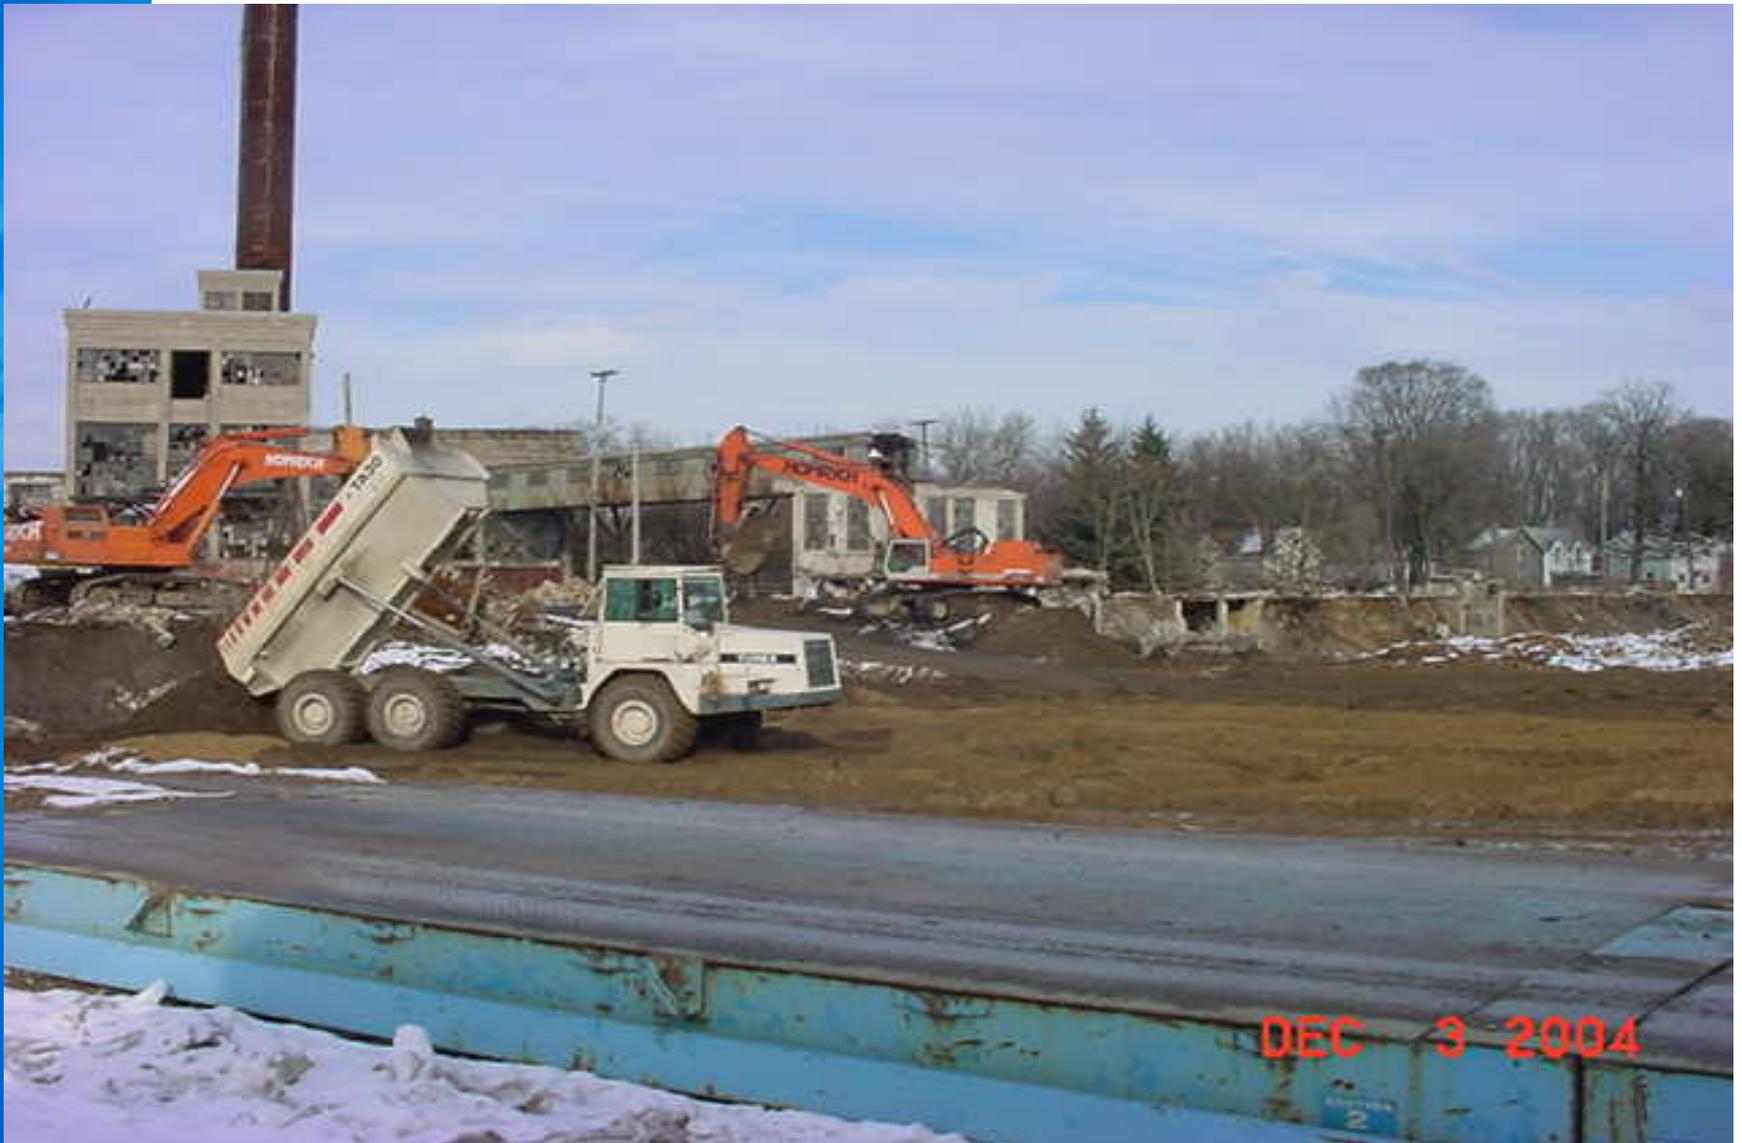
Demolition activities (Power Plant and the pipe bridge leading to what's left of Mill "C" in background) (looking north)

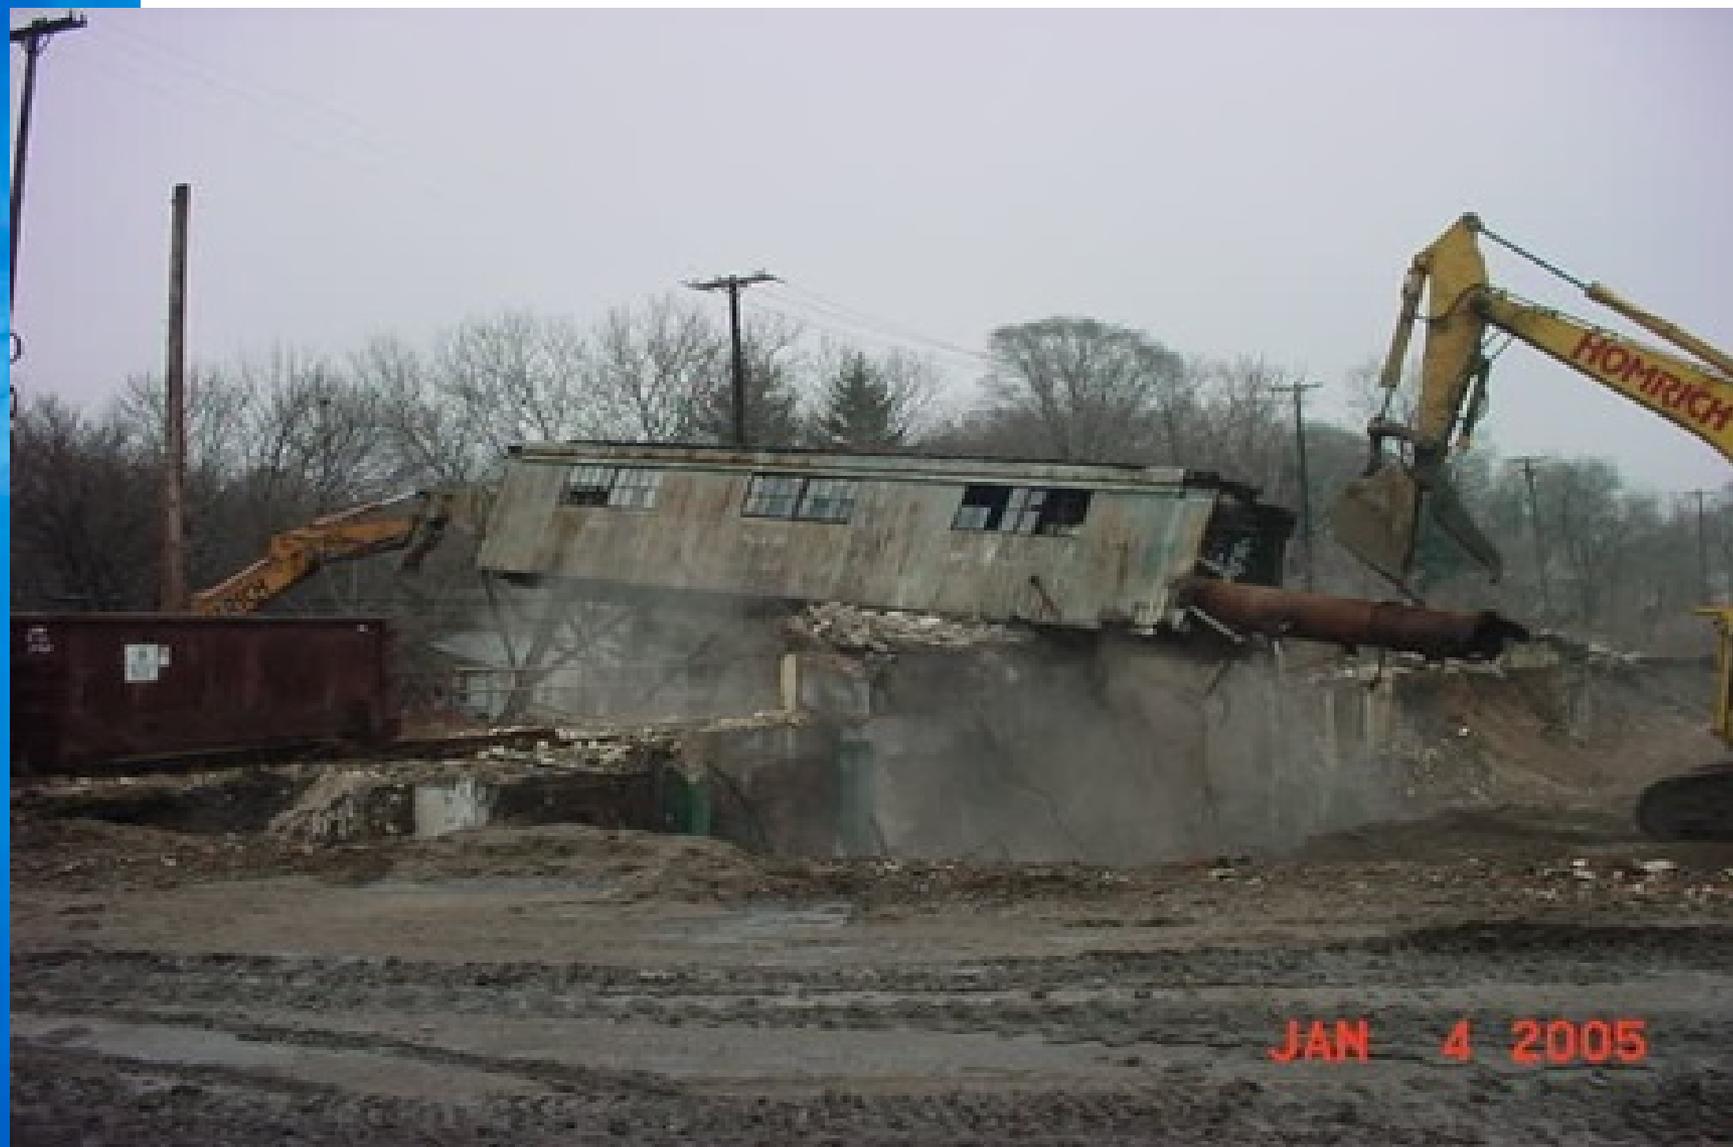
Demolition of pipe bridge over Bryant Street (looking southwest)

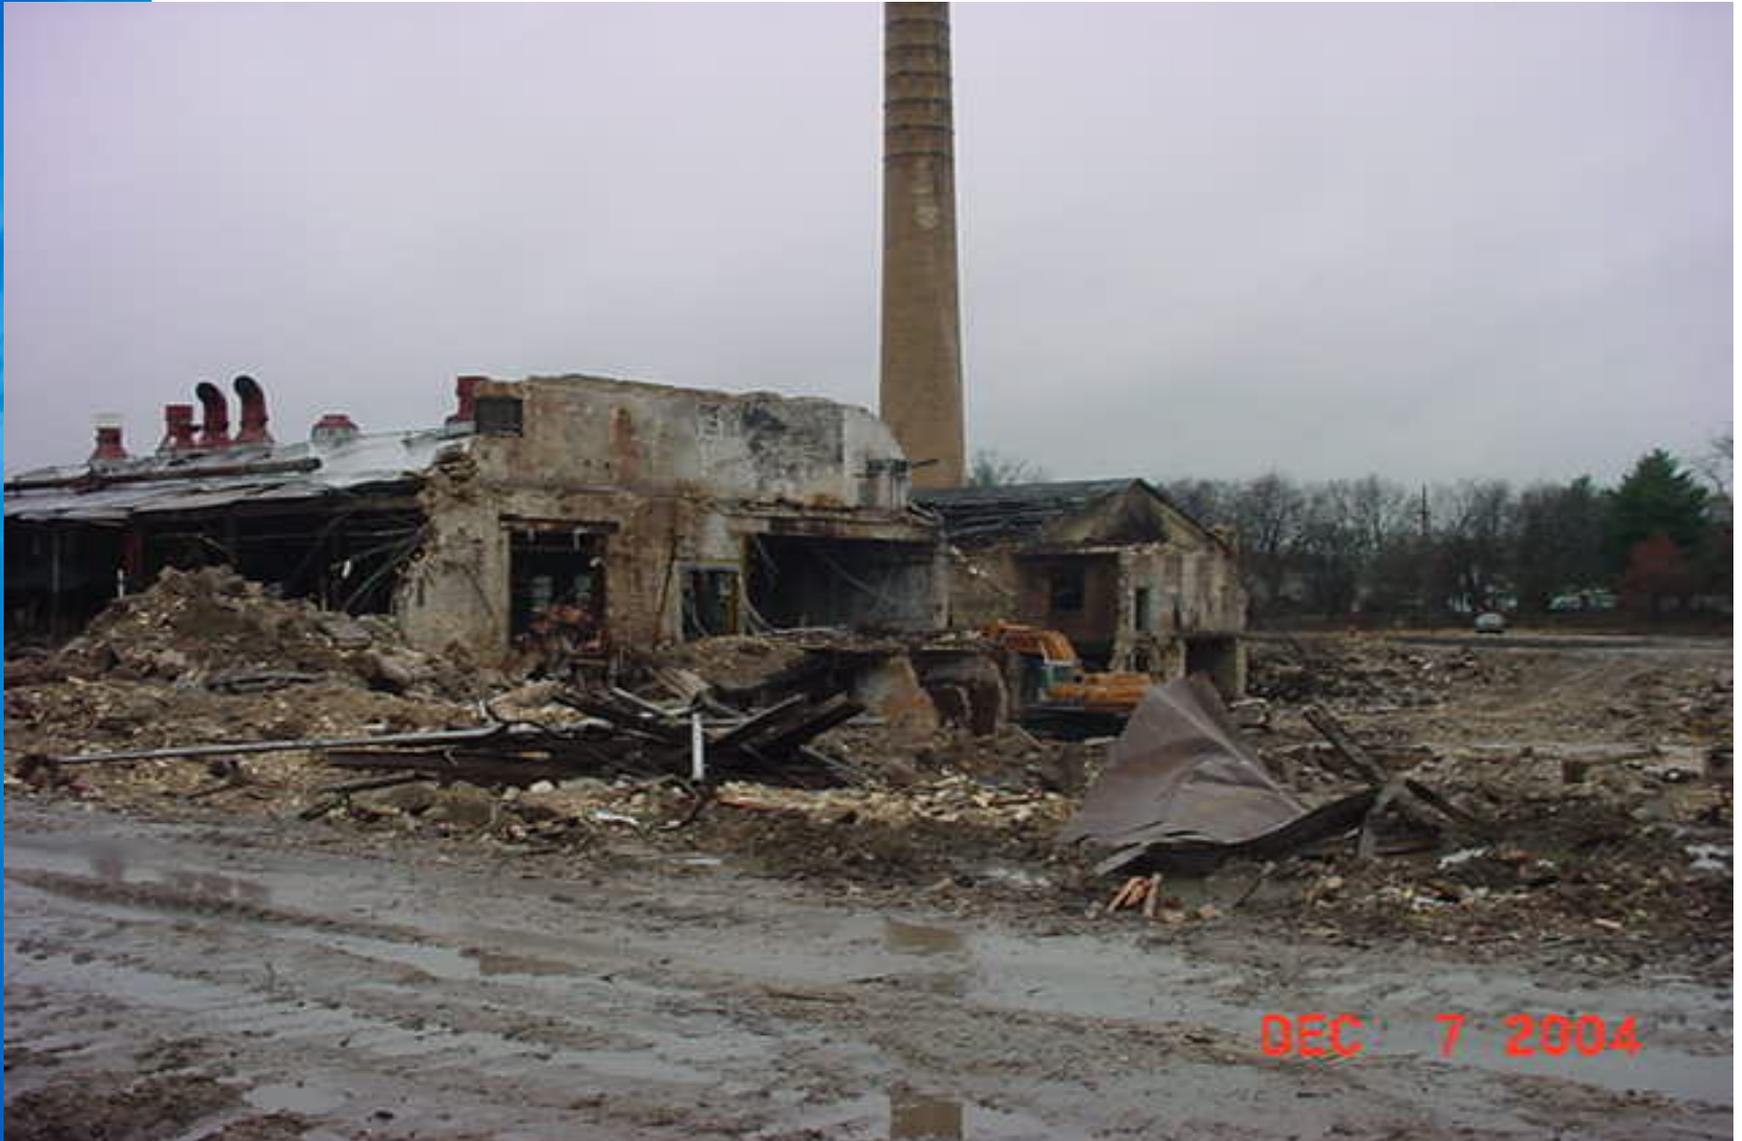
Mill "D" Building 3 demolition (looking southwest)

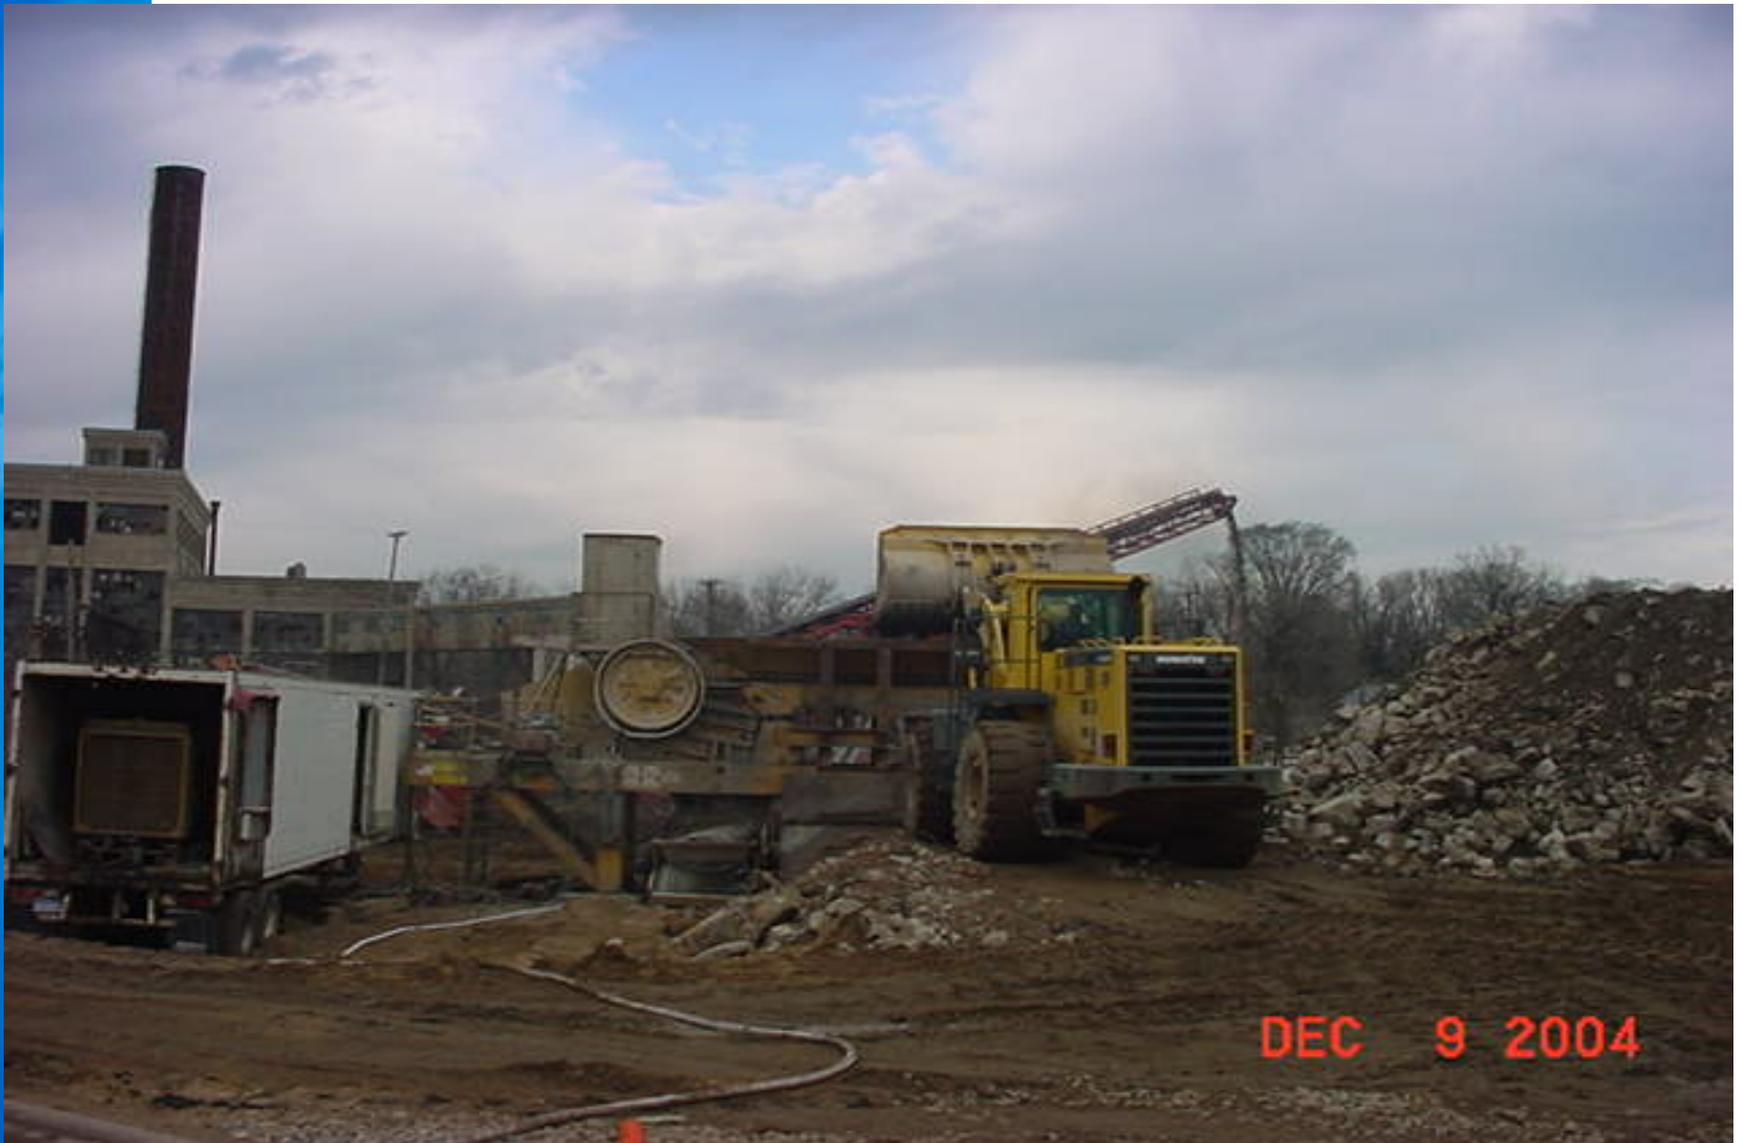
Concrete crushing/recycling area (looking north)

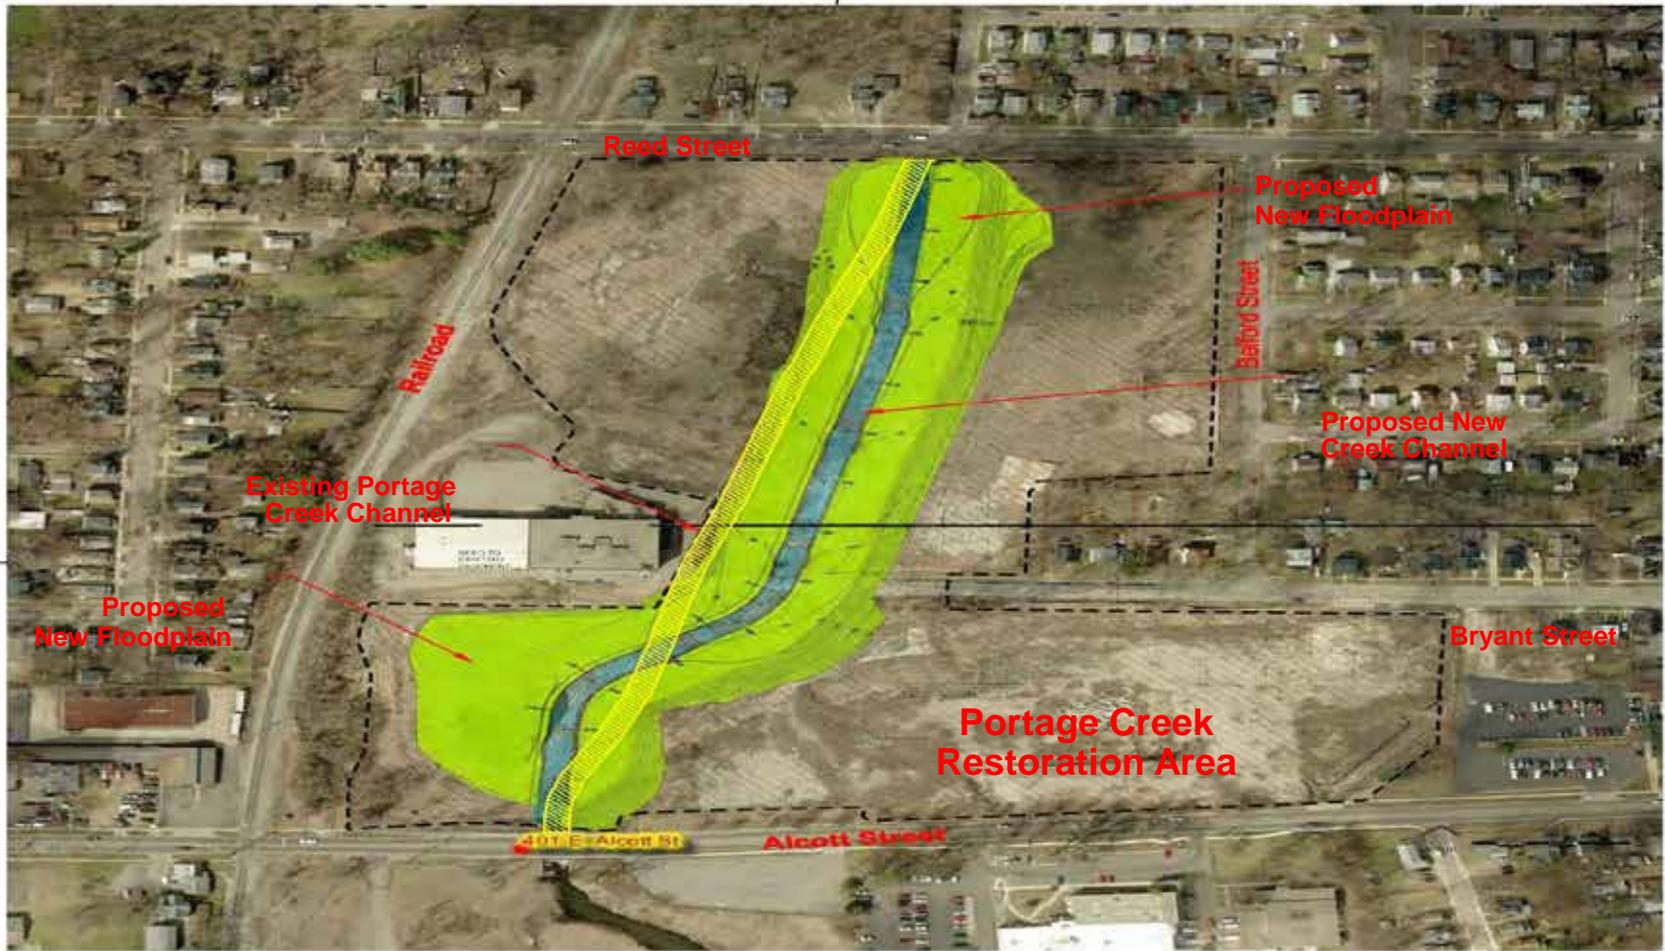
FIGURE 1

TITLE
PROPOSED FLOODPLAIN
 UFS CORPORATION, SOUTHFIELD, MI., 248-204-5900

PORTAGE CREEK TOXIC
 SUBSTANCE SOURCE REDUCTION
 KALAMAZOO, MICHIGAN

- Evaluate soil and groundwater quality in restoration project area
- Establish floodplain and increase flood storage
- Natural stream channel design techniques
- Incorporate fish, aquatic, and riparian habitat

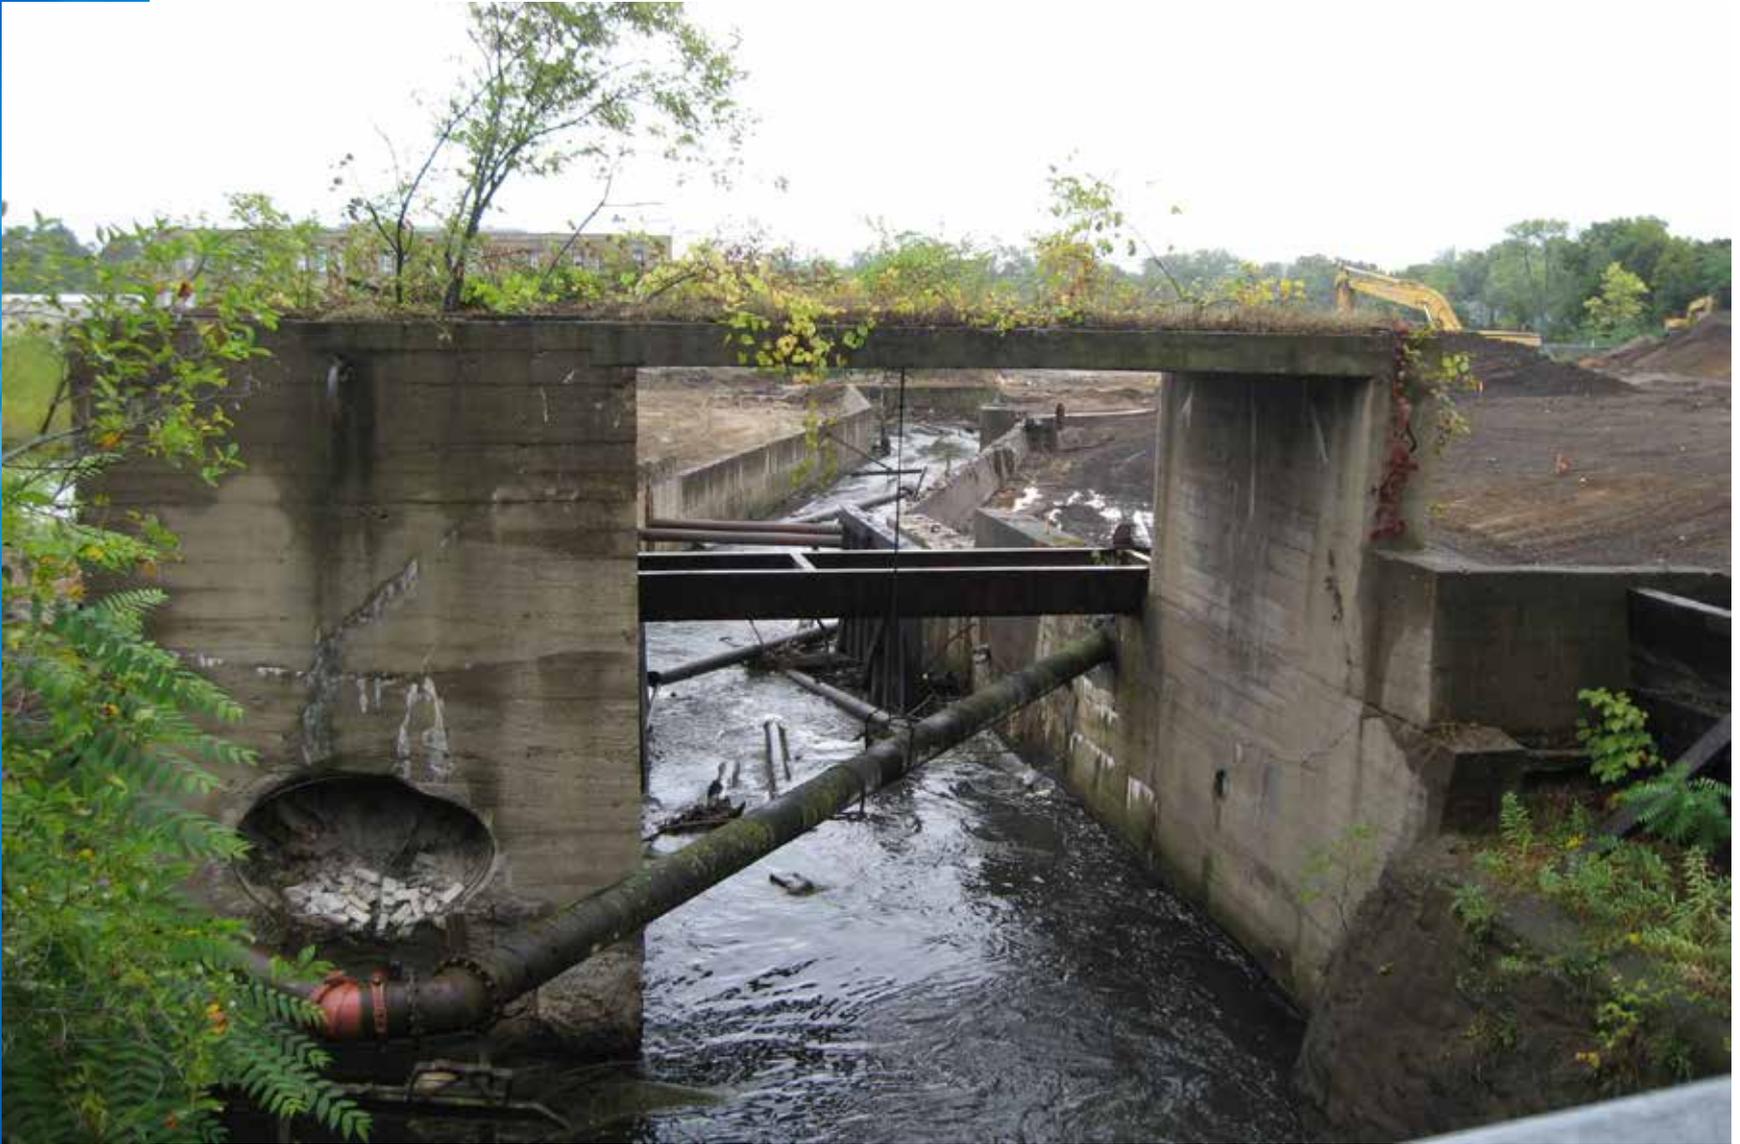
Concrete channelized creek (looking north from Alcott Street)

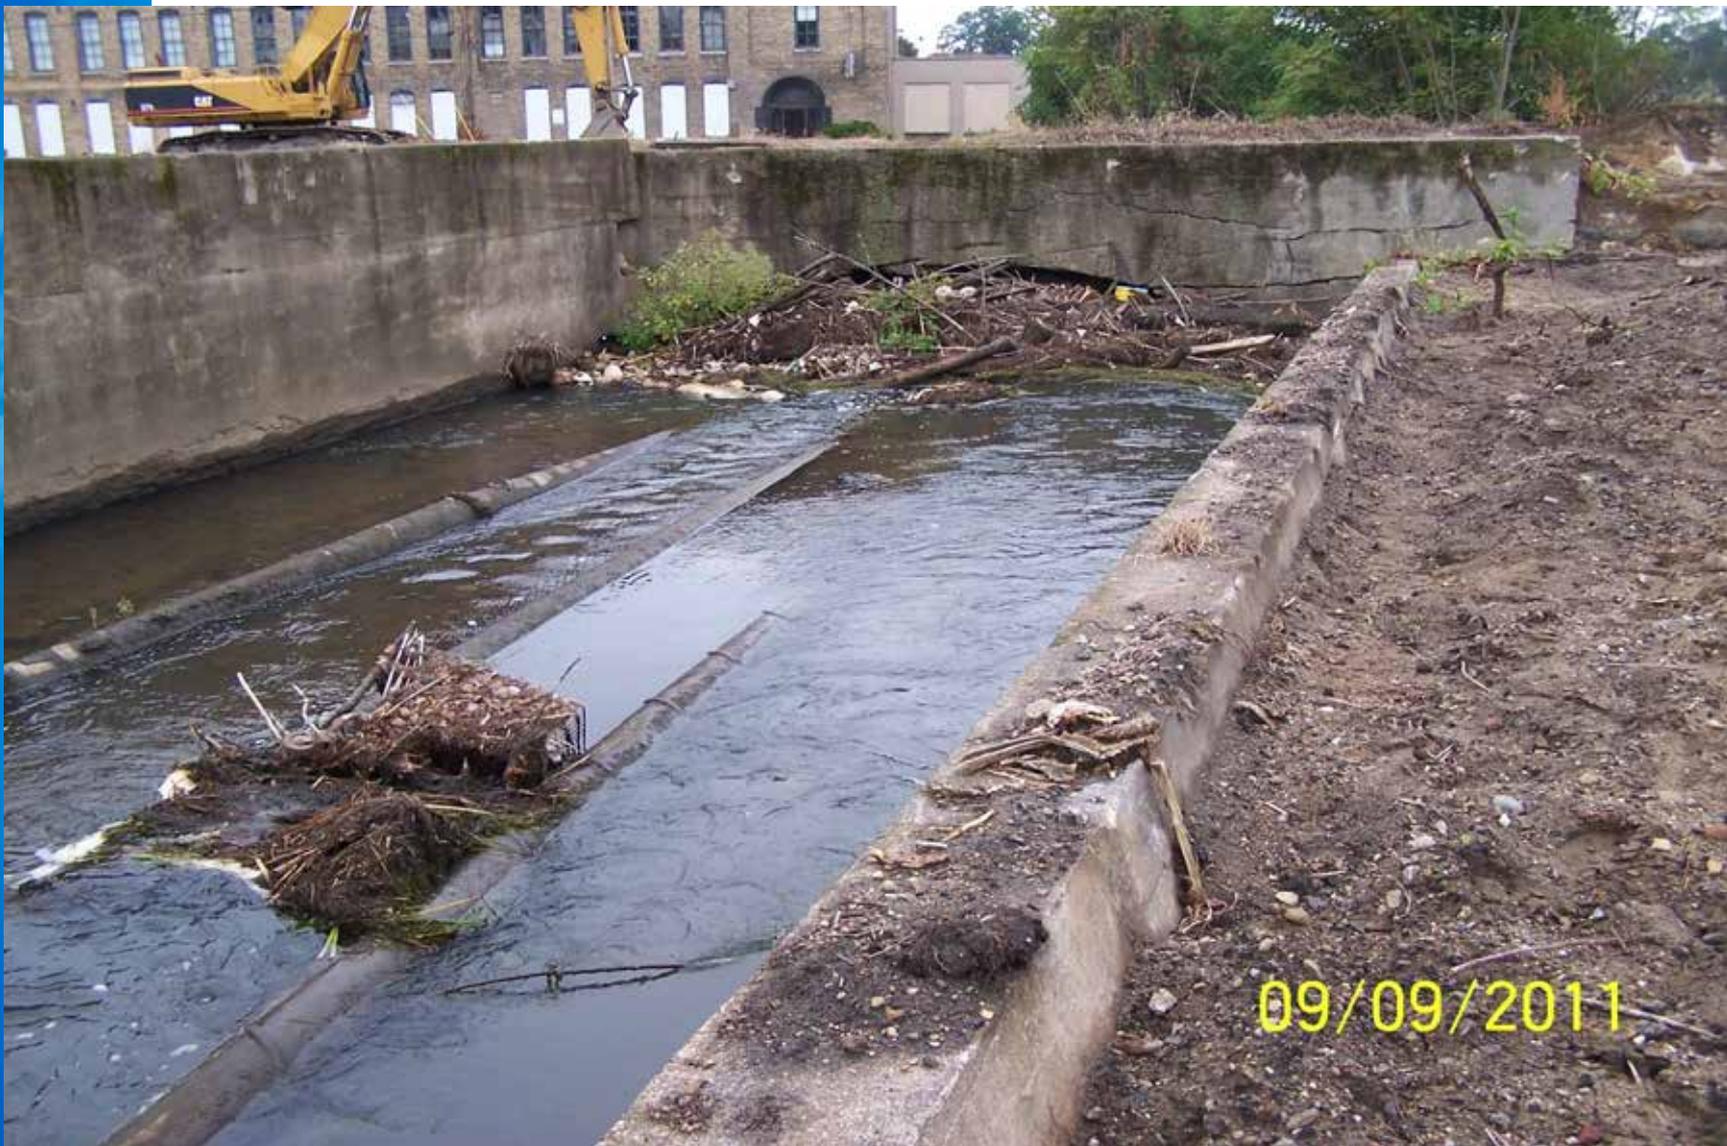
Concrete channelized creek upper reach (looking north)

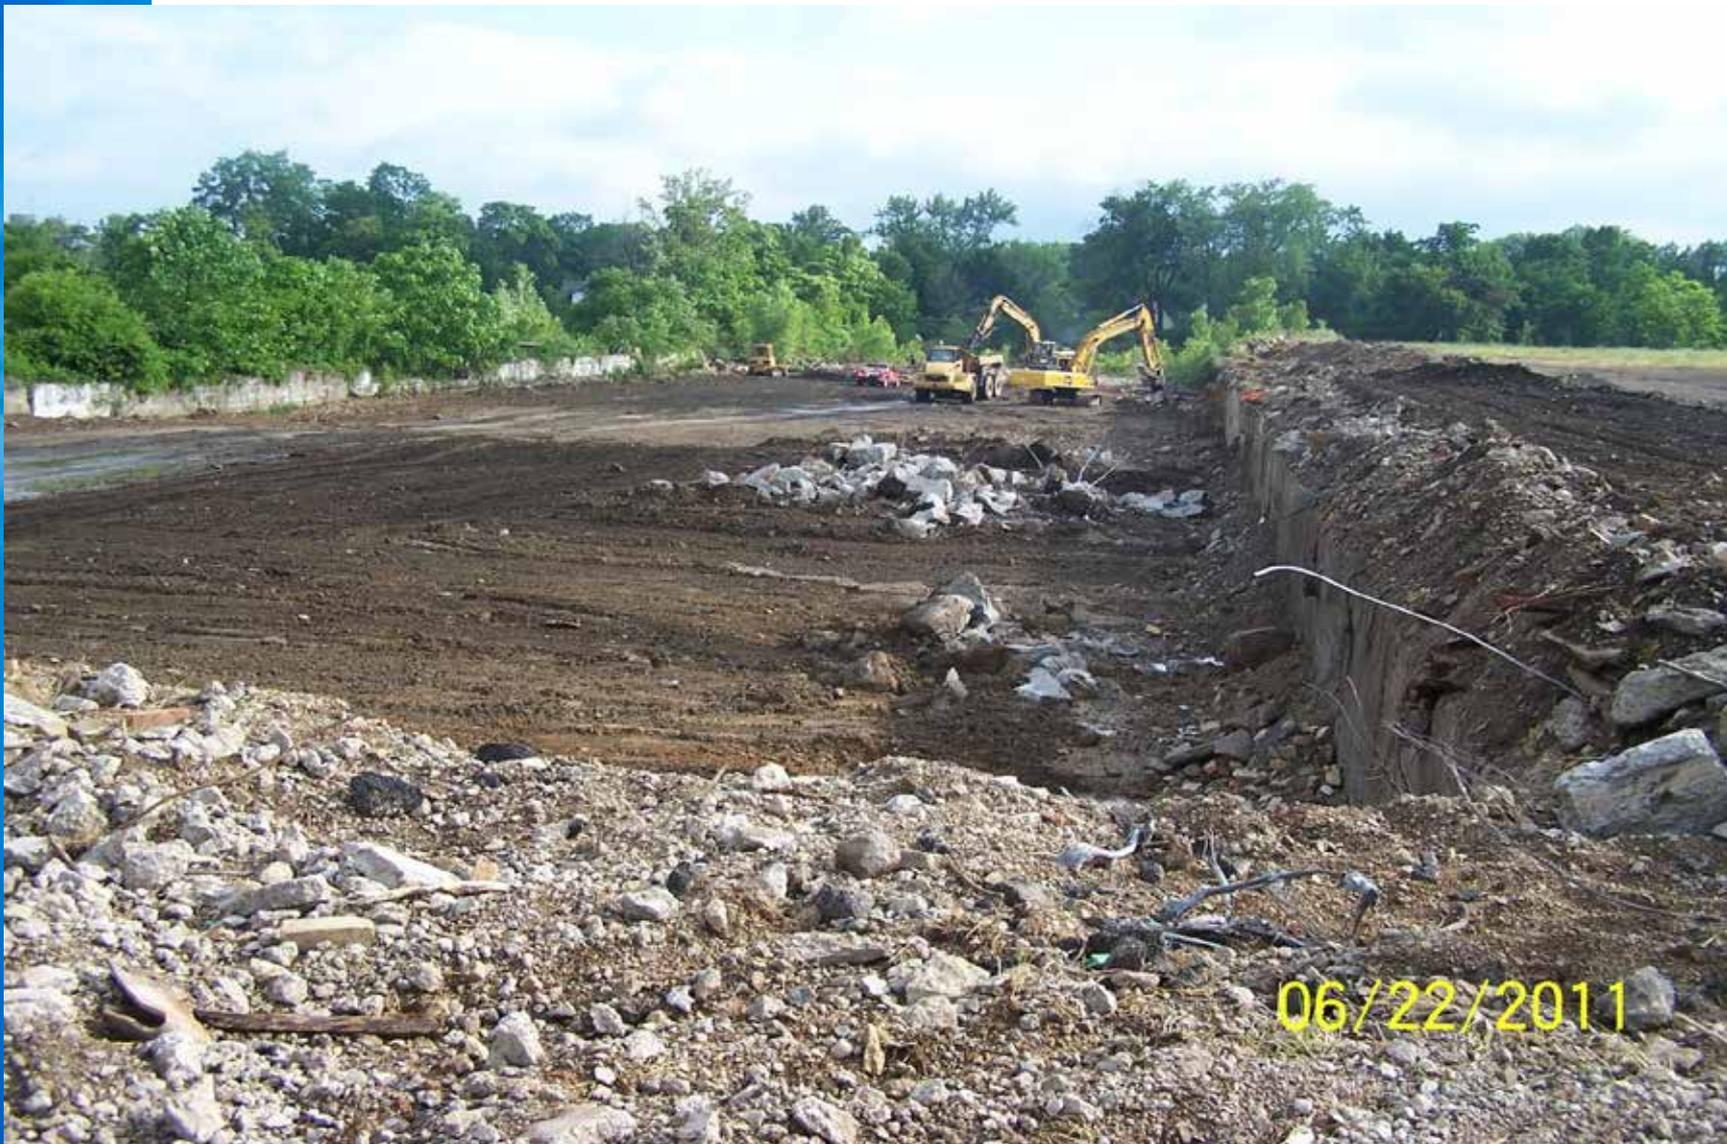
Former Mill D Building (looking north)

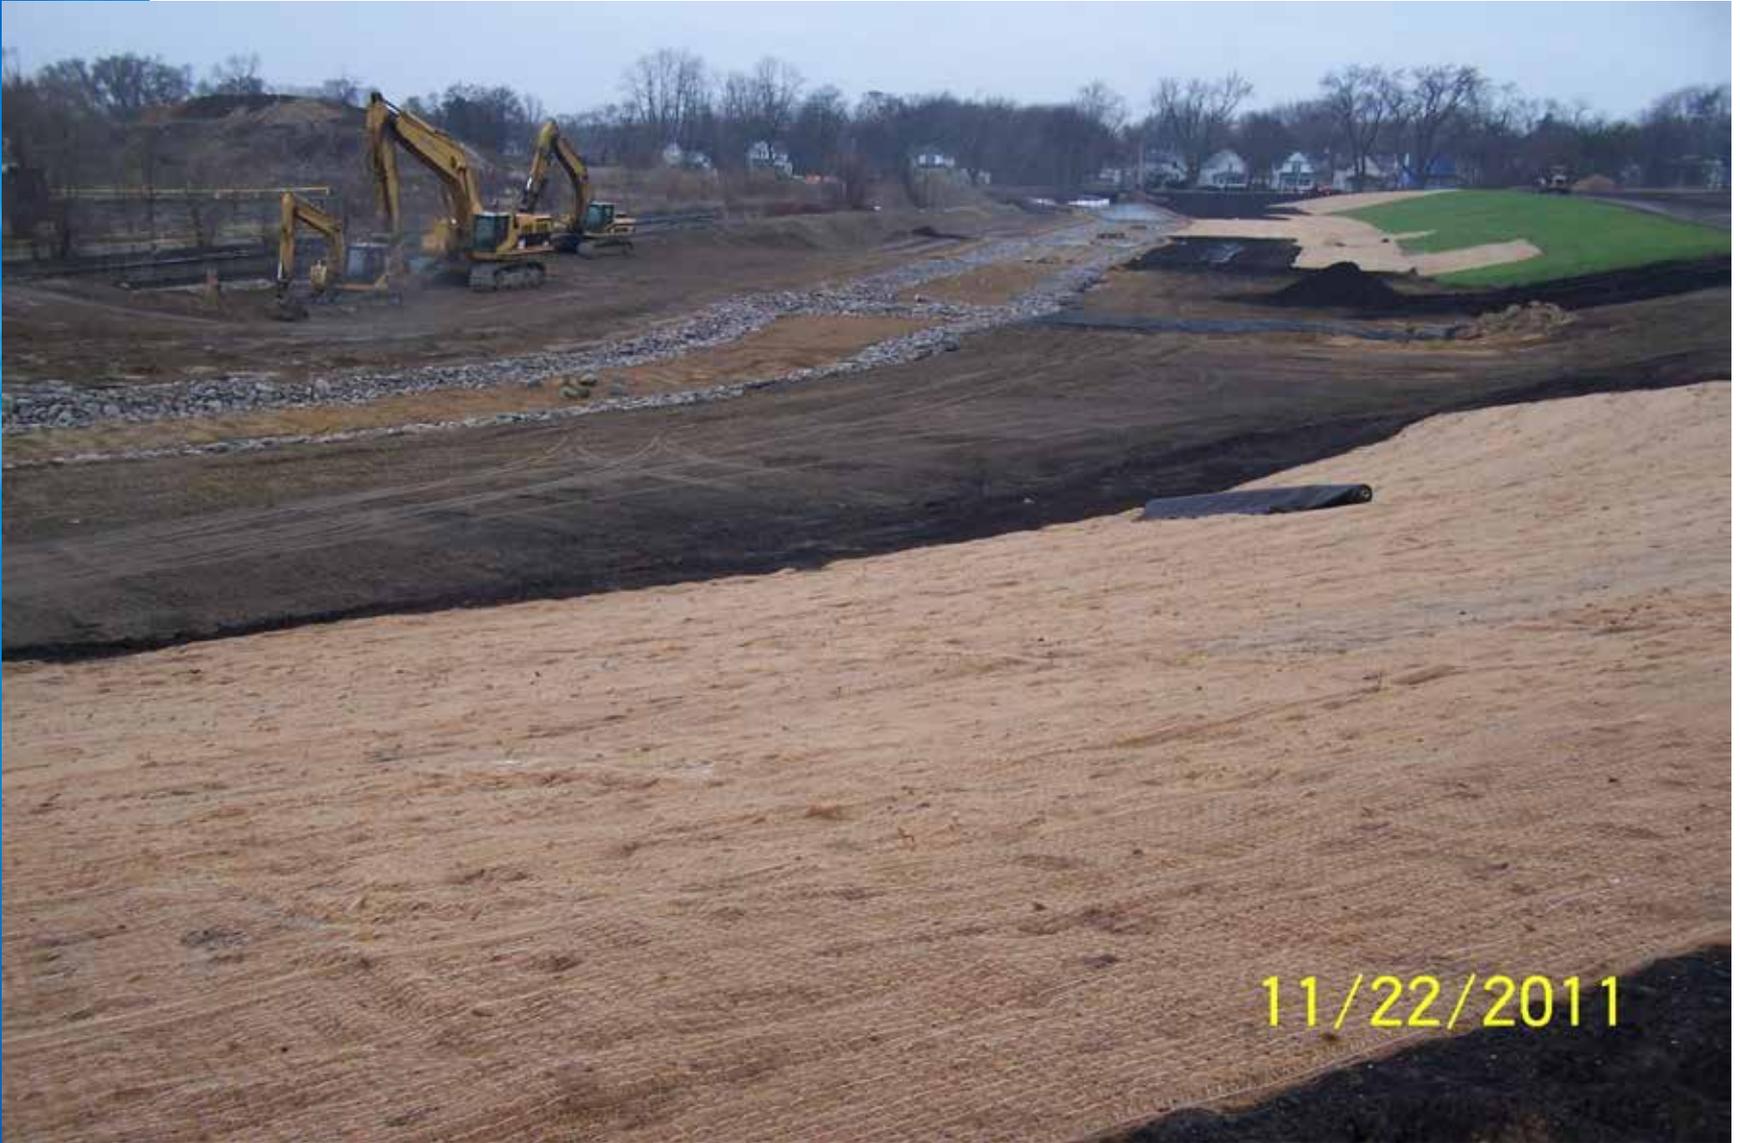
Creek channel and floodplain construction (looking north)

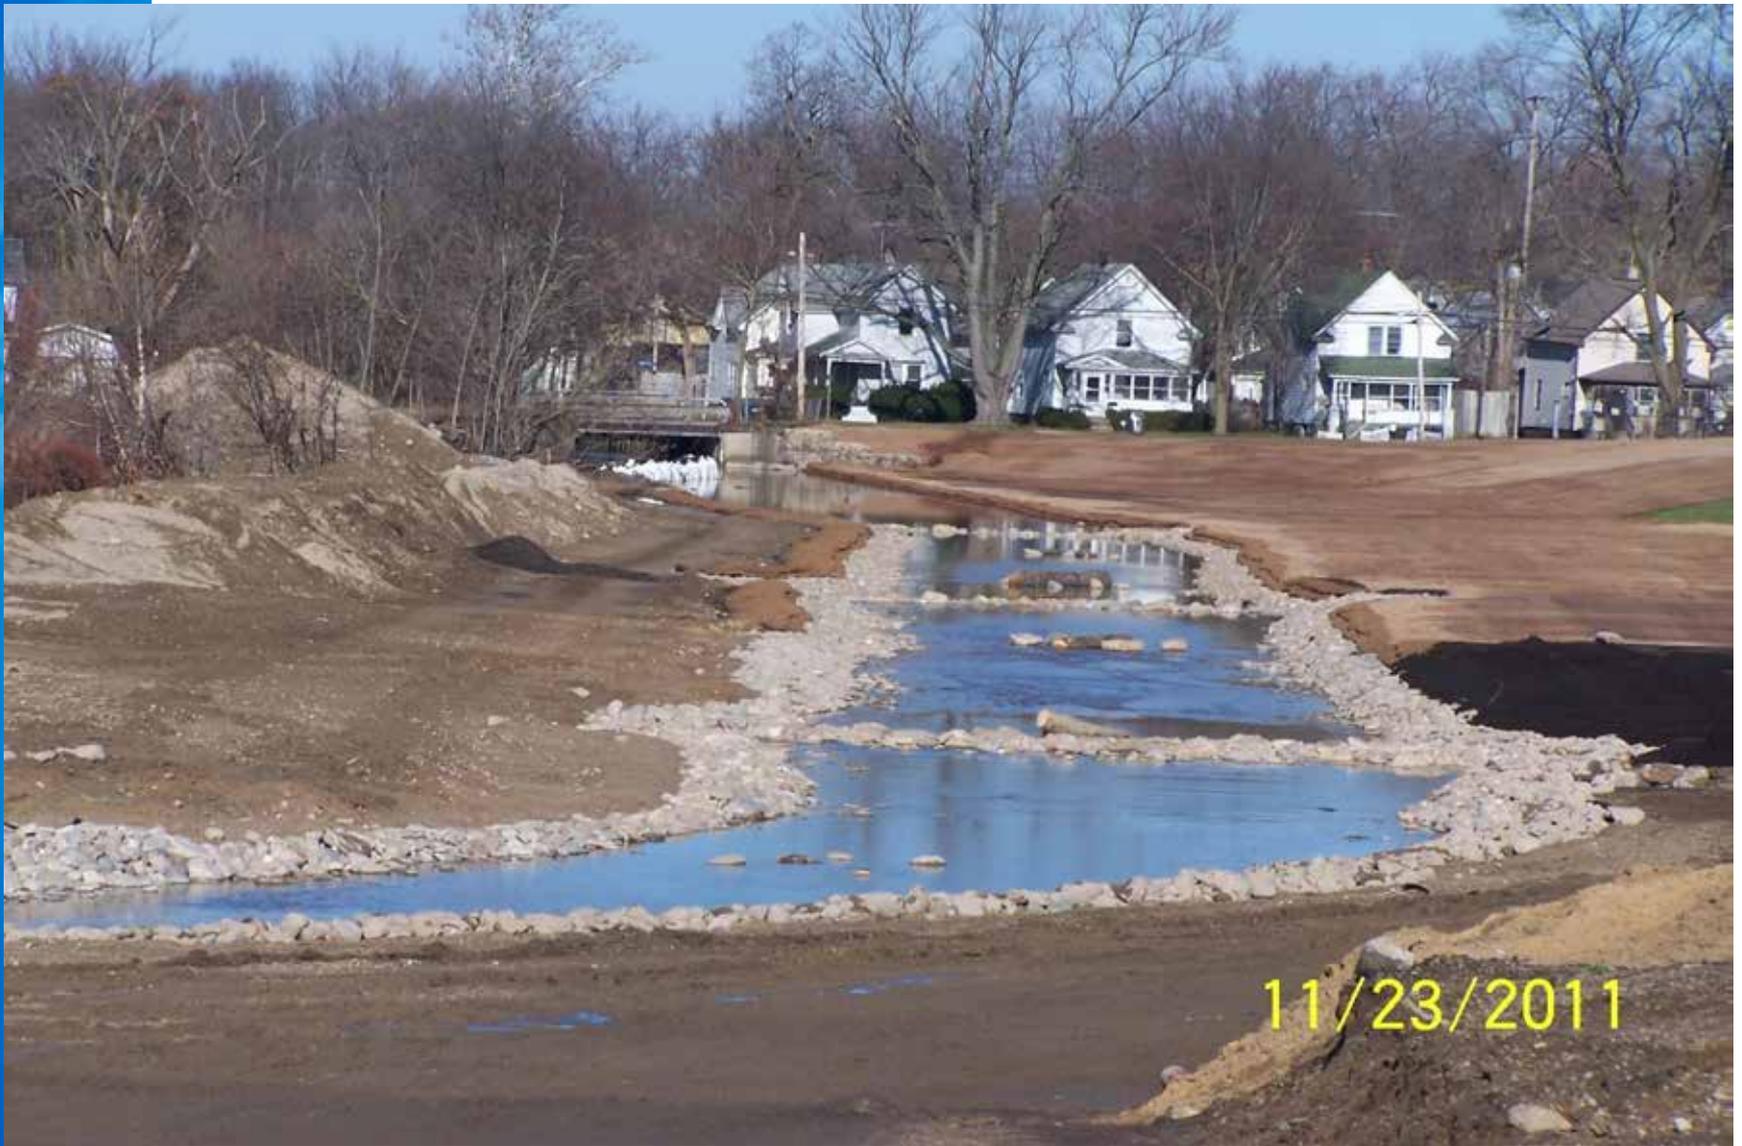
Low-flow water diversion to the new creek channel (looking north)

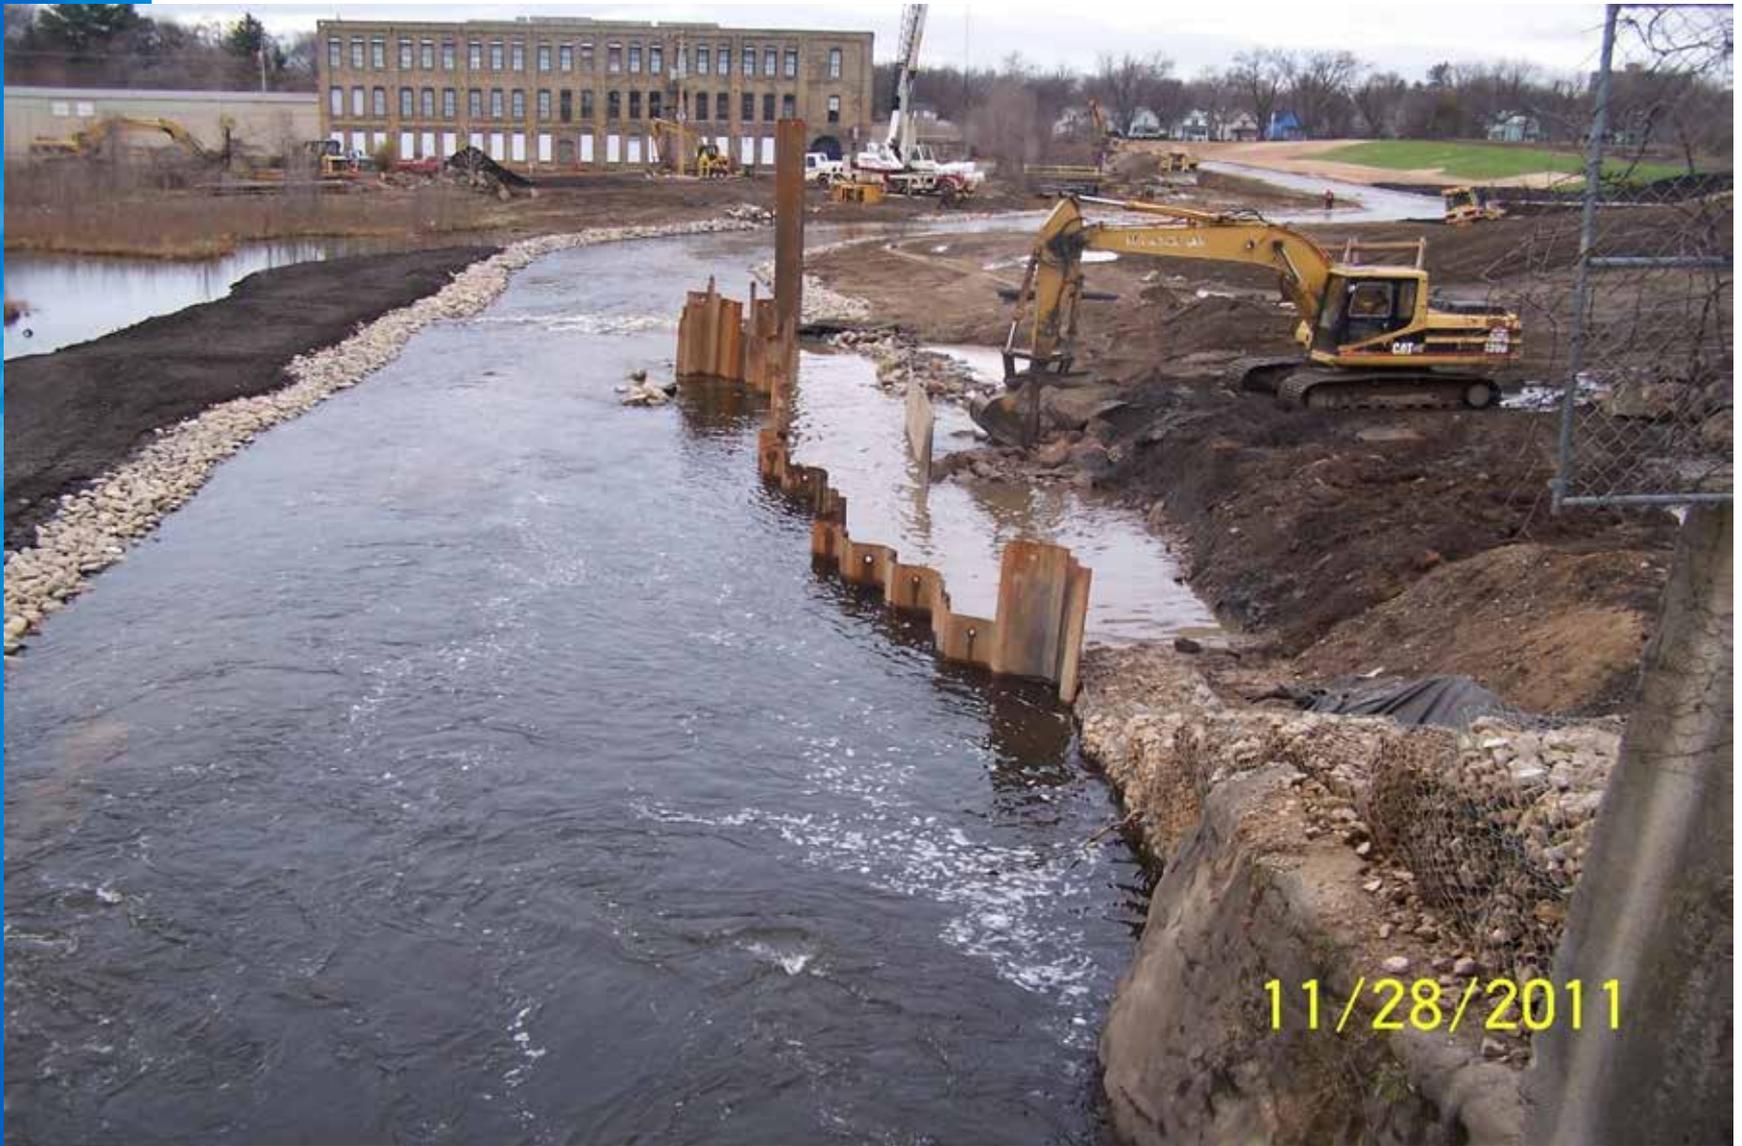
Creek channel as seen from Alcott Street (looking north)
