Former Performance Paper Mill Property: From Demolition to Revitalization

Michigan Department of Environmental Quality

City of Kalamazoo

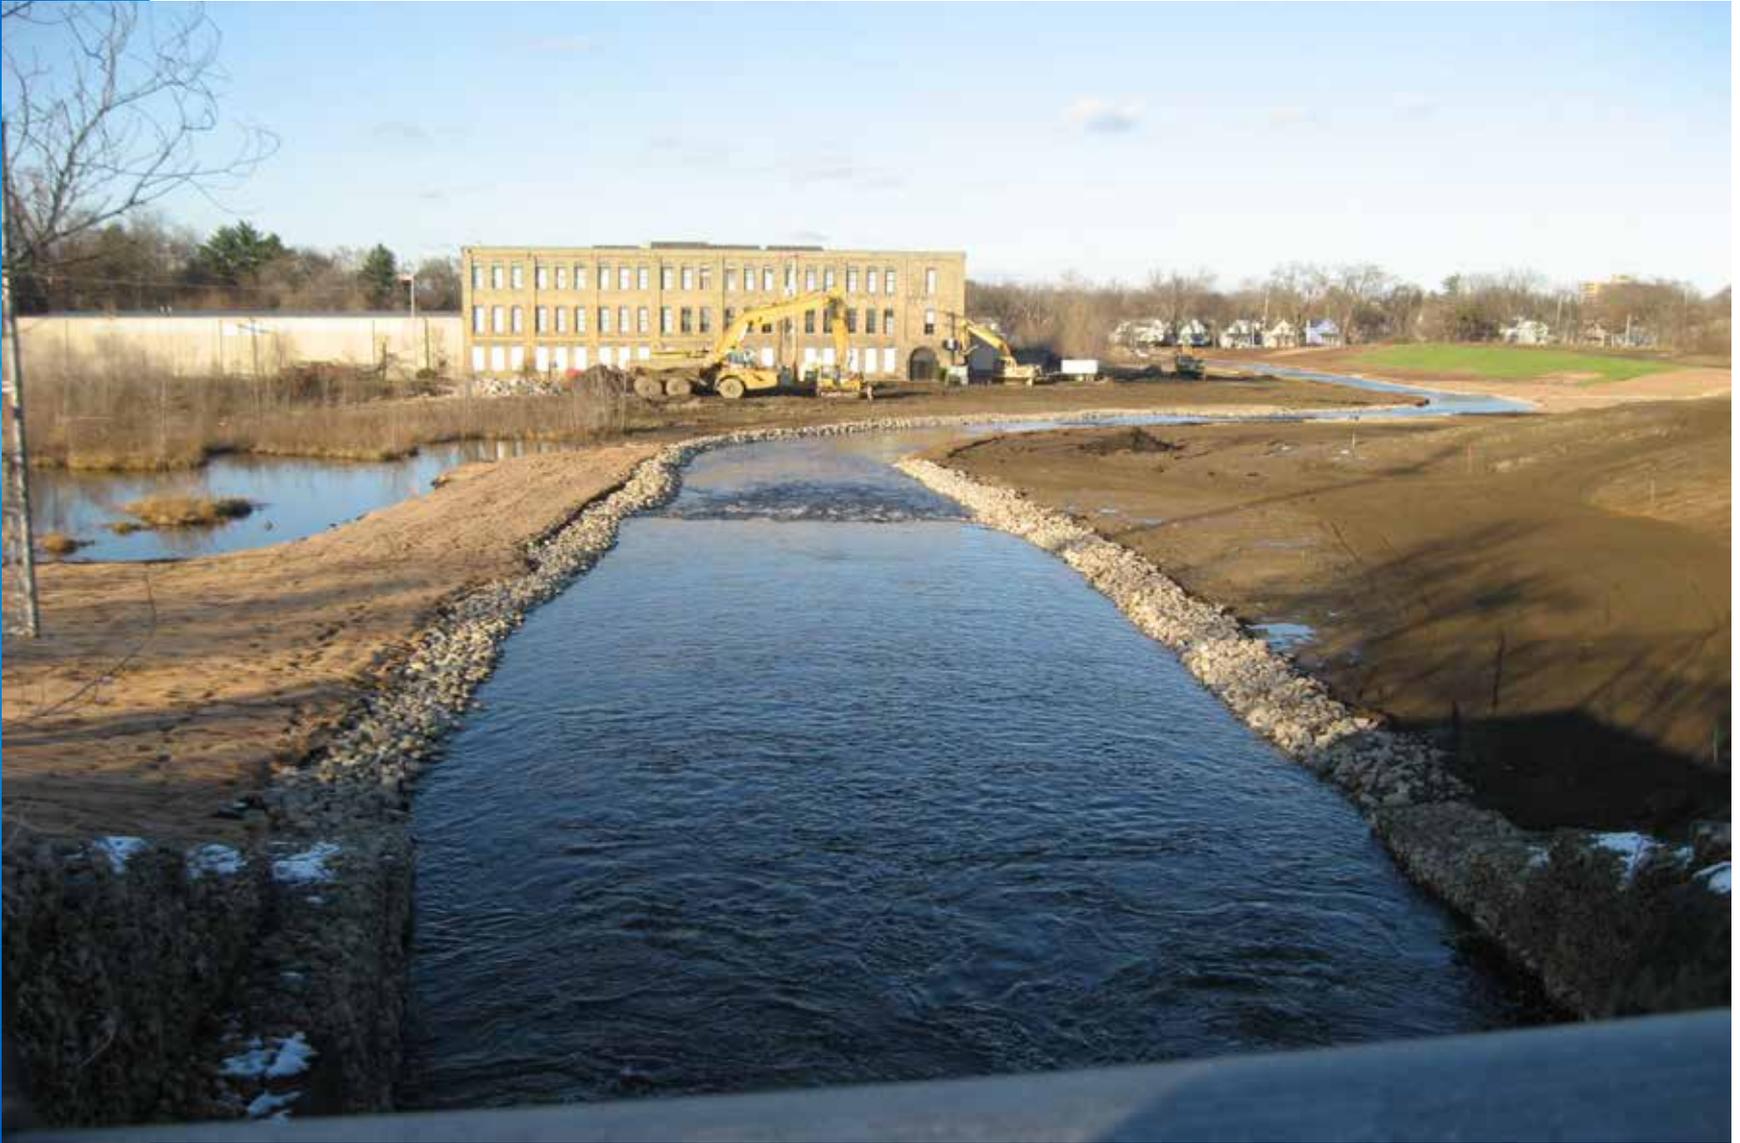
Completed creek channel as seen from Alcott Street (looking north)

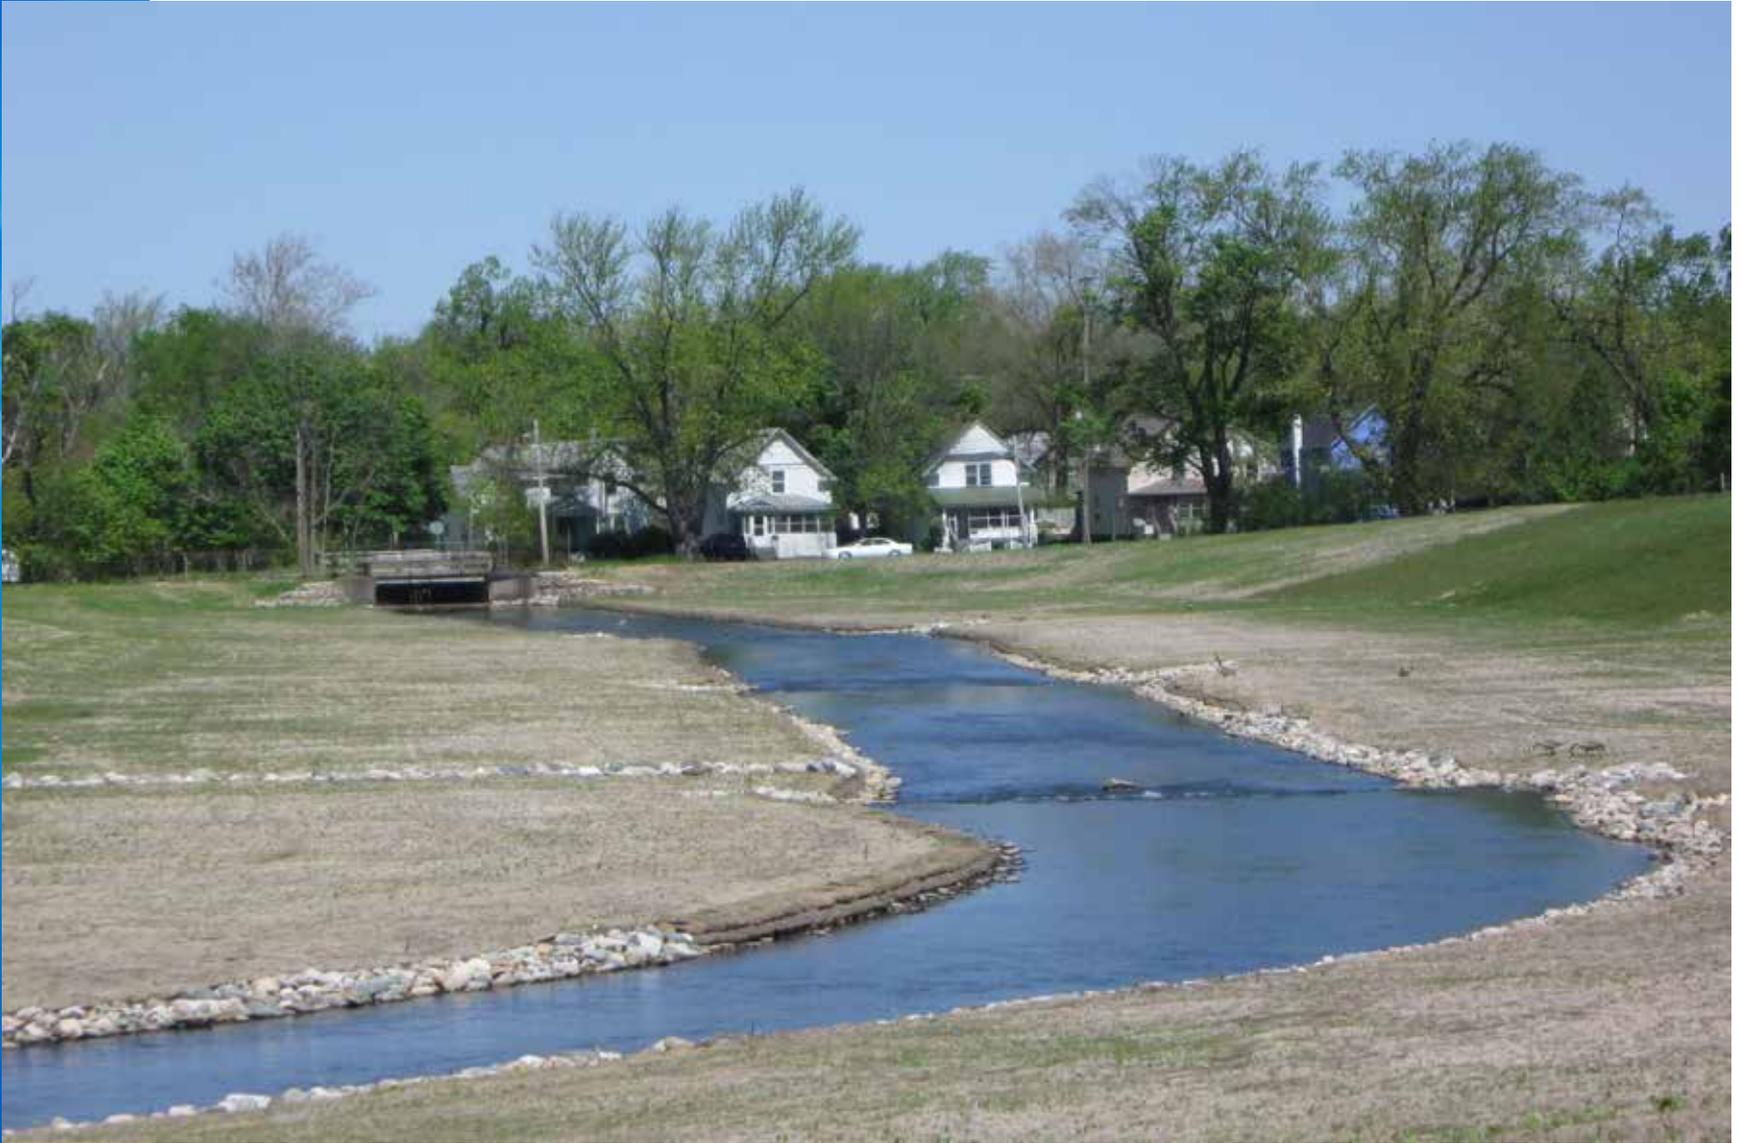
Restored creek channel and floodplain (looking north)

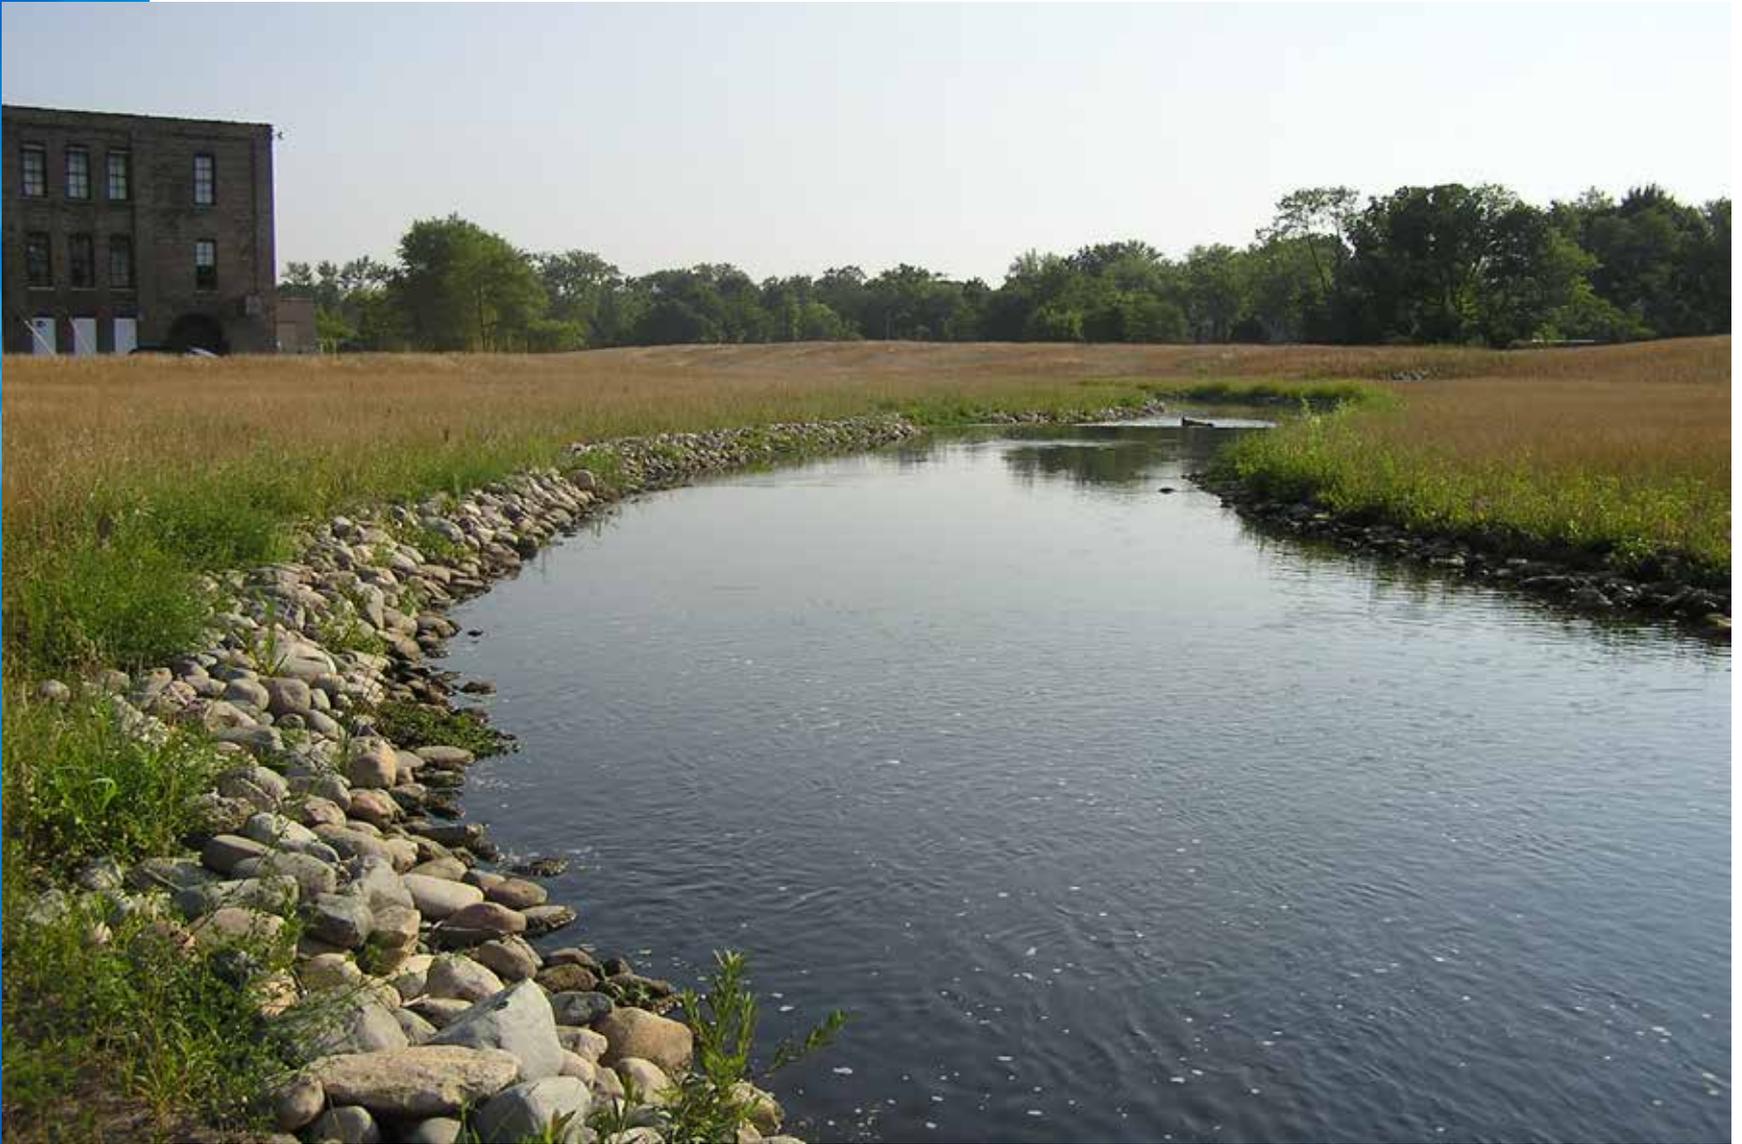
Restored creek channel (looking northeast)

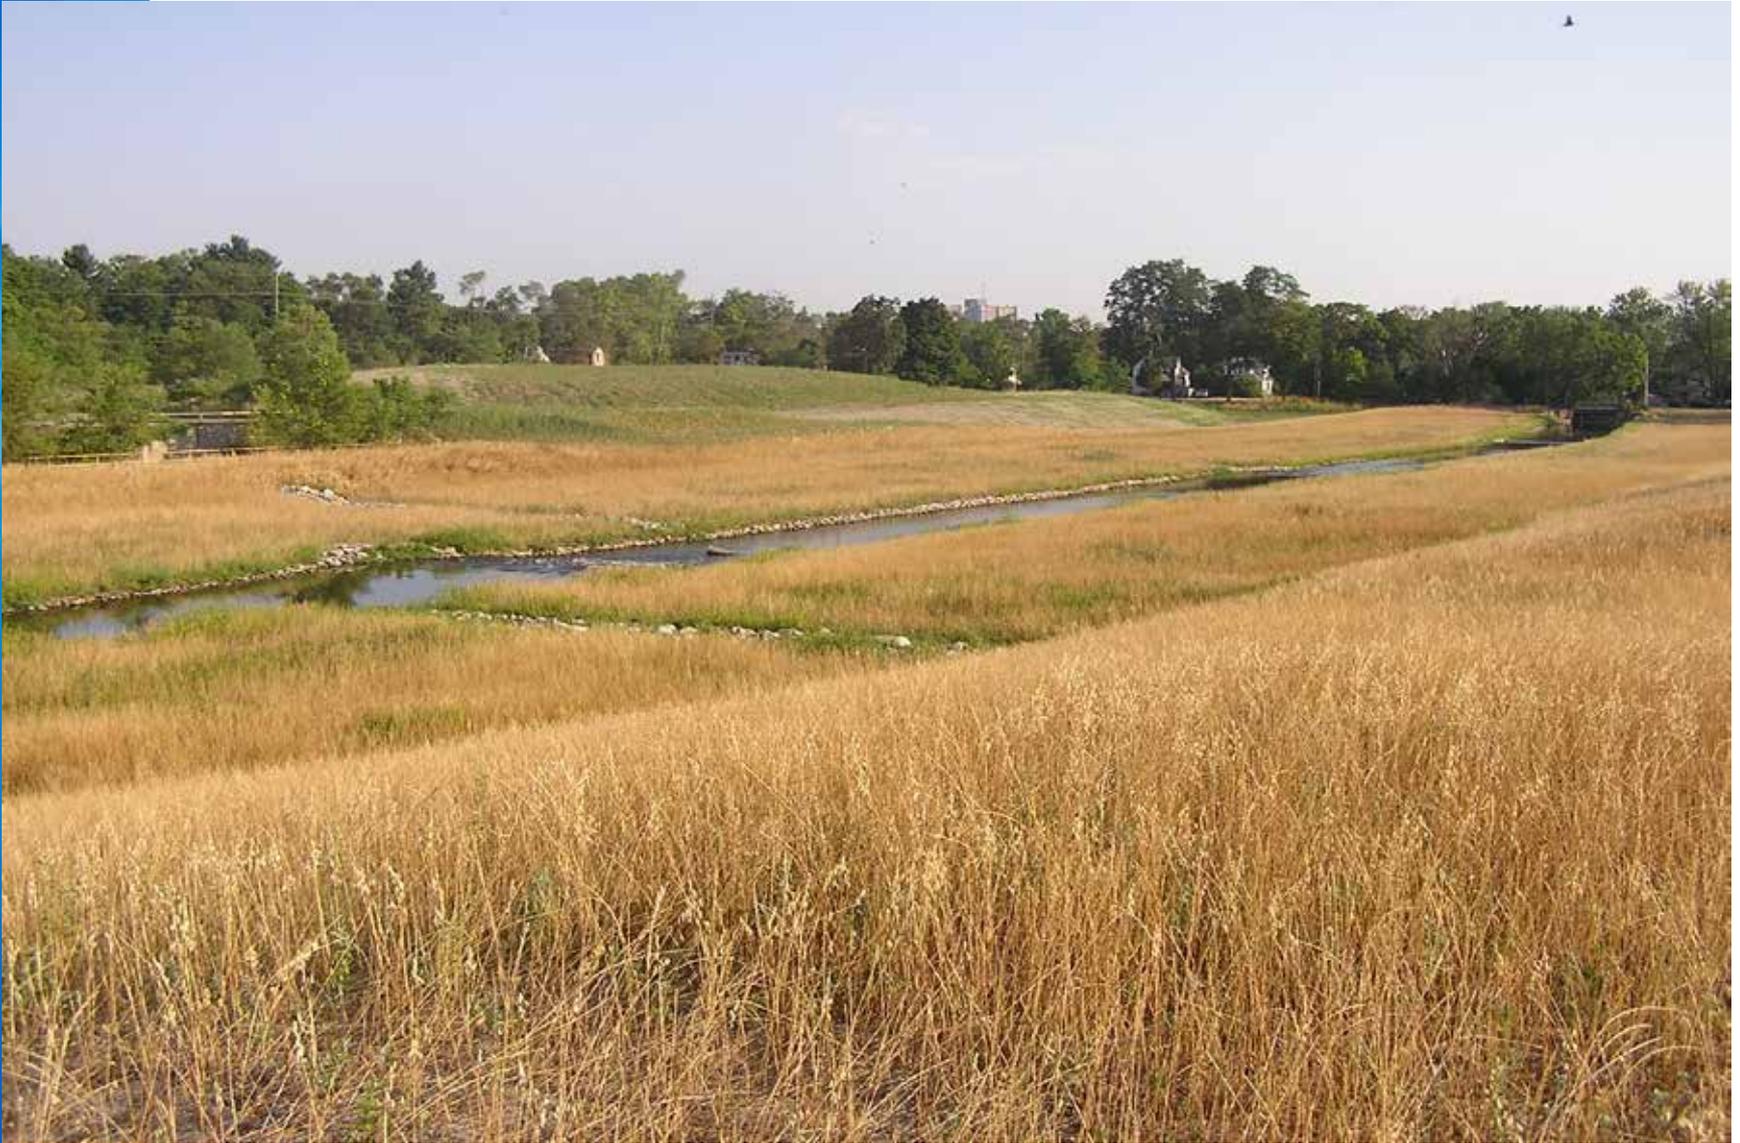
Restored creek channel and floodplain (looking northwest)

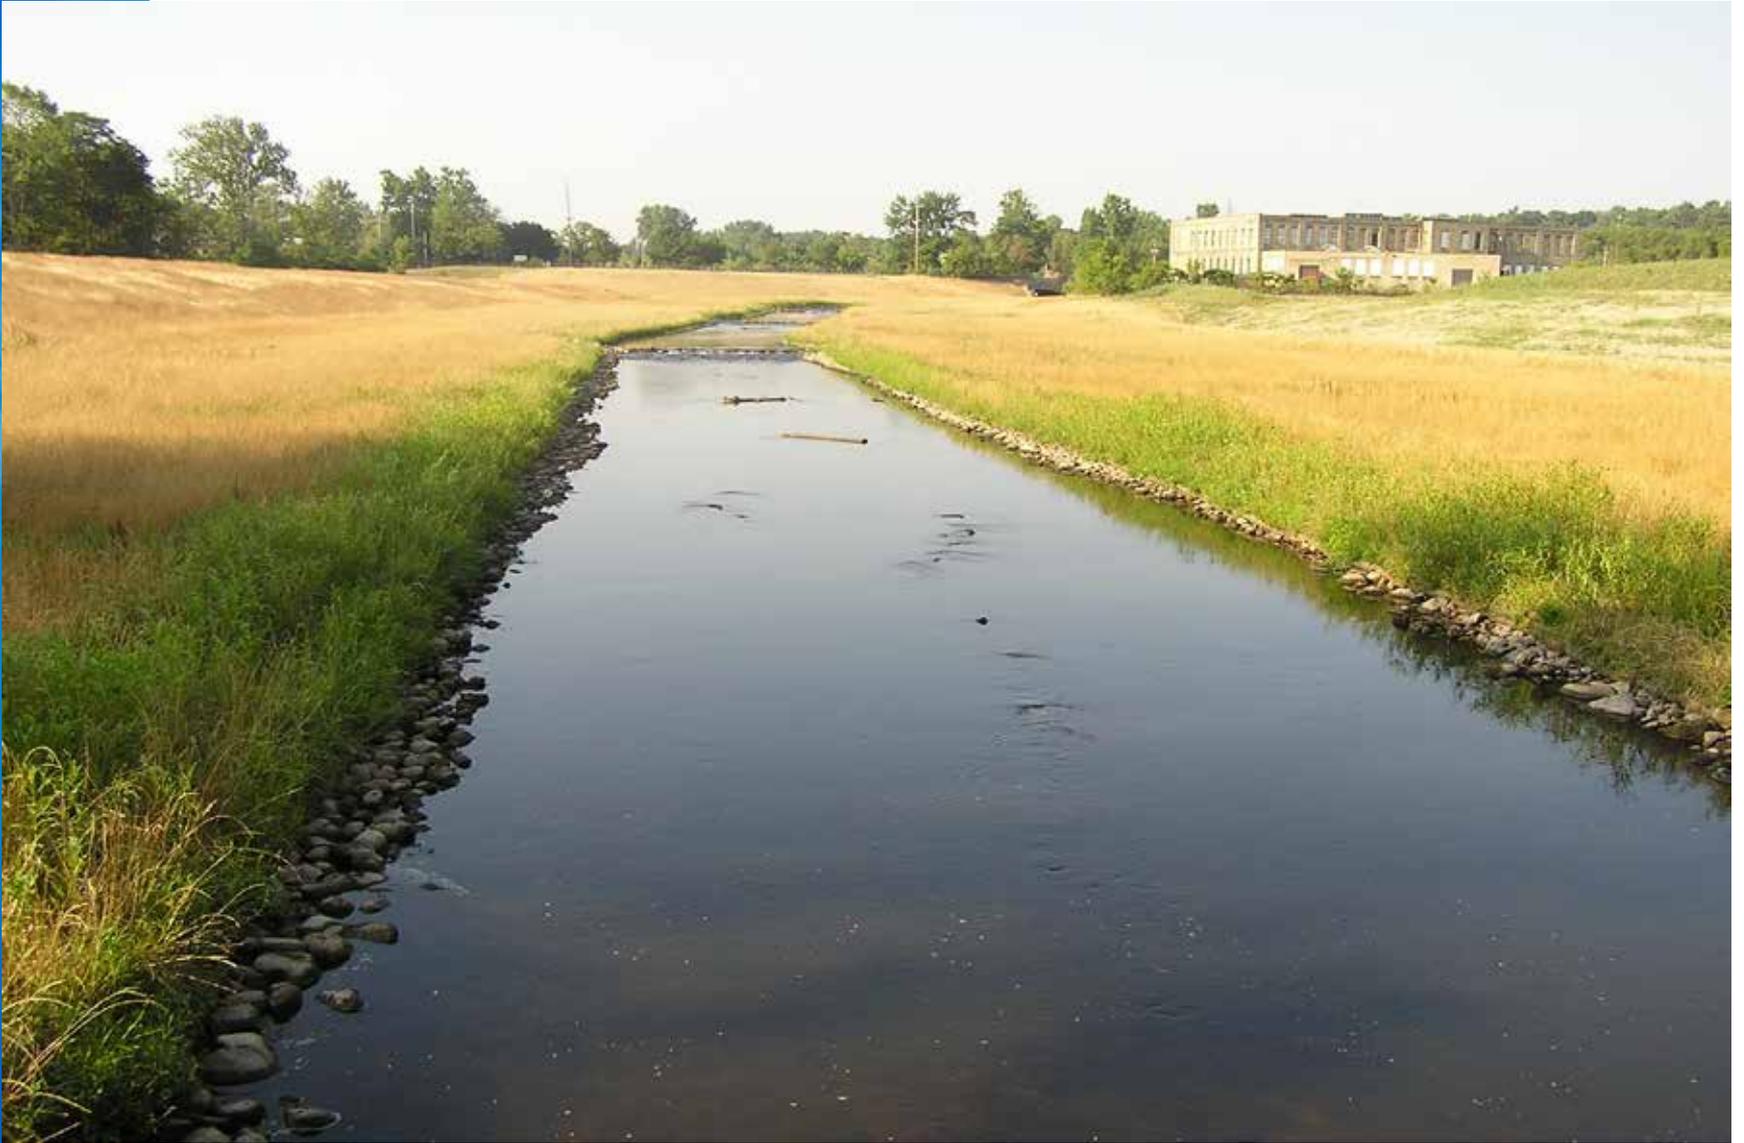
Restored creek channel and floodplain (looking south)
