DIFFICULT MITIGATIONS - AFTERNOON TECHNICAL SESSION

Joshua J. Kerber, MS
MN Dept. of Health

2015 MI Radon Stakeholder Workshop

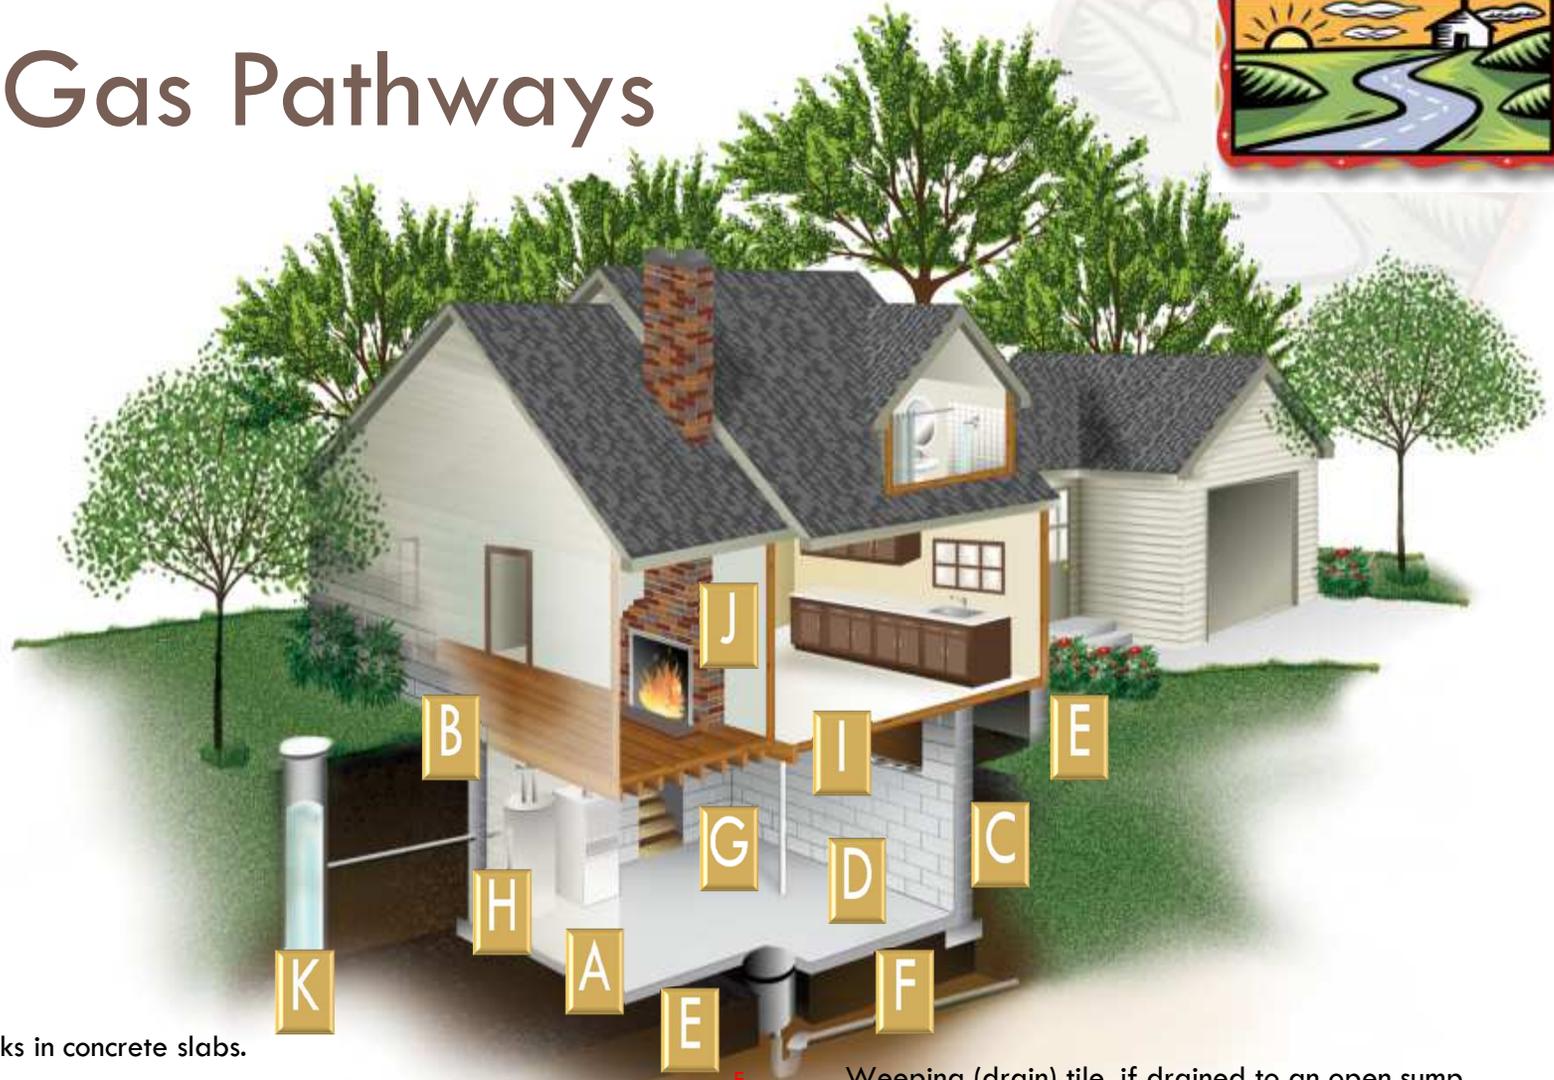
Soil Gas Pathways

- A. Cracks in concrete slabs.
- B. Spaces behind brick veneer walls that rest on uncapped hollow-block foundations.
- C. Pores and cracks in concrete blocks.
- D. Floor-wall joints (cold joints).
- E. Exposed soil, as in a sump or crawl space.
- F. Weeping (drain) tile, if drained to an open sump.
- G. Mortar joints.
- H. Loose fitting pipe penetrations.
- I. Open tops of block walls.
- J. Building materials, such as brick, concrete, rock.
- K. Well water (not commonly a major source in Minnesota homes)

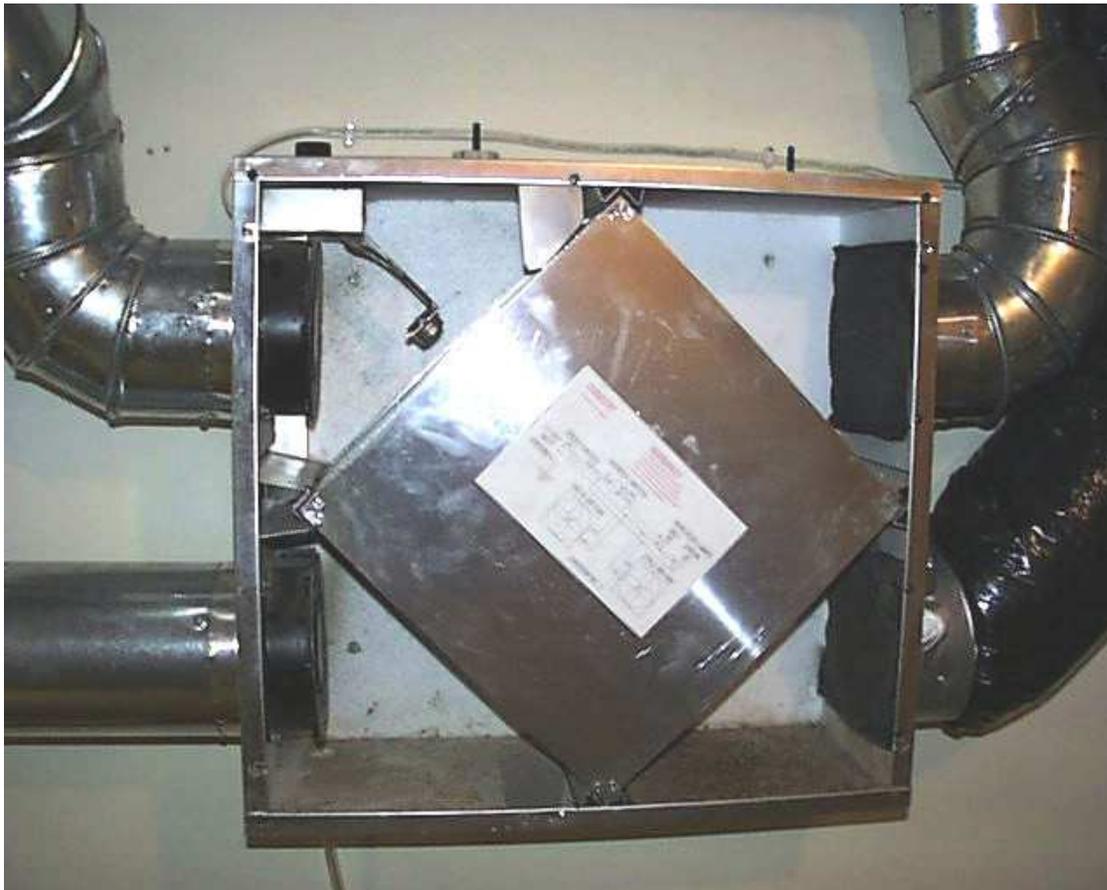
Why do all that, I have an HRV for that...

- Dilution Helps...a little bit
- Can cause more problems if not maintained

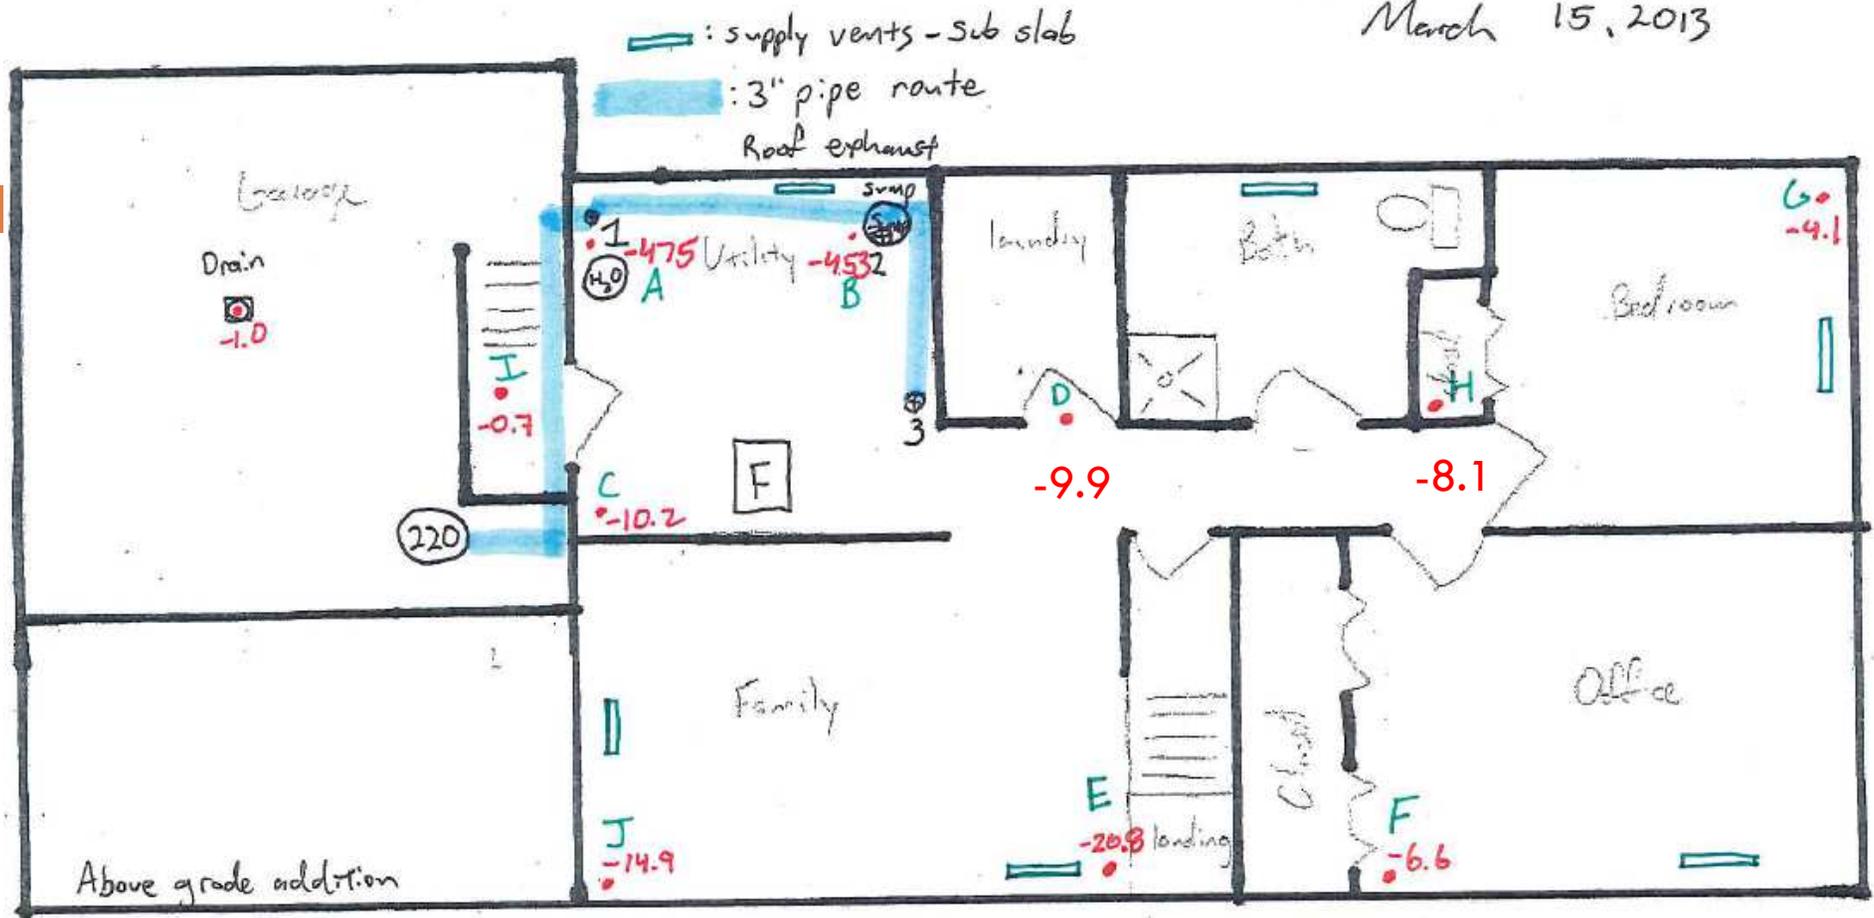
Is There an Air Leak?

System Specs upon arrival

- 3" pipe
- HP 220 @ 1.1" WC on U-tube
- 3 suction pts - 2 floor
- 1 Sump lid

Weather: Overcast
 Flurries
 25° F
 Snow Cover

Flows: SP1 = < 10 cfm
 SP2 = 26 cfm
 SP3 = < 10 cfm

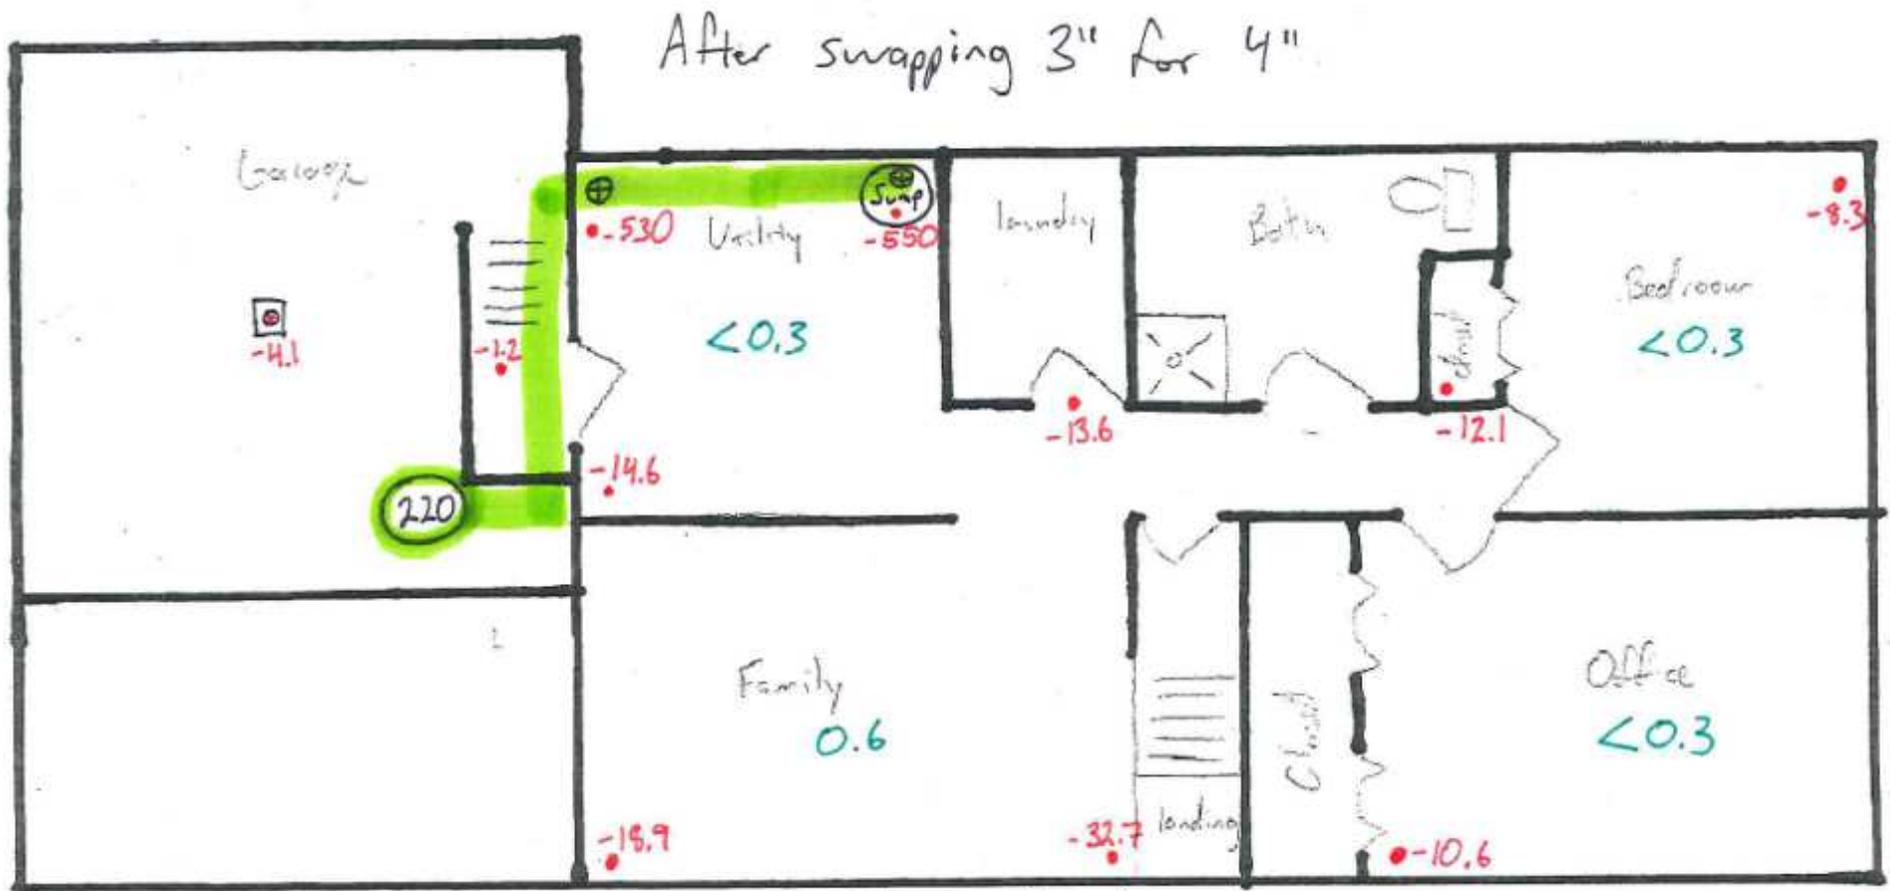
Final System Design

Flow increased to 120 cfm. U-tube ≈ 1.4

- Move more air
- Used same fan
- Increased pipe size to 4"
- Radon levels in heating season w/ snow cover:
 - ▣ < 0.3 – 0.6 pCi/L

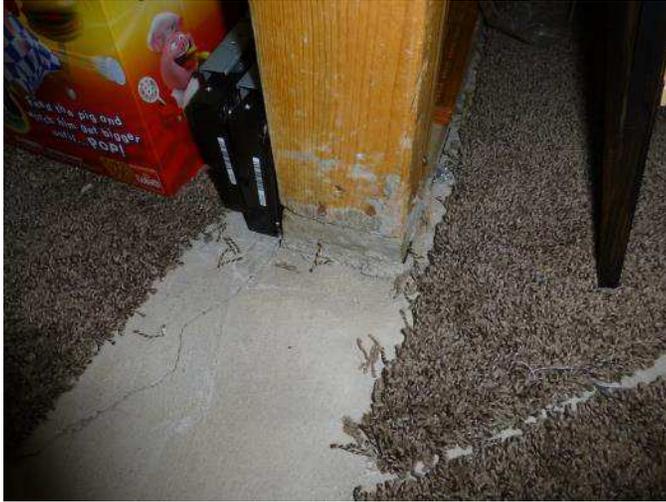
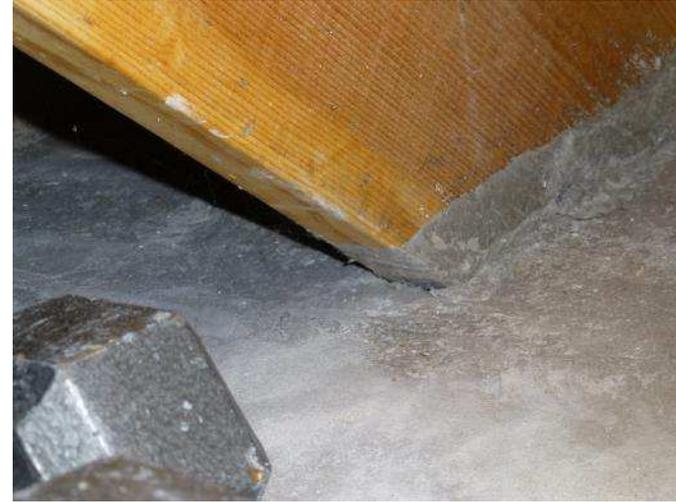
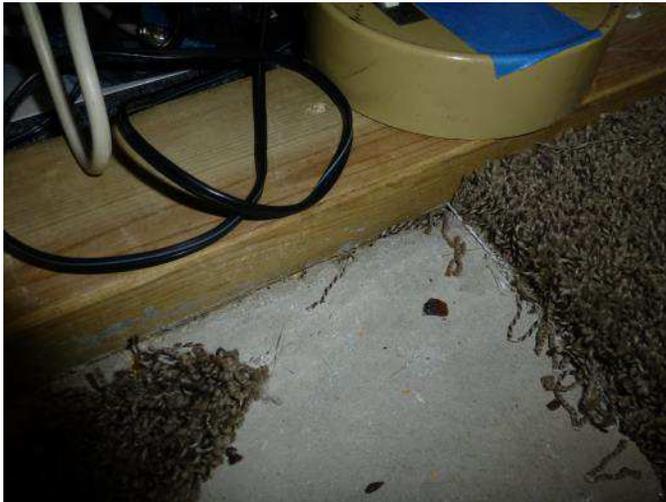
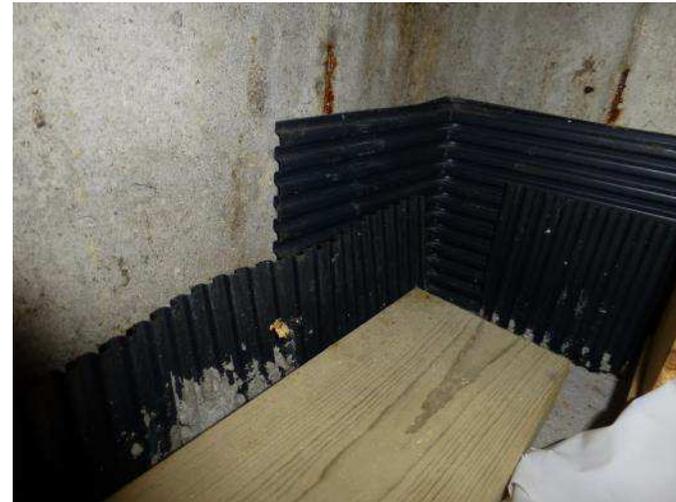
On-Site Building Inspection: Air Leaks

- Air Leaks
- Depressurization sources
 - ▣ HRV and ducts – unsealed, but insulated
 - ▣ Furnace ducts - unsealed
 - ▣ Exhaust fans

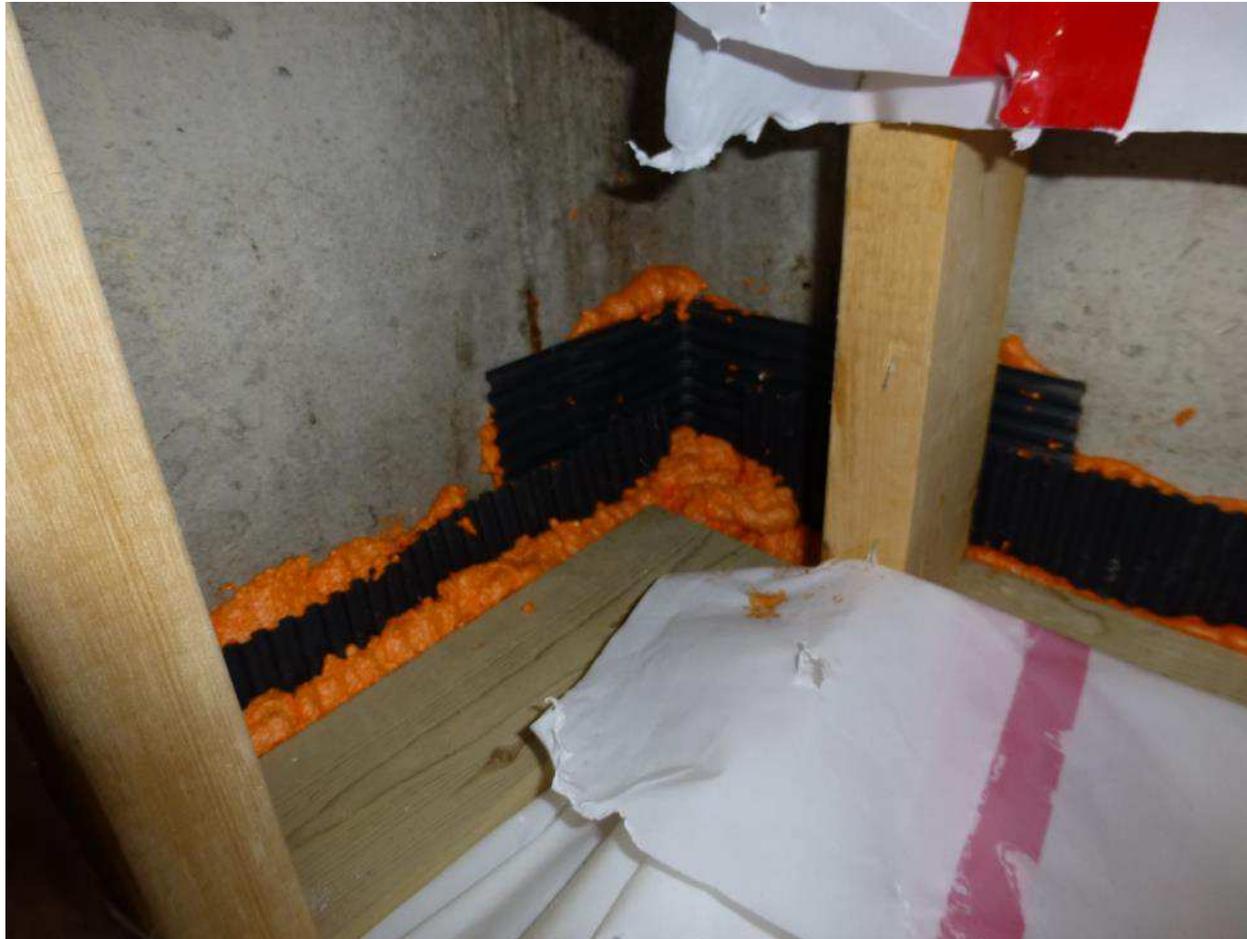
Sealing Leaks

- Crawlspace
- Utility room
- Sump

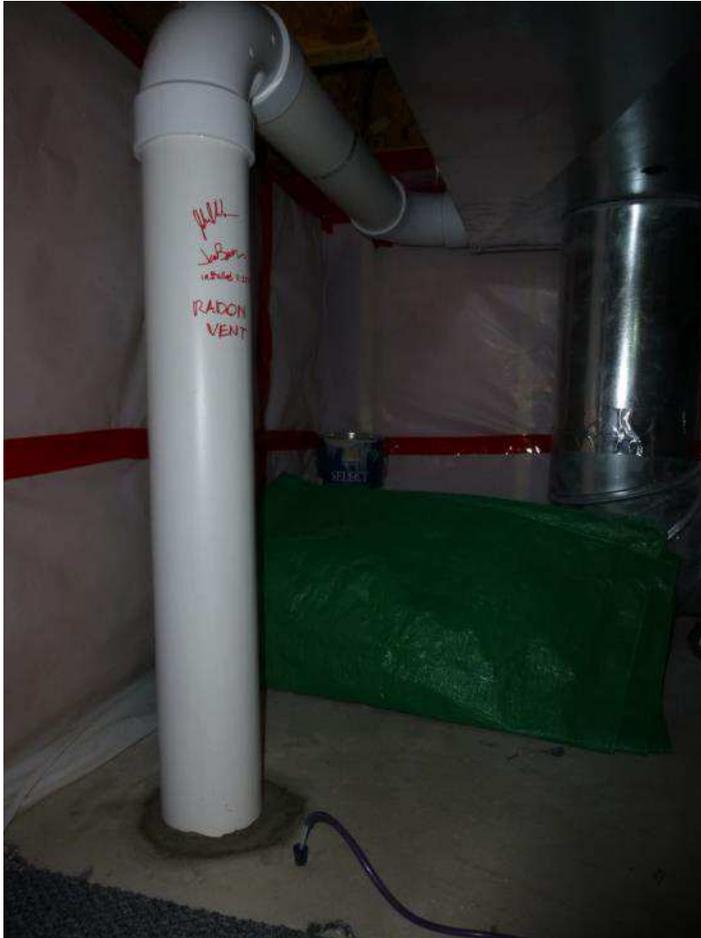
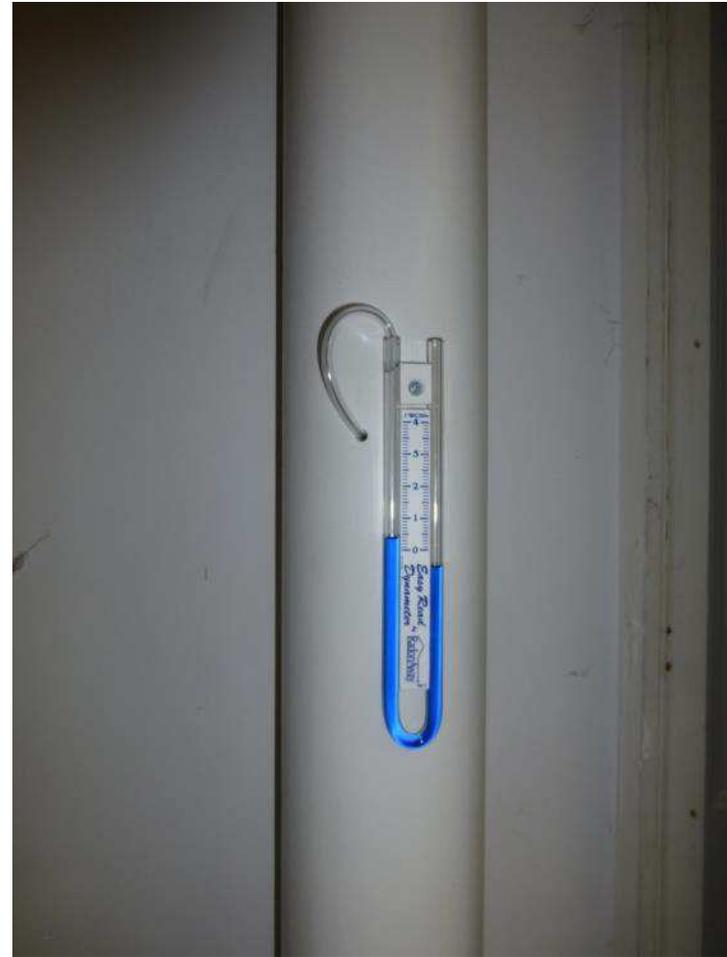
Final System Install

ΔP in Pascals			
DTH	Vac @ C	Vac @ D	<u>RP140</u> @ D
1	--	--	--
2	-0.1	-0.3	-0.3
3	-0.1	-0.4	-0.2
4	-9.0	-14	-15
5	-14.2	-23	-24.2
6	-17.0	-28	-29.1
7	-134	-76	-77.7
Flow	80 cfm	60 cfm	55 cfm
