Drainage Improvement Case Study

Niagara
Development
Landfill

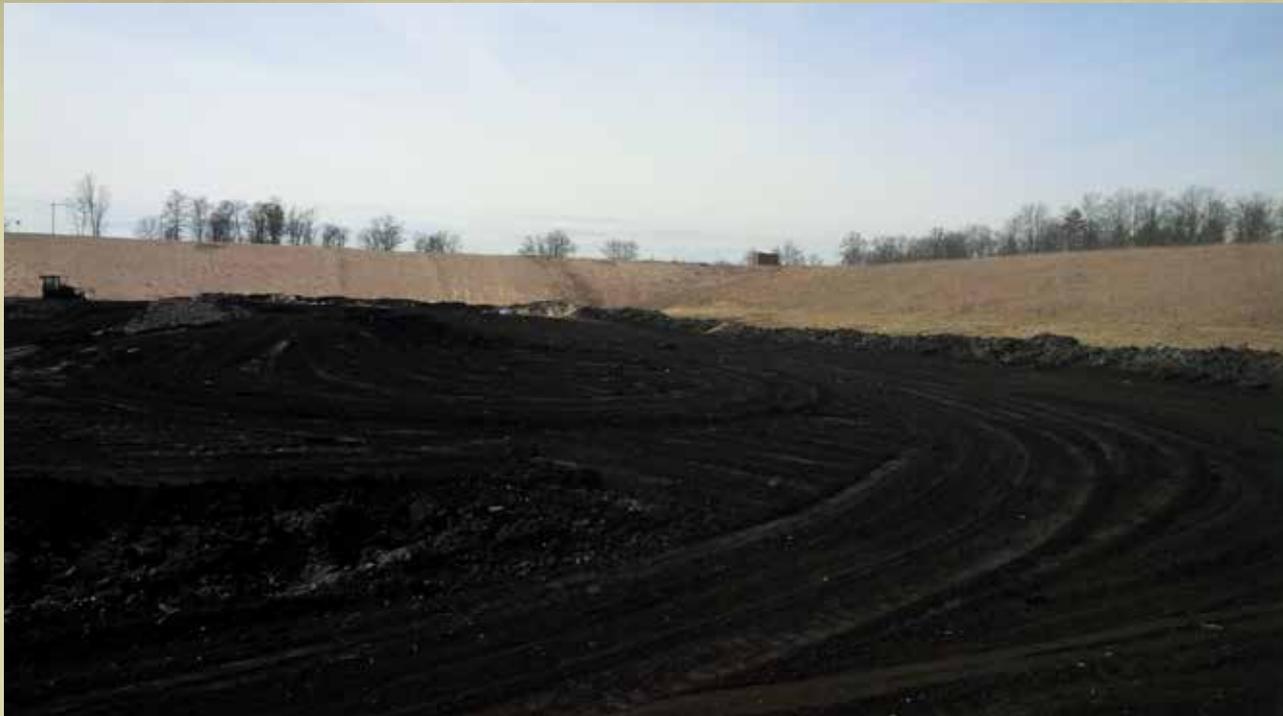
Niagara Development Landfill

- Initial source of waste largely consisted of foundry sand.

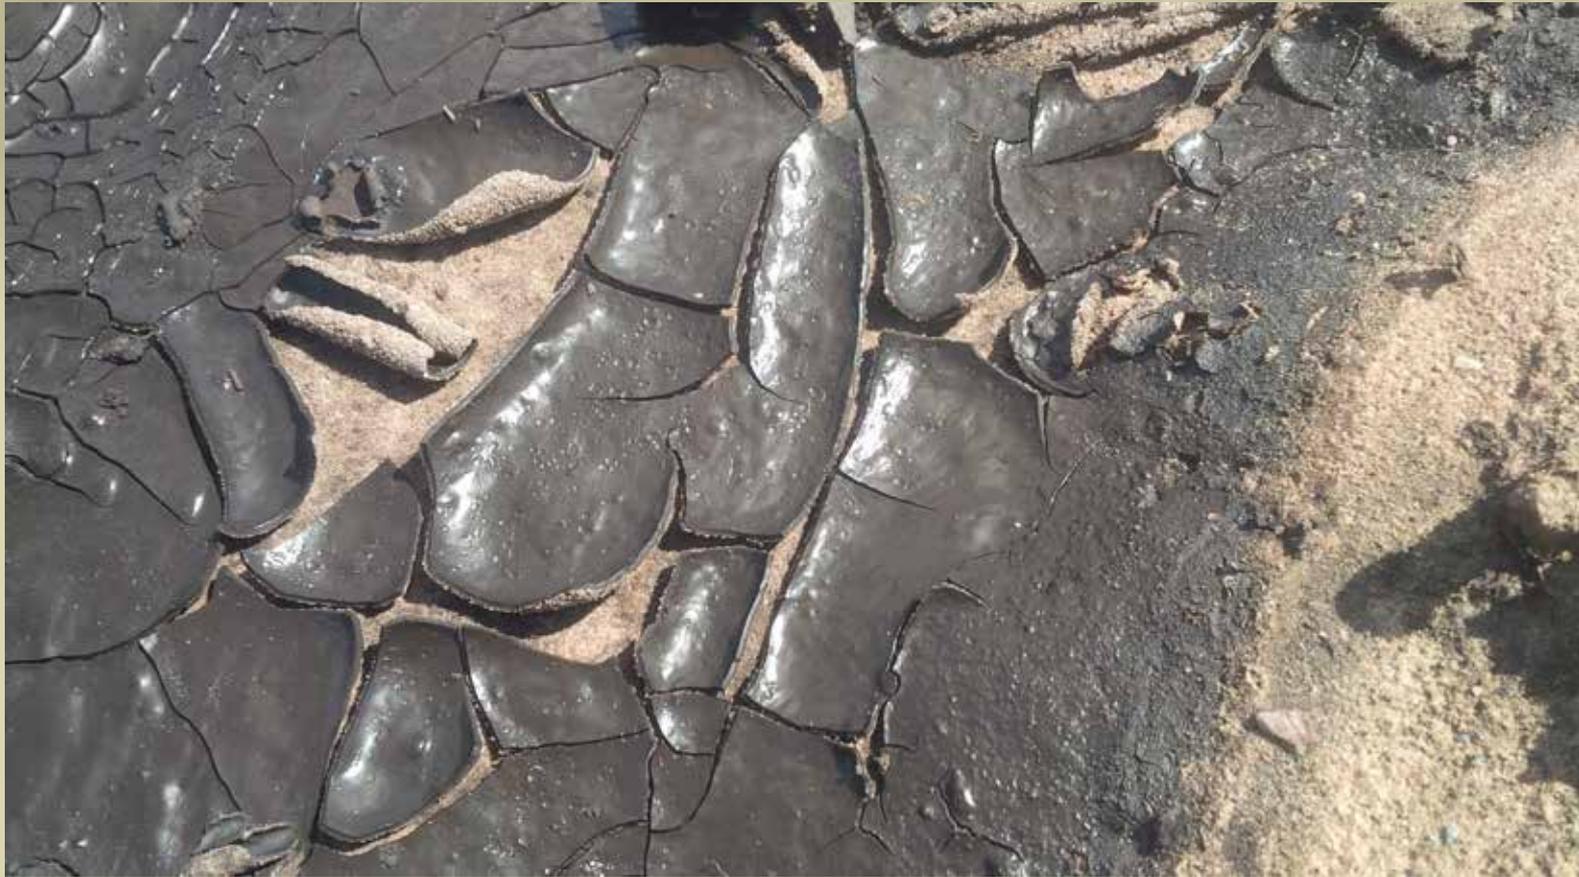
Cause – Foundry Sand Binder

Bentonite / Kaolinite

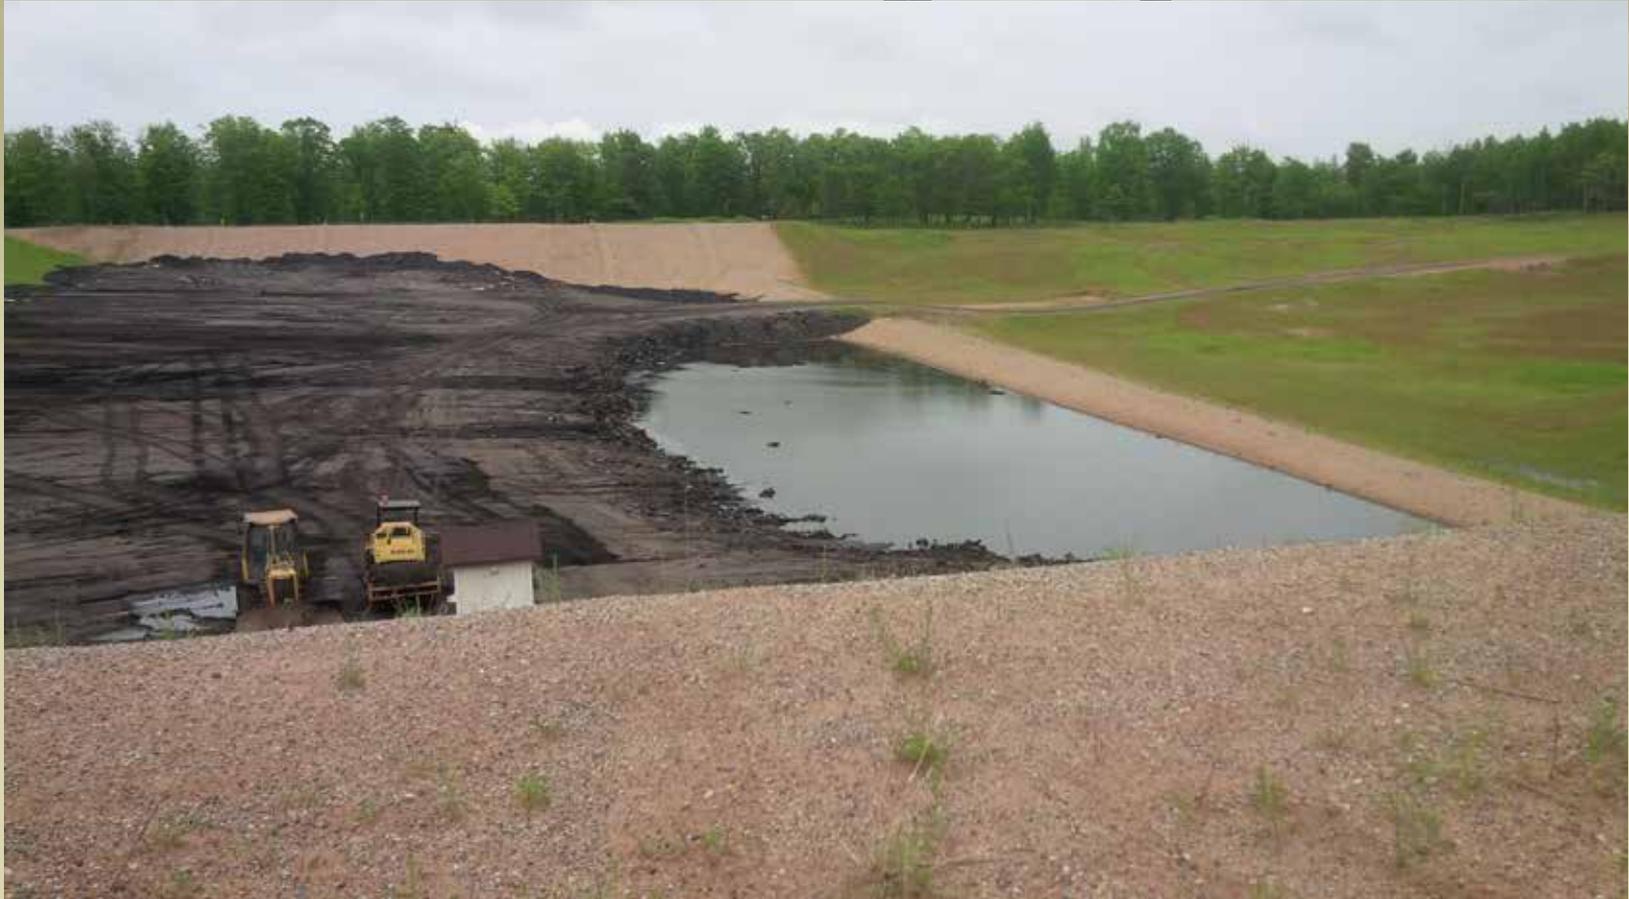
Effect – Sealing the surface of the drainage layer

1. Restore conditions of the drainage layer.
2. Limit potential for future occurrences.
