***Technical Memorandum for:***

**Compilation and Interpretation of Key Historic Studies  
Abandoned Mining Wastes - Torch Lake non-Superfund  
Site**

**November 2014**

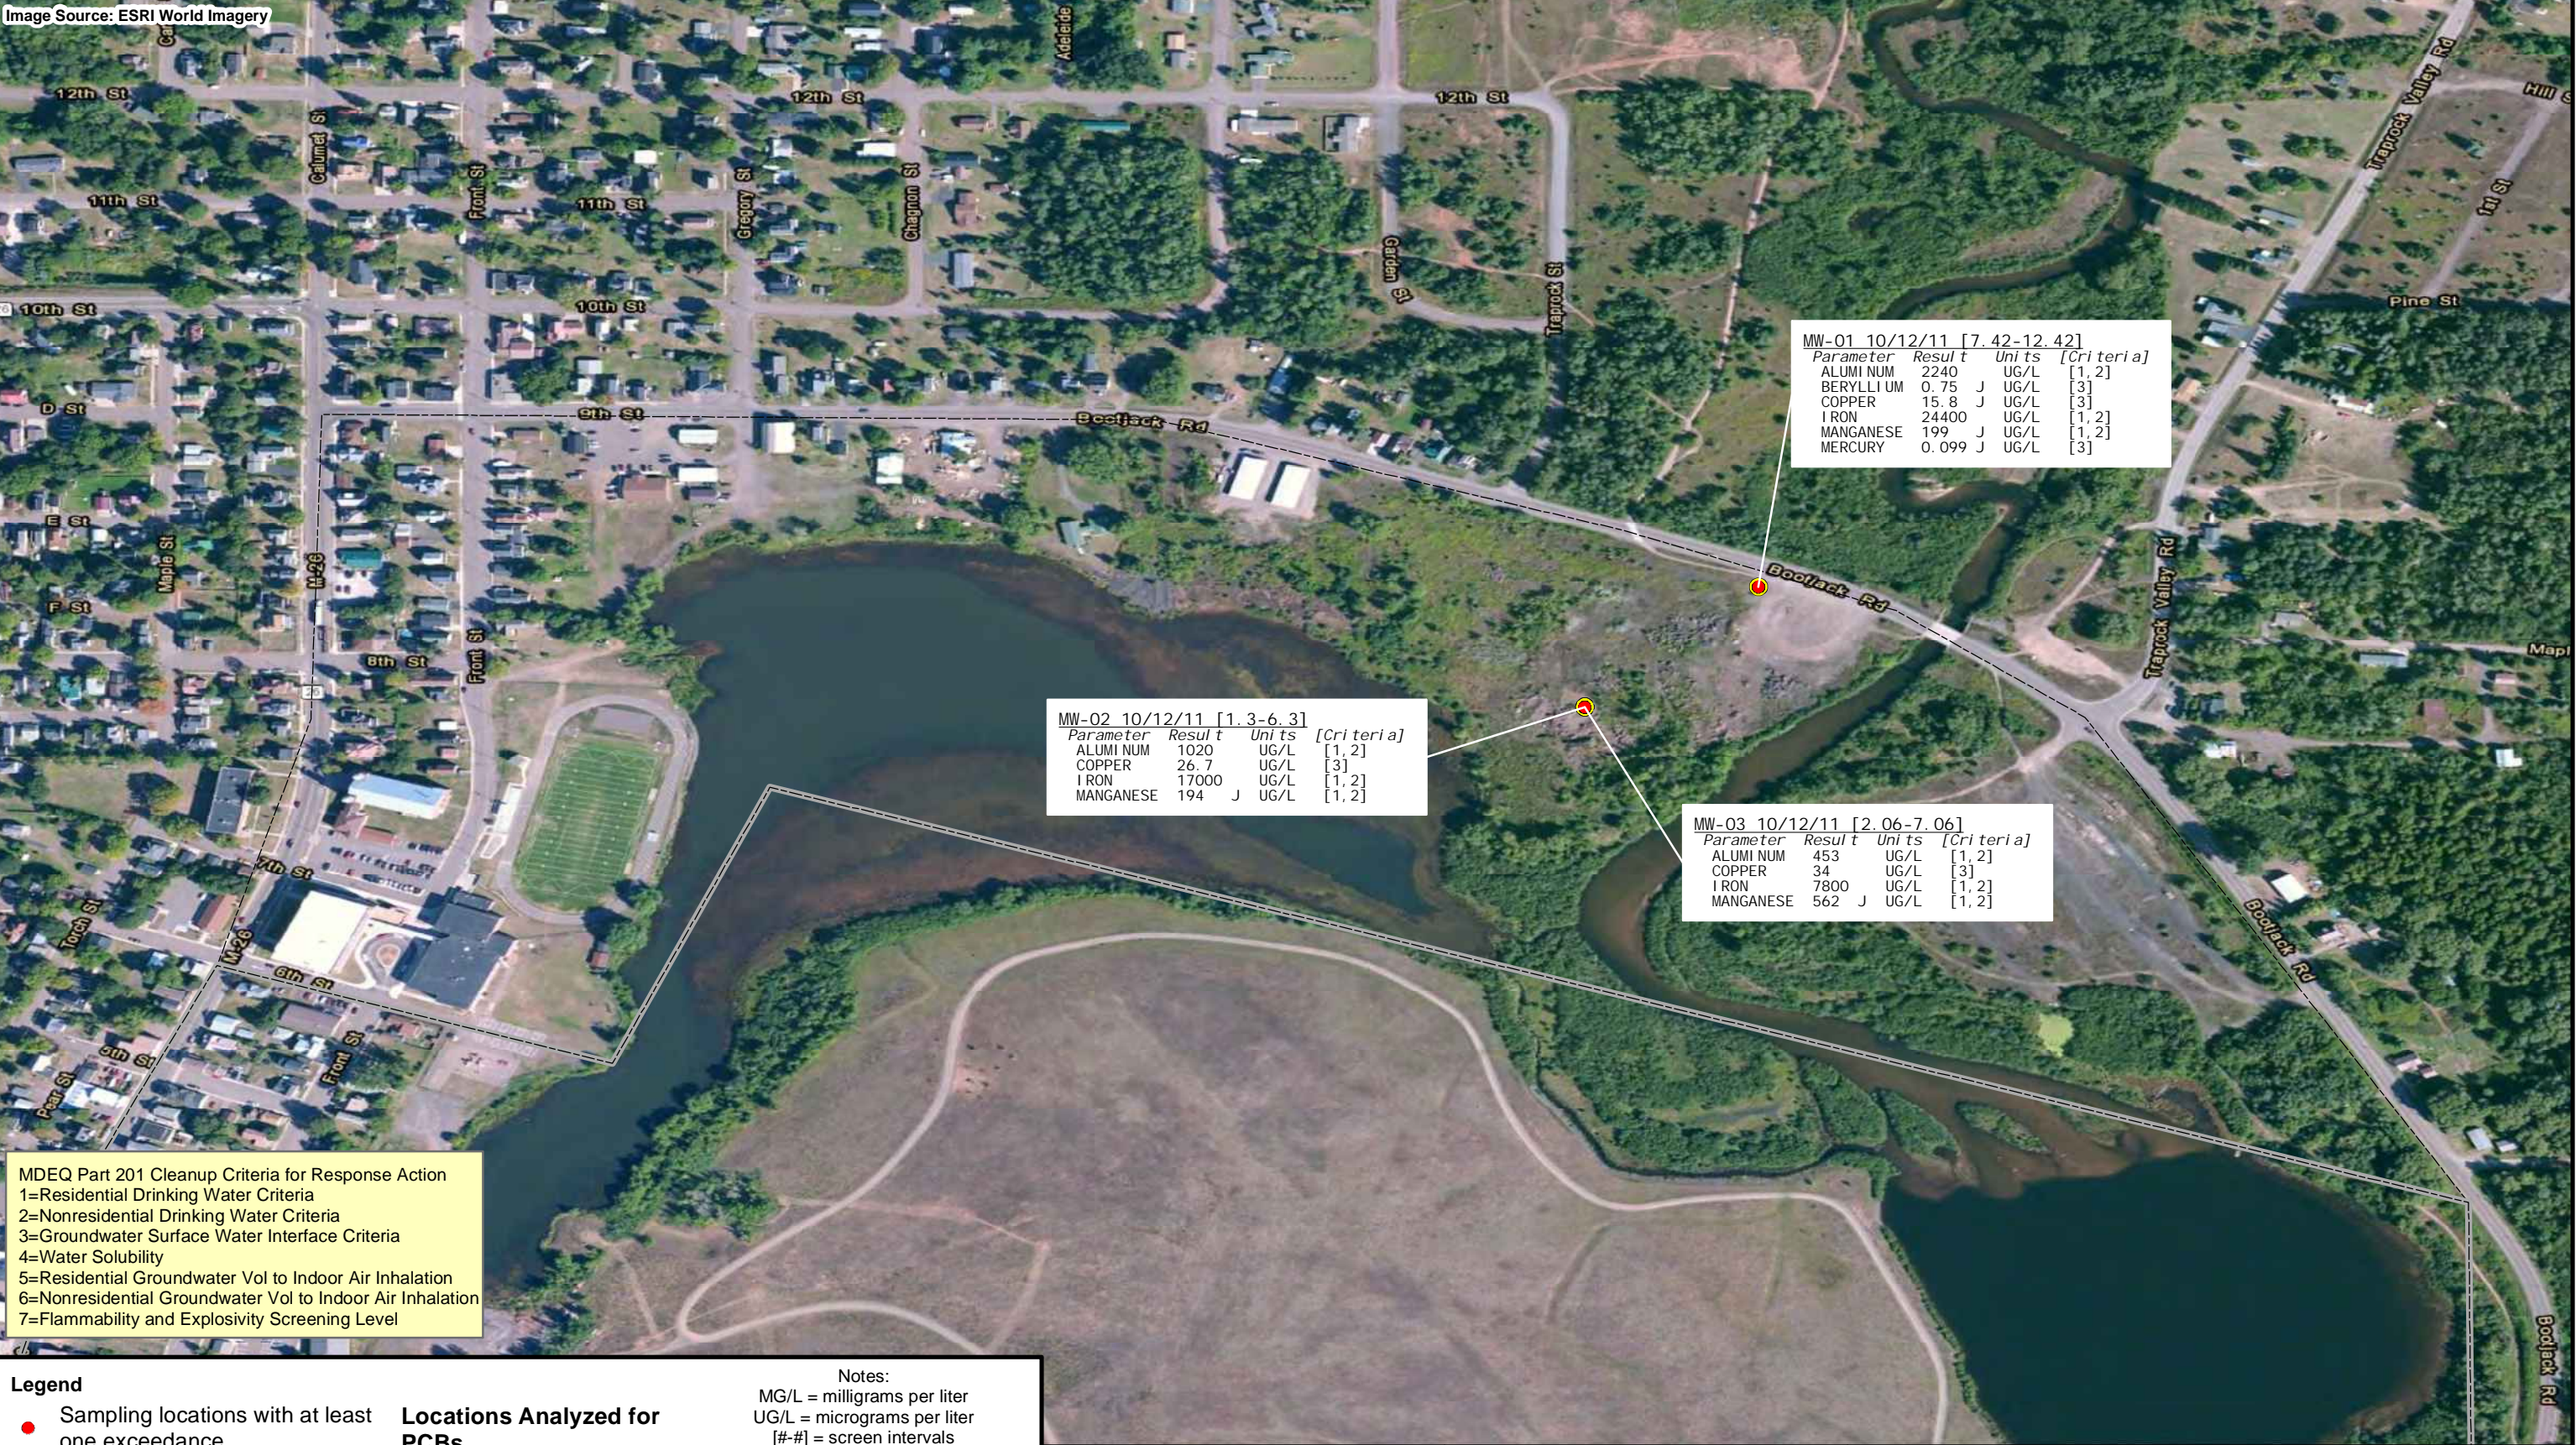
**Figure 5**  
Groundwater Sample Location Map - Torch Lake Backwater Area  
C & H Lake Linden Operations  
Lake Linden, Houghton County, Michigan

MW-01 10/12/11 [7.42-12.42]

Parameter	Result	Units	Criteria
ALUMI NUM	2240	UG/L	[1, 2]
BERYLLIUM	0.75	J UG/L	[3]
COPPER	15.8	J UG/L	[3]
IRON	24400	UG/L	[1, 2]
MANGANESE	199	J UG/L	[1, 2]
MERCURY	0.099	J UG/L	[3]

- **Figure 3:** Soil Sample Location Map – Torch Lake Backwater Area;
- **Figure 4:** Soil Screening Location Map – Torch Lake Backwater Area;
- **Figure 5:** Groundwater Sampling Location Map – Torch Lake Backwater Area;

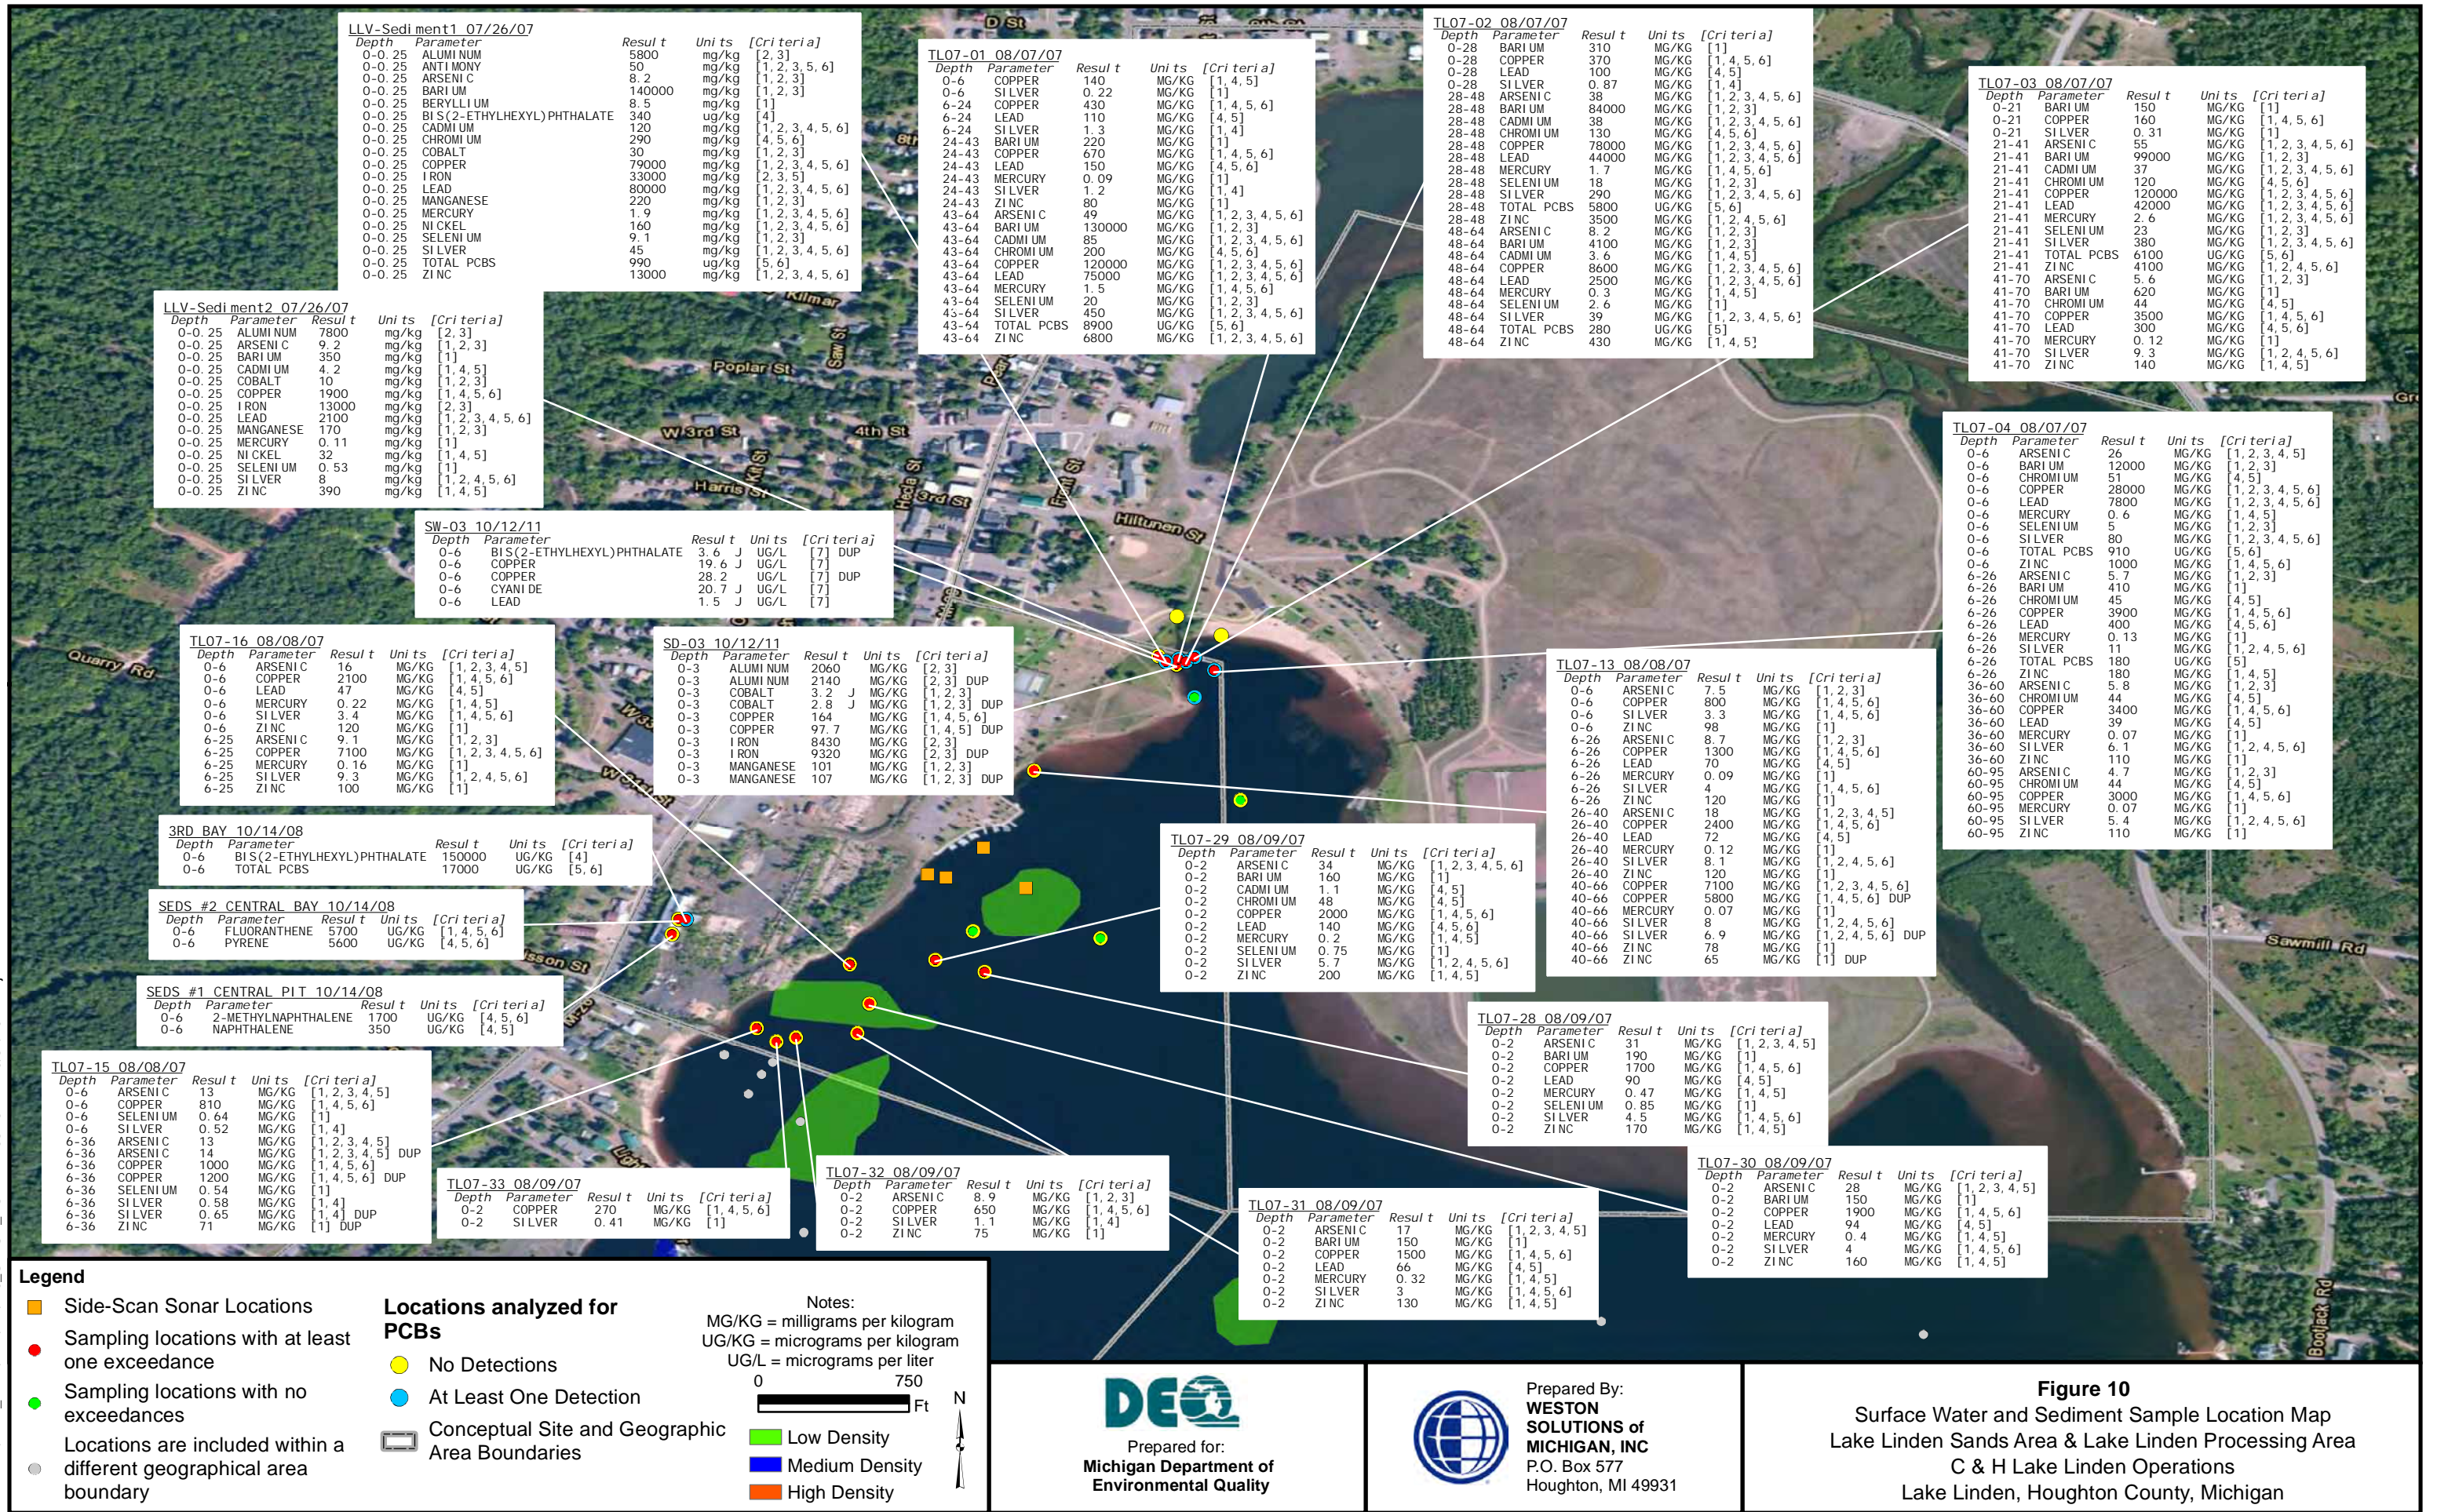
**Figure 11**  
Soil Sample Location Map -  
Hubbell Coal Dock Area & Hubbell Smelter Area  
C & H Lake Linden Operations  
Lake Linden, Houghton County, Michigan

SS-17 10/11/11					
Depth	Parameter	Result	Units	[Criteria]	
0-8	ANTIMONY	5.1	MG/KG	[2, 4, 11]	
0-8	ARSENIC	134	MG/KG	[1, 2, 4, 10, 11, 17]	
0-8	CADMIUM	1.5	MG/KG	[1]	
0-8	COBALT	12	MG/KG	[1, 2, 4, 11]	
0-8	COPPER	24500	J	MG/KG [1, 2, 4, 10, 11]	
0-8	CYANIDE	0.36	J	MG/KG [2]	
0-8	IRON	12500	J	MG/KG [1, 4, 11]	
0-8	LEAD	267	MG/KG	[1]	
0-8	NICKEL	102	MG/KG	[1, 2, 4, 11]	
0-8	SELENIUM	0.74	J	MG/KG [1, 2]	
0-8	SILVER	2.6	MG/KG	[1, 2]	
0-8	ZINC	2310	J	MG/KG [1, 2]

- **Figure 10:** Surface Water and Sediment Sample Location Map – Lake Linden Sands and Lake Linden Processing Area;
- **Figure 11:** Soil Sample Location Map – Hubbell Coal Dock and Hubbell Smelter Area;

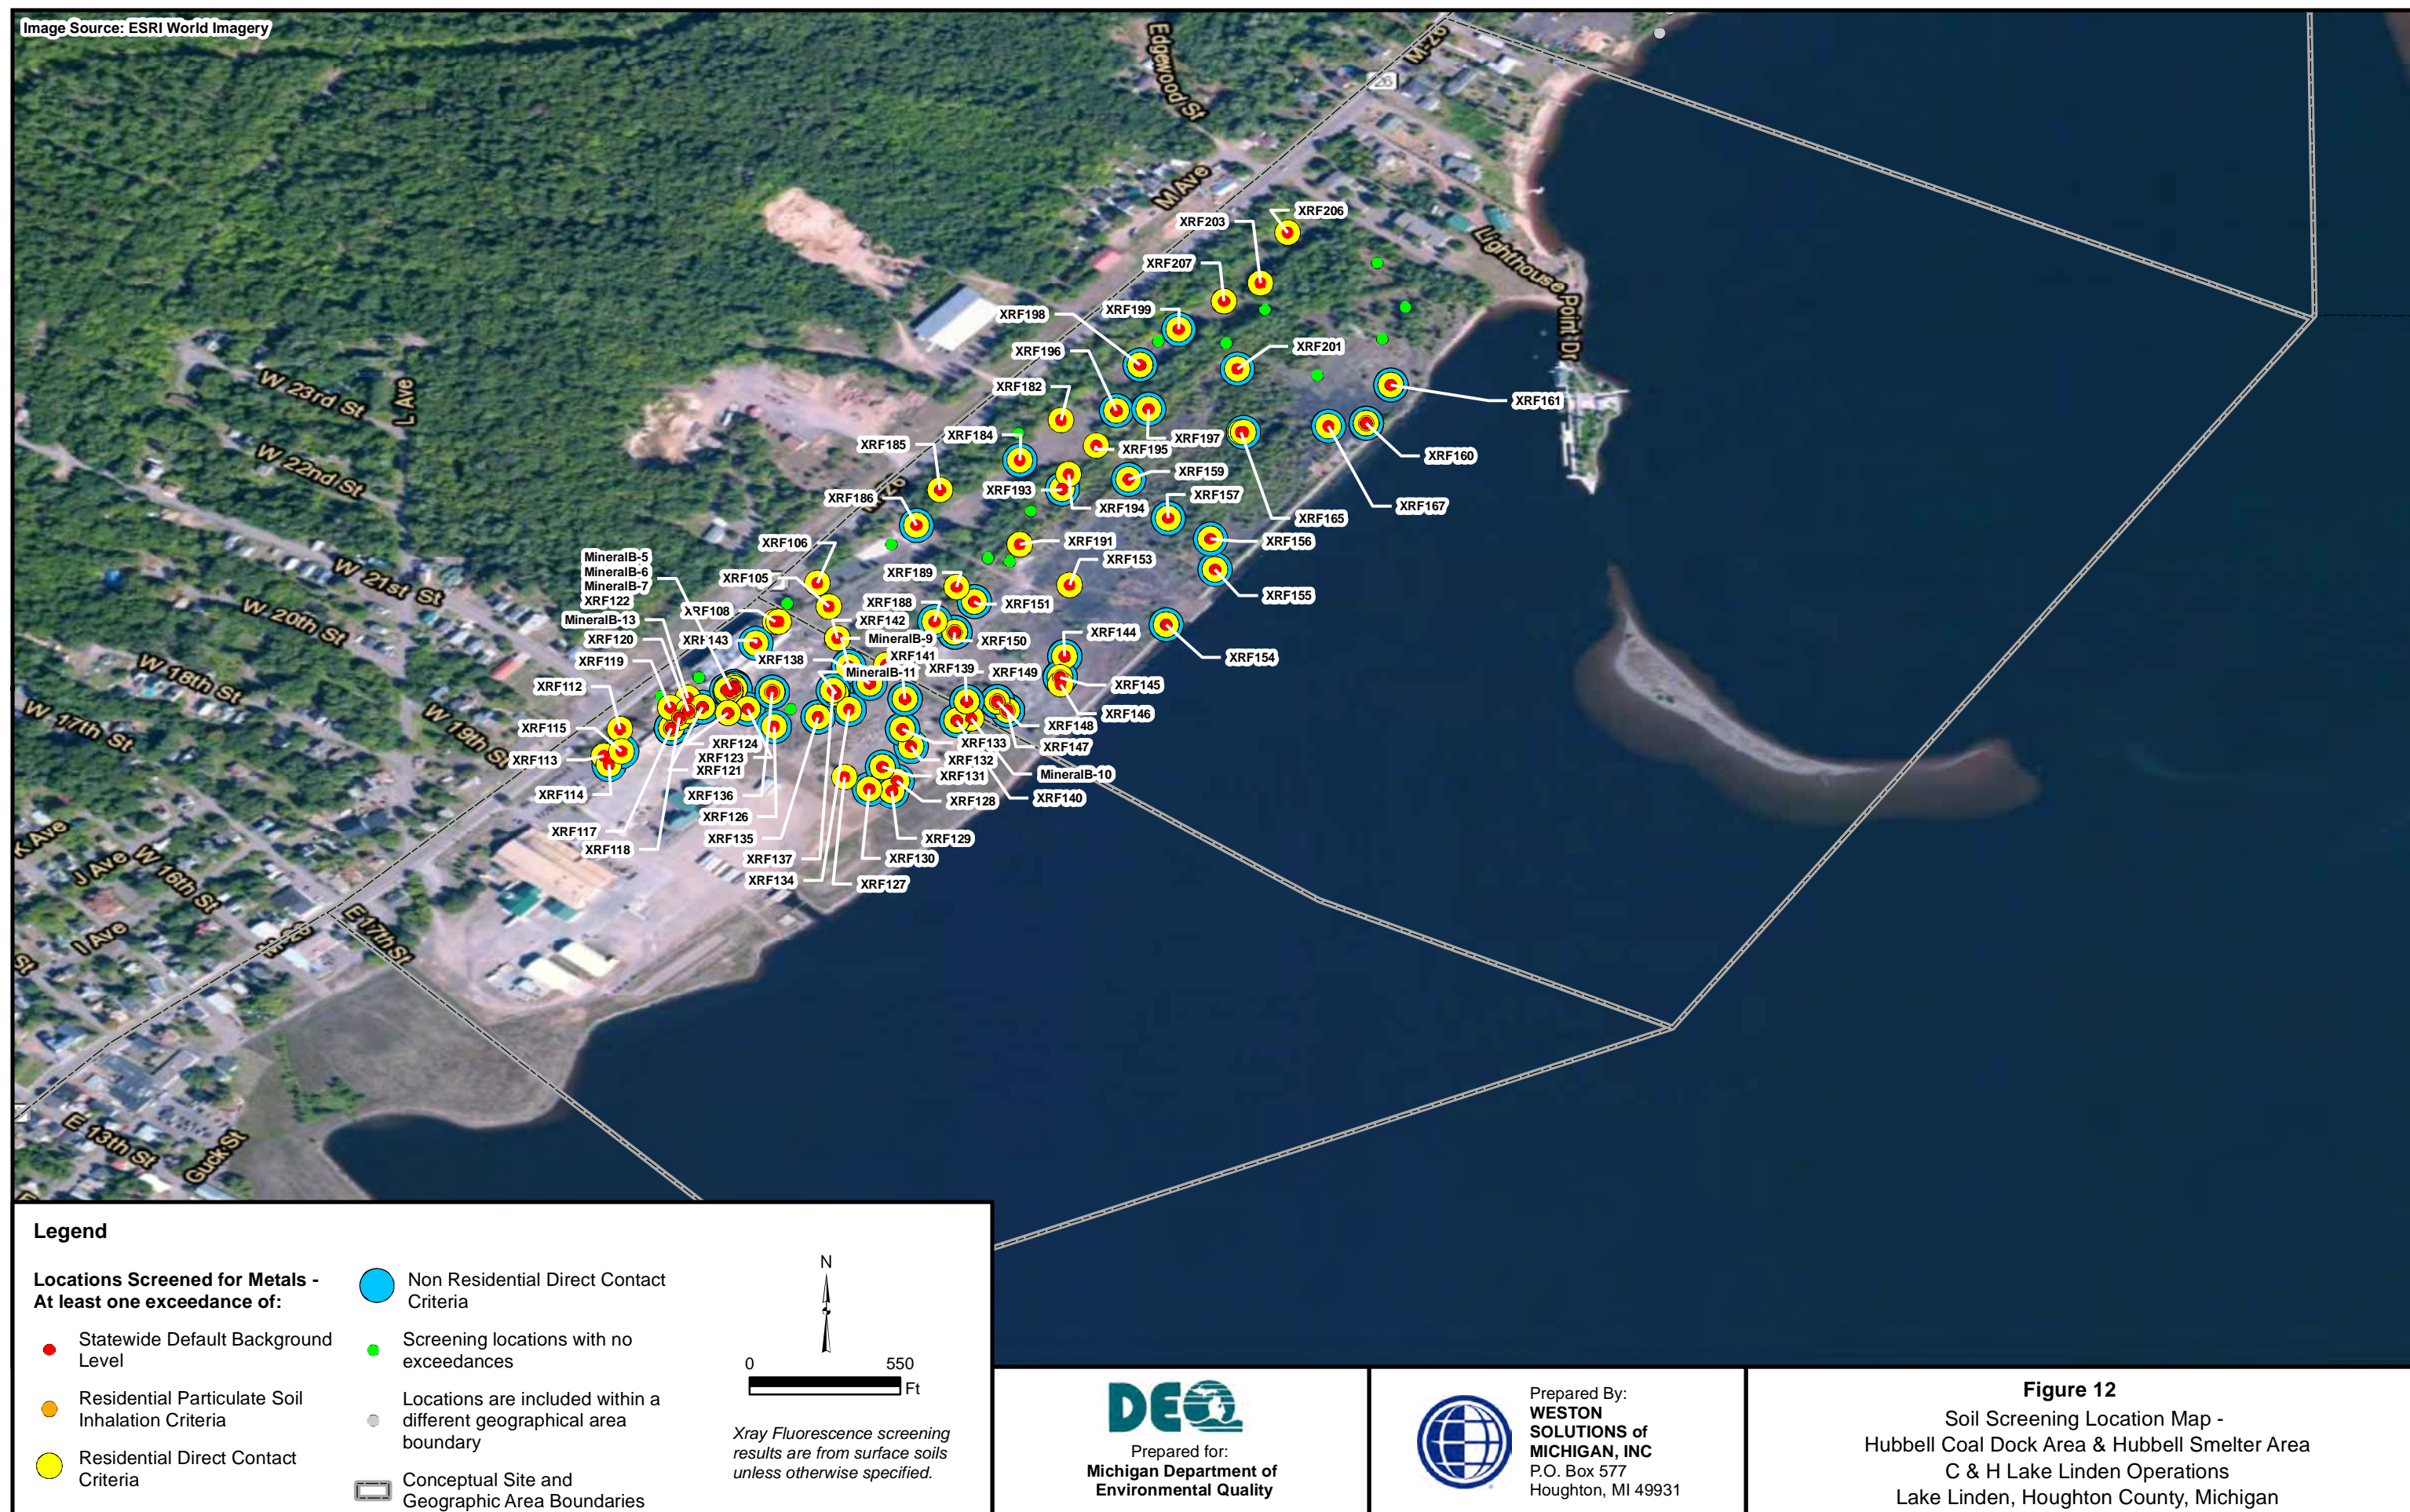
**Figure 13**  
Surface Water and Sediment Sample Location Map  
Hubbell Coal Dock Area  
C & H Lake Linden Operations  
Lake Linden, Houghton County, Michigan

SD-04 10/12/11					
Depth	Parameter	Result	Units	Criteria	
0-3	1,2-BENZPHENANTHRACENE	11000	J	UG/KG	[5, 6]
0-3	ACENAPHTHENE	3900	J	UG/KG	[4, 5, 6]
0-3	ACENAPHTHYLENE	780	J	UG/KG	[4, 5, 6]
0-3	ALUMI NUM	13800	J	MG/KG	[2, 3]
0-3	ANTHRACENE	3800	J	UG/KG	[4, 5, 6]
0-3	ANTI MONY	2.3	J	MG/KG	[1, 5]
0-3	ARSENI C	27.3	J	MG/KG	[1, 2, 3, 4, 5]
0-3	BENZO(A)ANTHRACENE	11000	J	UG/KG	[4, 5, 6]
0-3	BENZO(A)PYRENE	8800	J	UG/KG	[4, 5, 6]
0-3	BENZO(B)FLUORANTHENE	9500	J	UG/KG	[5]
0-3	BENZO(G, H, I)PERYLENE	4300	J	UG/KG	[4, 5, 6]
0-3	BENZO(K)FLUORANTHENE	9100	J	UG/KG	[5]
0-3	CADMI UM	3.2	J	MG/KG	[1, 4, 5]
0-3	COBALT	14.8	J	MG/KG	[1, 2, 3]
0-3	COPPER	2340	J	MG/KG	[1, 4, 5, 6]
0-3	DI BENZO(A, H)ANTHRACENE	1400	J	UG/KG	[4, 5, 6]
0-3	FLUORANTHENE	43000	J	UG/KG	[1, 4, 5, 6]
0-3	FLUORENE	1500	J	UG/KG	[4, 5, 6]
0-3	I NDENO(1, 2, 3-CD)PYRENE	4100	J	UG/KG	[4, 5, 6]
0-3	I RON	45300	J	MG/KG	[2, 3, 5, 6]
0-3	LEAD	223	J	MG/KG	[4, 5, 6]
0-3	MANGANESE	233	J	MG/KG	[1, 2, 3]

- **Figure 12:** Soil Screening Location Map – Hubbell Coal Dock and Hubbell Smelter Area;
- **Figure 13:** Surface Water and Sediment Sample Location Map – Hubbell Coal Dock Area;
