2009 Update on Corrective Action Activities Tittabawassee and Saginaw Rivers

May 6, 2009

The Dow Chemical Company
Off-Site Corrective Action Program

Al Taylor, Geologist
Waste and Hazardous Materials Division

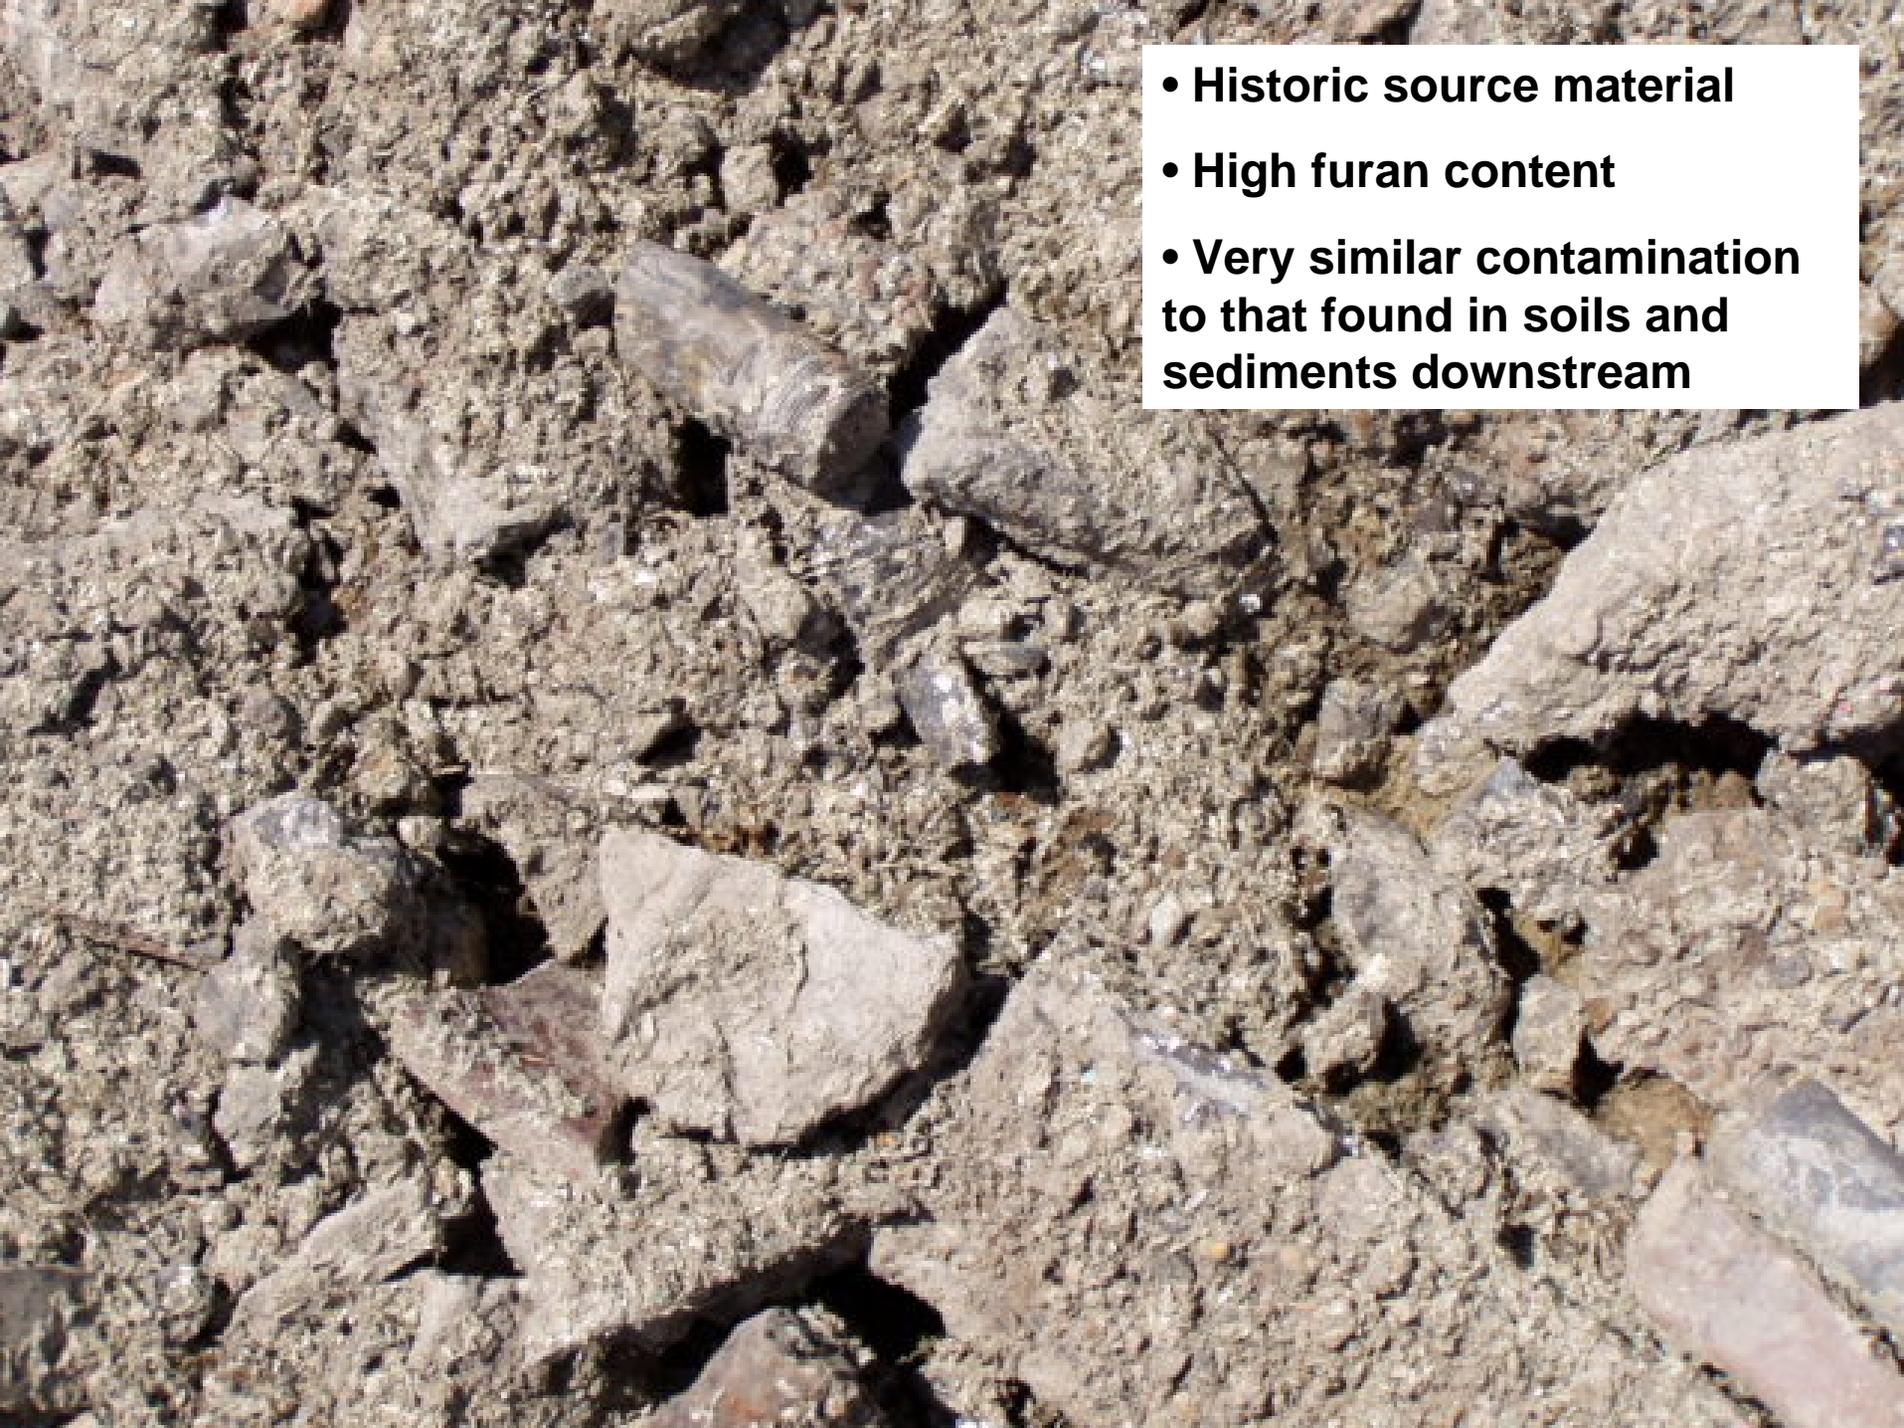
- The image shows a close-up view of a sediment surface. The ground is composed of a mix of fine, brownish-grey soil and larger, angular, light-colored rock fragments. The texture is rough and uneven. In the upper right corner, there is a white rectangular box containing three bullet points in black text.
- **Historic source material**
 - **High furan content**
 - **Very similar contamination to that found in soils and sediments downstream**

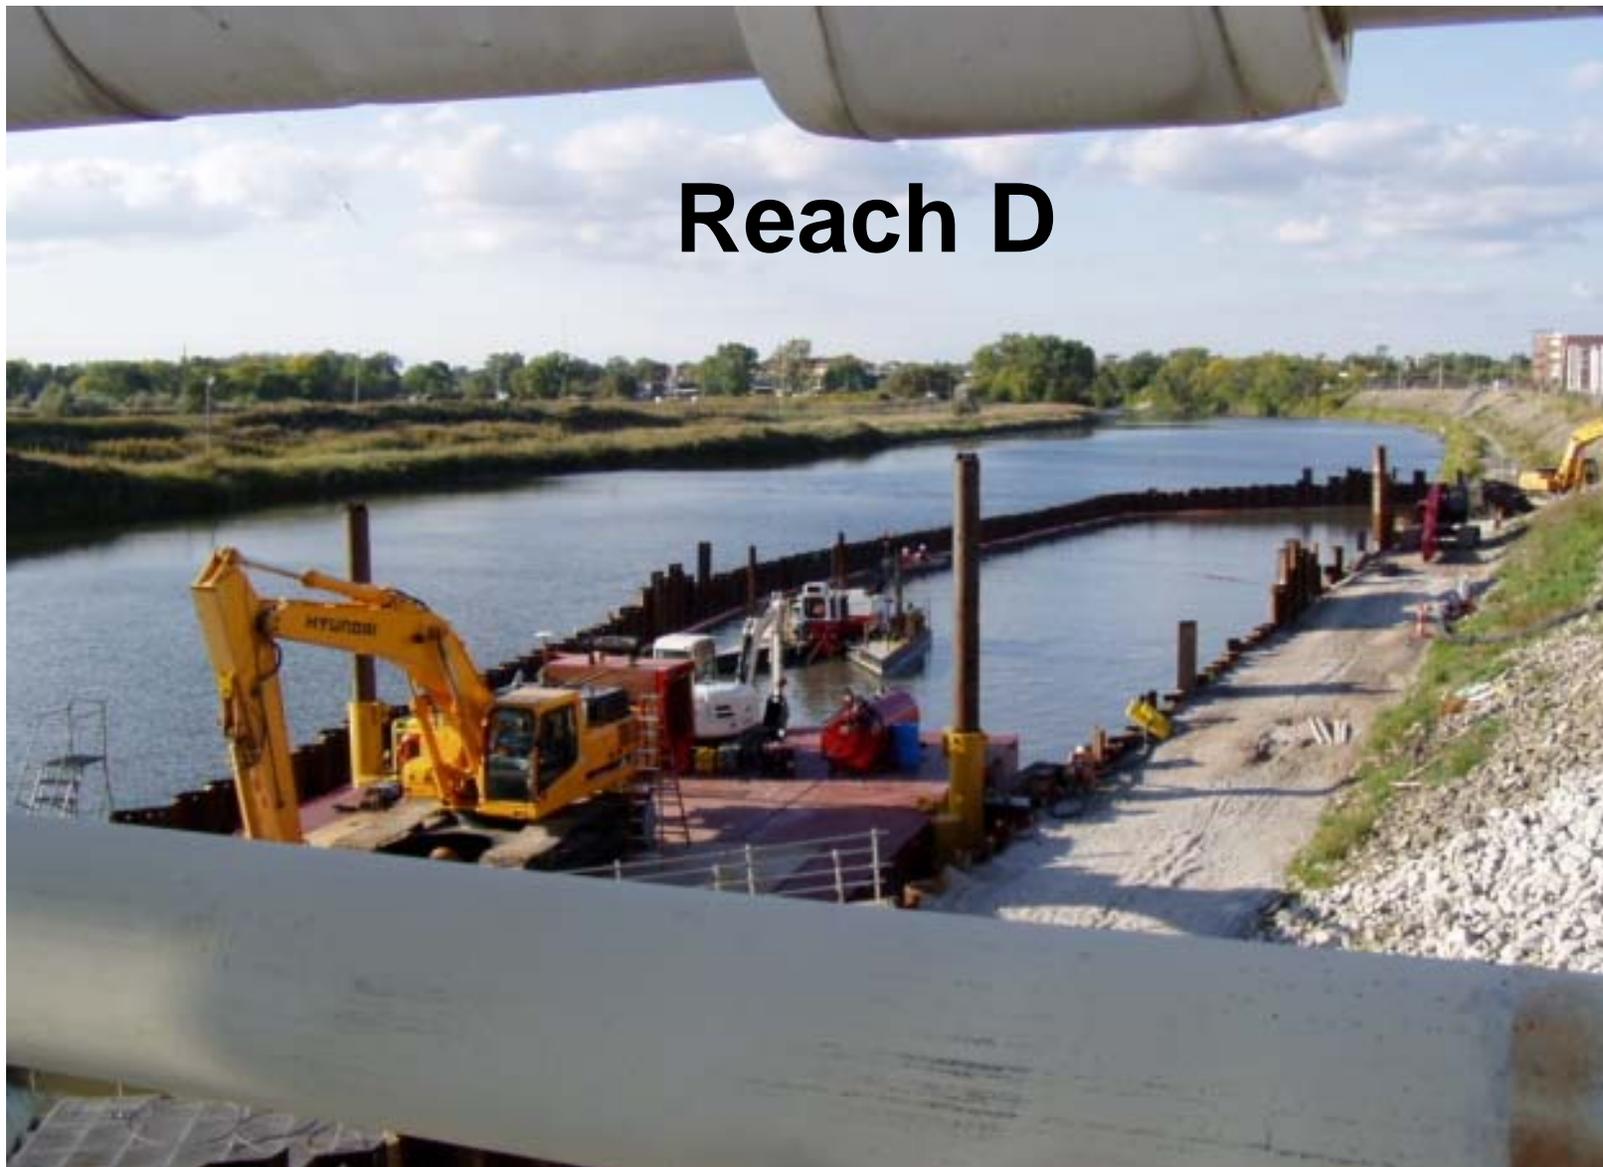
Reach D

- **Transition from CERCLA Removal Action Process back to the Operating License corrective action process**
- **CERCLA Order did not specifically address contaminants other than dioxins and furans**

- Additional work necessary to cap or remove other contaminants (e.g., hexachlorobenzene, parathion, dichlorobenzenes, etc.)
 - Additional characterization, toxicity testing, design of cap, etc. as part of IRA work plan – material inside cell is toxic to invertebrates

- Approval of capping plan “inside cell” to address residual contamination from dredging – many details to be worked out for implementation in 2009 field season.

- Characterization on-going “outside cell” to determine what additional material needs remediation (e.g., removal, capping, etc.)
 - Toxicity testing
 - Removal of sheet piling in 2009

- Scour adjacent to sheet piling has resulted in loss of some sediment and exposure of contaminated materials at the river bottom
- **IRA consistent with anticipated final corrective action in this area**

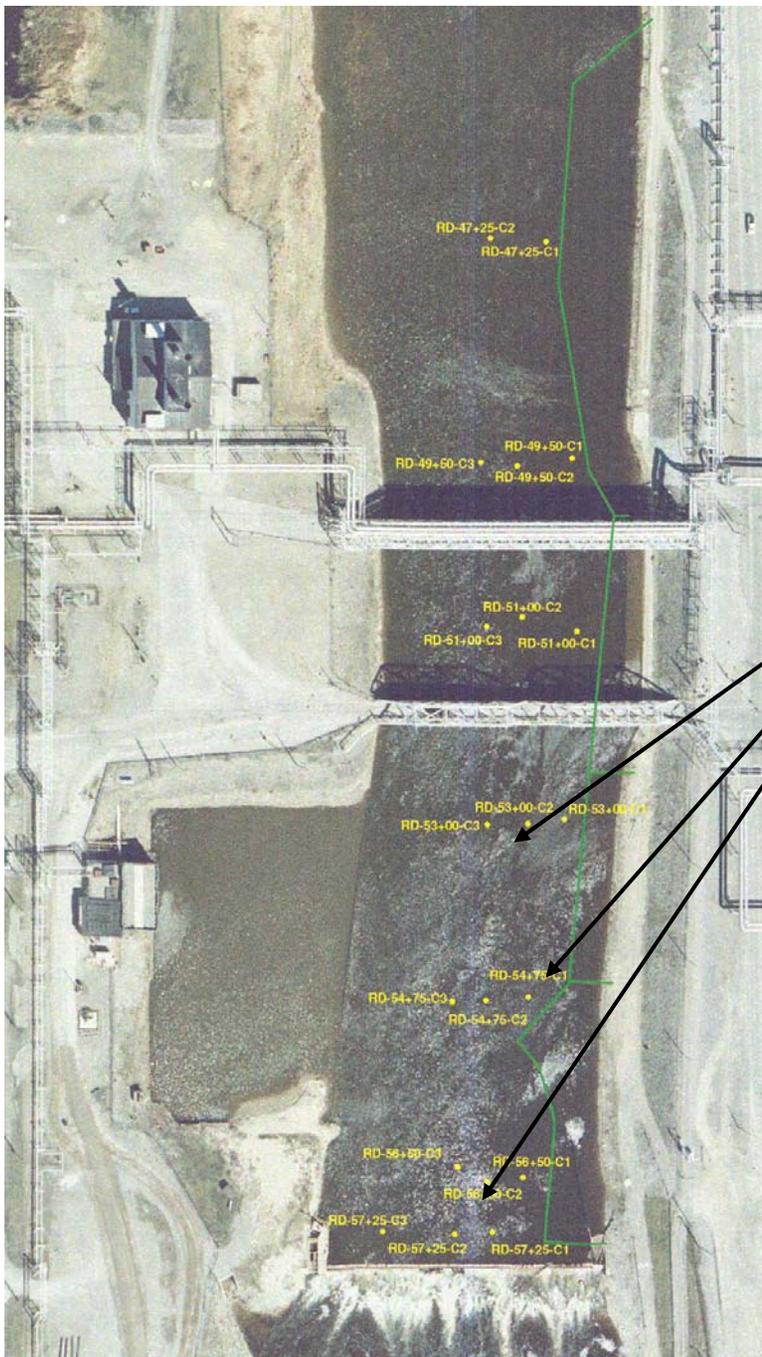
Reach D Sediment Cap Design Section

- Capping will require long term monitoring and maintenance

- Additional work if not determined to be effective via monitoring

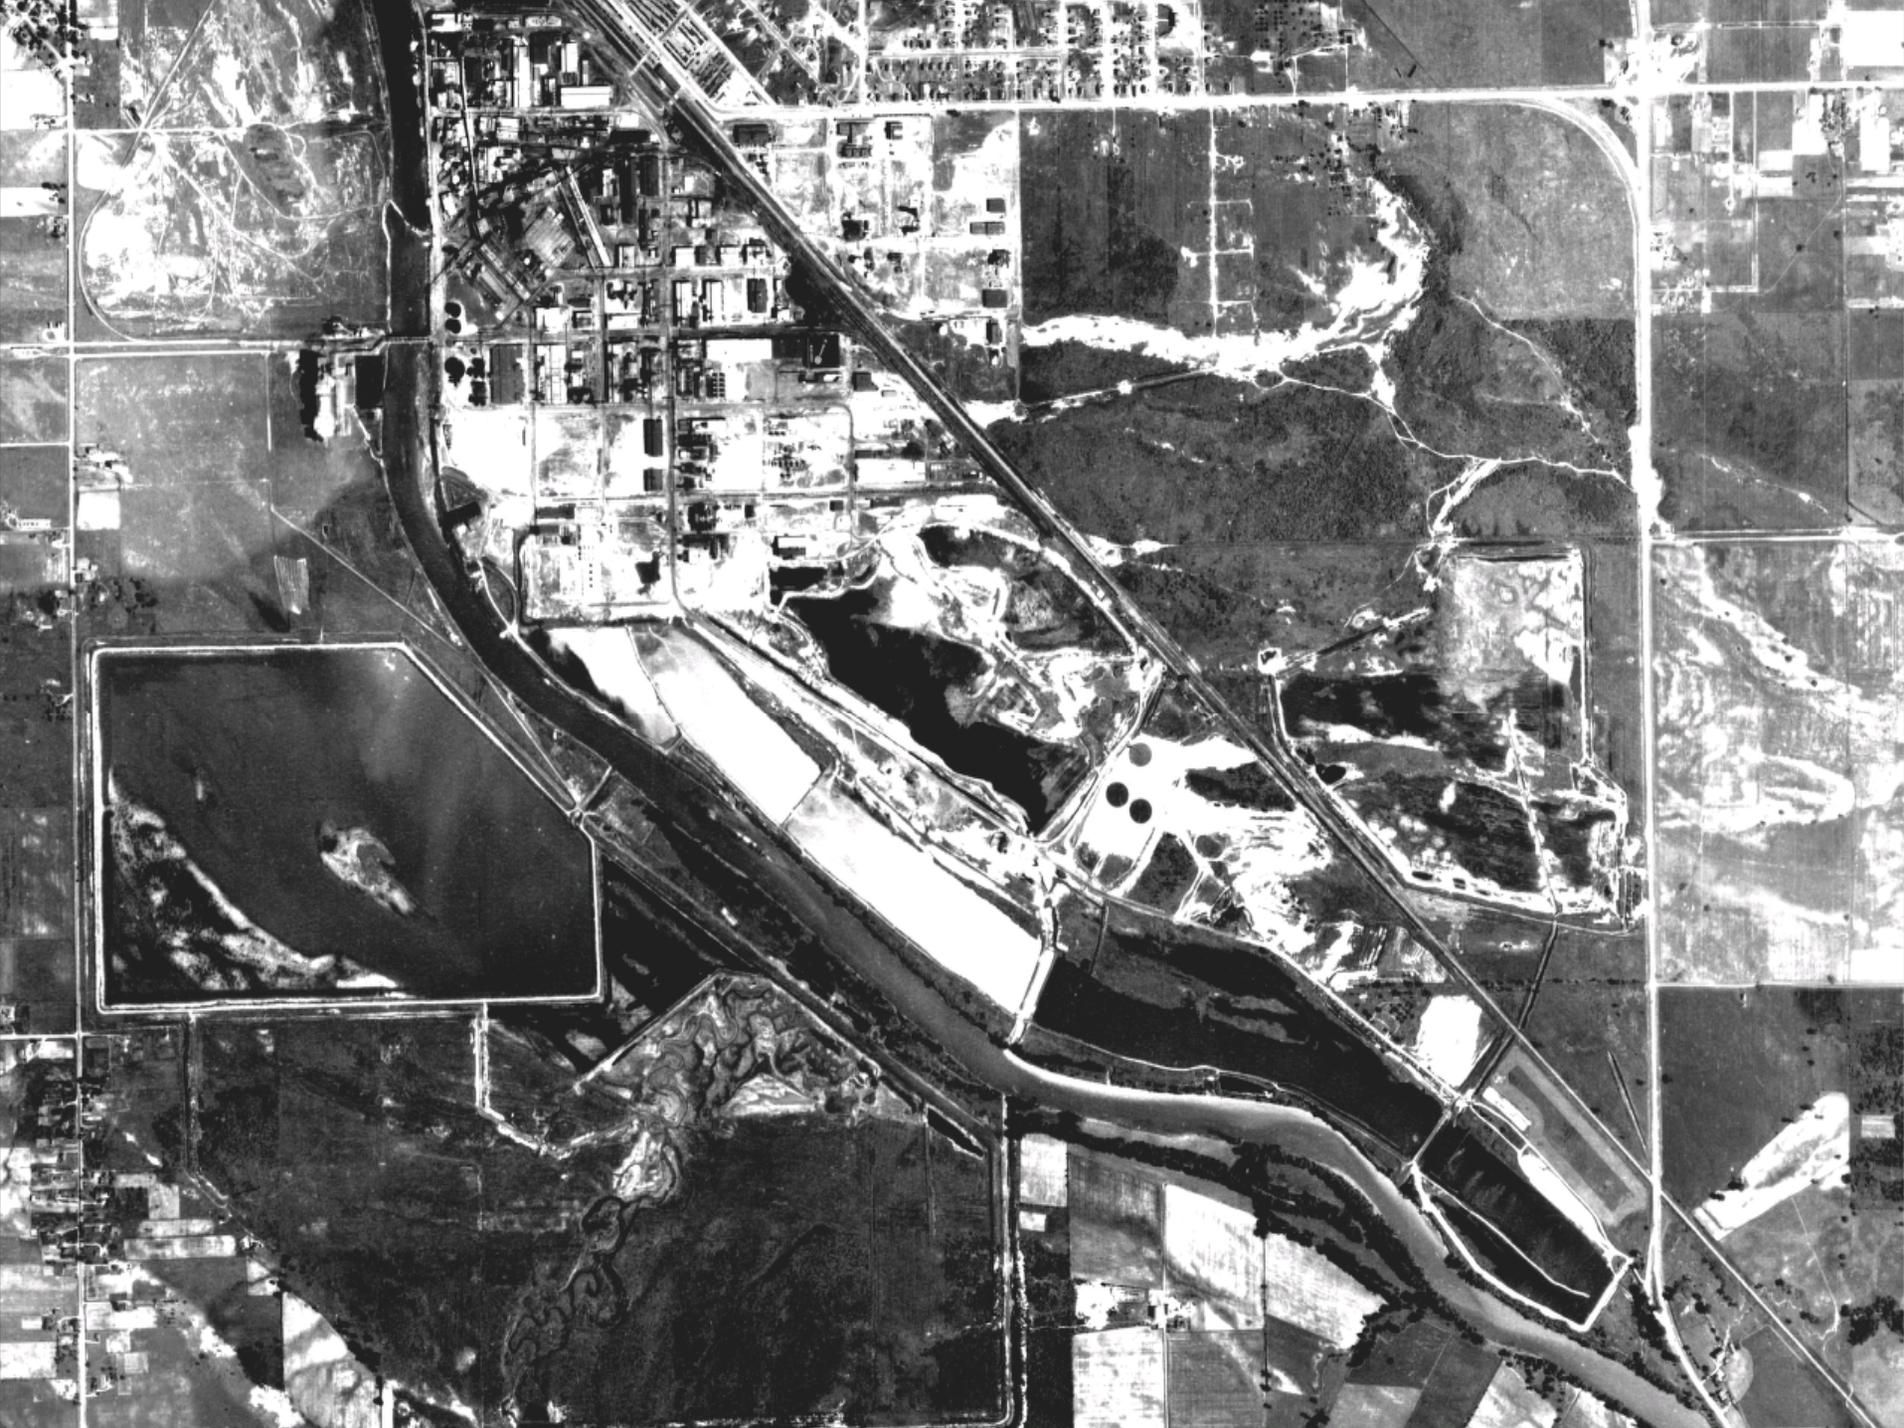
H-12 Historic Outfalls

- **Part of License Compliance Schedule - currently not an IRA**
 - H = High Priority in Operating License
- **Work Plan submitted to MDEQ - investigation is underway**
- **Source Area work – other high concentration deposits (e.g., Reach D) to be identified and remediated**
 - Not only dioxins and furans; other contaminants significant and present at elevated concentrations
 - Dioxins and furans not necessarily co-located with other contaminants of concern
- **Working upstream to downstream**
- **Areas for further evaluation to see if IRAs are appropriate prior to final remedy (e.g. toxicity testing, bed measurements, etc.)**
 - Reach D – Outside the sheet piling
 - Reach H – Ethyl parathion/hexachlorobenzene area
- **Iterative Process**
- **Good progress being made**

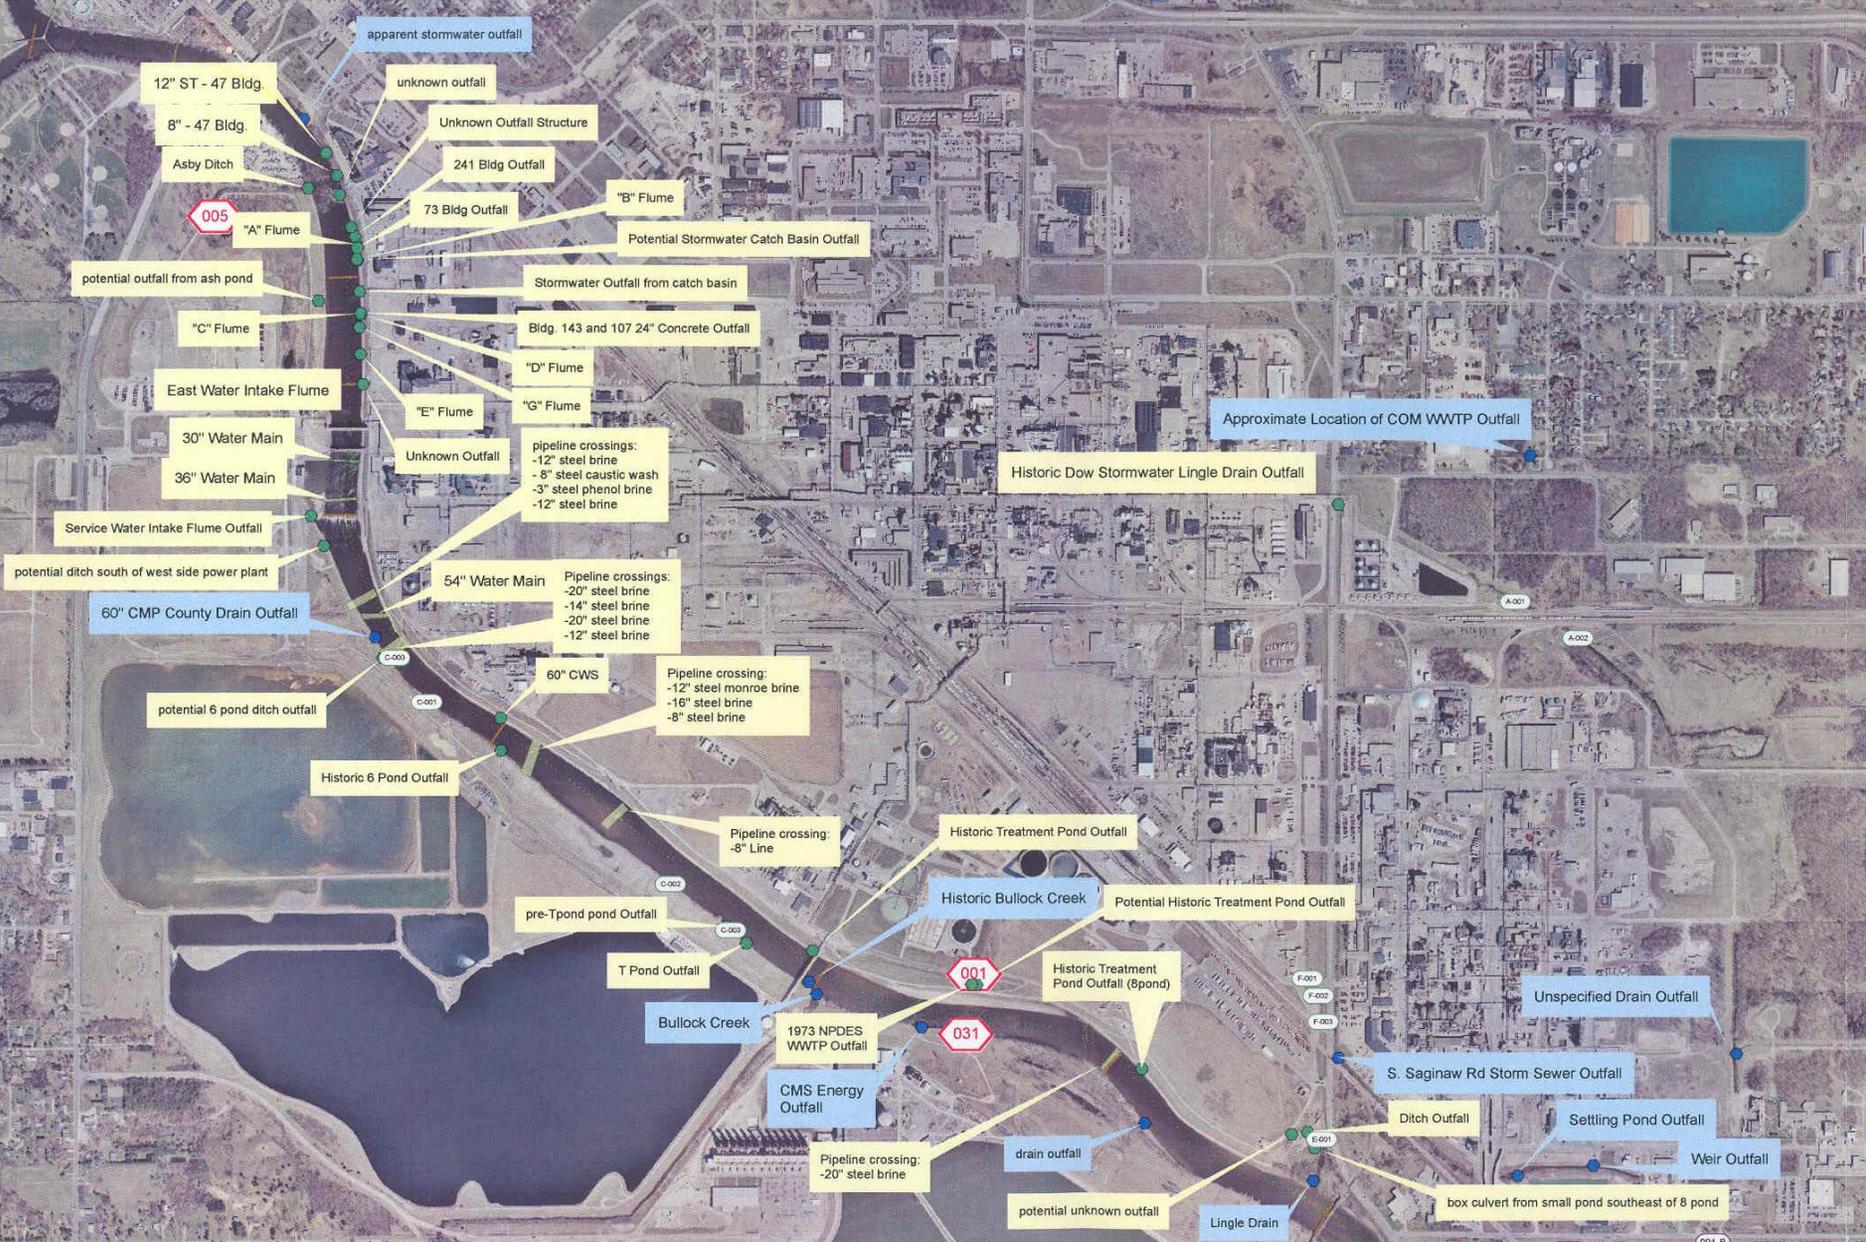
Pipeline Crossing:
-20" steel brine

Historic Treatment
Pond Outfall (8pond)

drain outfall

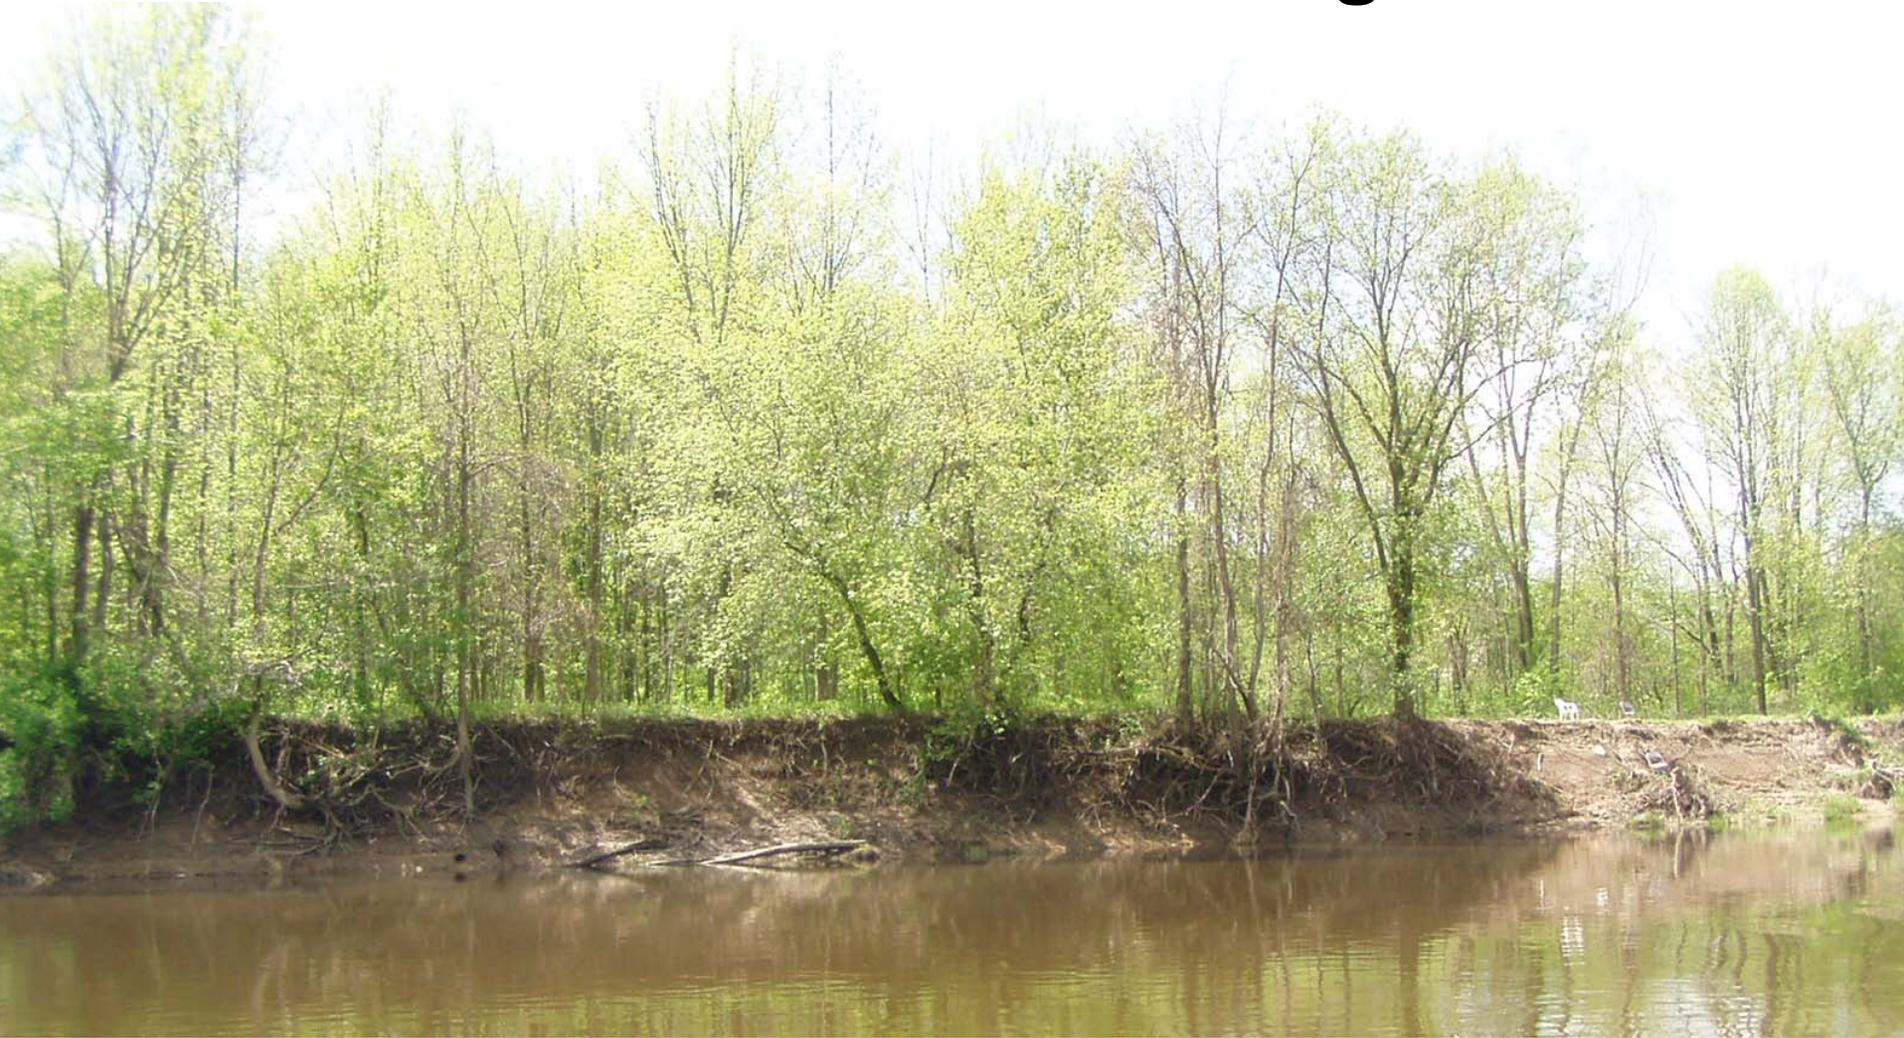
Bank Stabilization – Eroding Banks

- **High levels of dioxin/furan in bank “levee” deposits**
- **Active source of contamination into the river as these banks erode**
- **Bank erosion is significant and widespread**
- **Consistent with EPA/MDEQ guidance to control sources first**
- **Pilot different technologies - “softer footprint” where possible**
 - 4 pilot stabilization areas
 - 3 additional areas – monitoring only
- **MDEQ approval of Pilot Work Plan on July 10, 2008**

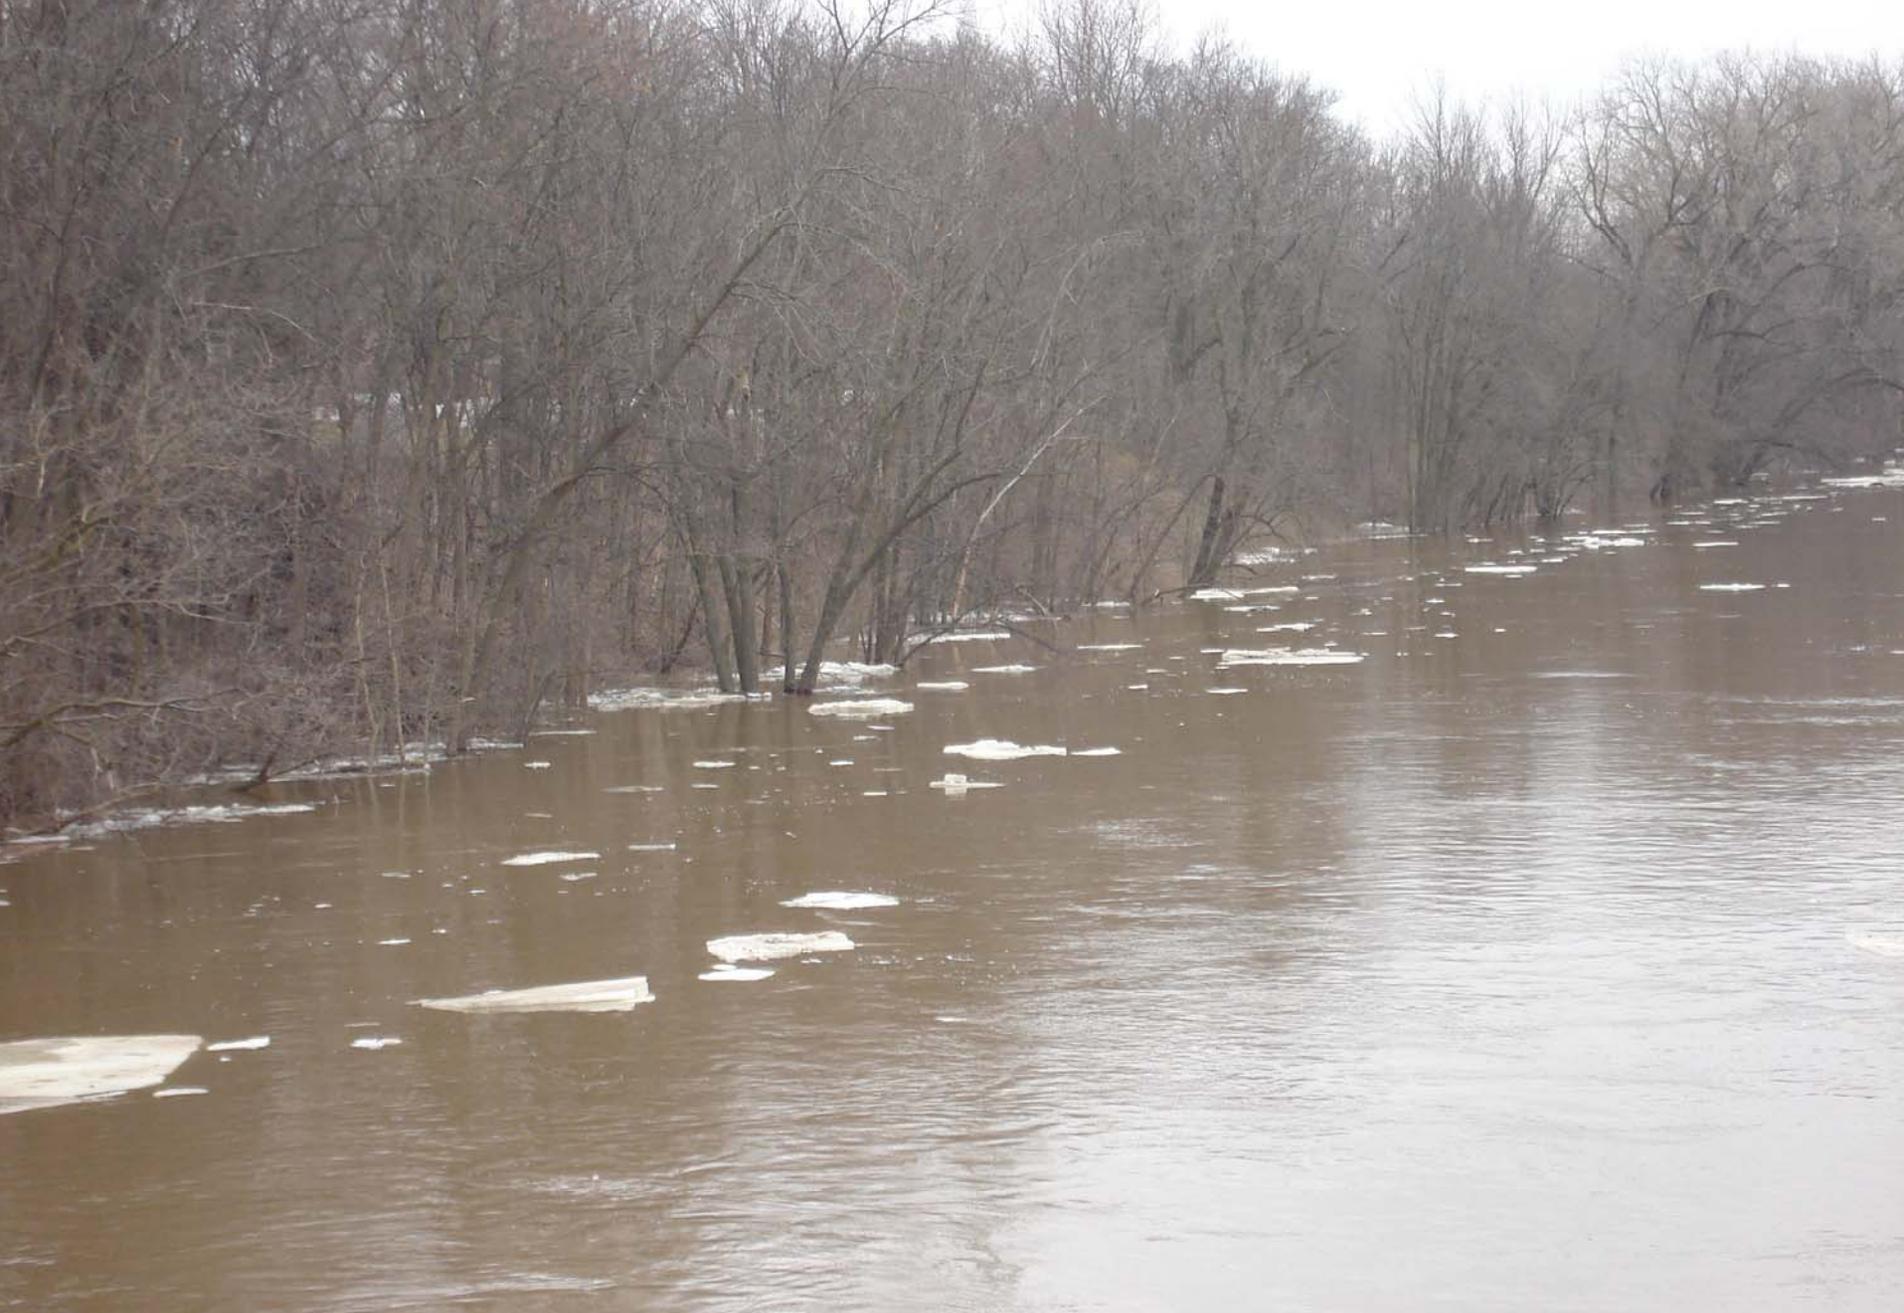
February 2009 – Ice and flood flows along bank at Freeland

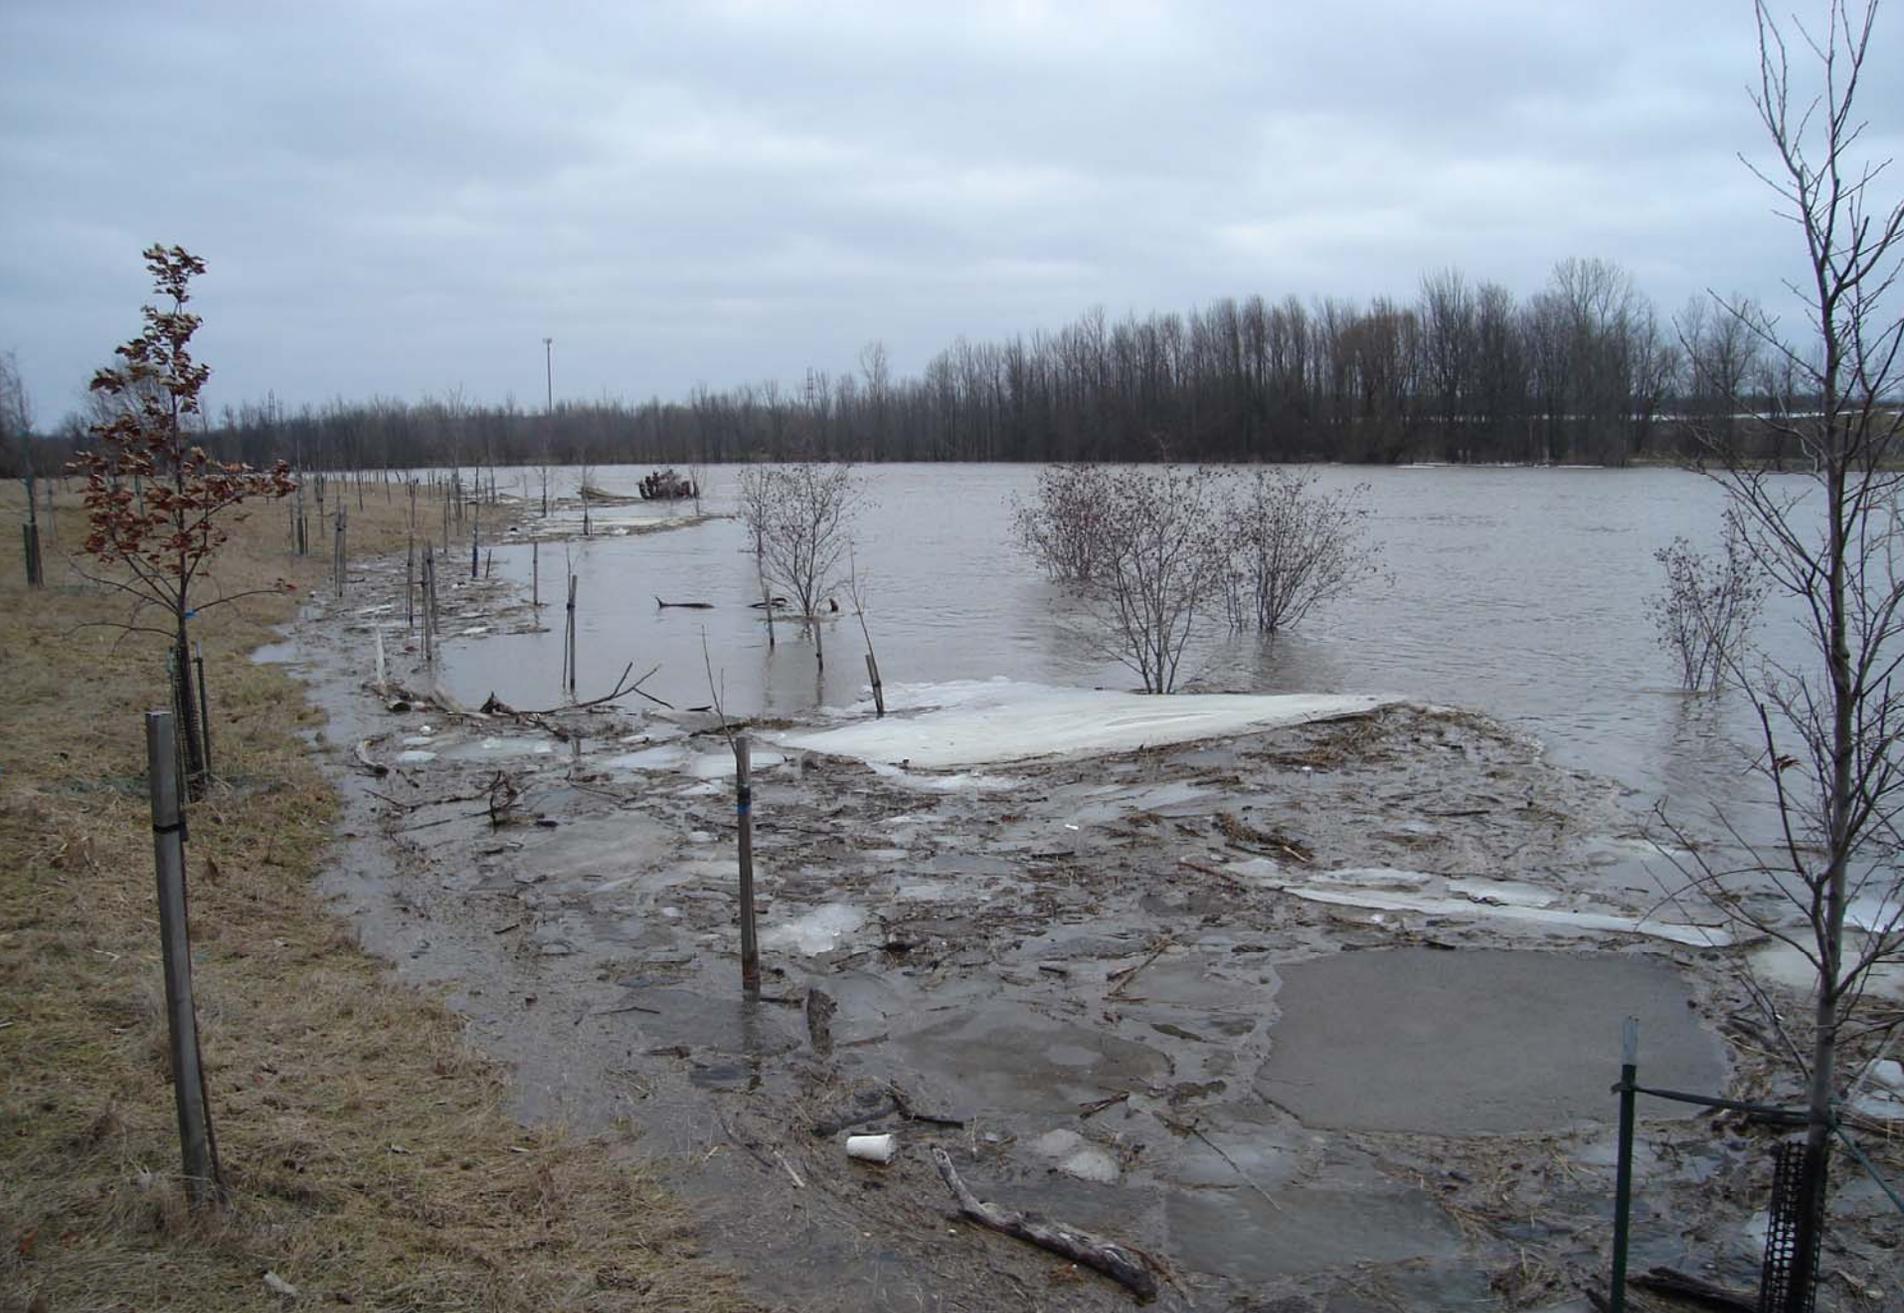
February 2009 – Ice and flood damage at Reach J/K remediation area
