2009 Update on Corrective Action Activities Tittabawassee and Saginaw Rivers

May 6, 2009

The Dow Chemical Company
Off-Site Corrective Action Program

Al Taylor, Geologist
Waste and Hazardous Materials Division

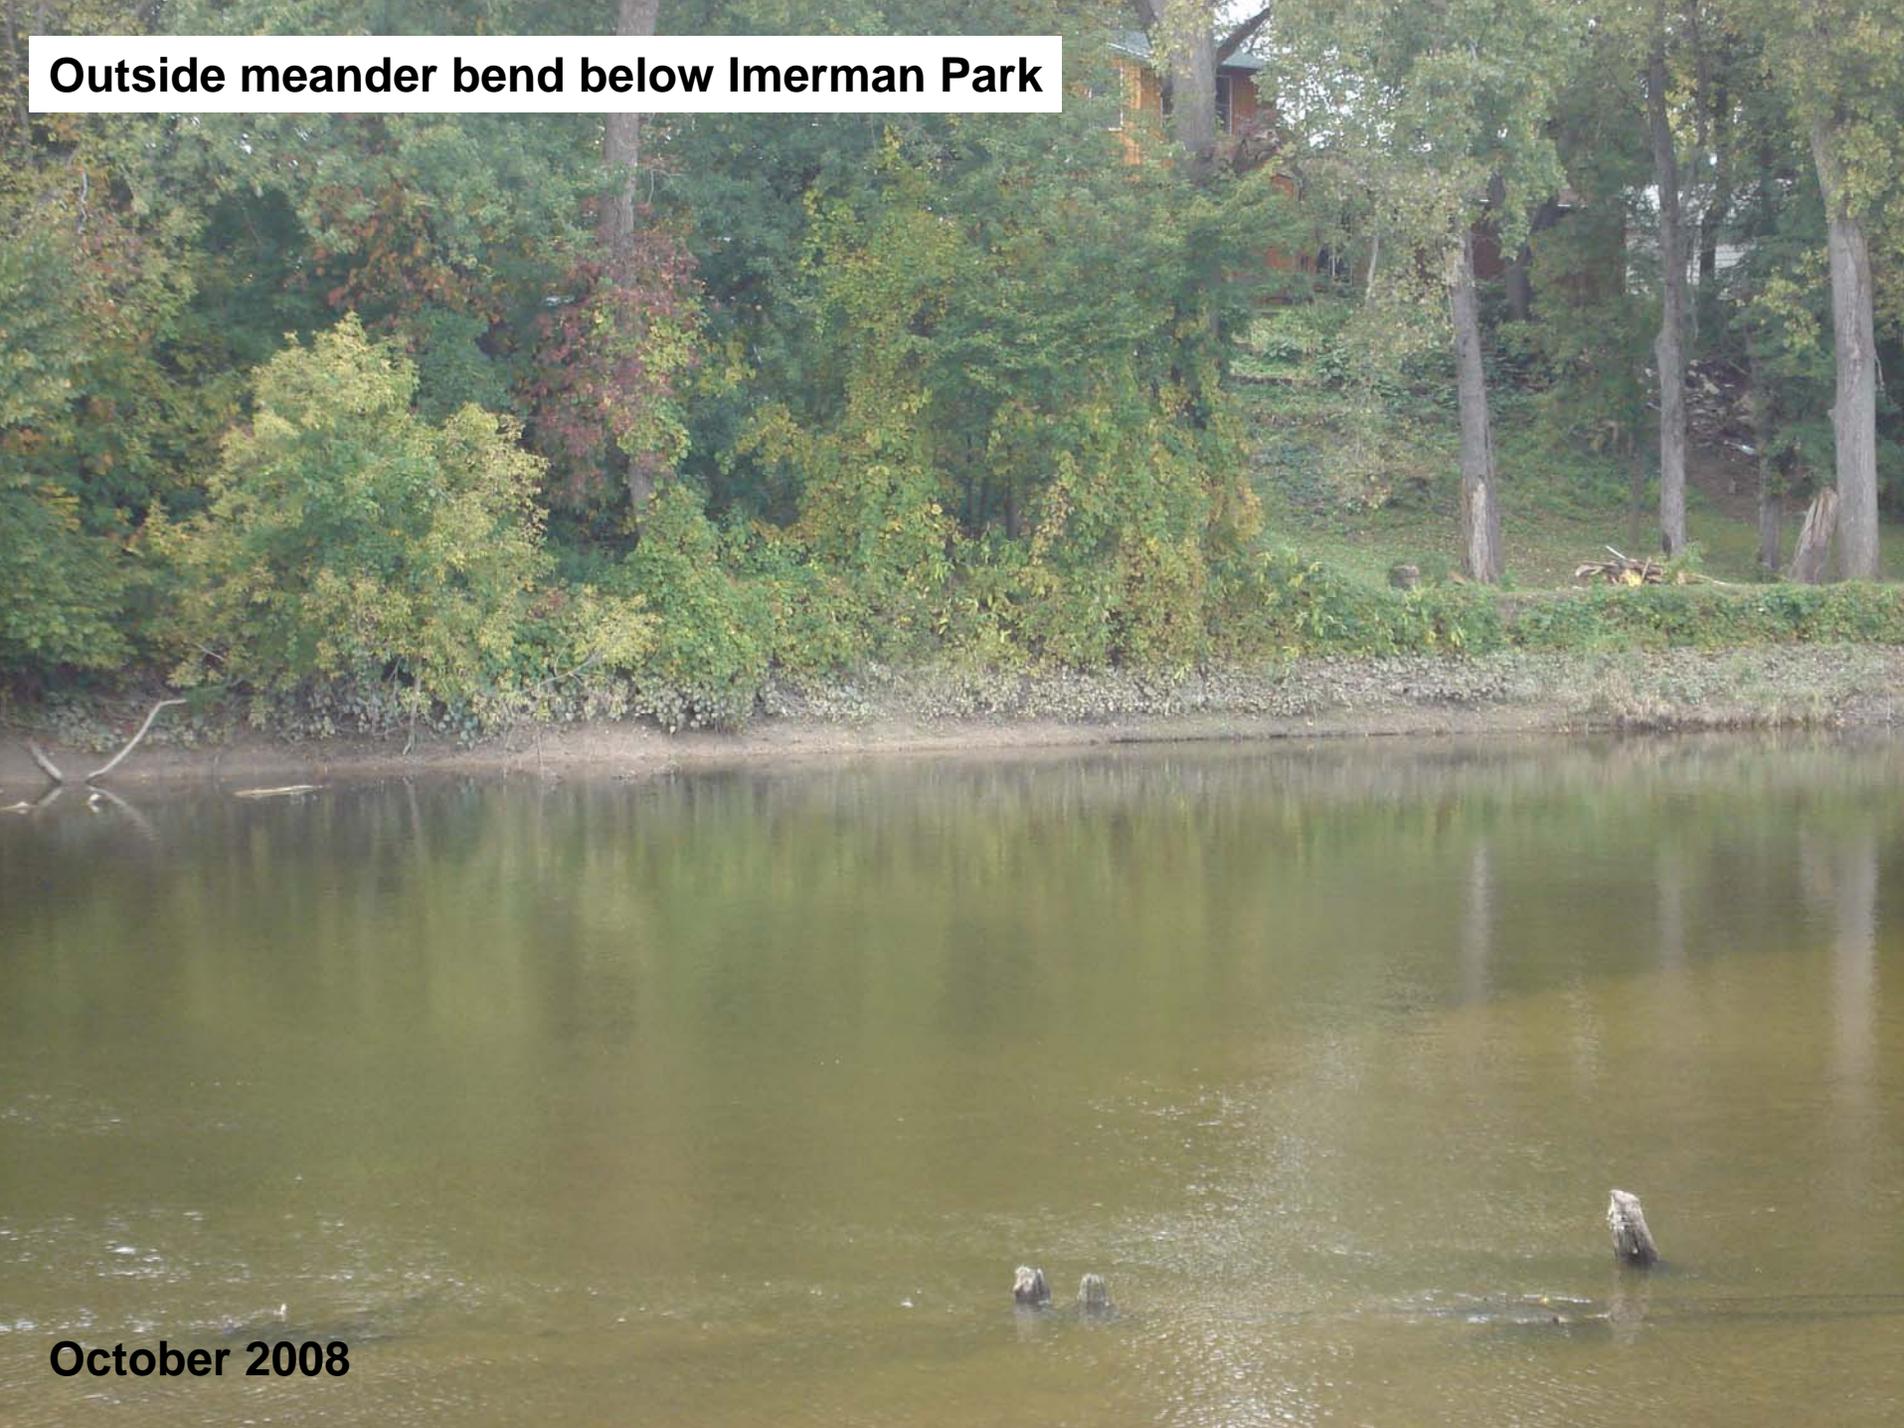
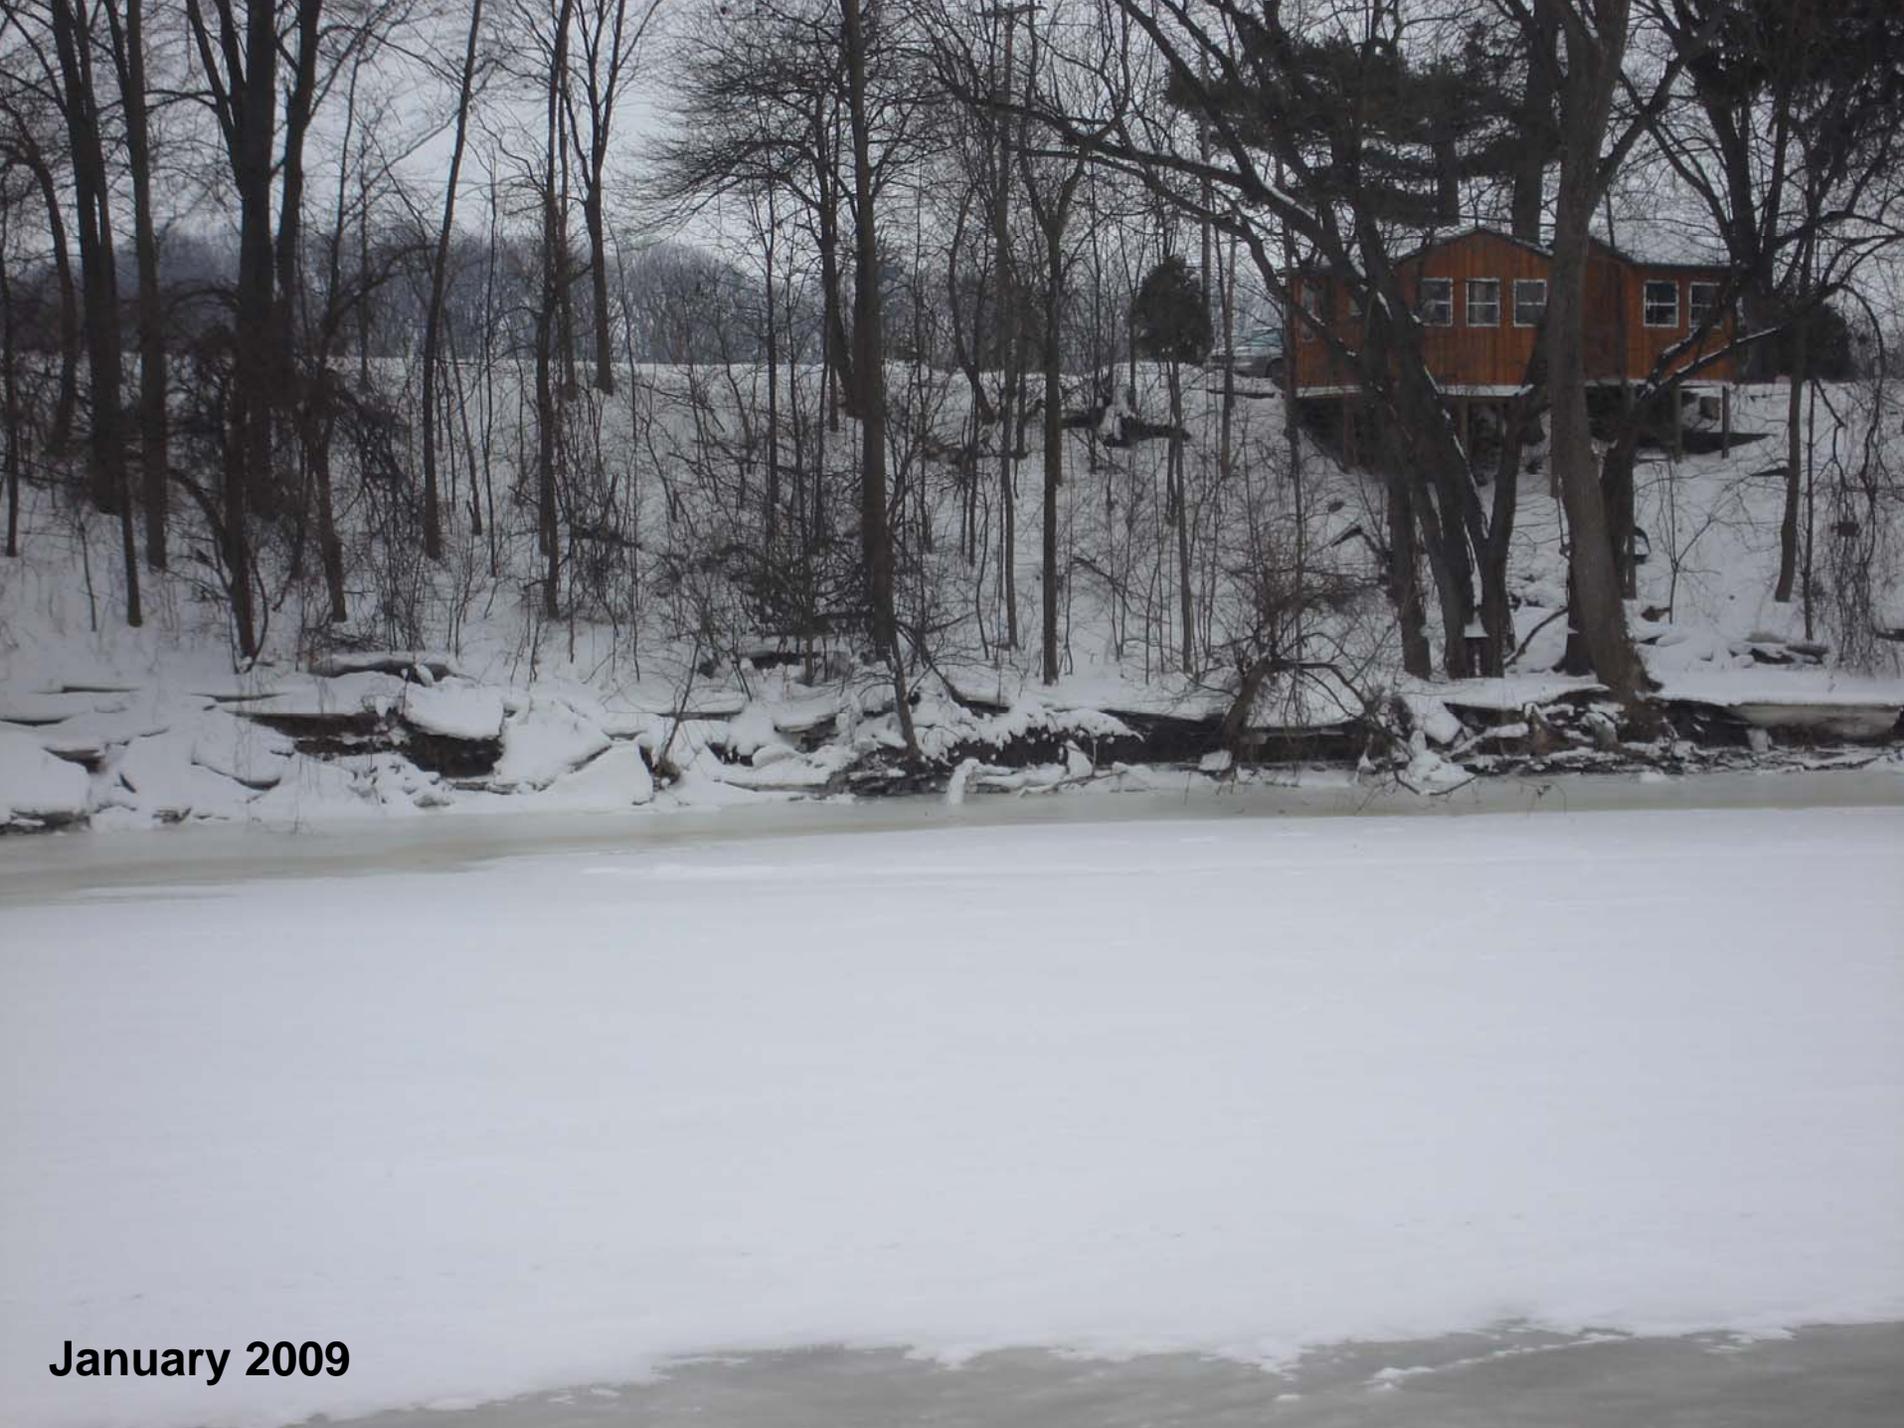
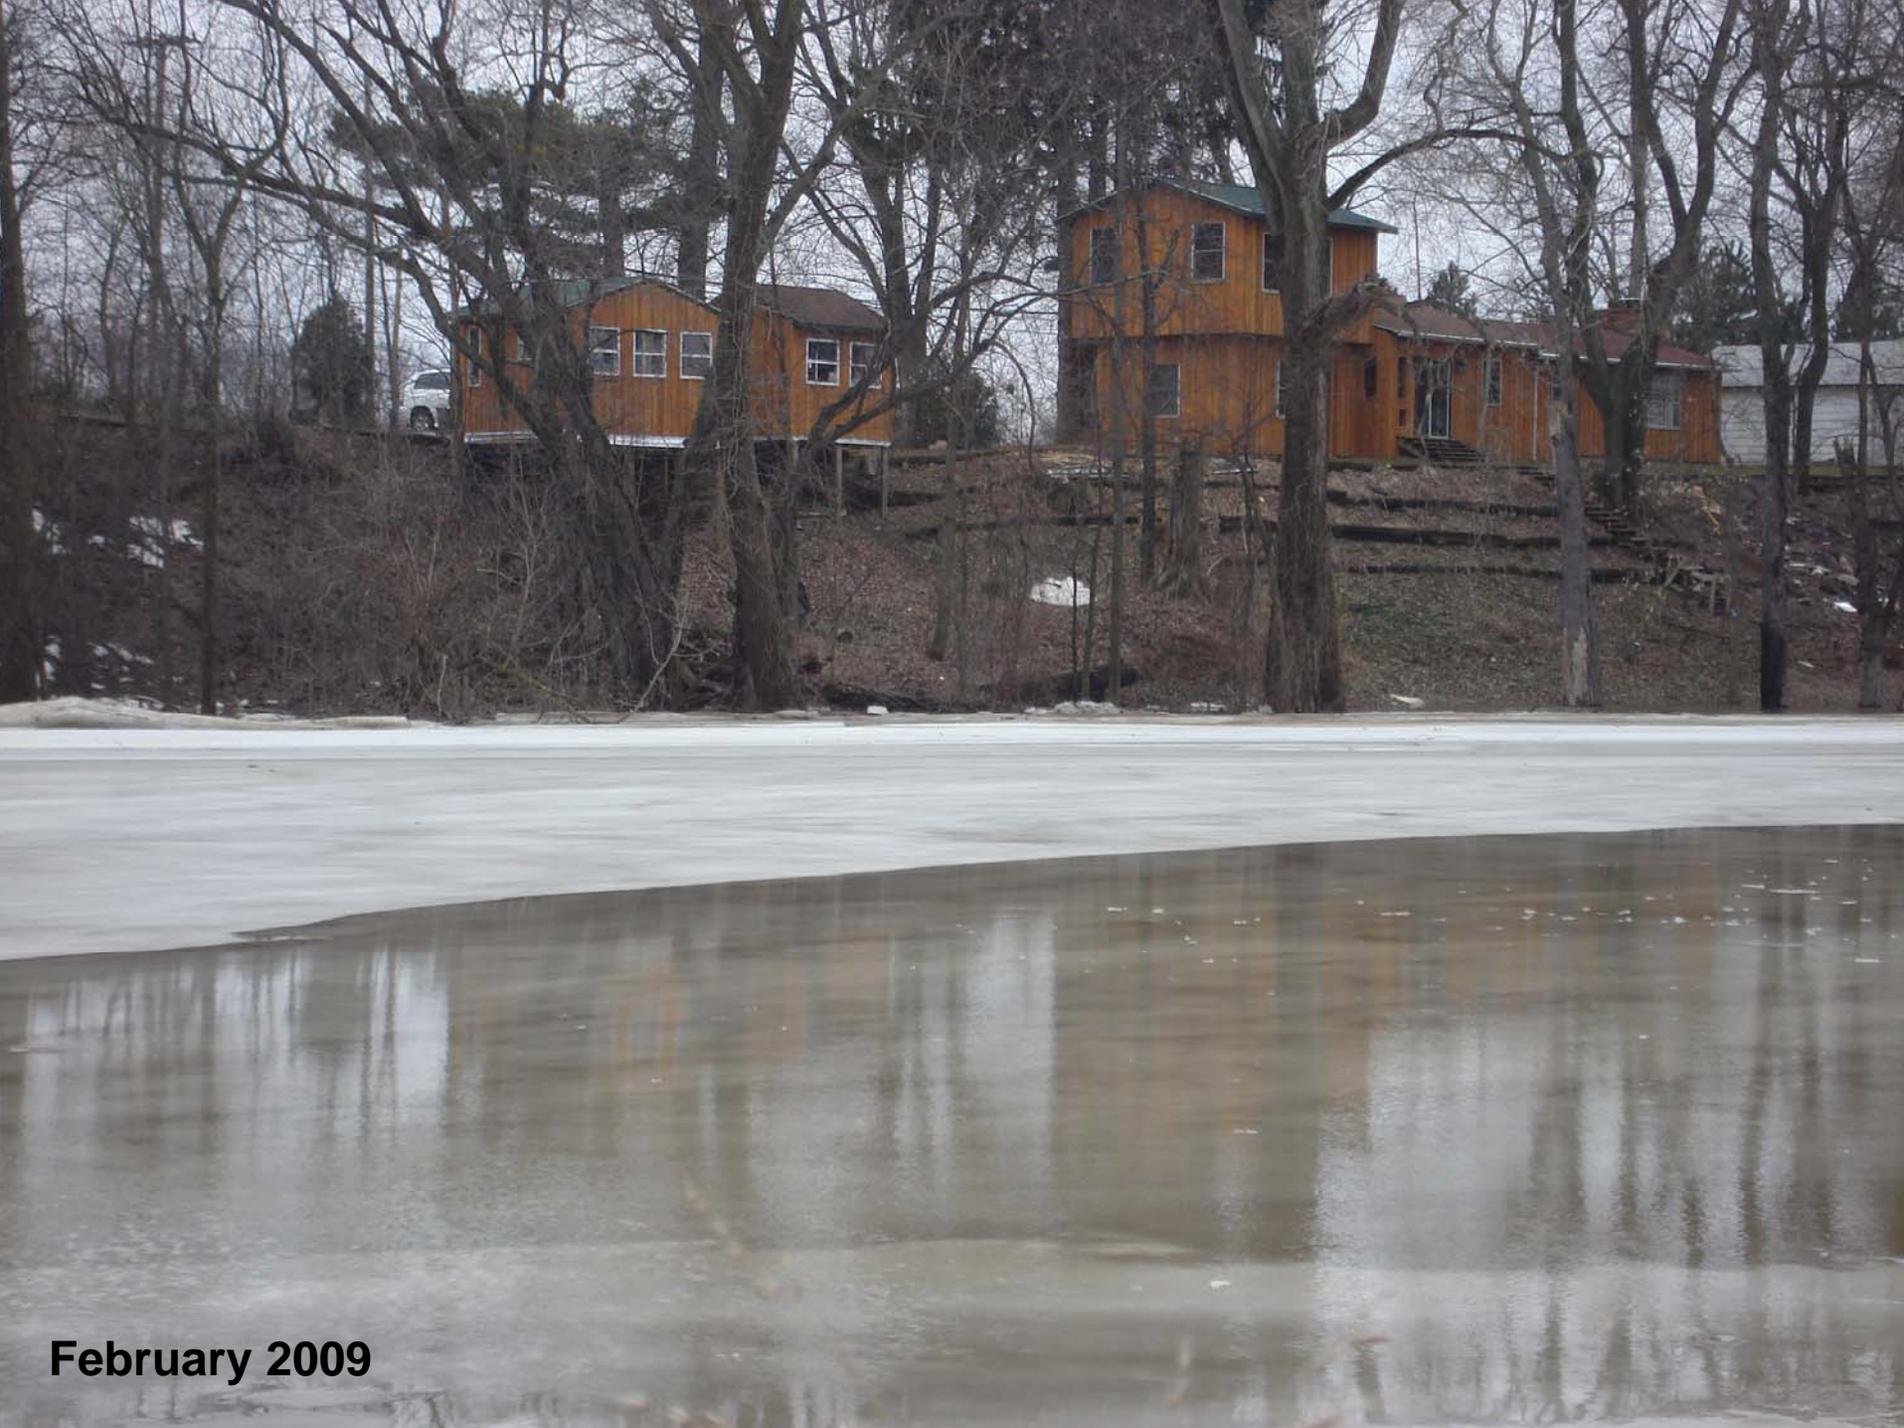
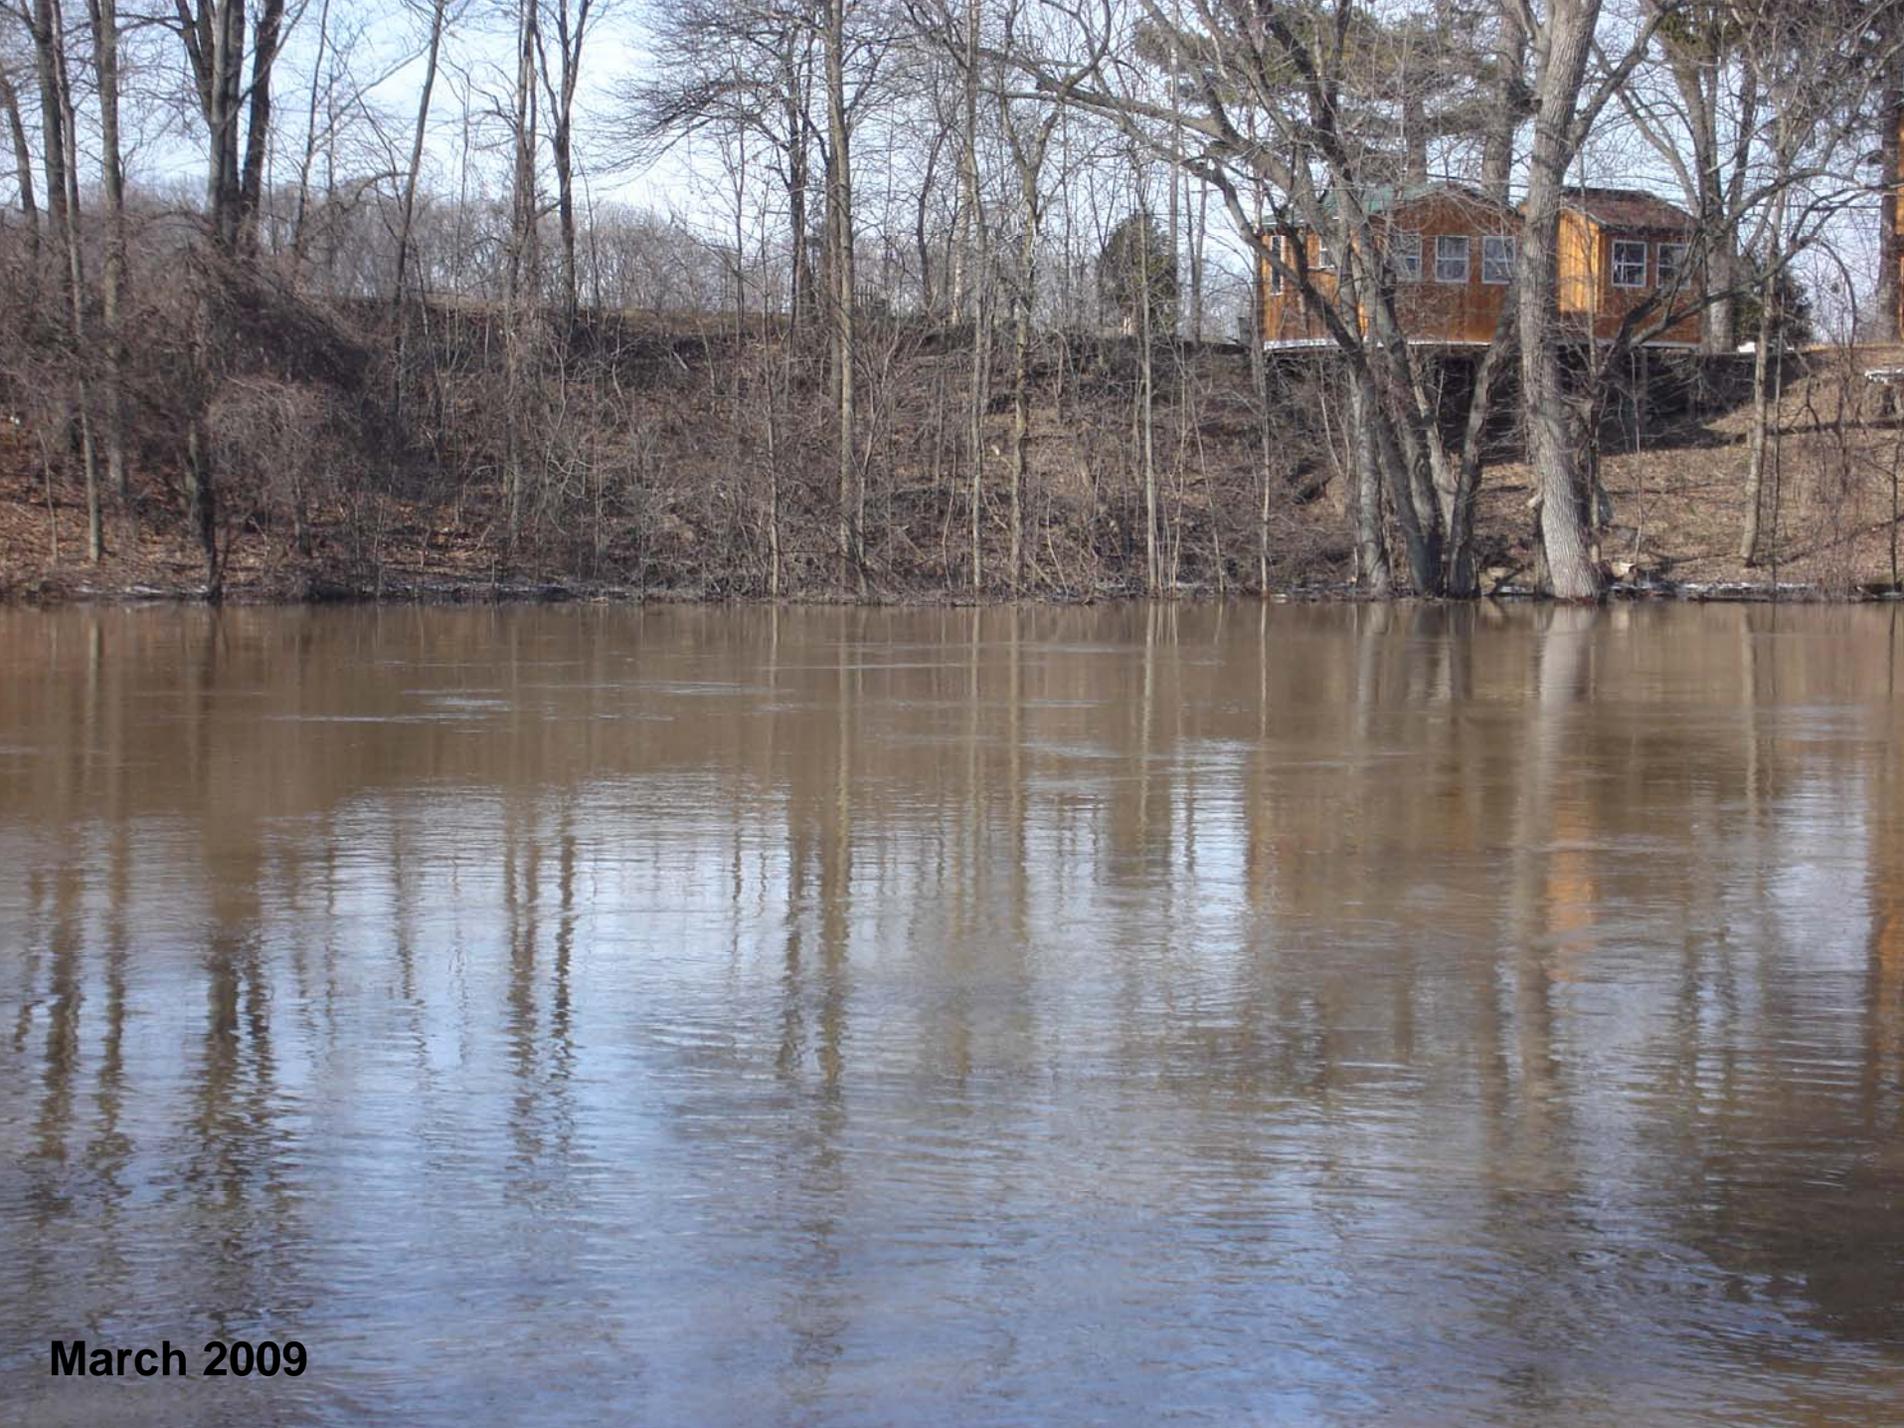
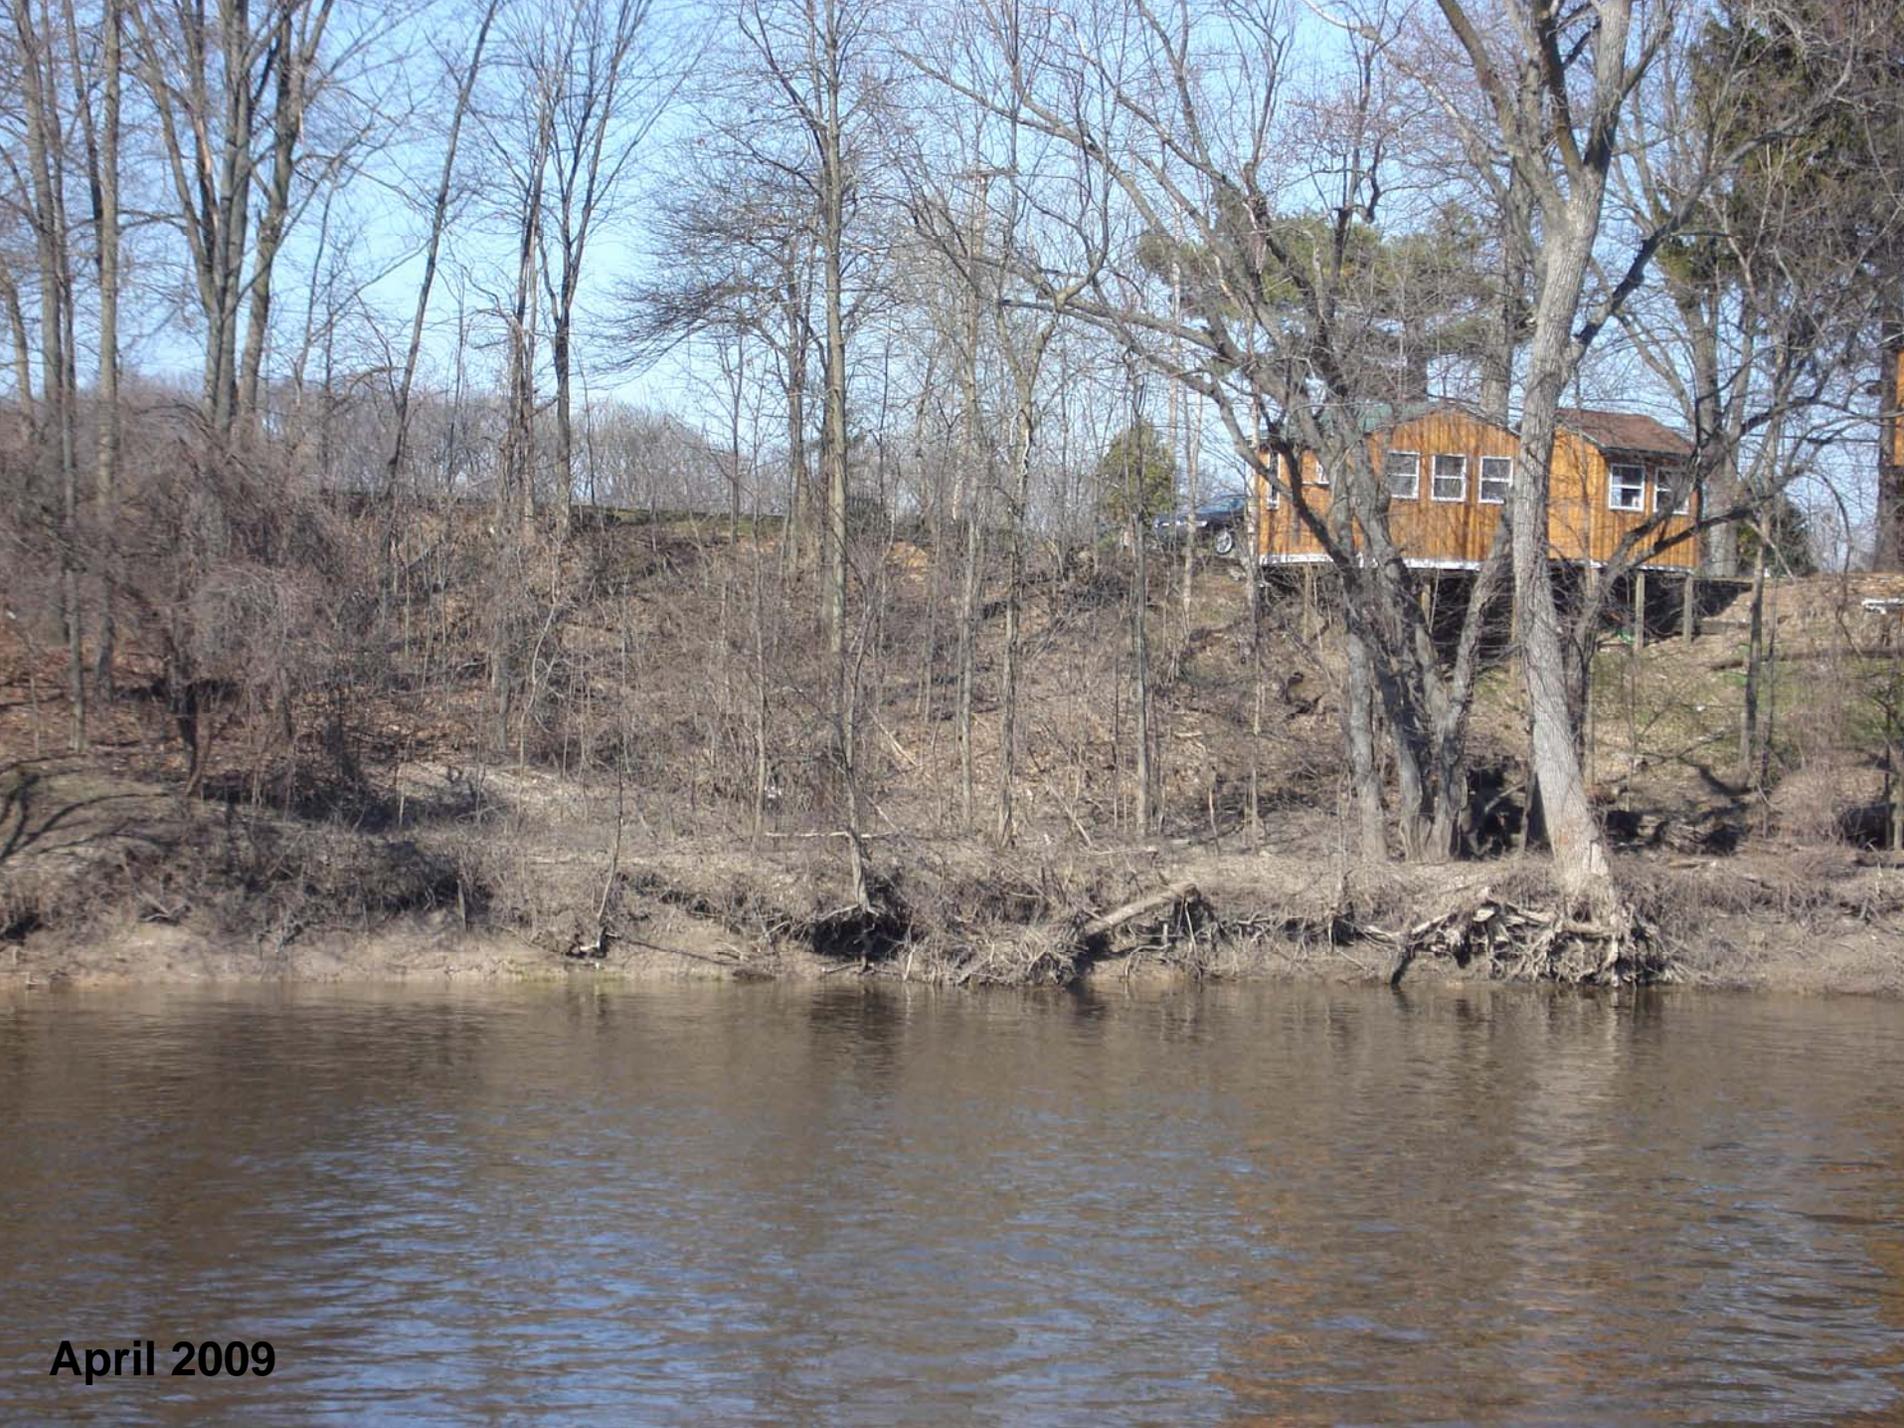
Outside meander bend below Imerman Park

**Monitoring banks in
different conditions to
determine where efforts
are best applied**

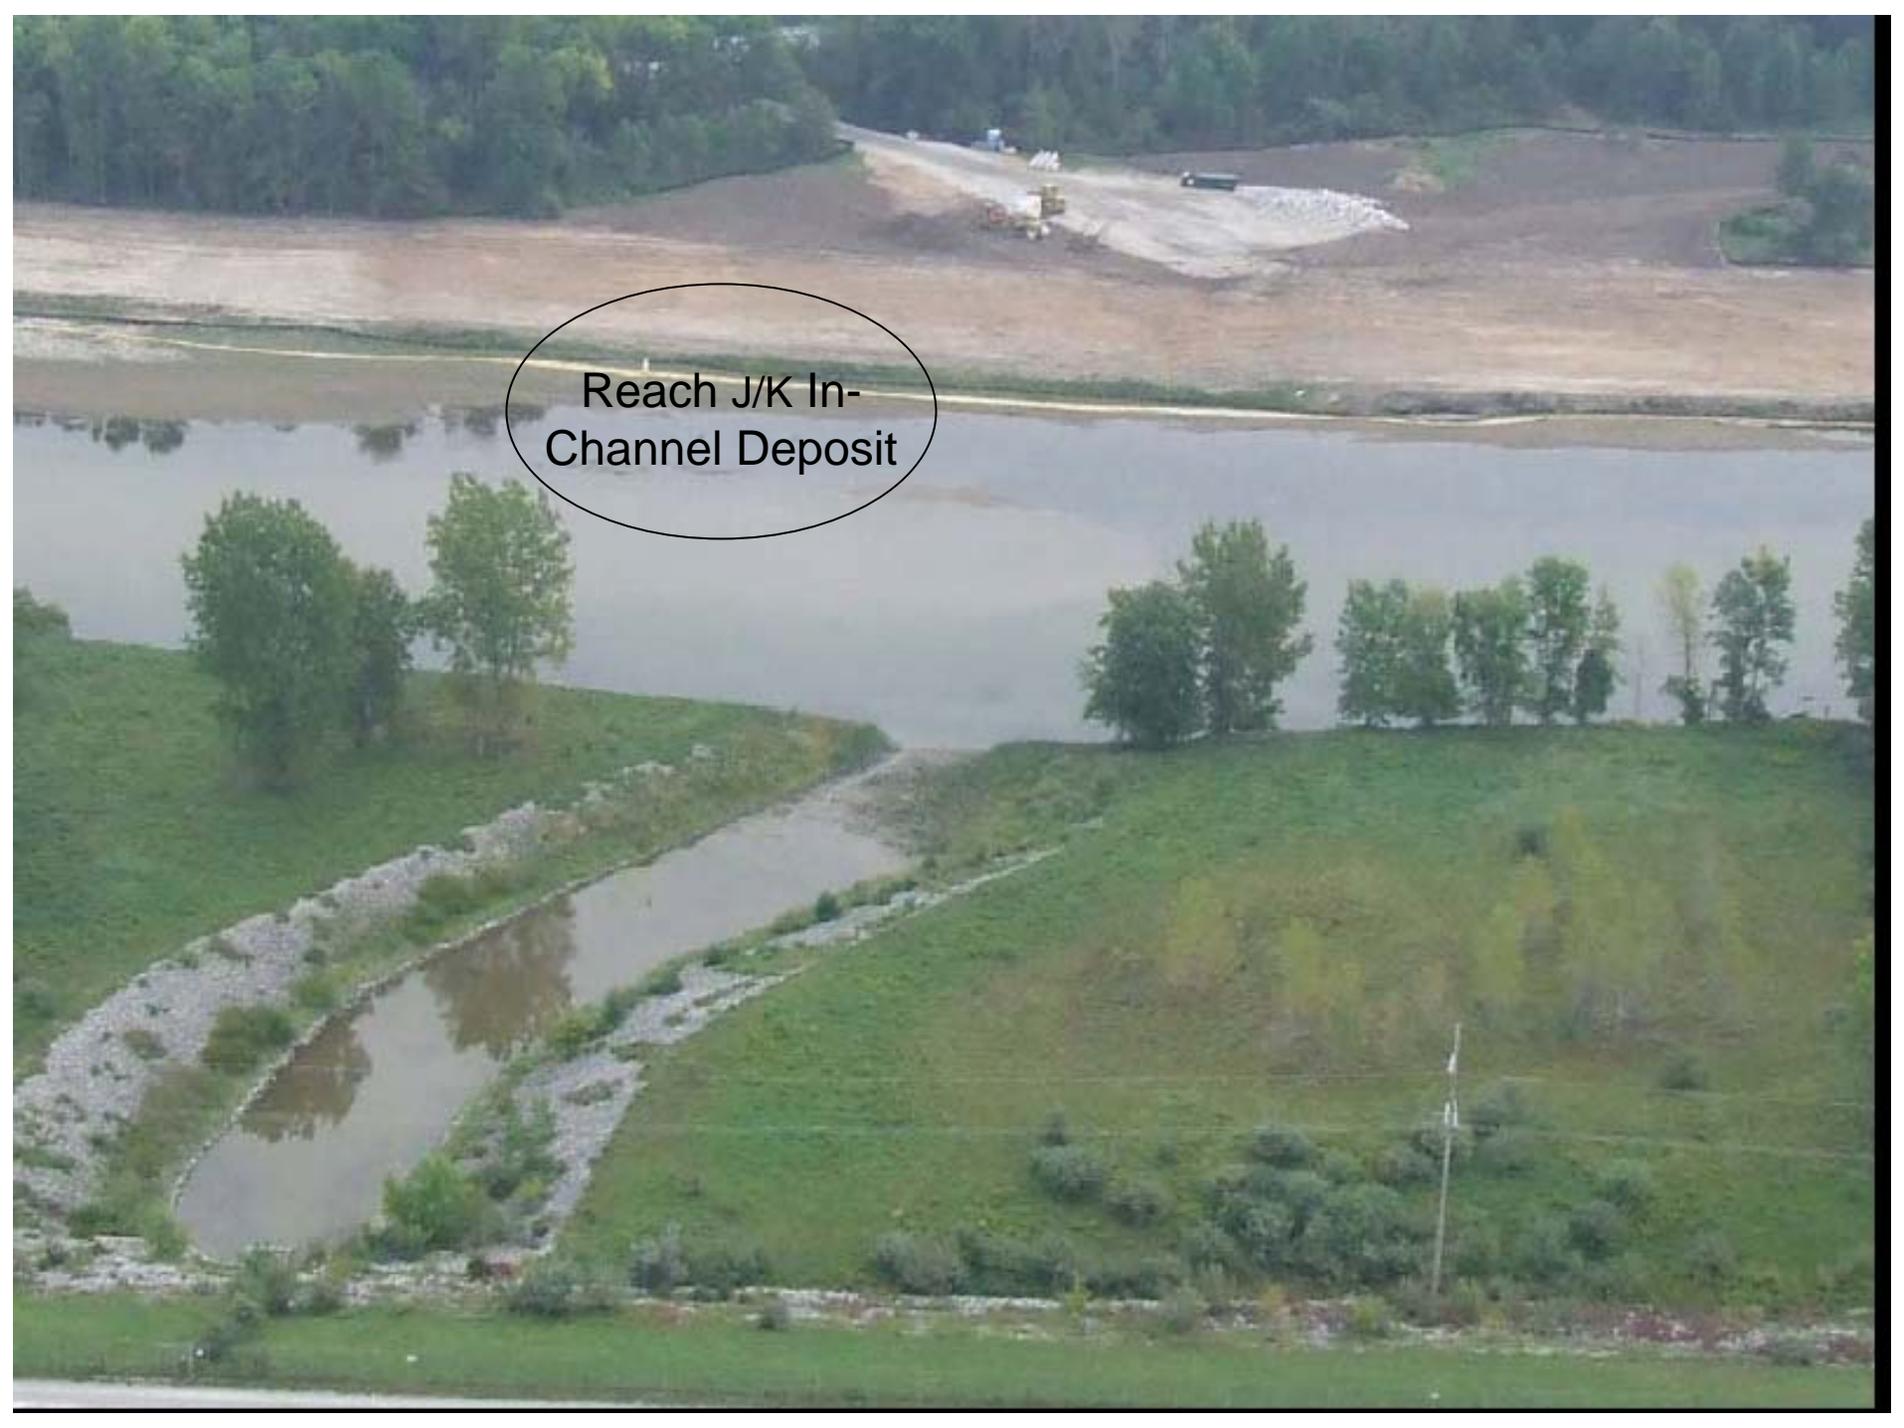
Reach J/K In-Channel Deposit

An aerial photograph showing a wide river with a large, light-colored, irregular deposit in the center. The deposit is surrounded by water. In the foreground, a smaller channel with a rocky bed flows into the main river. The surrounding landscape is green with trees and grass. In the background, there is a construction site with a dirt road, a yellow excavator, and a pile of white material.

- **Address surface concentrations that are high**
 - Reach J/K - TEQ/Parathion
- **Collect additional data to determine/verify stability of deposits Dow is proposing to leave in place in the short term (field validation of modeling)**
 - Reach J/K
 - Reach L and others – data to be provided in June 1 GeoMorph® Report or sooner
- **Comparison of channel conditions between 2008 and 2009**
 - Bathymetry
 - Erosion pins
 - Scour chains
- **Conduct sediment toxicity testing**
- **Reach J/K data in from 2008**
 - Under review
 - Toxicity does not appear to be acute
 - Does not appear to be eroding based on Fall 2008 data - need to see spring data which would capture effects of winter/spring flood events

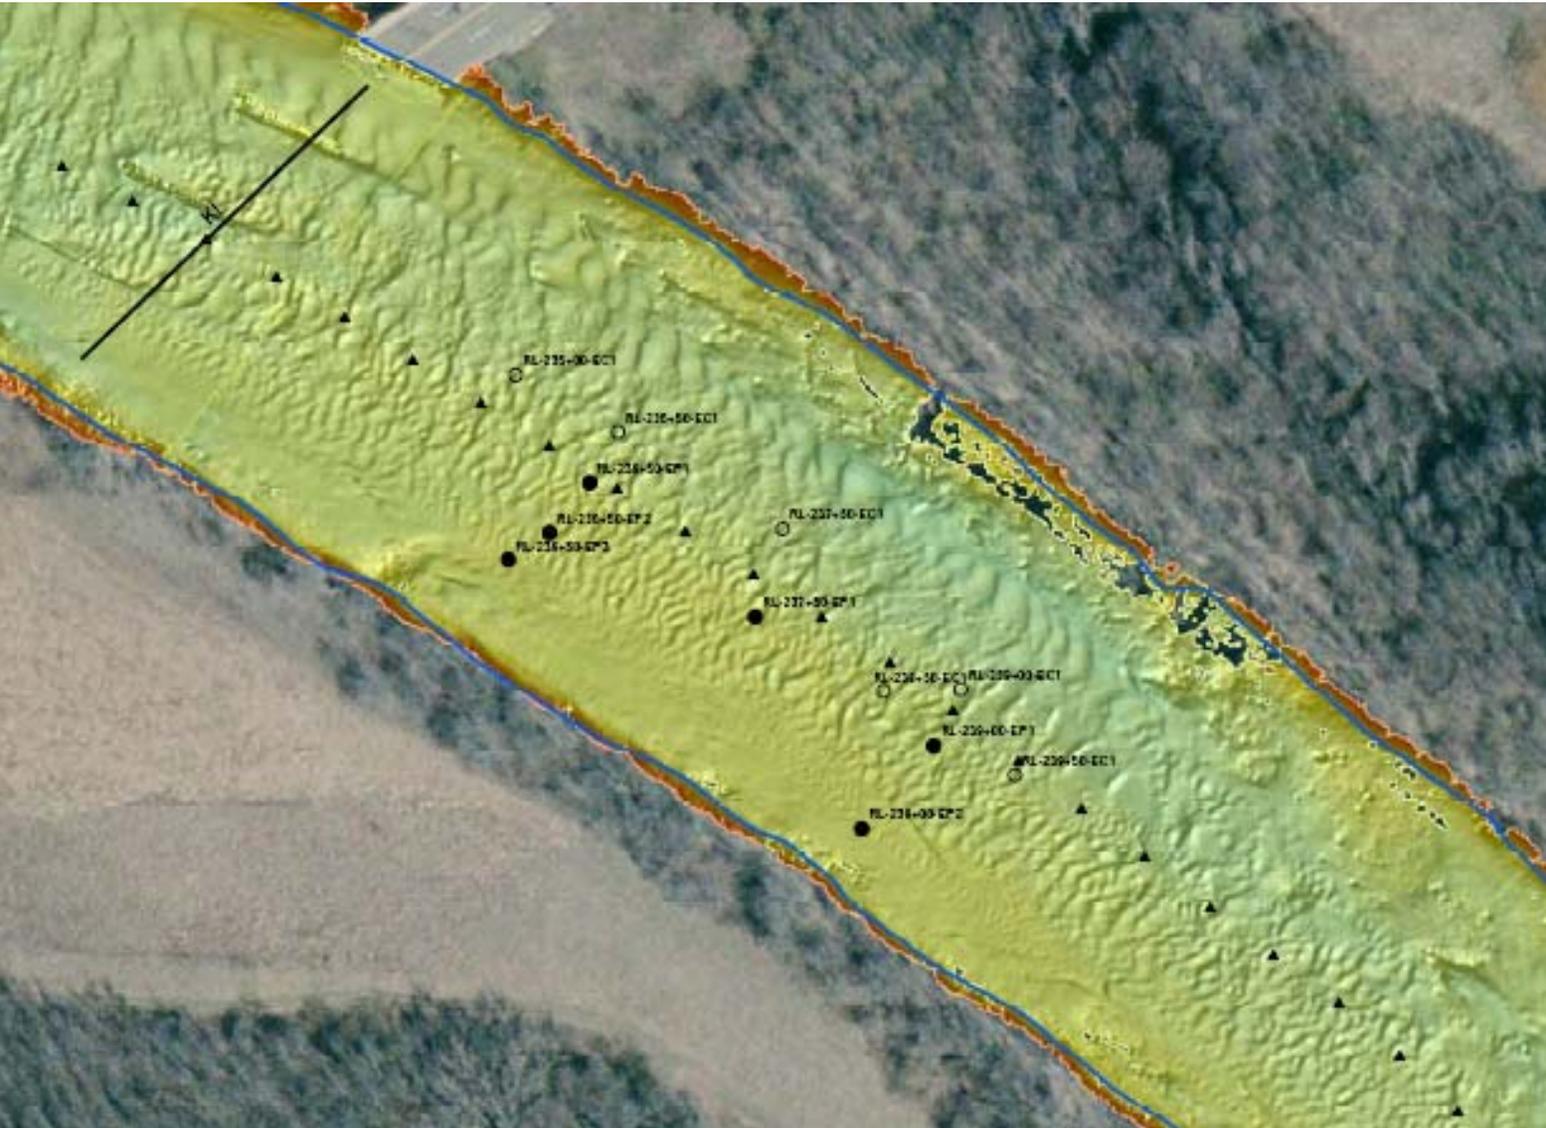
Example - Erosion Pins/Scour Chains

● Erosion Pin
○ Scour Chain

Notes:
1) In-channel base layer is 2006 bathymetry data. Tan colors indicate shallower areas.
2) Overbank base layer is 2006 aerial photography.

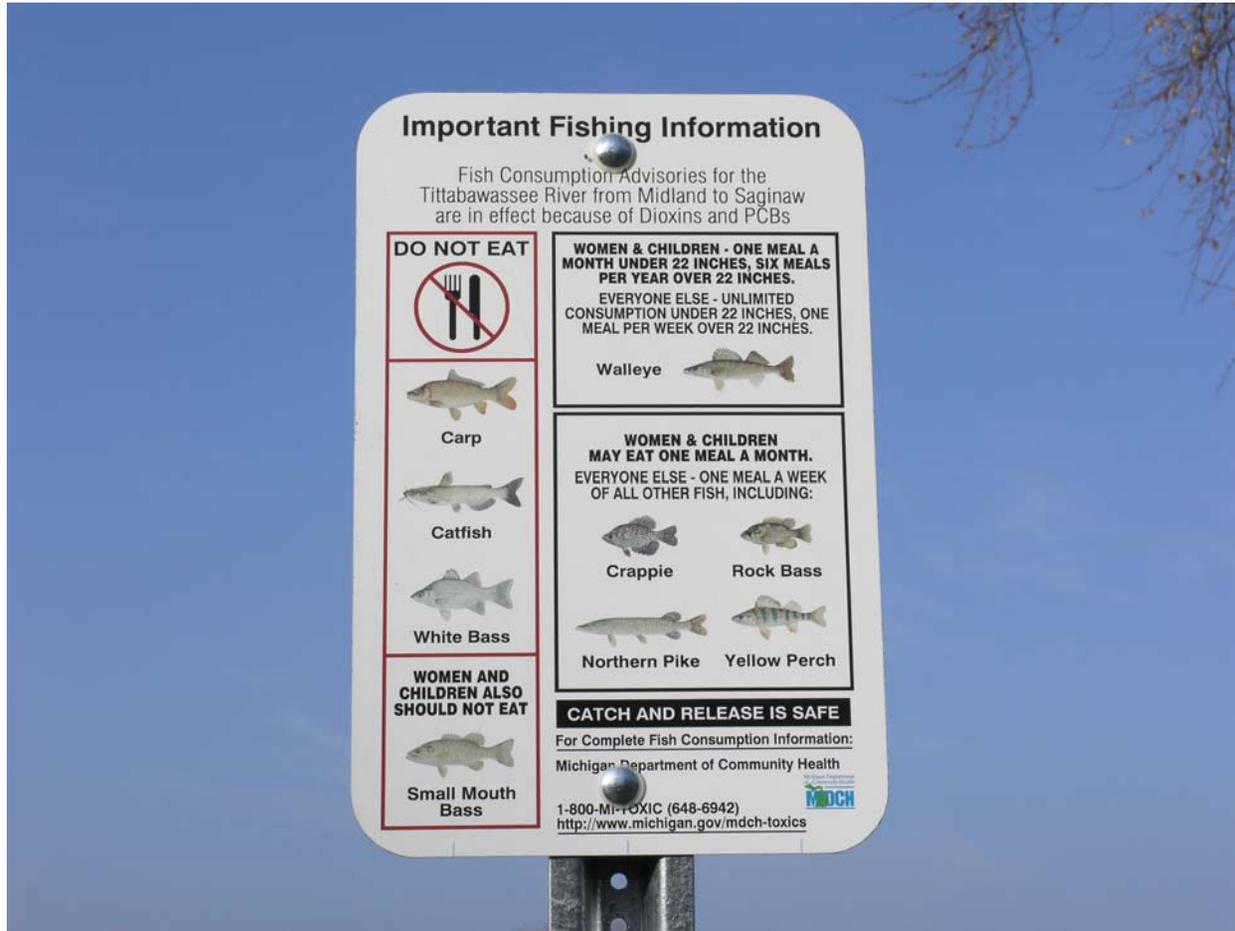
Update Signs to be Consistent with Updated Fish Advisory

- Department of Community Health available after meeting to discuss
- Advisories have become more stringent
- Signs need to be updated – funding dependent
