Black River Watershed Management Plan

**MDEQ Tracking Code 2002-0067
April 2005**

**Prepared by:
Erin Fuller
Black River Watershed Coordinator
Van Buren Conservation District
1035 E. Michigan Avenue
Paw Paw, MI 49079
(269) 657-4030**

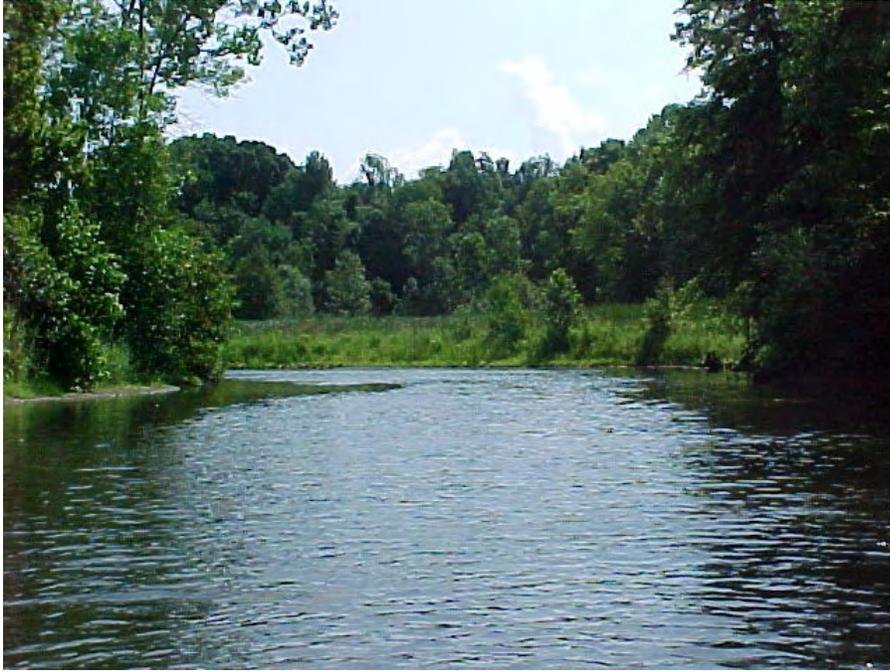
Figure 13: Natural vegetation buffer along the North Branch (Casco Twp.)

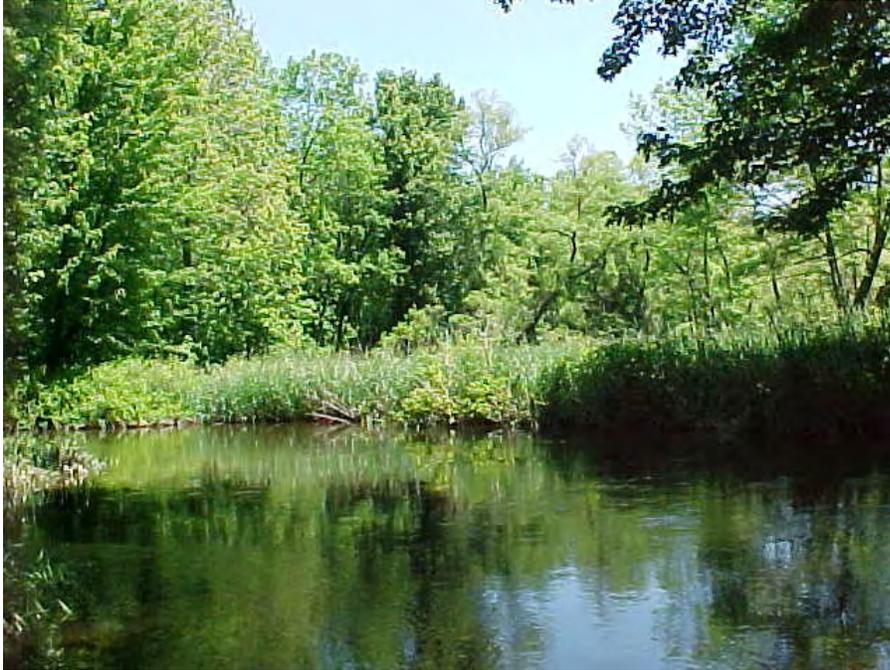
The North Branch of the river downstream of 108th Ave. is primarily forested. Very few houses are visible along the river. The floodplain is wide, and woody debris is prevalent within the channel. The banks appeared stable and well-vegetated. There were a few small emergent wetlands along this stretch, dominated mostly by Reed Canary Grass (Figure 15).

Figure 15: Emergent wetland along the North Branch

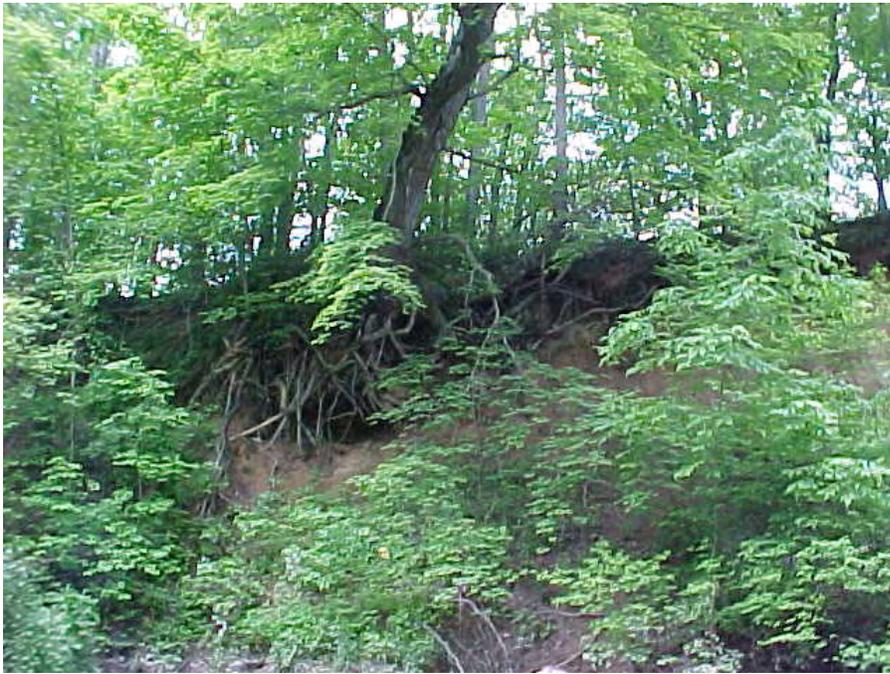
Upstream of the confluence with the North Branch, the banks of the South Branch are in some places quite high and eroding (Figure 17). This is in most cases not a result of current land use practices, as the river is forested along most of these sections.

Figure 17: High, eroding bank along the South Branch

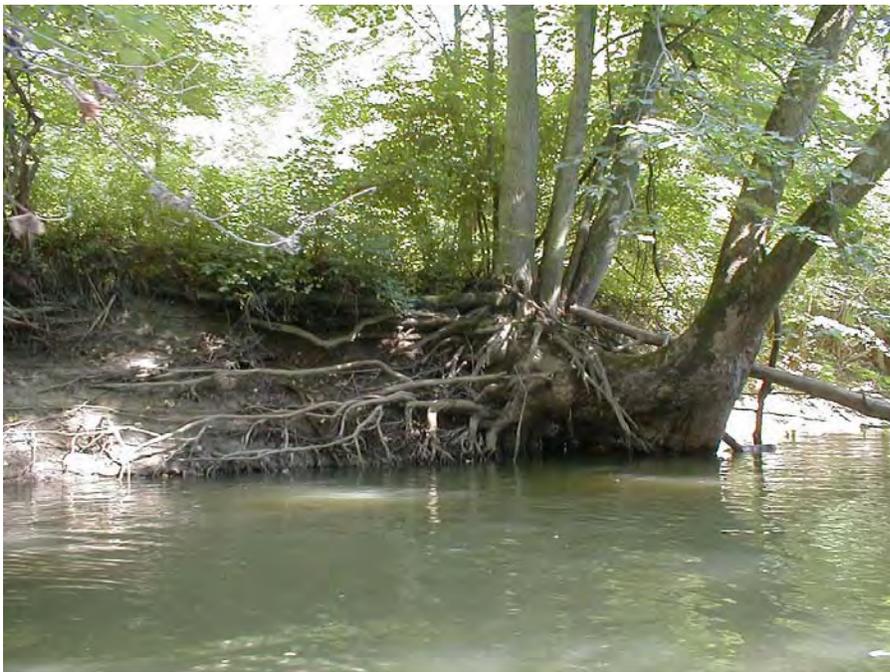
The South Branch between Phoenix St. and 70th St. has high, somewhat unstable banks. Roots of many trees have been undercut, indicating that the channel of the river is changing faster than the vegetation can adapt (Figure 18).

Figure 18: Undercutting of tree roots along the South Branch

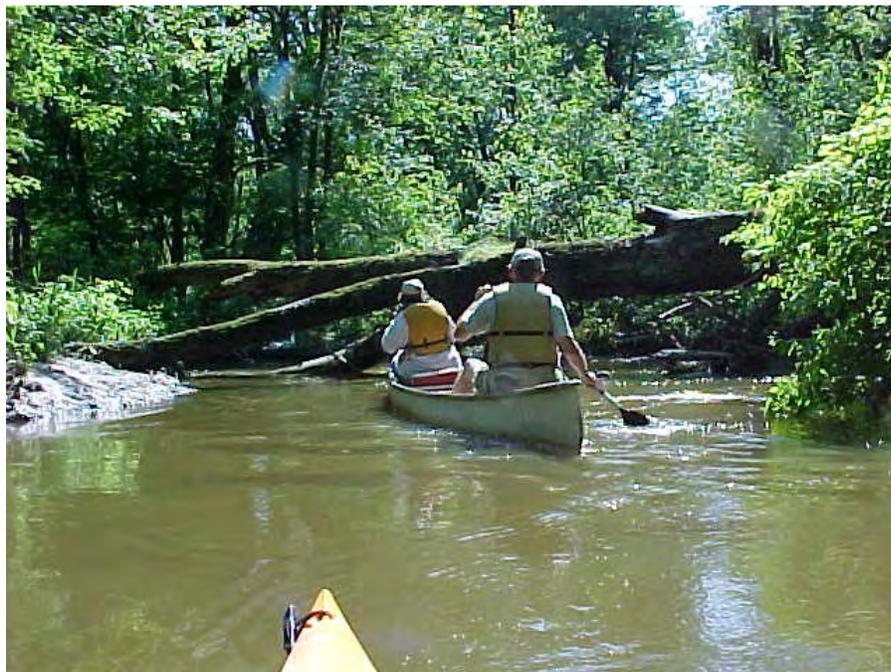
The South Branch downstream of Lion's Park in Bangor is very forested. The prevalence of woody debris makes this a slow and difficult paddle (Figure 19).

Figure 19: Canoeists negotiate a large tree across the South Branch, downstream of Bangor
