Galien River Watershed Management Plan

MDEQ Tracking Code #2000-0122

Berrien County Drain Commissioner

**JULY 2003
PROJECT NO. G01338**

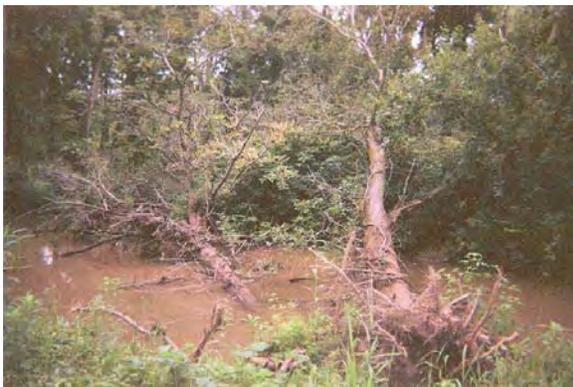
Photograph 1: Fallen Tree Diverting Flow

County drain information was made available by the BCDC. Frequent maintenance on a stream may indicate that the reach is unstable. It is not uncommon for trees to fall into the stream at the bank. The frequency of this occurrence varies widely, depending on soil type, topography, vegetation type, and flow rates. A fallen tree will cause the stream to change flow paths, but normally the stream will maintain the channel with slight alteration of the banks. It may scour the streambed below and the banks around the obstacle, creating an increased sediment load in the River (Photographs 1 and 2). This sediment load may be deposited downstream in the form of a sandbar. It may also alter a fast flowing channelized system into a slower meandering system with riffles, pools, and snags, which provide fish habitat. Major changes to flow paths and heavy sediment load are causes for concern.

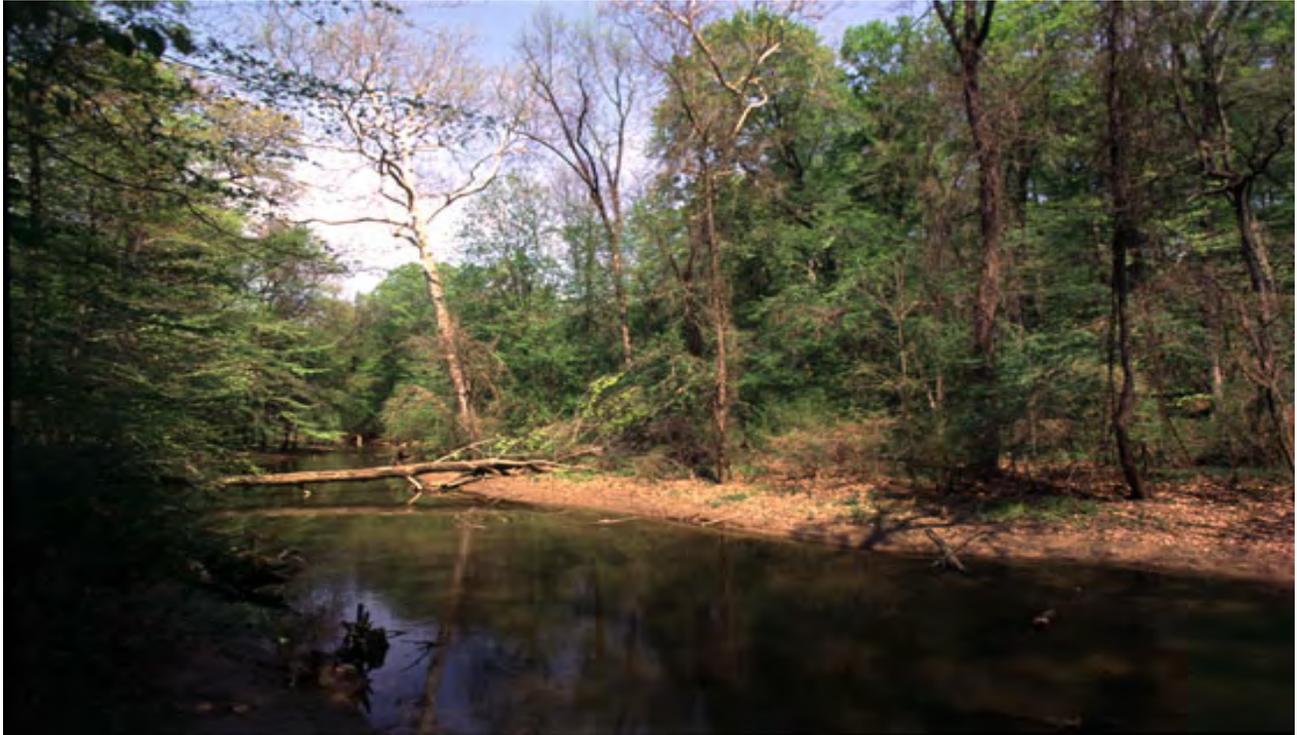
Photograph 3: Galien River Between Lake Michigan Channel and Red Arrow Highway

Reach 1 - Galien River Between Lake Michigan Channel and Red Arrow Highway

This reach of the River was classified as E6 (Photograph 3). An E classification represents the developmental “end-point” of channel stability and fluvial process efficiency for certain alluvial streams undergoing a natural dynamic sequence of system evolution (Rosgen, 1996). The E stream types are typically slightly entrenched (>2.2), exhibit very low channel width/depth ratios (<12), and display very high channel sinuosity (>1.5). This reach is very slightly entrenched (22), since it is mostly a low marshy area and forested floodplain. The width/depth ratio is 9.6, indicating a wide, relatively deep river. The sinuosity is not as high as a typical type E stream, calculated at 1.3, but the number does indicate meandering, which is evident in the historical photographs. The slope (0.0012) and channel materials (Aquents and Histosols) identify the stream as E6. The relatively deep channels maintain a high resistance to change, resulting in channel stability. The stability can be compromised, however, when streambanks are disturbed or significant changes occur in the sediment loads or flows.

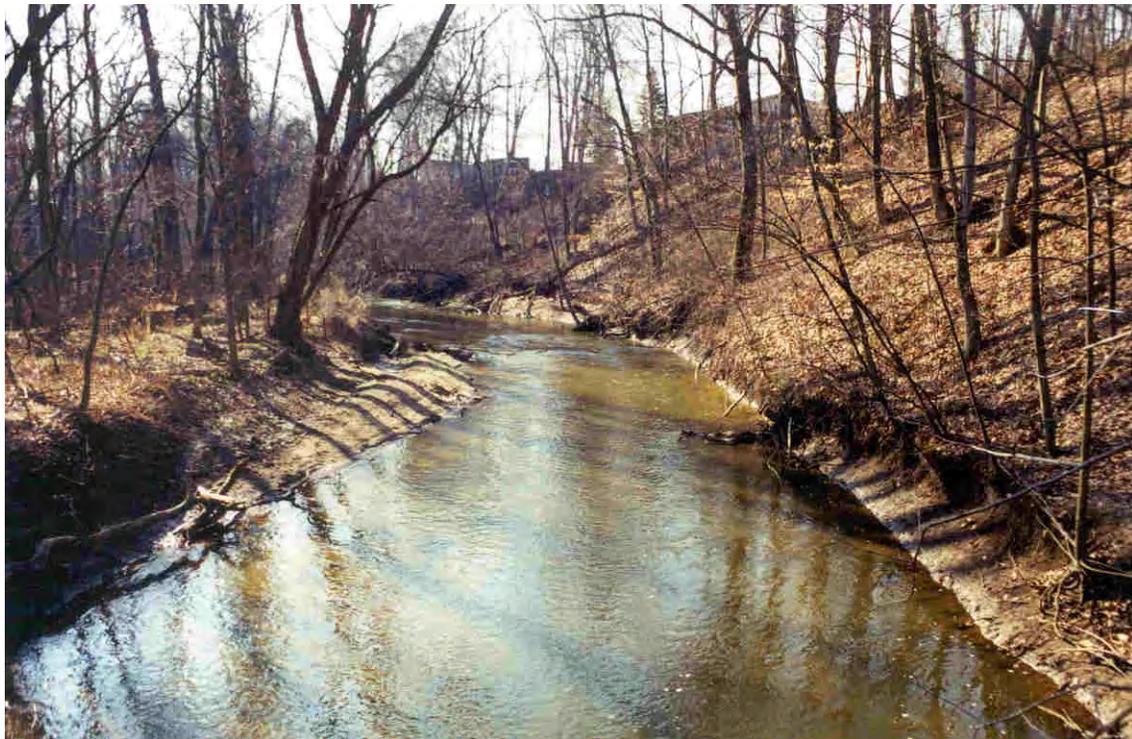
Photograph 4: Galien River at Minnich Road

Reach 2 - Galien River at Minnich Road

This reach of the River was also classified as E6 (Photograph 7). The E stream types are typically slightly entrenched (>2.2), exhibit very low channel width/depth ratios (<12), and display very high channel sinuosity (>1.5). The entrenchment ratio of 25 for a single stream indicates either a type C or E stream. The width/depth ratio of 8 indicates a wide, relatively deep river, resulting in an E classification. The sinuosity (1.4), slope, (0.0023) and channel material (Cohoctah sandy loam) yields a classification of E6. The relatively deep channels maintain a high resistance to change, resulting in channel stability. The stability can be compromised, however, when streambanks are disturbed or significant changes occur in the sediment loads or flows.

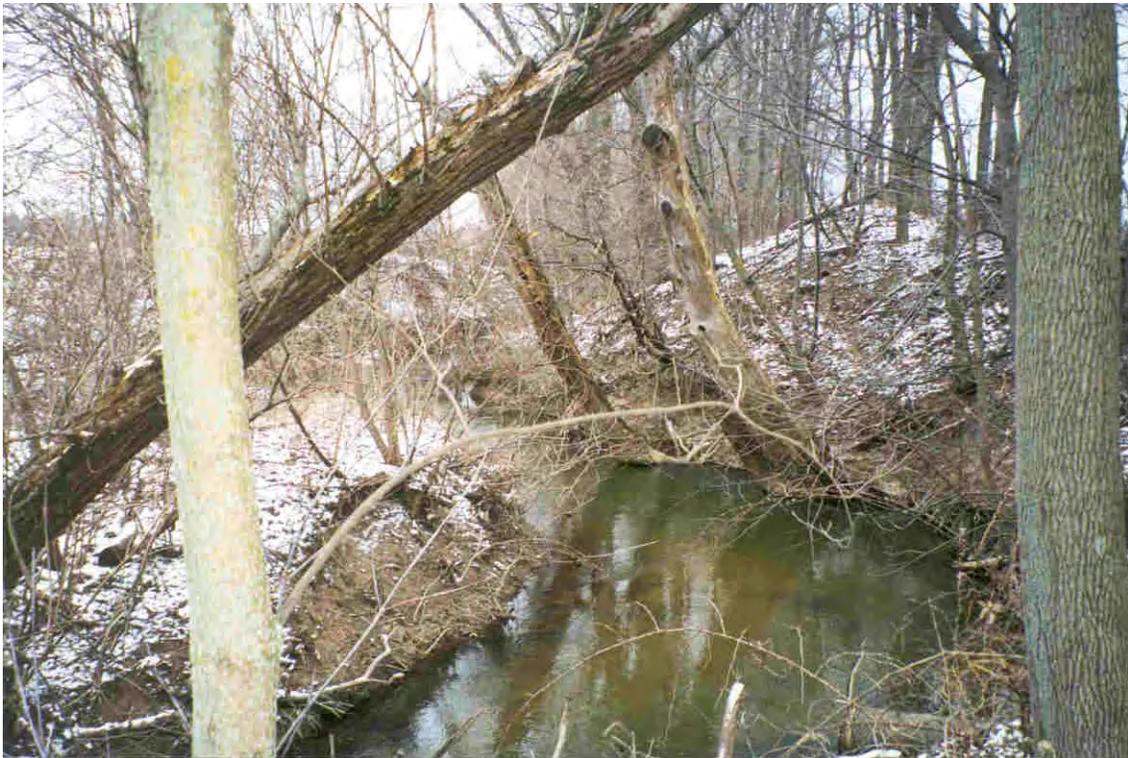
Photograph 5: Blue Jay Drain Between Holden and Pardee Roads

Reach 3 - Blue Jay Drain Between Holden Road and Pardee Road

The Blue Jay Drain was classified as E6 (Photograph 5). An E classification represents the developmental “end-point” of channel stability and fluvial process efficiency for certain alluvial streams undergoing a natural dynamic sequence of system evolution (Rosgen, 1996). The E stream types are typically slightly entrenched (>2.2), exhibit very low channel width/depth ratios (<12), and display very high channel sinuosity (>1.5). The entrenchment of this reach is slight (6), as it is located in an area that was a Black Ash swamp in presettlement days. The channel width/depth ratio is very low (5.8), indicating that the narrow and relatively deep channels maintain a high resistance to change, which results in channel stability, unless streambanks are disturbed and significant changes in the sediment loads or flows occur. A tributary to this reach had maintenance performed in 1996, which could have added a large sediment load and increased flows to the stream, thus creating an unstable condition. The reach has moderate sinuosity (1.2). The slope (0.0009) and channel materials (silt loam) are indicative of the E6 classification.

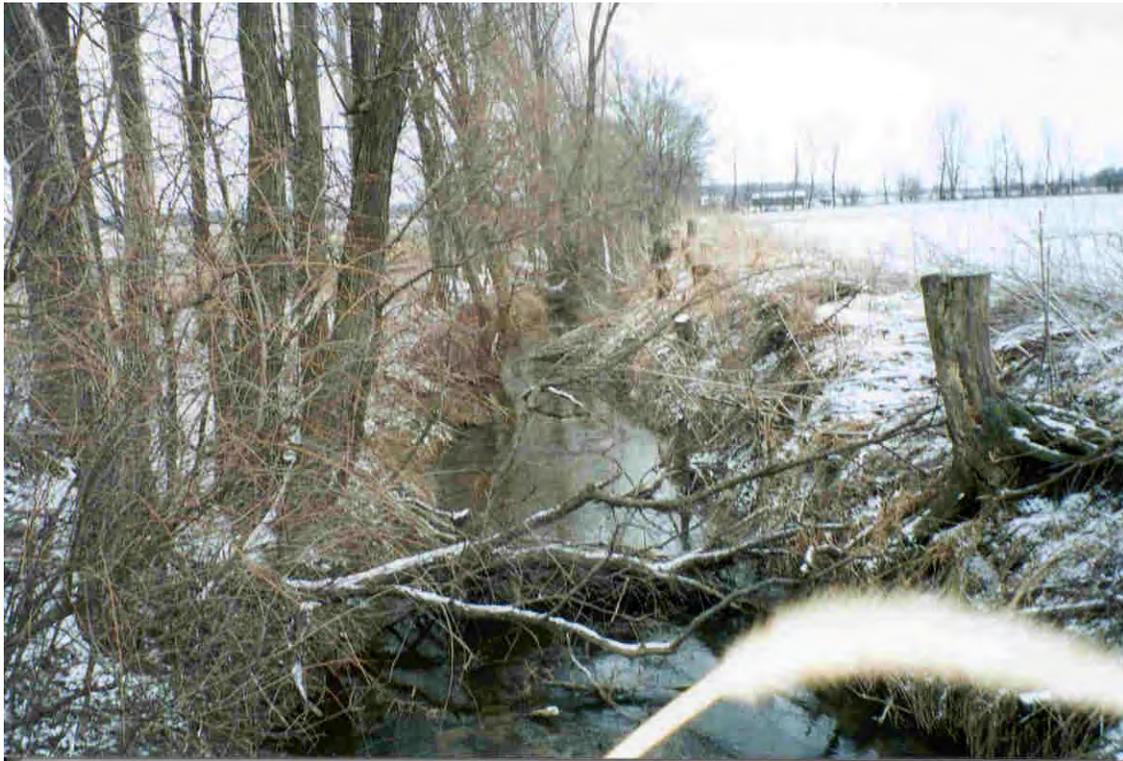
Photograph 6: Dowling Creek East of Hampton Road

Reach 4 - Dowling Creek East of Hampton Road

Dowling Creek is classified as C5 (Photograph 6). The C stream types have a well developed floodplain, are relatively sinuous, and have a low relief channel (Rosgen, 1996). Channels of these types of streams can be significantly altered when the effects of changes in bank stability, watershed condition, or flow regime are combined to cause an exceedance of the channel stability threshold. Dowling Creek is very slightly entrenched (3.3), located in the Elm Valley area of glacial outwash in the Watershed. The channel has a moderately high width/depth ratio (14) and a high sinuosity (1.21), indicative of the depositional characteristics of the stream bed and the active meandering. The slope of the channel (0.0018) identifies the reach as C5. This stream type is susceptible to shifts of stability caused by direct channel disturbance and changes in the flow and sediment regimes of the contributing watershed, but is able to recover quickly if no further disturbances occur.

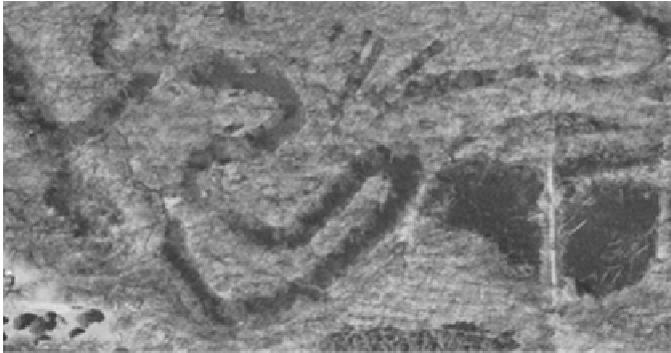
Photograph 8: Log Jams on the Galien River

The River in this lower area of the Watershed has a wide floodplain and the pattern of its sinuosity has shifted over time. It is a constantly changing river with meanders that slowly move as trees fall in at the banks. Its history can be seen in the convoluted meanders and oxbow lakes (Photograph 8).

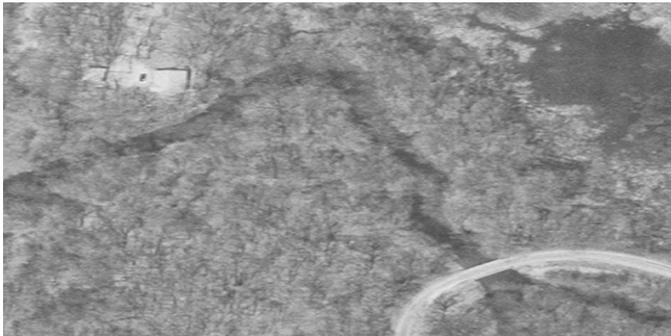
Photograph 9: Decreasing Meander of the Galien River

The meander in the southwest quarter of Section 13 in Chikaming Township appears to be moving toward Flynn Road. Meanders in the southwest quarter of Section 7 in Weesaw Township are decreasing (Photograph 9).

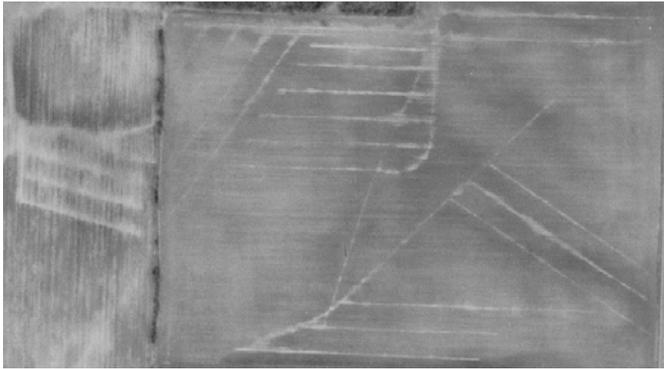
Photograph 10: Tile Network Draining Wetland of Elm Valley

The most significant change in the natural hydrology of the Watershed was the loss of a 5-square-mile wetland in Elm Valley, located in the southern central portion of the watershed around Avery Road (Figure 8). This wooded wetland system not only stored water, but through evapotranspiration and infiltration, prevented much of the runoff from entering the stream system. Artificial drainage in the form of tiles in fields and trenched open drains has converted this wetland into cropland (Photograph 10). The major wetlands that were drained were in Galien Township, Sections 5, 6, 7, and 8, as well as Weesaw Township, Sections 31 and 32. Restoring wetlands in these areas would reduce the volume and velocity of flows. The more water stored in this region, the less flooding will occur in Elm Valley. There are some

large tracts of land that may be available to enroll in the Wetlands Reserve Program, but even small wetlands will reduce flooding. An alternative to restoring the wetlands is to reduce drainage and grow specialty crops that require or can withstand greater moisture. New developments in and upstream of Elm Valley should be required to have onsite retention and detention of storm water.

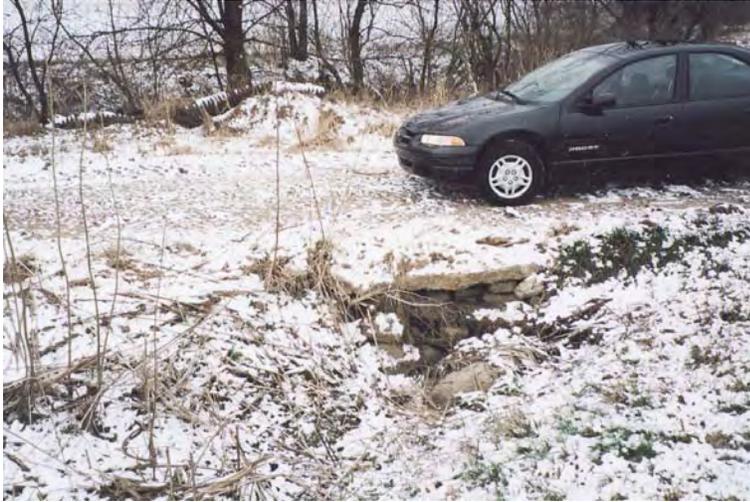
Photograph 11: Blocked Driveway Culvert

Much of the Elm Valley upstream from the confluence of the River and the East Branch of the River is farmed in the 2- to 5-year floodplain. Private drainage systems can be maintained to expedite the conveyance of water from the fields to the River once its level has gone down. Photograph 11 shows a blocked culvert that prevents drainage of water into the channel on the other side. Water will back up in the fields and overtop the driveway, causing both flooding conditions and erosion of the driveway.

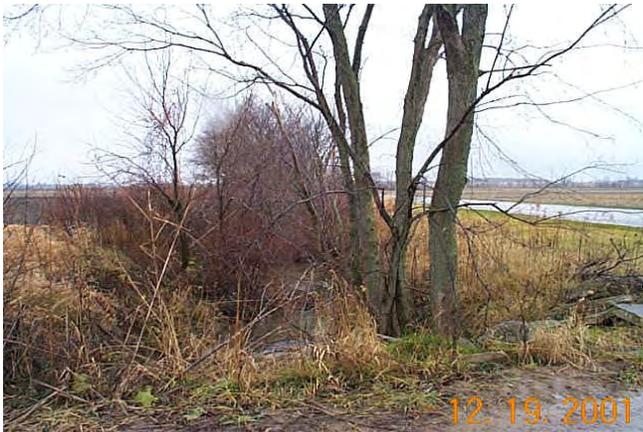
Photograph 12: Thick Brush on Banks

Flooding problems have been reported at Locations 18 and 24. Photographs of Location 18 show thick brush on the channel banks (Photograph 12). Channel conveyance will approach the 10-year storm event at this location with selective brush removal. Replacing the crossing and excavating additional channel will increase this location's conveyance capacity to the 25-year event. A channel's flow capacity is related to the channel roughness. Decreasing channel roughness often results in an increase of the channel's capacity. Selective brush removal within the channel can reduce a channel's roughness and increase the channel's capacity. Proper selective brush removal can also maintain the streambank vegetative cover, which benefits the stream by both shading the stream to maintain temperatures and stabilizing the streambank from possible erosion.

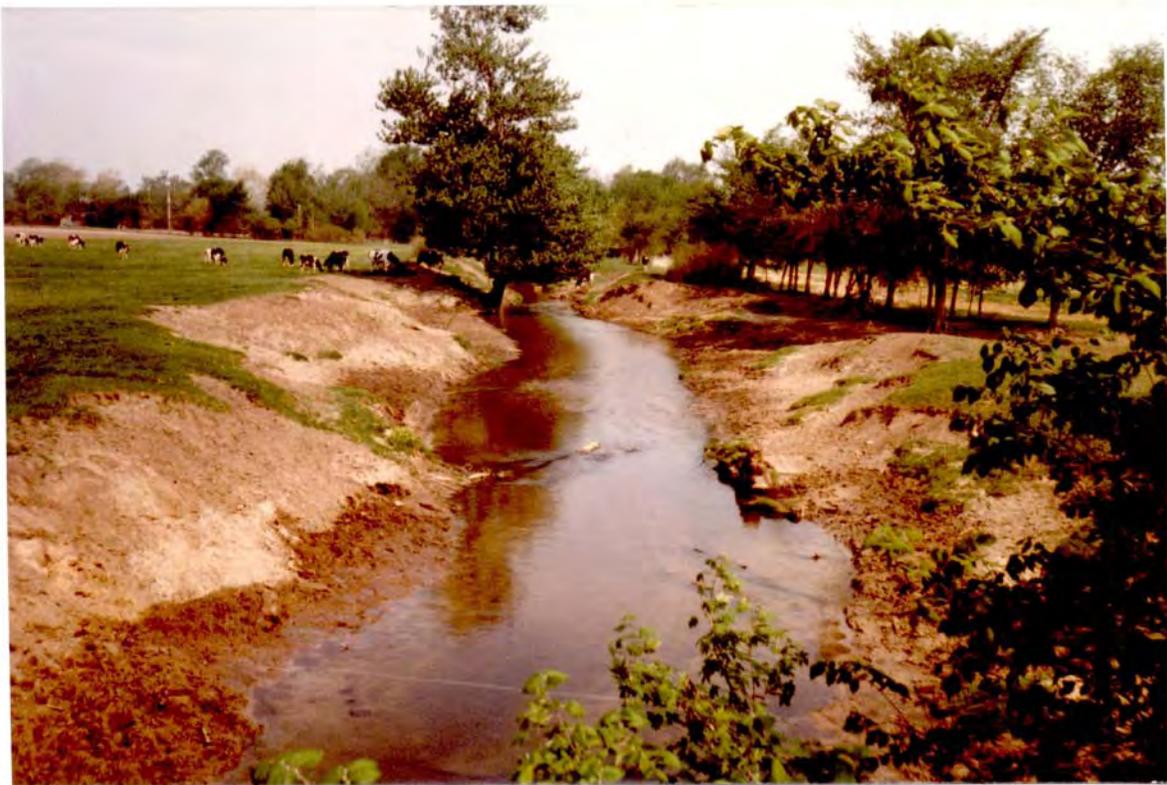
Picture 7: Unlimited Livestock Access (May 1982).

The effects of livestock access to streams can be severe. There is a twofold problem: waste elimination into the water and destruction of streambanks. *E. coli* and excessive nutrients pollute the streams from livestock waste. Even if livestock are allowed near the bank, their waste can wash directly into a water body. As livestock climb the banks of the river, the integrity of the banks suffers. Pictures 7 and 8 show the devastation that the weight of the cattle cause to streambanks. Livestock should be excluded from streams by use of fencing. Cattle crossings can be constructed of materials that will not erode under their weight. There should be substantial sized buffers, preferably 100 feet, between the fencing and the stream, especially on a slope. If gullies form, livestock should also be kept away from this region with fencing.
