Enbridge Line 6B MP 608
Marshall, MI Pipeline Release
Case No.: 15-1411-CE
Report of Findings
Large Woody Debris Riffle Survey

Prepared for Michigan Department of Environmental Quality

Enbridge Energy, Limited Partnership

Submitted: August 11, 2016

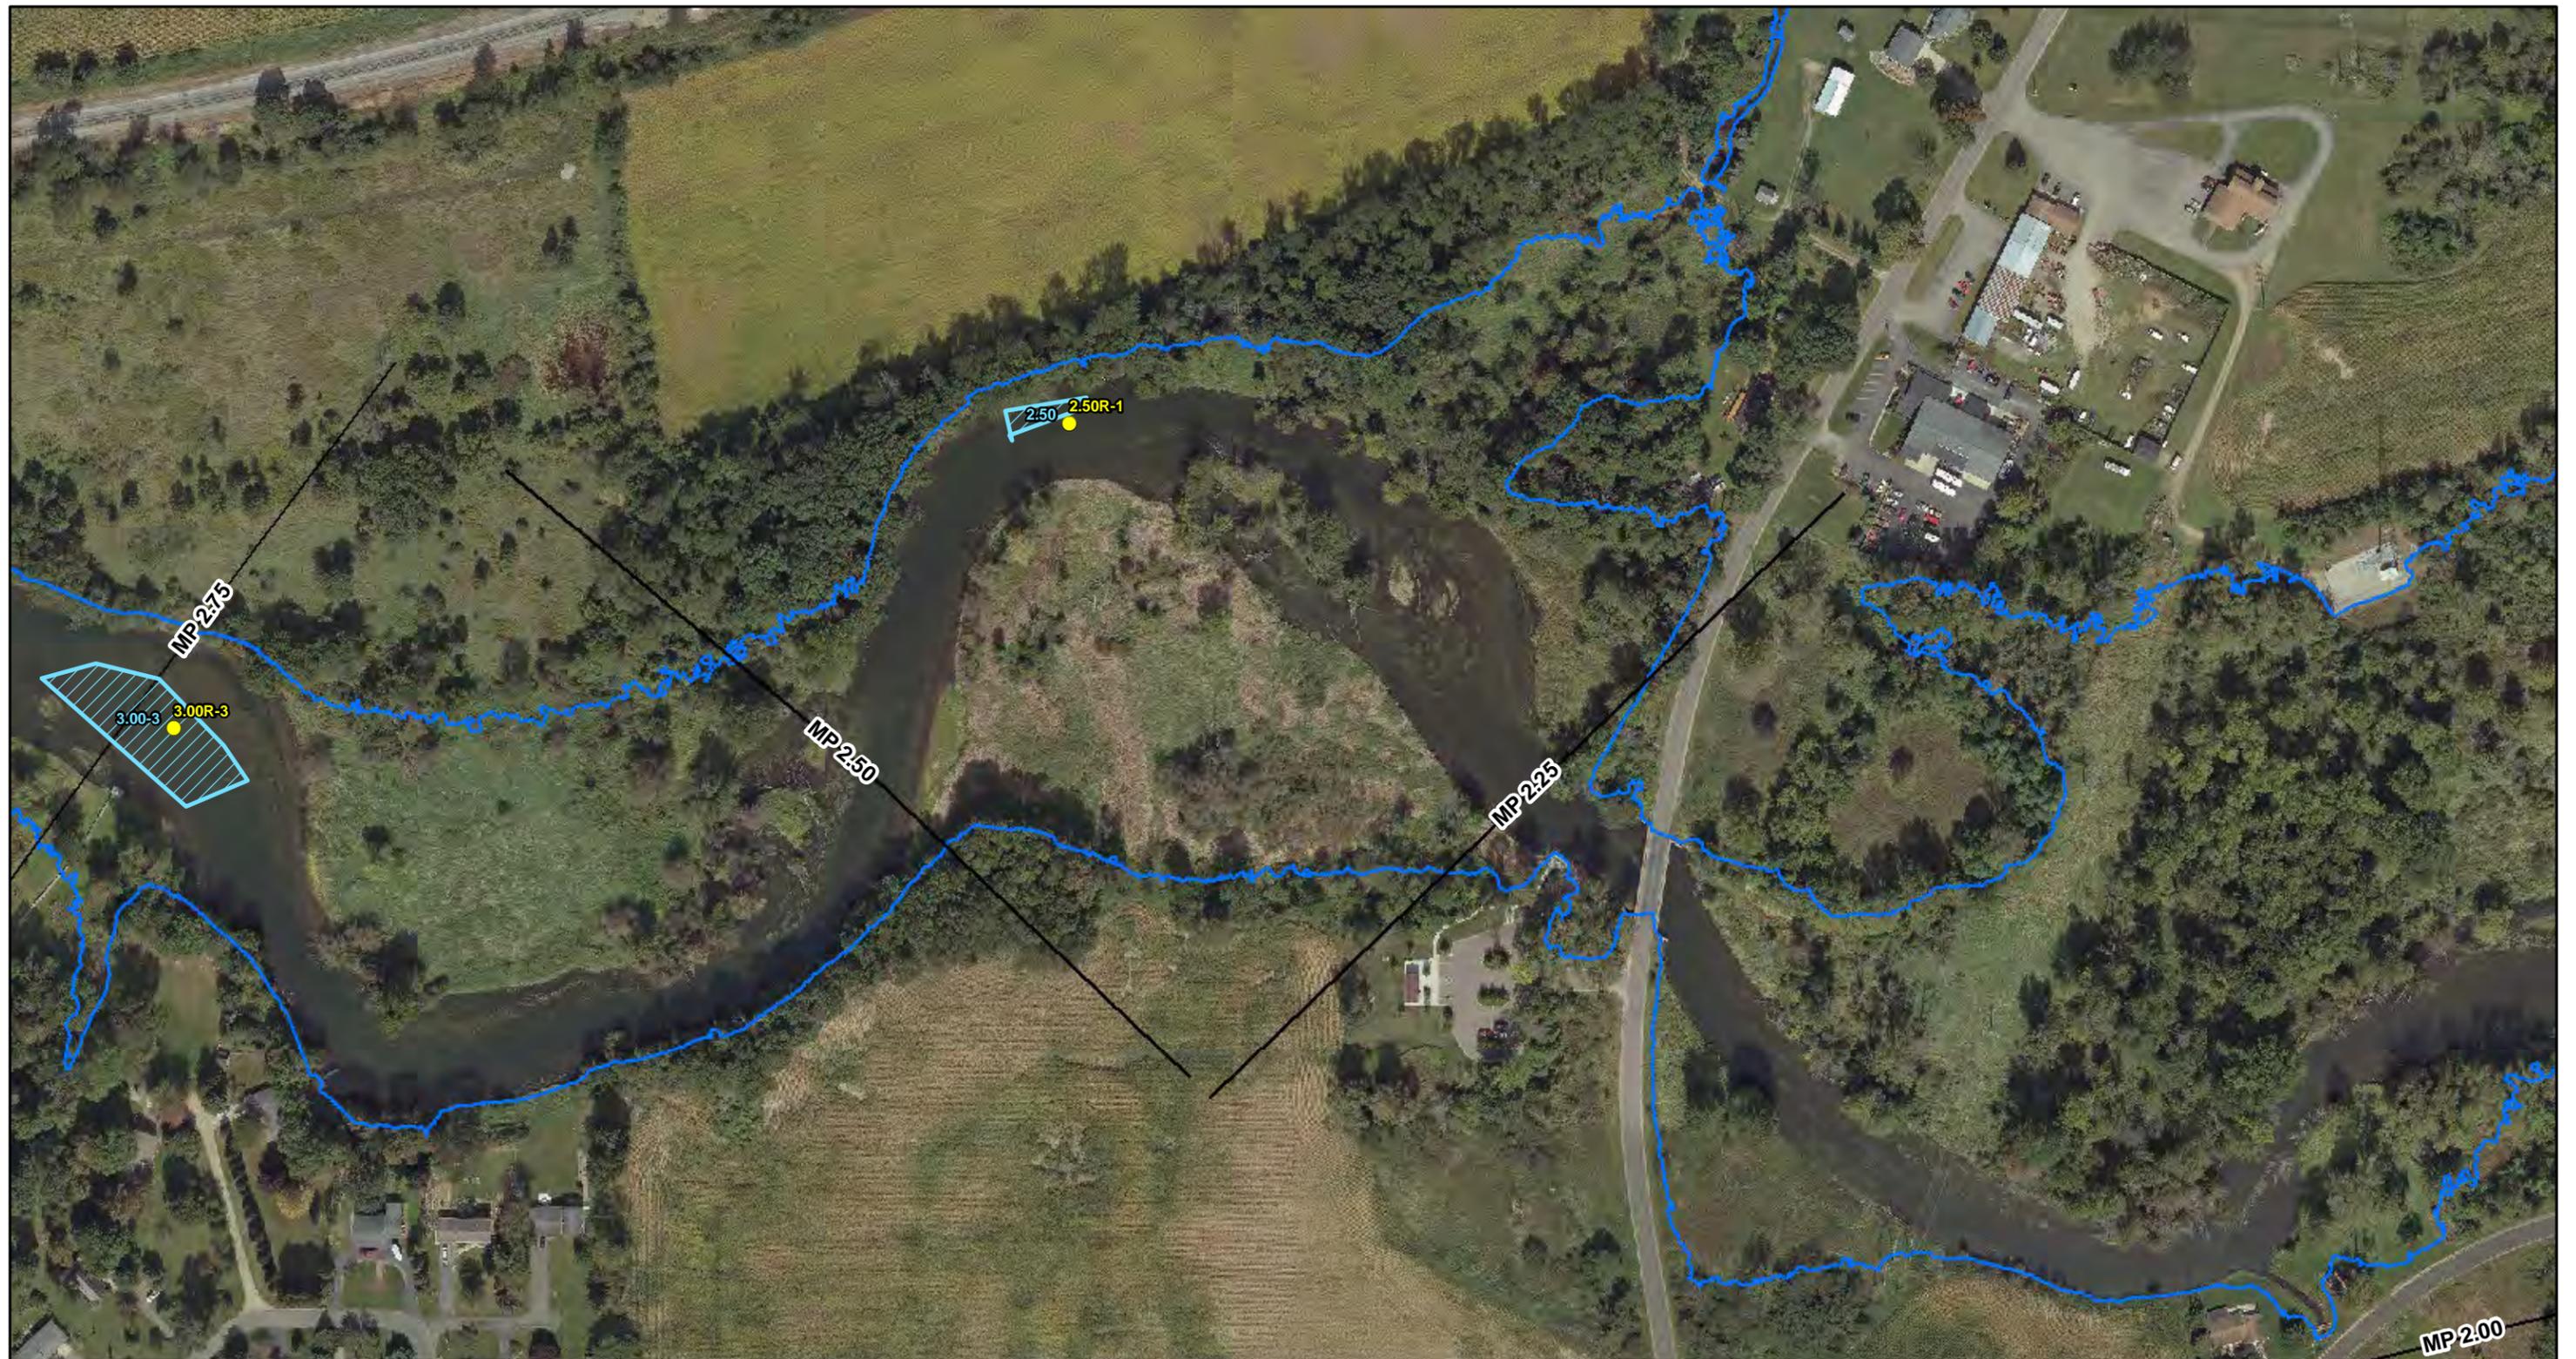
Survey Area 1 (MP 2.25 - MP 3.25) contained the highest riffle density of the four surveyed areas, including five locations exhibiting the field identification attributes for riffles (*Figure 1 – Sheet 1 and Sheet 2*). Riffles in this area were typically less than 1.5 ft in water depth with a mixture of cobble, gravel, and sand bottom substrates. Field observations included abundant fish and macroinvertebrates present within all of the mapped riffles. As previously noted, the lateral extents of the riffle across the river section were determined where a change in water depth (lack of consistent water depth near river banks) or bed sediment (change from cobble, gravel, sand mixture to sand/silt mixture) occurred. Therefore, riffle polygons in *Figure 1* do not extend laterally across the entire river channel from the left bank to right bank.

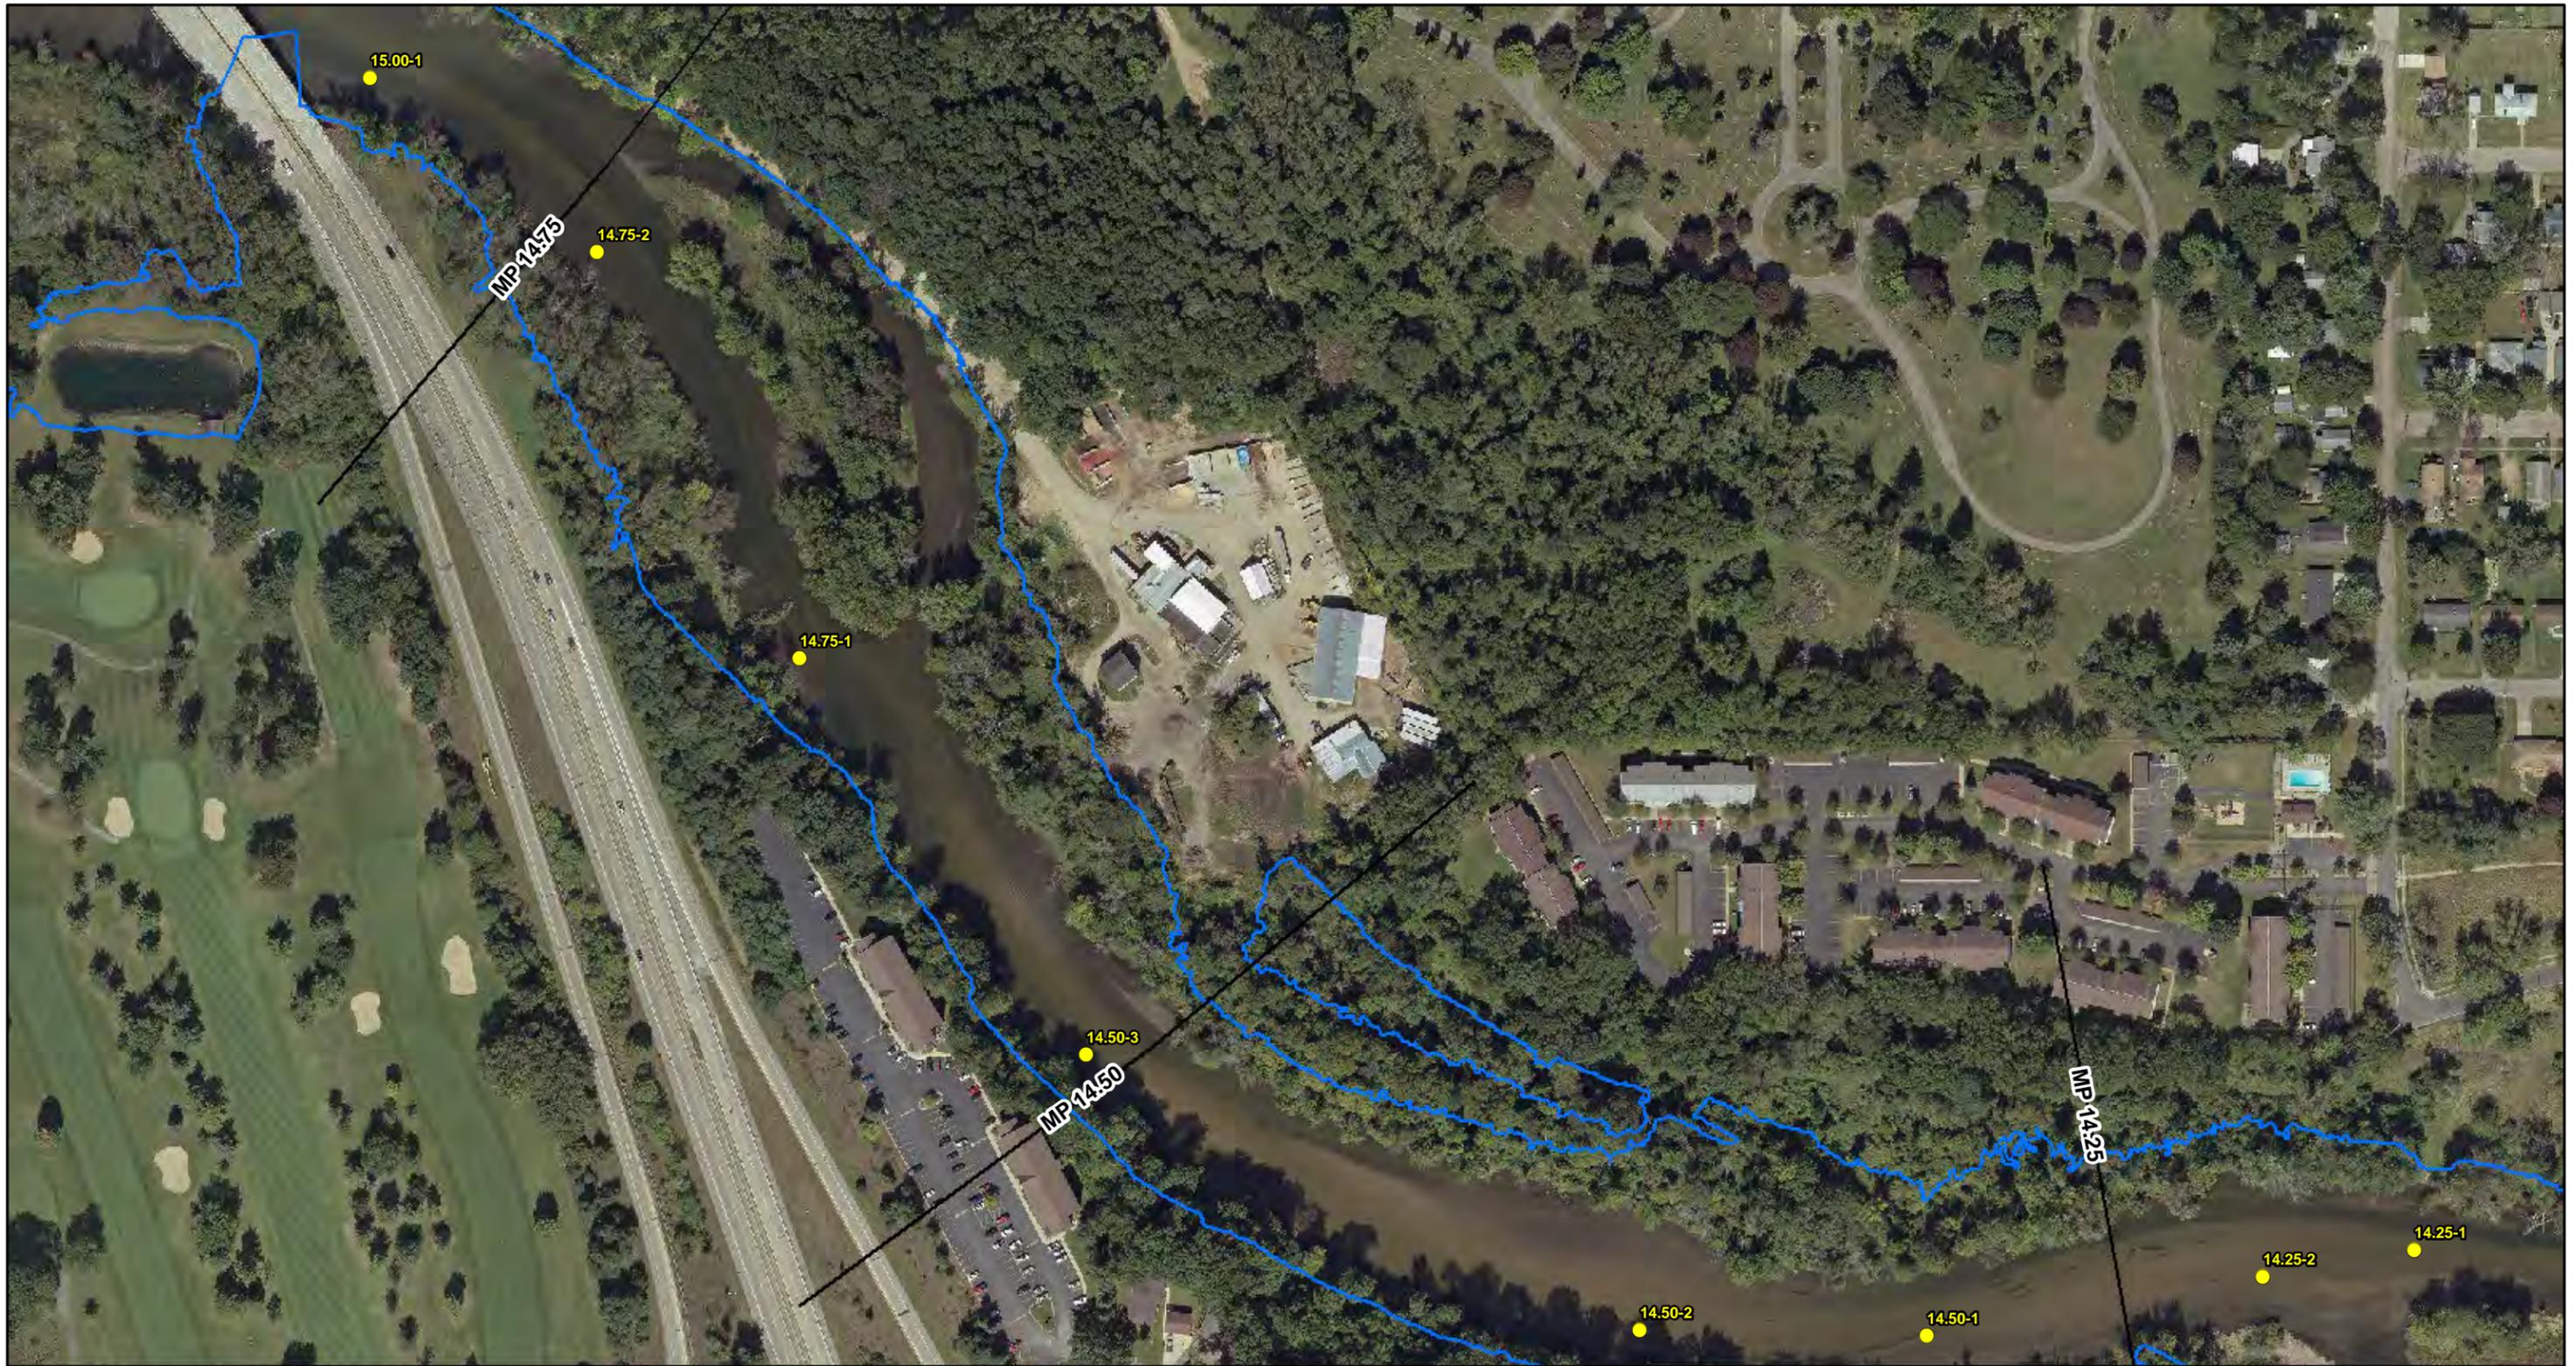
No riffles were identified in Survey Area 2 (MP 14.25 - MP 15.00), but survey points were documented (*Figure 1, Sheet 3*). The channel depths through surveyed areas varied from 0.7 ft to 2.6 ft, and the bed sediment was primarily fine sand and silt. No fish or macroinvertebrate sampling was conducted in this stretch, with few observed from the boat.

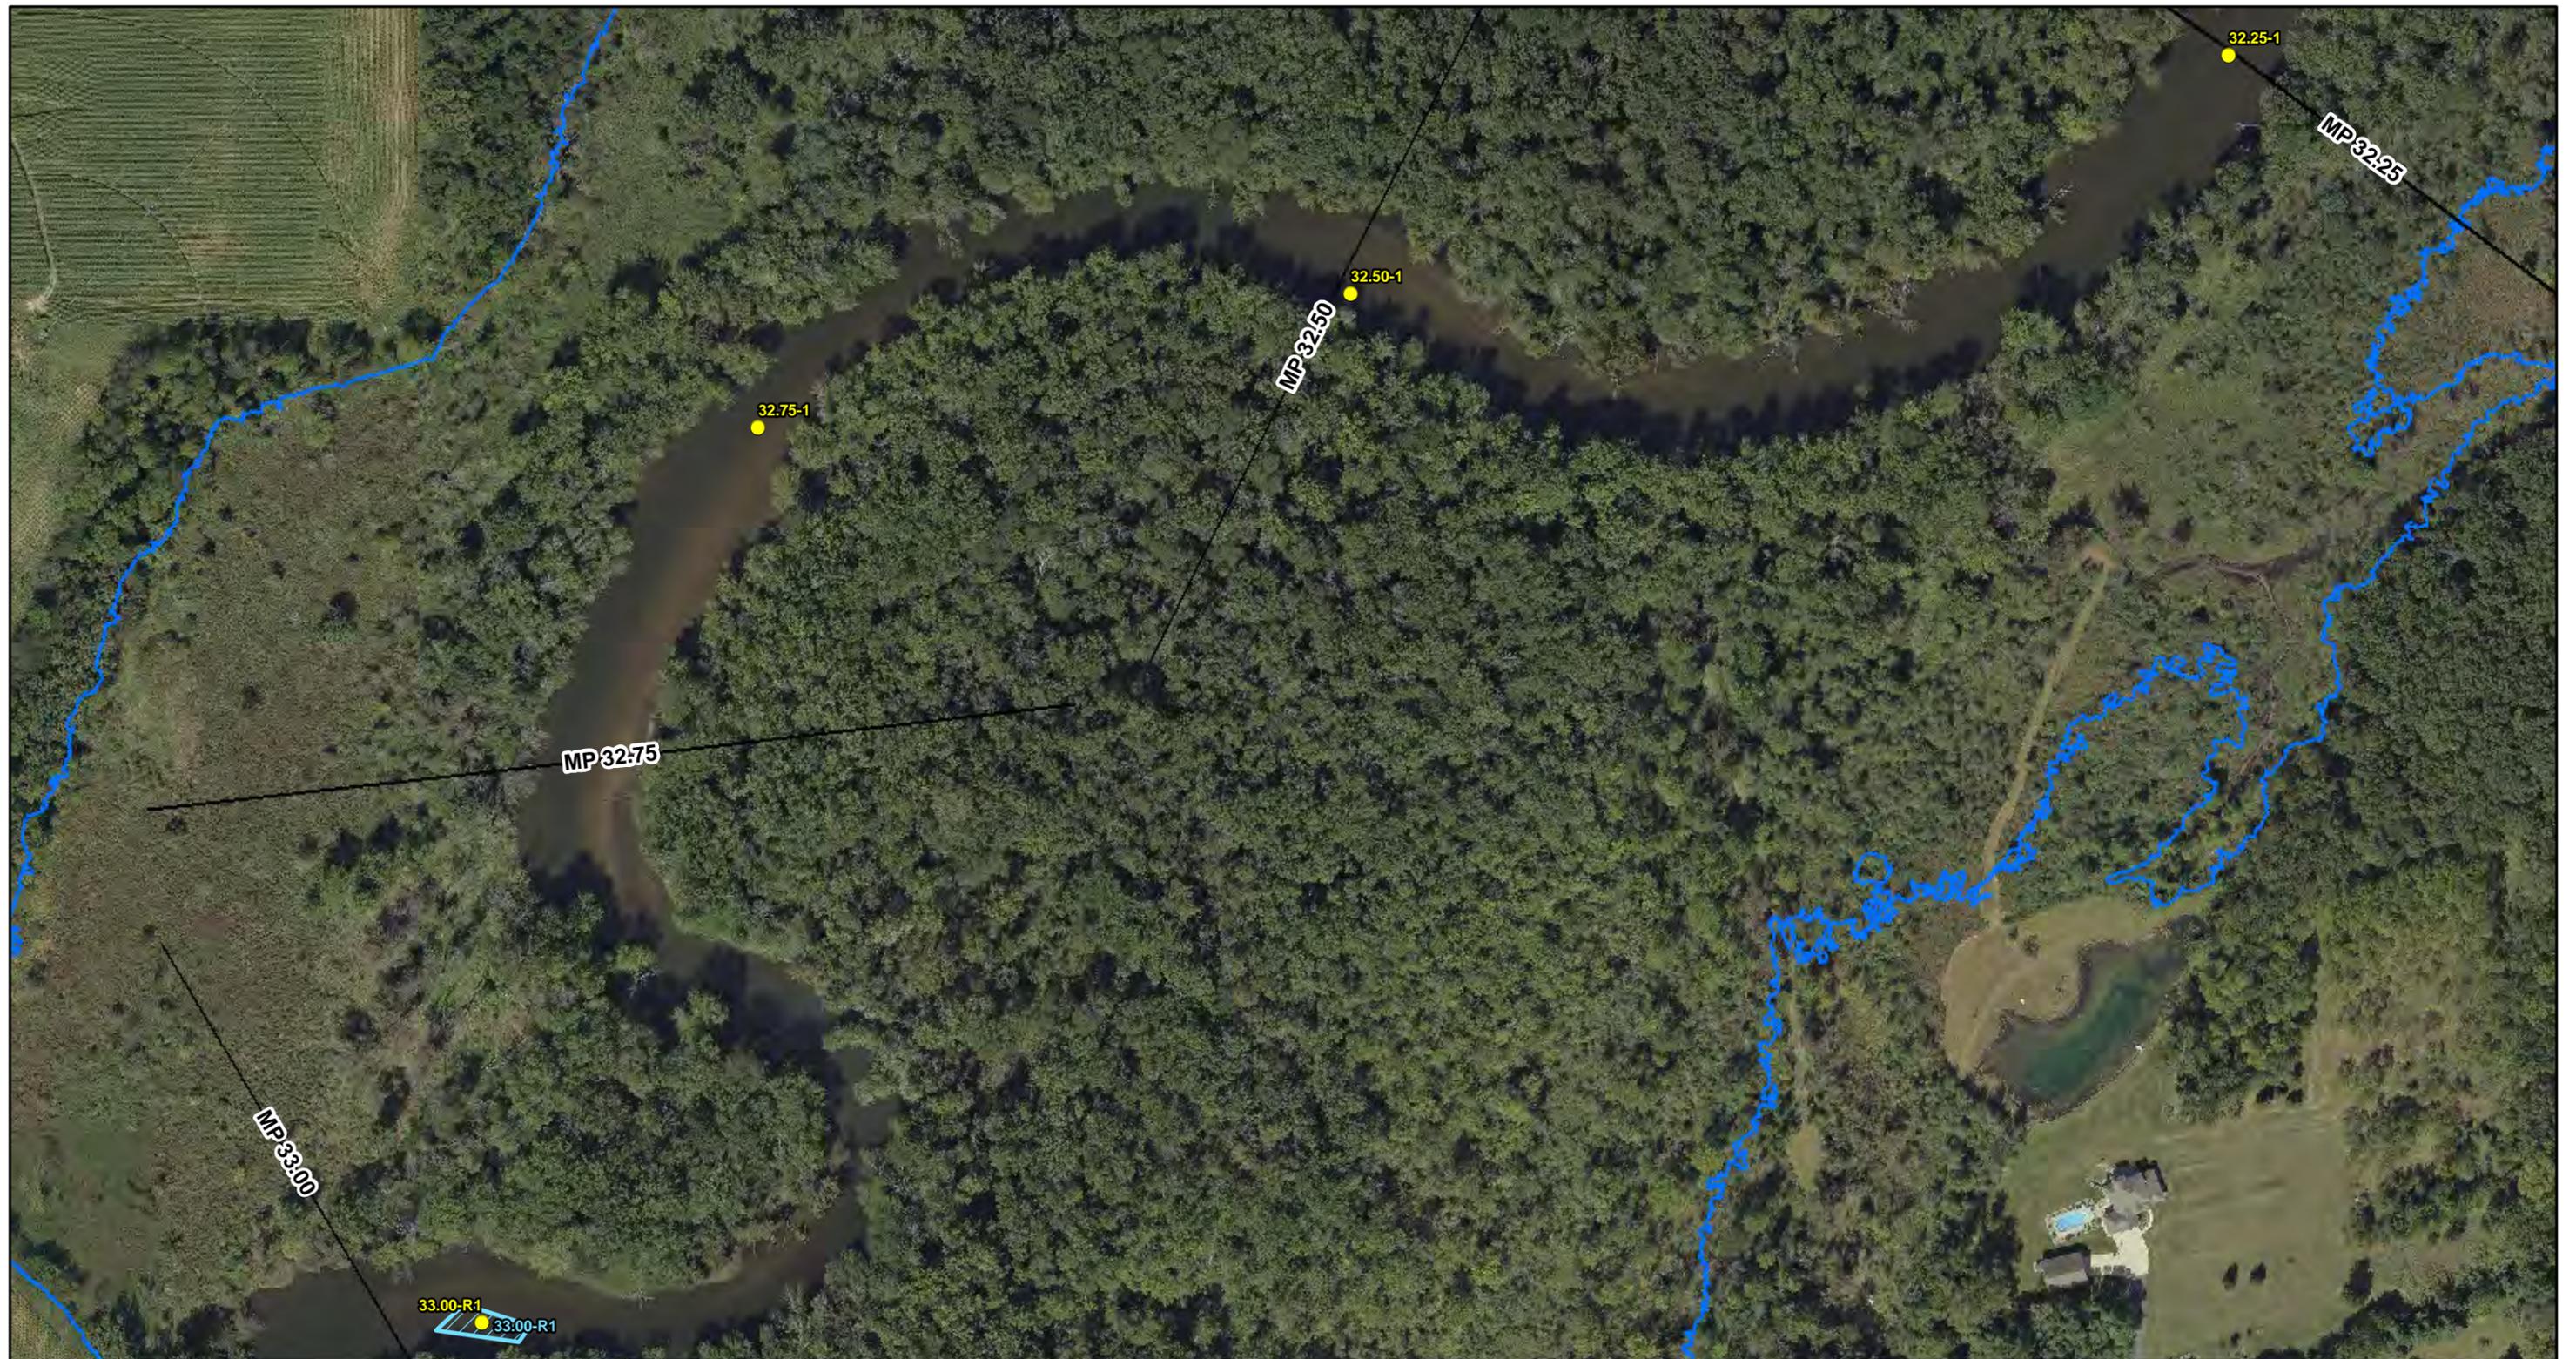
FIGURE 1
 LARGE WOODY DEBRIS - RIFFLE SURVEY
 SURVEY AREA 4
 SHEET 6 OF 11

Survey Area 4 (MP 32.25 – MP 36.25) contained six locations exhibiting the field identification attributes for riffles (*Figure 1, Sheet 6 through Sheet 11*). In contrast to the other three survey areas, a majority of the riffles contained boulders. Riffles also included a mixture of cobble, gravel, and sand with water depths ranging from 1.7 ft to 2.3 ft. Representative macroinvertebrate and fish taxa were observed, although the number and density were less than that observed in Survey Area 1.

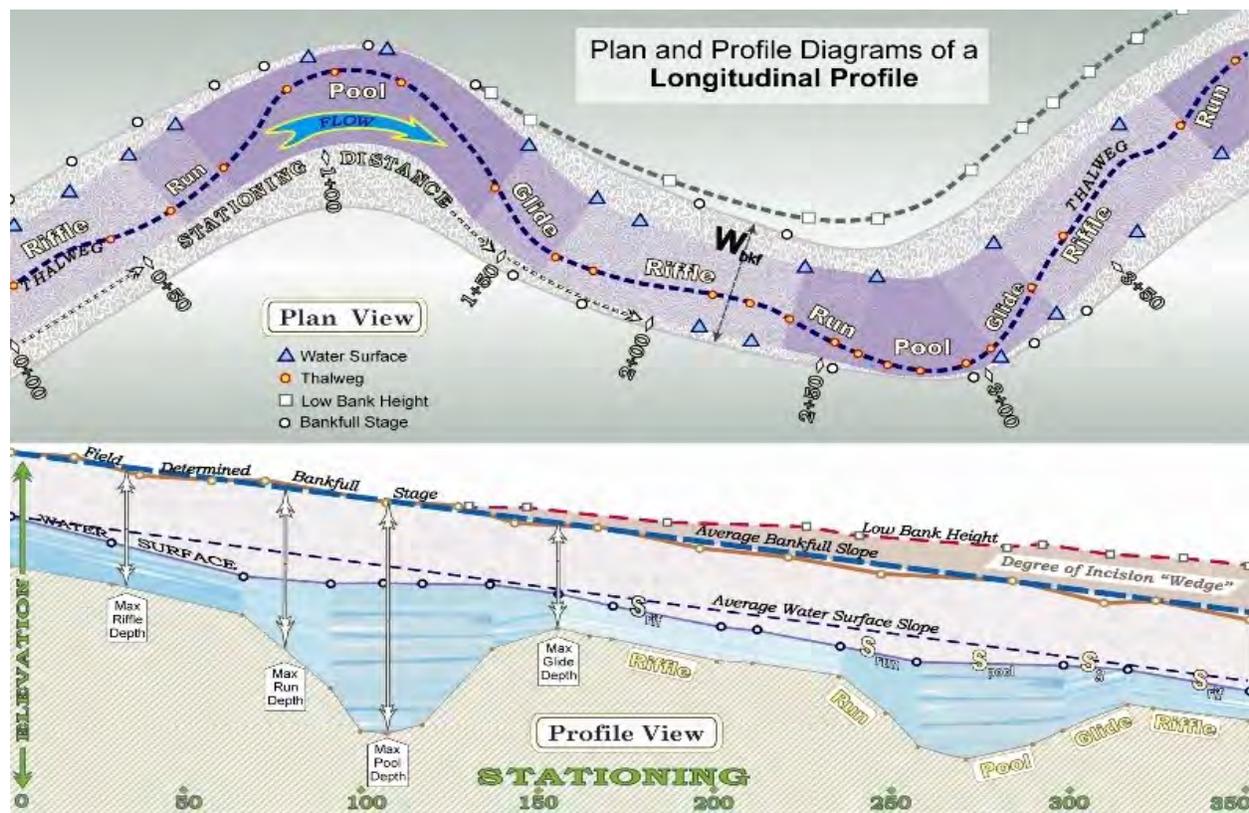
River and stream shape is driven by the balance between transporting incoming water and sediment and moderating the energy that drives this transport. Fluvial geomorphology theory holds that the shape of flowing water systems is driven by minimizing the total work (energy expenditure) and the variance of energy loss along the channel (uniform distribution of energy utilization) as the channel accommodates changes in both flow and sediment load (Leopold, 1994). Both the channel cross-section and the meandering plan form of channels exhibit the results of these tendencies (*Figure 1*).

Figure 1. Idealized stream channel plan and profile with facet features identified (Rosgen, 2006).

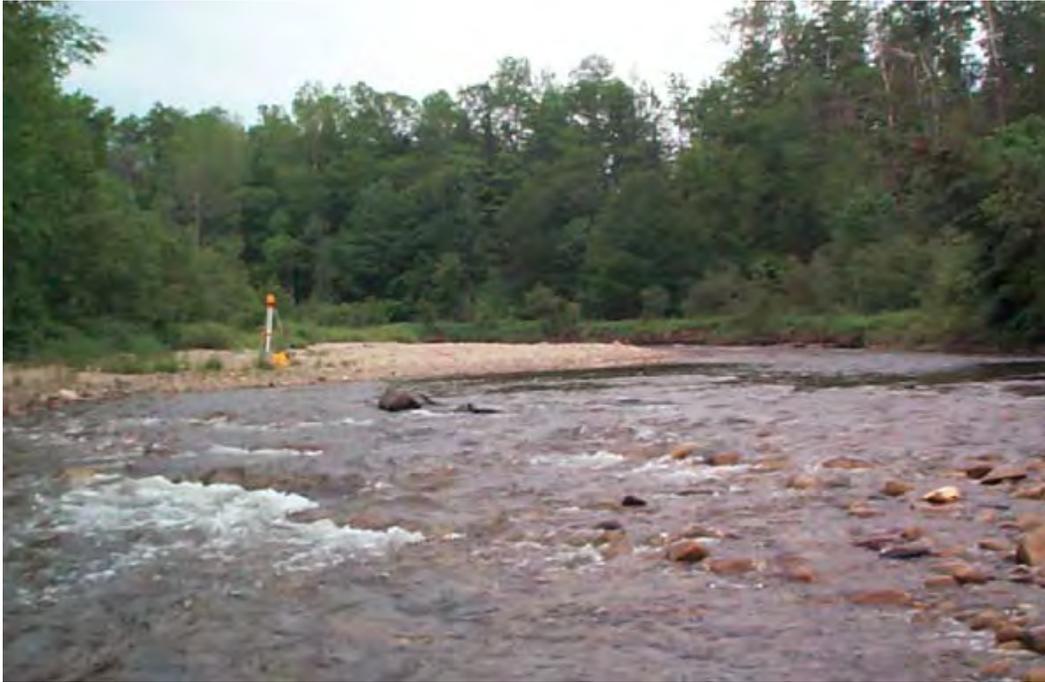
Photograph of a riffle on an un-named river in the State of Vermont. Note cobble-sized riffle substrate, shallow flows, and froth of water over the riffle. Note the point bar in the background.

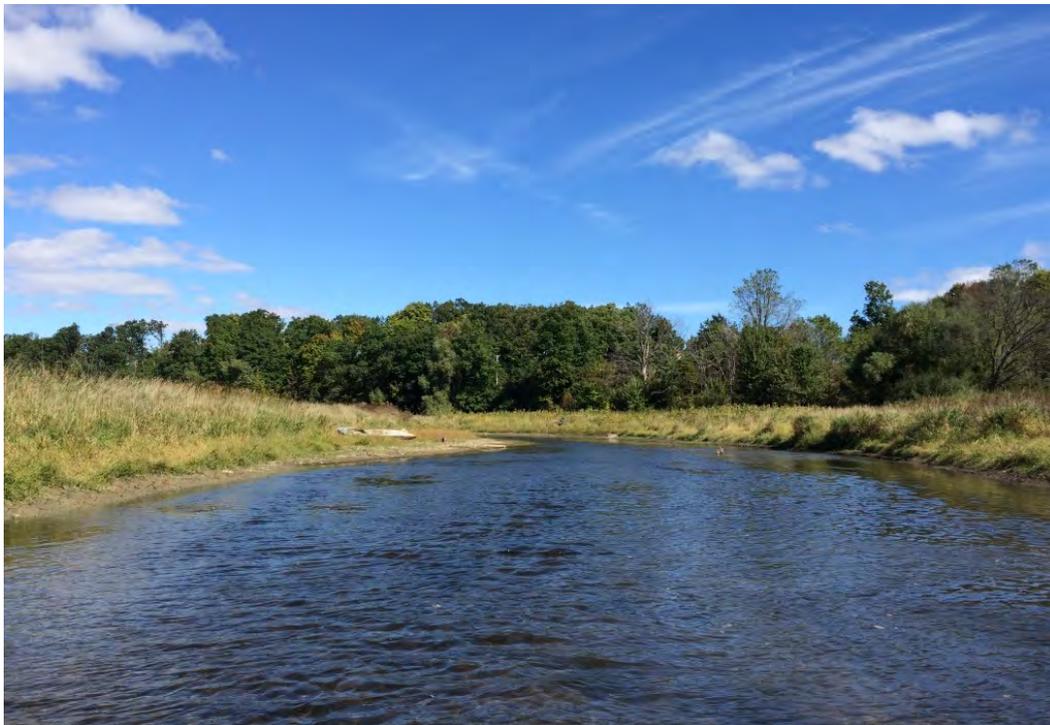
Photograph of a riffle on the Shiawassee River. Note the rippling of the water in the foreground as it goes over the riffle. Note meander bend and point bar in the background.

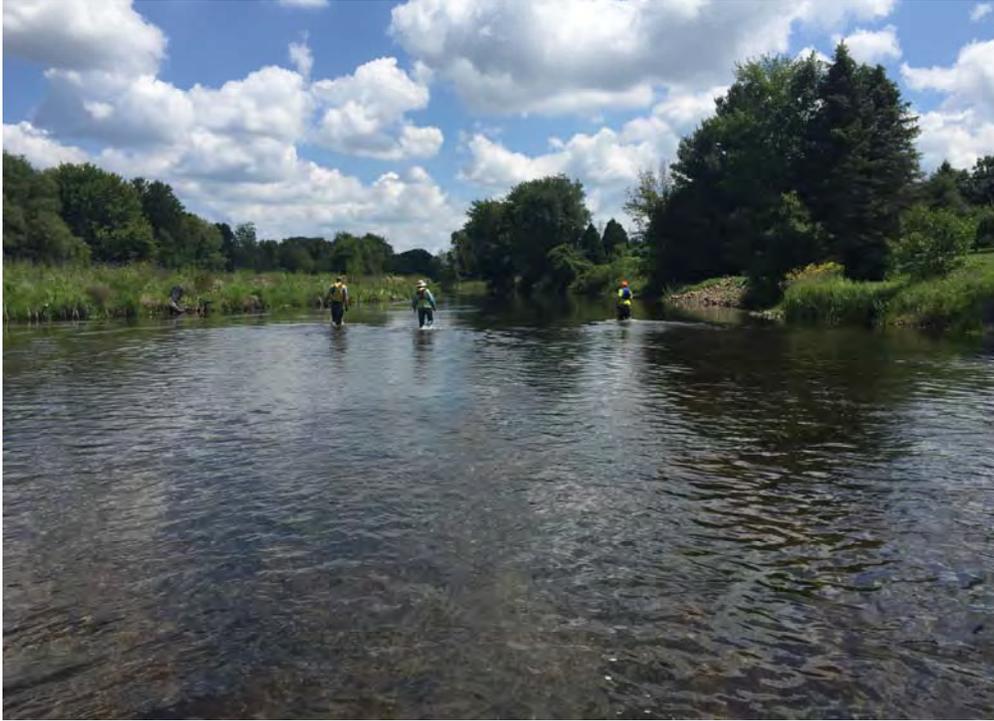
Photo 1. Field crew mapping a riffle in Survey Area 1: MP 2.25-3.25 (August, 2016).

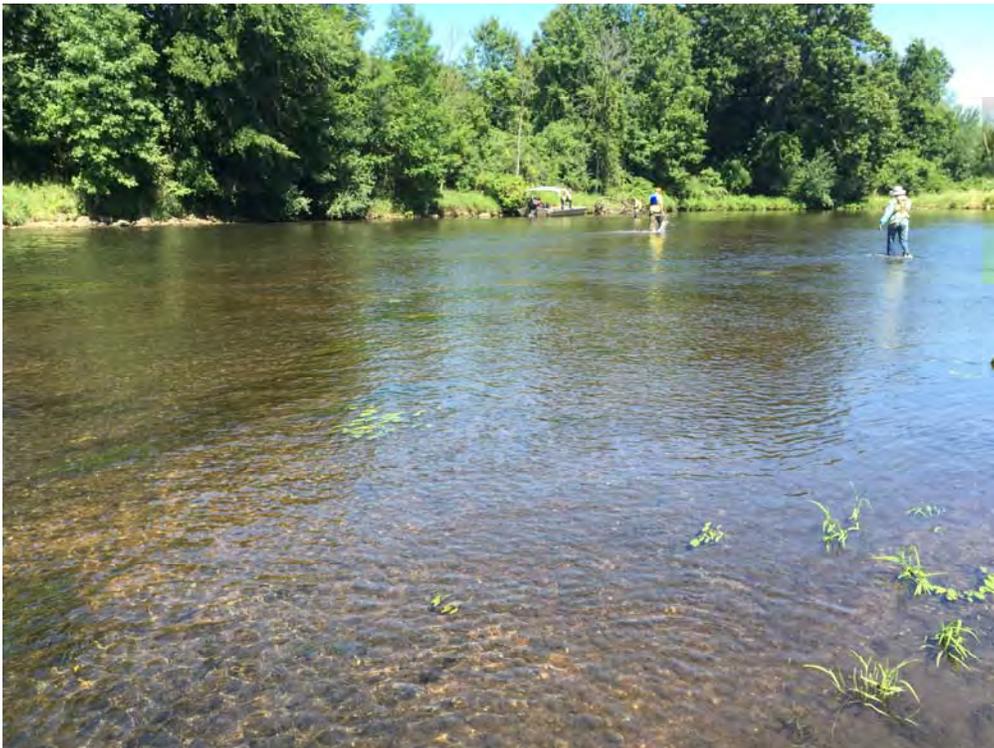
Photo 6. Riffle identified in Survey Area 1. Uniform shallow water depth and mixture of coarse substrate (August, 2016).

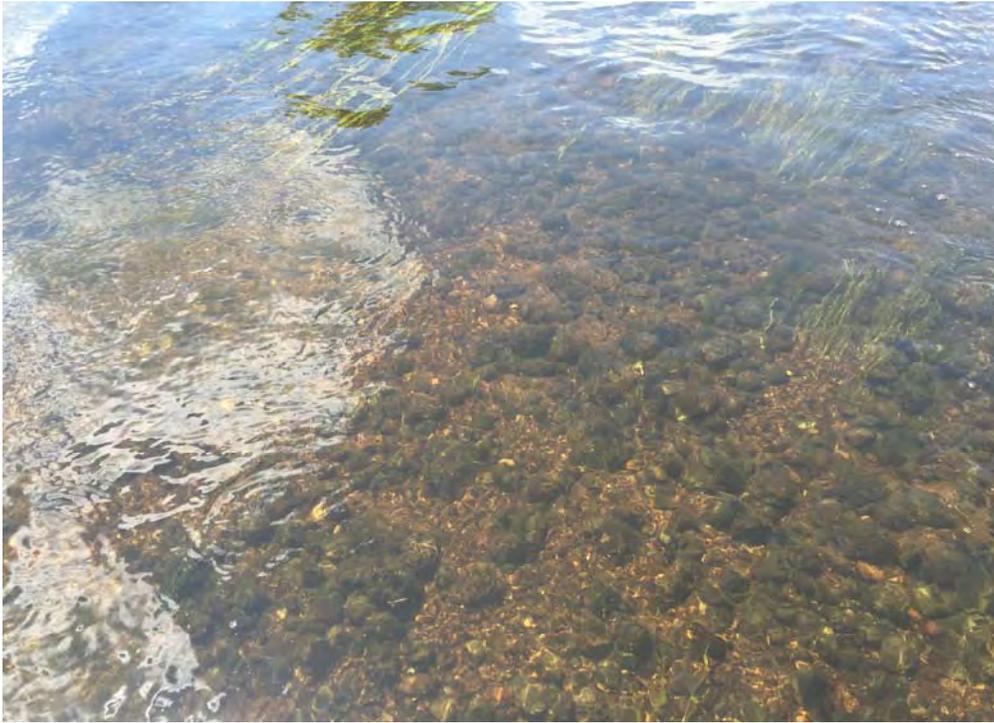
Photo 7. Typical riffle substrate consisting of cobble, gravel, and sand identified in Survey Area 1 (August, 2016).

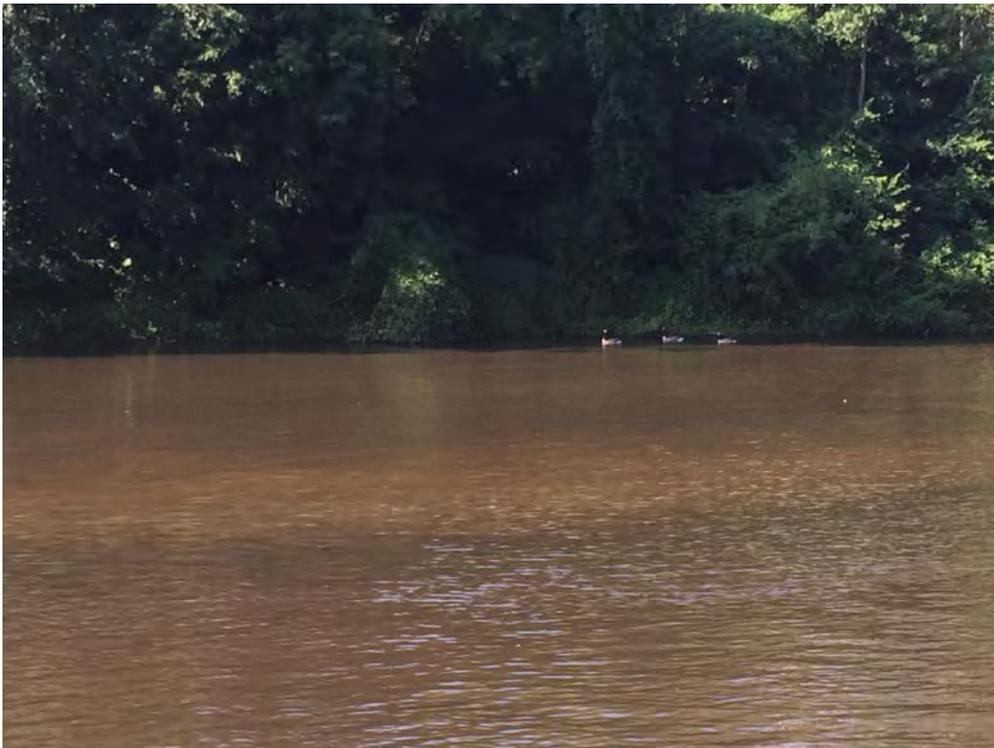
Photo 8. Typical habitat identified in Survey Area 2: MP 14.25-15.00 (August, 2016).

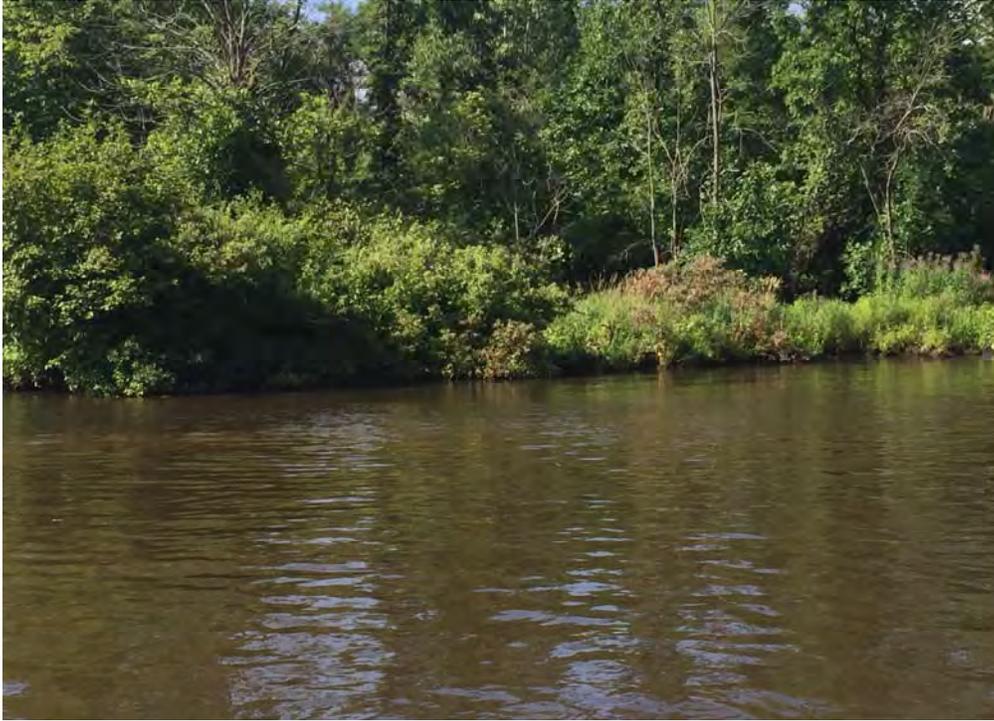
Photo 9. Typical habitat identified in Survey Area 2 consisting of homogeneous sand bed with aquatic vegetation (August, 2016).

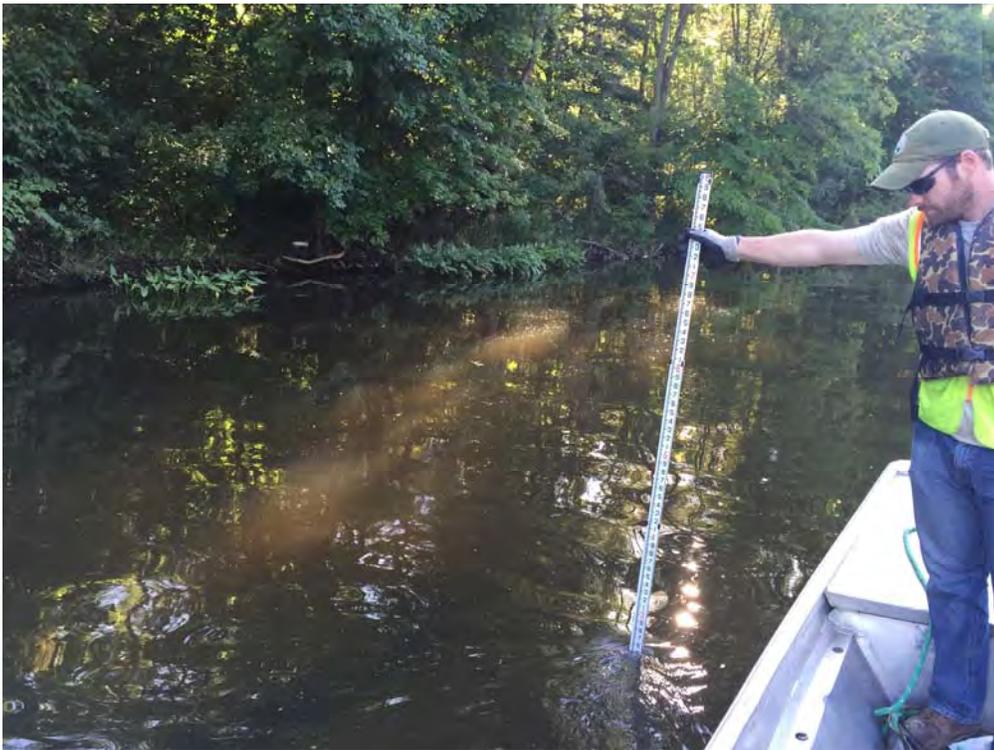
Photo 10. Collecting water depth in Survey Area 3: MP 19.25-20.25 (August, 2016).

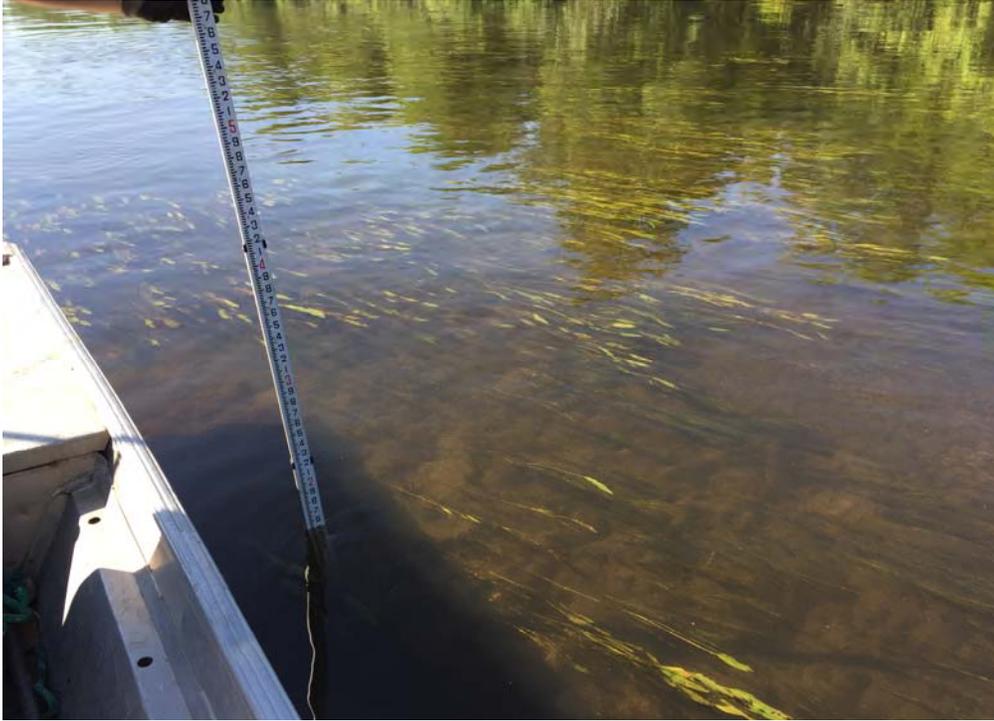
Photo 11. Survey point collected in Survey Area 3. Water is slow moving with homogeneous bed and dense aquatic vegetation (August, 2016).

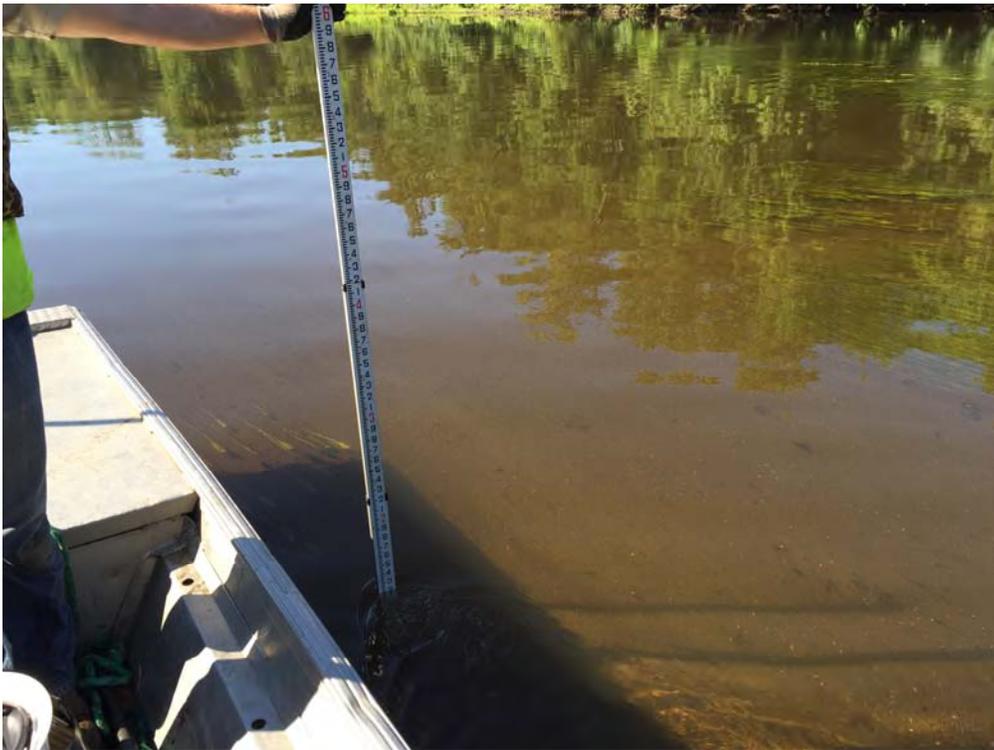
Photo 12. Survey point collected in Survey Area 3. Water is slow moving with homogeneous sand bed (August, 2016)

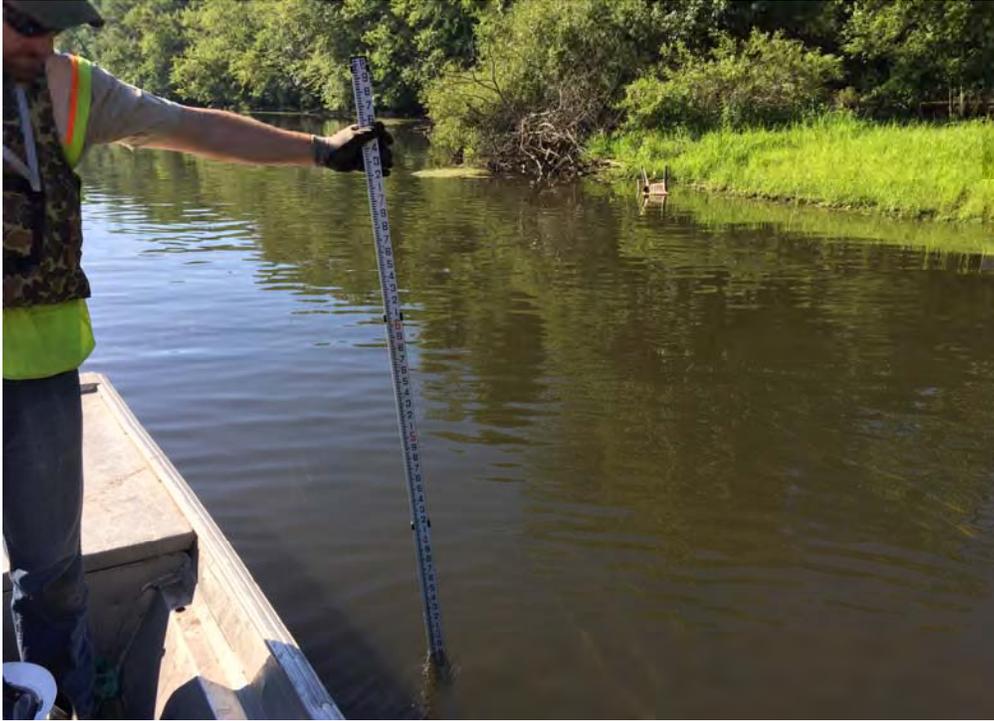
Photo 13. Survey point collected near large woody debris installation location. Water depth exceeds typical riffle depth (greater than 2.5 feet) (August, 2016).

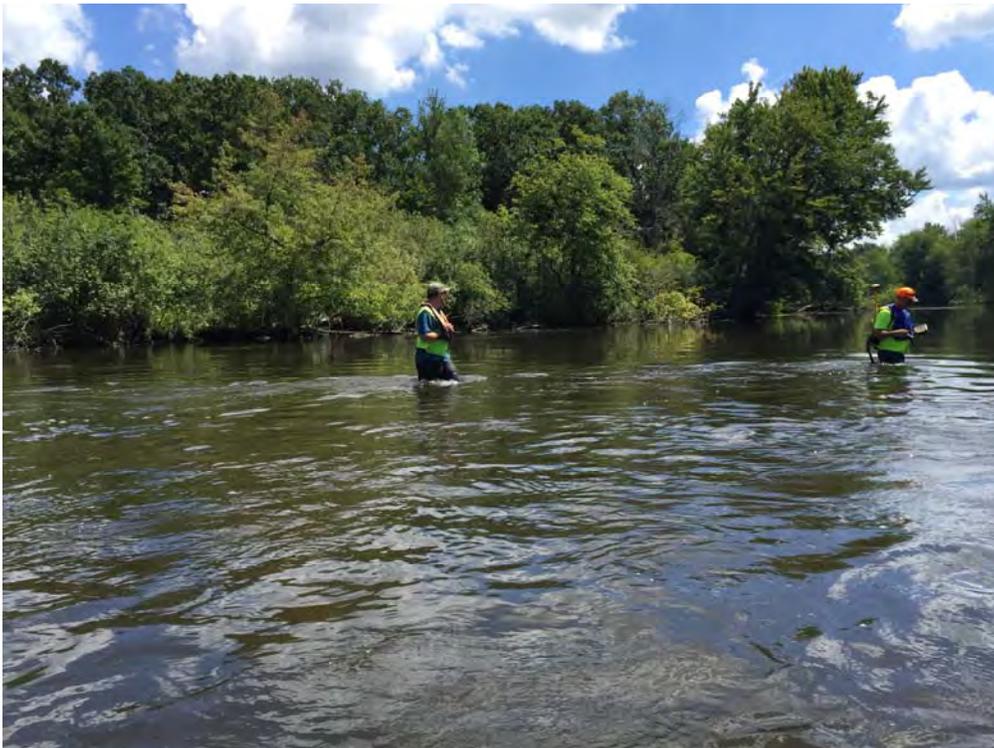
Photo 14. Mapping riffle boundaries in Survey Area 4: MP 32.25-36.25 (August, 2016).

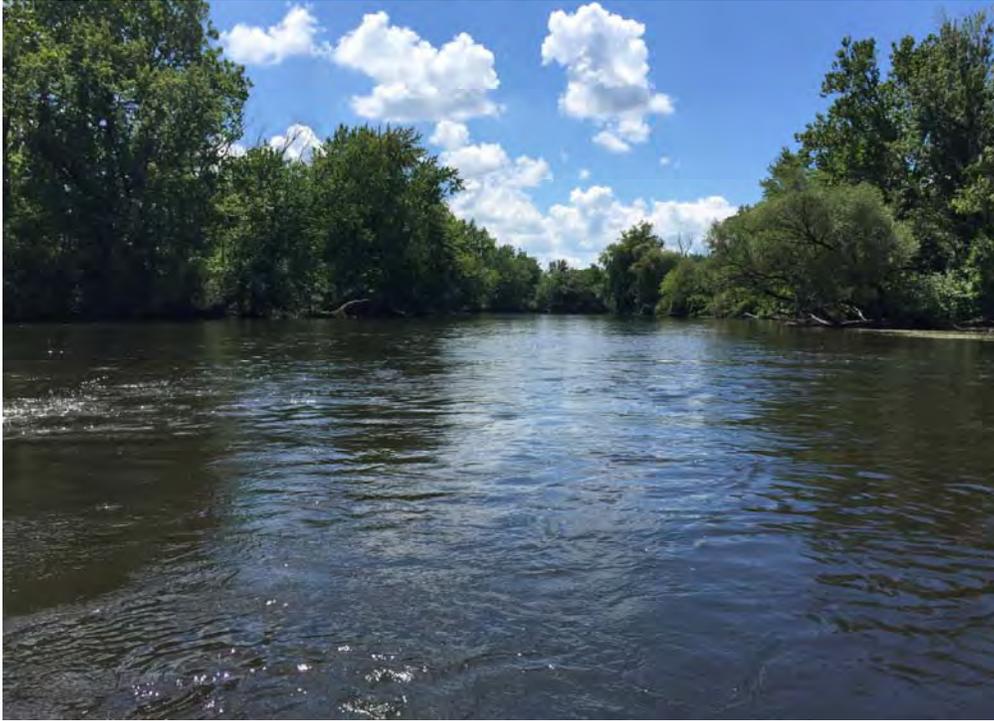
Photo 15. Looking downstream at an identified riffle area. Water depth is shallow (less than 2.5 feet) and uniform in cross-section (August, 2016).

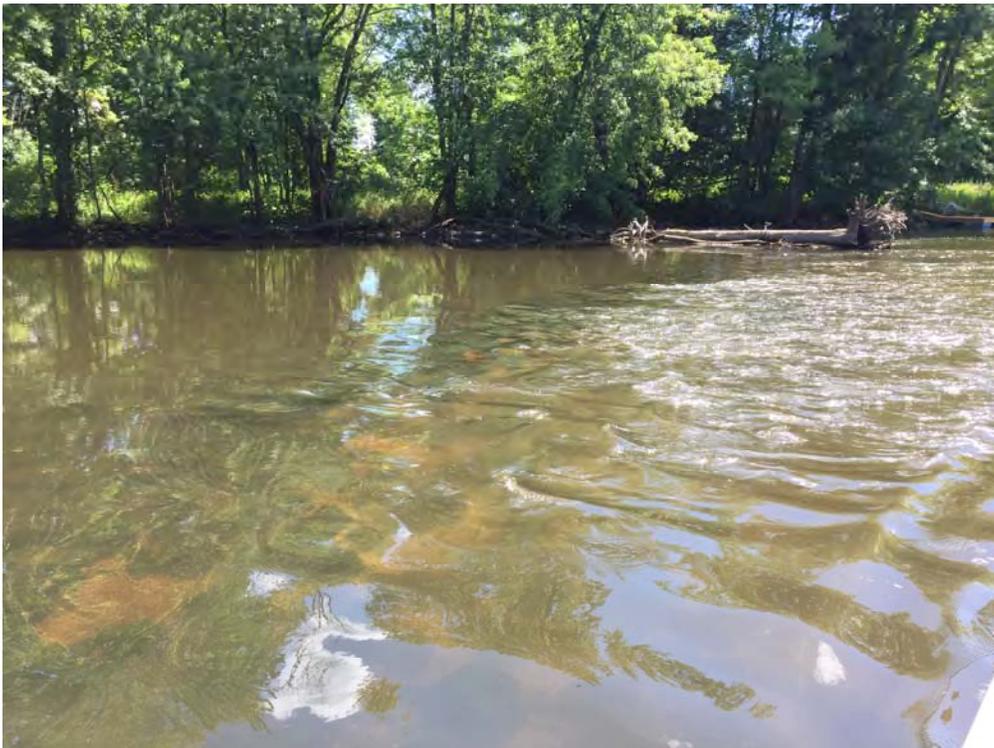
Photo 16. Riffle identified in Survey Area 4. High boulder content (40%) with mixture of gravel, cobble, and sand. Whitewater exists at upstream edge of riffle feature (August, 2016).
