Enbridge Line 6B MP 608
Marshall, MI Pipeline Release
Case No.: 15-1411-CE
Report of Findings
Large Woody Debris Riffle Survey

Prepared for Michigan Department of Environmental Quality

Enbridge Energy, Limited Partnership

Submitted: August 11, 2016

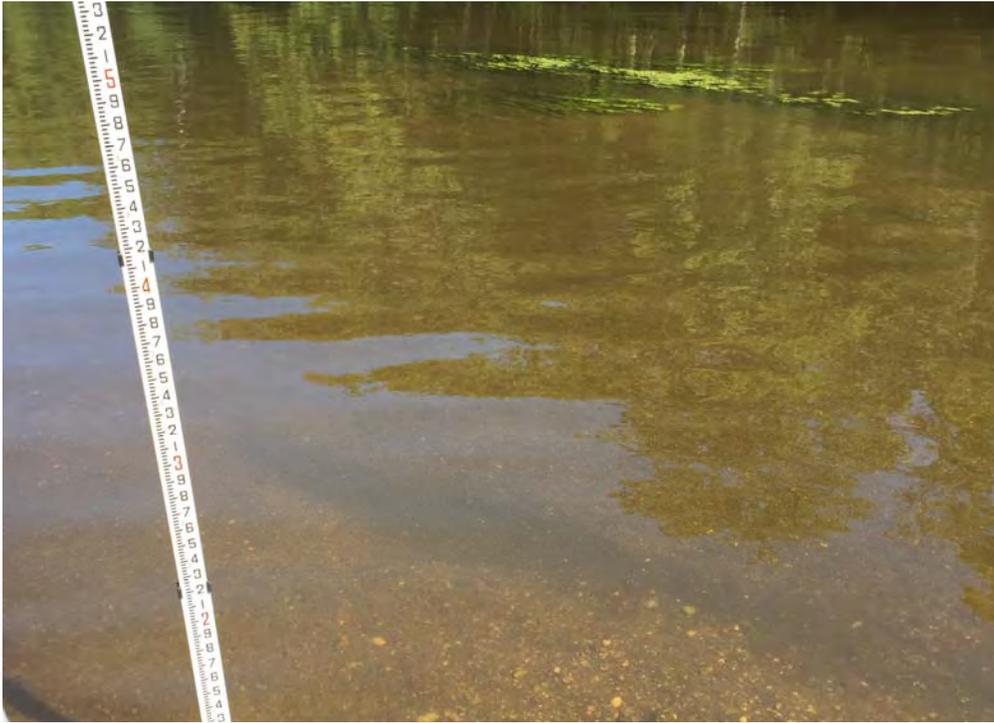
Photo 17. Survey point collected in Survey Area 4. Bed substrate is homogenous and primarily comprised of sand with little gravel. Water is slow moving (August, 2016).

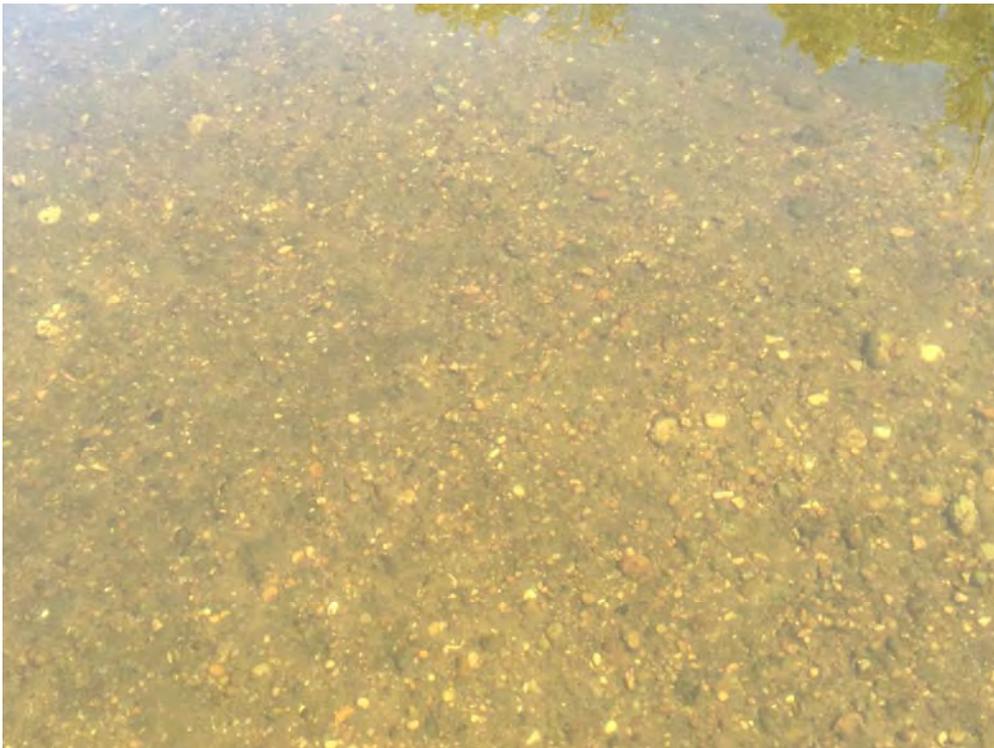
Photo 18. Close up view of bed substrate primarily comprised of sand with little gravel (August, 2016).
