MICHIGAN DEPARTMENT OF ENVIRONMENTAL QUALITY
WATER RESOURCES DIVISION
JANUARY 2018

STAFF REPORT

BACTERIAL MONITORING RESULTS FOR MICHIGAN RIVERS AND STREAMS
2016

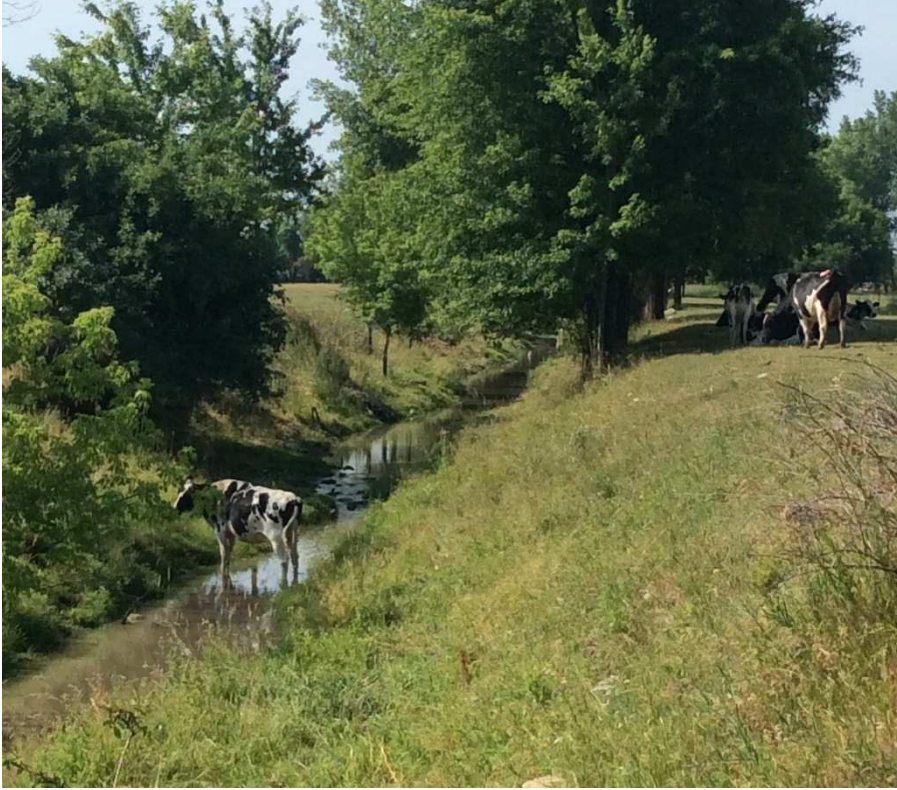
Figure 2. Cattle in White Creek (790224) were a known source of *E. coli* during 2016 monitoring (Appendix 1). The cattle have since been excluded.

River [760257]), while another exceeded on 4 of 5 dates (Turtle Creek [760260]). These exceedances occurred during all weather and flow conditions sampled (Appendices 2 and 3). This indicates a serious and persistent contamination issue due to illicit connections, failing septs, or livestock with direct access to the water. At the time of sampling, cattle were observed in White Creek immediately upstream of the monitoring site (Figure 2). This issue was reported to Michigan Department of Agriculture and Rural Development staff for investigation and the cattle are now excluded from the creek by fencing.

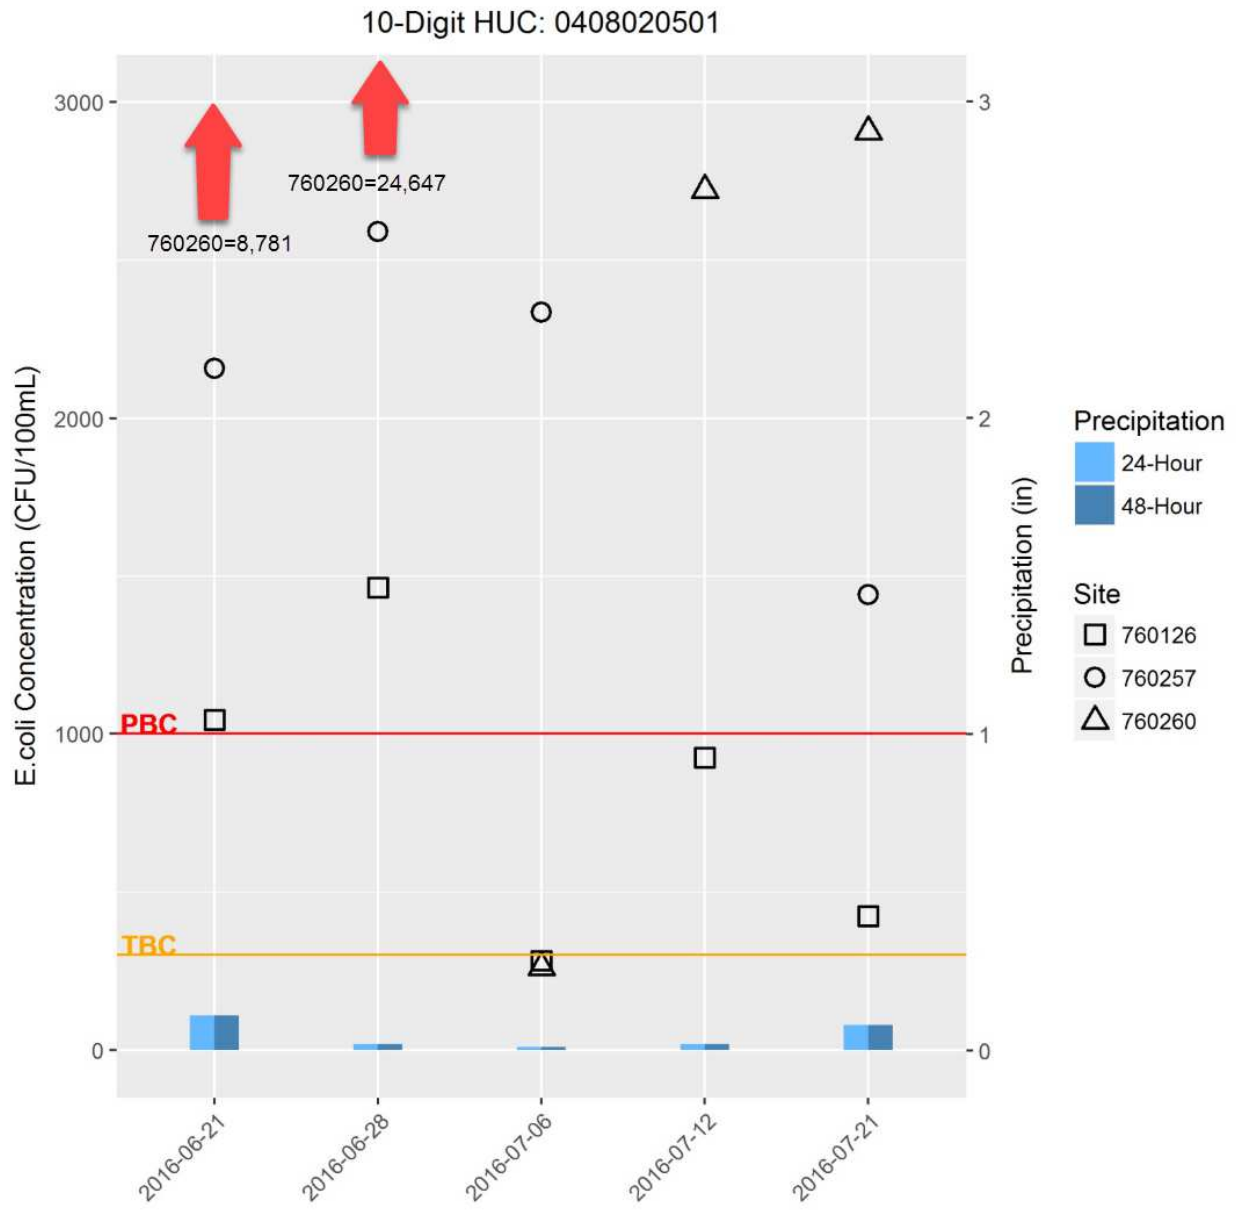
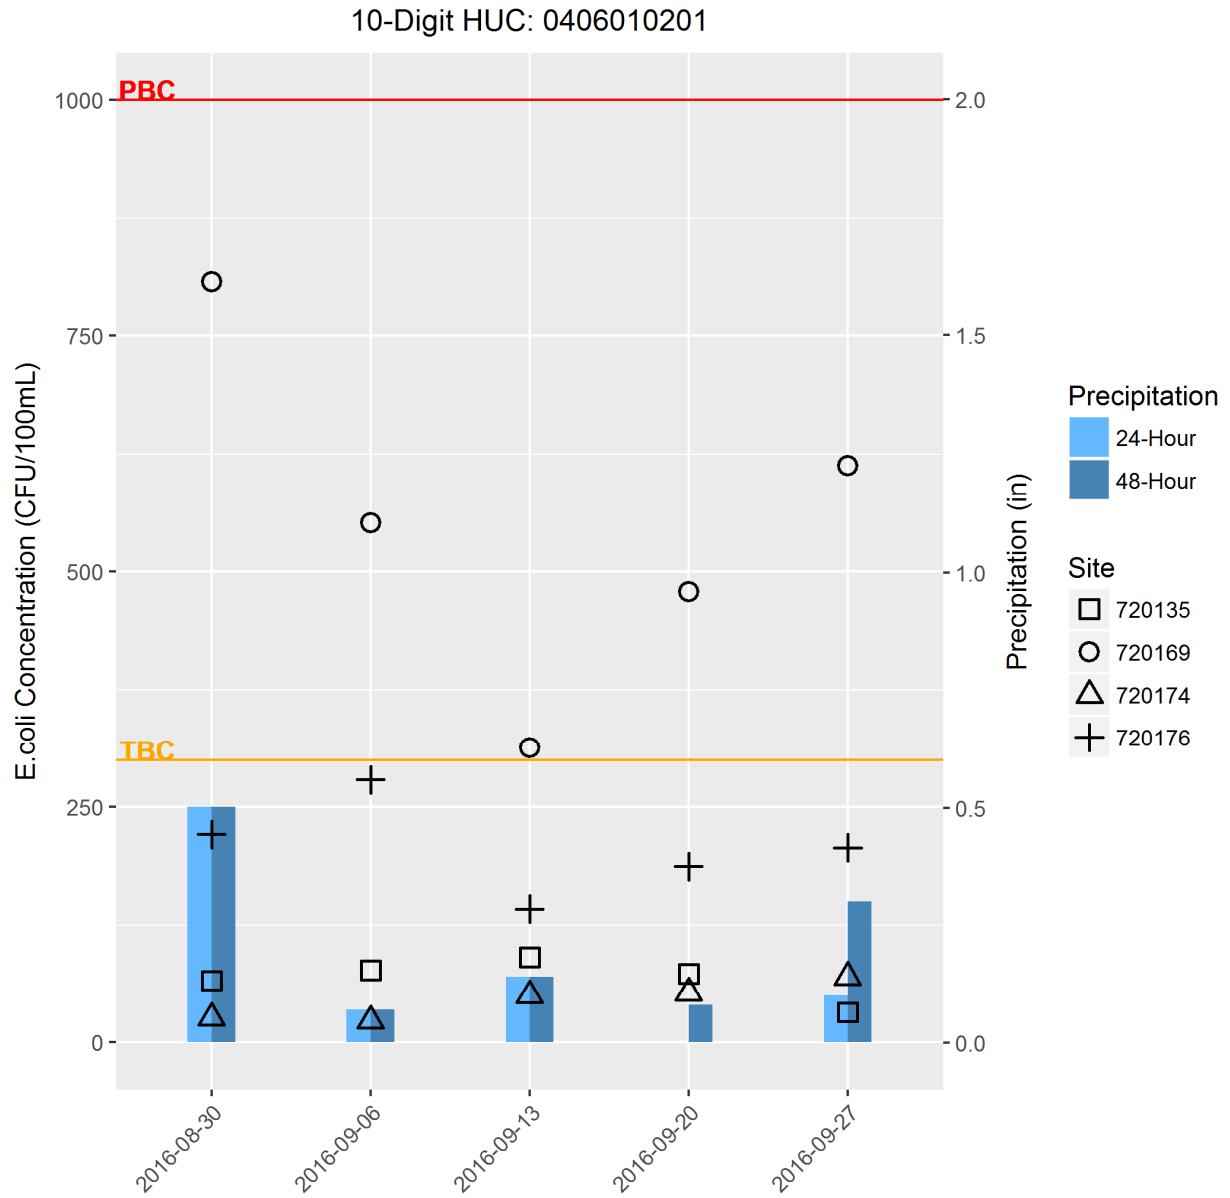
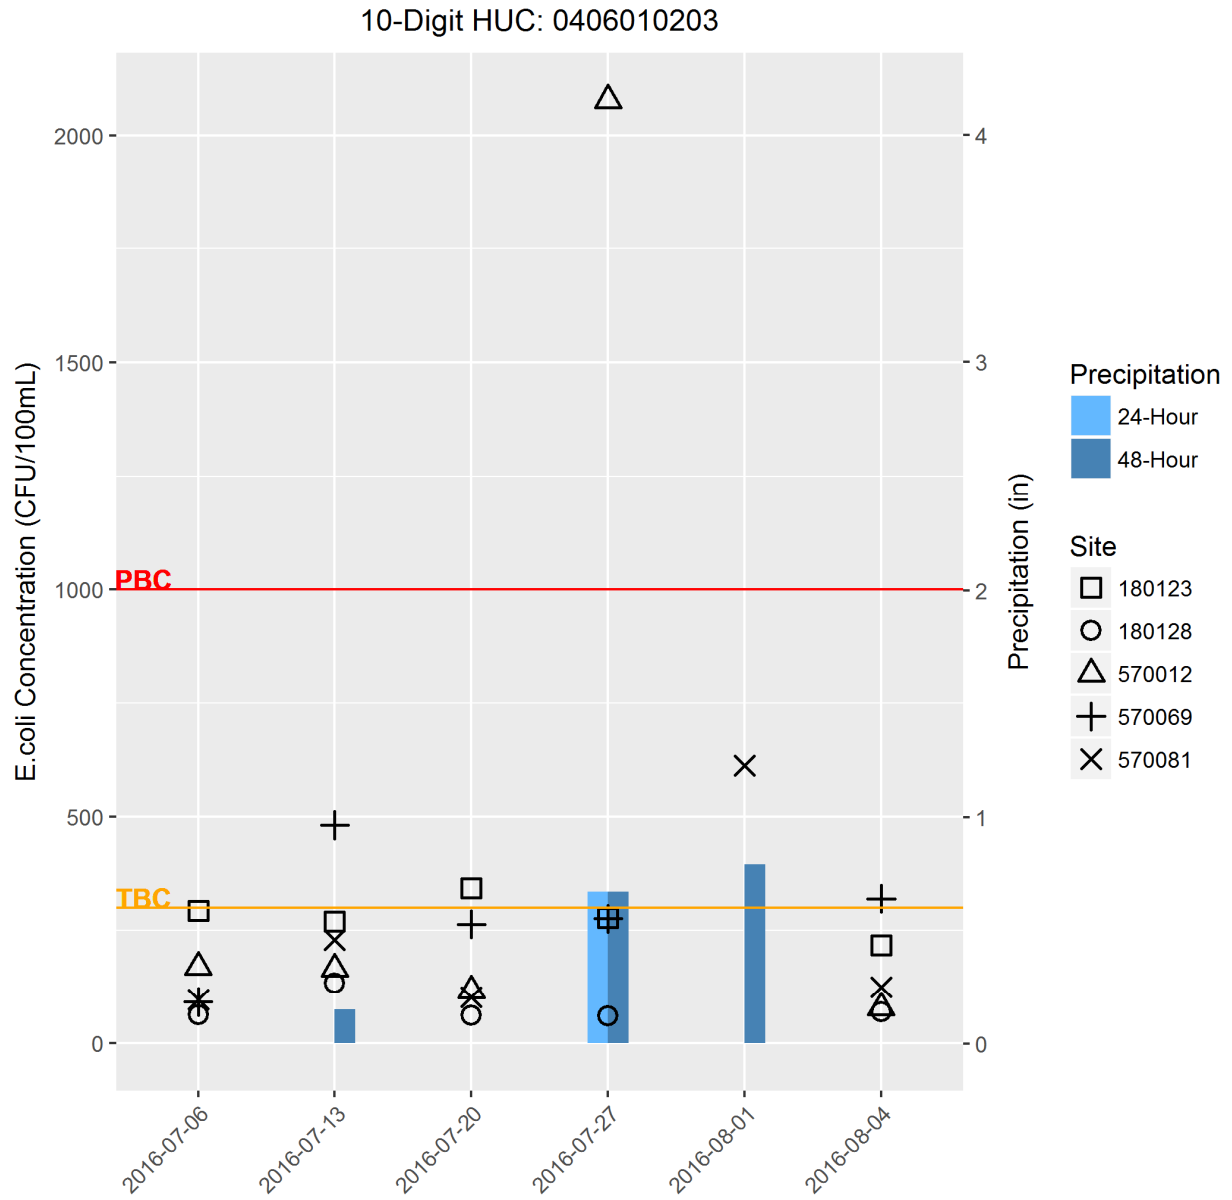
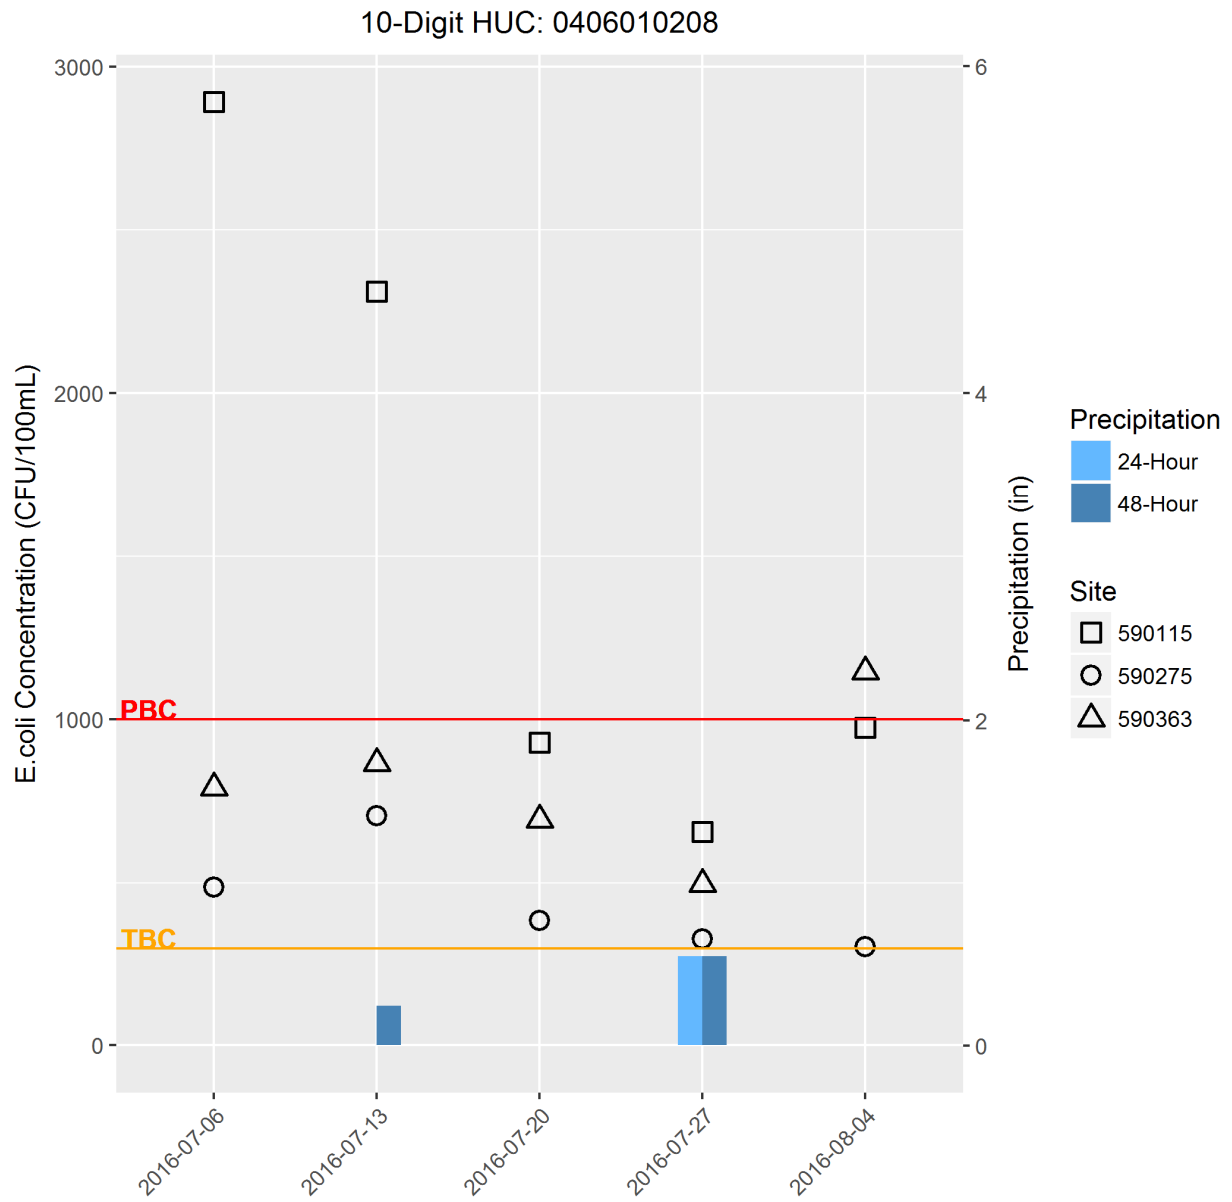
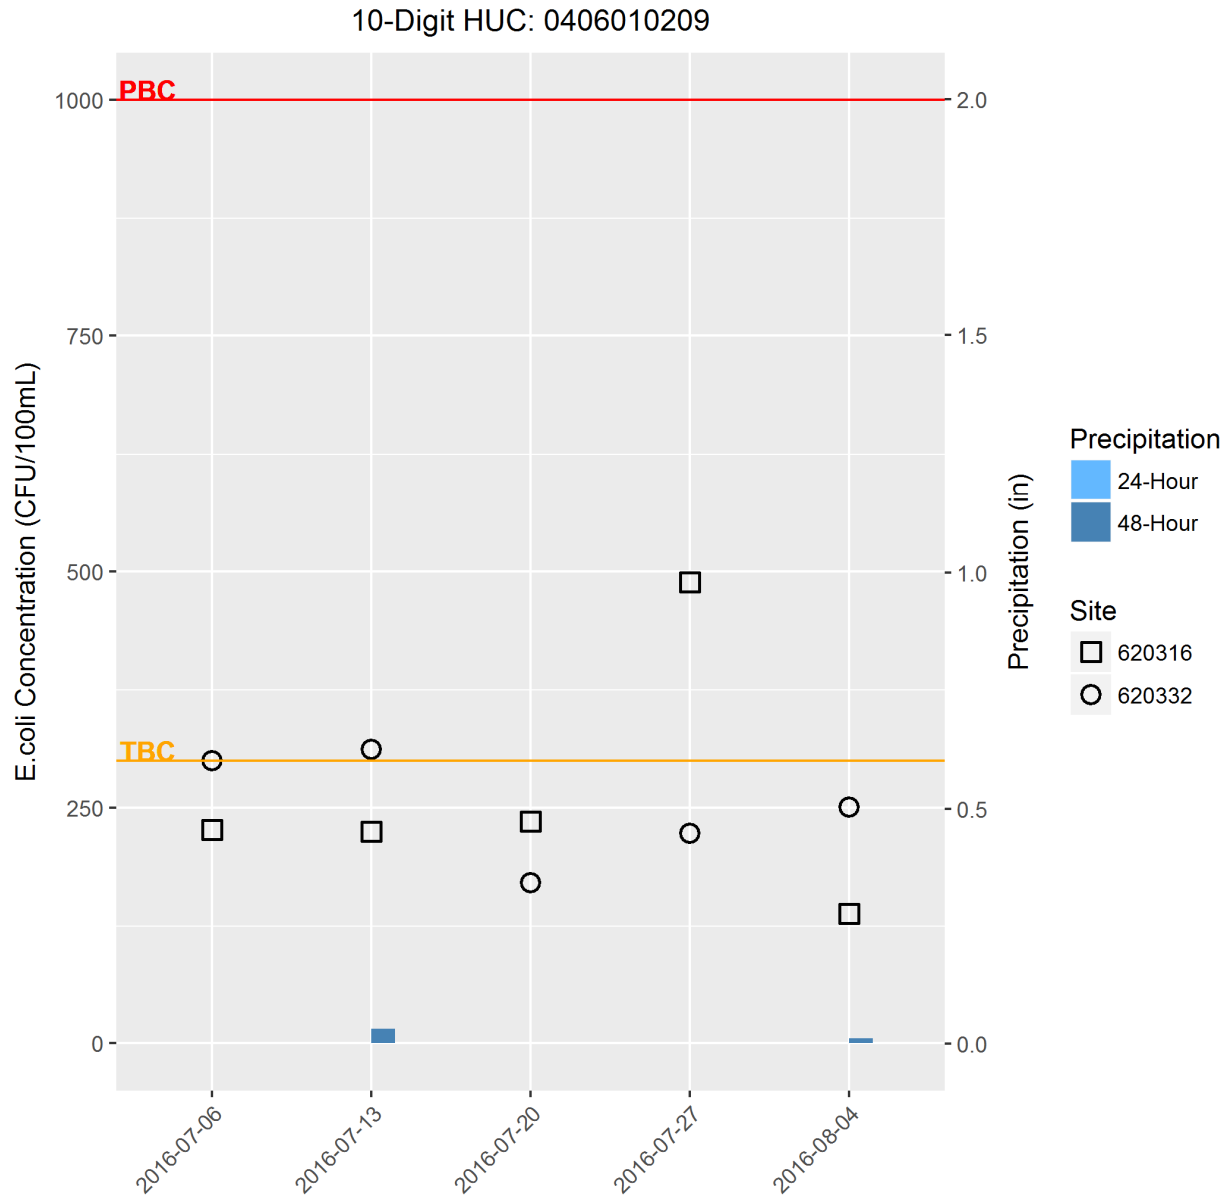
Appendix 2. *E. coli* results and recorded precipitation prior to sampling, grouped by 10-digit Hydrologic Unit Code (HUC).

Precipitation data for the 24 hours and 48 hours prior to each sampling event are recorded in Appendix 1 and graphed in Appendix 2, and were obtained from nearby weather stations (Michigan State University Extension, 2015; Weather Underground, 2015). Where possible, the relative water level was determined at each sampling event by measuring the distance from a set point on the bridge or culvert to the surface of the river using a weighted metal tape (Appendix 3).

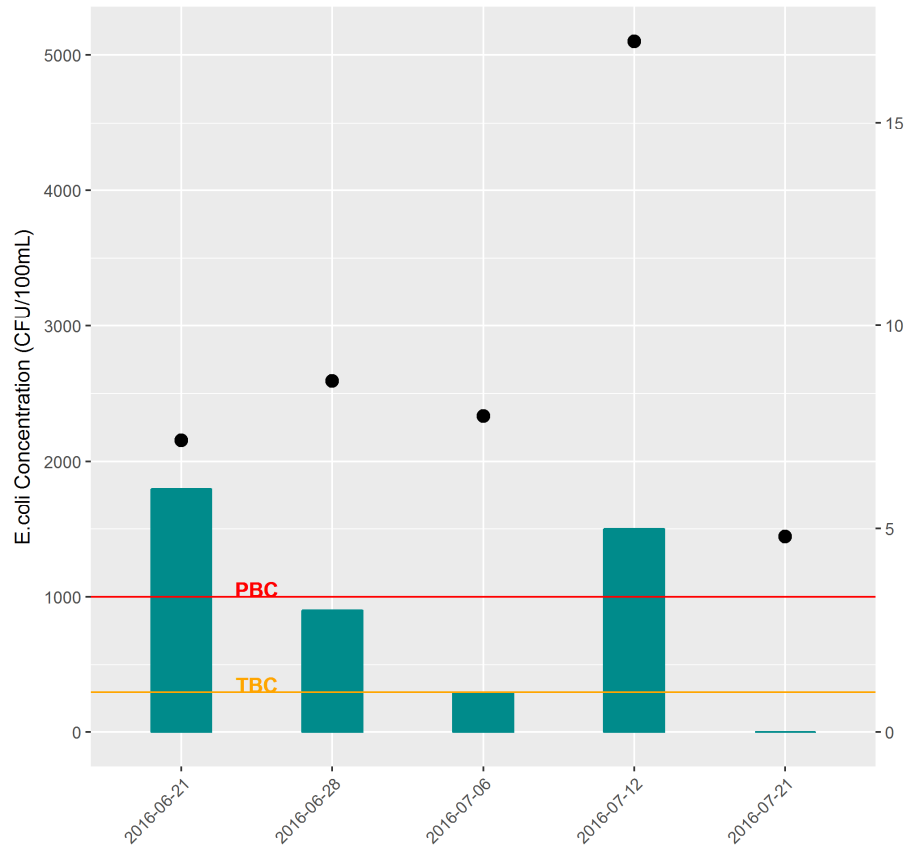
Site ID: 760257

Appendix 3 – Cass watershed *E. coli* concentrations and water levels (relative to the lowest recorded during sampling period).

SOUTH FORK CASS RIVER; FREIBERGER ROAD; AUSTIN TOWNSHIP, SECTION 11

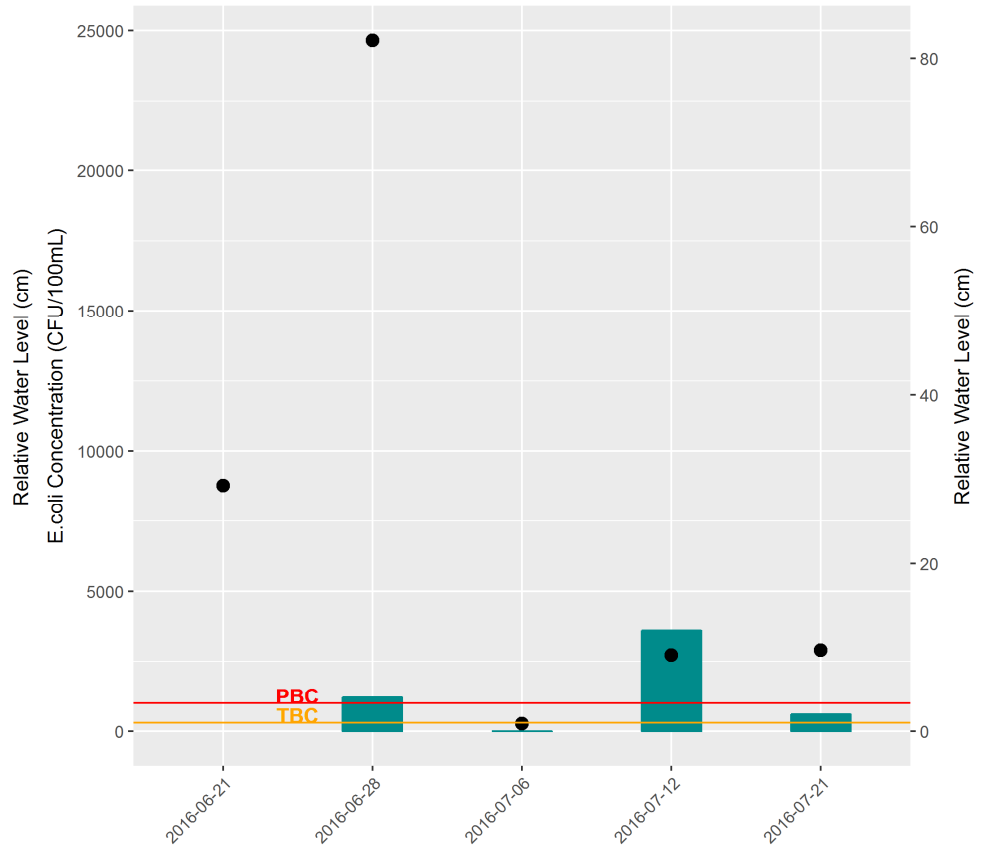
Site ID: 760260

TURTLE CREEK; SNOVER ROAD; MOORE TOWNSHIP, SECTION 19

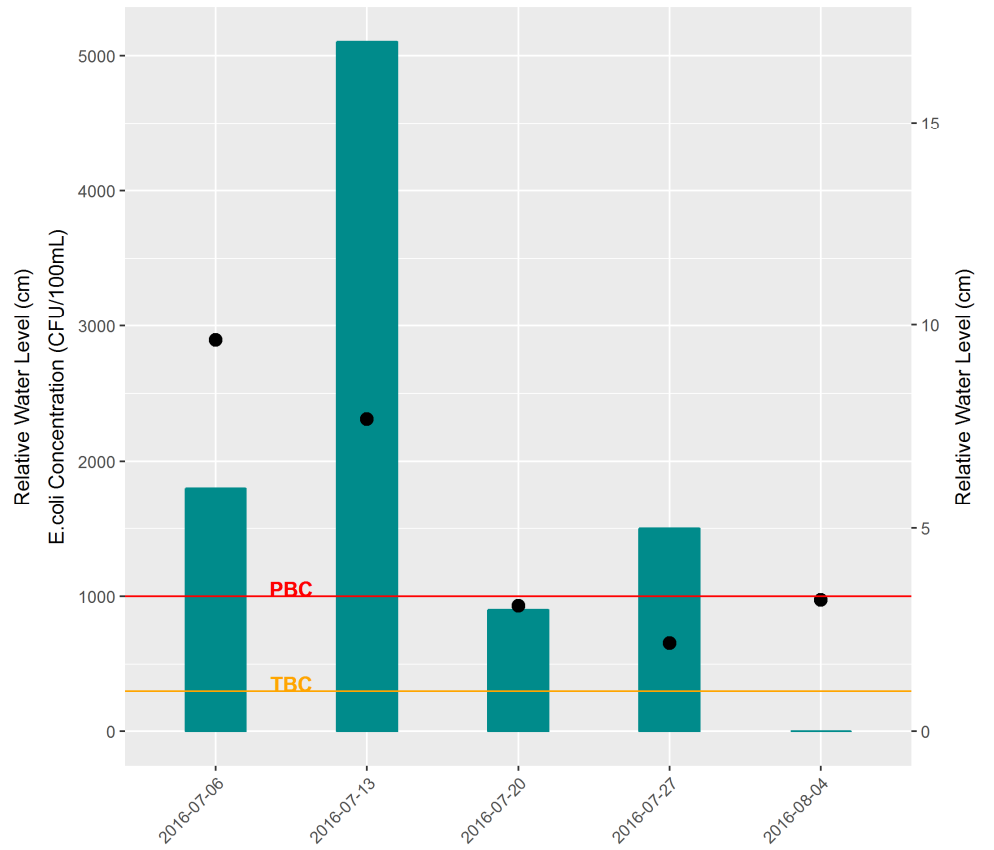
Site ID: 590115
TAMARACK CREEK @ TAMARACK RD

Appendix 3 – Muskegon watershed *E. coli* concentrations and water levels (relative to the lowest recorded during sampling period).

In the Muskegon River watershed, several sites consistently exceeded the daily TBC WQS, including: Tamarack Creek (590115, 590275, and 590363) and Knappen Creek (720169) (Appendix 1). These exceedances occurred during all weather and flow conditions sampled (Appendices 2 and 3). *E. coli* levels in the Clam River and Cut River were low relative to other water bodies sampled in 2016, although exceedances did occur.

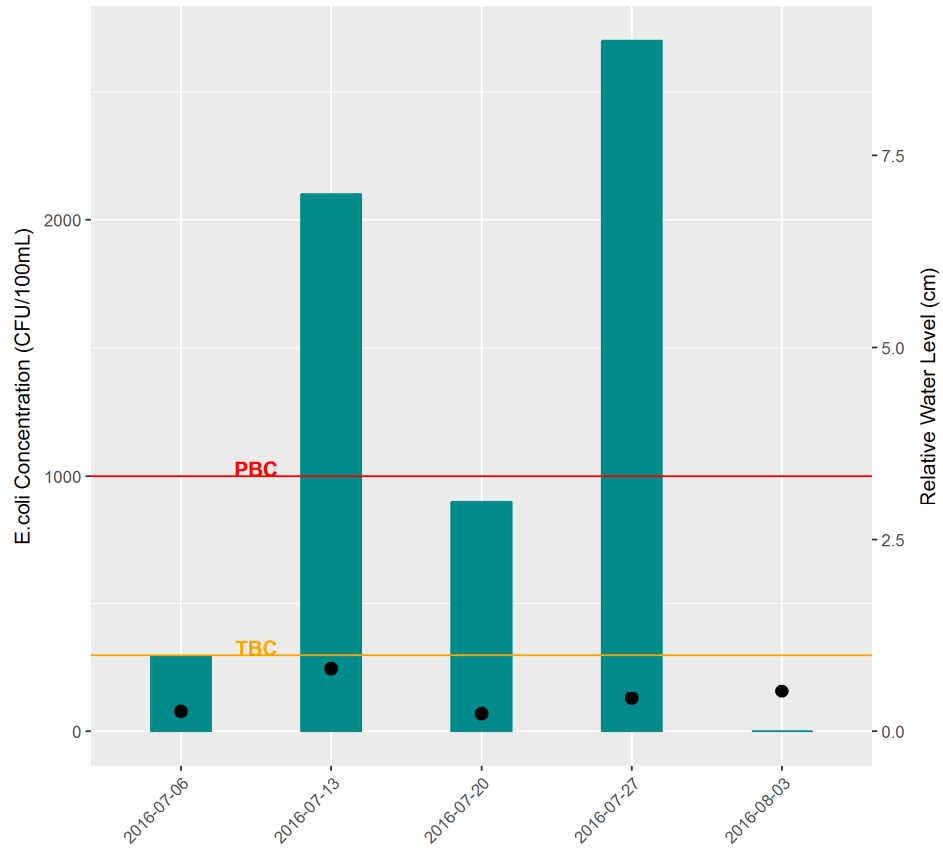
Site ID: 170305

Appendix 3 – St. Marys watershed *E. coli* concentrations and water levels (relative to the lowest recorded during sampling period).

FRECHETTE CREEK @ RIVERSIDE DR

sanitary collection system. The August 10, 2011, 30-day geometric mean was 511 *E. coli* per 100 mL. Follow-up monitoring in 2016 found that Frechette Creek met all applicable WQS with a 30-day geometric mean of 121 *E. coli* per 100 mL during the critical period (July), and during both wet and dry weather (Appendices 1-3).
