**Clean Michigan Initiative
Nonpoint Source Grant**

Calhoun Conservation District
13464 Preston Drive
Marshall MI 49068

Rice Creek Floodplain Restoration Project

Tracking Code: 2009-0044

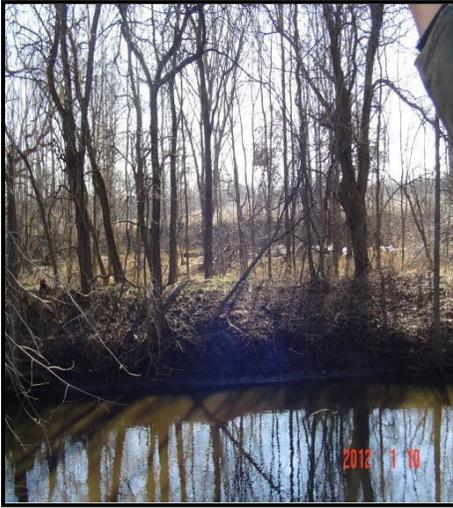
VANSICKLE SITE

BEFORE: Berm prior to tree removal and excavation. Stream is disconnected from floodplain causing bank erosion due to occasional increases of in-stream water velocity. Berms were created by historic dredging.

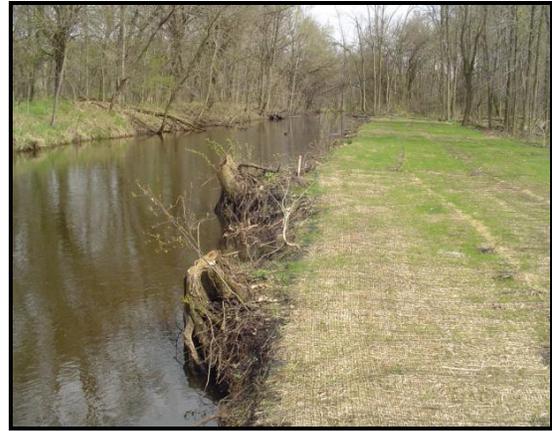
AFTER: Berm from "before" picture removed. When rainfall runoff increases the water level, the stream is now able to overflow onto 6 acres of floodplain storage to the right.

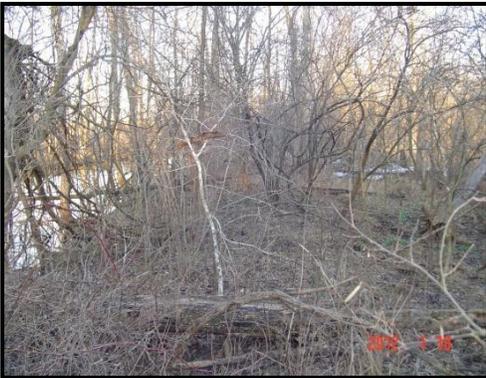
BRANDT WOODS SITE

BEFORE: Thick brush on a berm separates Rice Creek from its natural floodplain. Being disconnected from its floodplain caused bank erosion due to occasional increases of in-stream water velocity. Berms were created by historic dredging.

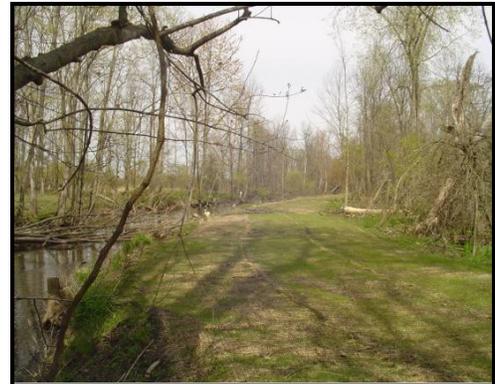
AFTER: Same site after berm removal. Notice the higher berm across the stream is still in place. When rainfall increases water level it is now able to overflow onto 17 acres of floodplain storage to the right.
