Septic Systems and Nutrients

STATE OF MICHIGAN, DEPARTMENT OF ENVIRONMENTAL QUALITY

Nutrient Framework to Reduce Phosphorus and Nitrogen Pollution

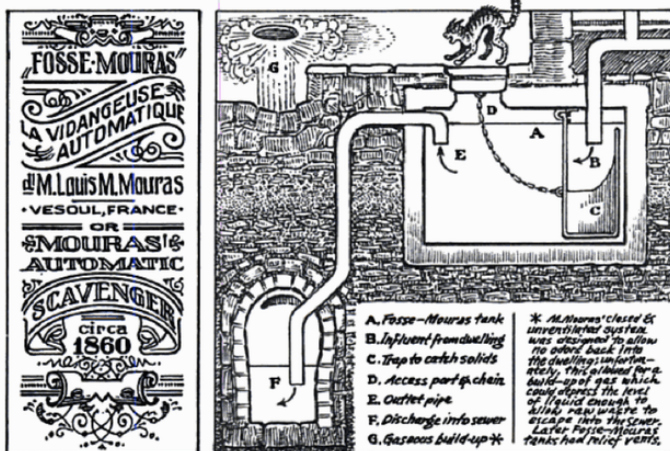
Fig 1. Schematic of an early-design septic tank from 1860. (from <http://djwl.co.uk/blog/brief-history-septic-tanks/>)

The invention of the first septic tank is often credited to a Frenchman by the name of Jean-Louis Mouras in 1860 (Fig. 1). Mouras invented a tank for waste disposal with the idea that storing the solid wastes would be a better disposal method than discharging them straight into the nearest waterway. Which, up until then, had been the preferred method of waste disposal. The first septic tank was later installed in the U.S. in 1883. Some 50-60 years later, drainfields or “soakaways” were recognized as being necessary for the liquid effluent that left the tank. Today, the basic design and concept of the septic tank system has changed little from its earlier prototypes.

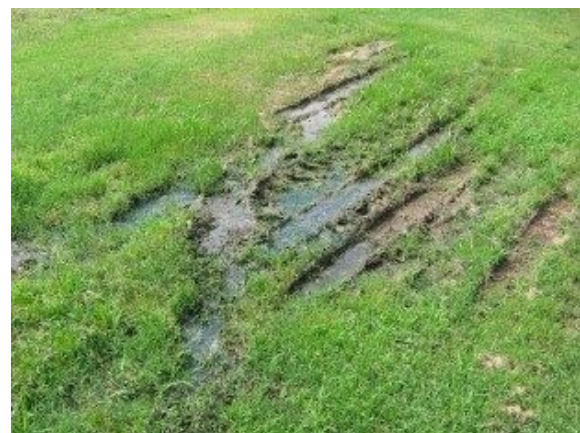
Figure 2. Saturated drainfield that has become clogged and has ponding water at the lawn surface. Photo from <http://www.aero-stream.com/septic-tank-problems.html>

Poor septic system performance, or failure, typically occurs when effluent loading is too high, the soil type is unsuitable, the drainfield is too small, or the drainfield is too close to the water table. Also, neglecting to pump a septic tank often enough can lead to failure. Most septic system manufacturers recommend that the tank be pumped when it becomes 30% full of solids, though this recommendation is often ignored by home owners. When a tank becomes damaged or full of sludge, the solids may end up entering the drainfield tile network, which may then become clogged. When a system is clogged, the drainfield may become “soggy” and water may start ponding in the yard (Fig 2.). In worse-case scenarios, water may stop draining from the sinks, bathtubs, and toilets in the house that are hooked up to the septic system.

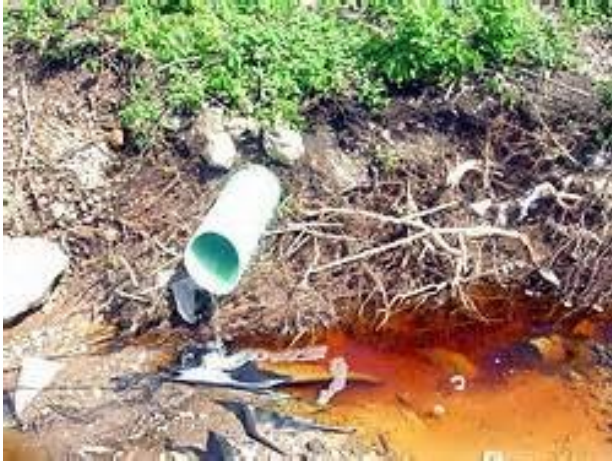
Fig 3. Illicit sewage discharge to a ditch. Photo from www.oregonohio.org.
