# Flint Water Treatment Plant Improvements Plan

## FINAL REPORT

City of Flint, Michigan  
January 30, 2017

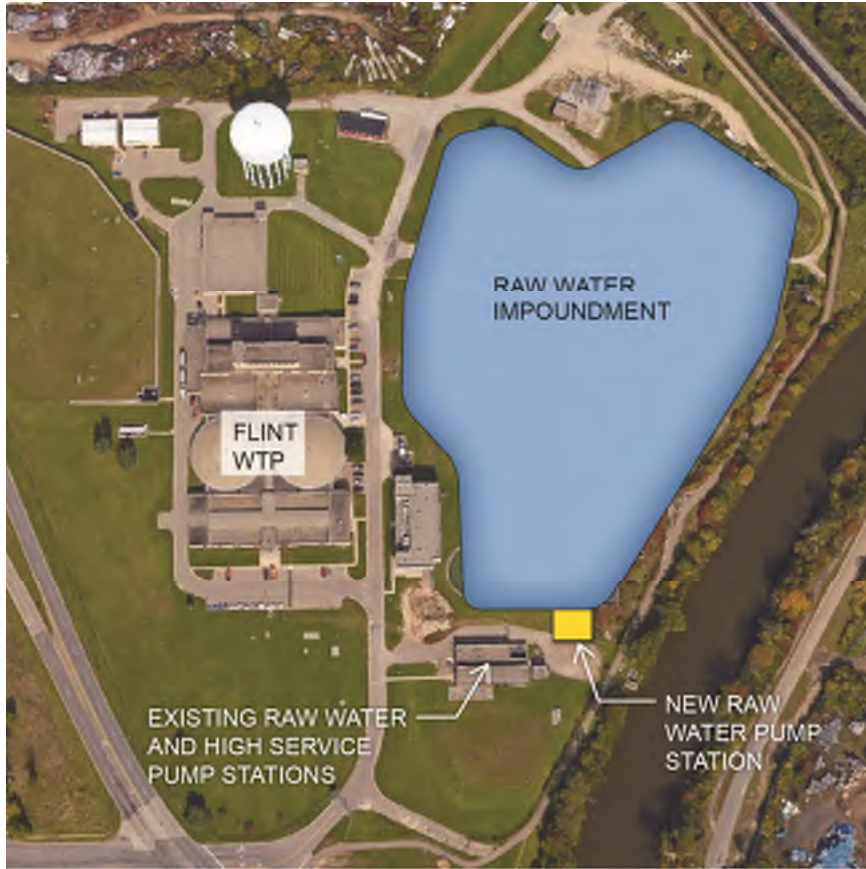
**Figure 3.3 – Earthen Berm Impoundment Plan View**

Using these design criteria and the maximum available site area, a water depth of 25 feet is required to provide 42 MG of storage. This would extend the normal water level to elevation of 740 feet, which is 10 feet above the surrounding area. The berm should extend to approximately elevation 745 feet around the perimeter of the impoundment. **Figure 3.3** shows a proposed layout of the impoundment on the WTP site, which maximizes use of the site, but retains the ozone facility and the new electrical substation located to the north of the site. This arrangement also prevents the need to relocate any existing yard piping.

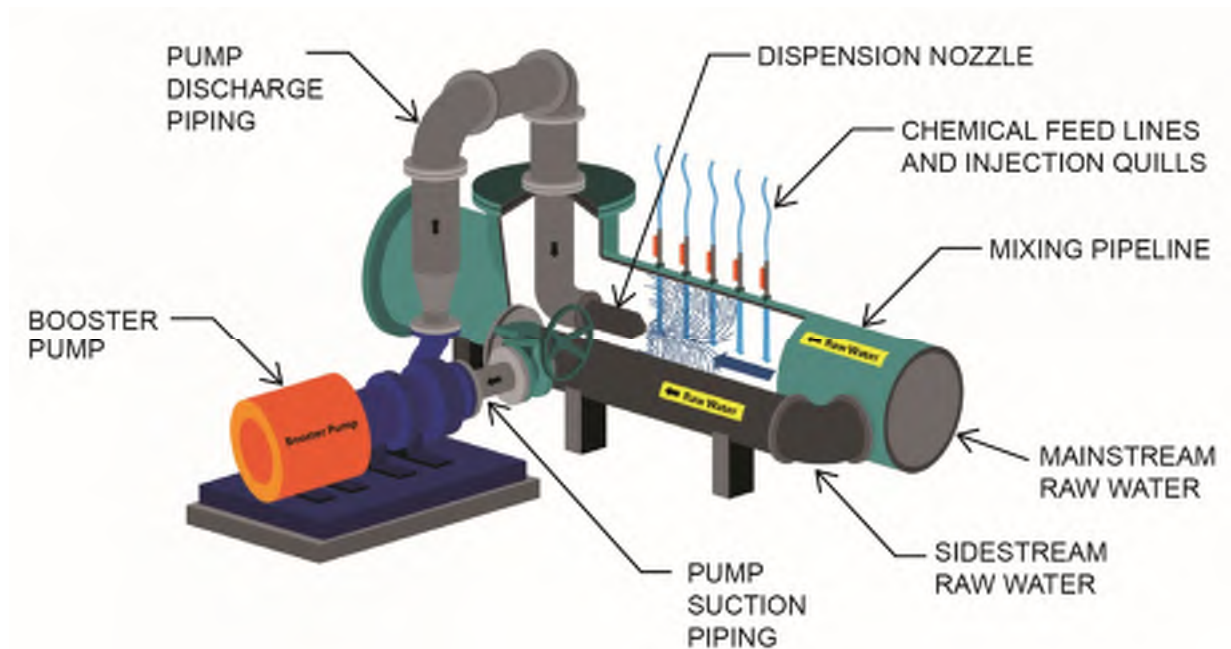
**Figure 4.11 – Schematic of Pumped Diffusion Mixing System**

**Figure 4.11** presents a schematic drawing of a typical pumped diffusion system. The main components of the system include the booster pump, spray nozzle, chemical diffuser quills, and interconnecting piping for mixing water. The booster pump is located adjacent to the mixing pipe and is easily assessable for maintenance. The spray nozzle is a 4-inch stainless steel flange-mounted device with a 90-degree full-cone spray pattern opposing the direction of the mainstream flow, for effective flash mixing. The nozzle assembly can be removed through an access hatch on the pipeline. Multiple chemical quills are located directly upstream of the dispersion nozzle, one per treatment chemical with one or more spares.

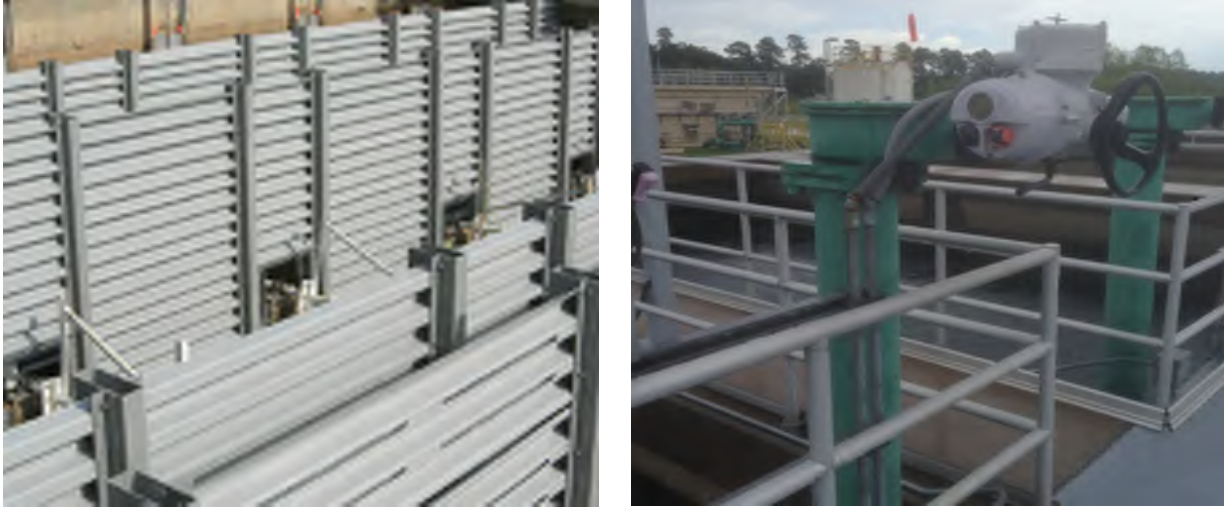
**Figure 4.14 – Structural FRP Panel (by Enduro) and Torque Tube Operator Installed in a Flocculation Basin**

- Butterfly valves with extended torque tube operators for the new inlet distribution pipe header. The torque tubes allow an extended operator to be used without the need for a floor standout to core through a concrete floor. The tubes can be supported on a concrete sidewall with standard pipe supports (see photo).

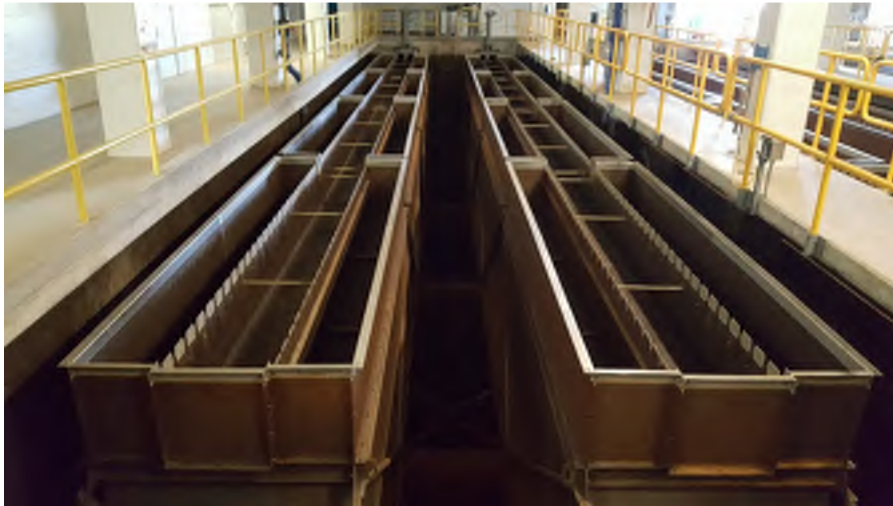
**Figure 4.17 – Inclined Plate Settler Packs in Basin No. 1**

The IPS basins at the WTP were constructed in 2000 and are located at the far north end of the WTP building, directly north of the flocculation process. The IPS basins are fed from the east and west flocculation modules by six 36-inch pipes which convey settled water to a settled water inlet conduit. Water enters each basin through two 54-inch by 54-inch square butterfly gates. Each basin contains four plate settler trains and two fixed-grid sludge collection systems. The design solids-loading rate is 0.3 gpm/sf at 36 MGD plant flow or 12 MGD per basin. The IPS basins are numbered 1 through 3 from south to north.

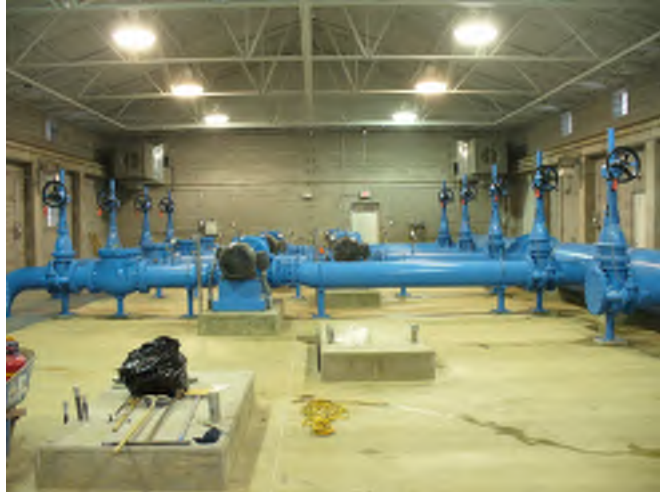
**Figure 6.1 – Horizontal Split Case**

A typical horizontal split case pump installation is illustrated in **Figure 6.1**. This type of pump offers excellent efficiencies and easy access to pump components. Disadvantages include sensitivity to net positive suction head conditions, larger/deeper footprints for installation, and longer lead times.

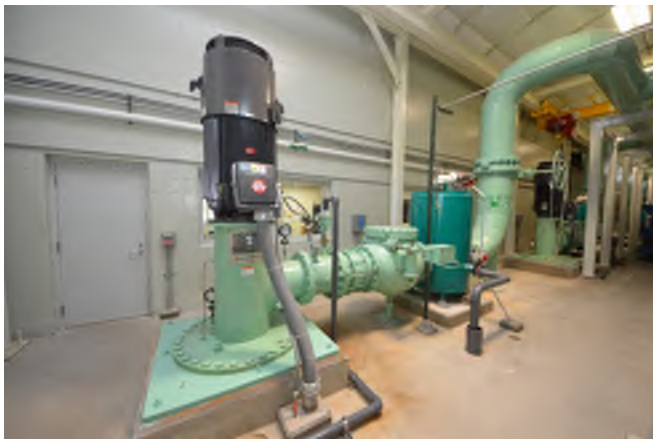
**Figure 6.2 – Vertical Turbine Pump**

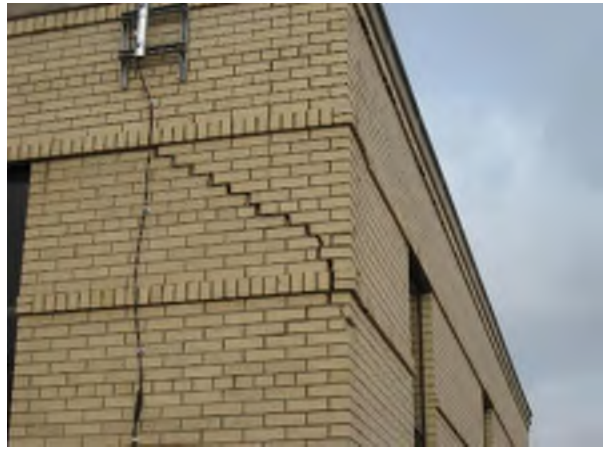
**Cracks at the Corner of Lime Area**

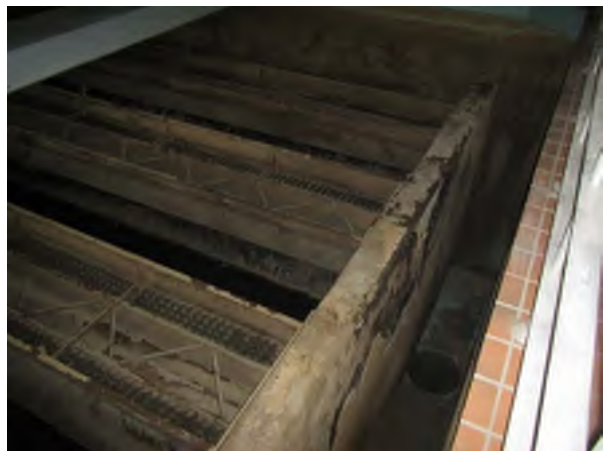
**Filter Box, Minor Discoloration but no Visible Cracking**

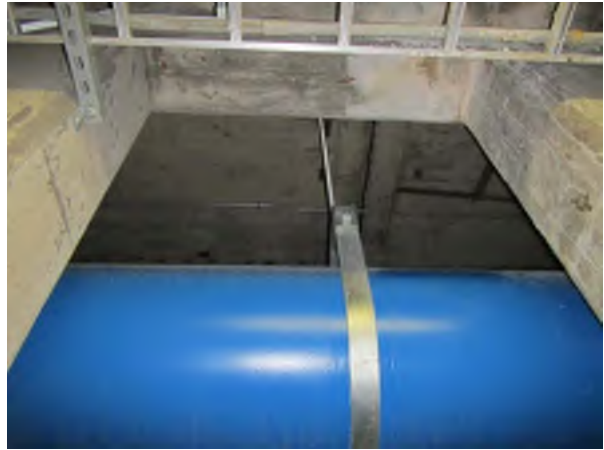
**Corrosion Visible on Concrete Beam, Previously Completed Cementitious Repair**

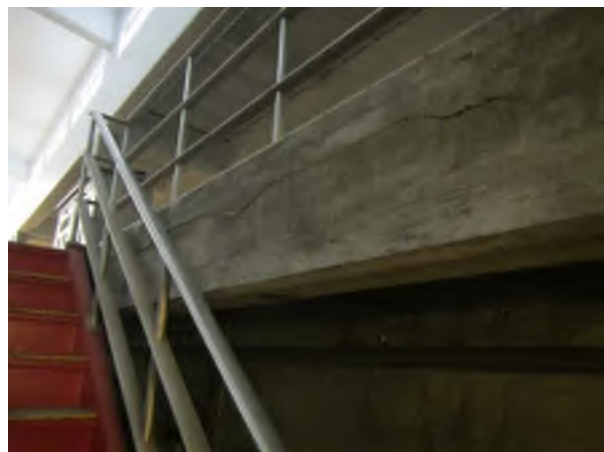
**Beam Cracking and Delamination at West Staircase**

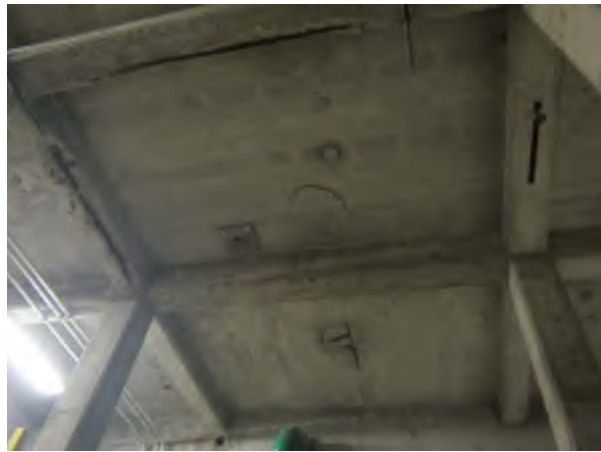
**Elevated Slab, Visible Delamination, Exposed/Corroded Rebar**

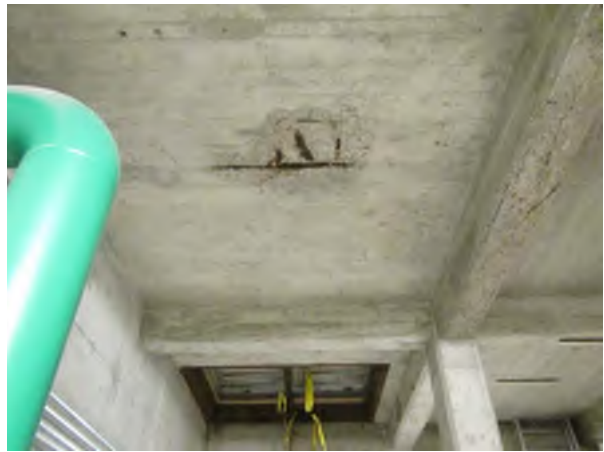
**Underside of Elevated Slab, Beam Cracking/Delamination, Slab Spalling**

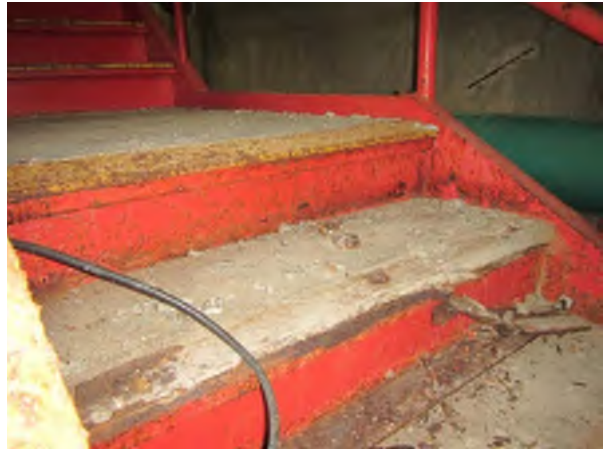
**Lower Staircase Corrosion**

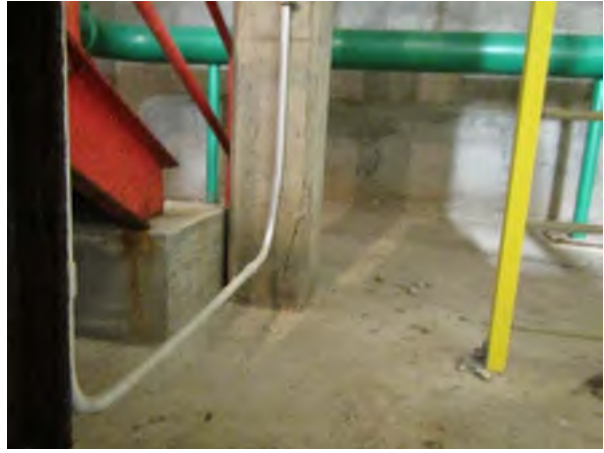
**Column Cracking at Base**

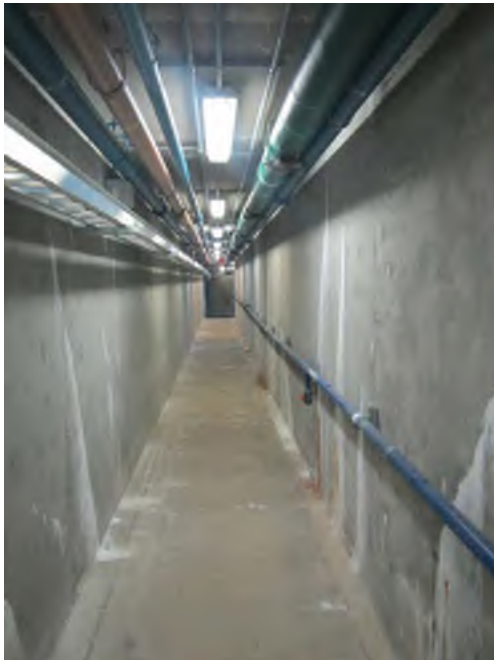
Wall and Slab Cracking in Lower Level, South Corridor

The walls of the IPS Clarifier Tanks show signs of cracking and past leaking. The tanks were dry at the time of observation, so it is unclear whether the cracks have 'self-healed' or are actively leaking cracks. These cracks do not appear to be structural cracks, and injection crack repair is recommended after determining whether the cracks are actively leaking.

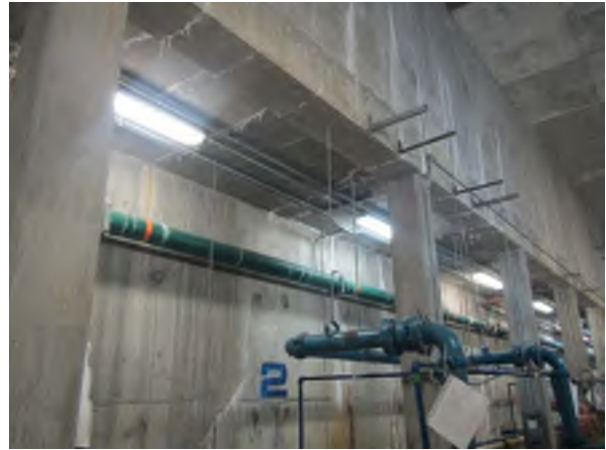
**West Wall, Visible Cracking, Looking East**

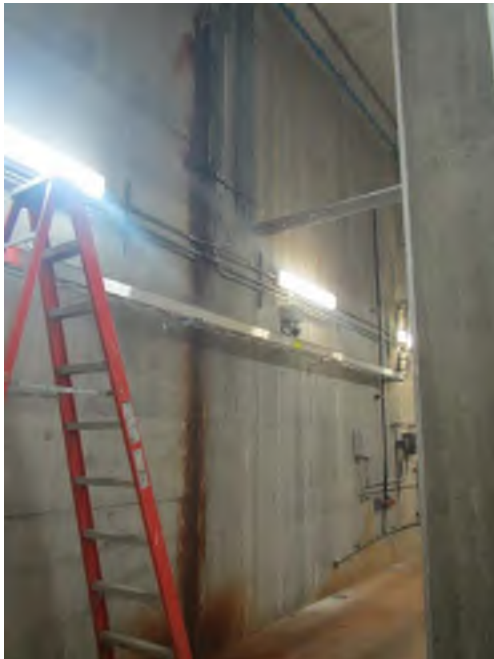
**West Exterior Wall, Lower Level,  
Corroded Electrical Conduit**

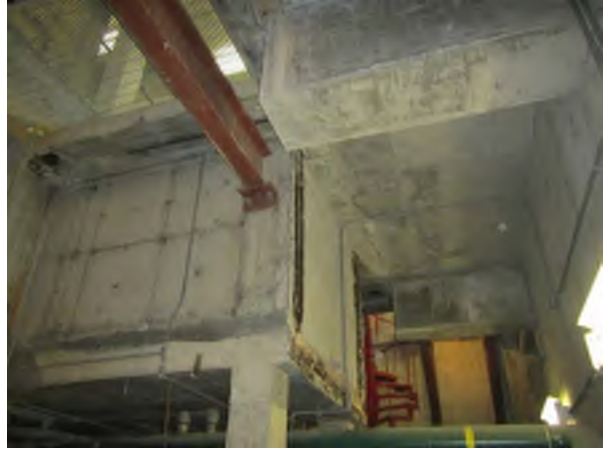
IPS Connection, Lower Level, Looking West, Local Spalling/Corrosion in Cantilevered Slab to East of Water Conduit

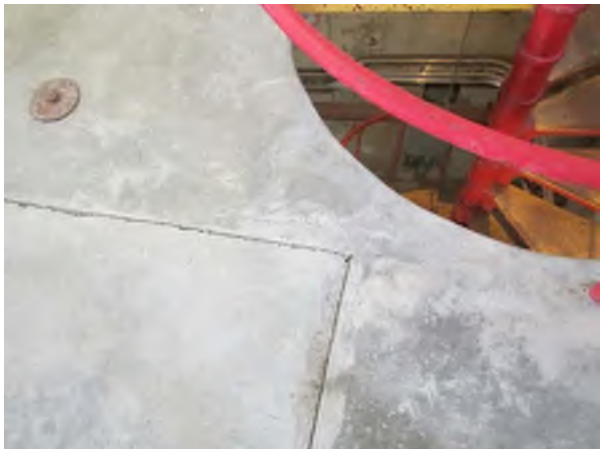
Slab Cracking Adjacent to Spiral Staircase

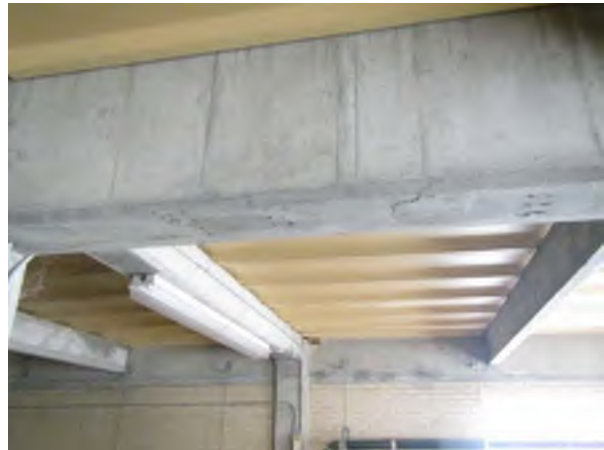
**Beam Delamination, Visible Corroded Rebar Chairs**

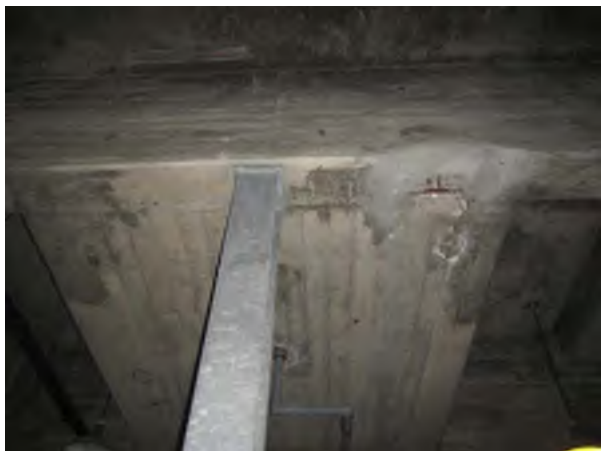
**Additional Steel Column, Previous Concrete Repair, Exposed/Corroded Reinforcing Steel, West Chemical Area Lower Level**

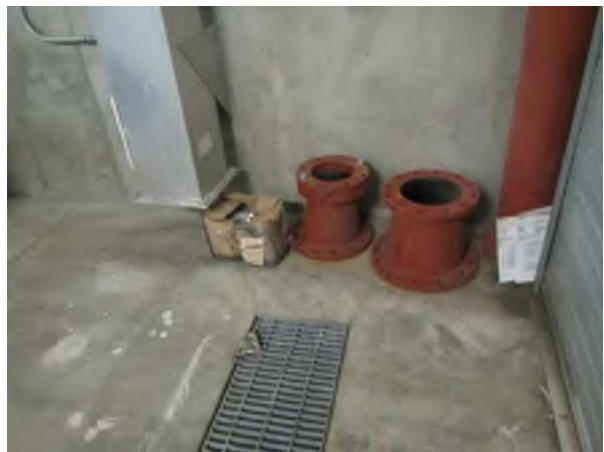
**Trench Drain Cracking at Re-Entrant Corners**

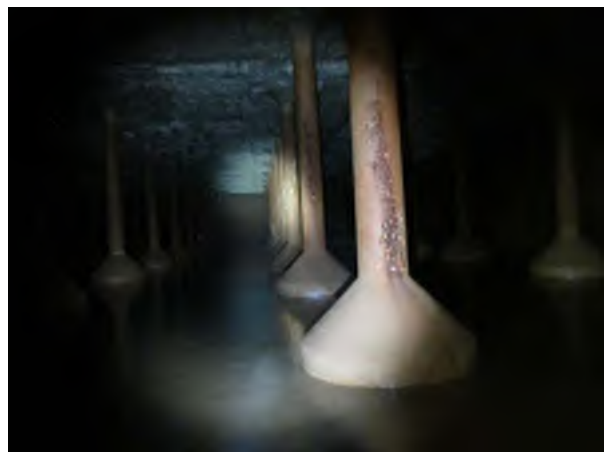
Column Deterioration and Corrosion

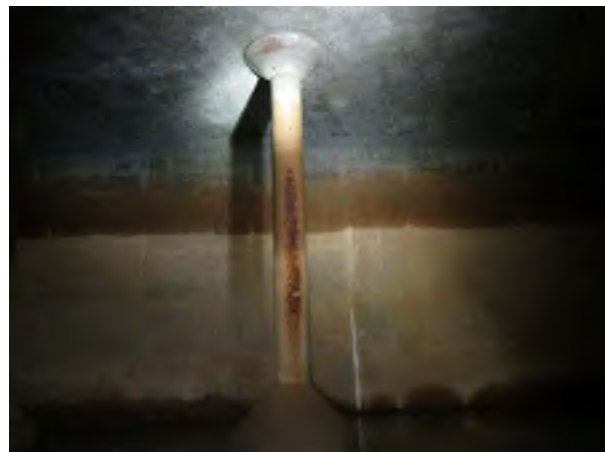
Column Deterioration and Corrosion

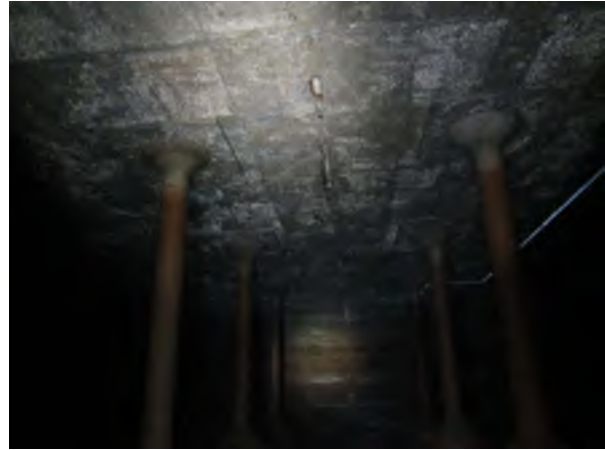
**Exposed Reinforcing and Spalled Concrete on Roof Slab**

In "Area #1" on the record drawings from 1966, approximately 90 feet east and 50 feet south of the extreme northwest corner of the reservoir, concrete spalling and exposed, corroded rebar are visible on a construction joint in the roof slab. The size of the area is approximately 12 inches wide by 30 feet long in the direction of the joint. Large pieces of delaminated concrete are on the verge of falling and it is recommended to wear a hard hat at all times during future entry into the reservoir, with careful consideration given to this particular area. Further investigation is required to determine the extent of preventative repair required to mitigate corrosion propagation in the roof slab. Repair is recommended

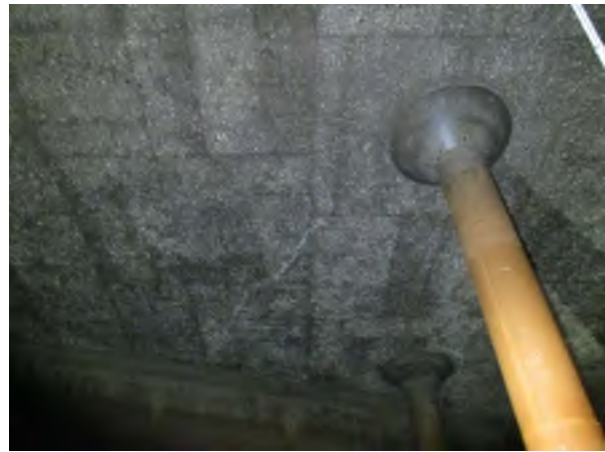
**Roof Slab Crack from Column Drop Panel to West Exterior Wall of Area #6**

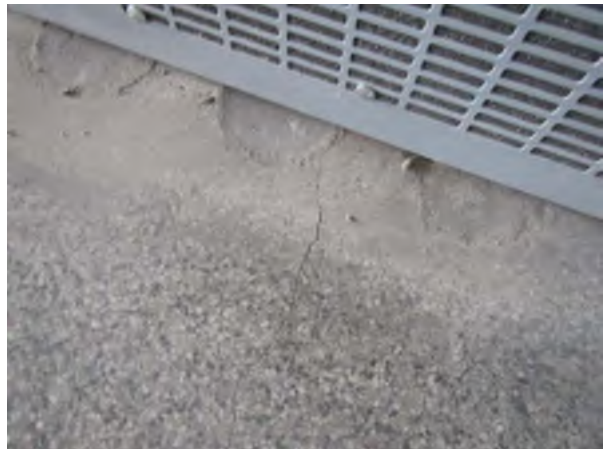
Floor Crack at Penetration

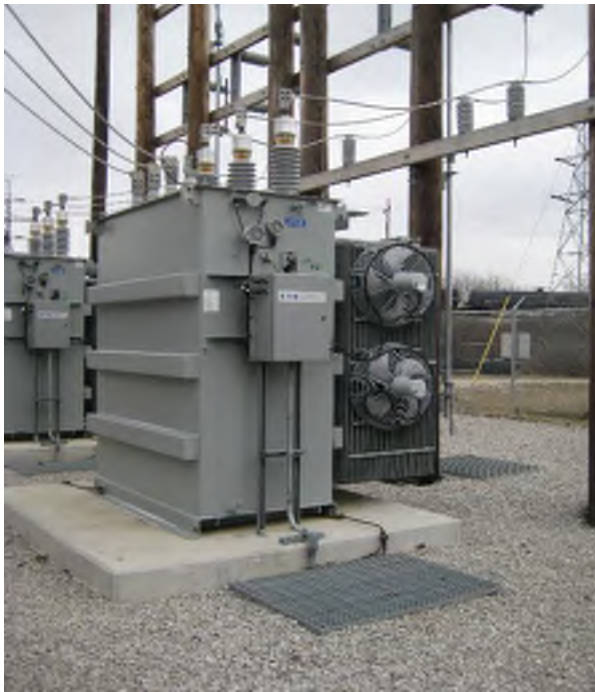
**Plant-Owned 3500kVA, 46-k-2400V Transformers**

- Perform power system study, including short circuit, coordination, protective device, and arc flash studies. Provide arc flash labeling in accordance with the latest version of NFPA 70E, Electrical Safety in the Workplace.

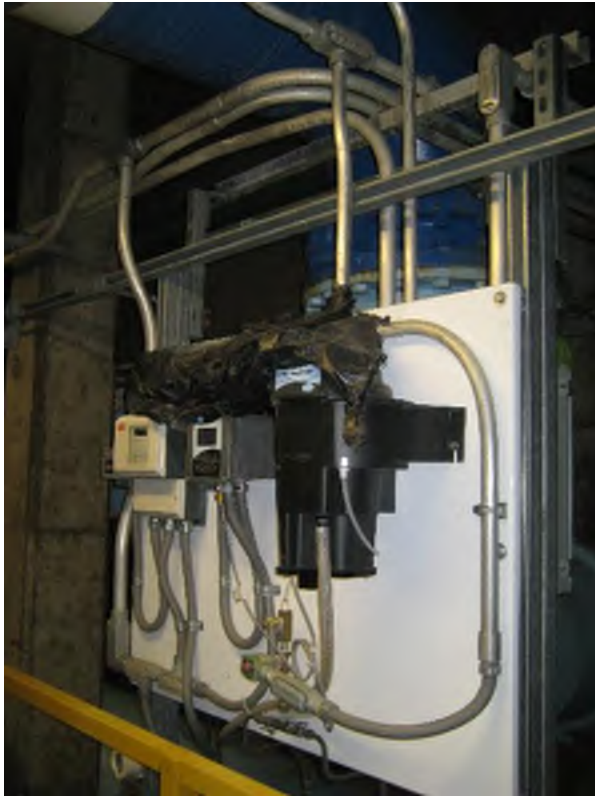
**Instruments in Filter Pipe Gallery Below  
Leaking Process Pipes**

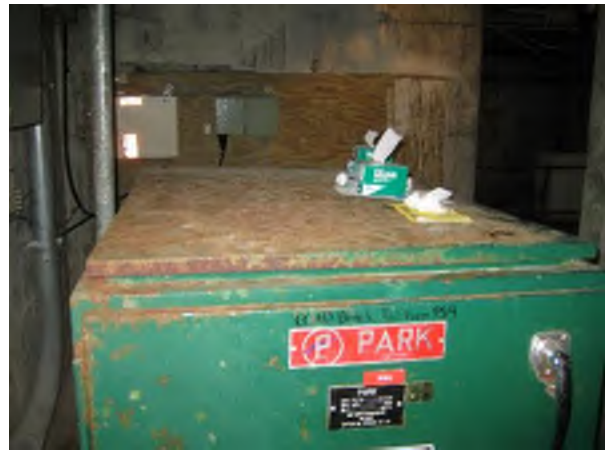
**Kitchen Electrical Room 2400-480V/277V  
Transformer Disconnect Switch in Basement –  
Corroded Top of Enclosure**

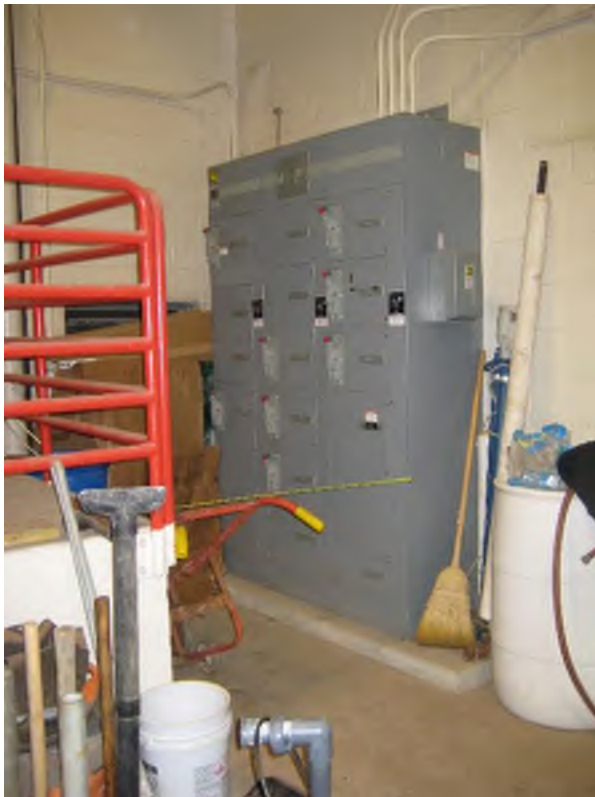
**Square D MCC-BB1 that was not Updated with Allen-Bradley in 2014**

- Replace the existing Square D MCC with an Allen-Bradley IntelliCENTER MCC with power quality metering, surge protection, and fiber optic communicating capabilities to match the MCCs from the 2014 upgrade.
- Perform power system study, including short circuit, coordination, protective device, and arc flash studies. Provide arc flash labeling in accordance with the latest version of NFPA 70E, Electrical Safety in the Workplace.
- Provide surge protection devices for the motor control centers.

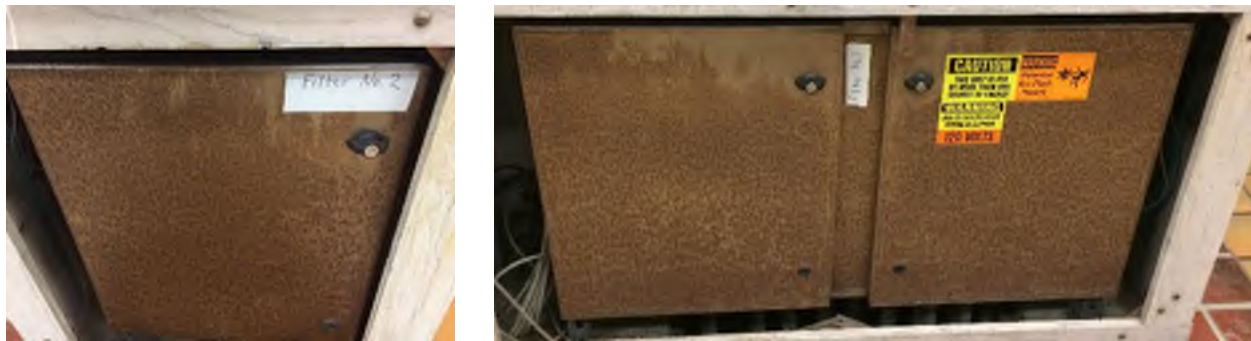
During visual inspection, it was noted that Filter 1 through Filter 10 control panel enclosures were severely damaged from corrosive exposure to sodium hypochlorite vapors.

**Filter Control Panel Enclosures**

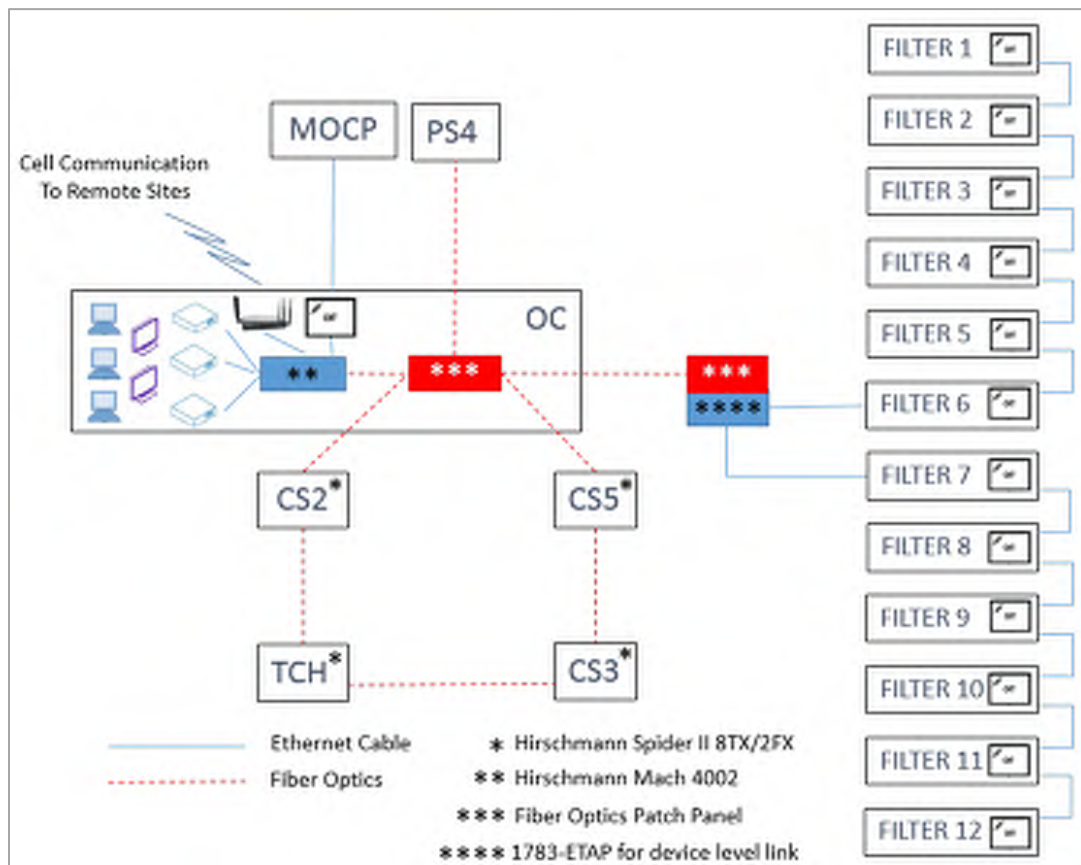
The diagram below represents the current plant SCADA network.

**Existing SCADA Network Architecture**

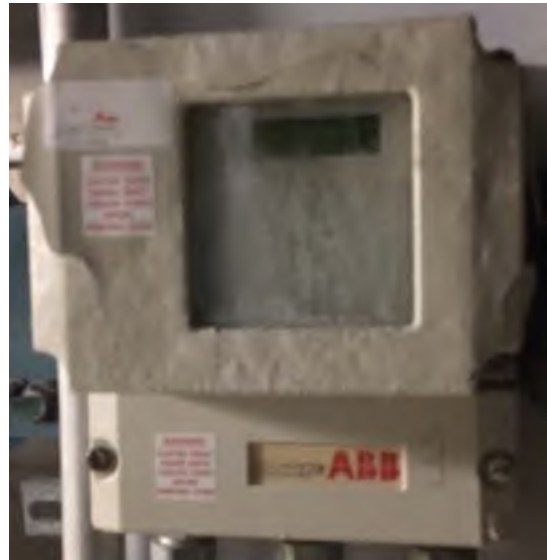
Filter No. 3 Damaged Flow Transmitter
