Michigan's Deteriorating Roads and Bridges

November 2014

Bay Region

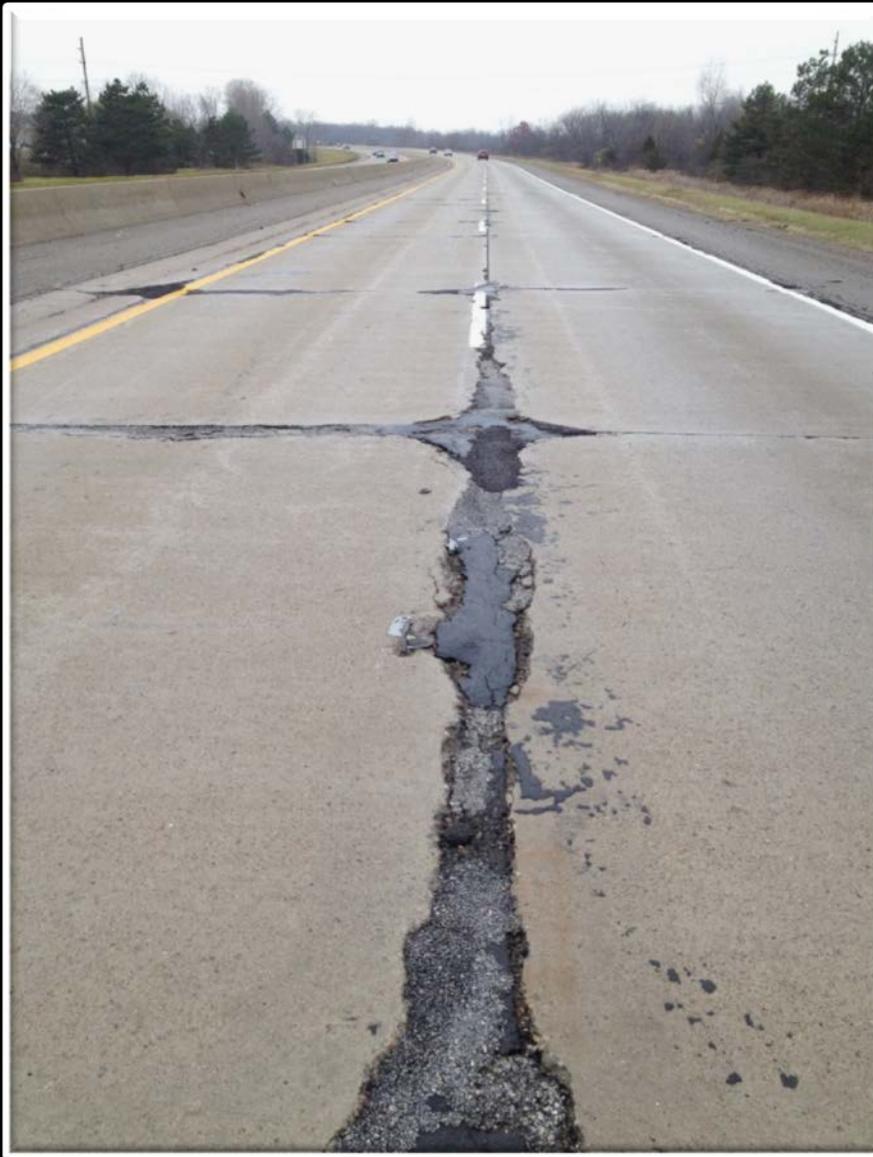
**I-475 in City of Flint & Mt. Morris Township
Concrete pavement joint failure due to water freezing in joints & years of aging.**

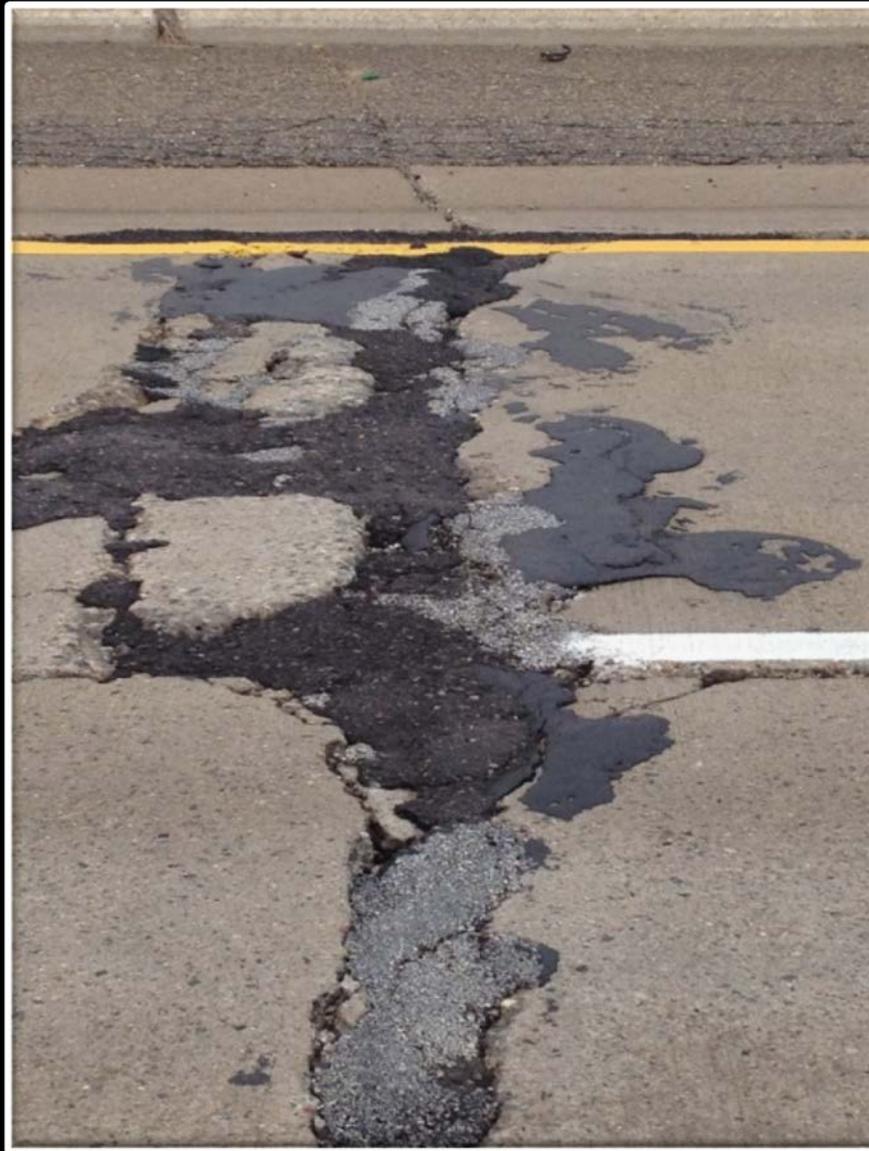
**I-475 in City of Flint & Mt. Morris Township
Concrete pavement joint failure due to water freezing in joints & years of aging.**

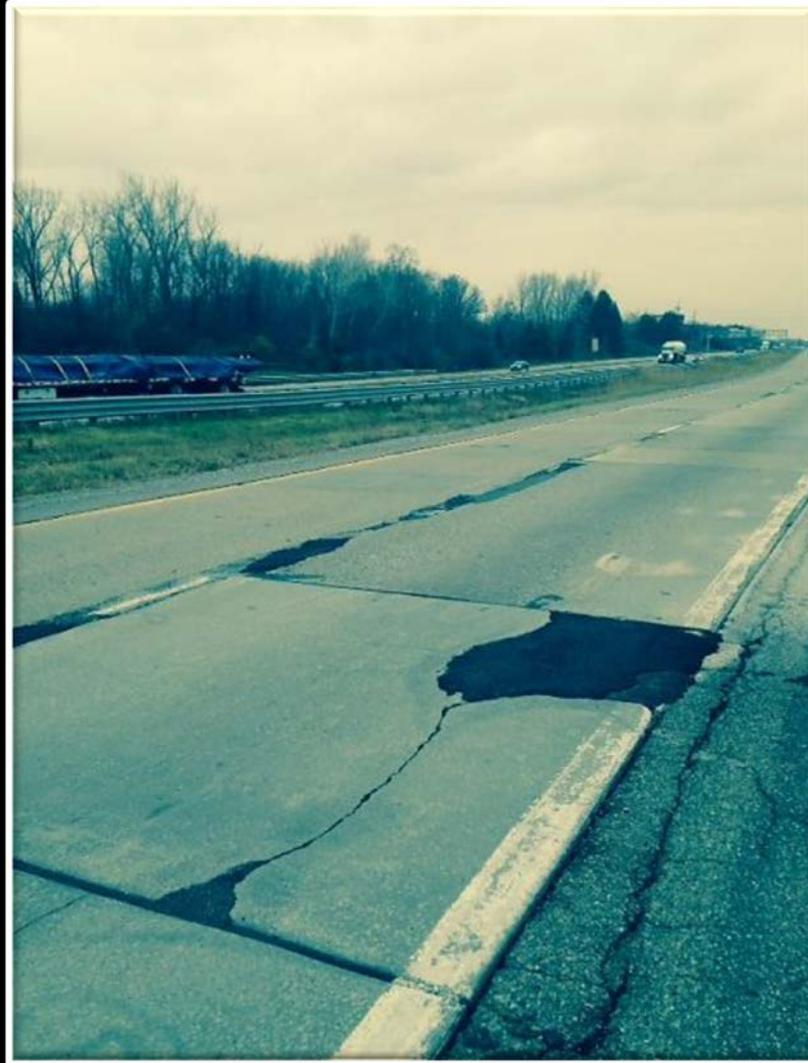
I-69 in City of Flint
Concrete joint failures due to water seeping through pavement & eroding under causing a fault.

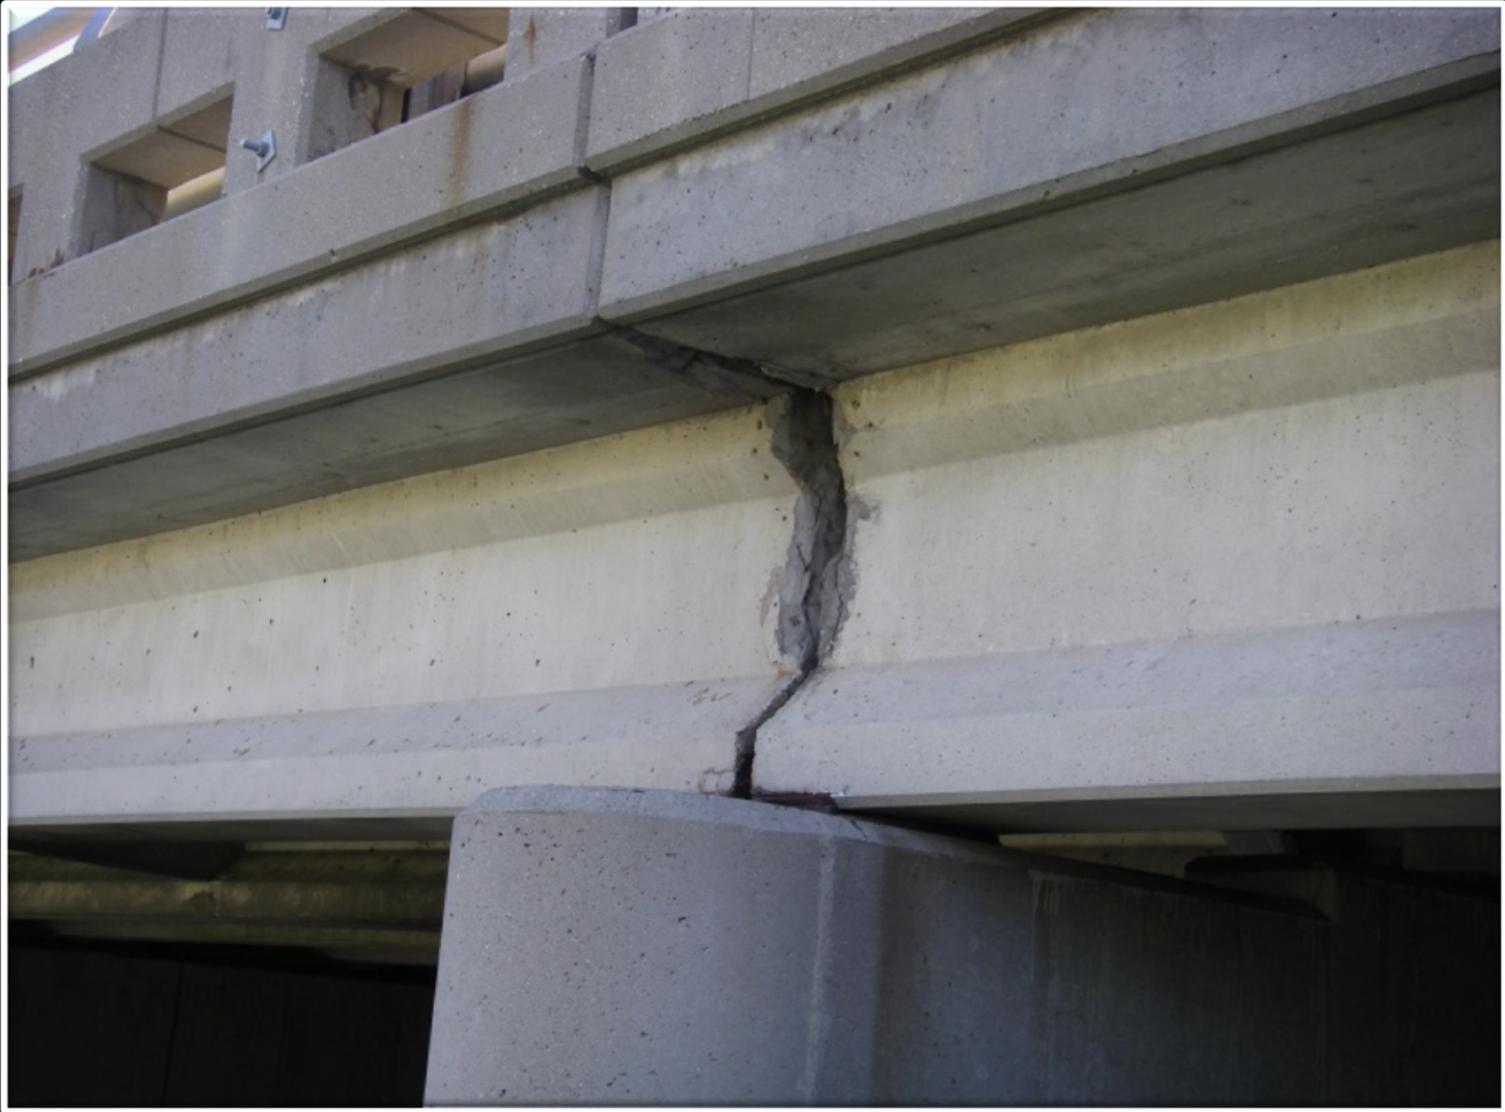
**I-475 over Atherton Road , Genesee County
Concrete beam ends are deteriorated caused by years of service & water leaking
through joints from above on deck.**

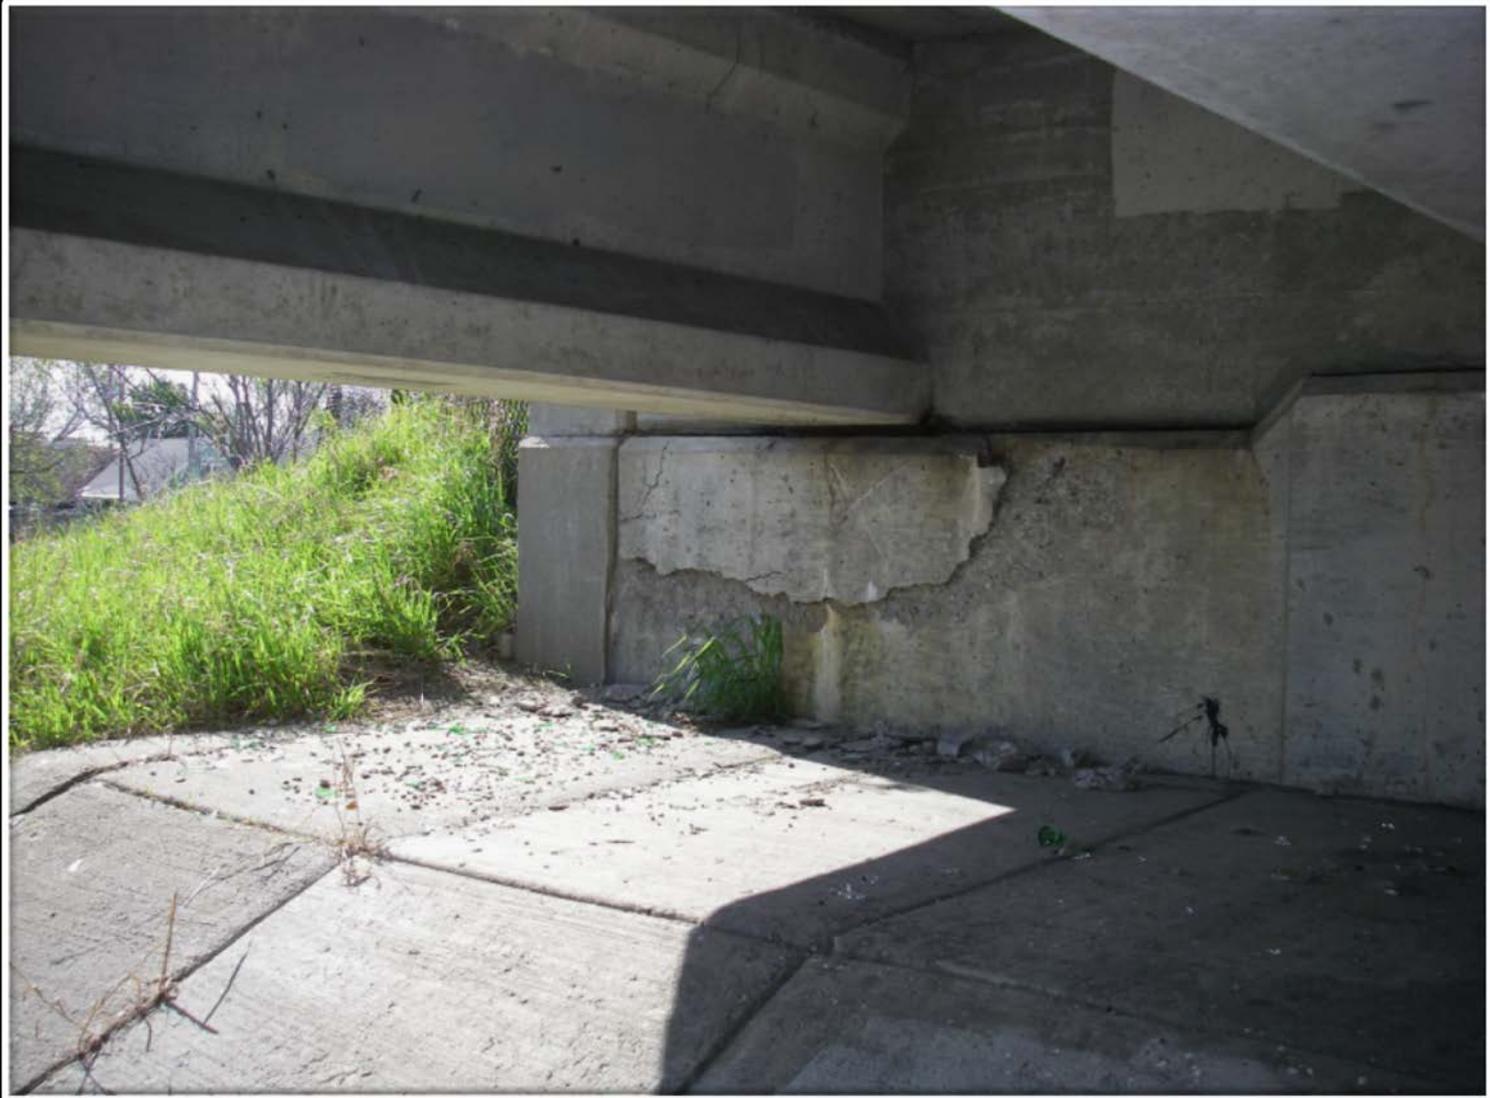
**I-475 over Atherton Road, Genesee County
Structural failure due to pavement expanding & pushing against beam
fracturing the bridge abutment support.**

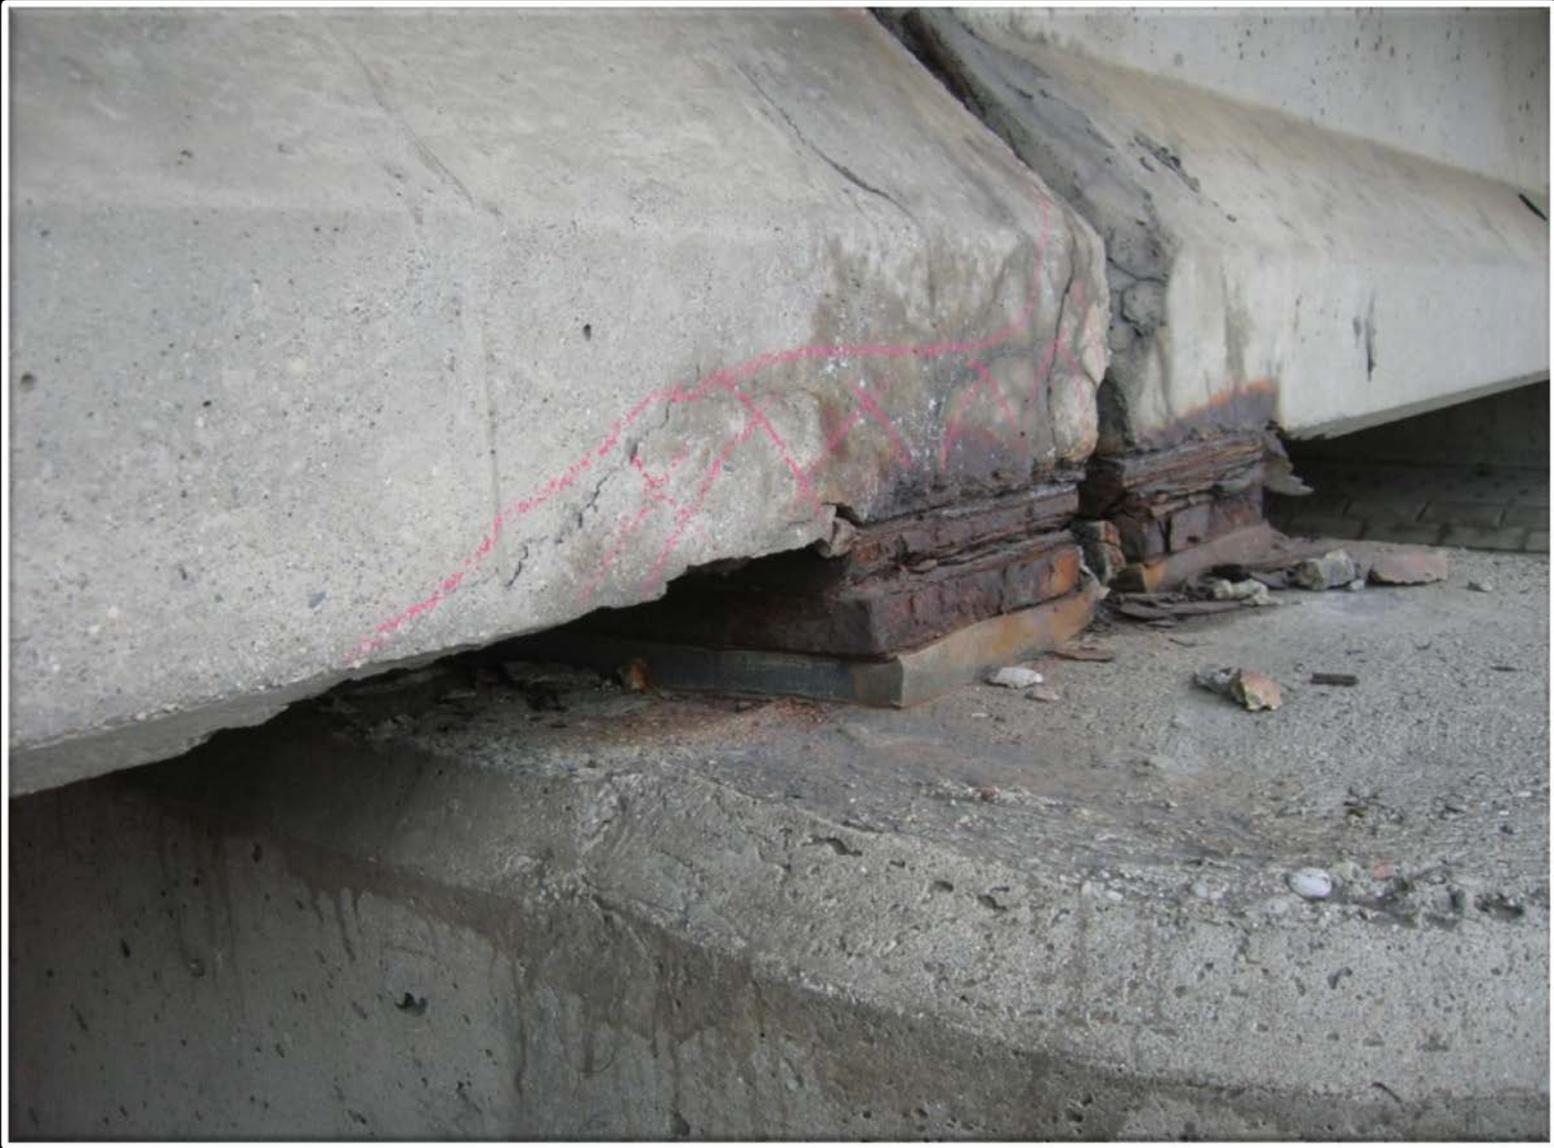
I-69 over Center Road , Genesee County

Rusting bearing pads where the beams sit due to years of exposure to water & salting.

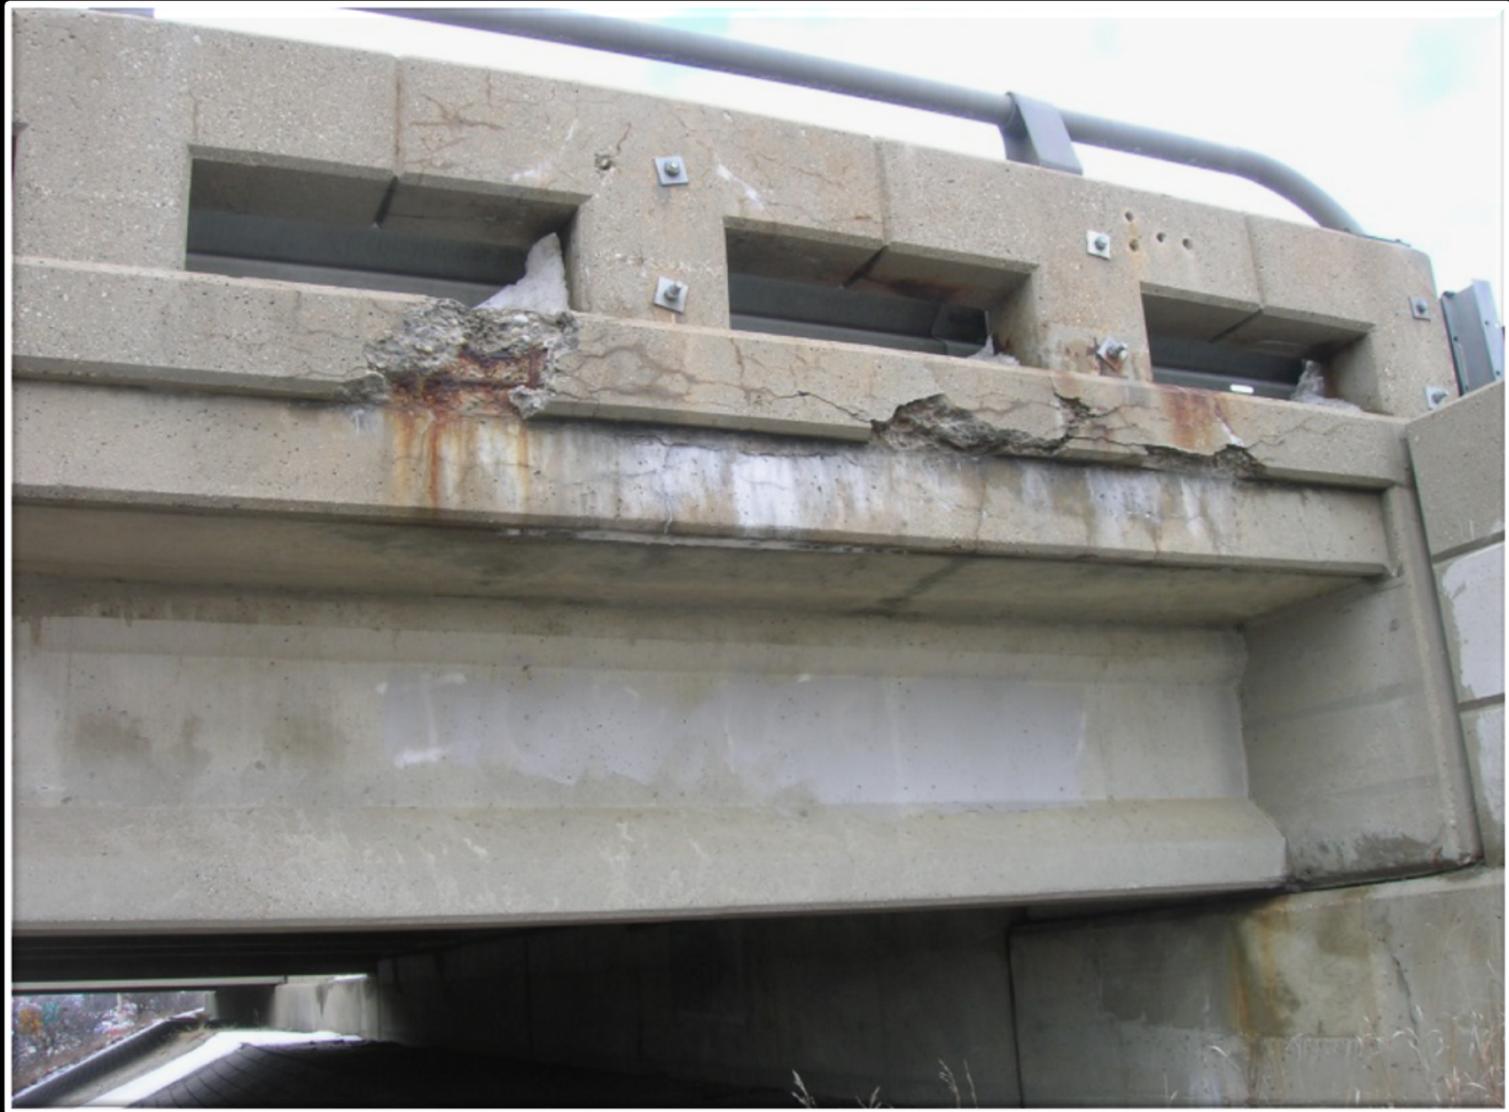
**I-69 over Center Road , Genesee County
Structural failure due to years of exposure to water & salt.**

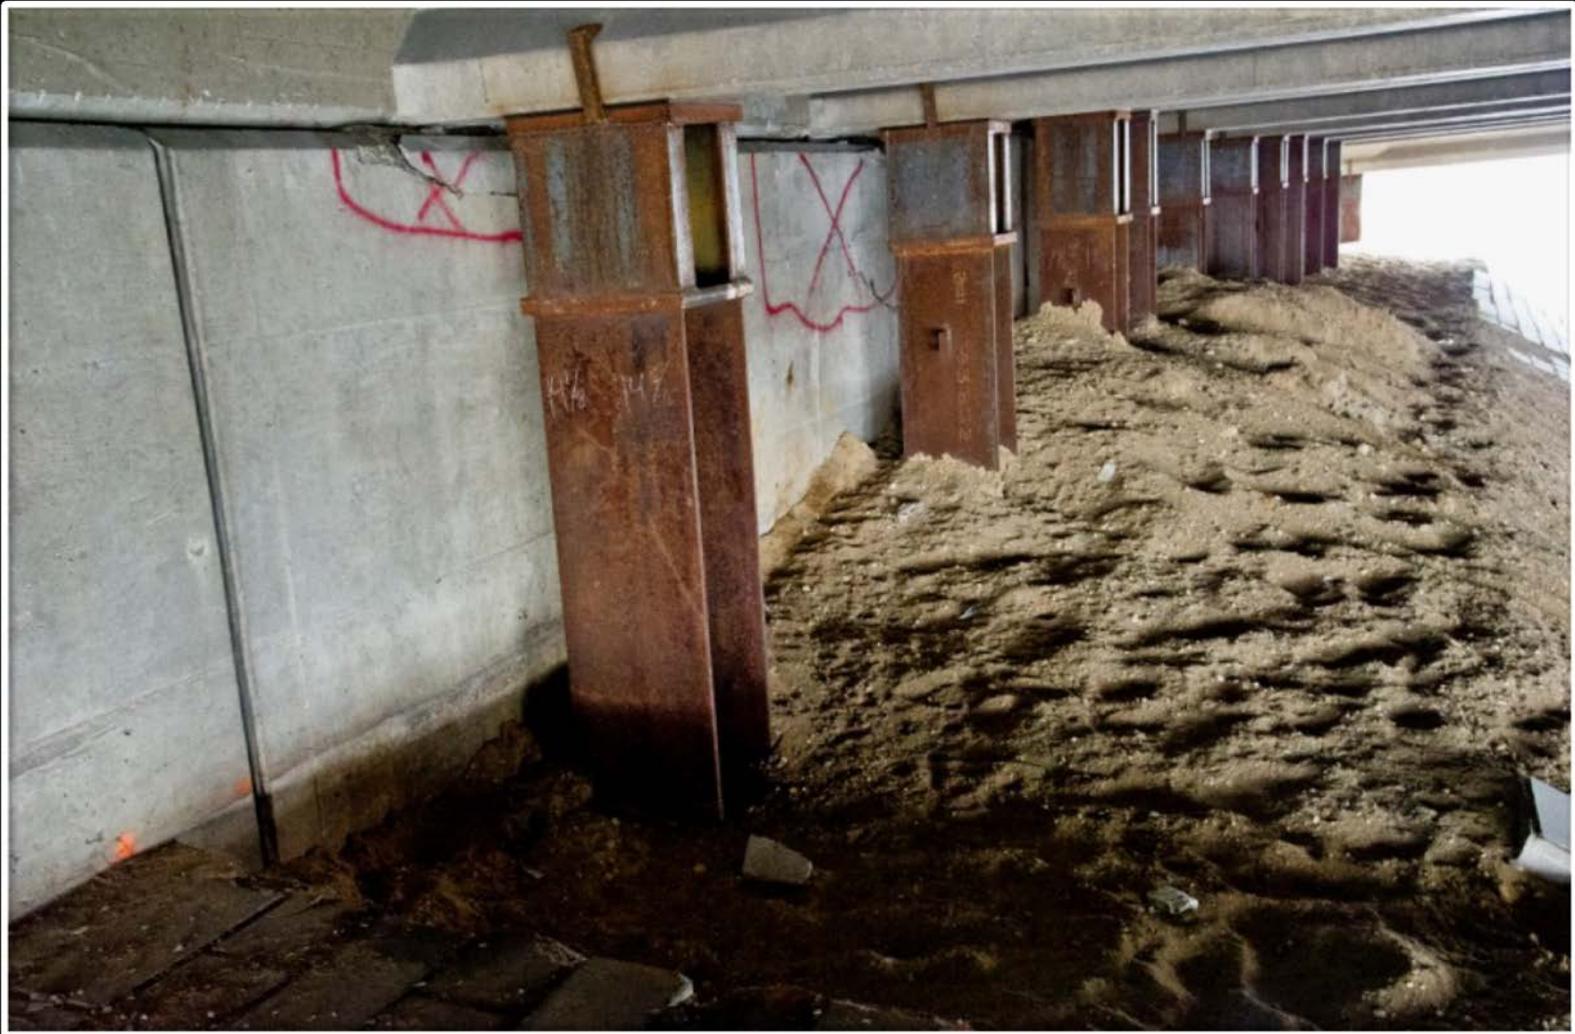
I-69 over Dort Highway, Genesee County

This bridge has temporary supports of the beams so they do not fail. This is due to structural failure & aging.

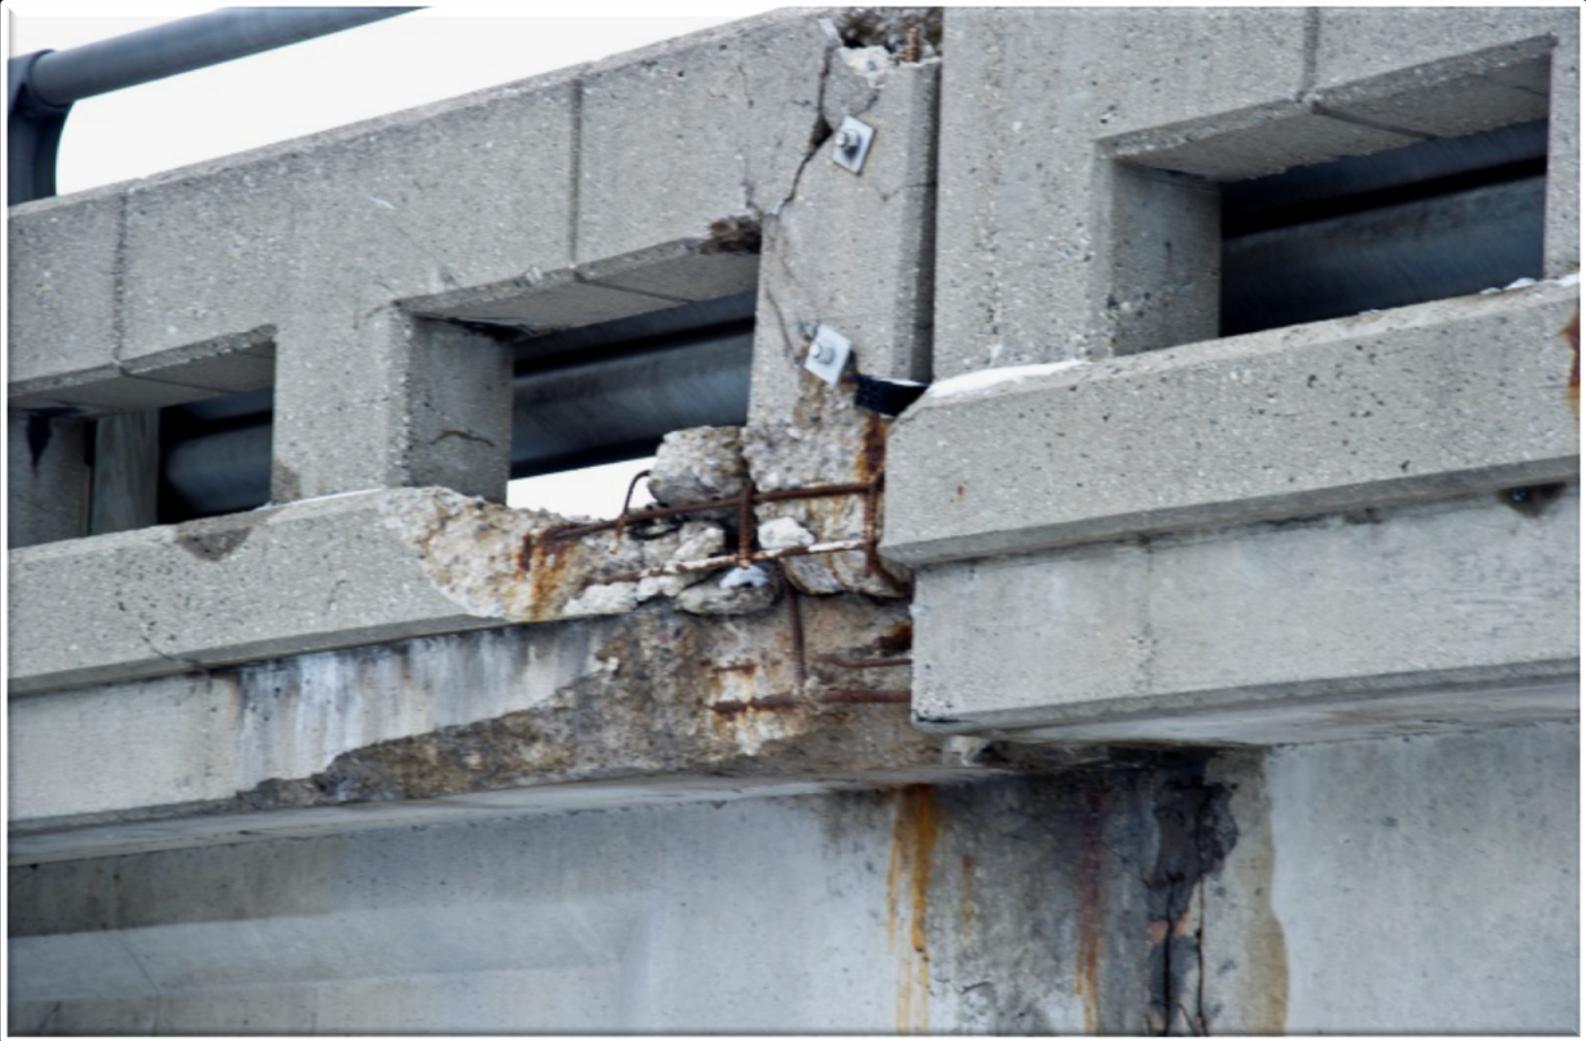
**I-69 over Dort Highway, Genesee County
Structural failure due to years of exposure to water & salt.**

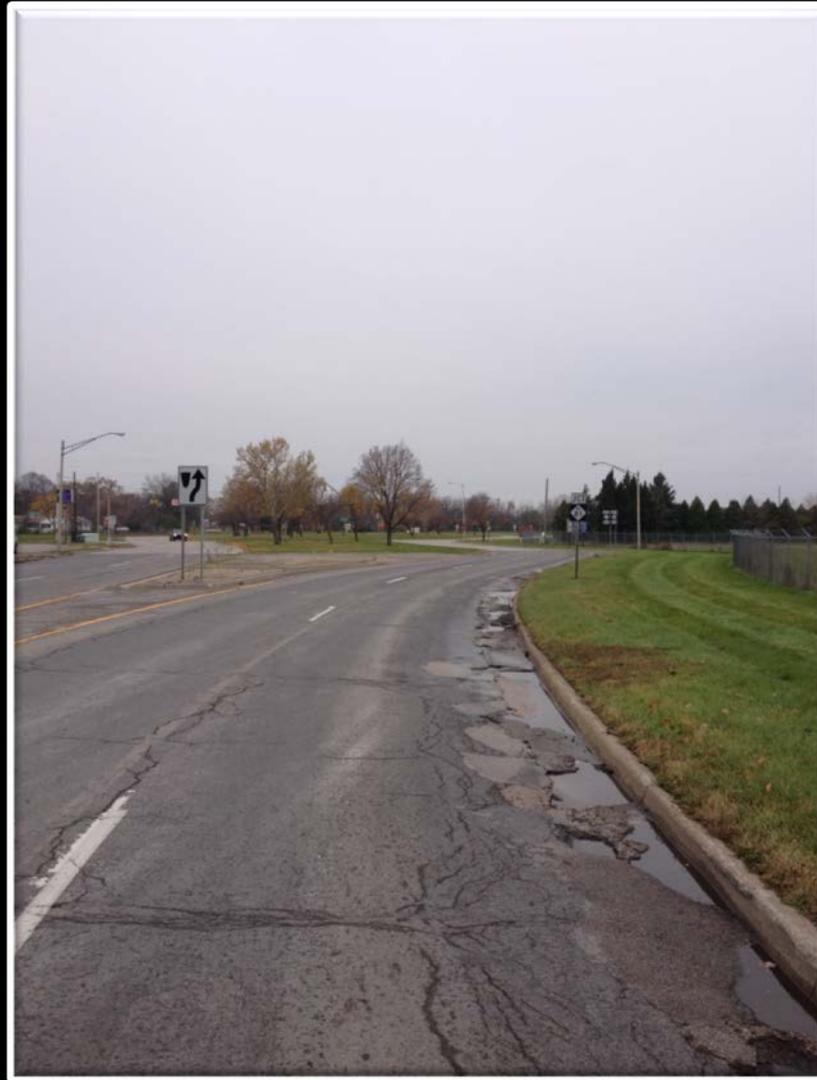
M-13, Saginaw County
Failed pavement due to lack of drainage, failed asphalt surface due to age & underlying concrete failed.

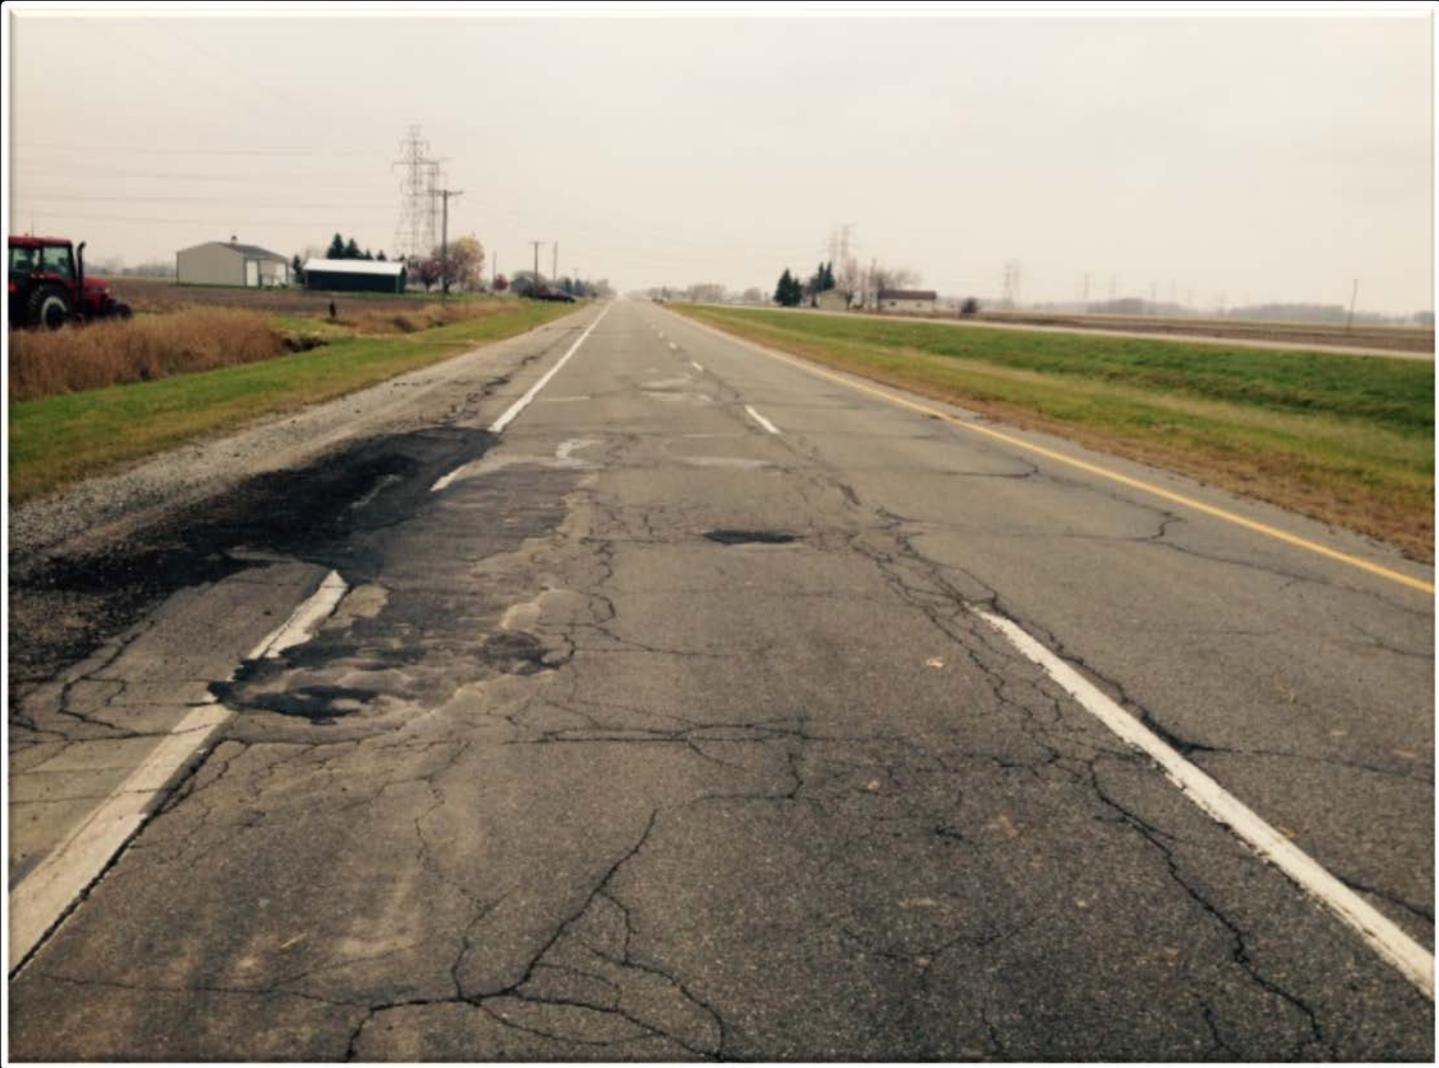
**M-15 from M-138 to Bay City South City Limit, Bay County
Base failure due to aging, surface cracking & breaking.**

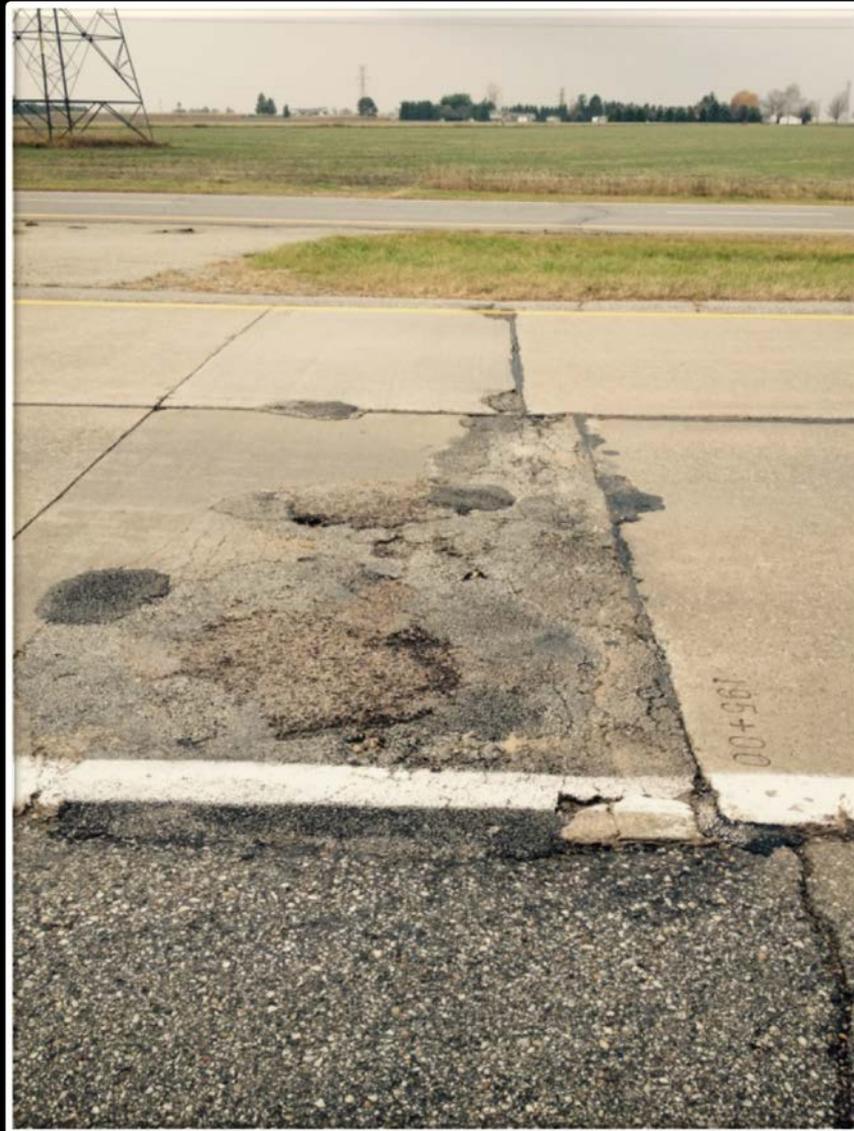
**M-15 from M-138 to Bay City South City Limit, Bay County
Base failure due to aging, concrete repair patch failed.**

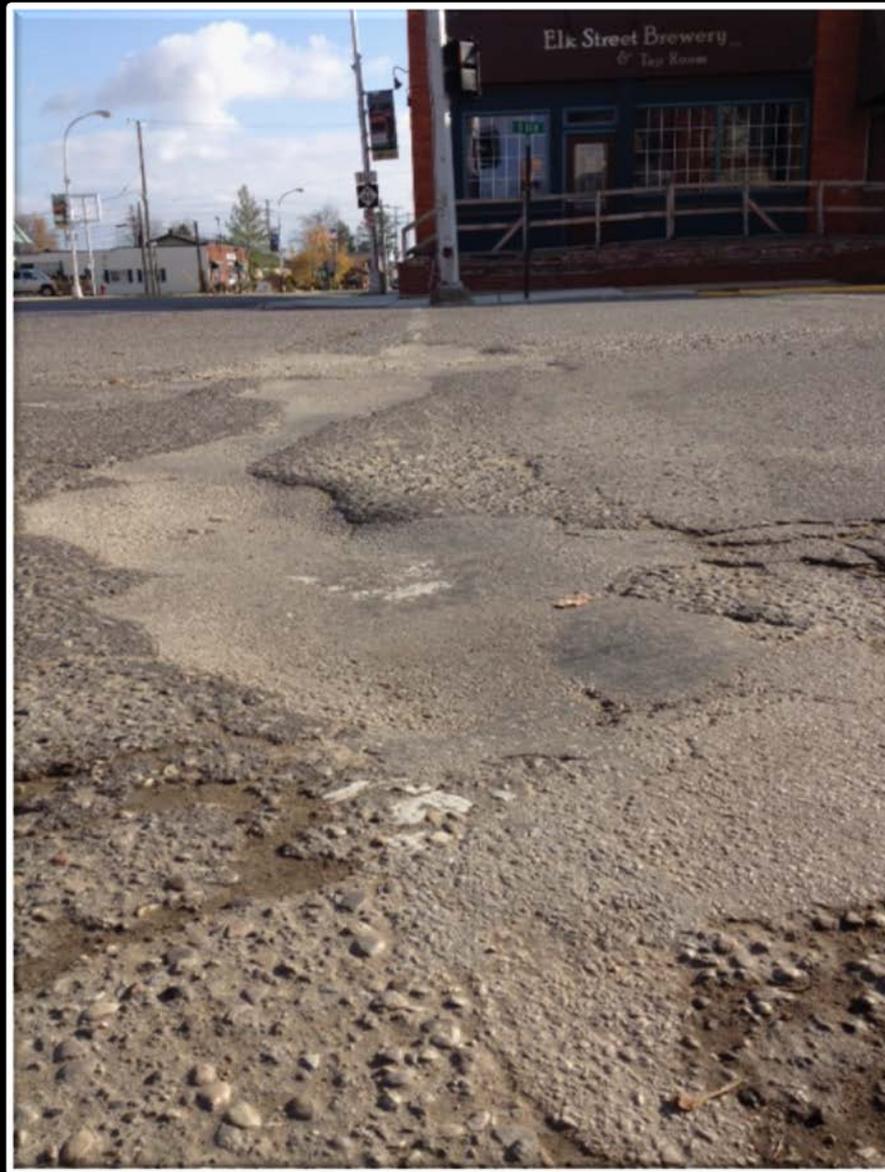
M-19 in Sanilac County
Base failure due to aging, joint failures, underlying concrete failed.

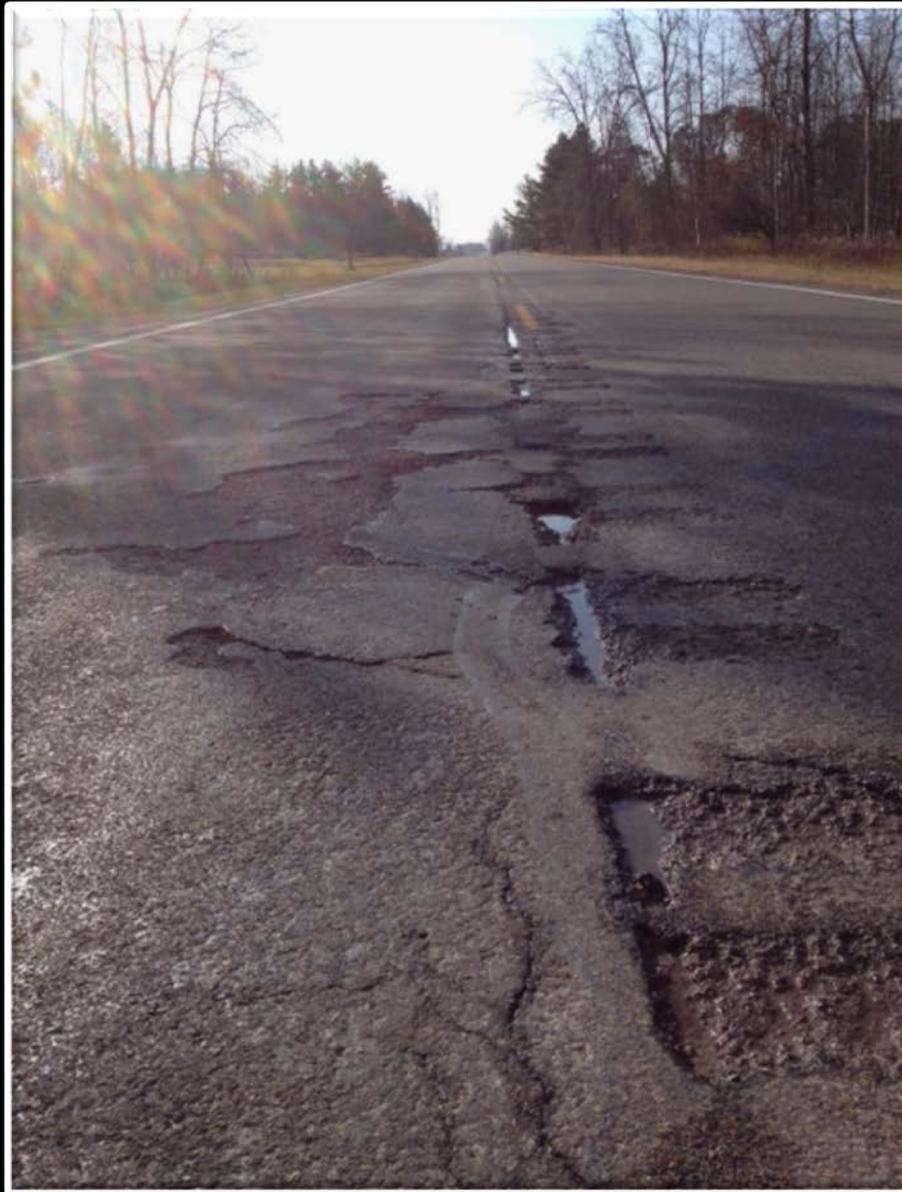
**M-19 in Sanilac County
Base failure due to aging, joint failures & drainage issues.**

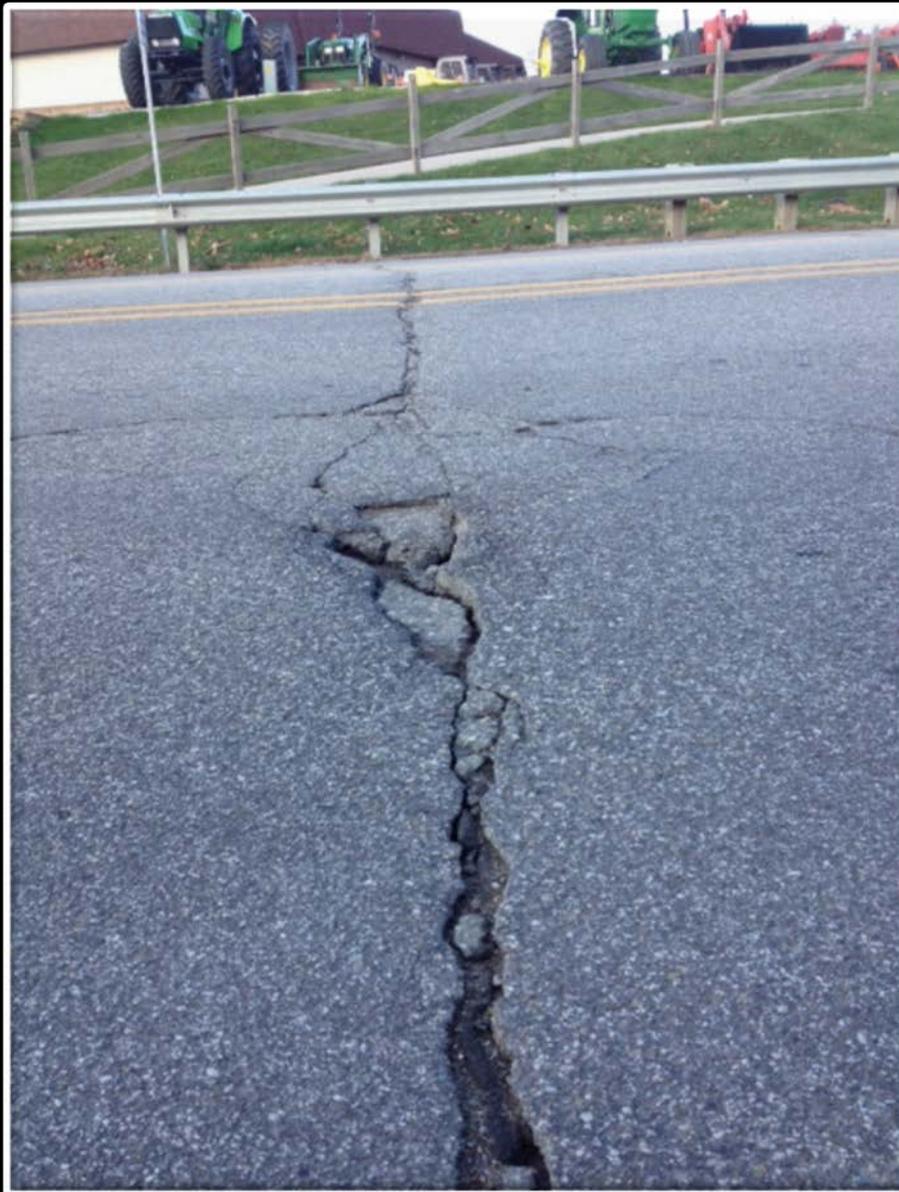
**M-24, South of Caro, Tuscola County
Failed concrete pavement.**

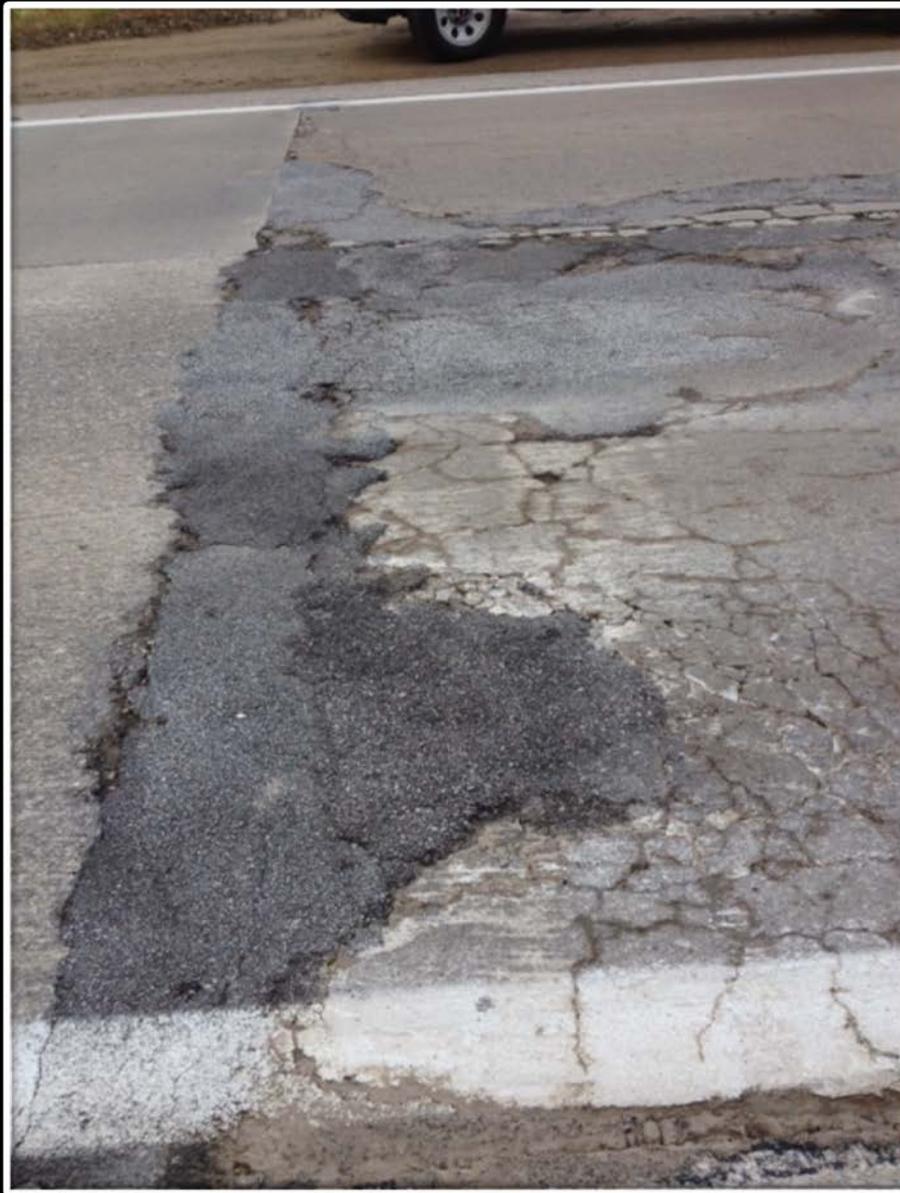
**M-46 from the Cass River to M-24, Tuscola County
Concrete pavement failure & cold patching due to aging concrete patches.**

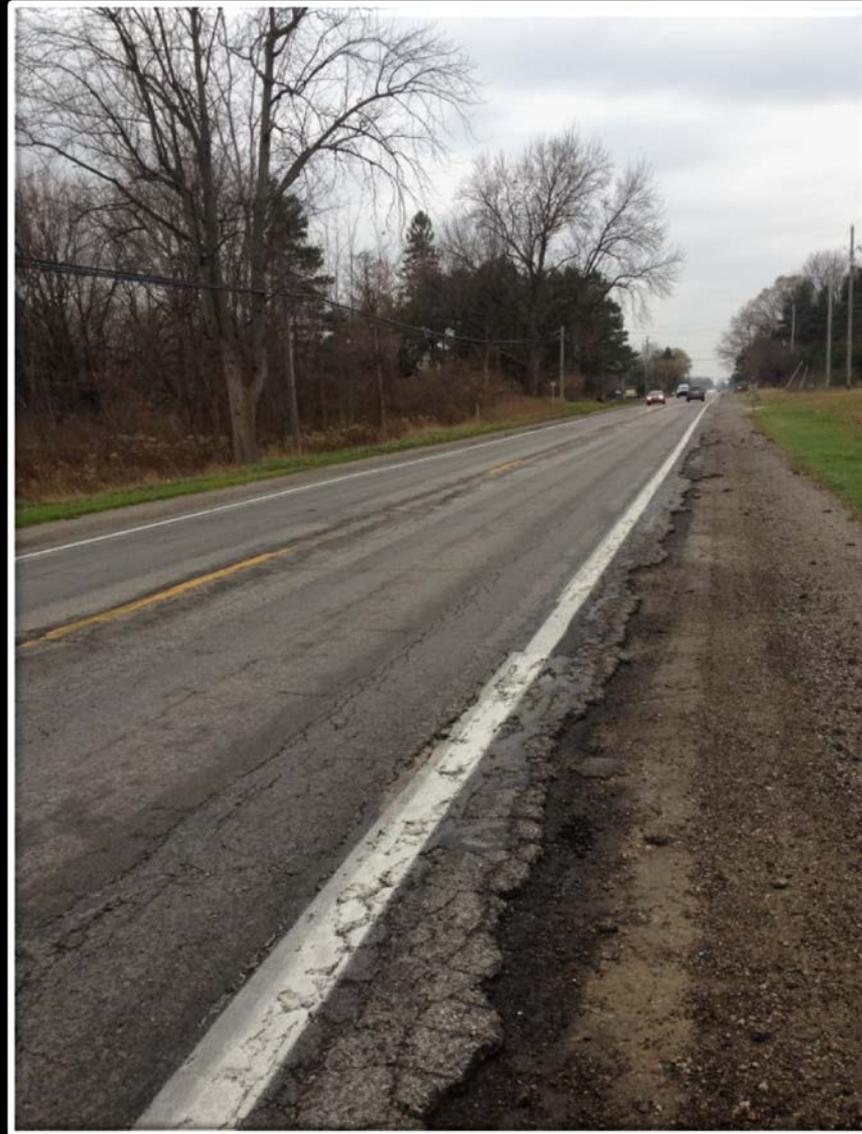
**M-46 from Hemlock to M-52, Saginaw County
Major drainage failures on shoulders & mainline due to water & salt causing
breaking up of asphalt pavement over broken concrete base.**

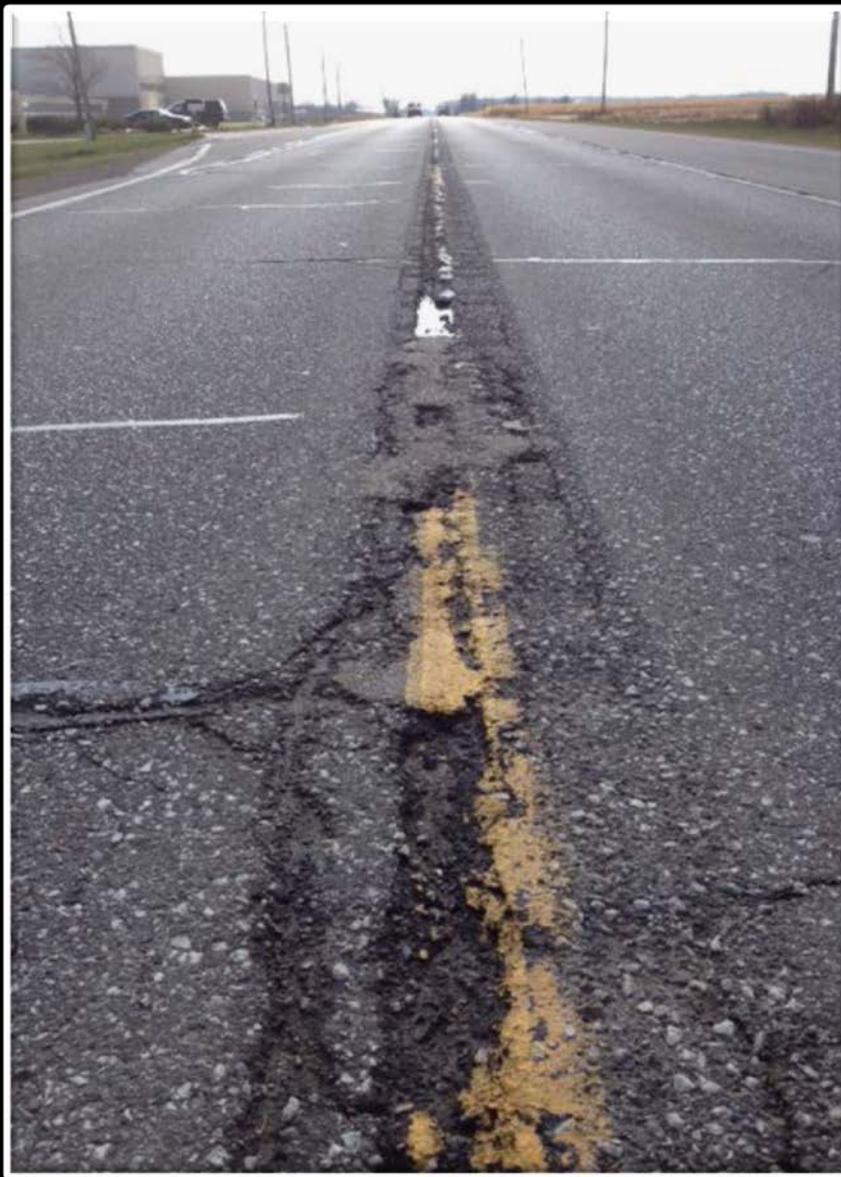
**M-53 near M-90, Lapeer County
Center line joint failures due to water & salt causing breaking up of asphalt
pavement seeping into concrete base.**
