Michigan's Deteriorating Roads and Bridges

November 2014

Bay Region

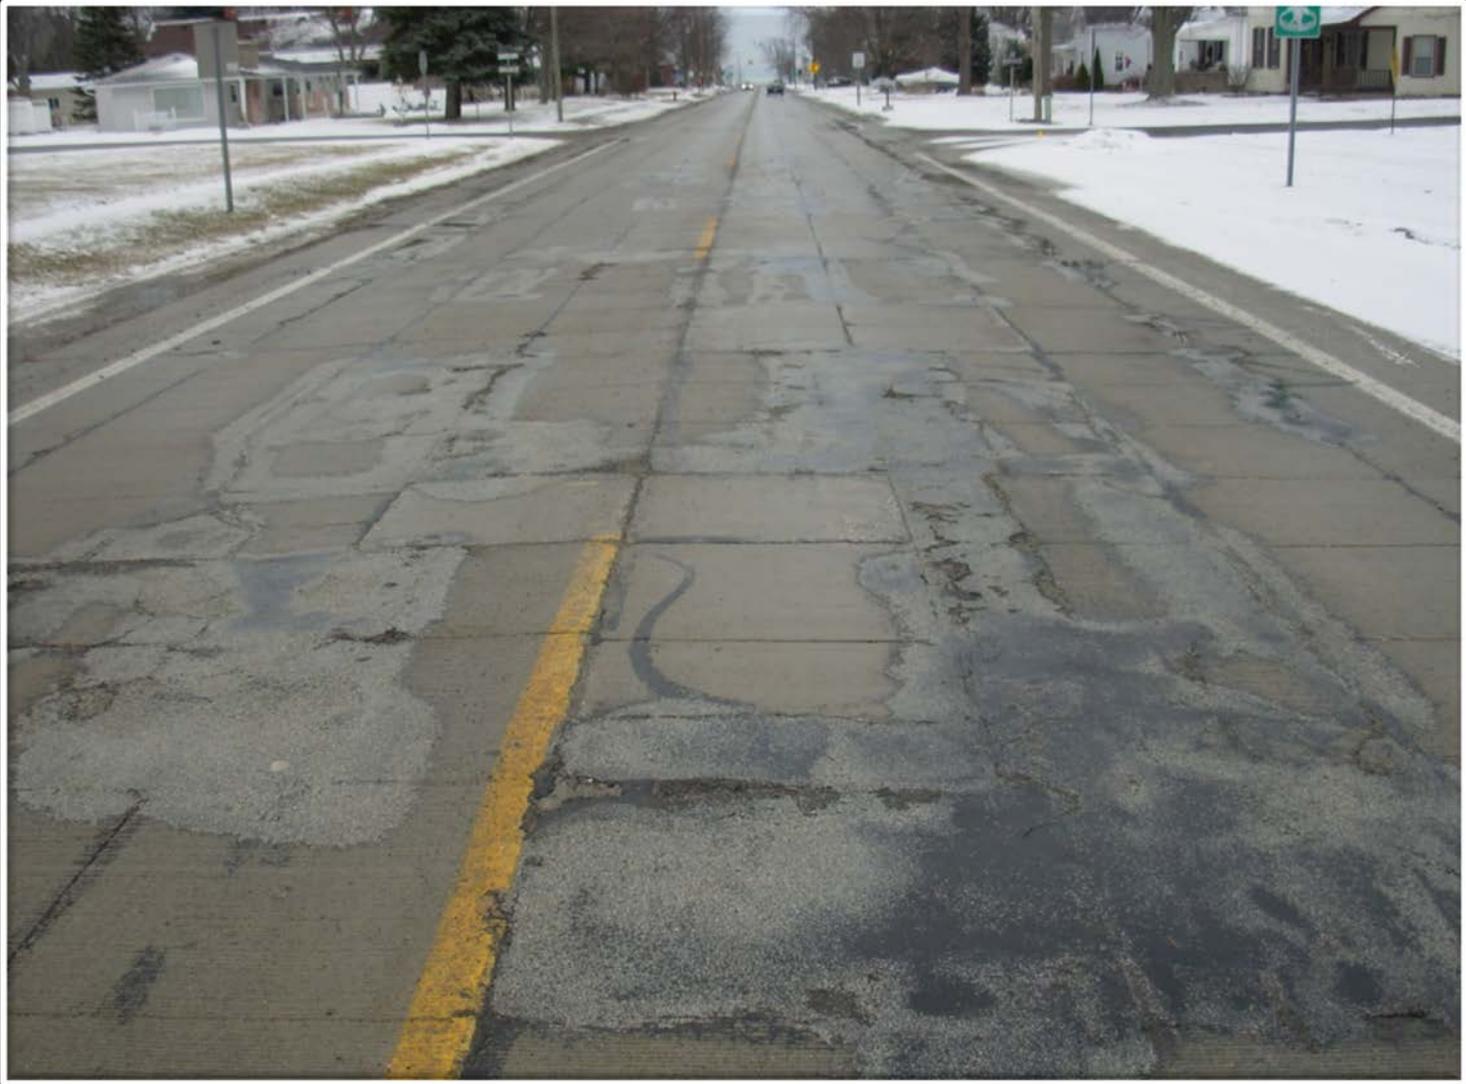
**M-46 in Port Sanilac, Sanilac County
Concrete surfacing failures, base failures, & water not draining off the roadway.**

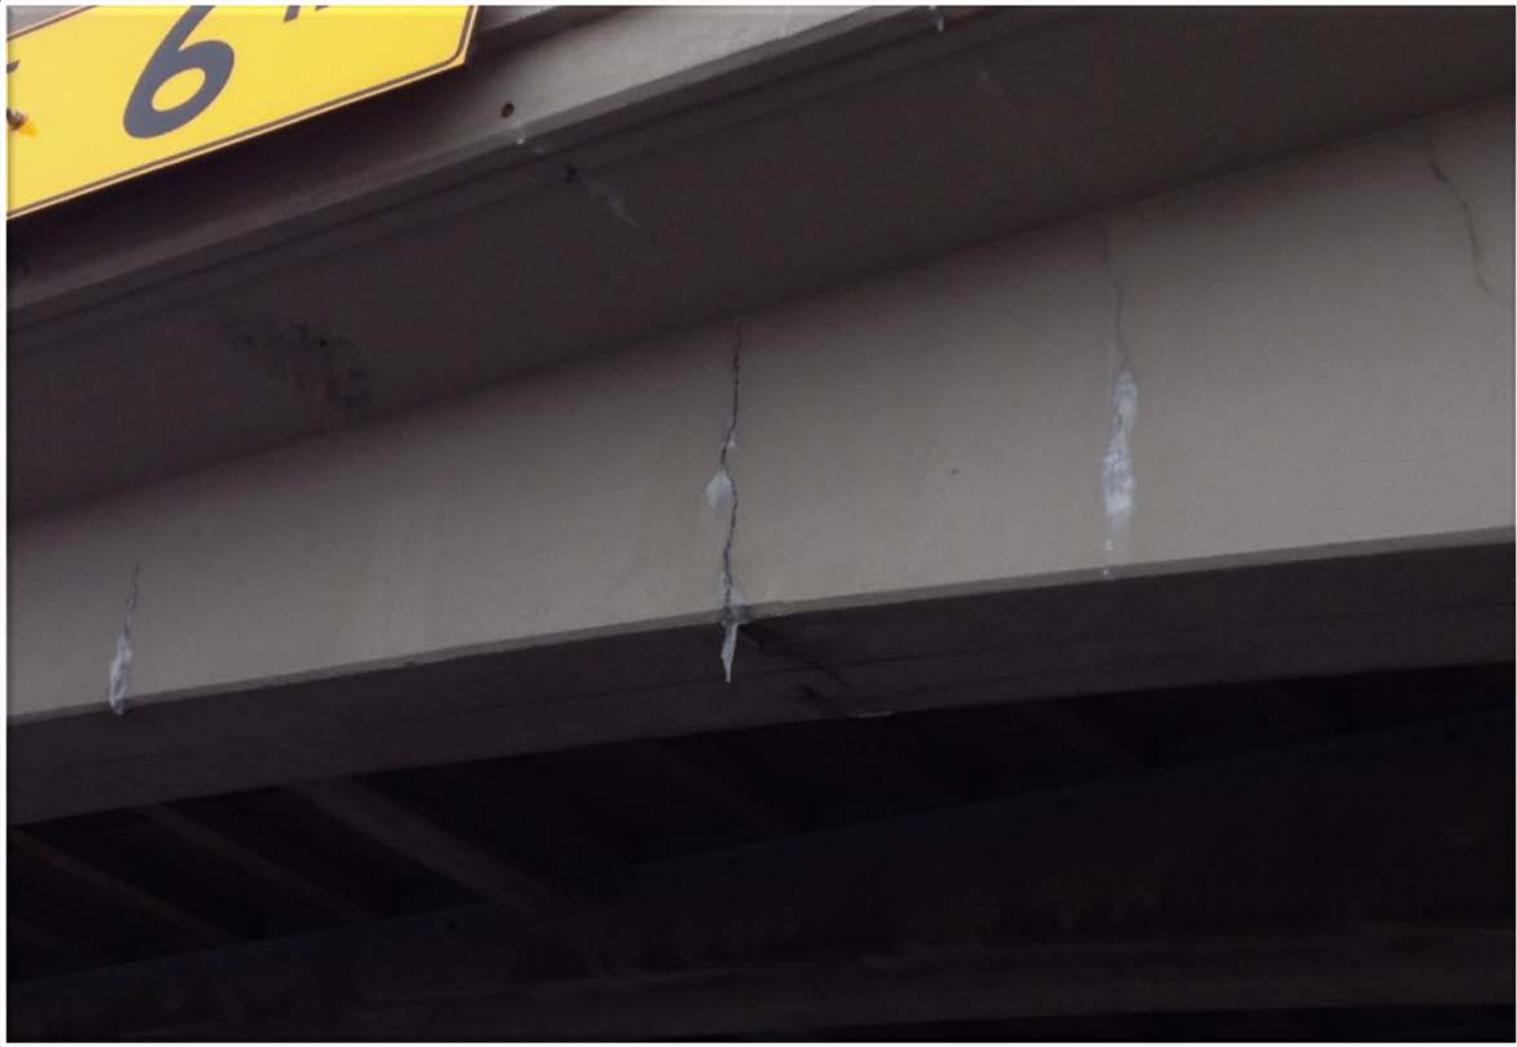
**Mackinaw Road over US-10, Bay County
Shear cracking in beams due to expansion & years of service life.**

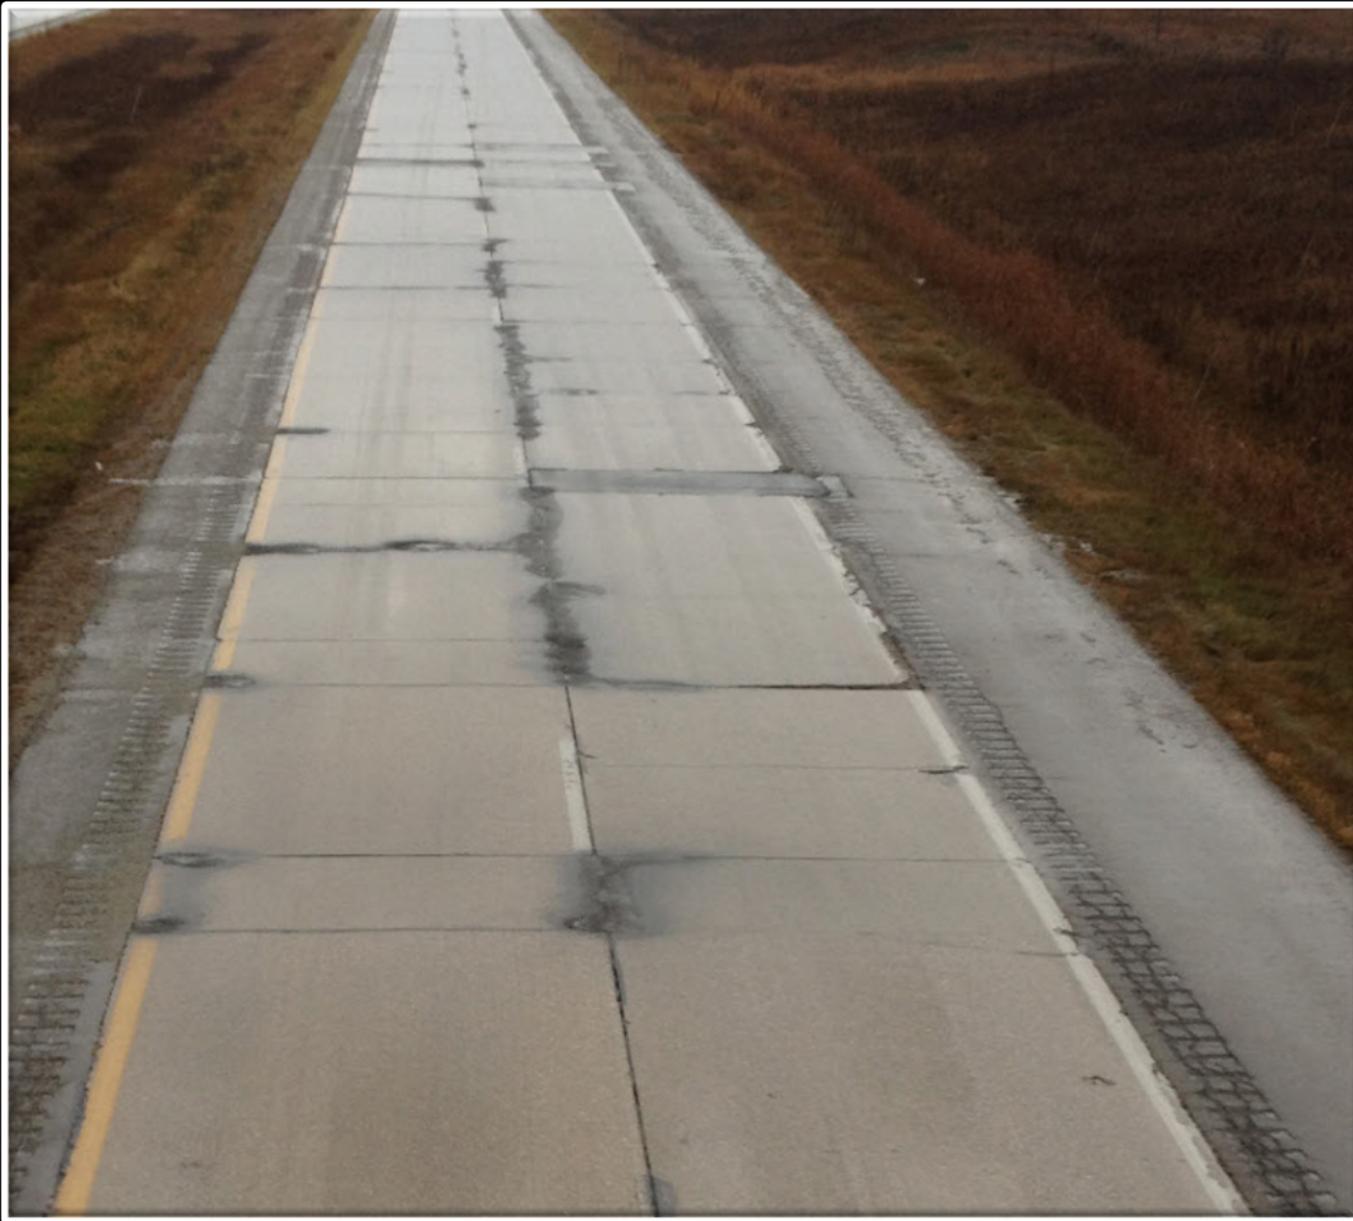
US-10 near Clarabella Road, Isabella County

Concrete joint failure & pavement fracturing due to years of aging & heavy loads.

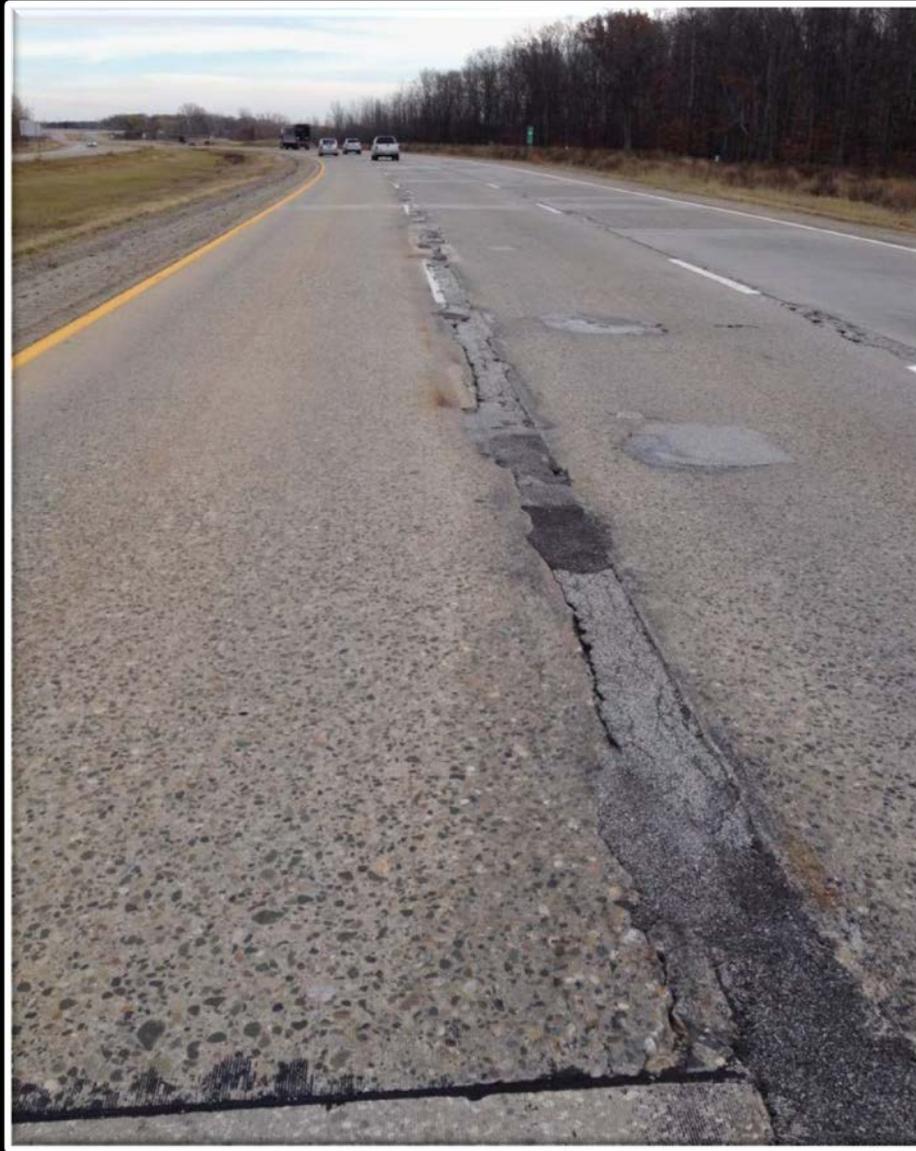
US-127 South of M-46, Gratiot County
Failure of centerline joints, water seeping in pavement & excessive cracking due to years of aging.

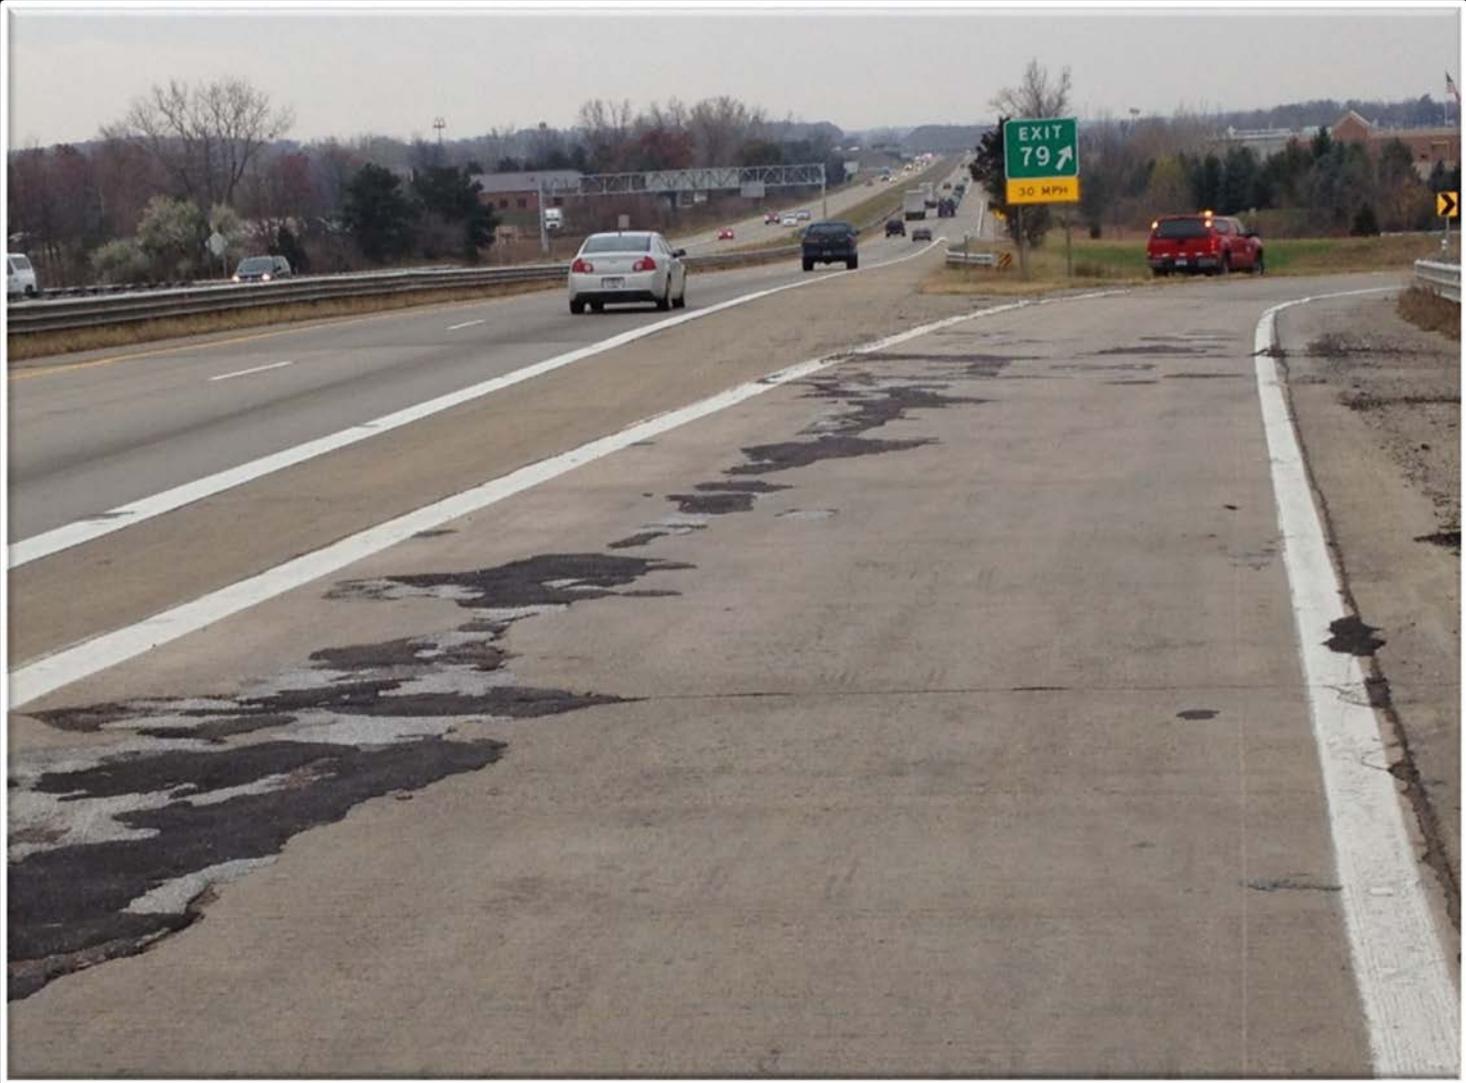
US-23 in Genesee County
Concrete pavement cracking & failure due to years of aging & heavy traffic.

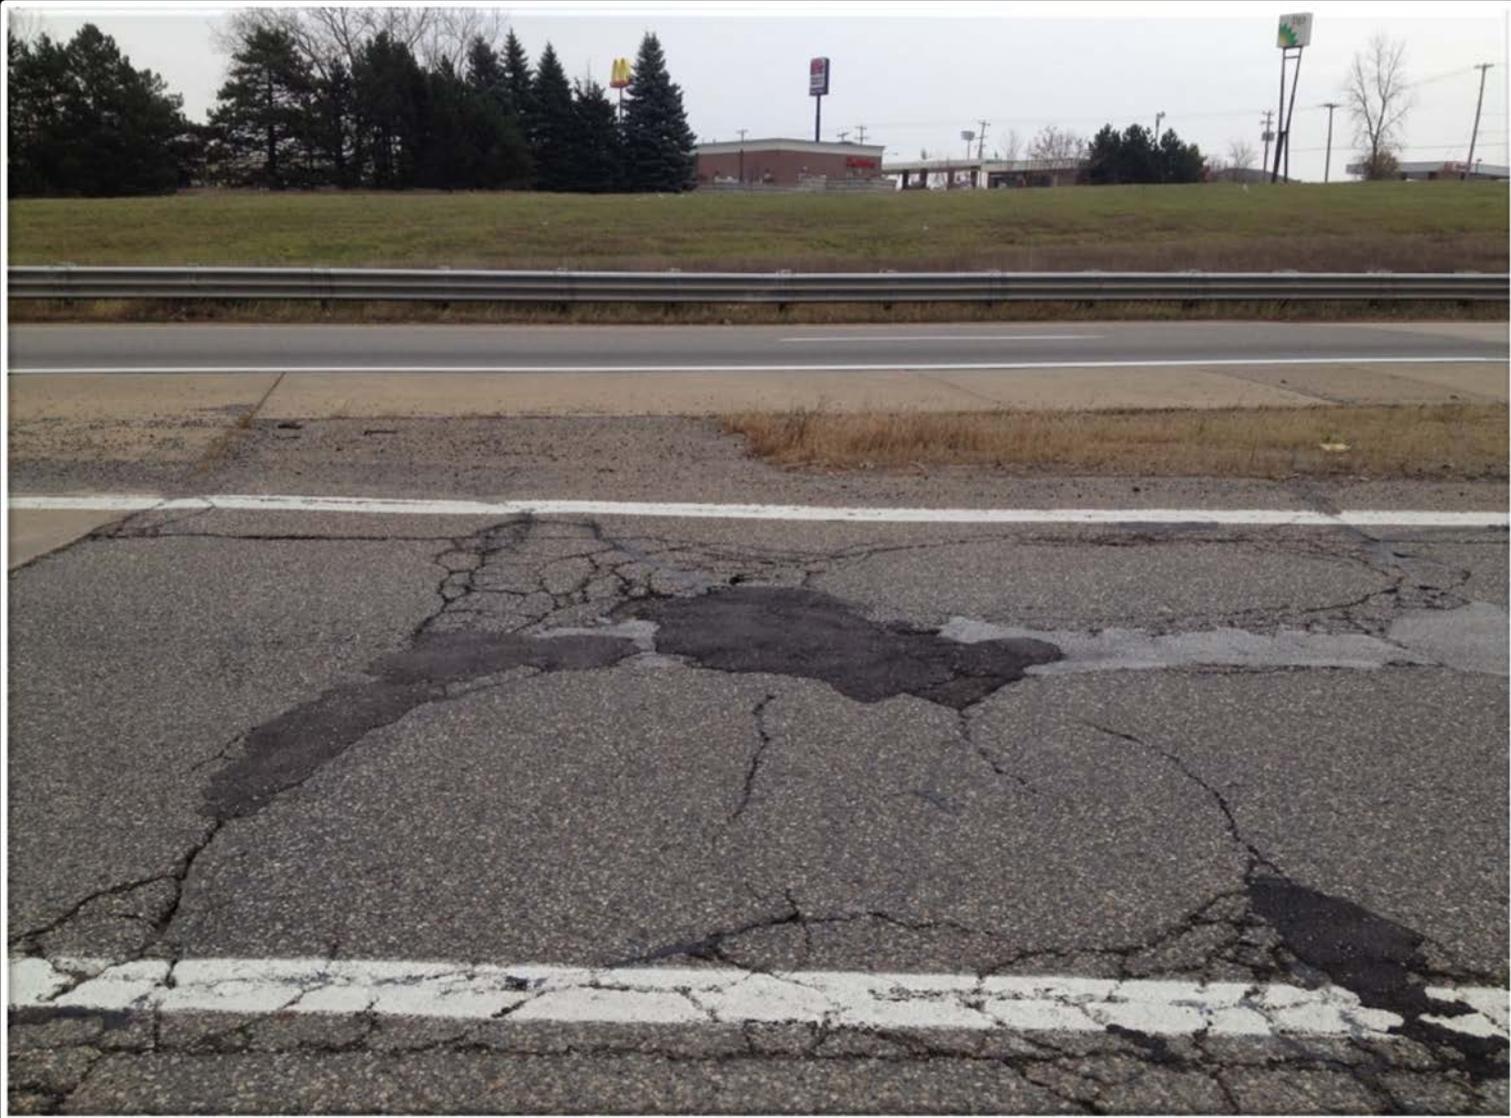
**US-23 in Genesee County
Pavement failures due to cracking, water seeping into base, resulting in
potholes.**

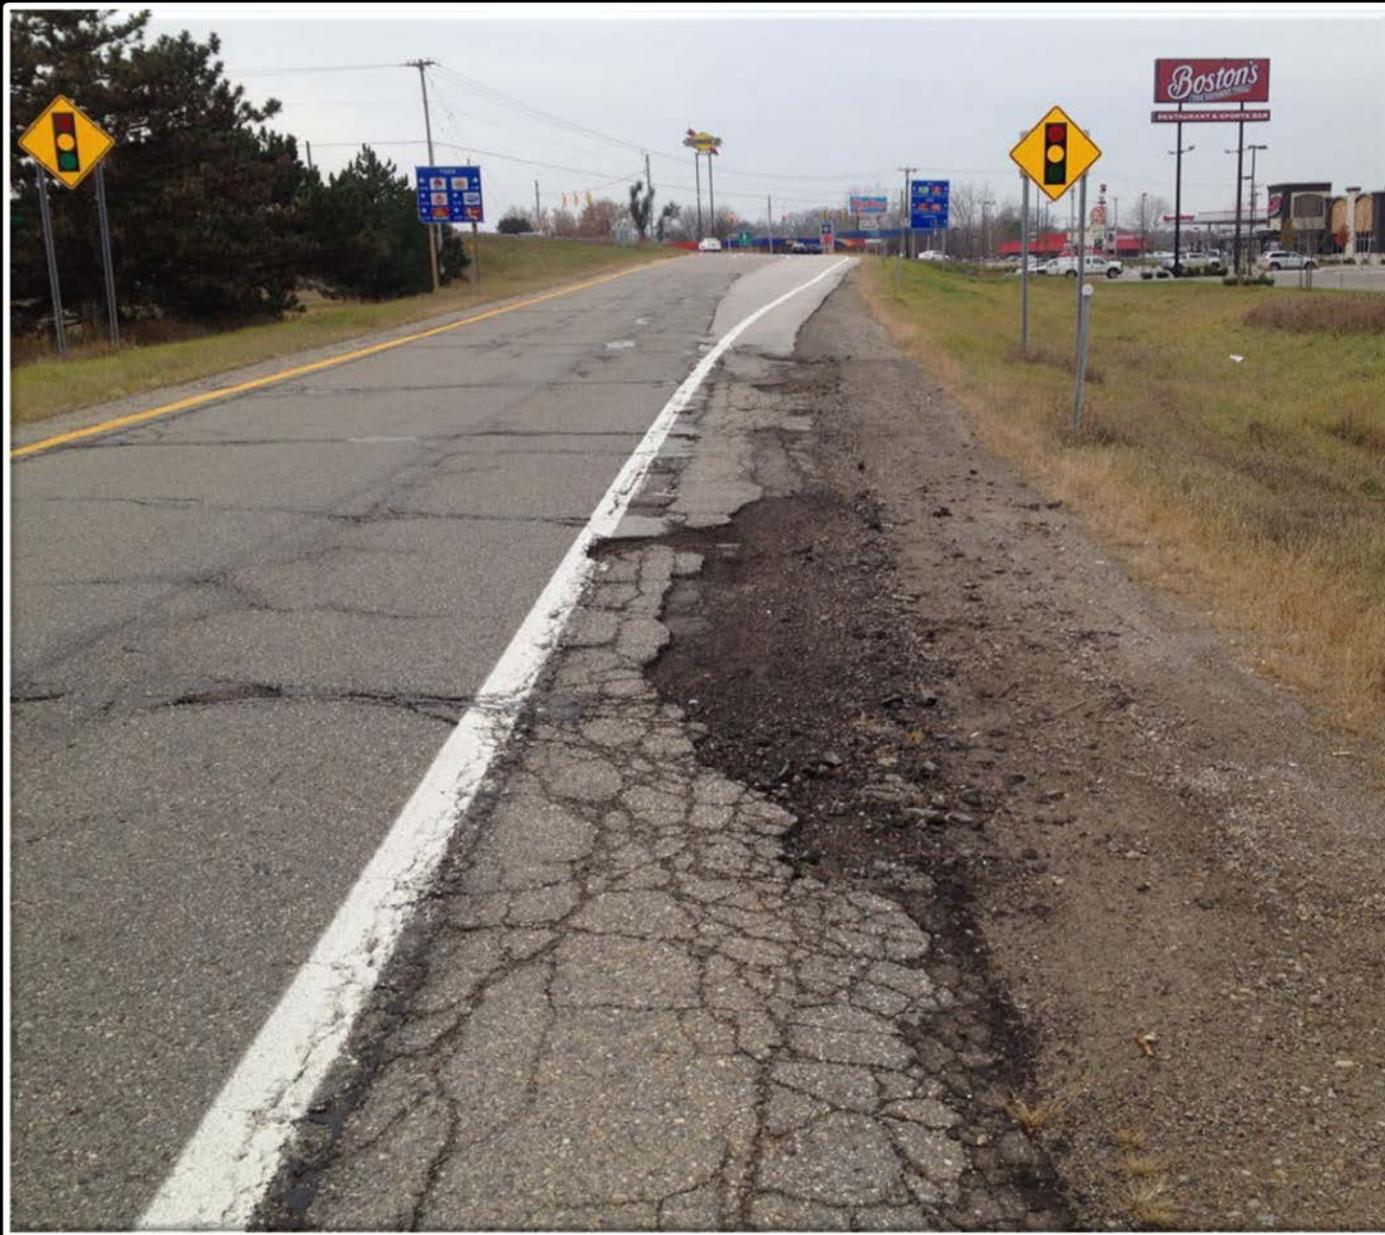
US-23 in Genesee County
Shoulder failure due to lack of edge support & water not draining.

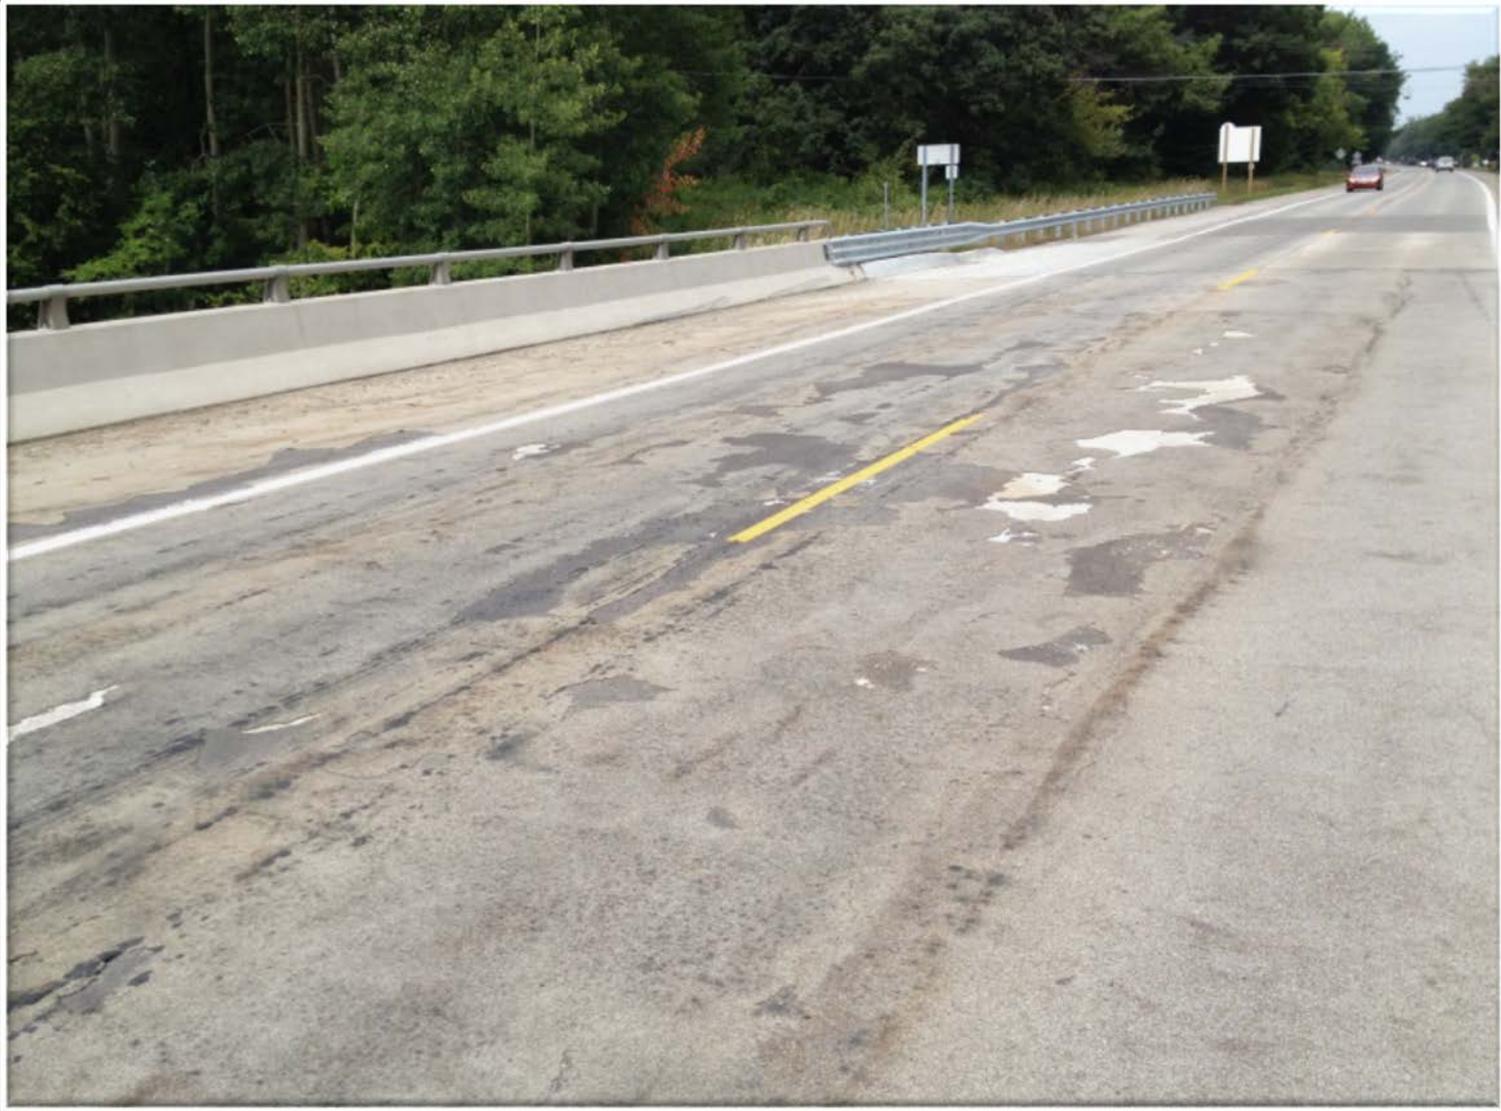
US-23 over Whitney Drain, Arenac County
Failing surface on bridge deck due to surface deterioration & water seepage.
