Research Report UMCEE 96-10

LOAD TESTING OF BRIDGES

the Michigan Department of Transportation

Andrzej S. Nowak and Vijay K. Saraf

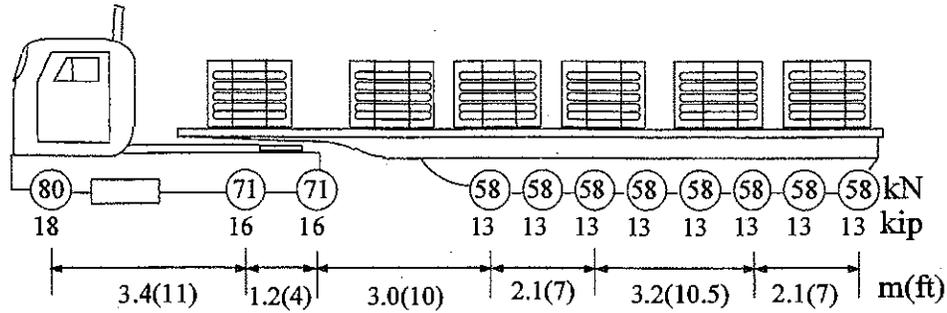
Figure 3-1 : 11-Axle Two-Unit Truck.

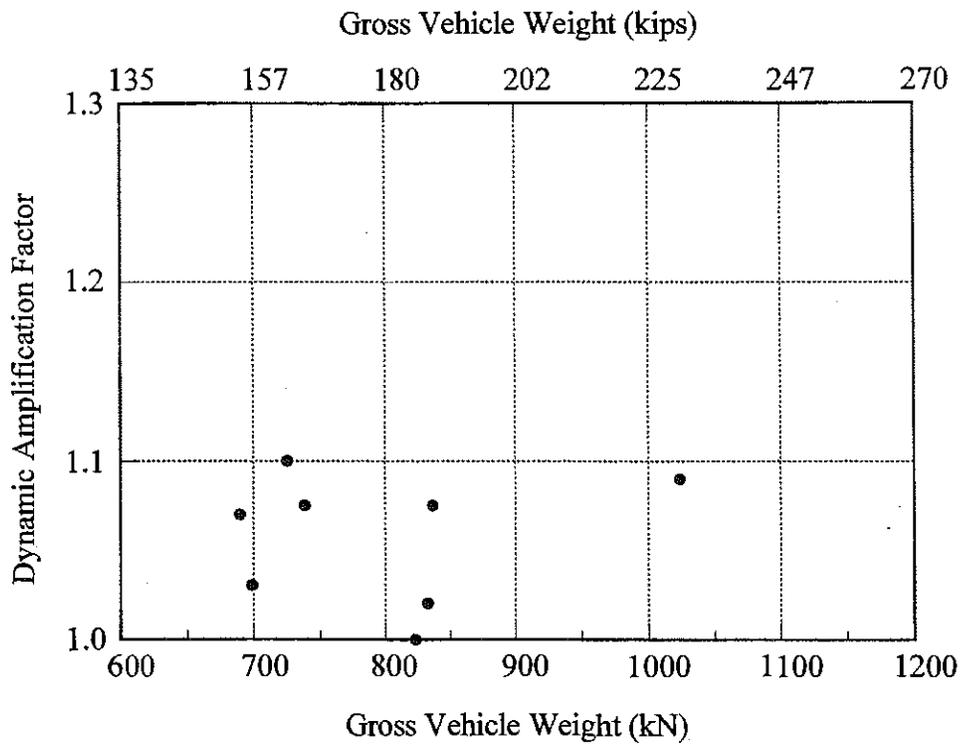
Figure 3-2 : Impact Factors for Heavy Vehicles (Nassif and Nowak, 1995).

As shown in Figure 3-2, the dynamic amplification factors for heavy 11-axle trucks were found to be less than 10 percent. Since allowable loads in Michigan are considerably different than other states, the experimental impact factors would be much more reliable than AASHTO (1992) specified impact factors (see Appendix B of NCHRP Report, 1993). In addition, both the top of the deck and the approach of

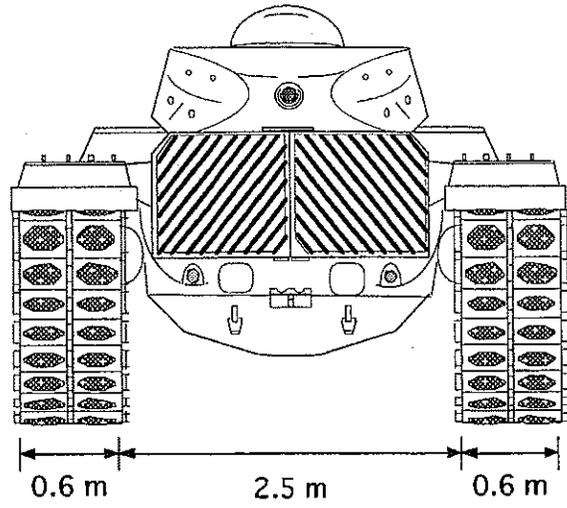
Figure 3-3 : Cross-Section of M-60 Tank.

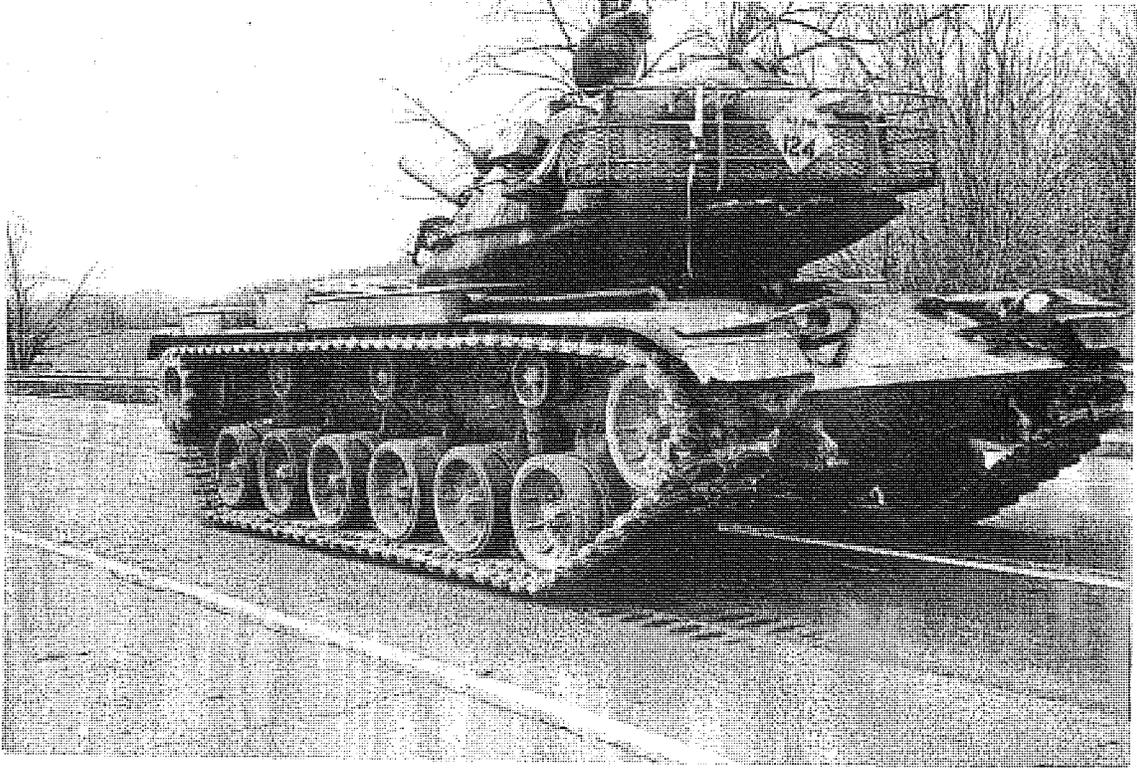
Figure 3-7 : M-60 Tank on Bridge No. 4.

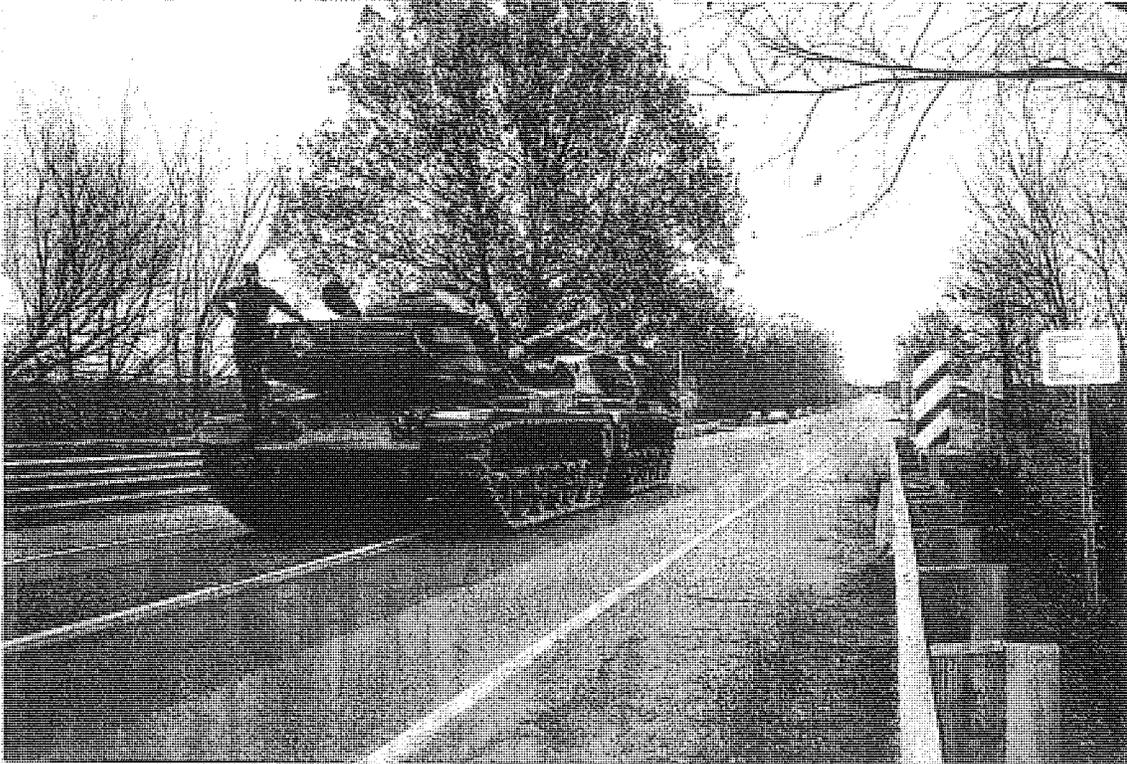
Figure 3-9: Two Tanks on Bridge No. 4.

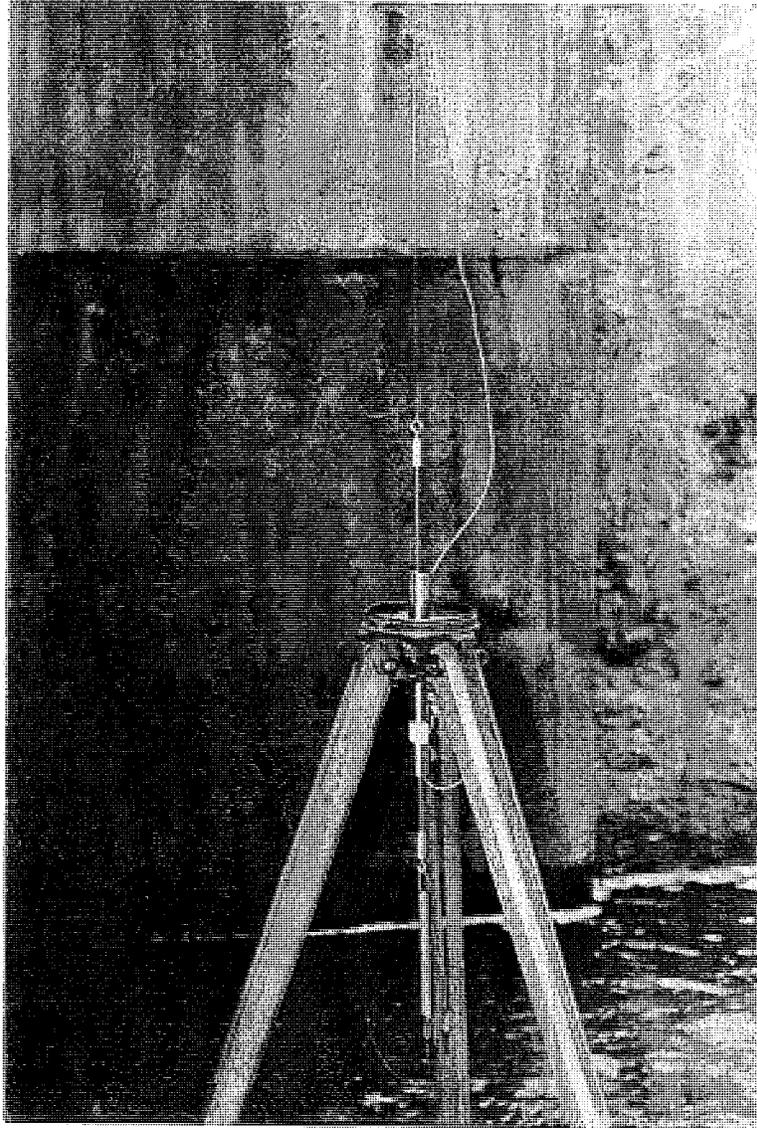
Figure 4-1 : Typical LVDT Setup.

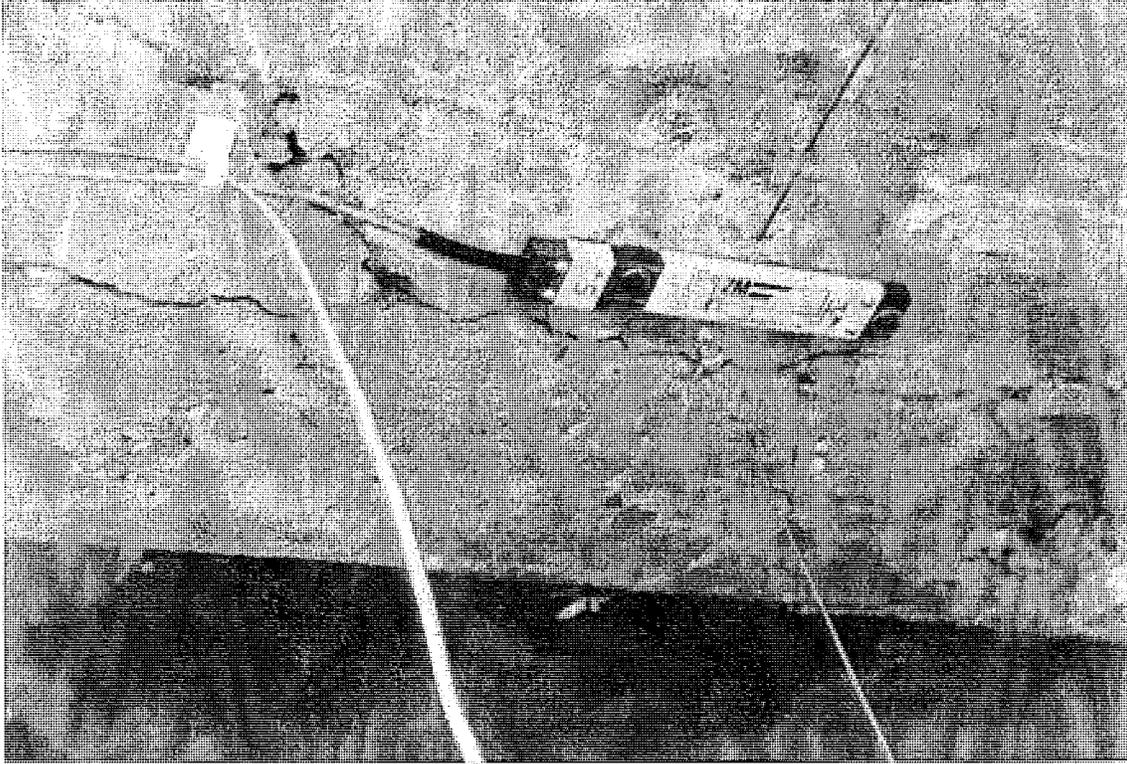
Figure 4-2 : Typical Strain Transducer Setup for Bridge No. 1.

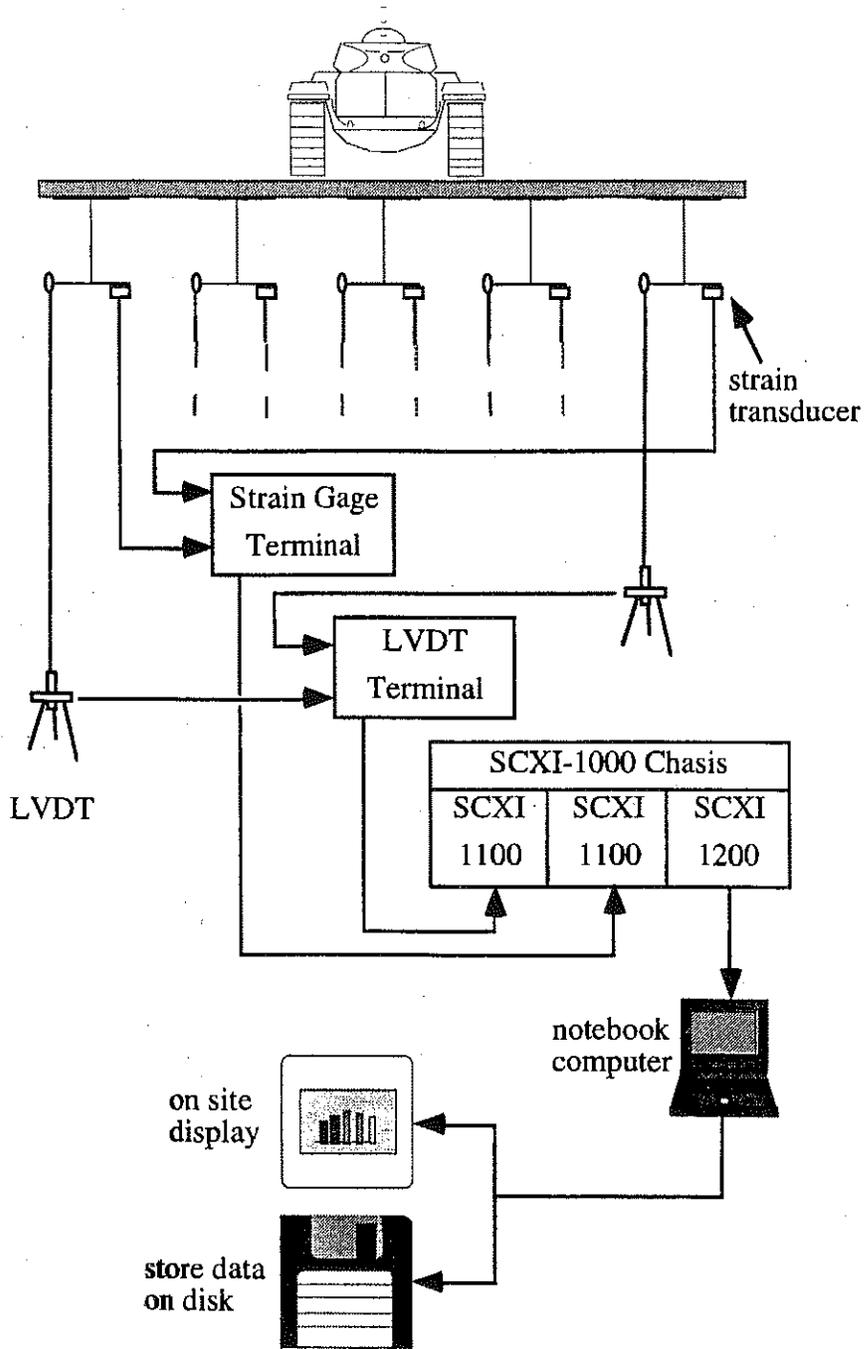
Figure 4-4 : Typical Data Acquisition Setup.

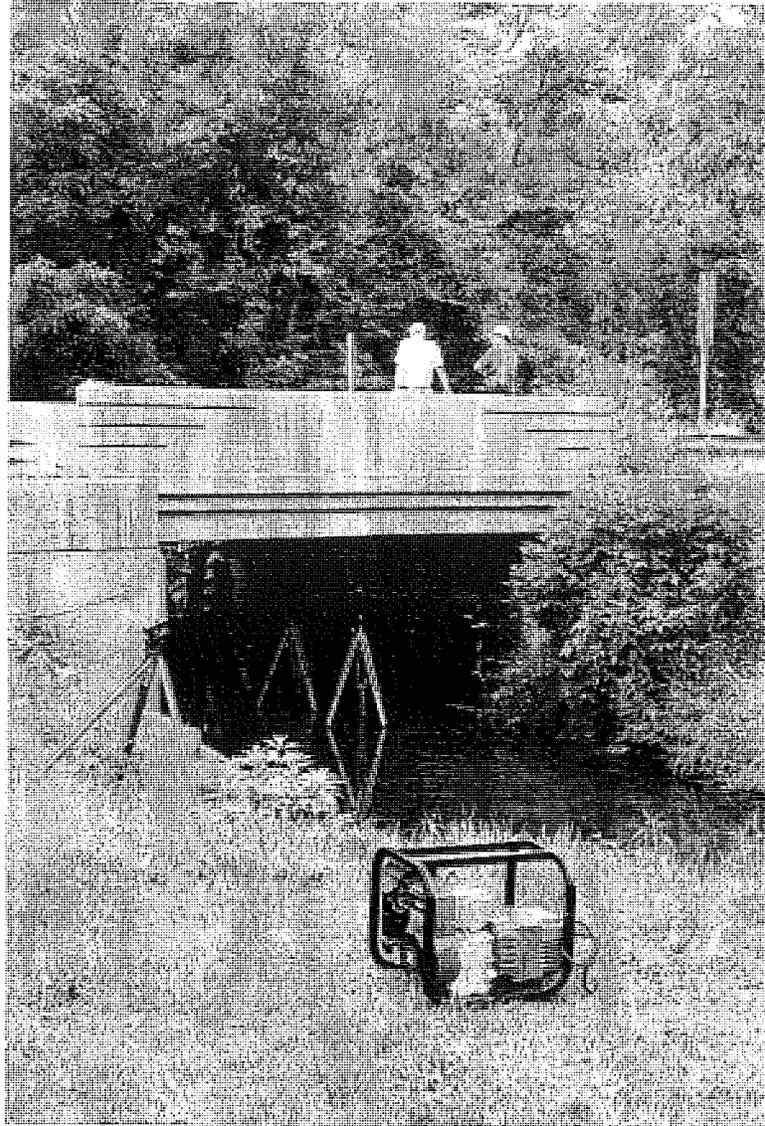
Figure 6-2 : Side Elevation of Bridge No. 1.

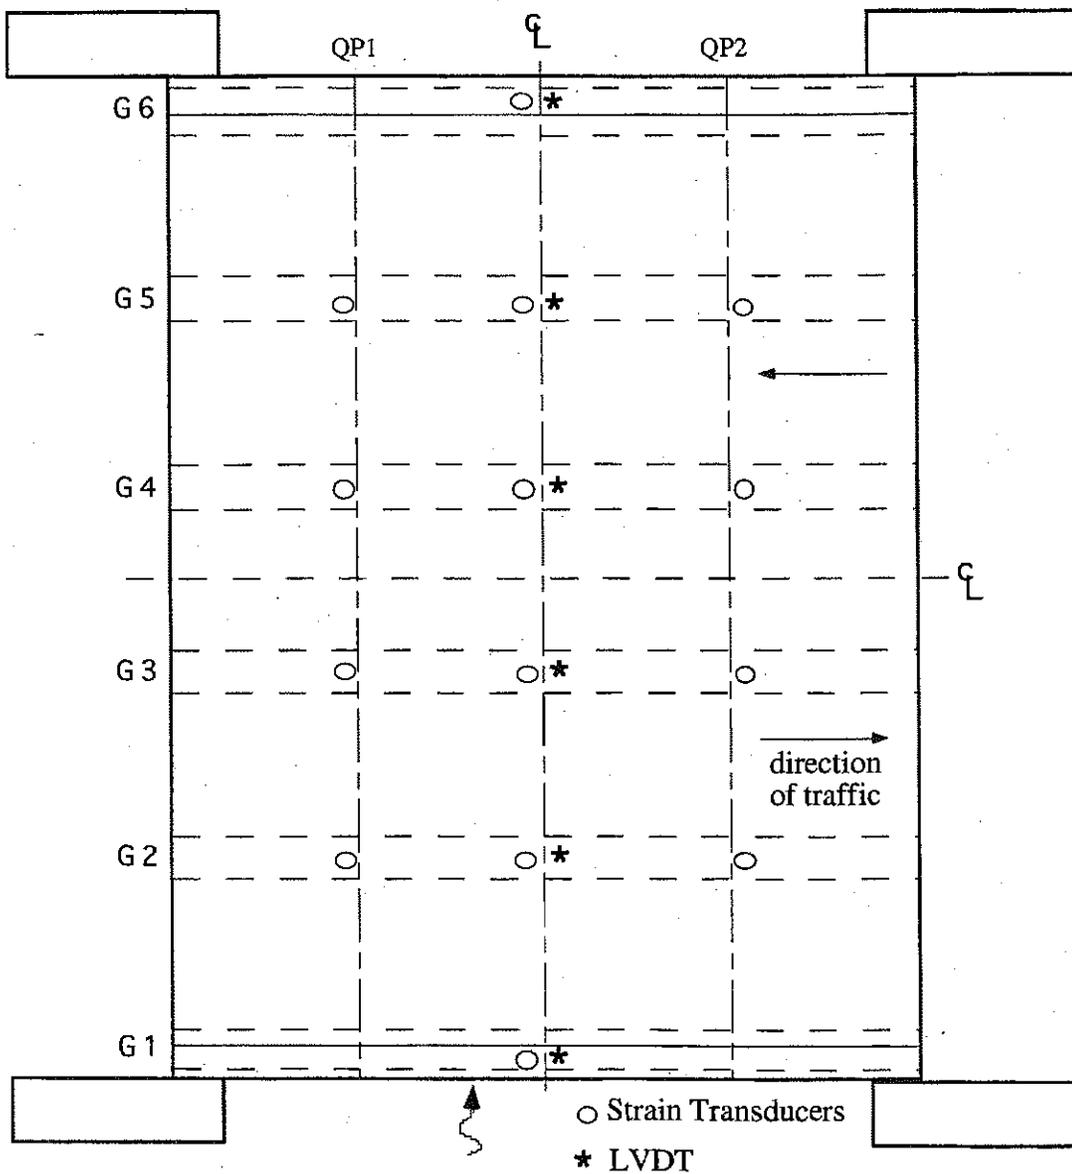
Deflections at mid-span of each girder were measured using six LVDT's. Sixteen strain transducers were also placed at the mid-span of all girders and quarter points of selected girders. However, due to extensive cracking of the concrete, it was not possible to measure the strains (see Section 4). Figure 6-3, shows the instrumentation layout for all transducers.

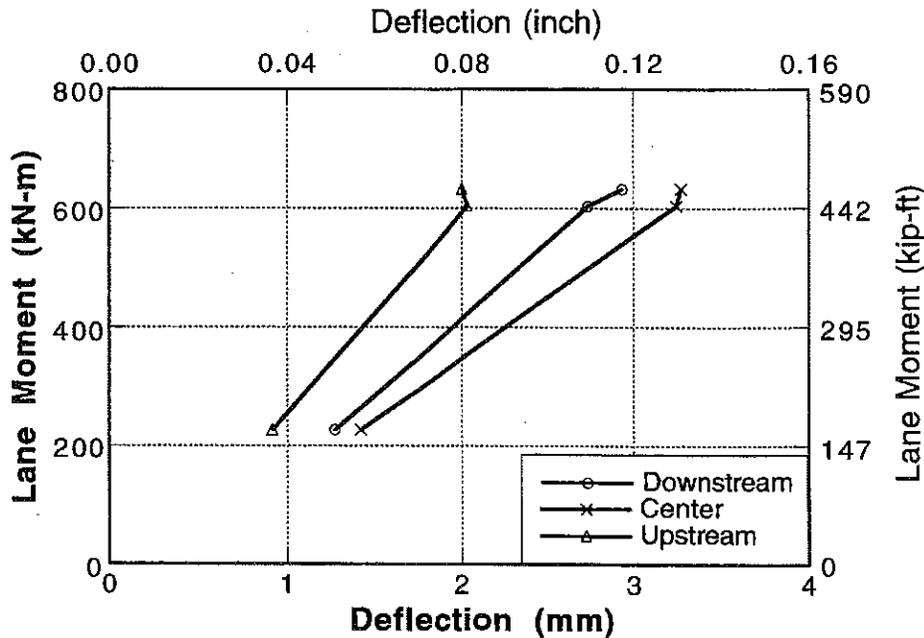
Figure 6-7 : Deflection at Mid-Span of Girder 4 of Bridge No. 1.

The maximum lane moment achieved during the proof load test of this bridge was 630 kN-m (466 k-ft). According to Equation 3-5, the operating load carrying capacity to carry live load and impact was found to be 393 kN-m (290 k-ft), which is higher than the analytically predicted value by MDOT i.e. 342 kN-m (252 k-ft). The applied proof load moment

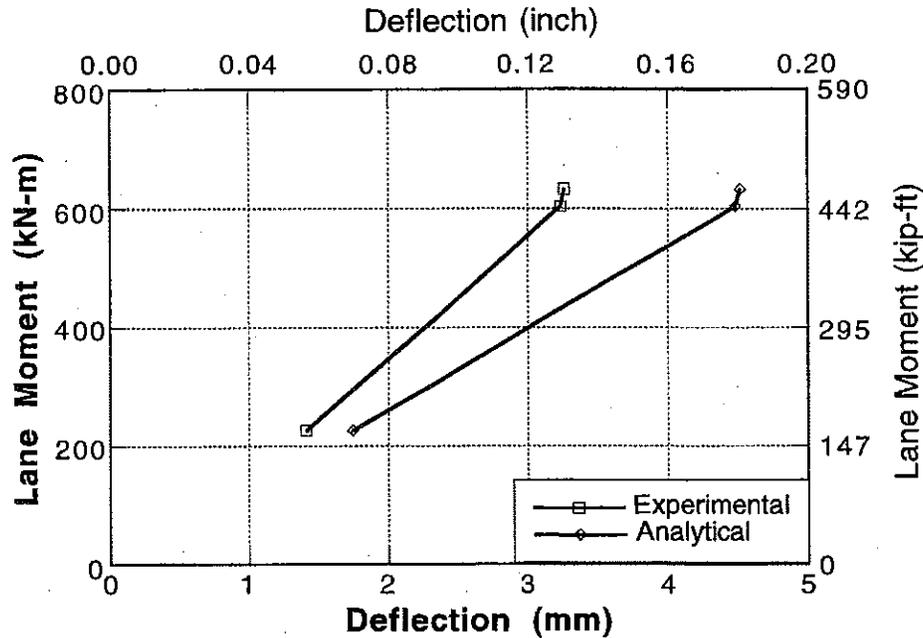
Figure 6-8 : Deflections at Mid-Span of Girder 4 for center loading on Bridge No. 1.

Deflections for each transverse load position increased linearly with increasing lane moment. Strains in most girders could not be measured due to severe cracking of concrete (Section 4). Both

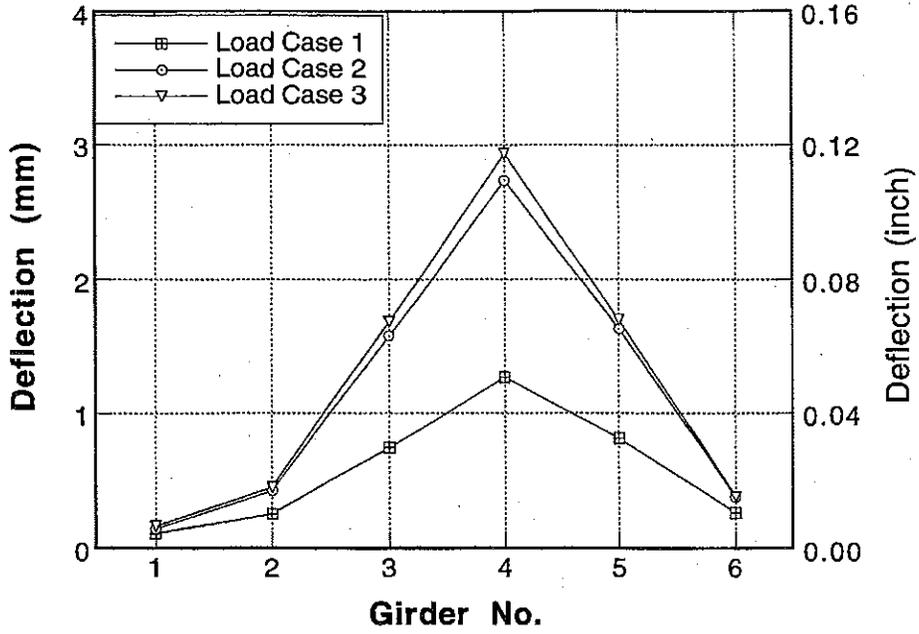
Figure 6-9 : Lateral Load Distribution for Downstream Loading on Bridge No. 1.

For most load cases, the experimental deflections were smaller than the analytically predicted values, which means that the structure is stiffer than the analytical model. The additional unaccounted reduction in deflection at mid-span is caused by partial restraint provided by end supports. The lateral distribution of deflections is also shown in Figure 6-9. Additional graphs and the processed data are listed in Appendix-A. The target proof load was reached without any noticeable non-linearity in bridge response. The new operating rating factor for a two-unit 11-axle truck is 1.21, using Equation 3-6. Therefore, the bridge was found to be safe to carry legal truck traffic.

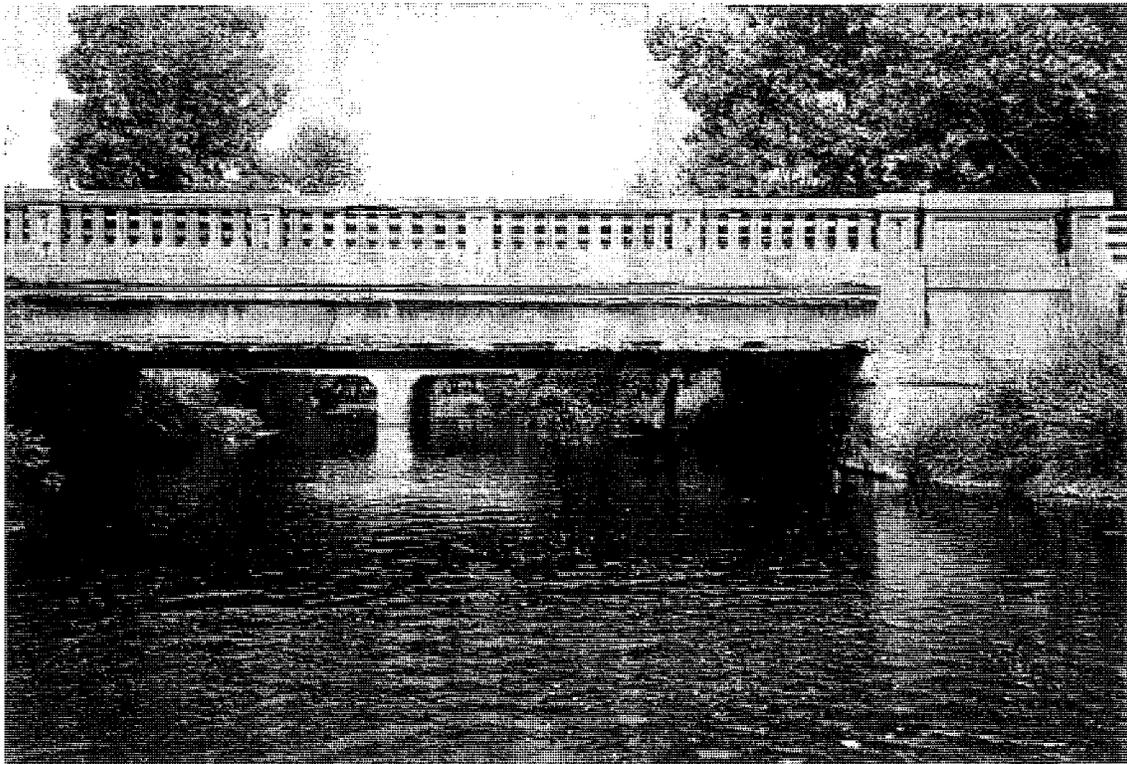
Figure 7-1 : Side Elevation of Bridge No. 2.

This bridge was built in 1926 and is located over Grand River in Jackson county, Michigan. The side elevation of the bridge is shown in Figure 7-1. It has one lane in each direction carrying state highway M-50 and the business loop of US-127 with a total ADT of 11,900. As shown in Figure 7-2, it has ten steel girders and a 165 mm (6.5 in) thick reinforced concrete slab with 150 mm (6 in) thick cast-in-place concrete wearing surface and 170 mm (6.7 in) thick bituminous overlay. It is a simply supported single span structure, which was designed to behave as a noncomposite section. The total span length is 14.6 m (48 ft) and the width is 13.8 m (45 ft).

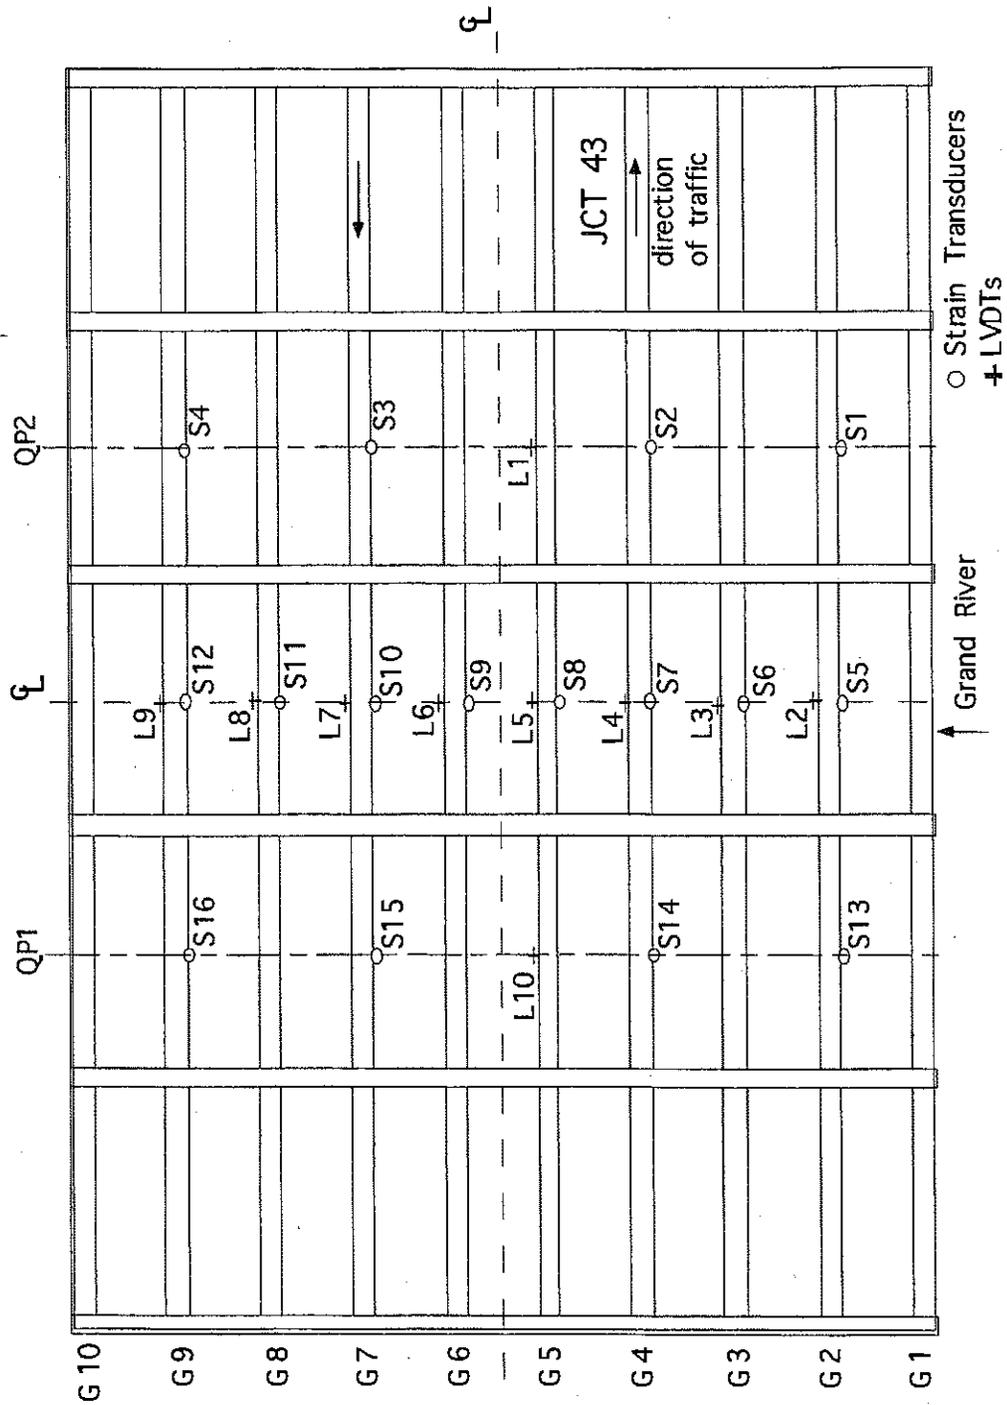
Ten LVDT's and sixteen strain transducers were used to instrument the bridge. LVDT's were placed at the mid-span and quarter points of selected girders. Strain transducers were placed at the lower flanges of the steel girders close to the mid-span and quarter points of selected girders. The exact location of the strain transducers was decided based on the amount of corrosion in those areas. The location with the smallest remaining flange thickness was chosen for strain monitoring. Actual instrumentation layout is shown in Figure 7-3. Strain transducers attached to the girder nos 4 and 7 did not work due to seepage of water into the connectors.

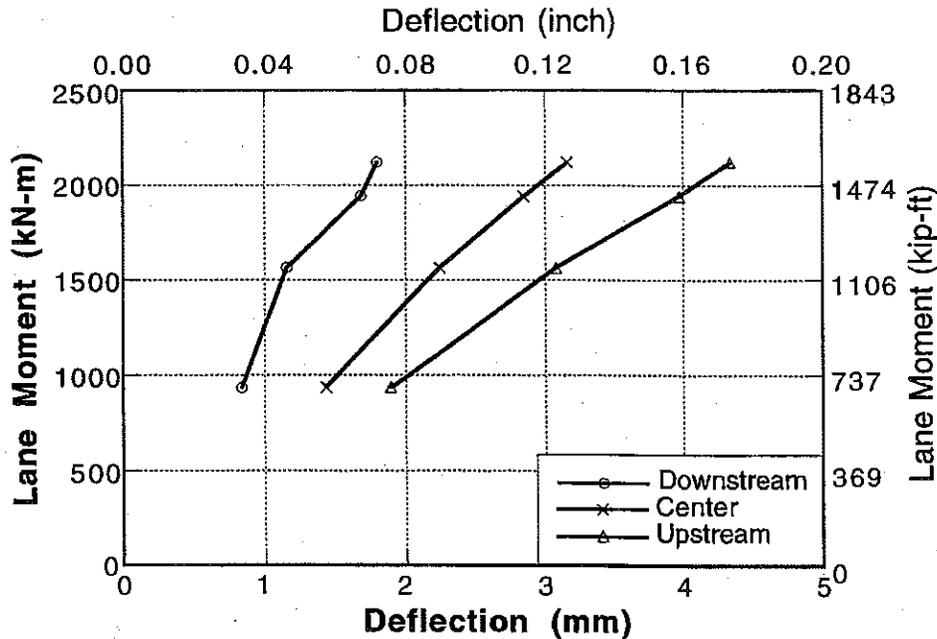
Figure 7-7 : Deflections at Mid-Span of Girder 3 of Bridge No. 2.

Deflections at the mid-point of all interiors girders and at the quarter points of selected girders were measured for each load case. The maximum deflection was only 4.7 mm (0.19 in) for girder no. 4, which corresponds to the maximum applied lane moment of 2,120 kN-m (1560 kip-ft), for upstream loading. The applied proof load moment was over 2.6 times that corresponding to HS20 loads and 1.7 times the two-unit 11-axle moment. Figure 7-7 shows the deflection at the mid-span of girder no. 3.

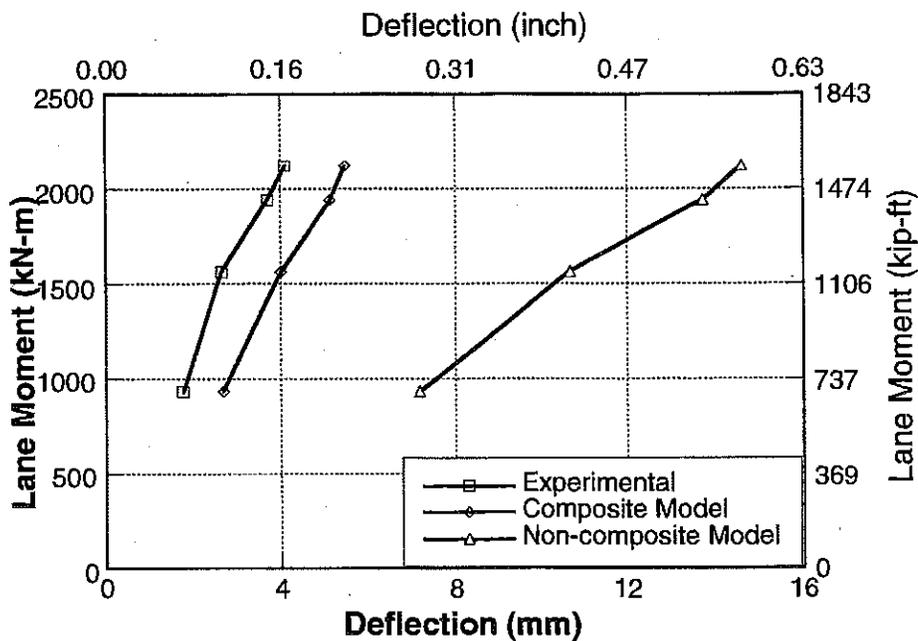
Figure 7-8 : Deflections at Mid-Span of Girder 6 for Downstream Loading on Bridge No. 2.

deflection limits. The maximum analytical deflection for the non-composite model was 16 mm (0.63 in). As shown in Figure 7-8, the actual deflections in Girder no. 6 are even smaller than the composite model, which also includes the effects of non-structural members.

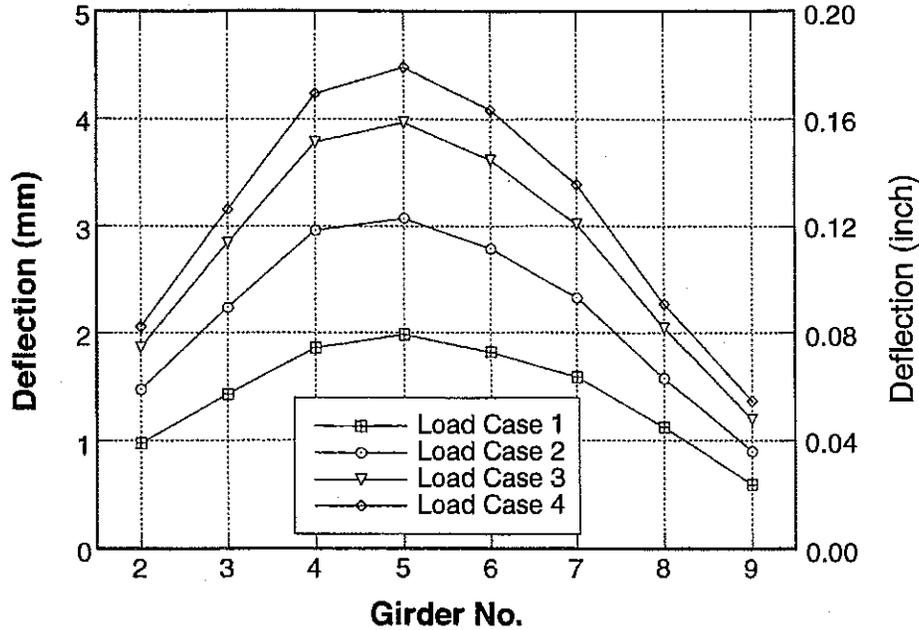
Figure 7-9 : Girder Distribution of Deflections due to Center Loading on Bridge No. 2.

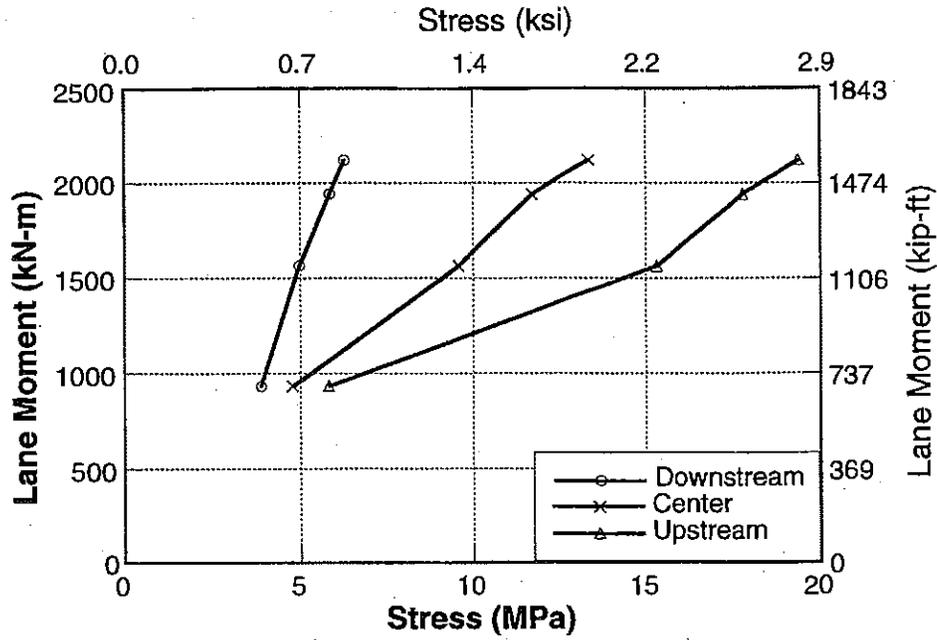
Figure 7-10 : Stresses at Mid-Span of Girder 3 of Bridge No. 2.

Stresses in the lower flanges of the steel girders were also very small, although the strain transducers were placed over areas with potential for stress concentration. Figure 7-10 shows the stresses observed in the lower flange of girder no. 3. The maximum observed stress was only 19.4 MPa (2.8 ksi), which is less than 0.1 of the yield strength of steel. The maximum stress of 48 MPa (6.9 ksi) was expected based on the non-composite model. The experimental stresses are proportional to the applied moment. A nearly linear stress-moment behavior and small values are indications of an adequate safety reserve.

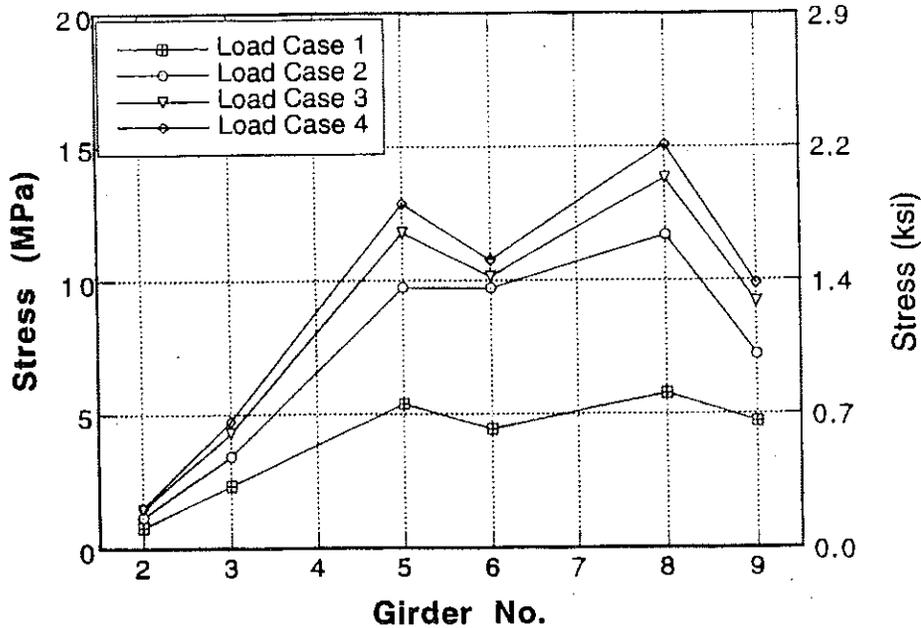
Figure 7-13 : Girder Distribution of Stresses due to Downstream Loading on Bridge No. 2.

pattern. Lateral distribution of load between different girders is also shown for downstream loading in Figure 7-13. The actual distribution is

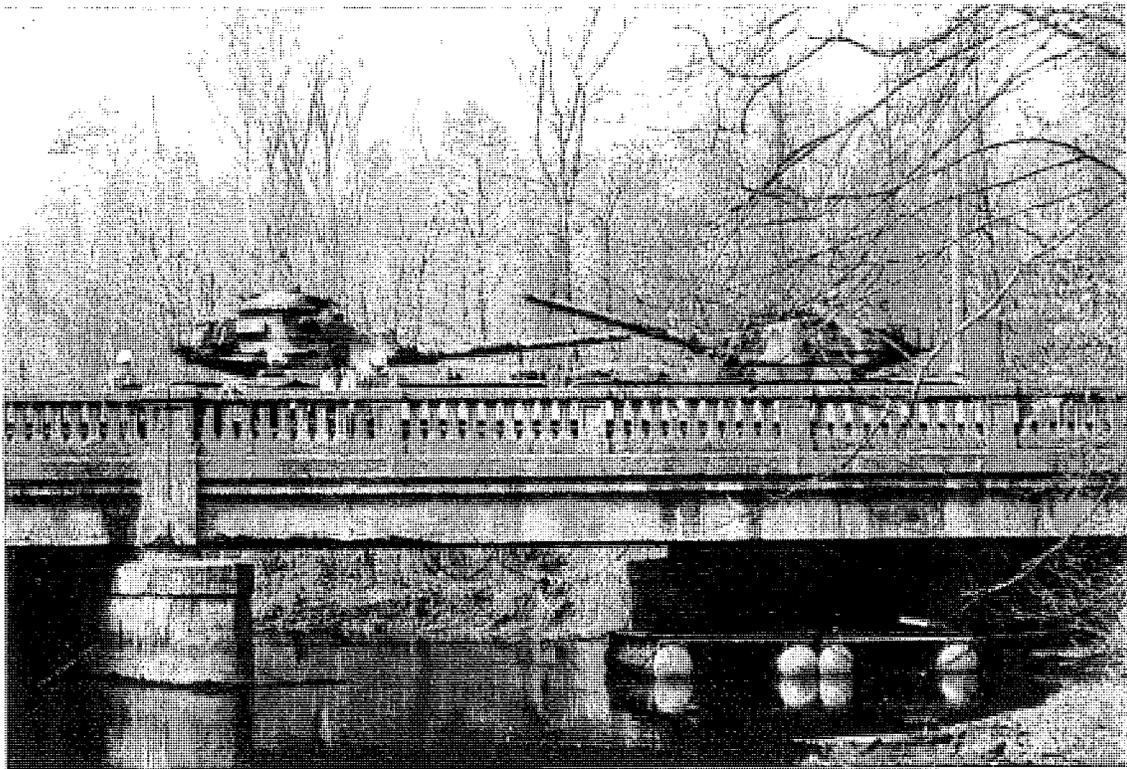
Figure 8-1 : Side Elevation of Bridge No. 3.

This bridge has two identical simply supported spans. It is located in St. Joseph County, Michigan, near Mottville. The side elevation of this bridge is shown in Figure 8-1. It was built in 1931 and carries state highway route M-103 over the White Pigeon River with ADT of 5,300. There are ten steel girders with a 165 mm (6.5 in) thick concrete slab on top. The thickness of the concrete wearing surface is 150 mm (6 in) at the center and 75 mm (3 in) on the sides. Each span has a span length of 14.8 m (48.5 ft) and about 35° skew. The total width of the structure is 14.1 m (46.3 ft) and the total length is about 36.6 m (120 ft). Figure 8-2 shows the cross-section and dimensions for the exterior and interior girders for both spans.

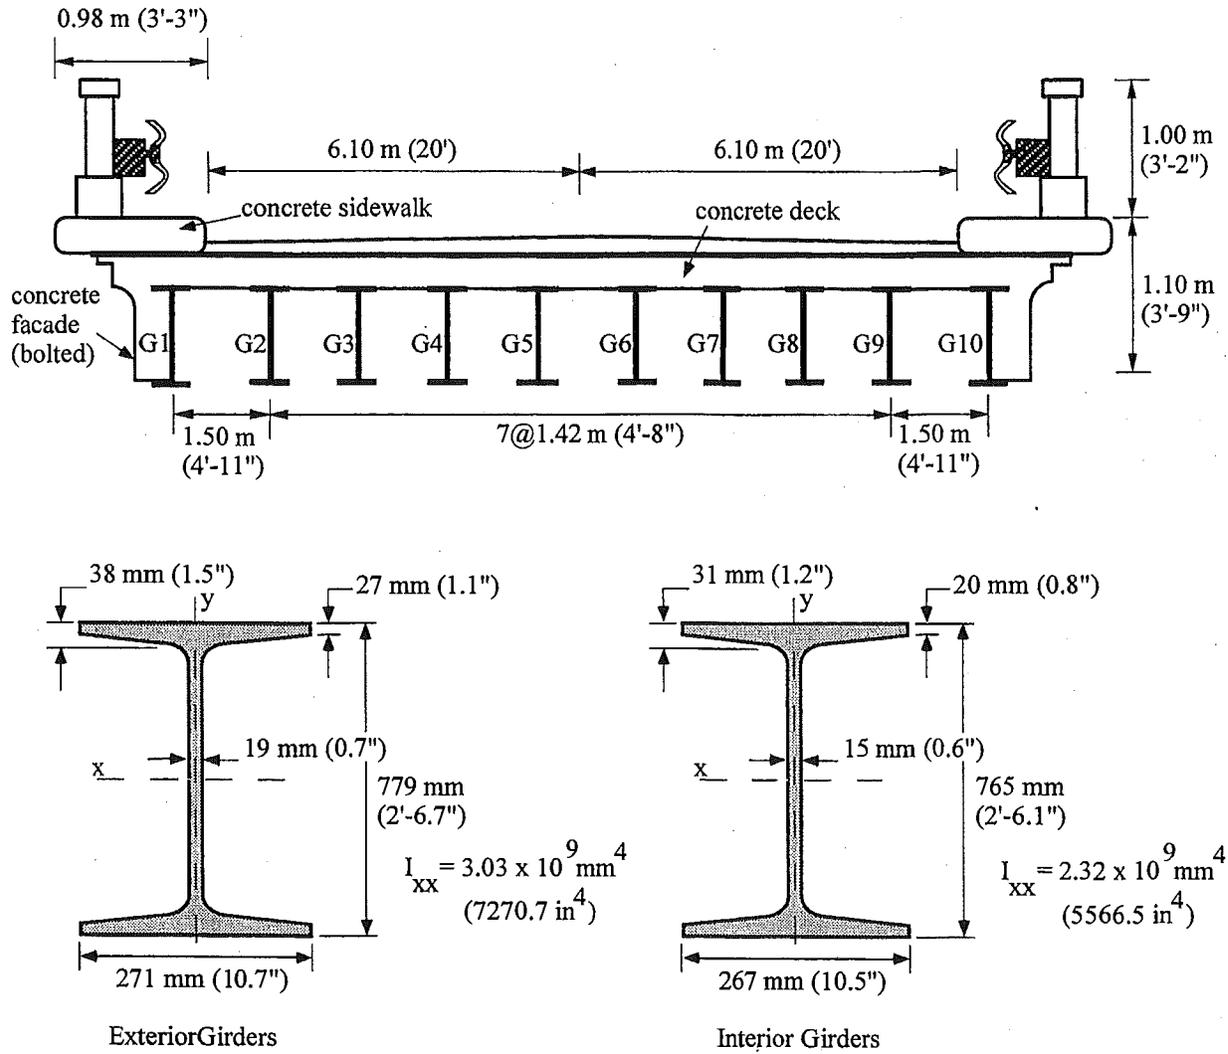
Figure 8-2 : Cross-Section of Bridge No. 3.

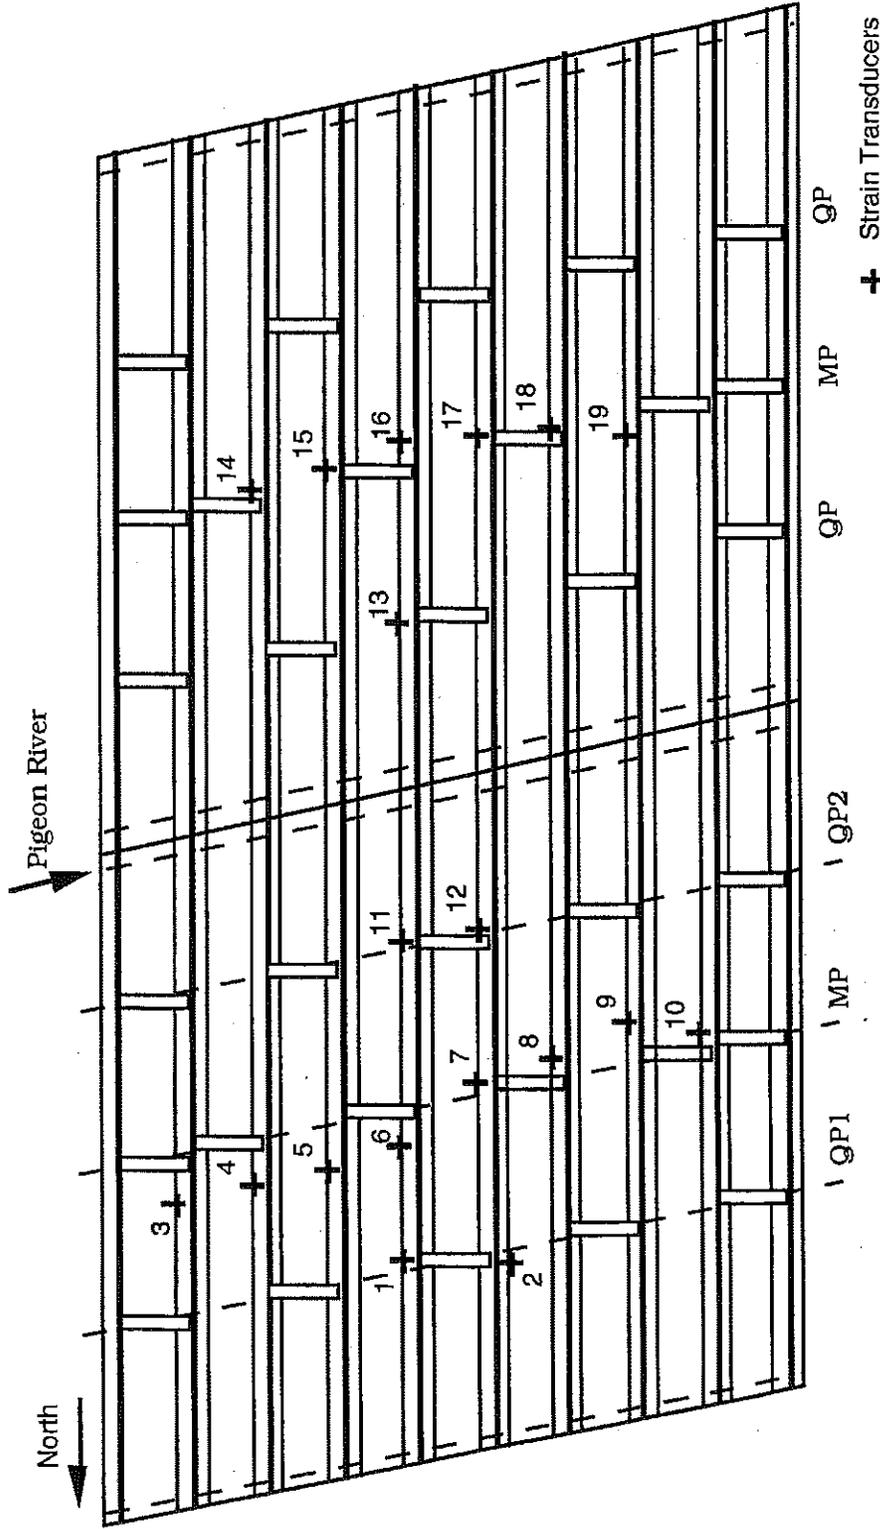
Figure 8-3 : Instrumentation Layout for North Span of Bridge No. 3.

during the test of each span, the unloaded span was also instrumented to check if any load was being transmitted from one span to the other. Nineteen strain transducers were used to measure strains in the lower flanges of the steel girders at the mid-span and quarter points. The locations with the smallest flange thickness were selected for instrumentation. The water level in White Pigeon River was quite high, therefore, floating platforms were required to install instrumentation. Deflections of steel girders could not be measured due to high water level, which exceeded the height of the tripod that would hold the LVDT's. Instrumentation layout for testing of the north and south spans are shown in Figures 8-3 and 8-4, respectively.

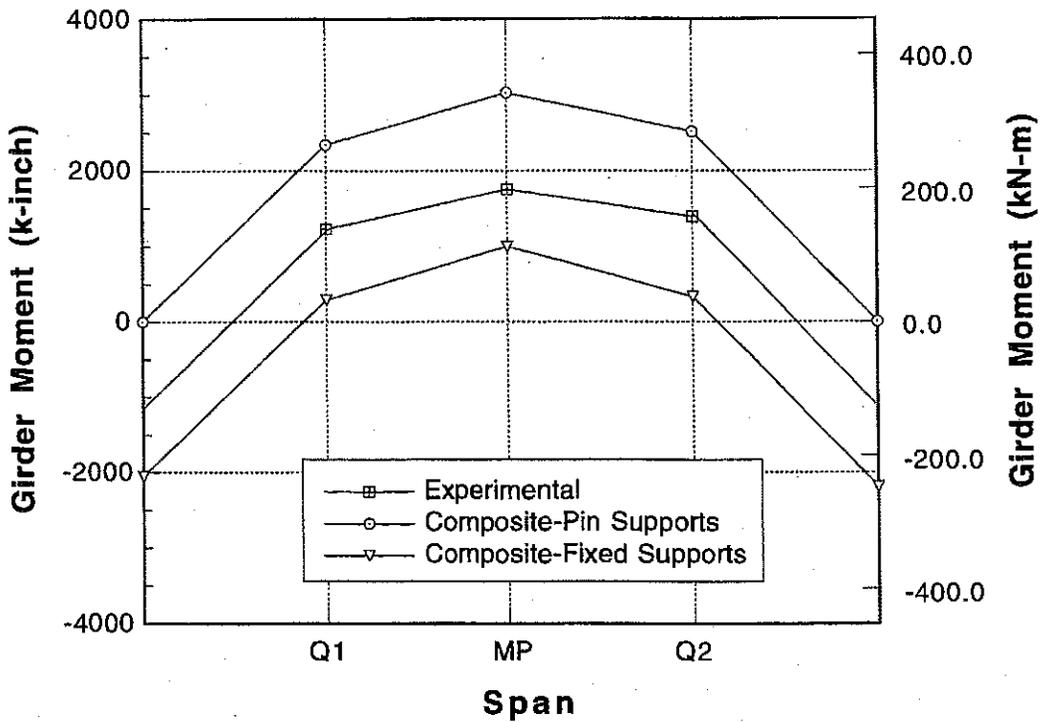
Figure 8-13 : Longitudinal Distribution of Stresses in Girder No. 5 due to the Center Loading on Bridge No. 3 - North Span.

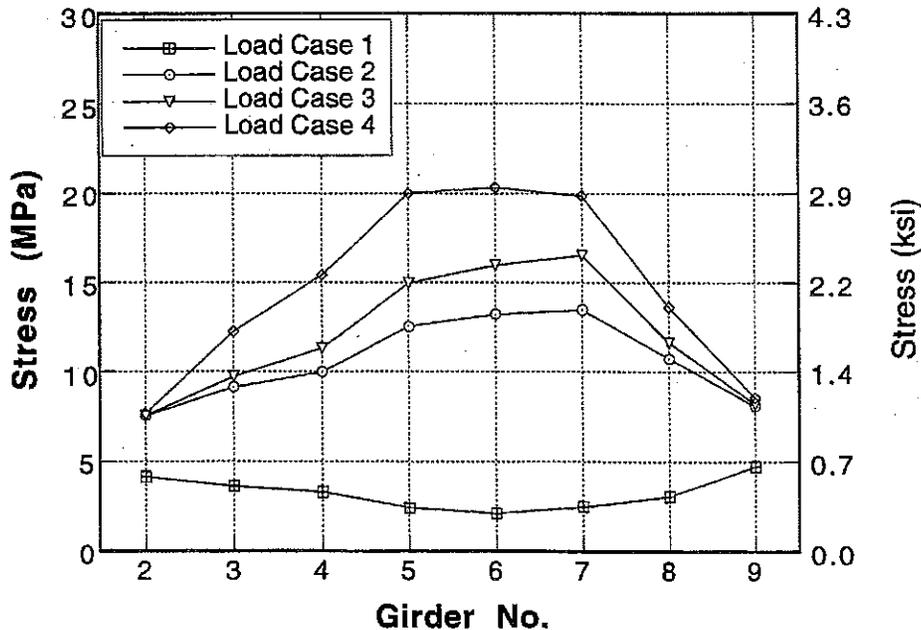
Figure 8-14 : Girder Distribution in terms of Stress due to Center Loading on Bridge No. 3 - North Span.

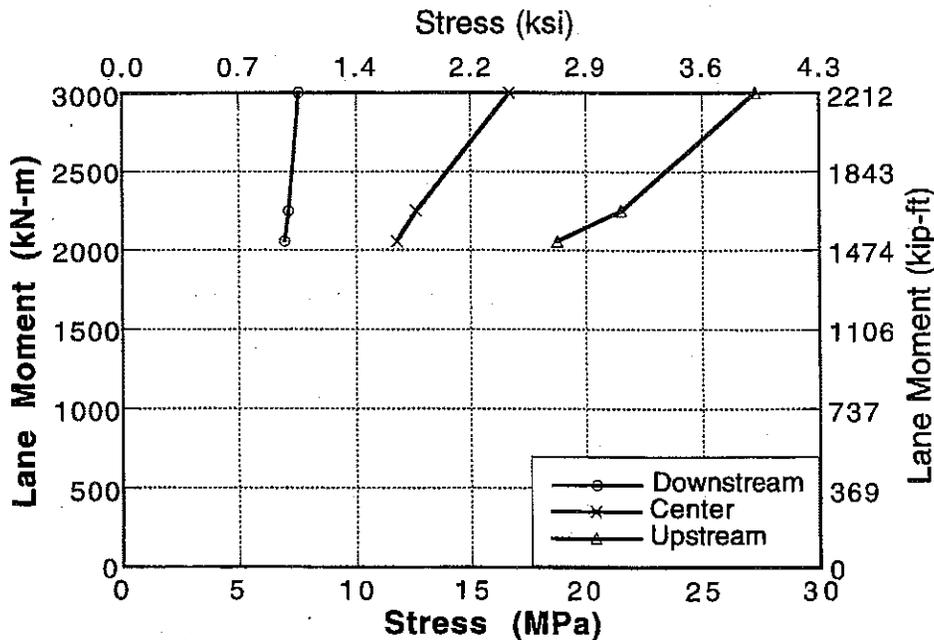
Figure 8-15 : Stress in Girder 3 on Bridge No. 3 - South Span.

Analytical results for this span were identical to the north span of the same bridge, since the original designs and the repair process for both spans were similar. However, during testing a higher proof load level of 3,000 kN-m (2,212 k-ft) was reached for this bridge. The maximum measured stress of 29.98 MPa (4.34 ksi) was recorded in girder no. 5 under the center load position. The maximum stress is about 0.15 of the yield strength of steel girders. Figure 8-15 shows the response of girder no. 3. The stress-moment response is linear, which indicates that the bridge is strong enough to support more load than the applied proof load. Stresses at the mid-span and quarter points of other girders also point to the same conclusion. Once again, the repair work in the lower flanges of this bridge appears to be effective.
