Research Report UMCEE 96-10

LOAD TESTING OF BRIDGES

the Michigan Department of Transportation

Andrzej S. Nowak and Vijay K. Saraf

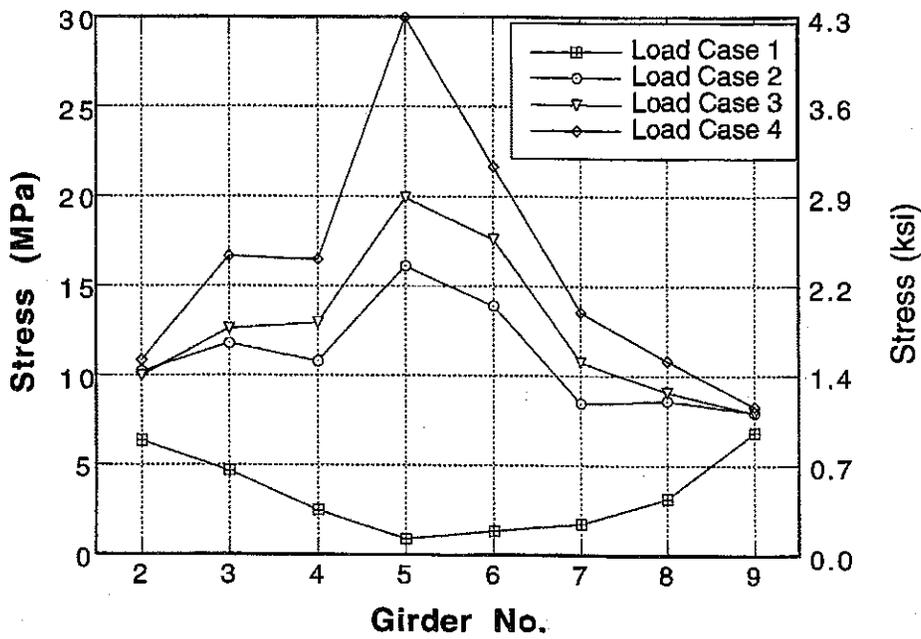
Figure 8-18 : Girder Distribution of Stress for Center Loading on Bridge No. 3 - South Span.

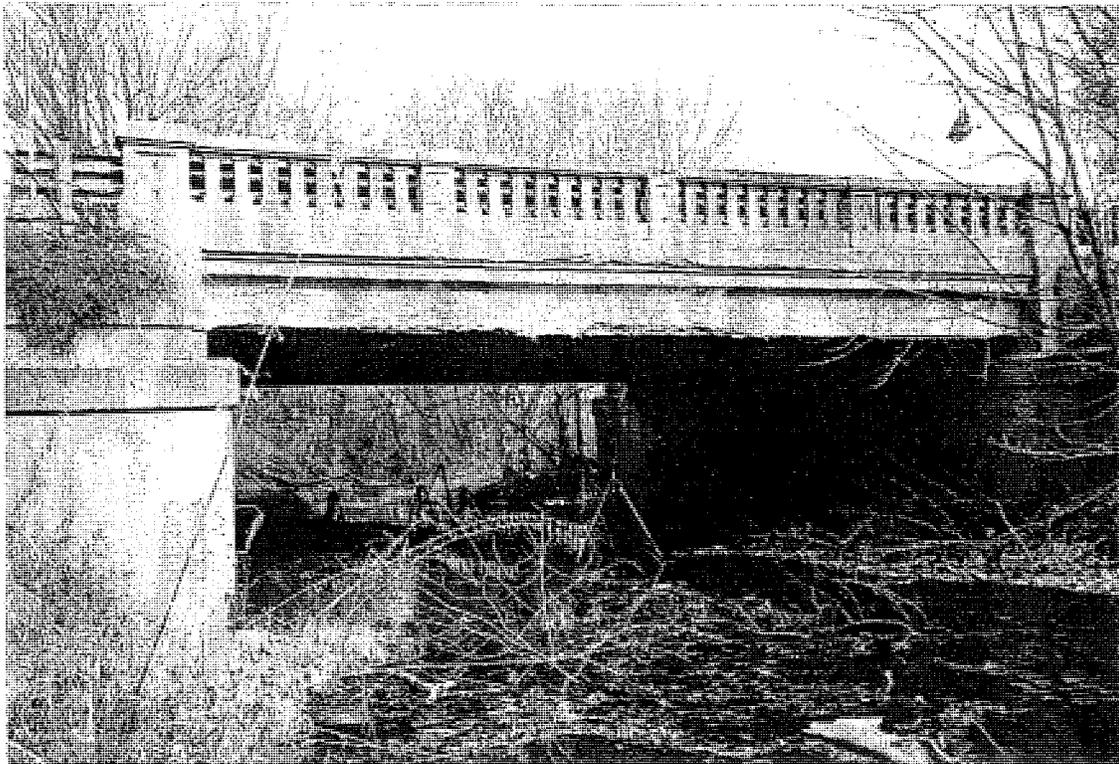
Figure 9-1 : Side Elevation of Bridge No. 4.

This bridge is located in Clinton County, Michigan, close to Ovid. It carries state highway M-21 over Little Maple River. The side elevation of the bridge is shown in Figure 9-1. It was built in 1929 and has ten steel girders with a 165 mm (6.5 in) thick concrete slab. The thicknesses of the concrete wearing surface and the asphalt are 152 mm (6 in) and 76 mm (3 in), respectively. The width of the structure is about 22.2 m (74 ft) and the span length is 11.7 m (38.5 ft). The ADT on this bridge is about 5,100. The cross-section and the girder details are shown in Figure 9-2.

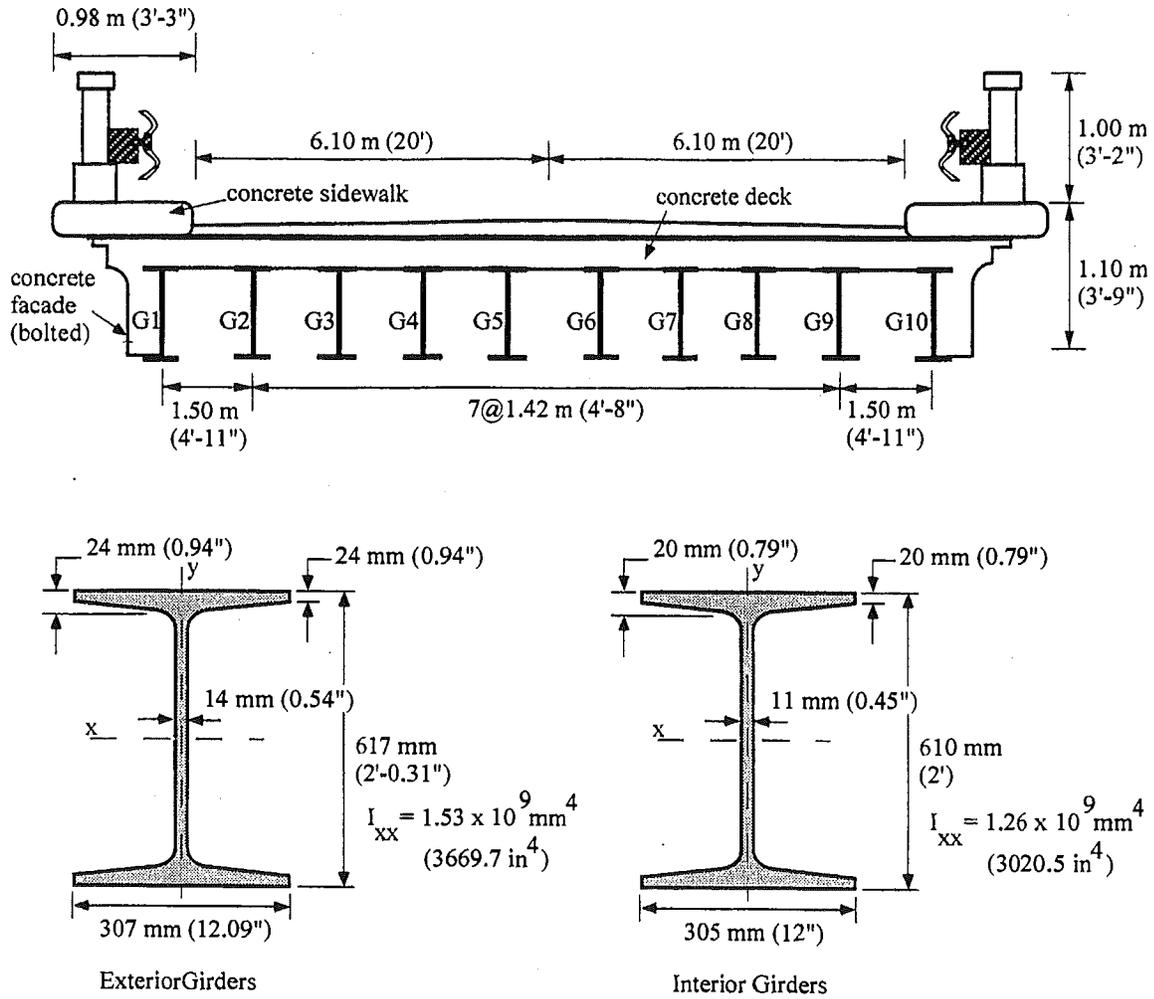
Figure 9-2 : Cross-Section of Bridge No. 4.

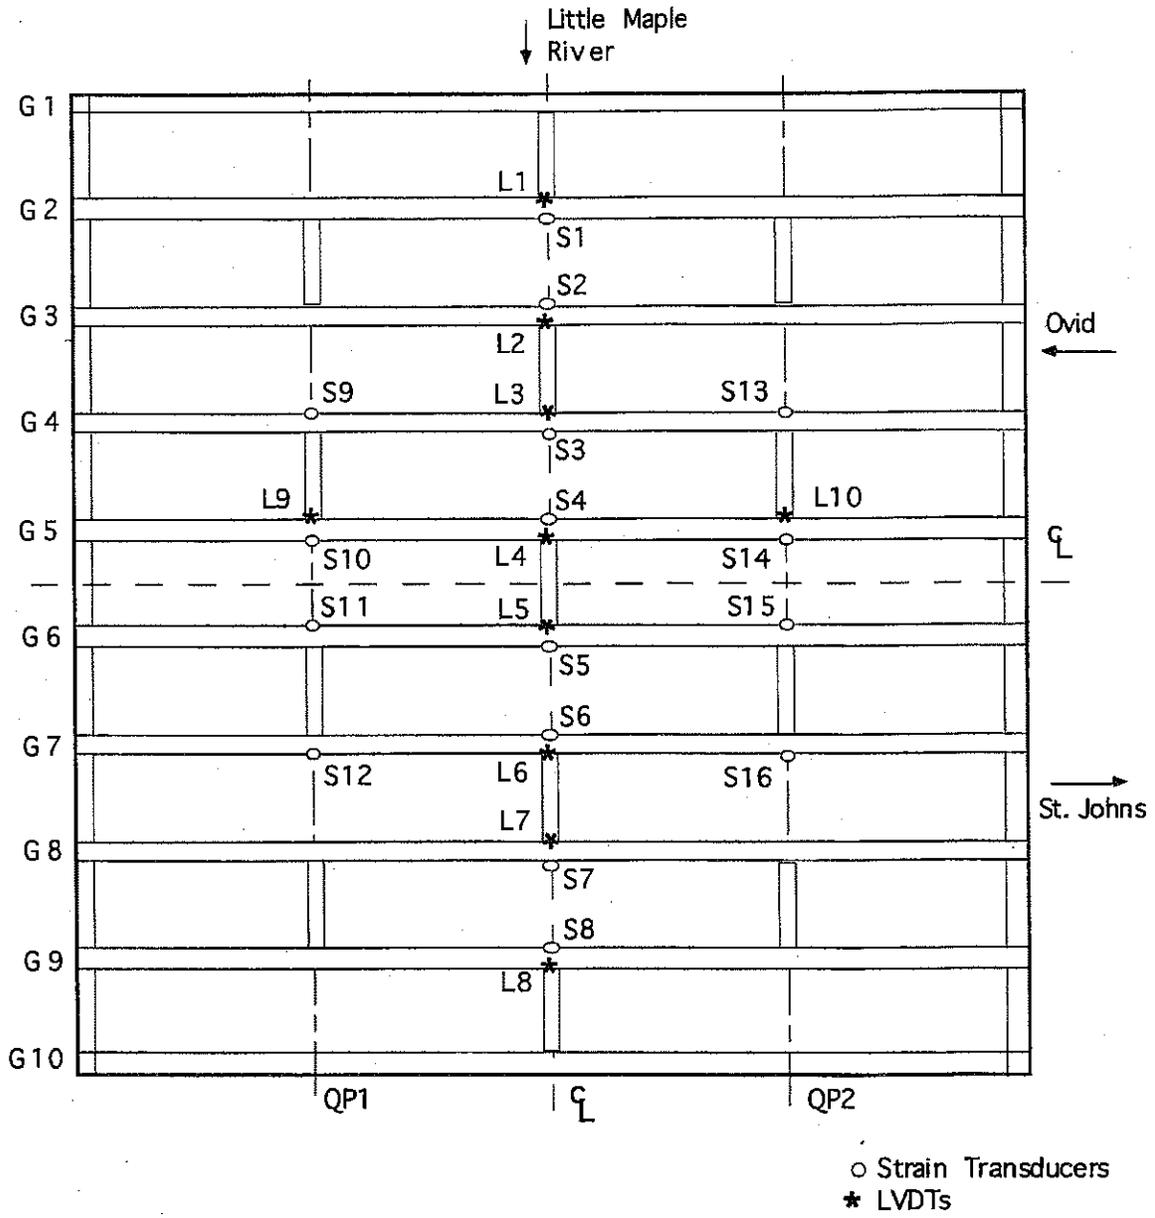
All interior girders of the bridge were instrumented at the mid-span using LVDT's and strain transducers. The exterior girders were not instrumented, since the response was expected to be very small due to the presence of the bolted concrete facade. In addition, for selected girders the instruments were mounted at the quarter points. In total, sixteen strain transducers and ten LVDT's were used. The instrument layout for this bridge is shown in Figure 8-3.

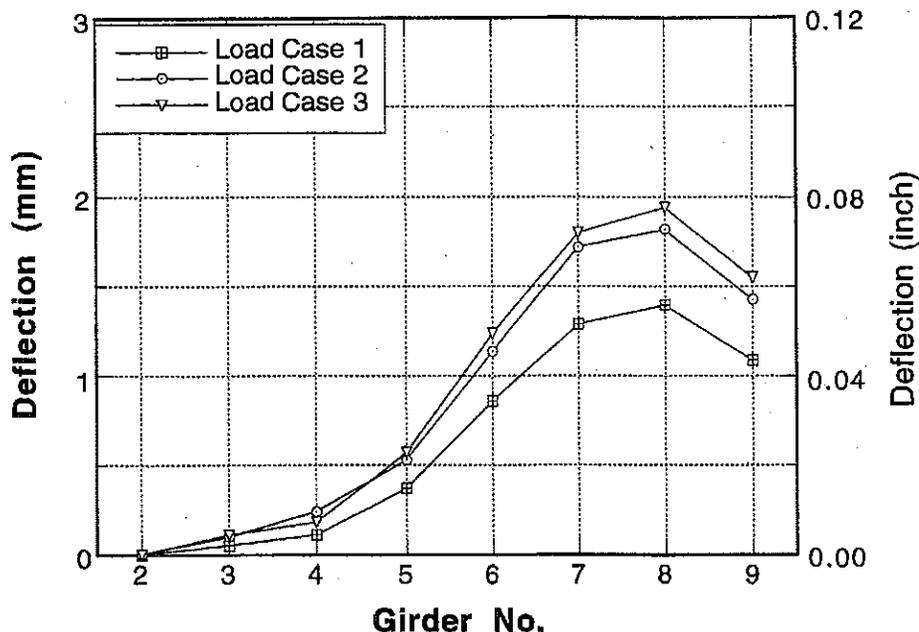
Figure 9-9 : Girder Distribution of Deflections due to Downstream Loading on Bridge No. 4.

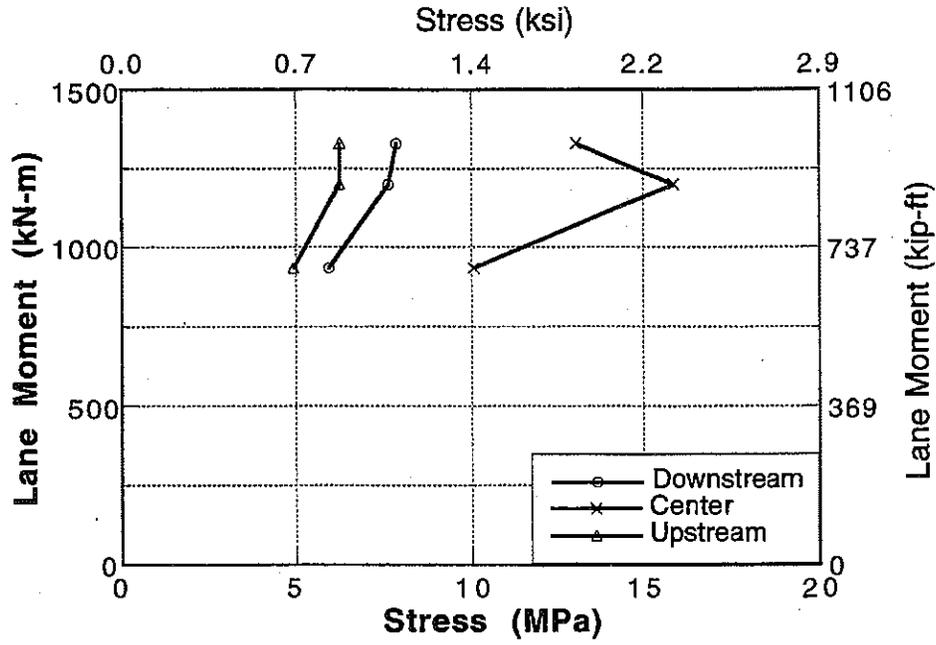
Figure 9-10 : Stresses at Mid-Span of Girder 6 of Bridge No. 4

Figure 9-10 shows the measured stress and the applied lane moment at the mid-span of girder 6. The maximum measured stress was only 15.9 MPa (2.3 ksi), which is much smaller than the yield strength of 207 MPa (30 ksi). The stress for load case 3 in center loading decreased while the applied lane moment increased. One tank was enough to produce moments for load case 1 and 2. For load case 3, the first tank was kept at the same position as in load case 2, while a second tank was placed close to the east support to increase the lane moment. Observed stresses should have increased if the supports were behaving as pin connections. A decrease in stress due to the placement of additional load close to the support was observed because the supports provide some moment resistance. This decrease in stress due to bearing restraint disappears for the girders which are further away from the applied load. Therefore, the measured stress for downstream and upstream loading did not show a decrease for load case 3.

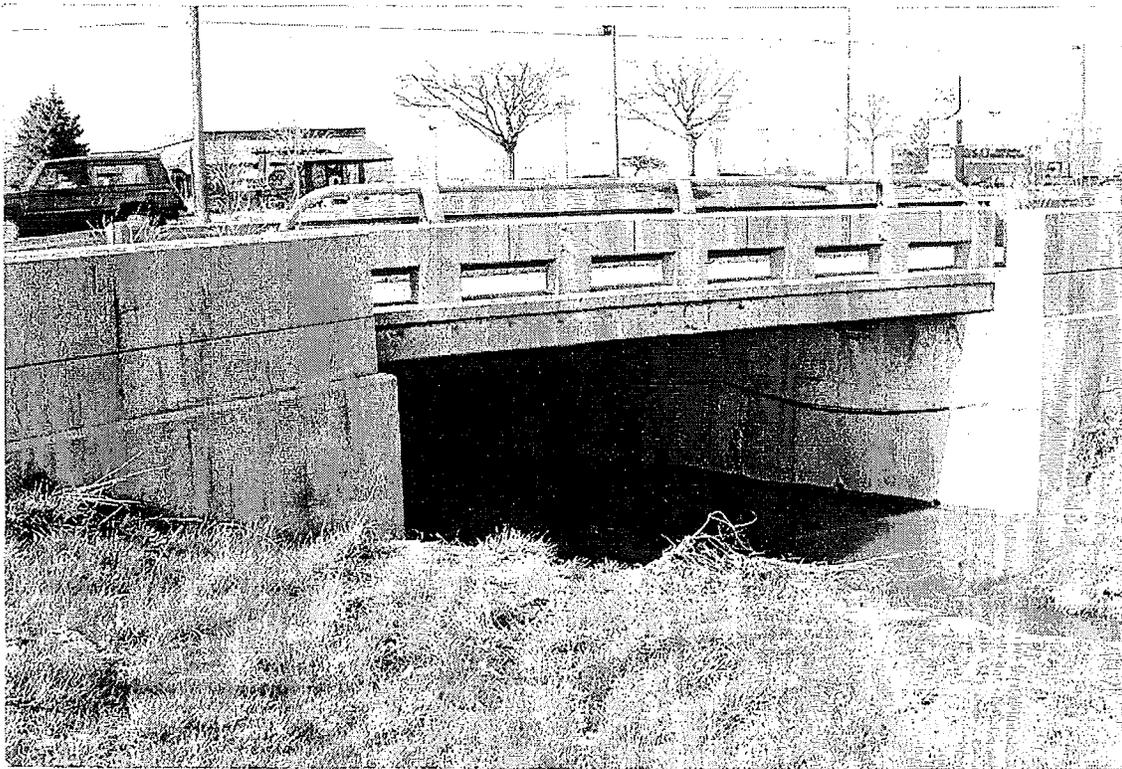
Figure 10-1 : Side Elevation of Bridge No. 5.

This is a single span structure over Fellows Creek, located in Canton Township, Michigan. It carries five lanes of state highway M-153 (Ford Road), with a total ADT of 32,400. The original structure was built in 1920, which consisted of nine reinforced concrete T-beams, with a 150 mm (6 in) thick slab and a 150 mm (6 in) thick concrete wearing surface. It was widened in 1979, and 300 mm (12 in) precast concrete slabs were added on each side. The span length of the current structure is 7.8 m (25.5 ft) and the width is 24.4 m (80.2 ft). The side elevation of the bridge is shown in Figure 10-1. The cross-section of the interior structure with RC beams is shown in Figure 10-2.

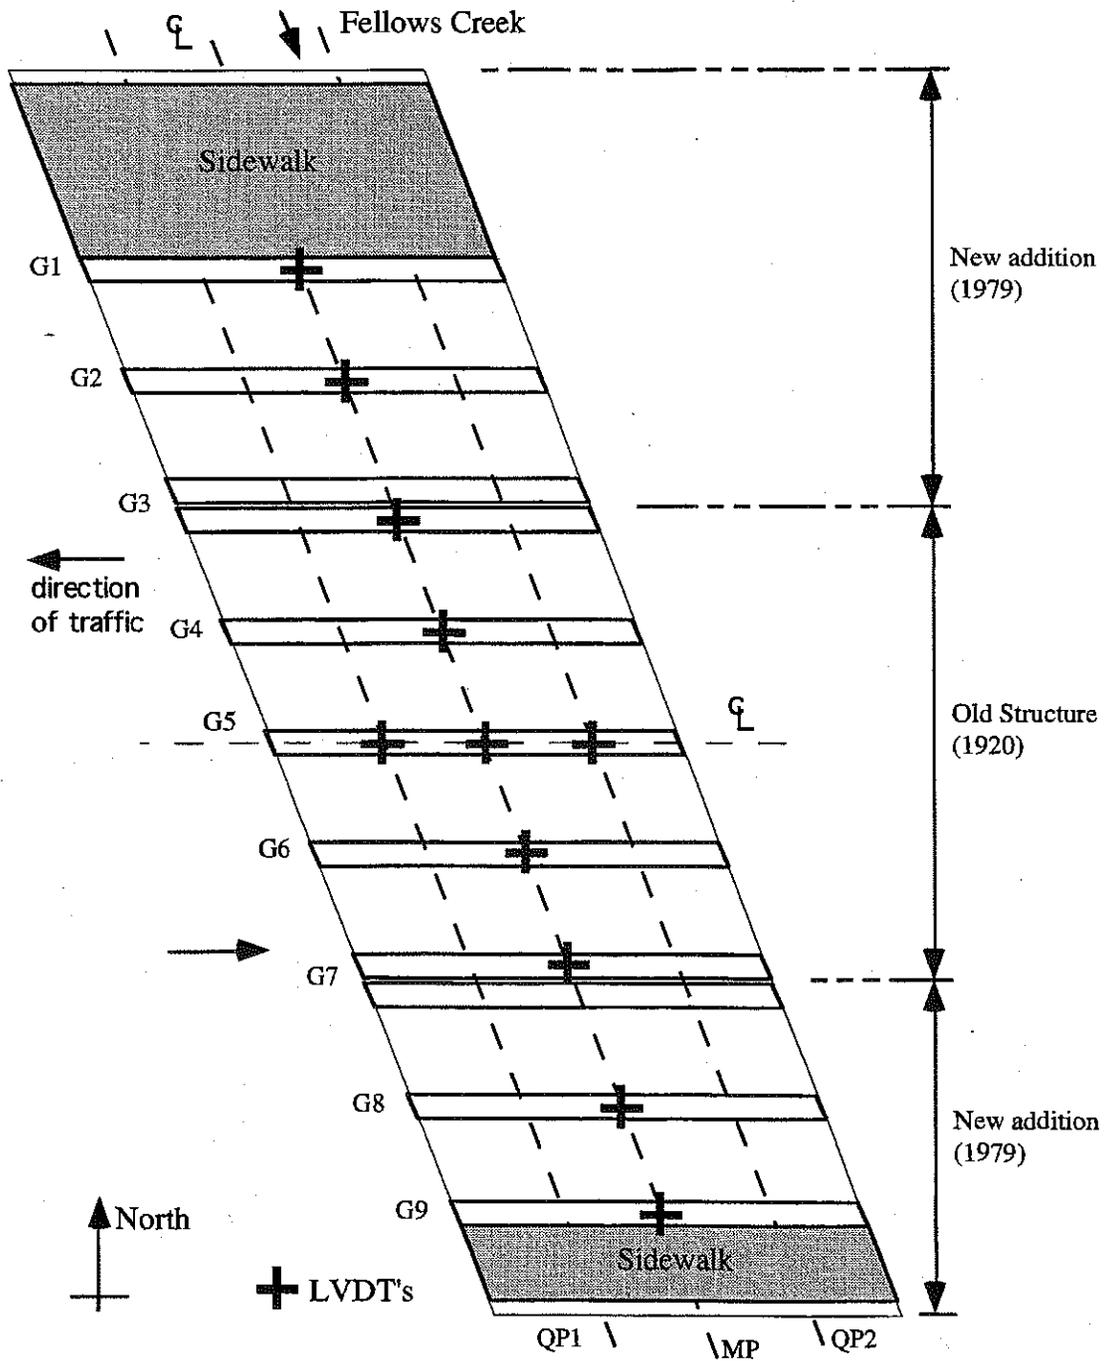
Based on the experience during the test of Bridge No. 1, it was decided not to measure the strains in concrete girders. Therefore, the interior structure with reinforced concrete beams was instrumented using LVDT's only. The deflection was measured at the mid-span of all nine girders. In addition, for girder no. 5, the deflections at the quarter points were also measured. The instrumentation layout is shown in Figure 10-3.

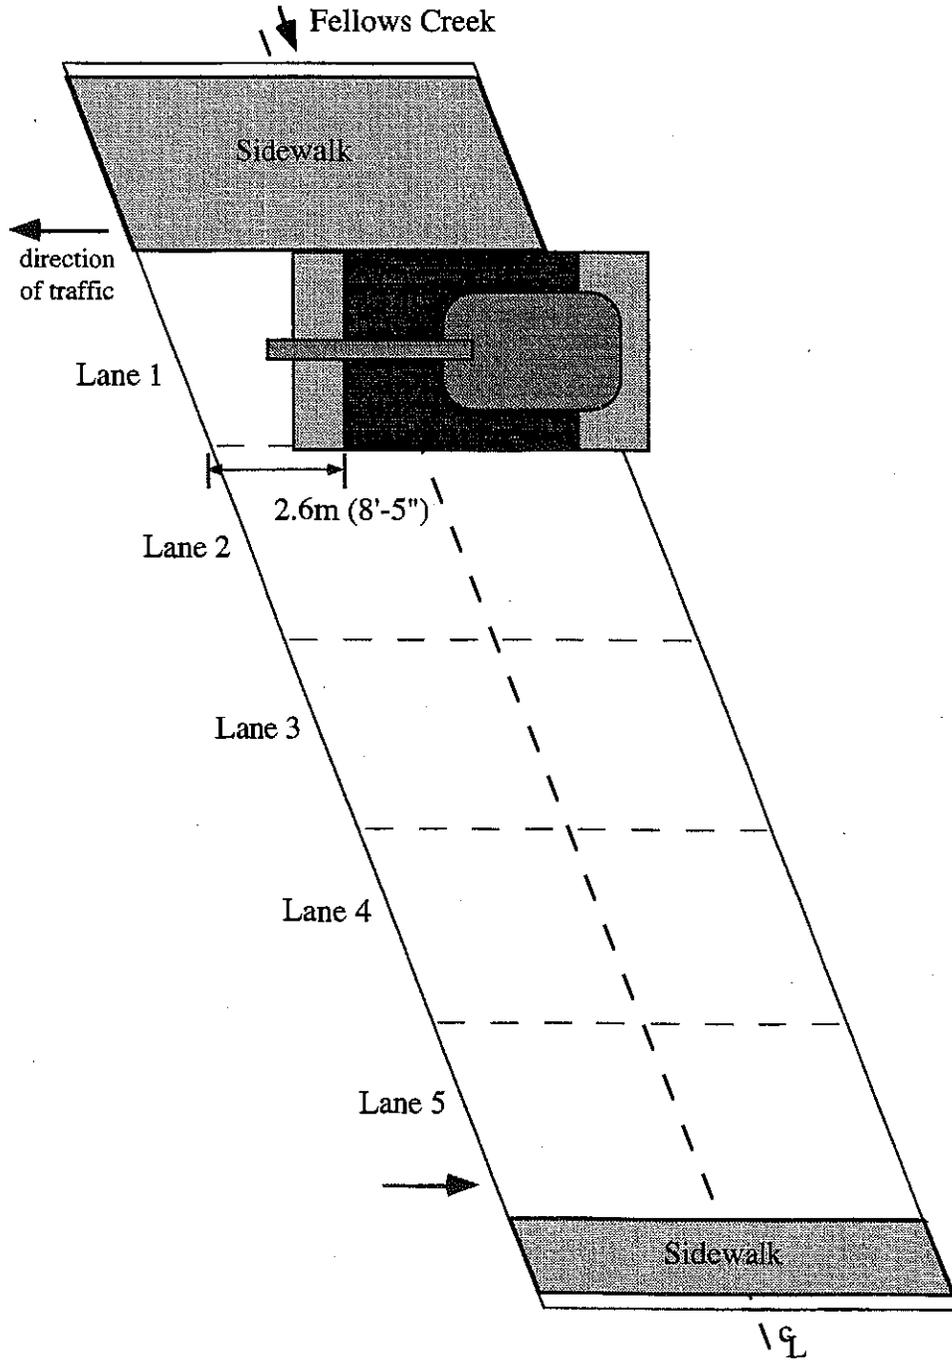
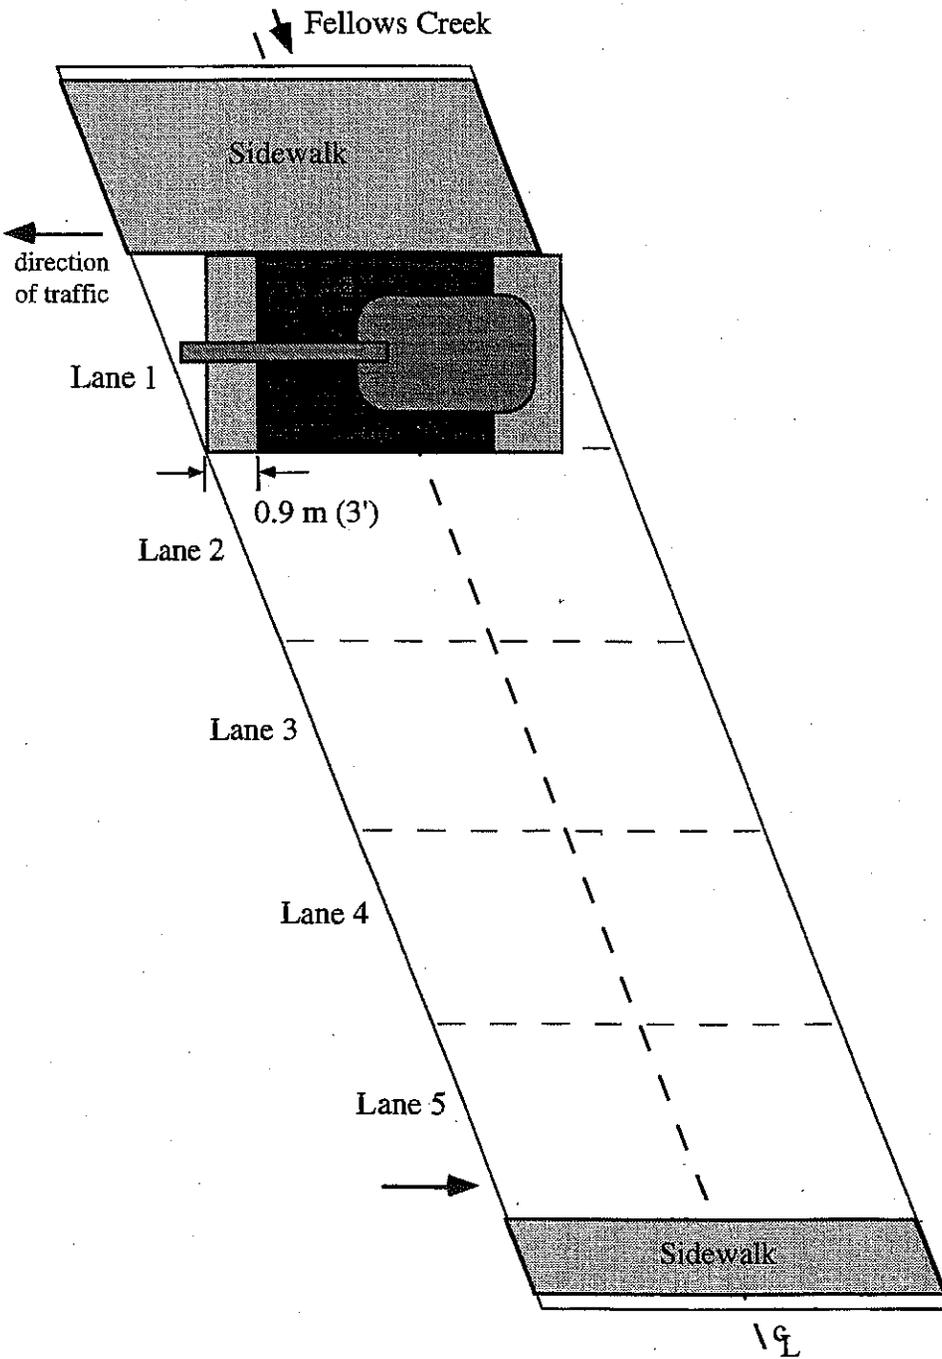
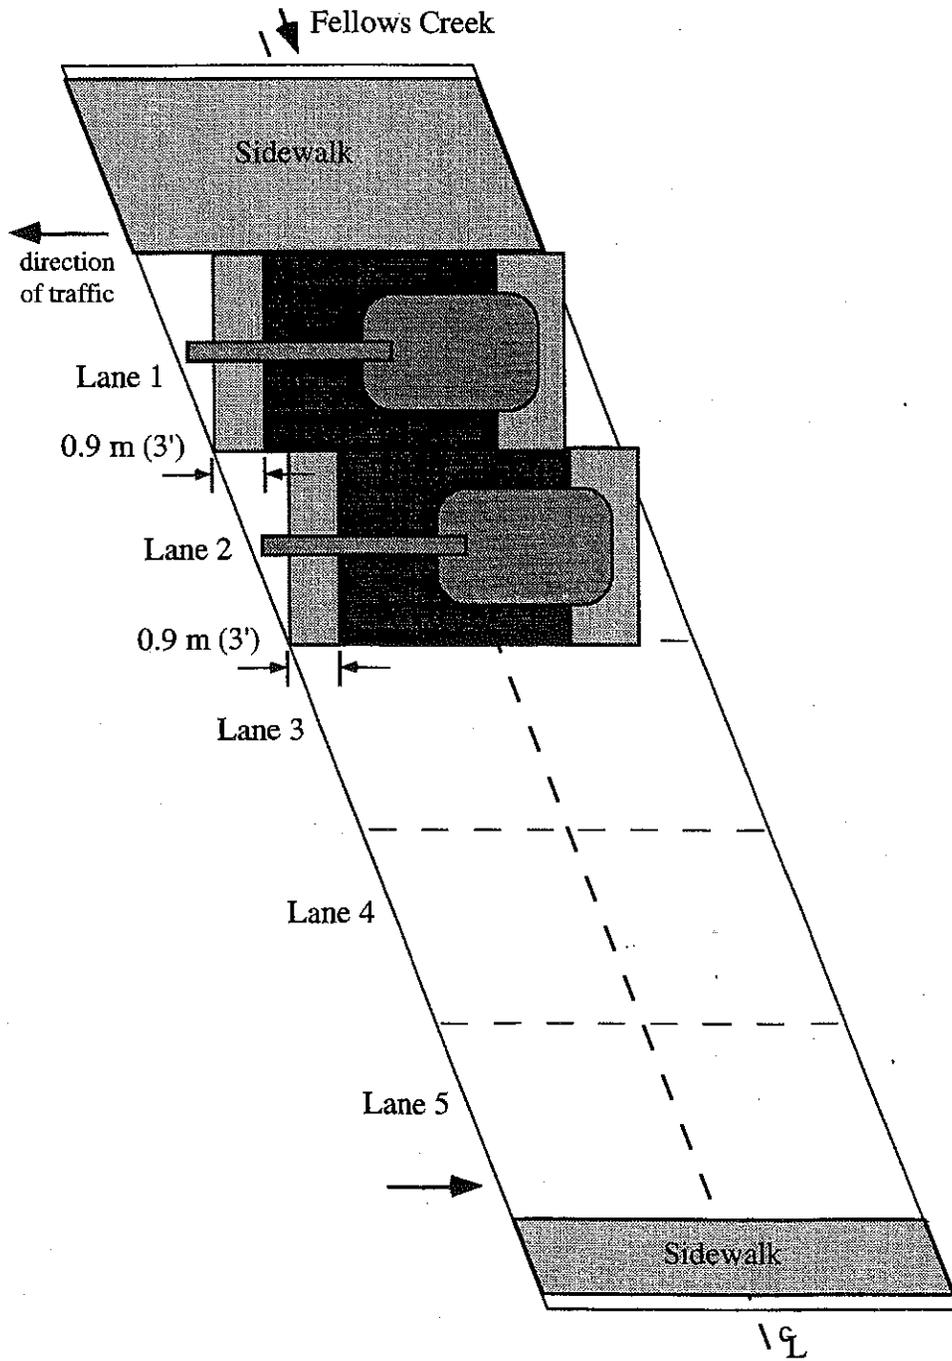
Figure 10-4 : Longitudinal Load Positions for Lane 1 and 2 Test.
