***BITUMINOUS PAVEMENT  
RESURFACING AT  
SNOWMOBILE CROSSINGS  
FIRST YEAR REVIEW***

**Bituminous Pavement Resurfacing at Snowmobile Crossings  
First Year Review**

**Testing and Research Section  
Construction and Technology Division  
Research Project 97 D-0065  
Research Report No. R-1359**

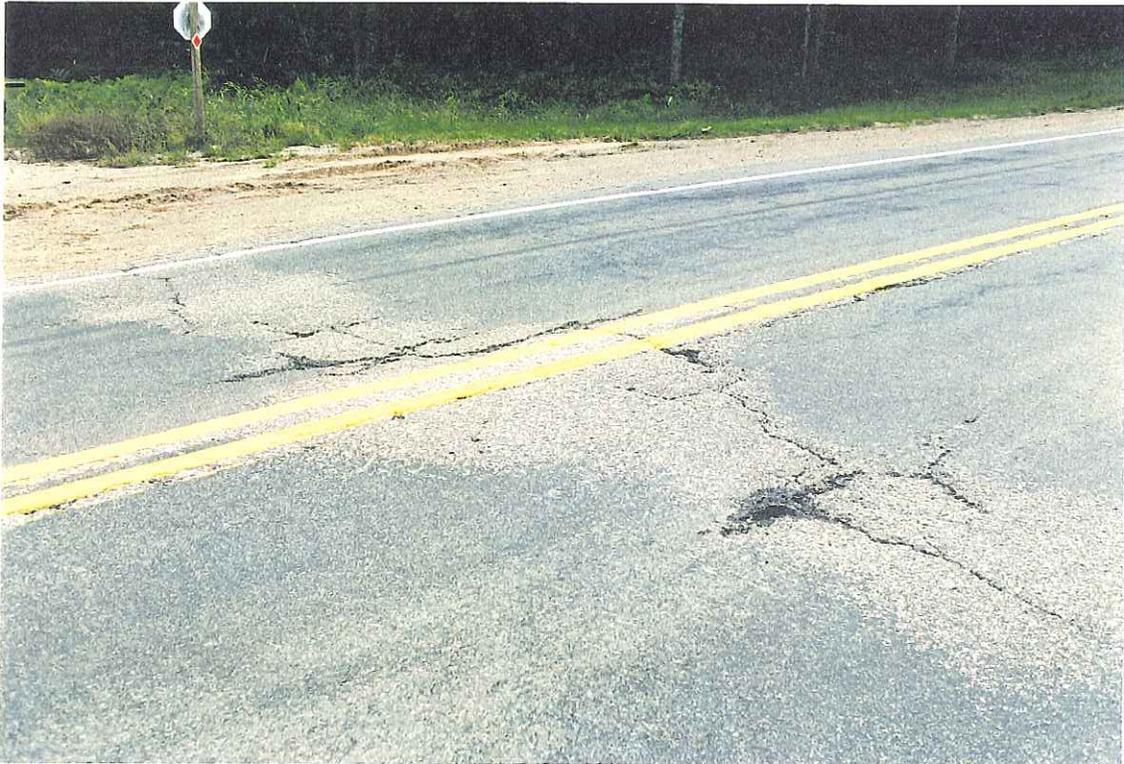
Figure 1. Deteriorated pavement at a snowmobile trail crossing

In January 1997, a meeting was held at the Michigan Department of Transportation (MDOT) Cadillac district office to discuss the premature deterioration of bituminous pavements caused by traction control devices on snowmobiles. The traction control devices on the sleds consist of studded tracks and carbide runners mounted on the skis. These traction control devices are *milling* away the bituminous surface of the roads at snowmobile trail crossings (Figure 1).

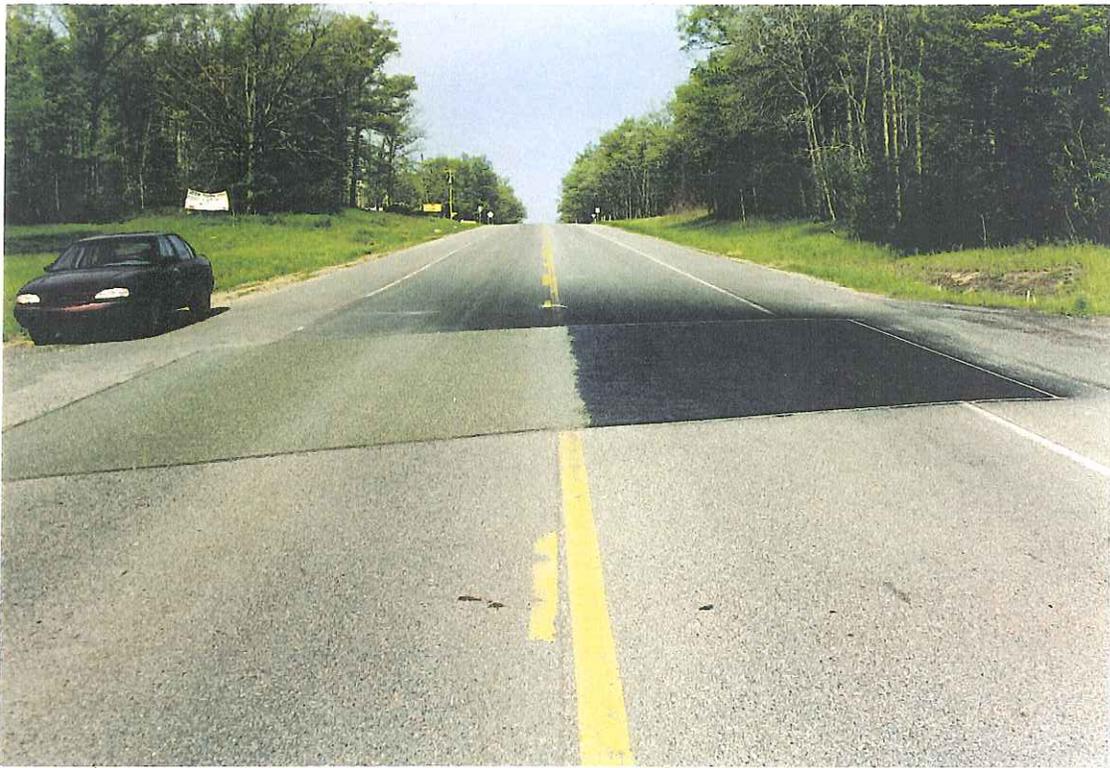
Figure 2. Each trail crossing was divided into two sections

A test section located on M-55 near Wellston, Michigan was established to study several experimental protective coatings for the road surface. This location was chosen because of the high number of snowmobilers that are attracted to this area during the winter months, and also because that section of M-55 had been resurfaced two years prior and was in relatively good condition. Four individual crossings were chosen to be included in the test section. Each crossing was divided into two subsections, each section being a 3.7 meter lane and 0.9 meter shoulder wide by 7.3 lineal meters in length ( Figure 2 ).

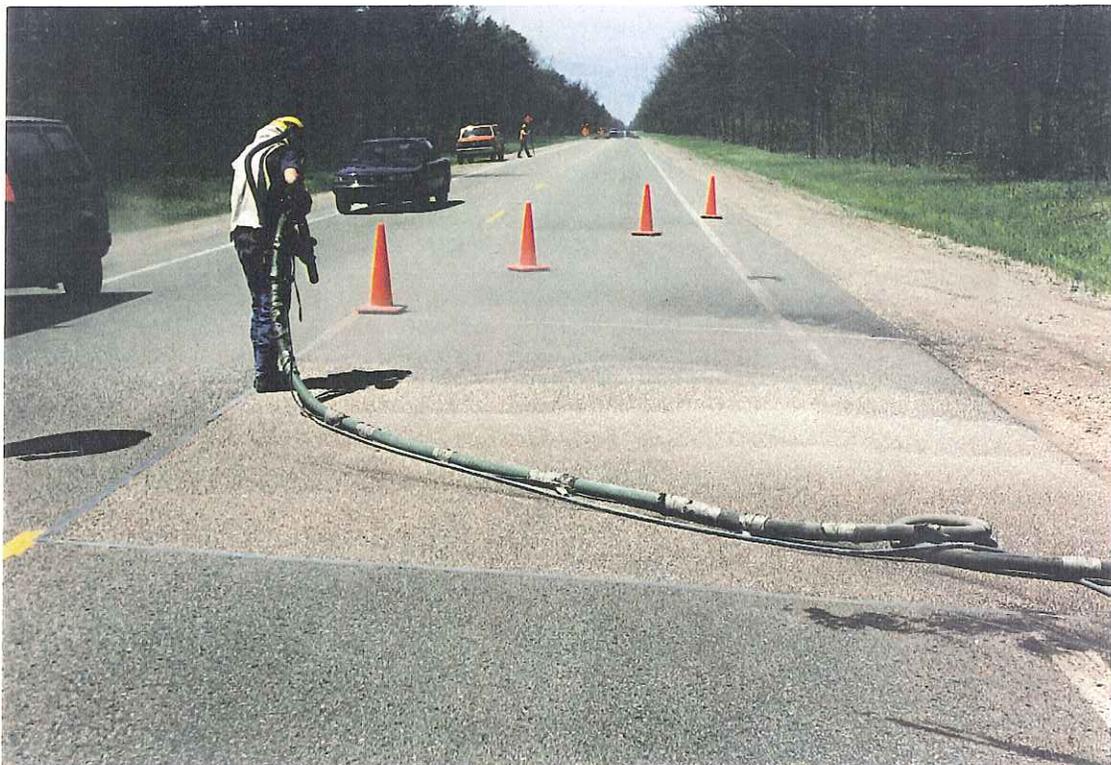
Figure 3. Typical preparation of the test sites

Eight material manufacturers were chosen to apply their respective products to a crossing location specified by MDOT personnel. Each manufacturer was required to have a representative on site to assist with the installation of their product and to make sure it was installed to their specifications and satisfaction. All traffic control and test section preparation work was performed by MDOT personnel. Each location was thoroughly sandblasted and blown clean with oil-free compressed air. The perimeter of each test location was established and laid out with duct tape (Figure 3).

- Care must be taken during preparation of the area to be coated. The bituminous surface must be thoroughly sandblasted and blown clean with oil-free compressed air prior to application of the liquid binder. The leading and trailing edges of the area to be coated must be defined by laying several widths of duct tape on the road surface to ensure a straight transition edge. This will also prevent excess material from running onto the road surface outside the coating area. This method will provide a well-defined edge for the saw cut.

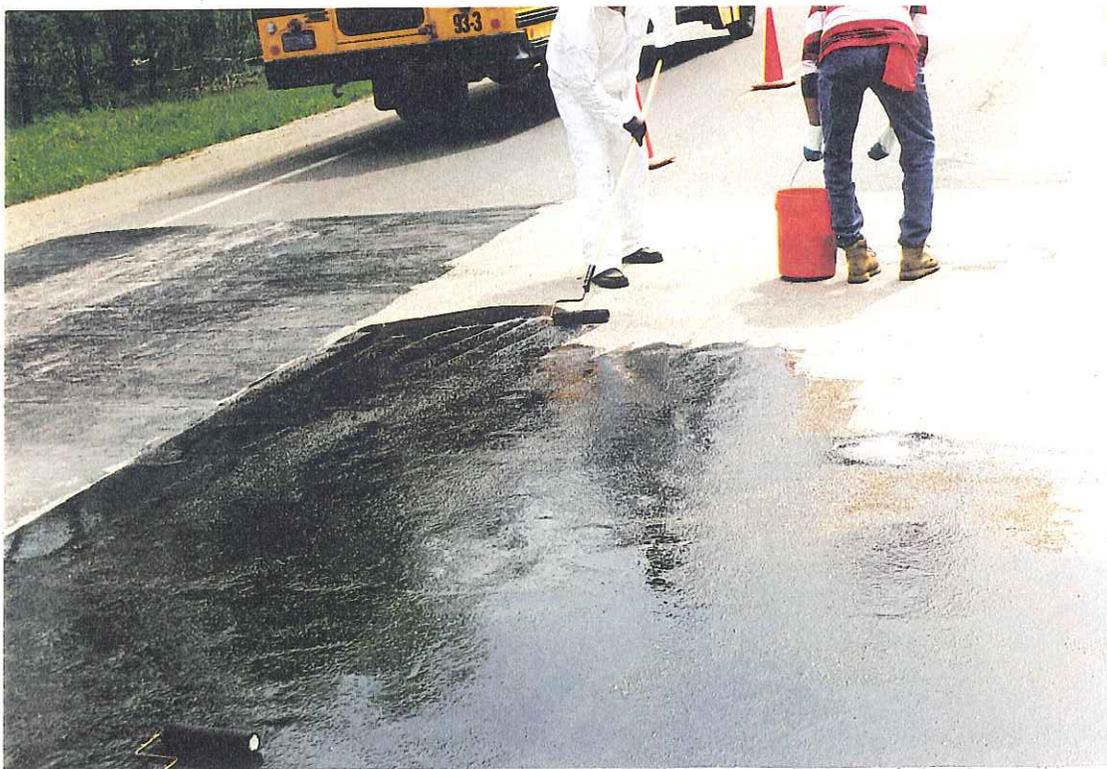
Figure 4. The most common application was the two coat system

Methods for installing the coating materials varied from *spray-on* to *broom and seed* to *trowel applied*. Several different types of aggregates were used as part of the coating systems as well. The aggregate types ranged from silica sand to aluminum oxide to chipped flint, depending on the recommendation of the manufacturer. Only one coating was applied as a one coat system. The spray-on applications applied as many coats as the representatives deemed necessary. The most common method of application involved applying two coats of material to the crossings. This was accomplished by applying the first coat of material to the road surface, allowing it to cure sufficiently, and then applying the second coat in the same manner as the first. The second coat was then permitted to cure, the excess aggregate blown off with compressed air and the roadway was re-opened to traffic (Figure 4).

- Two-coat systems appear to be more durable than the same material applied in one coat. One-coat systems may be a viable alternative at less heavily traveled crossings, and more importantly, where the road surface is not showing much deterioration. Test sections indicate that severe snowplow damage may occur to one-coat systems that have been applied to deteriorated and severely rutted roadways.

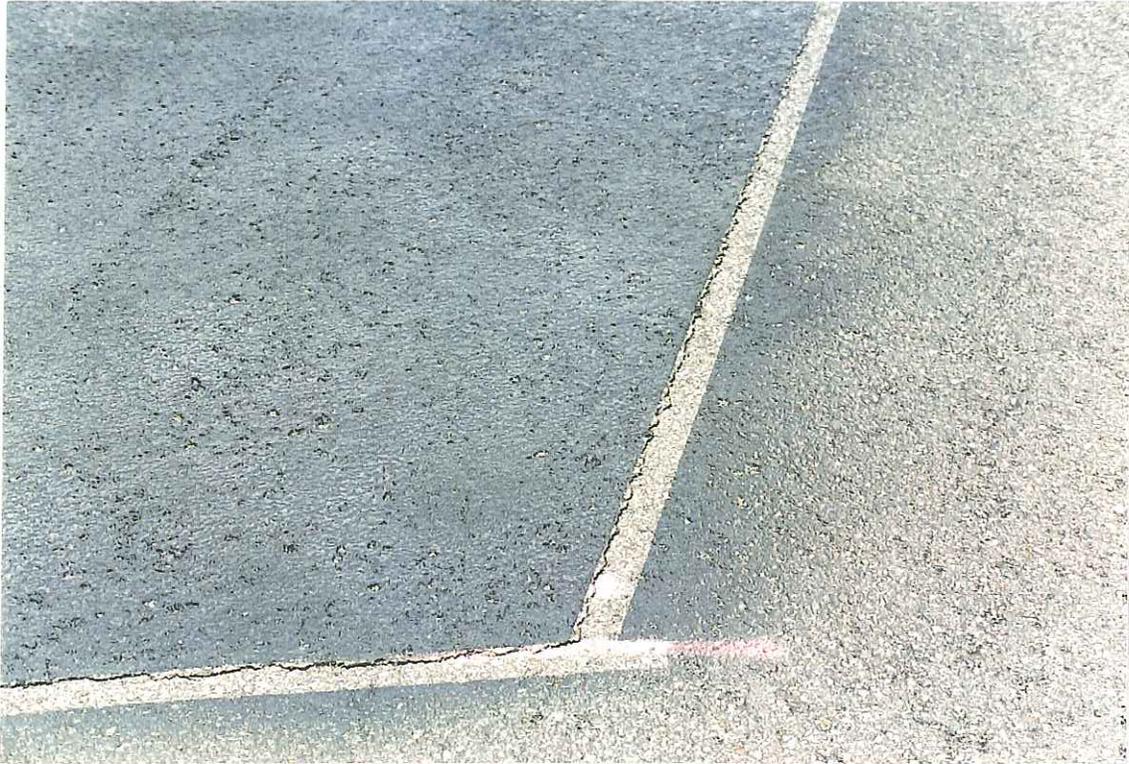
Figure 5. Perimeter cracking occurred after 24 hours

After application of the first six coating products, it was noted that cracking developed around the entire perimeter of each coated area within twenty four hours of application of each material (Figure 5). This cracking was likely due to stresses as a result of thermal incompatibilities between the coating and the bituminous concrete, or possibly tensile stresses from curing shrinkage of the coating materials. The perimeter cracking problem was solved by sawing 25mm deep by 3mm wide relief cuts at the interface of the coating and the pavement (Figure 6). This saw cut was then cleaned and sealed with silicone sealant.

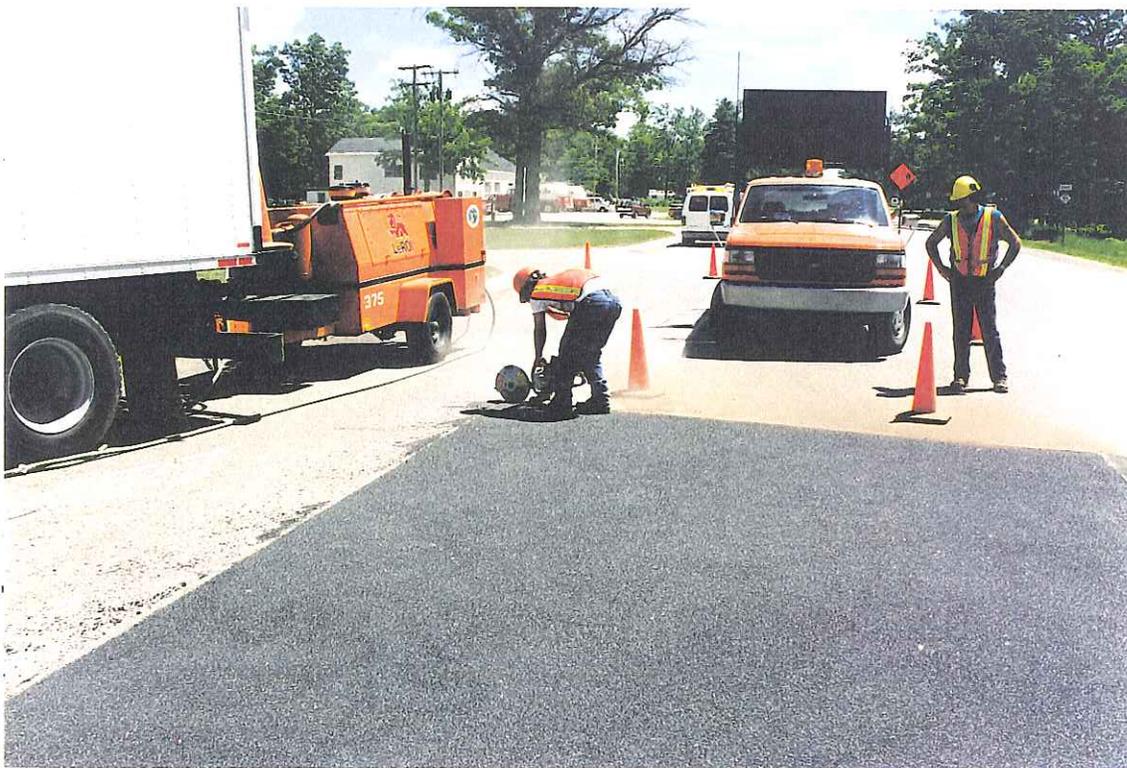
Figure 6. A relief cut was sawn and sealed to control the perimeter cracking

- Saw cuts are required at the leading and trailing edges of the coated area to prevent uncontrolled cracking of the road surface at this interface. These saw cuts must be cleaned and sealed with a silicone sealant to prevent the intrusion of incompressible materials.

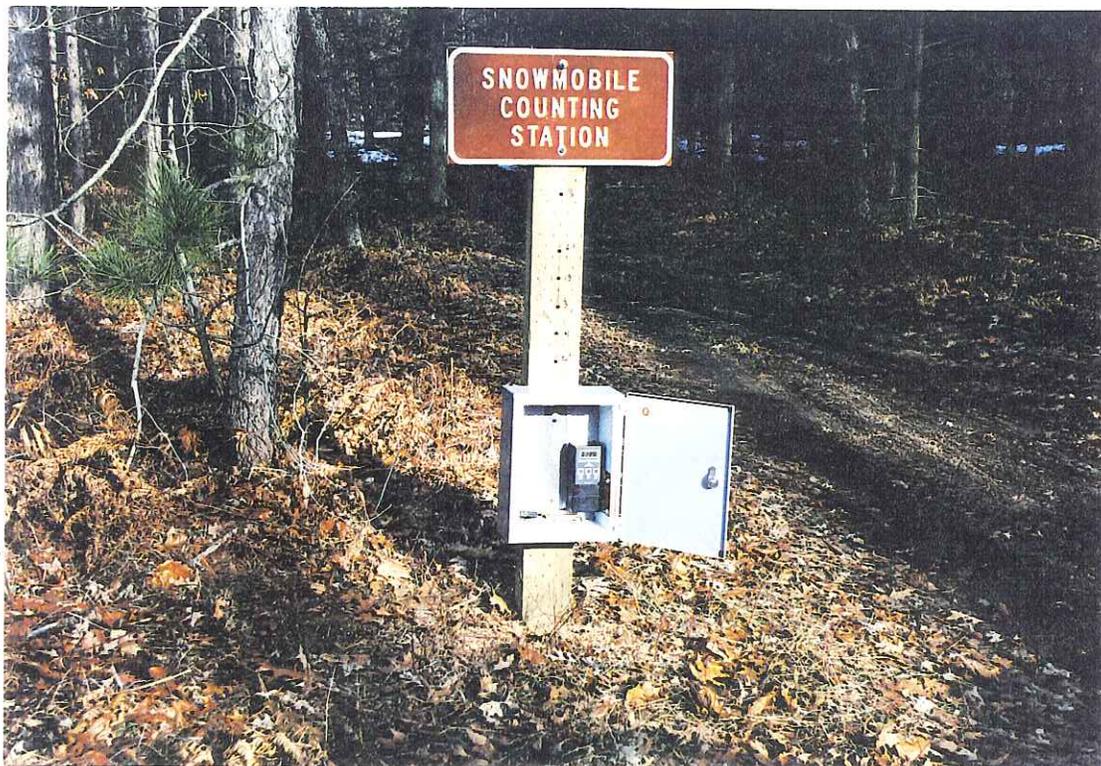
Figure 7. Snowmobile traffic counters

In order to correlate the effectiveness of the coatings to actual use of the crossings, snowmobile traffic counters were developed specifically for this project (Figure 7). These counters were installed at selected crossings in the Wellston test section, and also on M-41 near Mohawk, to document the number of sleds using the crossings.
