## 5. Discussion

## **5.2 Estimating Collection and Processing Times for Future Large-deck Bridges**

**5.3 Project Outreach - MDOT General Training Session**

MDOT Project #: OR10-043, Auth. No.7, R1-R4

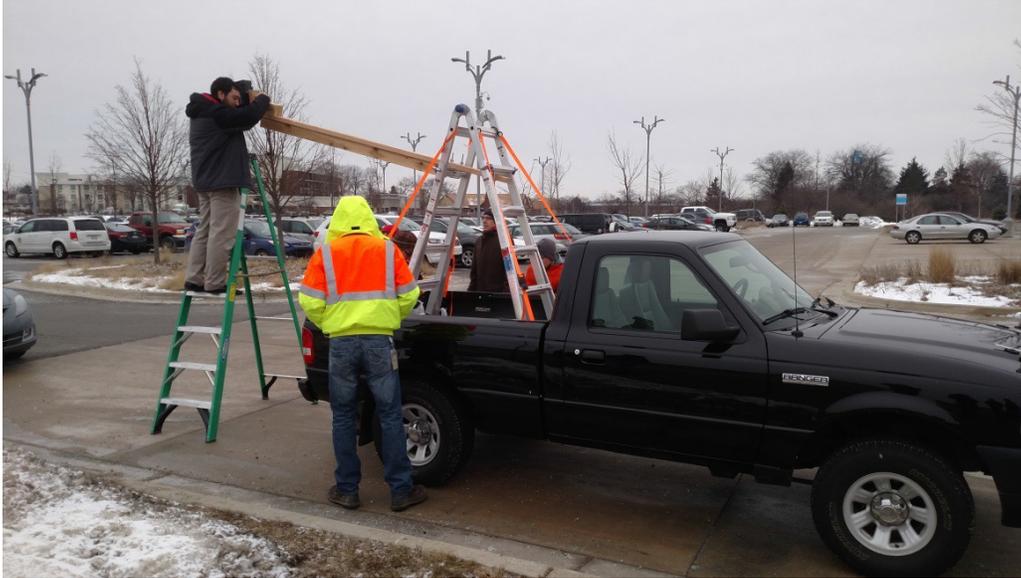
**Figure 48: MTRI setting up 3DOBS and BVRCS at the AAATA “Park and Ride”.**

After the presentation, MDOT was led to a local Ann Arbor Area Transit Authority (AAATA) “Park and Ride” center, located at intersection of Plymouth Road and US-23, less than one mile away from the MTRI office building. While at the AAATA “Park and Ride” center, MTRI set up 3DOBS and placed the BVRCS GoPro Hero3 cameras on the hood of the data collection vehicle to demonstrate the simplicity of setting up the platform, a process that took about five minutes (Figure 48). After the platform and sensors were assembled, MTRI personnel drove across the Plymouth Road bridge over US-23 (MDOT Structure ID 10873). MTRI drove across the bridge enough times to collect 3DOBS and BVRCS data for each of the bridge’s four lanes (Figure 49). During the collection, MDOT personnel stood alongside of the road and observed how quickly bridge condition data was collected using these two systems. After completing the data collection, MTRI disassembled 3DOBS and BVRCS at the AAATA “Park and Ride” while also answering questions that MDOT personnel had after observing the live data collection demonstration.

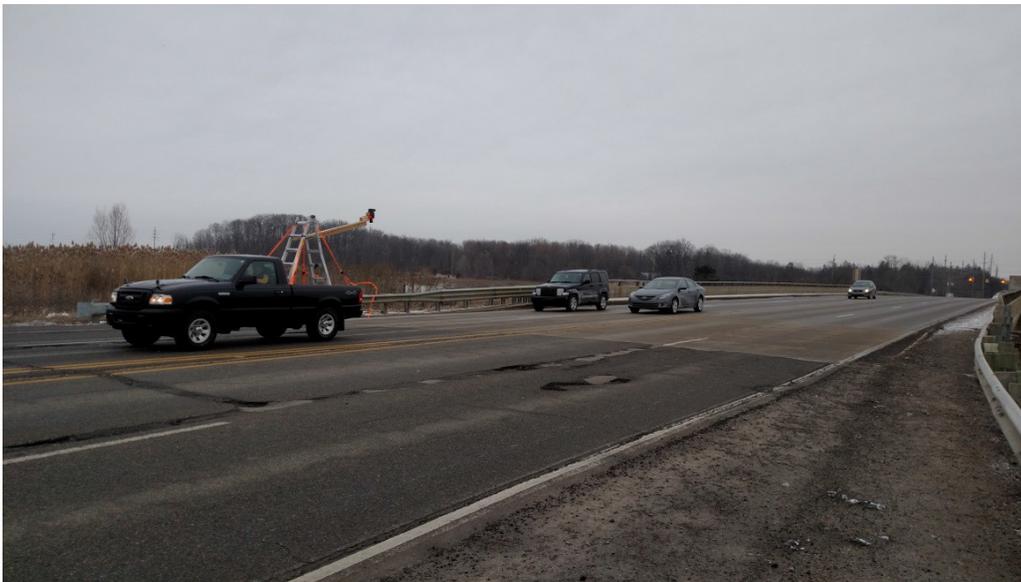
**Figure 49: 3DOBS and BVRCS being driven across the Plymouth Road bridge for the data collection demonstration.**

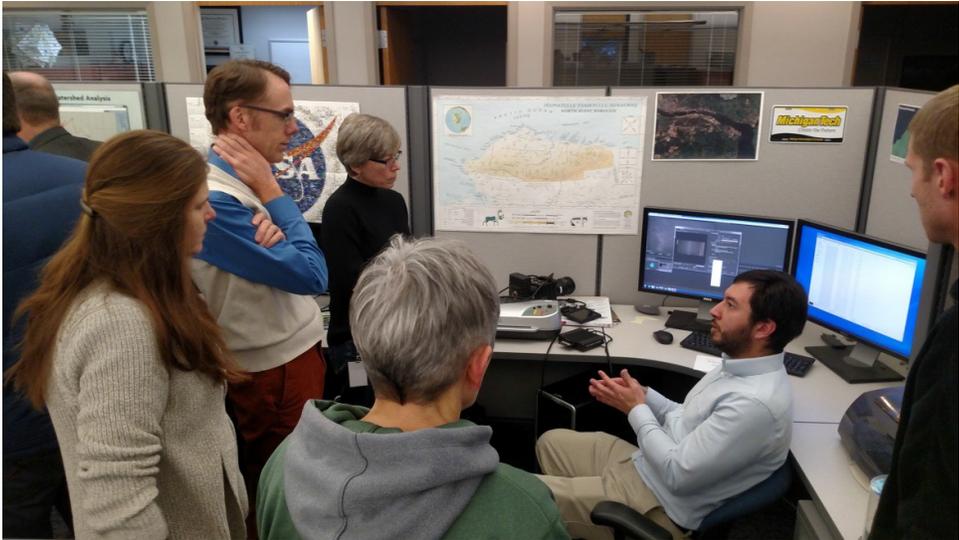
**Figure 51: MTRI project team member, Rick Dobson, providing an overview of 3DOBS imagery processing and output.**

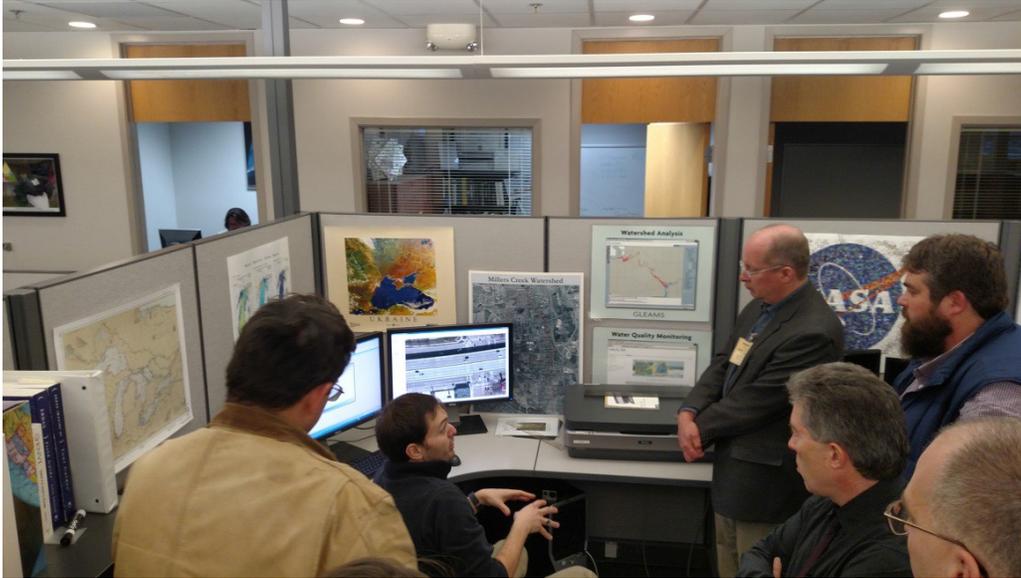
Figure 52: MTRI project team member, David Banach, providing an overview of BVRCS imagery processing and output.
