FIELD TESTS OF EPOXY GROUT AND EXPANSION ANCHORS
Supplement to Research Report No. R-579

Research Laboratory Division
Office of Testing and Research
Research Project 65 F-85 (1)
Research Report No. R-619

State of Michigan
Department of State Highways
Lansing, January 1967

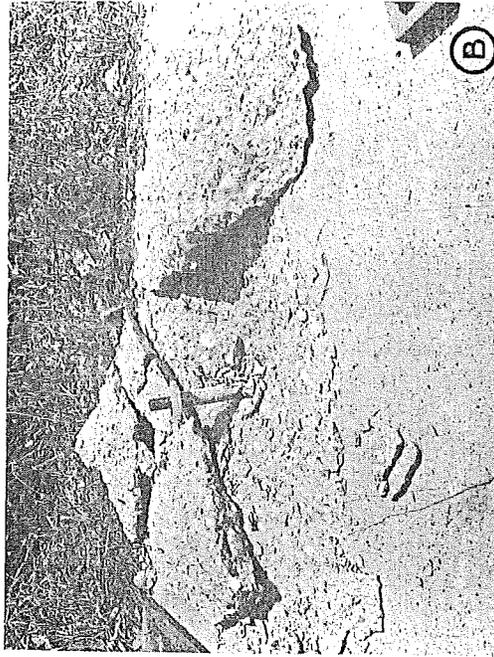
650 psi

1300 psi

910 psi

Figure 4. Series 1 specimens in 7-in. holes included a) one with small amount of concrete failure and considerable shear bond failure, indicating poor bond due to dust in hole (left); b) strongest specimen, with large concrete spill and some epoxy-steel bond failure (center); and c) typical failure of average strength anchorage (right). Psi values given are nominal epoxy-concrete shear-bond stress at failure.

test series is shown in Figure 4c. The second series of test installations was then made, using a more thorough cleaning method, with brushes and water. Results of the second test series are also given in Table 1. Typical failures of the deeper anchorages were similar to Figures 4b and 4c. Nominal epoxy-concrete shear bond stresses at failure ranged from 1,100 to 1,800 psi and averaged more than 1,300 psi, a considerable improvement over the results of Series 1. Some of this increase in pull-out strength may have been due to the concrete used for Series 2, which was somewhat stronger than for Series 1. However, little benefit could have been derived from the stronger concrete, if the epoxy-concrete bond had been insufficient to transfer the load to the concrete. Several anchorages were set at various distances from the edge of the slab to determine the extent to which edge distance would affect

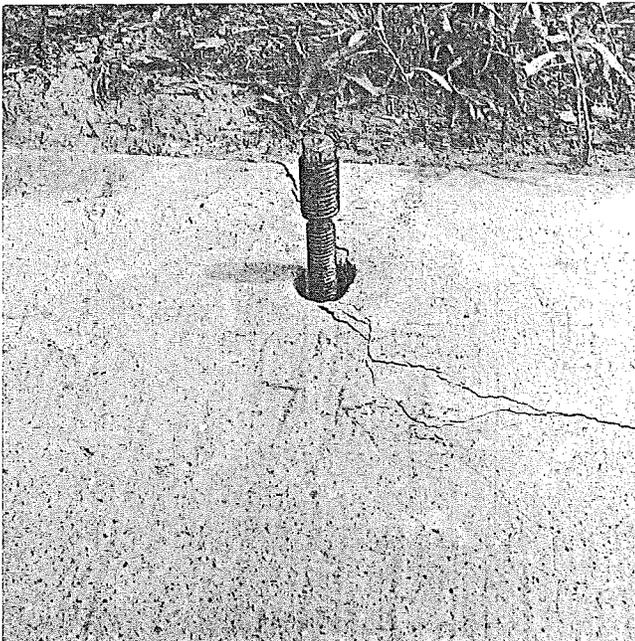
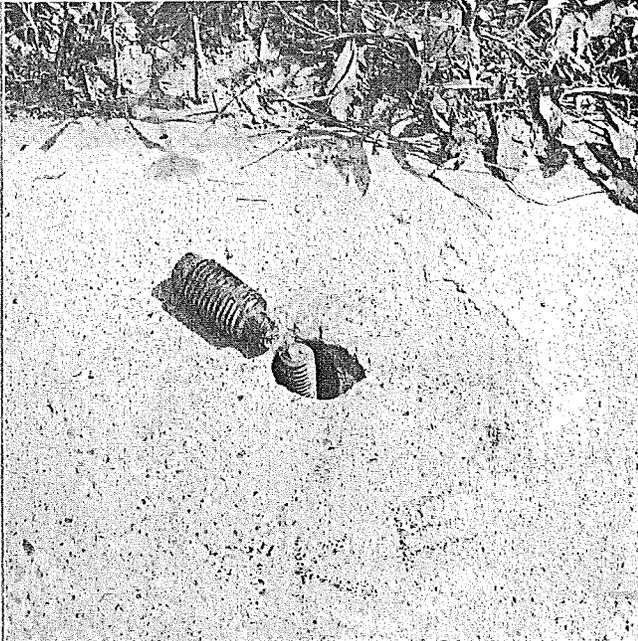
7-in. Deep
6 in. From Edge

Figure 7. Expansion anchor broke large corner from slab even though 1-1/2 ft from transverse joint (left), but another (right) far from transverse joint developed full strength of the bolt without damage to the pavement.

Twelve 3/4-in. Bethlehem K-1 expansion anchors were included in the field tests, with the results given in Table 2. All of the anchors were set in nominal 1-1/4 in. diam holes, 7 in. deep. Various edge distances were tried, as shown in the table, to establish the minimum distance required to develop the full strength of the anchor bolt. Anchors set at 3-1/2 and 5-1/2 in. from the pavement edge failed as shown in Figure 6, by spalling out full depth to the pavement edge. One anchor set 6 in. from the pavement edge failed by breaking a large corner off the slab (Fig. 7a), even though the distance to the transverse pavement joint was about 1-1/2 ft. This indicates that caution is required in selection of locations for such anchors near joints or corners. Another anchor with 6-in. edge distance, set far from a transverse joint, developed the full strength of the bolt without damage to the slab (Fig. 7b). Anchors set in the interior of the slab developed the full strength of the bolt and failed in the same manner shown in Figure 7b.
