"PARLON"-BASED CURING AND SEALING COMPOUNDS
SECOND PROGRESS REPORT

MICHIGAN DEPARTMENT OF STATE HIGHWAYS

Research Laboratory Section
Testing and Research Division
Research Project 63 NM-96
Research Report No. R-662

State of Michigan
Department of State Highways
Lansing, March 1968

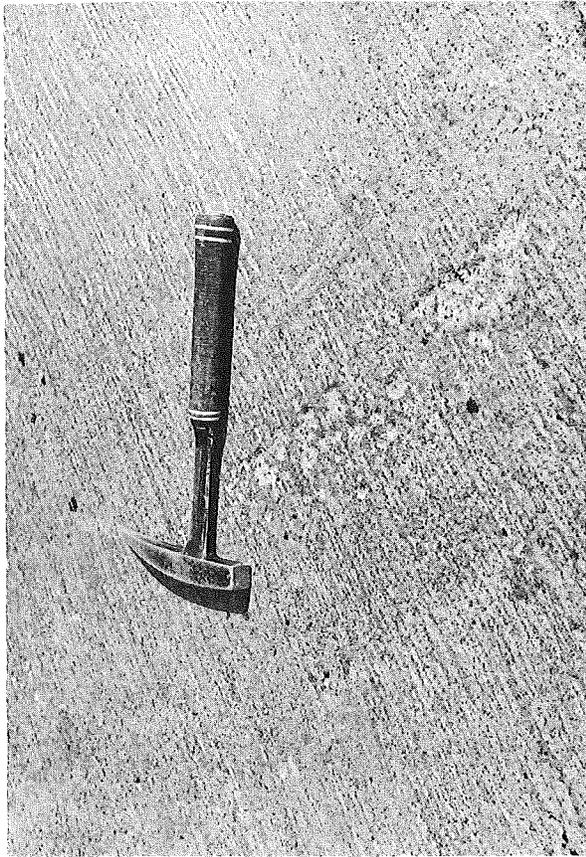
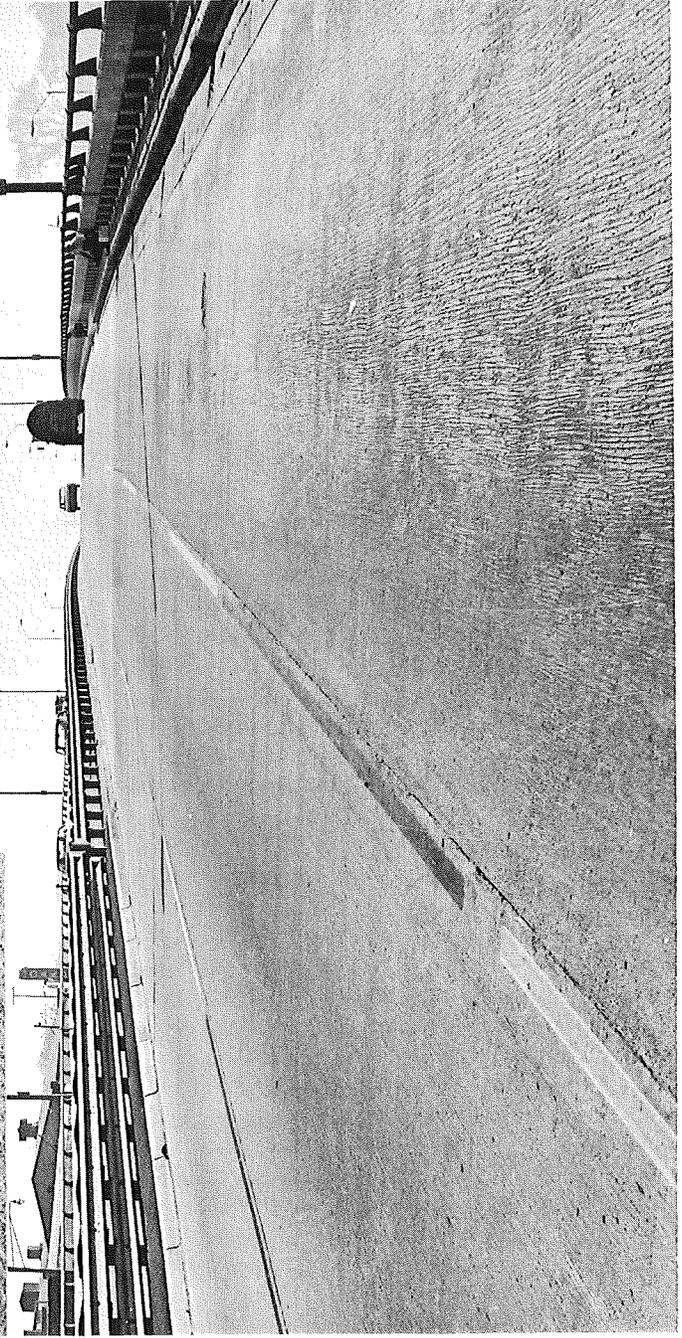
Figure 1. Eight Mile Rd Bridge over I 75.

When first inspected (November 16, 1966), it was noted that the white membrane curing compound had a yellowish-white color, the white Euco had a brilliant white color, and the clear Euco was colorless. On December 21, 1966, the bridge was opened to traffic and was in service almost one full year before it was inspected again (September 15, 1967). At this time, the appearance of the deck was generally very good. Both the white membrane curing compound and the white Euco were mostly worn off the eastbound traffic areas, but were still visible along the curb lines. The spans protected with clear or white Euco were completely free of scale, but small isolated areas of light scale were starting to develop on the spans cured with white membrane curing compound. This light scale was most prominent in span six of the eastbound roadway. Figure 1 shows the bridge and this scaling.

Scale developing in center lane of span 6.

Eastbound roadway of Eight Mile Rd Bridge over I 75.

The Eight Mile Rd Bridge has undergone one complete operational winter and at this time shows negligible weather damage. The clear and white Euco-treated areas are all in good condition and only the first eight eastbound spans cured with conventional white membrane show any signs of beginning scale. Another winter's exposure may produce more obvious differences in the sealant coatings in combination with the slag aggregate concrete.

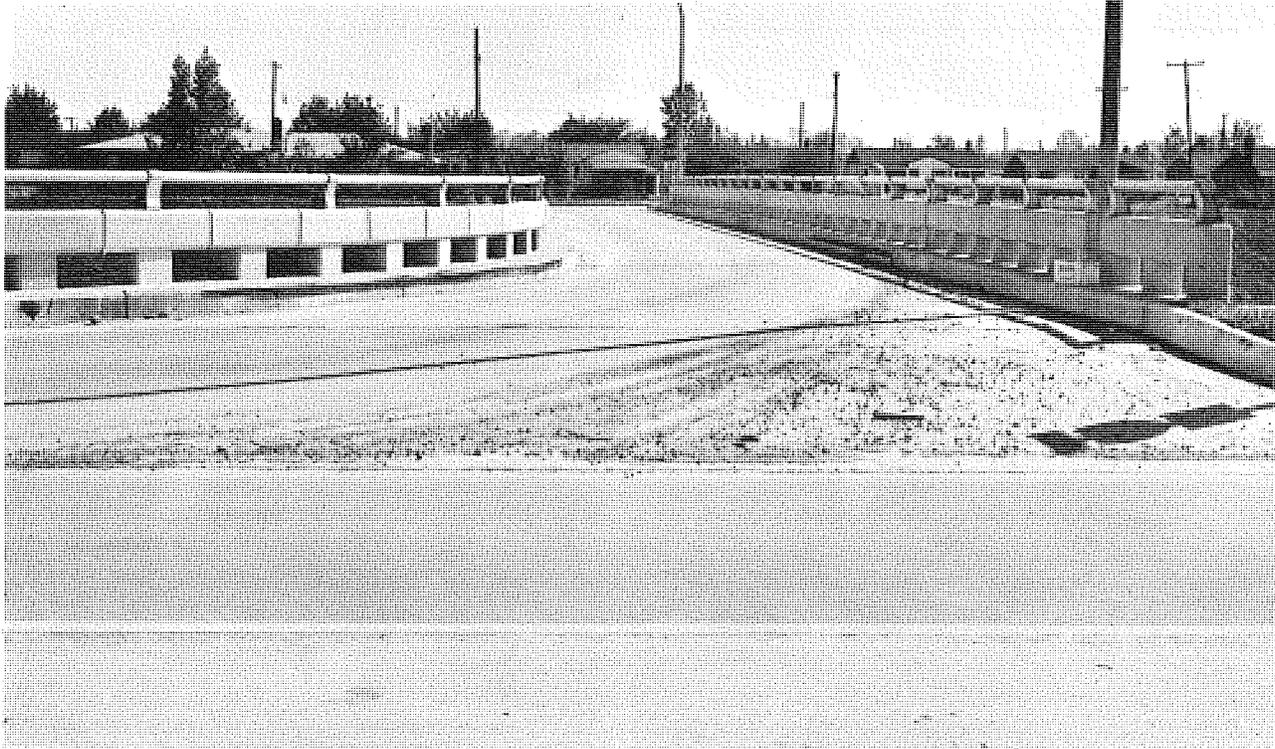
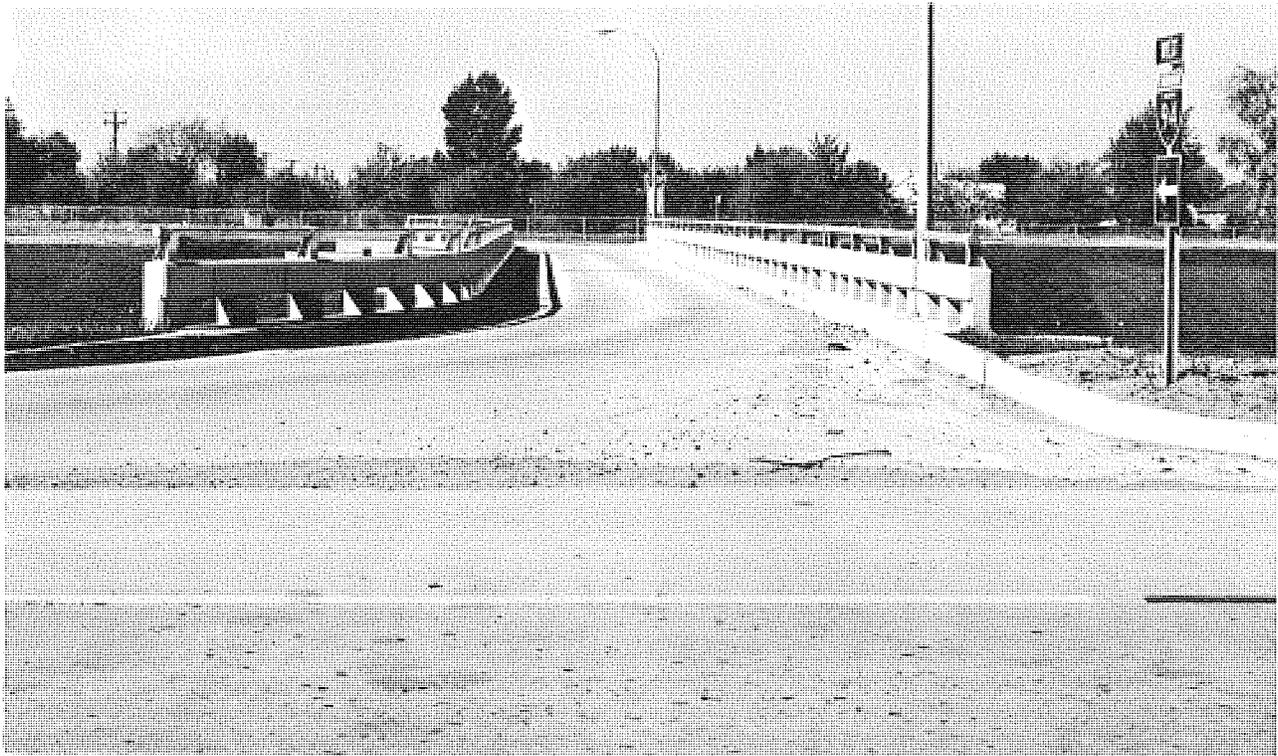
Figure 2. Left-turn structures over I 94 at Twelve Mile Rd.

Our second inspection was made on October 3, 1967. At this time the bridges had been open to traffic for about three months but had not undergone an operational winter. Figure 2 shows the bridge decks of S14 and S16. The white Euco was plainly visible on the entire surface except where it had been darkened or removed by traffic. In general the concrete decks looked very good and were free of scaling and cracks; however, areas of deficient consolidation were noticed on the sidewalks and parapet rails of both bridges.

S14 Bridge deck as viewed from west approach.
S16 Bridge deck as viewed from east approach.

The two left-turn structures at Twelve Mile Rd over I 94 have not undergone an operational winter yet and thus have not been subjected to any destructive weathering action. The original intent on these bridges was never to use them as a part of an experimental testing program, but rather to protect the "green" concrete from ice removal chemicals that were expected in the anticipated early opening date to traffic.

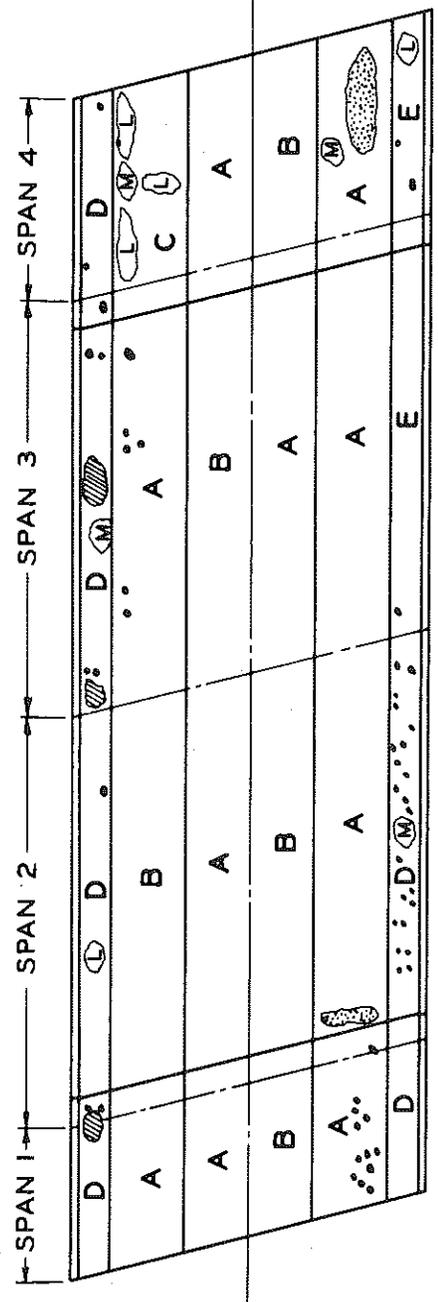
Figure 3. Weathering damage on Nine Mile Rd Bridge over I 75 (May, 1967).

The Nine Mile Rd Bridge has four spans, consisting of a concrete deck on steel stringers and four traffic lanes. The concrete deck was poured in late November 1965. Ten deck pours were sprayed with white Euco the day after they were poured and one was sealed with two coats of a mixture of 40-percent boiled linseed oil and 60-percent naphtha (white gas). The actual coverage was reported to have been excessively heavy (76 sq ft per gal for each coat). Six sidewalk pours were cured and sealed with clear Euco sprayed on fresh concrete, and two sidewalk pours were sprayed with clear Euco the day after they were poured (Fig. 3). The bridge was opened to traffic in January 1966.

The bridge was first inspected on September 9, 1966, and covered in the First Progress Report (R-617). At this time the prominent plastic shrinkage cracks were described, but no significant weathering had occurred. At the time of the second bridge inspection (May 3, 1967), certain portions of the deck had begun to exhibit signs of weathering and traffic damage. Figure 3 shows the location and extent of this damage. This figure shows that the deck pours are still free of significant weathering damage with the exception of the westbound traffic lane of span four which has developed much scale, and the eastbound traffic lane of span one which has developed many pop-outs. The south sidewalk of span two has also developed many pop-outs. On the eastbound traffic lanes of spans two and four, there are large areas of traffic abrasion caused by braking vehicles. The photographs in Figure 4 show some of the traffic and weathering damage diagrammed in Figure 3. The westbound traffic lane of span four which was coated with linseed oil-naphtha never showed any signs of puddled linseed oil scum along the curb line.

The weathering diagrams (Figs. 3 and 5) were inspected and the numerical values for the various types of weathering damage observed were totaled by spans for the sidewalks and for each traffic lane. The results of these ratings are given in Tables 1 and 2.

On the Nine Mile Rd Bridge, three different sealants were used with three different methods of application, resulting in five different sealant combinations. Thus, on eight traffic lane spans there were six where white Euco was applied to fresh concrete, one where white Euco was applied to day old concrete, and one where linseed oil-naphtha was applied to cured concrete. On eight passing lane spans, four were sealed with white Euco

Table 1 shows that of the six traffic lane spans that were sealed with white Euco on fresh concrete, sealant performance on three of them was rated excellent, with little or no weathering damage. On the other three, the sealant performance was rated good, with only light damage inflicted to the concrete. The sealant performance on the one traffic lane span which was sealed with white Euco on day old concrete was rated excellent while the performance on the traffic lane sealed with linseed oil-naphtha was rated poor, with extensive weathering damage inflicted to the concrete. Table 1 also shows that the sealant performance on all the passing lane spans was rated excellent. Of the six sidewalk spans sealed with clear Euco on fresh concrete, two gave excellent performance, two were rated good, one fair, and one poor. Of the two sidewalk spans sealed with clear Euco on day old concrete, one gave excellent and the other good performance.

The pour protected with linseed oil presents an enigma. The degree of scaling in this pour is not typical of properly proportioned air entrained concrete after only two winters exposure. In addition, the linseed oil-naphtha sealant, applied at the reported heavy rate, could have been expected to provide a considerable degree of protection; similar to its performance on the John R. Bridge.

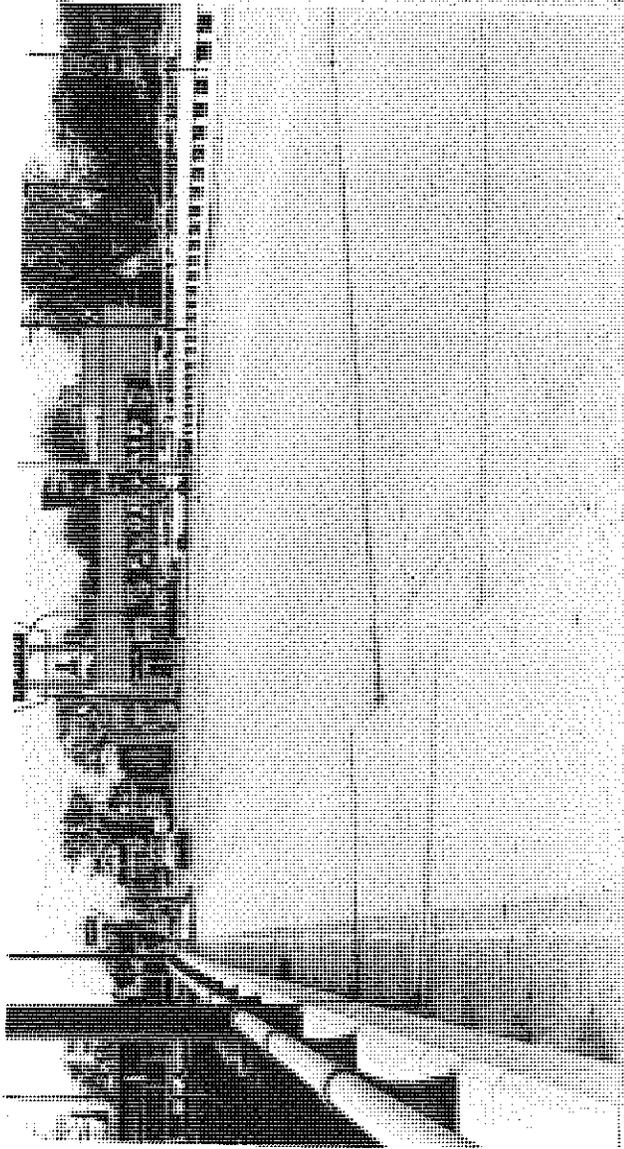
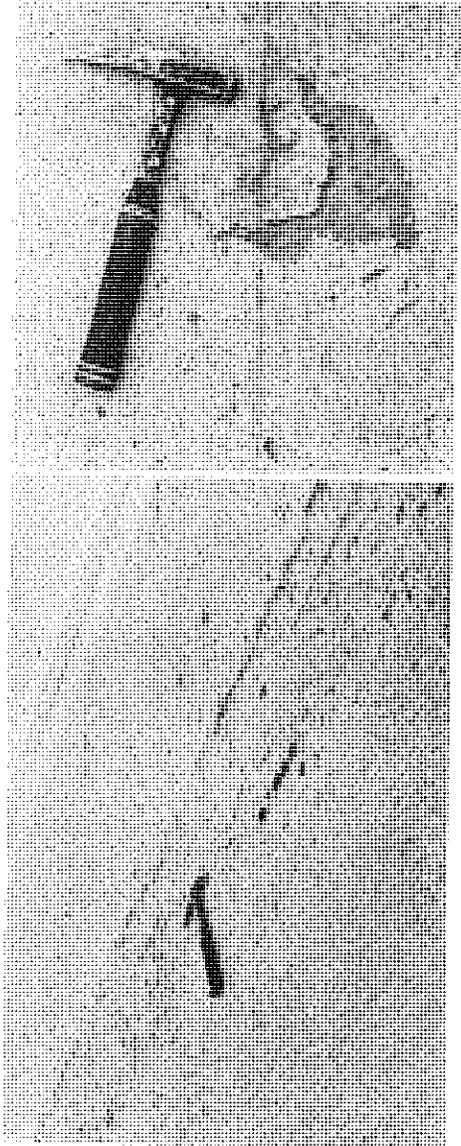
Figure 4. Nine Mile Rd Bridge
Over I 75.

Nine Mile Rd Bridge deck looking west.

Heavy abrasion on eastbound traffic lane at south side of span 4.

Scale on south sidewalk of Bridge in center of span 3.

Scale along North curb line in span 4.

The plastic shrinkage cracks, described in the first report, were repaired on September 15, 1967; the treatment is described in a separate report entitled, "Repair of Plastic Shrinkage Cracks in the Deck of the Nine Mile Road Bridge Over I 75" Research Report No. R-667.

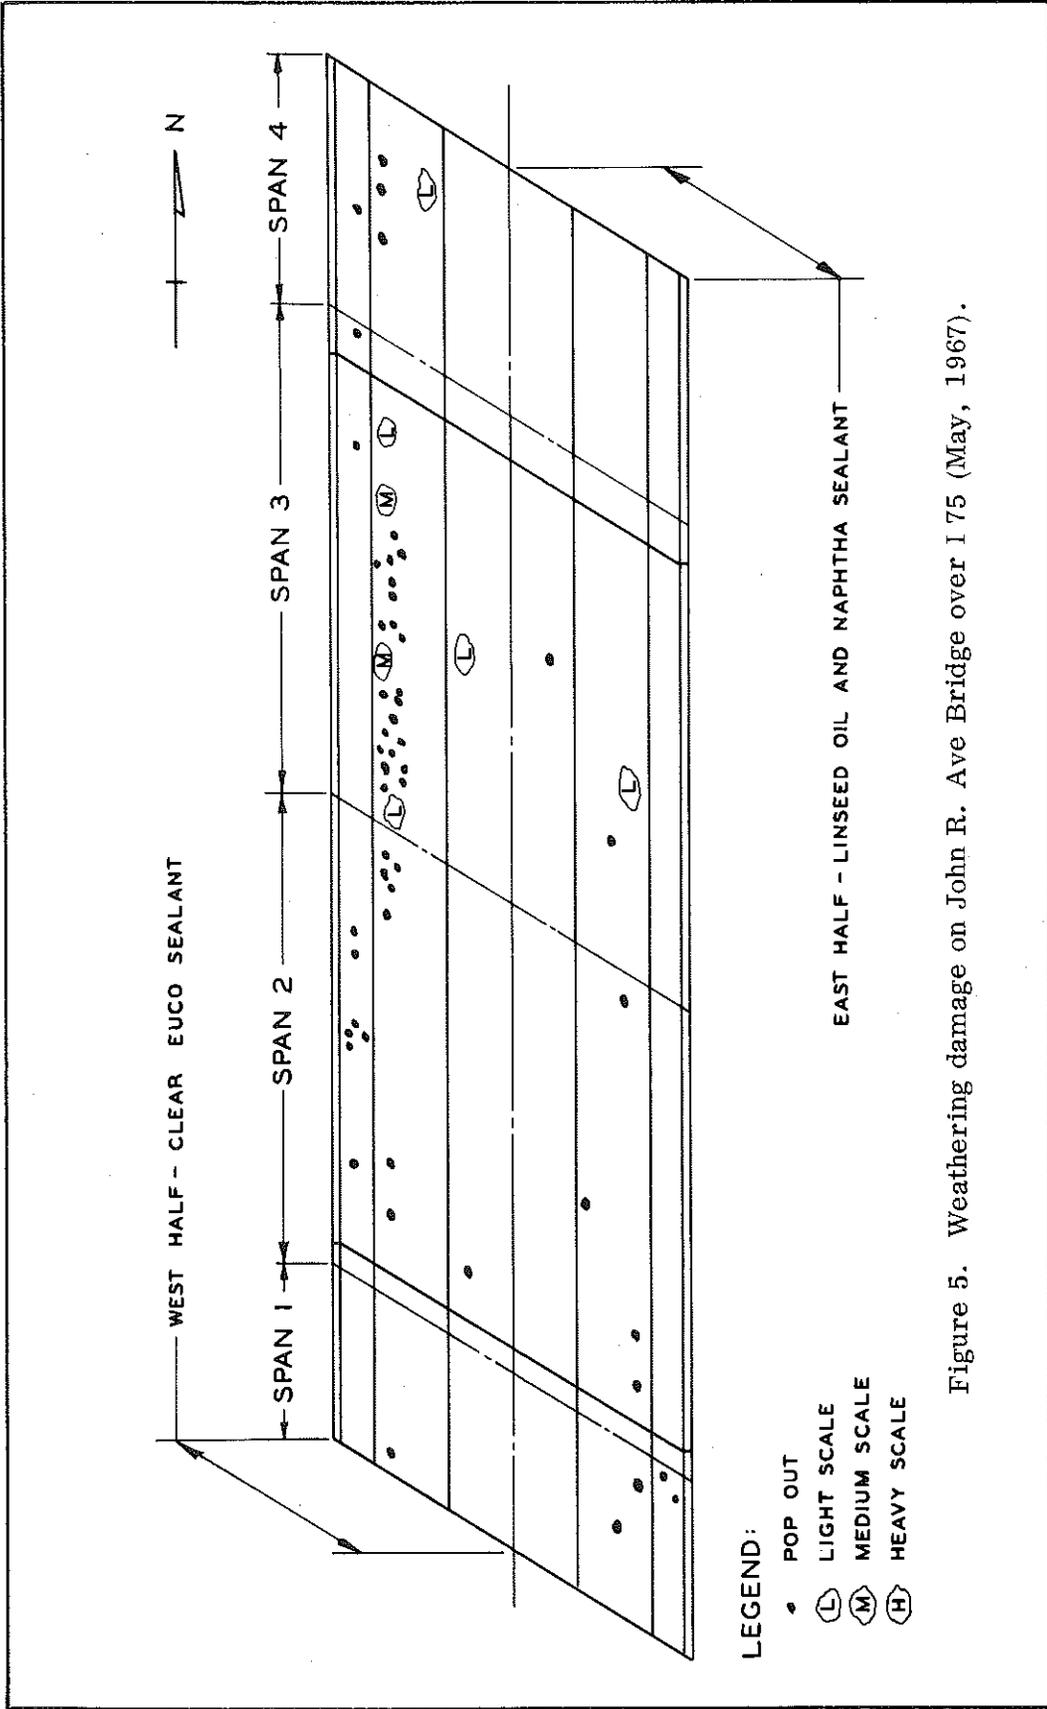
Figure 5. Weathering damage on John R. Ave Bridge over I 75 (May, 1967).

Figure 5 is a diagram of the bridge deck which indicates the sealant used and the weather damage incurred as of May 3, 1967. At that time it was noted that the linseed oil scum which was so prominent along the east curb line in September 1966, was now almost gone; however, the linseed oil sealant appeared to be doing an excellent job since both northbound lanes were in fine condition except for a few shale or chert pop-outs in each of the first three spans.

On spans one, two, and four of the southbound roadway, the clear Euco afforded equal protection to that of the linseed oil-naphtha mixture; however, the traffic lane of span three did not fare as well. About 2 ft from the curb line throughout the full length of span three, a large number of pop-outs and spots of light scale had developed.

The east and west sidewalks which were sealed with the linseed oil-naphtha mixture and clear Euco, respectively, presented the same general appearance as the bridge deck slab. All the sidewalks seemed to receive excellent protection except the west sidewalk of span two which had developed several pop-outs.

On the northbound side sealed with linseed oil-naphtha, the sealant performance on three of the traffic lane spans was rated excellent while the fourth was rated good (Table 2). On all of the passing lane and sidewalk spans, the sealant performance was also rated excellent.

On the southbound side sealed with clear Euco, sealant performance on the traffic lane was rated excellent for one span, good for two other spans, and poor for the fourth span. Sealant performance on all the sidewalk and passing lane spans was rated excellent except for one sidewalk span where it was rated good.

The results here seem to indicate that the linseed oil is a superior sealant to the clear Euco as they were applied to this bridge deck; however, to reliably substantiate this conclusion, at least two other bridge decks should be sealed in the same manner and observed for several years.

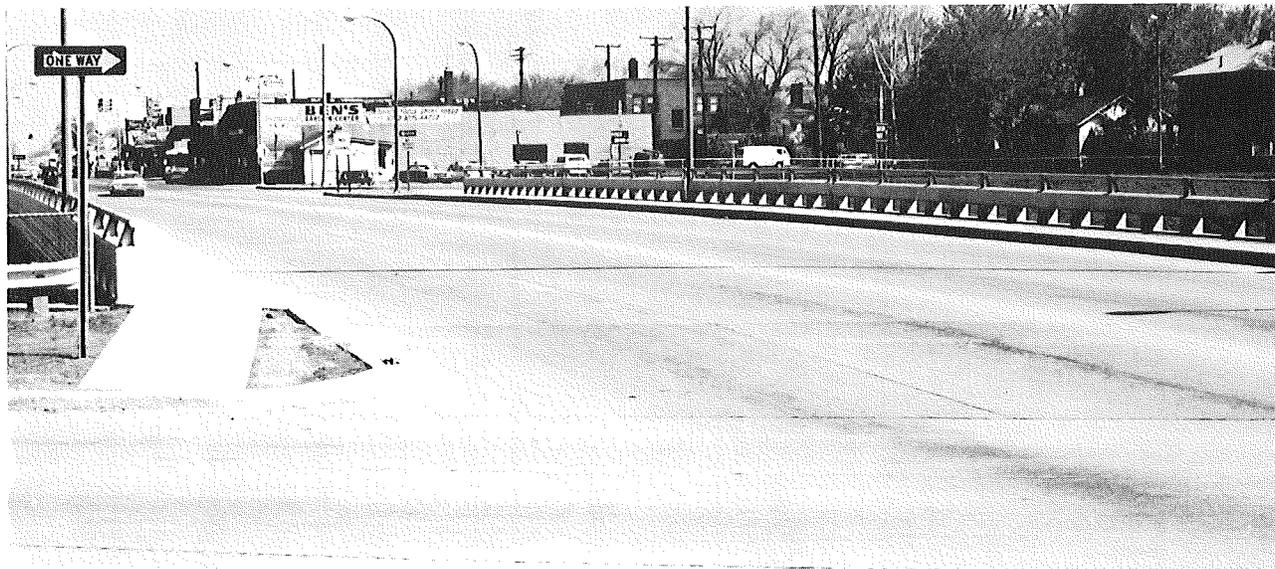
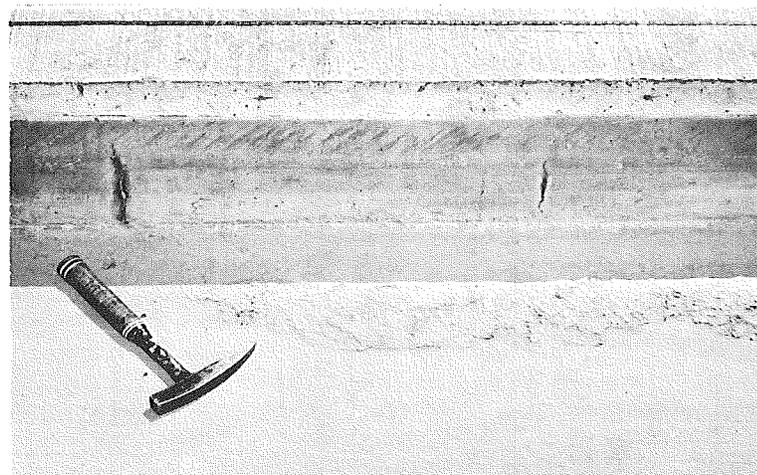
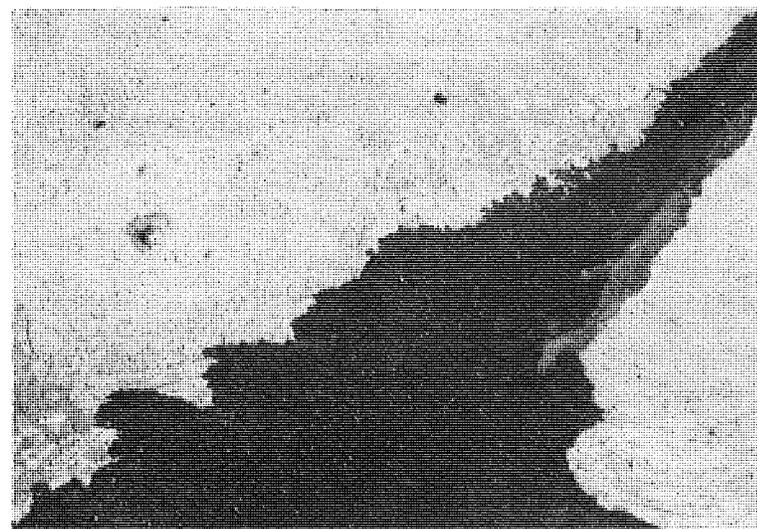
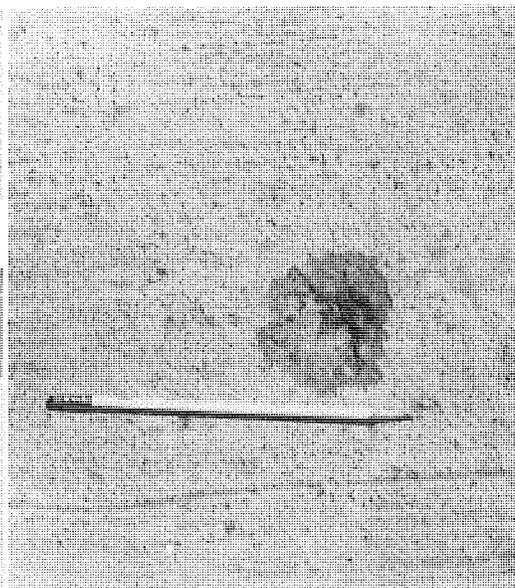
Figure 6. John R. Ave Bridge over I 75.

Figure 6 shows various bridge deck features noticed during the May 3rd inspection.

View of Bridge deck looking north.

Typical pop-out and surrounding light scale in span 3 about 2 ft from west curb line.

Remaining linseed oil scum along east curb.

Typical shale aggregate pop-out on east side of deck over pier 2, span 2.
