MICHIGAN
DEPARTMENT OF STATE HIGHWAYS

Subject: "Alert Reflective Liquid" (Cataphote Corp.): Research Project
67 NM-172. Research Report No. R-713.

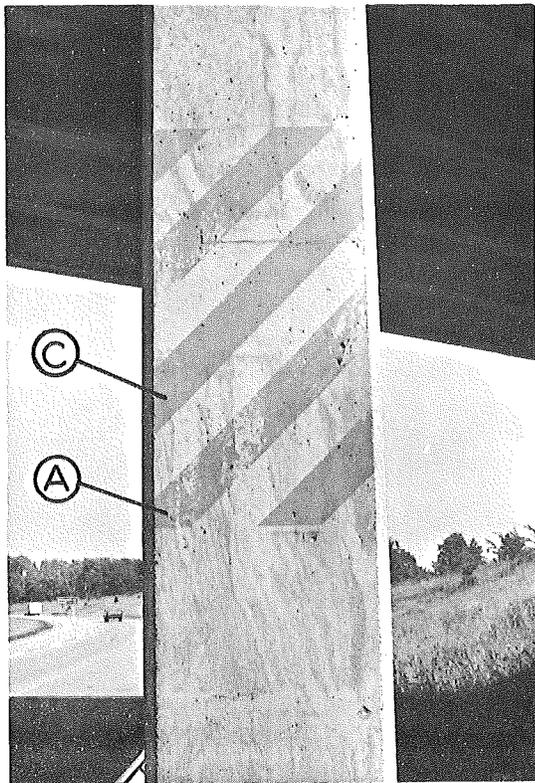
Figure 3. Alternate stripes of "Alert" silver and "Codit" white on Crietz Rd pier, WB I 96. Some flaking loss of silver paint is evidenced after 1-1/2 years of service.

Daytime observations confirmed variable loss of the "Alert" material on one pier (Fig. 2). This condition was also evident to a lesser degree on the other pier and also on the stripes applied earlier on the westbound piers (Fig. 3).

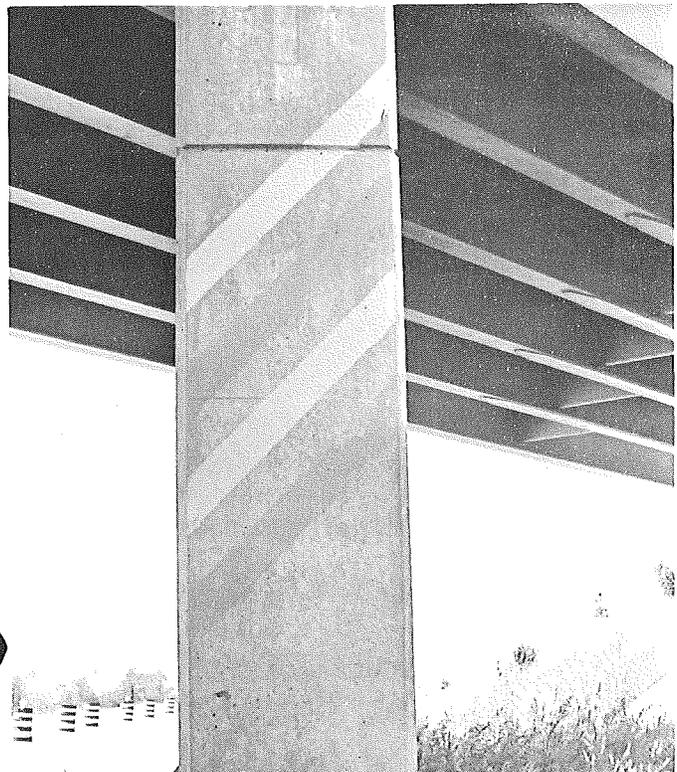
Figure 2. Alternate stripes of "Alert" silver (A) and "Codit" silver (C), Crietz Rd pier, EB I 96. Note flaking loss of the "Alert" after 8 months service (same as right pier in Fig. 1).
