FIELD EVALUATION OF ACID-TREATED OPEN HEARTH
SLAG BASE COURSE
(I 75 - Dearborn St Interchange)
PROGRESS REPORT

Research Laboratory Section
Testing and Research Division
Research Project 68 E-43
Research Report No. R-817

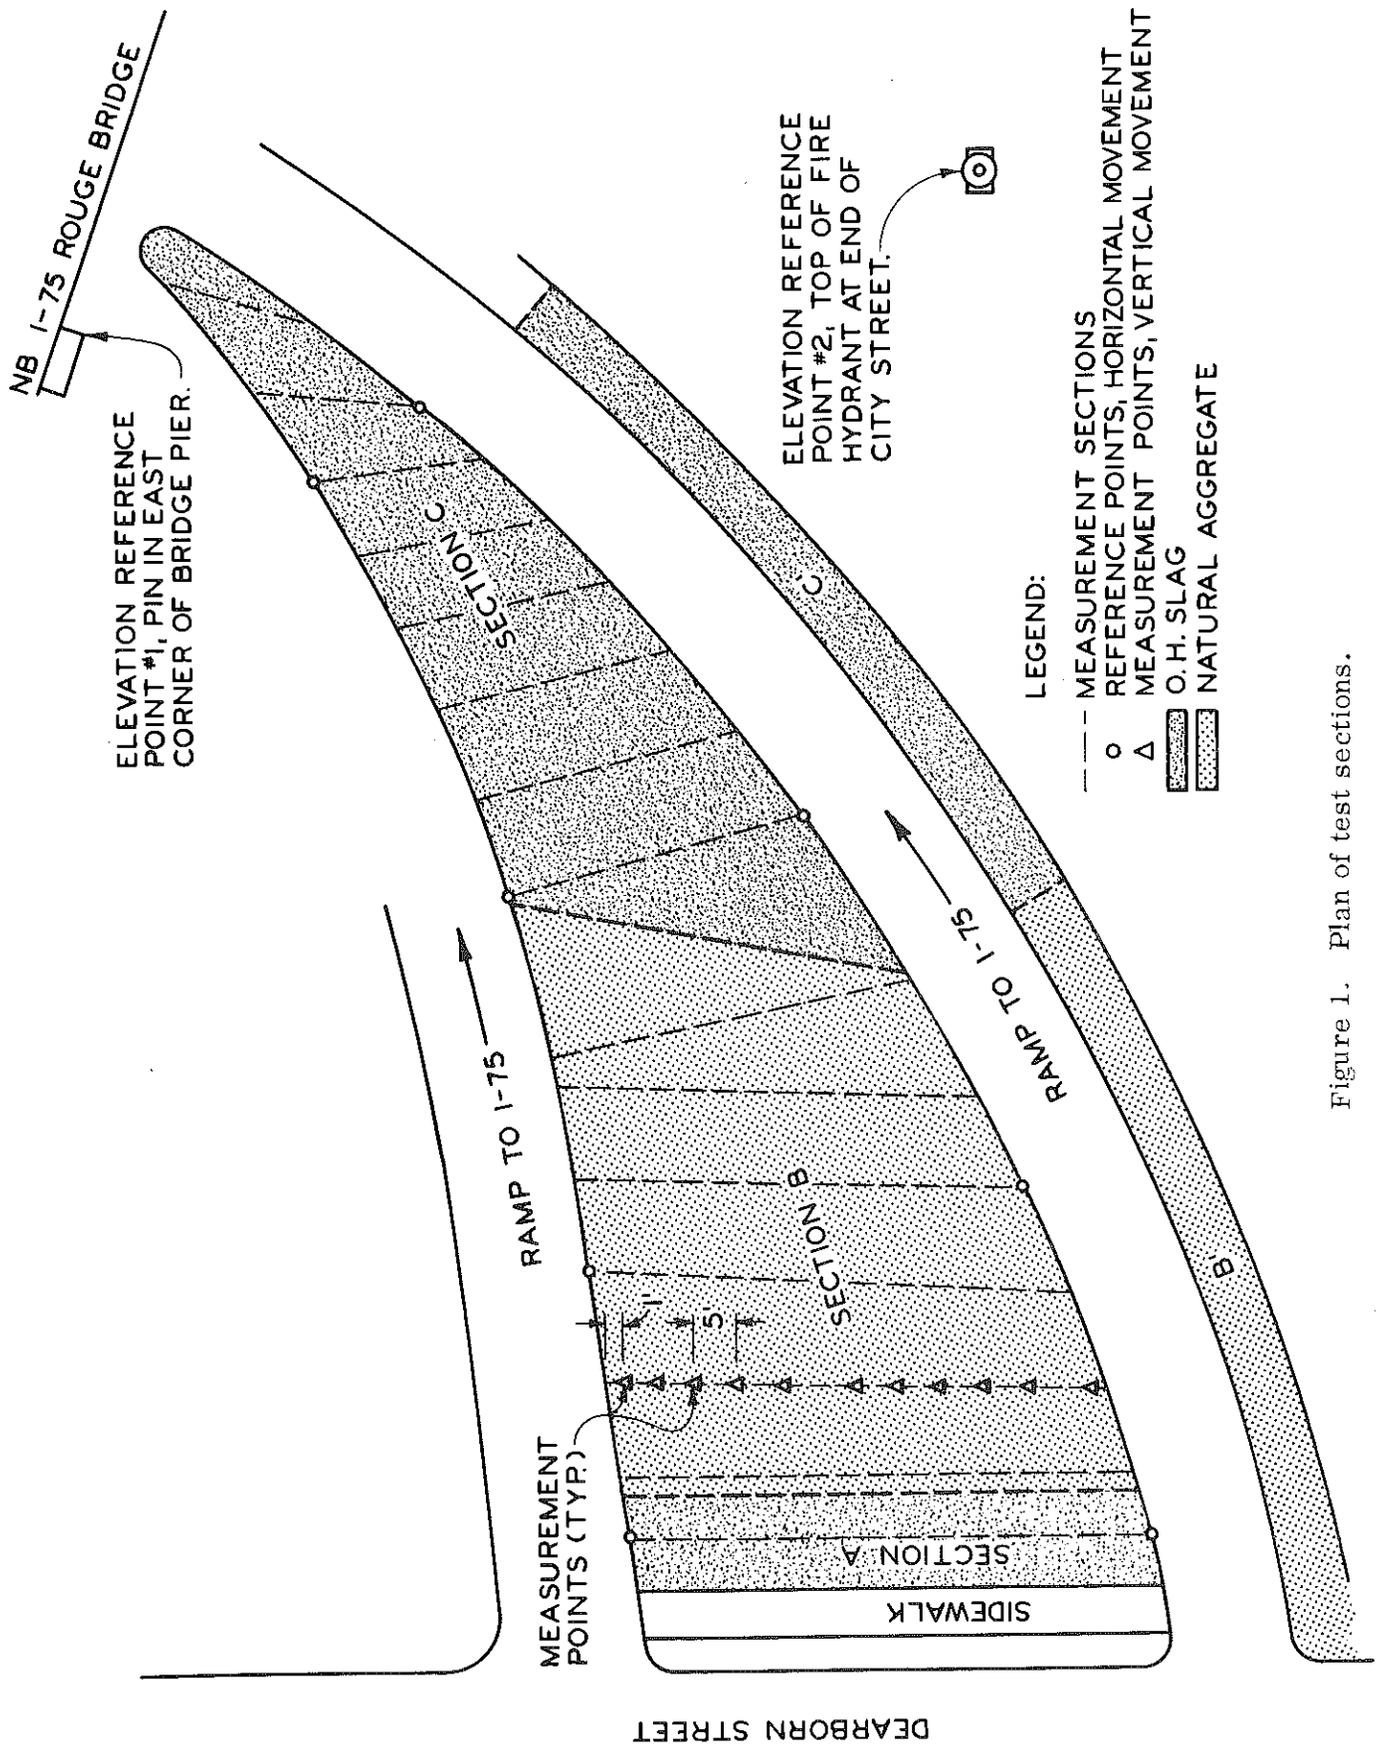
Figure 1. Plan of test sections.

The test areas, shown in Figure 1, were located in and around a traffic island located at the interchange of I 75 and Dearborn St in Detroit. This site originally contained open hearth slag which had experienced severe distress and required reconstruction. Reference elevation points were carefully located and measured at the conclusion of construction so any horizontal or vertical movement of the control and slag sections could be measured periodically. The general appearances of the test areas as built is shown in Figure 2.

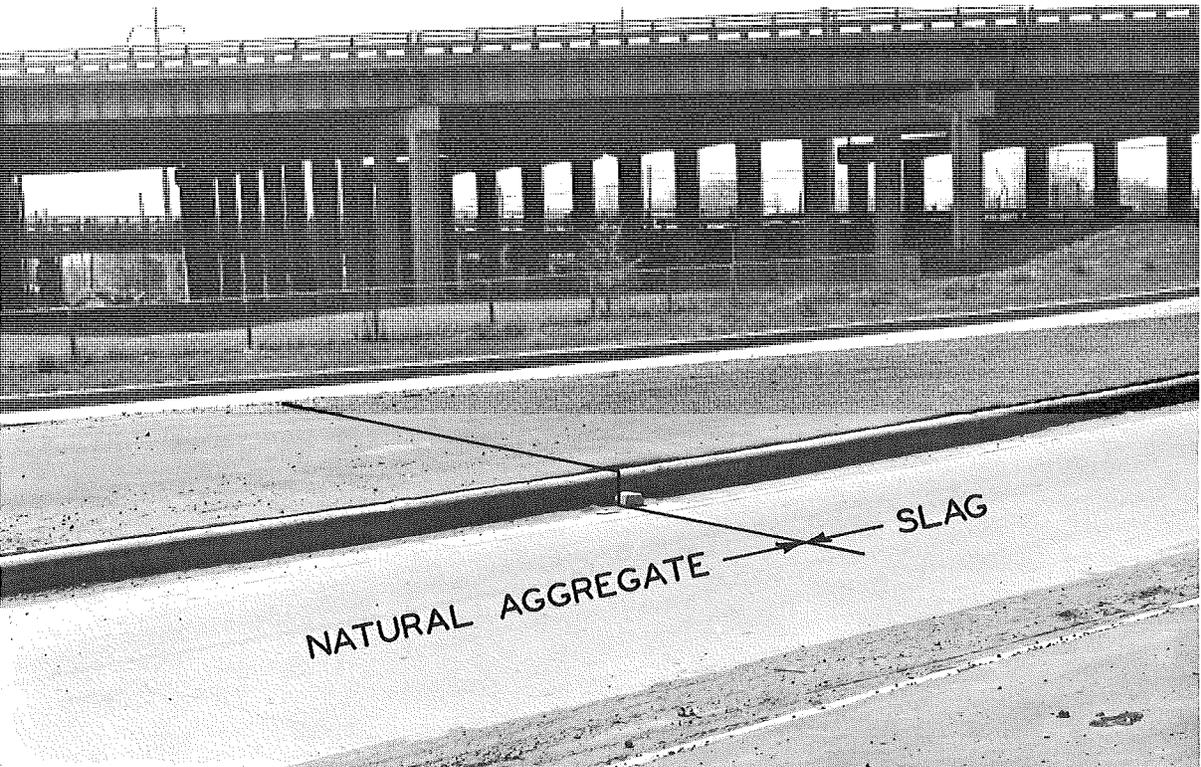
Figure 3. General appearance of the test area after one winter's exposure.

The general appearance of the test area after one winter of exposure (March 29, 1972) is shown in Figure 3. Elevation data through March, 1972 are shown in Figure 4. These observations show that, to date, there has been no severe heaving of the slag area as was experienced on some previous jobs. These data do show, however, that the slag areas heaved through a range of $\frac{3}{8}$ to $1\frac{1}{4}$ in., values about two to three times those measured for natural aggregate. Figures 5 and 6 show local heaving areas in the slag section, some of which indicate possible future trouble. Such heaving appeared greatest near the interface of the aggregate and slag areas and in the narrow, more confined part of the test area. Gradation curves for the aggregate and slag are shown in Figure 7. It should be noted that the natural aggregate contained 10 percent minus 200 material.

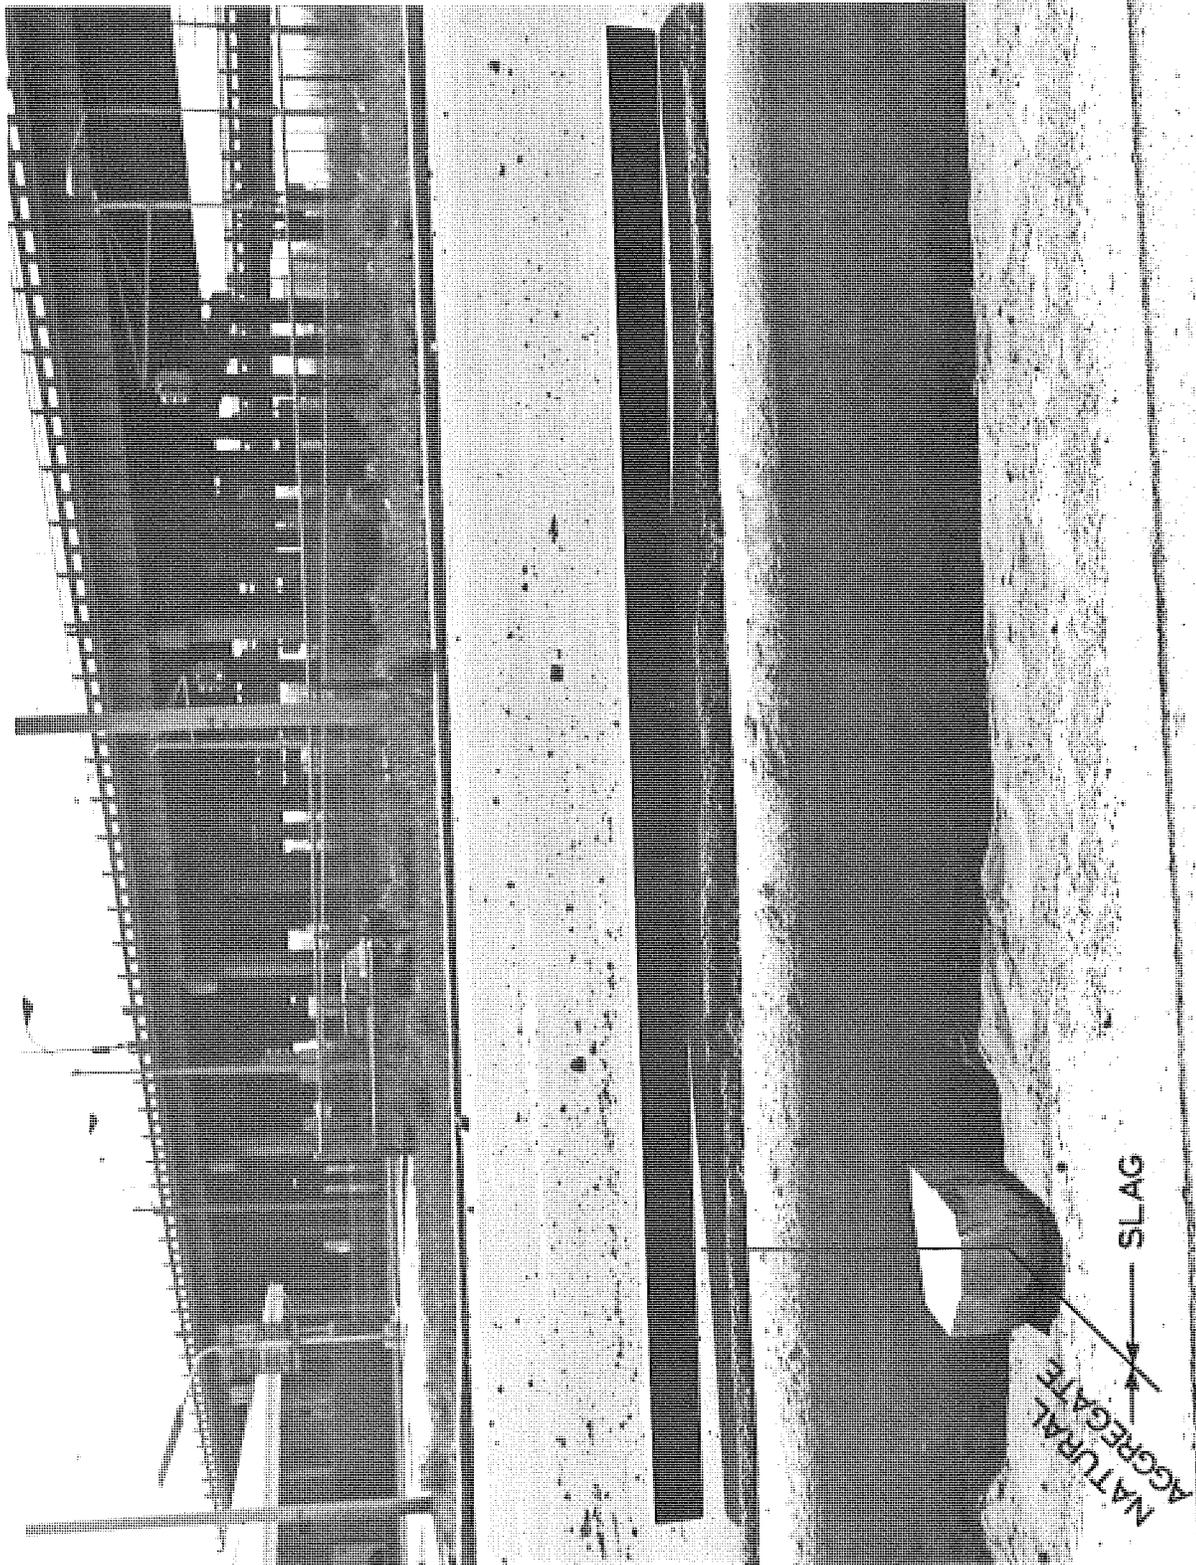
Figure 5. Local heaving area in slag section at aggregate - slag interface.

Because this job was constructed in October it has, so far, not been exposed to prolonged warm weather, a condition thought to accelerate expansion due to chemical action in the slag. For this reason significant conclusions concerning field performances of the slag section may not be available until this Fall. Furthermore, aging of the slag during the cooler months might have prevented expansion that could have taken place had the slag been placed during hot weather. Results, to date, do show, however, that volume change in the slag test area is greater than that in the natural aggregate section (a 22A material containing 10 percent loss-by-washing) and that this condition is duplicated by laboratory tests. Although there has been no severe heaving of the slag area, as was found in some previous construction, there are localized areas where future trouble is indicated.

It is recommended, therefore, that no changes in our present policy concerning the uses of open hearth slag as a base material be made until further observations on these test sections can be made, extending at least through the summer season and, preferably, through one more winter.

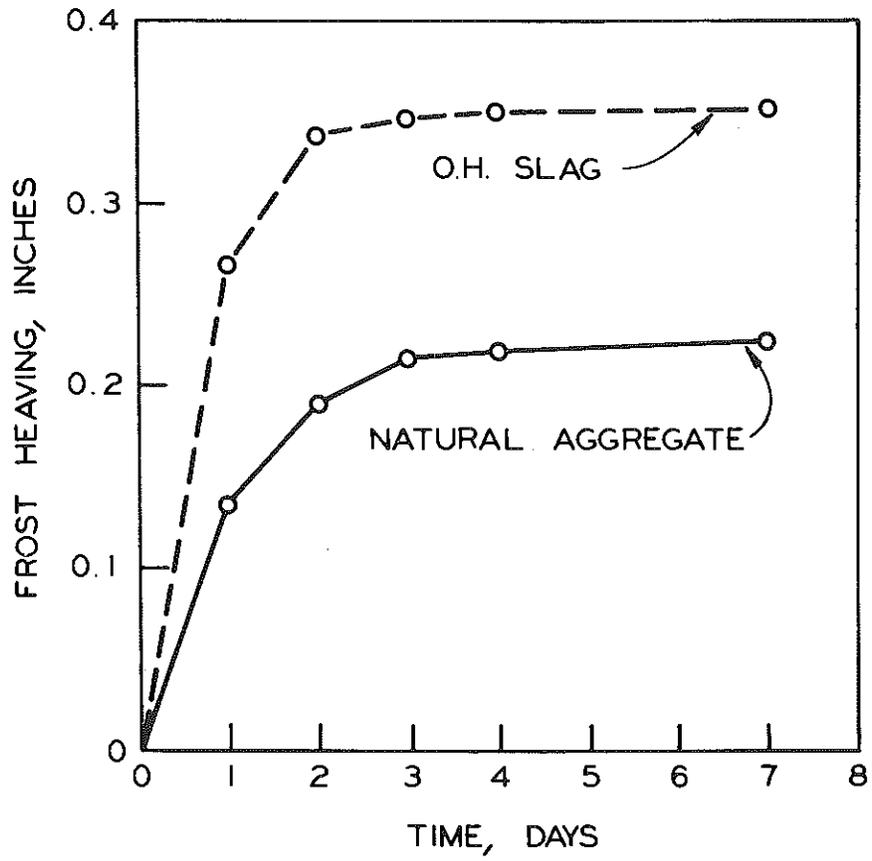
Figure 8. Laboratory frost susceptibility of base aggregates, Dearborn St. Island.

Both volume change (at room temperature in the presence of moisture) and frost susceptibility tests were performed in the laboratory on samples of the slag and natural aggregates used in the field test sections. Results of these tests, shown in Figures 8 and 9 indicate greater volume change for slag samples in both tests. The data, however, show changes in the volume of the slag samples to be much less than similar test values obtained from previous studies. In fact, slag expansion, in the present study, using newly produced acid-treated slag, is no greater than the values obtained with aged slag in the earlier studies (Fig. 9). Because past laboratory tests have shown no improvement due to acid treatment the reduced volume change found in these studies might be due to the use of aged slag which was also present in the stockpile.
