MICHIGAN
DEPARTMENT OF STATE HIGHWAYS

Subject: Paint Peeling on Pressure-Treated Posts: Test Correction by Substituting DuPont "Lucite" Latex for MDSH No. 6B White Paint. Research Project 62 G-114. Research Report No. R-752.

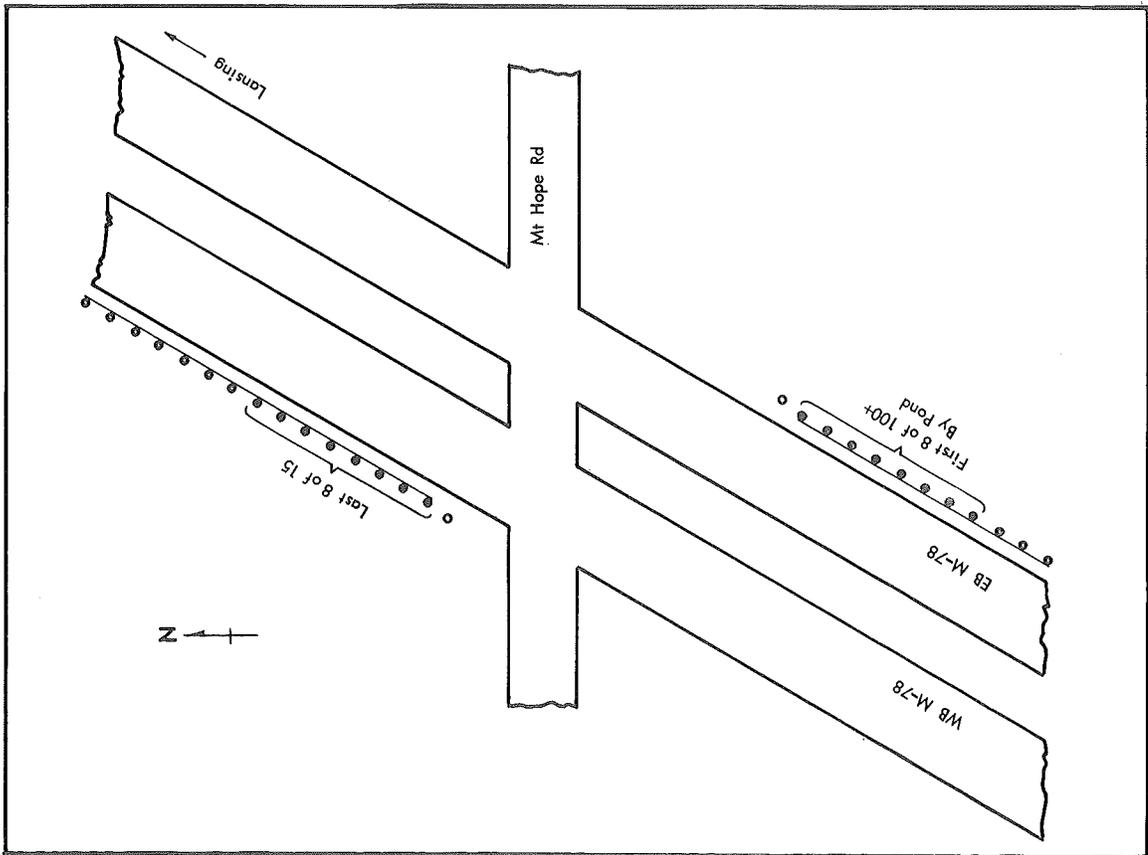
Figure 1. Location of test guardrail posts.

Eight more posts (Fig. 1) on Lansing-bound M 78 west of Mt. Hope Rd were painted and identified in the same manner. The posts selected for painting had been in service for some time (road built in 1953) and the existing paint was generally thick, cracked, and partially flaked off. Each post was scraped to remove the loose paint, then sanded with coarse sandpaper to provide a good base for painting. It was estimated that 20 to 35 percent of tightly adhered old paint remained on the test posts.

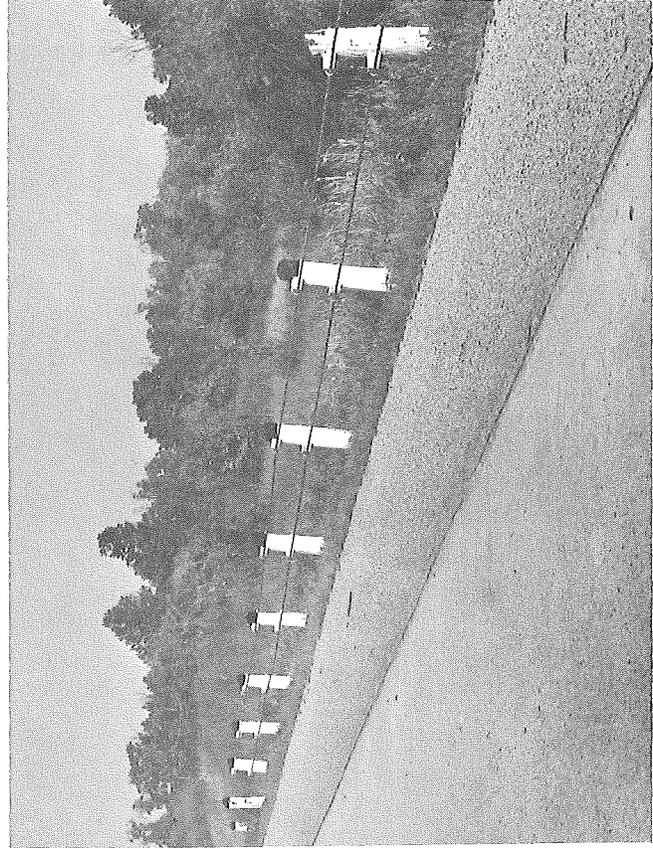
Figure 2. Eight guardrail posts alternately painted with Latex or standard paint. The posts at right and extreme left are outside the paint test area (Lansing-bound US 27, M 78, at Mt. Hope Rd).

Brushability was better on the Lucite and the hiding power was equal to that of the No. 6B white. The black caps were applied on September 25, 1970 as a touch-up for the old, using the standard No. 17A black paint. Figure 2 shows an overall view of this installation.
