PERFORMANCE EVALUATION OF MIXED-IN-PLACE
BITUMINOUS STABILIZED SHOULDER GRAVEL

Research Laboratory Section
Testing and Research Division
Research Project 69 F-111
Research Report No. R-792

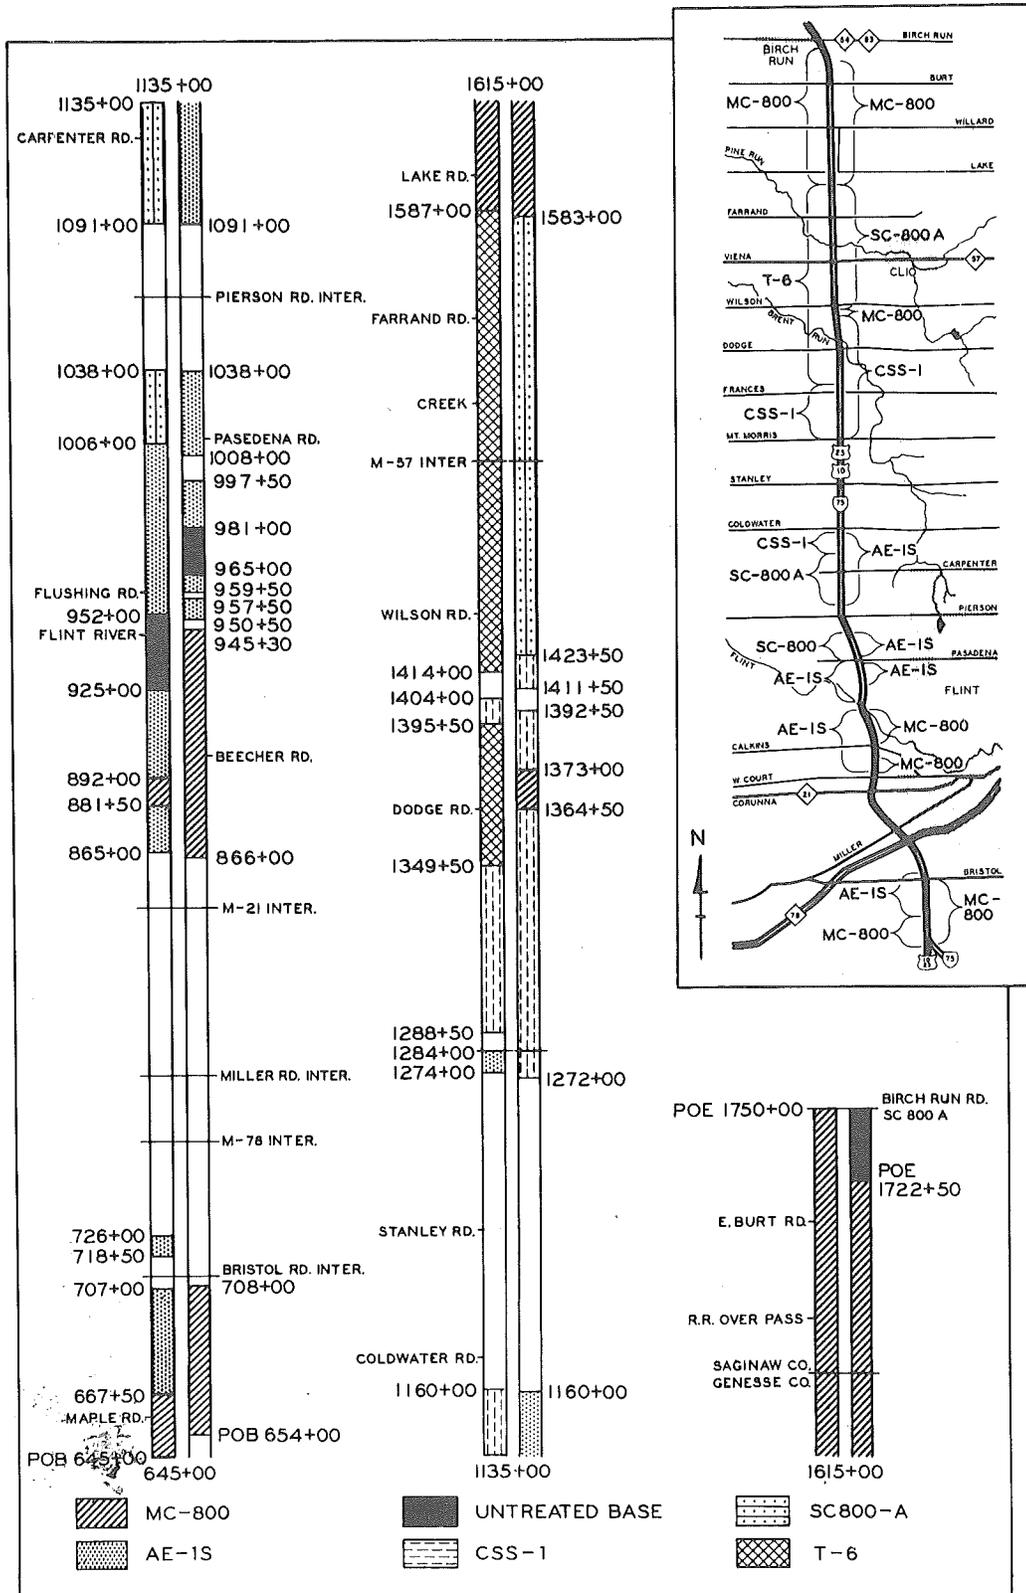
Figure 1. Schematic drawing showing relative locations of shoulder areas treated with P & H Stabilizer.

Five test areas, equal in net length, were to be constructed along each roadway (northbound and southbound) as shown in Figure 1. Areas containing curb and gutter, and areas where existing shoulders had no sand subbase (on the outside of superelevated pavements), were to be excavated and reconstructed as conventional paved shoulders. The lengths of conventional shoulder were to be subtracted from the gross shoulder length in determining net length of experimental shoulder.

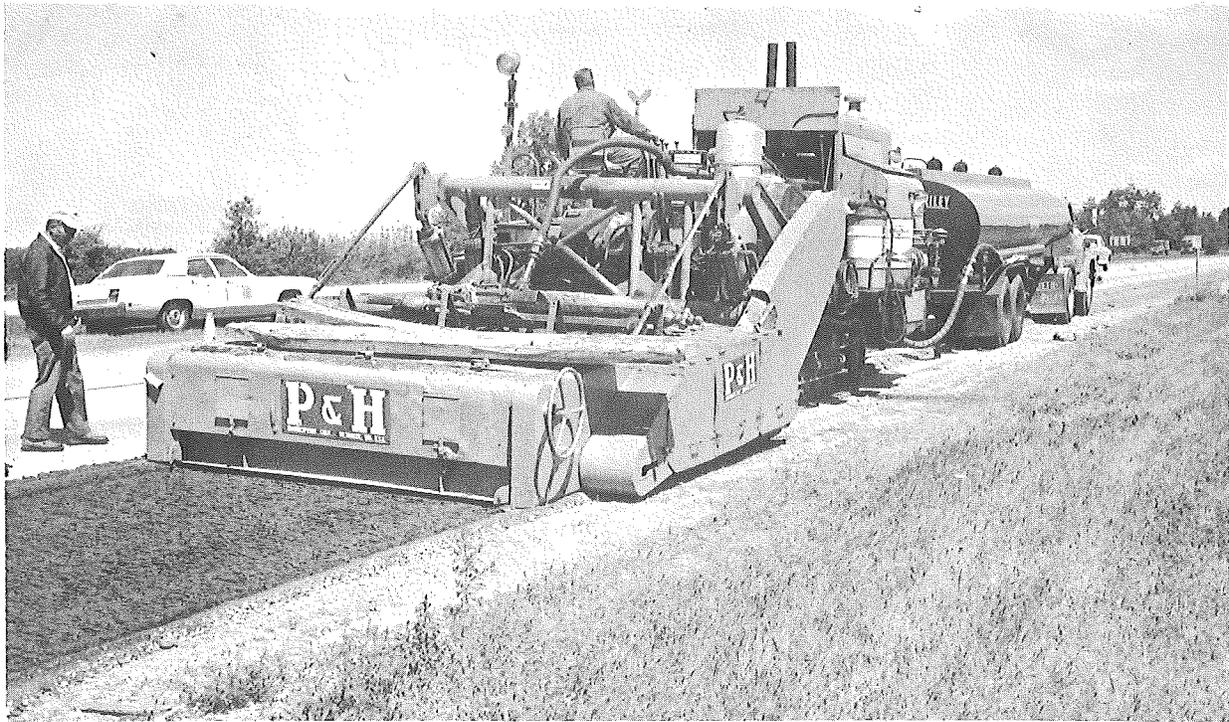
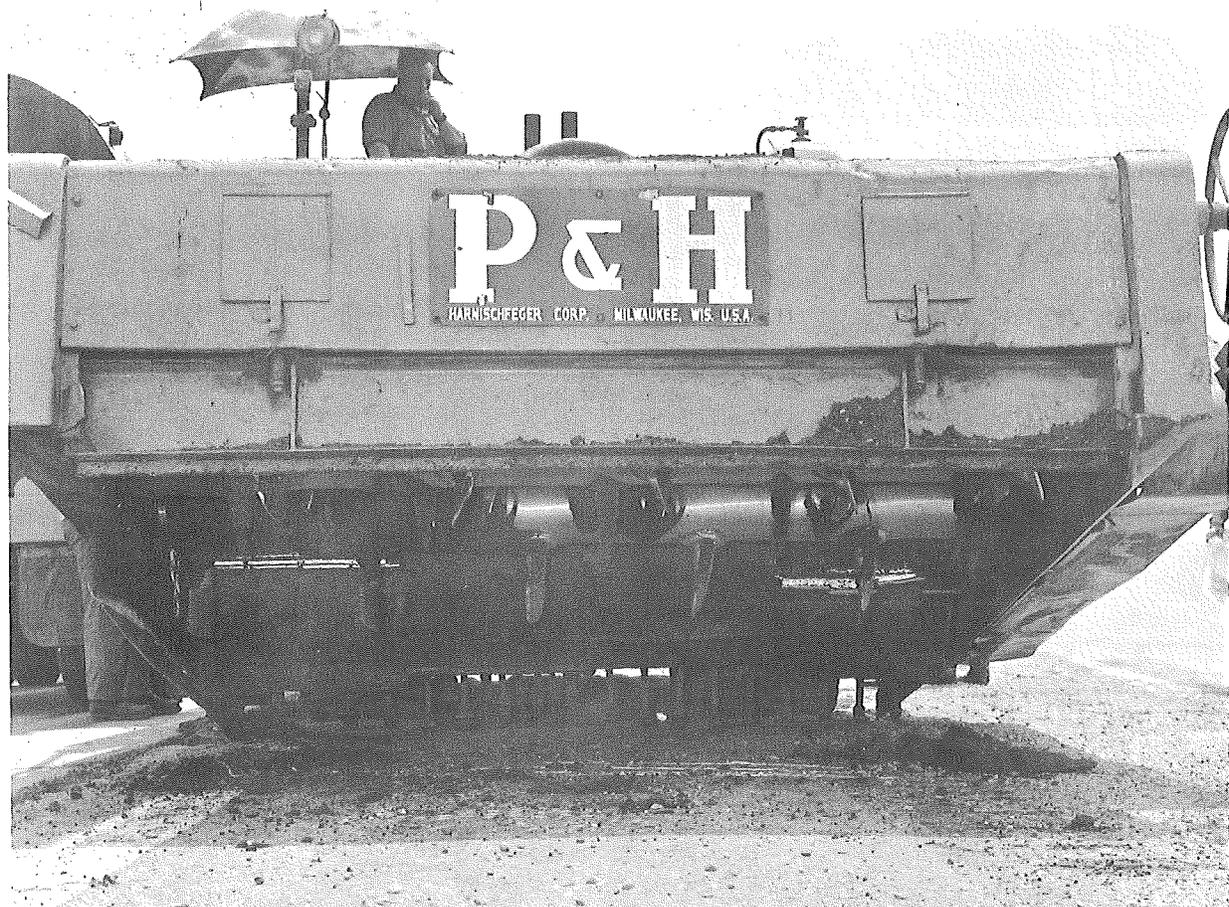
Figure 2. P & H Single-Pass Stabilizer. Lower photo shows underside of processing chamber.

The P & H Single-Pass Stabilizer (Fig. 2) is a self-propelled machine, consisting of a power unit which is mounted on tractor-type crawler treads, and a processing unit suspended from the rear of the power unit. It performs, in a single pass, all of the necessary operations for complete in-place processing of road materials, leaving them in position for immediate compaction where aeration is not required.

The power unit provides the means of propelling the entire machine and carries the processing chamber and the necessary liquid systems. It is mounted on crawler treads to provide low ground bearing pressure for ease in operation on loose sand as well as on a firm soil. A diesel engine provides the power to propel the entire machine and operate the liquid systems and processing units. The system for application of bituminous liquids is equipped with a positive displacement type pump and the necessary control valves, gages, meters, and thermometer. Liquids are supplied to the machine by a tank truck which is coupled to, and pushed by the Stabilizer. Small liquid tanks are built into the frame of the power unit and have sufficient capacity to keep the machine in operation while the supply trucks are being changed.

The entire unit is operated by one man with a helper on the ground to connect and disconnect liquid supply trucks. The processing chamber, which is suspended from the rear of the power unit, is composed of a chamber that houses all the mixing elements. The operator can raise and lower the entire processing chamber and regulate the depth of cut, as well as position the rear of the processing chamber to keep it parallel to the grade.

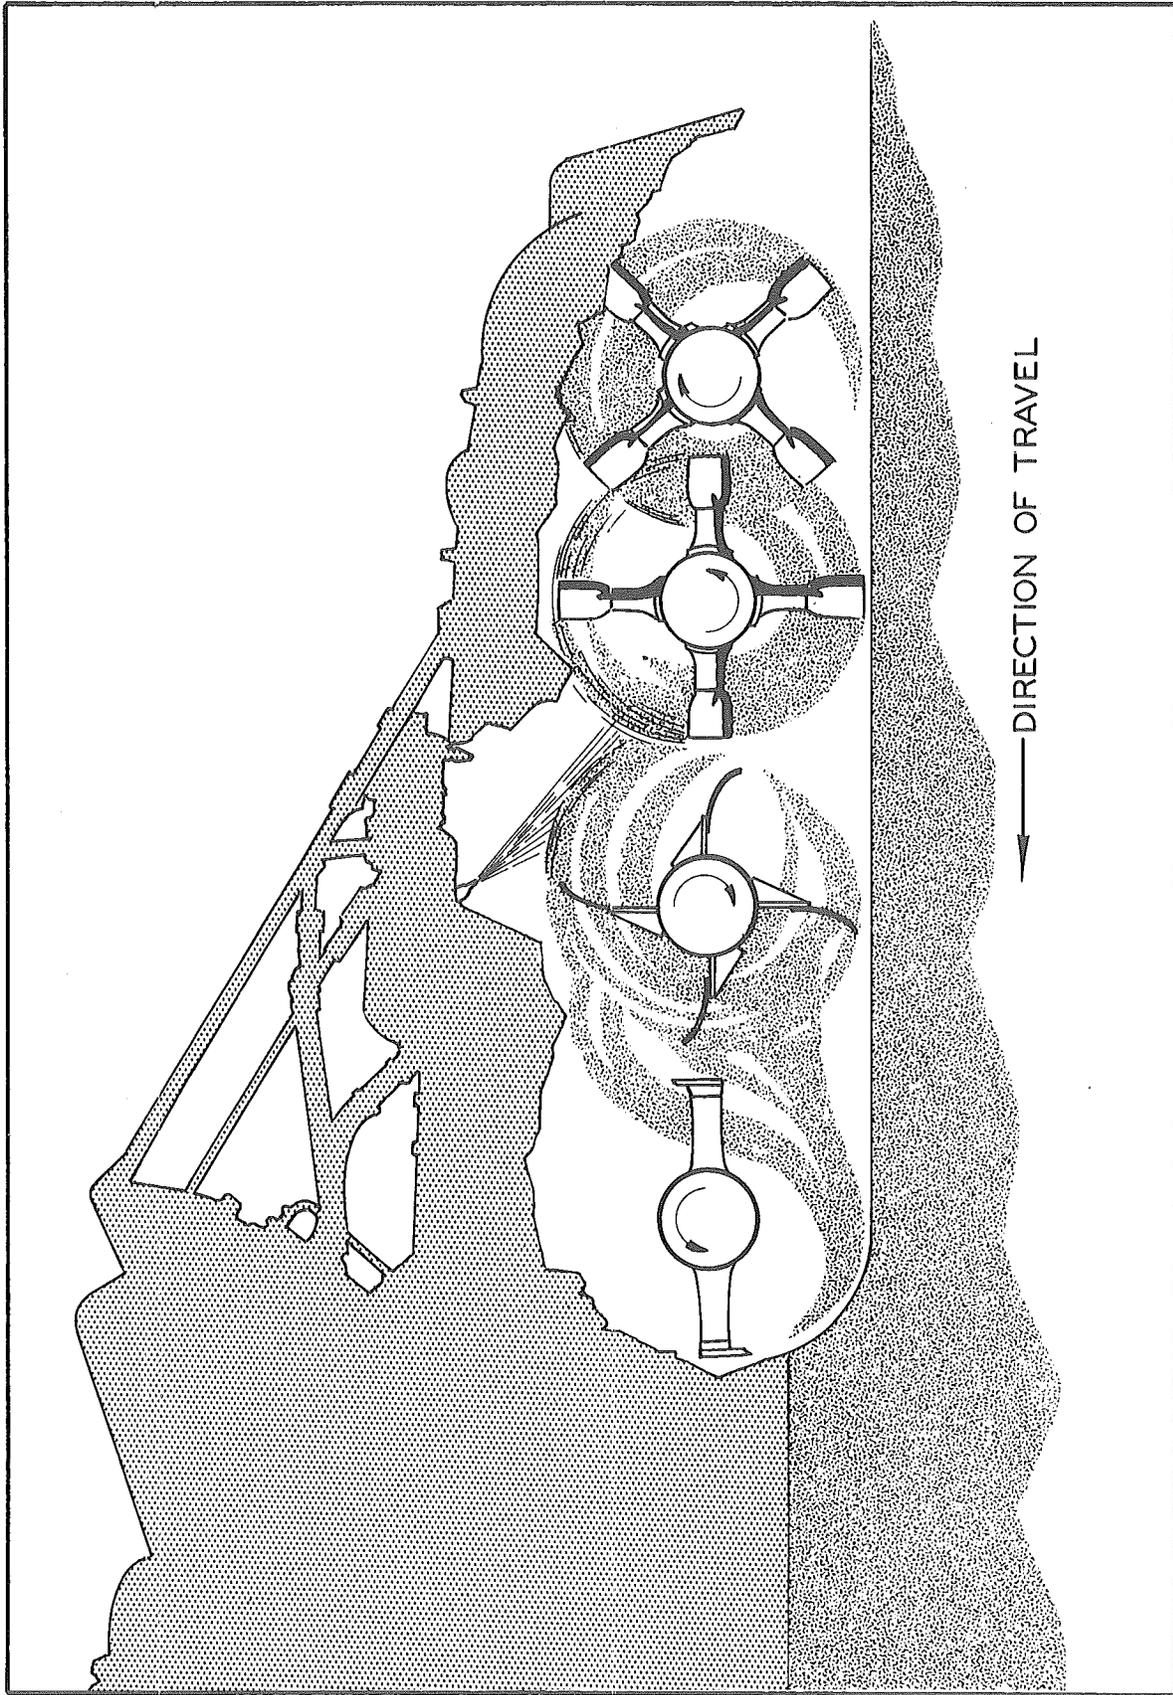
Figure 3. Schematic Diagram of Processing Chamber: P & H Single Pass Stabilizer

As shown in Figure 3, the processing chamber is equipped with four rotors. The first rotor to contact the material being processed is the high speed "cutting rotor." This rotor, cutting downward into the soil, cuts and pulverizes as the machine moves forward. The amount of cut necessary to obtain the required degree of pulverization is regulated by the forward travel speed of the machine.

The second, or blending rotor, rotates in a direction opposite to the cutting rotor, and at a much slower speed. It is equipped with curved blades, set in a staggered pattern. This rotor stops the velocity of material moved by the cutting rotor; moves material back toward the cutting rotor for thorough blending; trims the subgrade to a smooth plane; picks up all material from the subgrade, and casts it in a thin layer into the pugmill.

Liquids are applied as the material is in the air while being cast from the blending rotor to the pugmill. This permits a continuous combination of liquids and soils such that the liquids are dispersed throughout the entire

soil mass before it is fed to the pugmill for final mixing. Spray bars extend the full width of the processing chamber and are equipped with nozzles to give a fan-shaped spray pattern, providing a uniform liquid application throughout the full width of the processing chamber.

The last two rotors provide a twin transverse pugmill. The pugmill rotors are equipped with wide-face paddles set in opposing positions with the drums rotating in opposite directions. The rear end of the processing chamber is enclosed by an adjustable tail gate. This gate is adjustable to a variable processing depth and to regulate the volumes of material held in the pugmill.

This tail gate also acts as a strike-off to spread the mixed material to a uniform loose density the full width of the processing chamber. Immediate compaction may be accomplished on any mixture which does not require aeration.

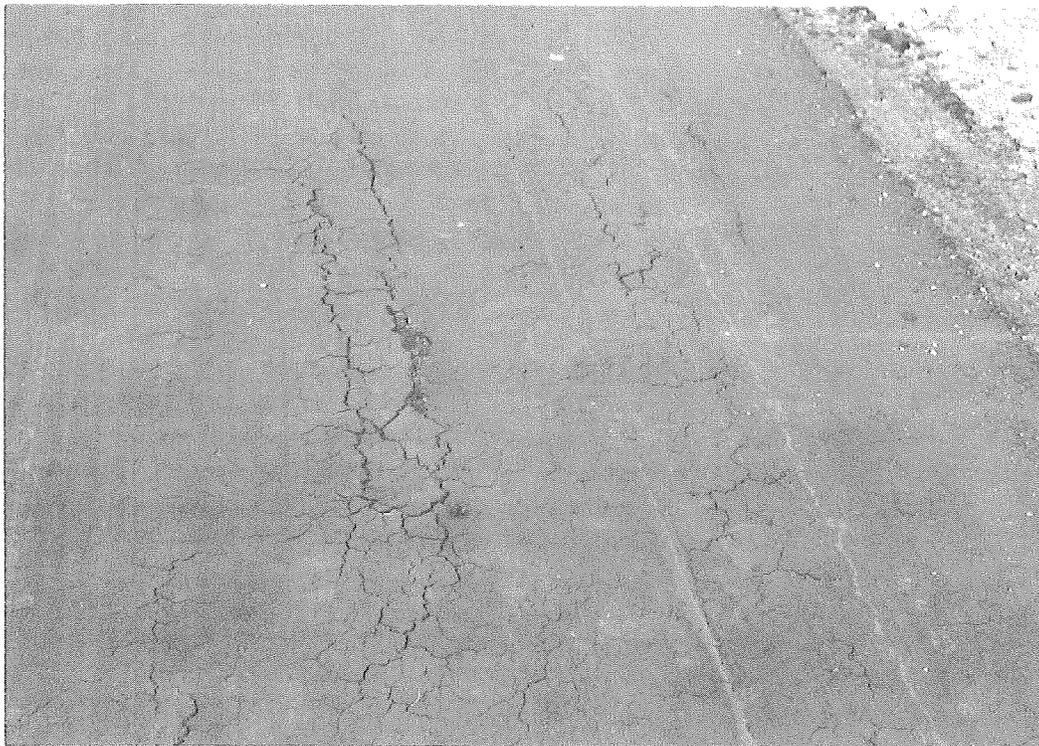
Figure 4. Failure of bituminous aggregate mat over base containing excessive quantity of stabilizing material.

In a few small areas, the small mixer applied excessive bituminous material and, in the worst of such areas, the mix was replaced with compacted 22A aggregate before surfacing. At some locations, material containing excessive bitumen were surfaced, and failure of the bituminous shoulder mat soon occurred (Fig. 4). Those areas were then excavated and replaced with conventional shoulders. Locations of excessive bitumen usually appeared where the small mixer was permitted to stand still.

After serving through one winter, some small portions of the shoulders also failed. Inspections indicated that these areas contained excessive bitumen and/or water.
