4.0 Identification of Bridges Prone to Deterioration (Task 3)

4.1 Introduction

The objective of Task 3 was to identify bridges that are vulnerable to end distress. Bridge management in Michigan is performed using a relational database integrated under a software program called "Pontis." Pontis data that has been collected by MDOT bridge inspectors was analyzed along with the data collected from the research team's field investigation. A cursory inspection of recent I-girders as well as a visit to the precast plant showed that the girder ends are often cracked. The primary objective of the Pontis data analysis is to evaluate the impact of early age cracking on girders durability. The methodology and results of the analysis are described in this chapter.

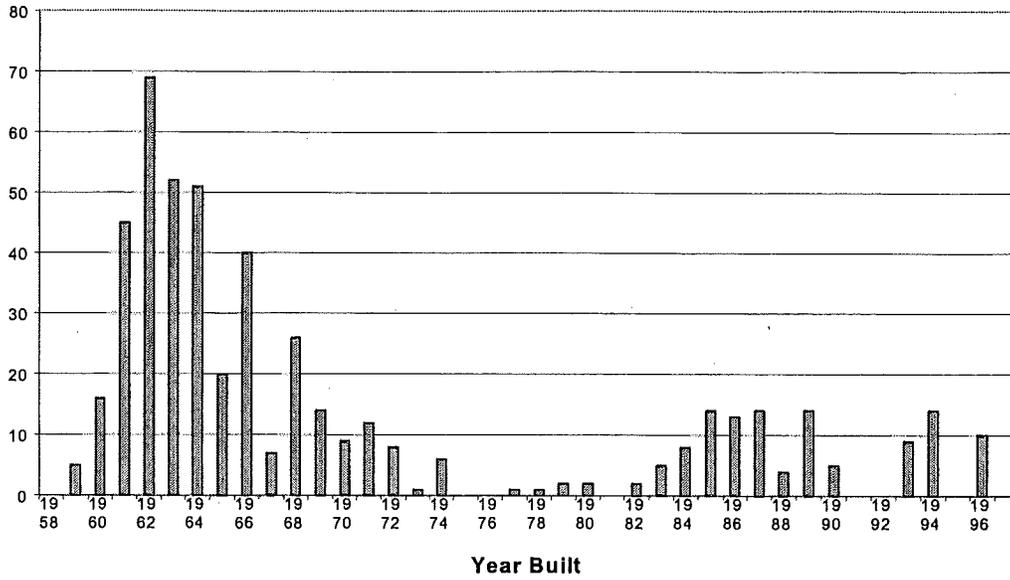
Figure 4-3. Prestressed Concrete I-Beam Bridges Constructed Since 1960

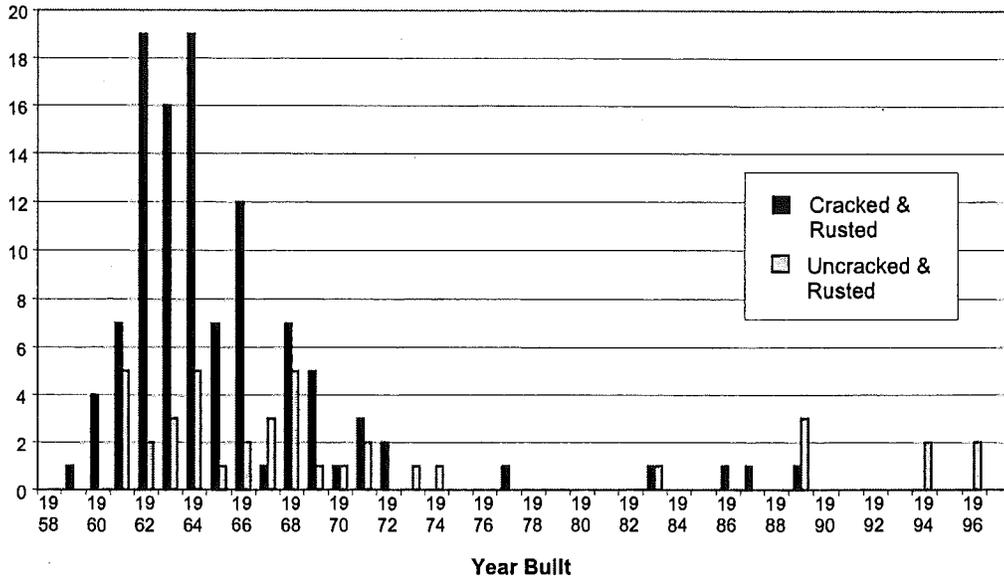
The histogram of cracked and uncracked prestressed concrete I-beams showing rust are shown in Figure 4-4. Using all 499 inspector comment records, the number of bridges with notes indicating cracked prestressed concrete I-beams was counted as 263, leaving 236 records for the bridges with no mention of beam cracking. Further review of inspector comments showed that 109 bridge beams include "cracks and rusting or corrosion," whereas 40 comments were found for the beams that only indicate "corrosion or rusting" but with no mention of cracking. When both "rusting or corrosion" and "spalling" are searched in the inspector comments, the numbers reported with cracked beams was 87, and 23 for the beams with no mention of cracks.

The influence of cracking on prestressed concrete I-beam durability is depicted in Figure 4-4. Taking beam corrosion as the primary parameter, the ratio of bridges with prestressed concrete I-beams showing signs of corrosion to the total number of cracked and uncracked beams document the importance of cracking in beam durability. The ratio of the number of bridges with observed signs of corrosion to the total number bridges with cracked beams is 0.41 whereas this ratio decreases to 0.17 for the bridges with beams where inspectors did not indicate any cracks.

Figure 4-4. Corrosion Comparison in Cracked and Uncracked Prestressed Concrete I-Beam Bridges showing rust

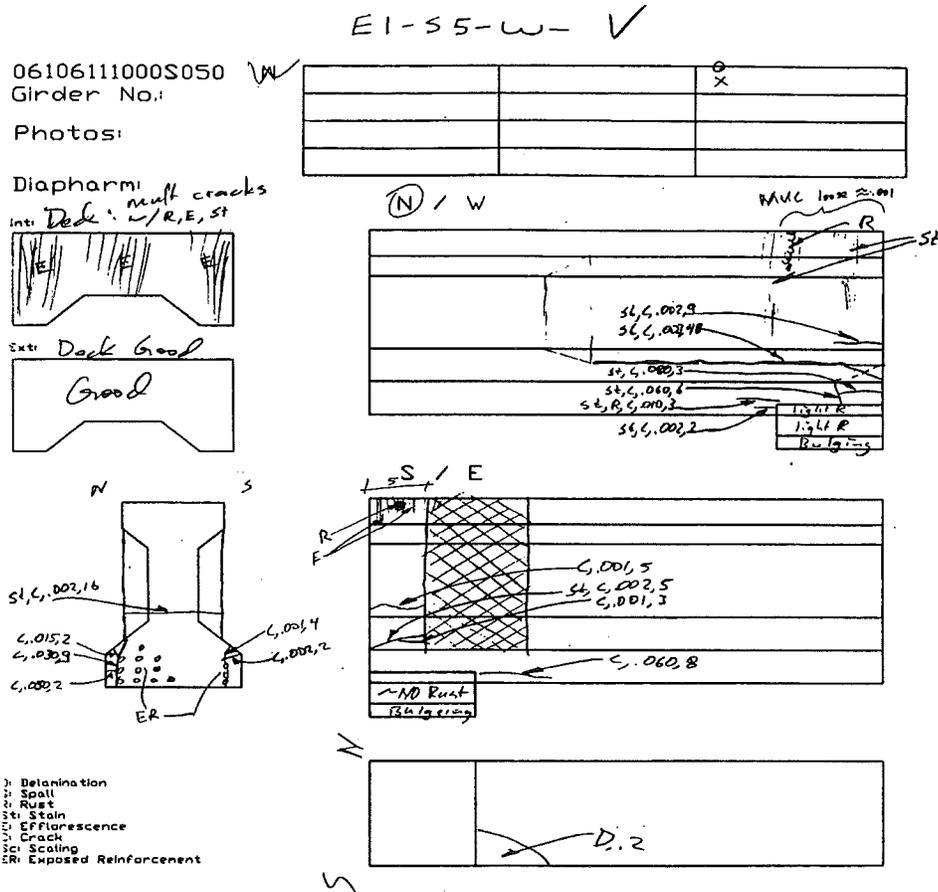
The field investigation data was collected on template forms. The template includes the bridge ID on the top left of the sheet and the beam layout on the top right of the sheet. The inspector designated the specific beam being inspected on the beam layout and completed the condition information on the beams and diaphragms.

During field visits, all faces of the beam-ends were inspected and signs of distress/deterioration were entered onto the form. Cracks were drawn to a rough approximation with respect to their length, location, and orientation. For each crack the length was measured and the width was estimated sometimes using crack gages. Corrosion, delamination, spall, water stain, efflorescence, and exposed rebar were carefully sketched onto the form to show approximate areas and locations. Figure 4-6 is an example of one of the field investigation forms with data sketched from the field. The data presented on all the field investigation forms is qualitative information, therefore a database was created to transform that data into quantitative information so it could be analyzed. The beam condition data was entered into a custom made Microsoft Access database that was described in Section 3.8.1.

Figure 4-6. Example of Field Investigation Template Form

As seen in Figure 4-6 there are six faces to a beam-end and the seventh face is the bearing. There are a total of 5364 faces in the database for the 20 bridges that were investigated. On those faces there are 5041 cracks for which four items of data was entered (width, length, location, and orientation). Additionally, the corrosion, delamination, and/or spall evidence on each face was entered. Sometimes for a face “notes” were entered describing the moisture stains, exposed rebar, efflorescence, and any other indicators of distress.

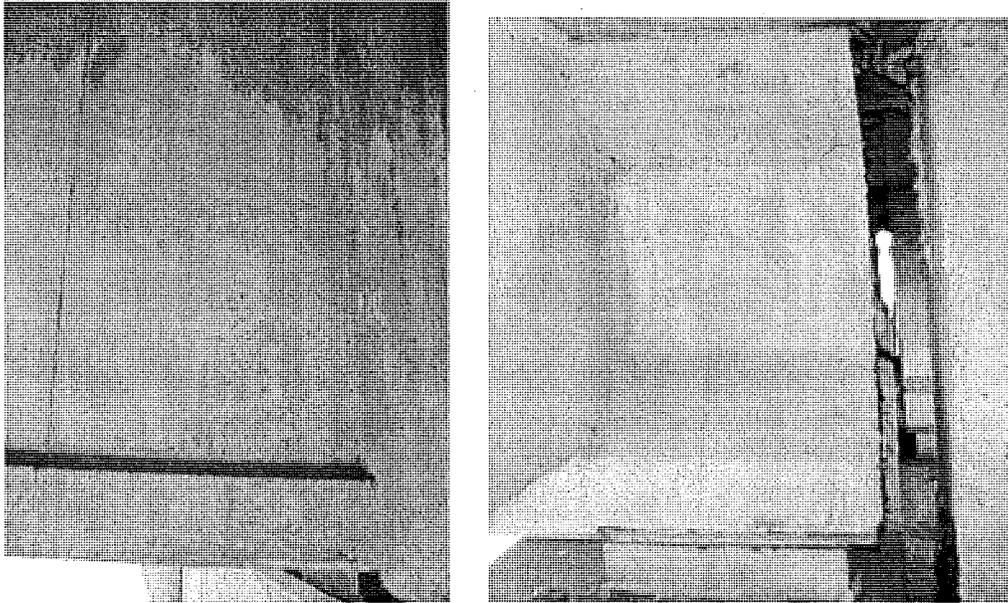
- No cracks or hairline cracks (≤ 0.001 inch) at the girder end,
- Joint intact (not leaking),
- Sole plate clean free of rust,
- Functional elastomeric bearing pad,
- Beam faces and pier caps are dry.

Photo 4-1. “Not vulnerable” Prestressed Concrete I-Beam

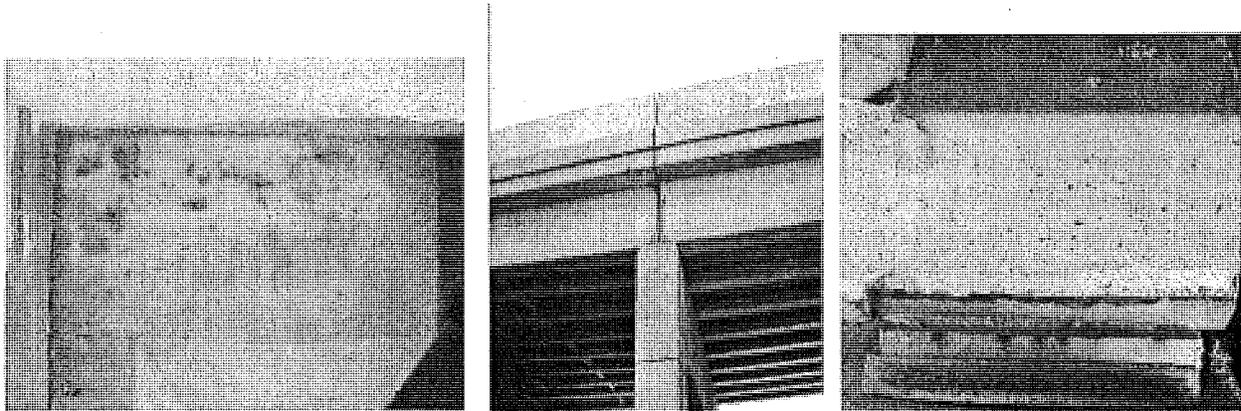
- Moderate cracks (0.002-0.01 inch) at the girder end,
- Corroding sole plate,
- Moisture staining or leaking joint,
- Non-functional elastomeric bearing pad,
- Beam faces and pier caps show moisture staining.

If the inspection indicates any one of the above conditions, the beam is considered as “vulnerable” to end deterioration (see Photo 4-2).

Photo 4-2. (Left and Middle) Wet stain at beam-end (Right) Sole plate corrosion

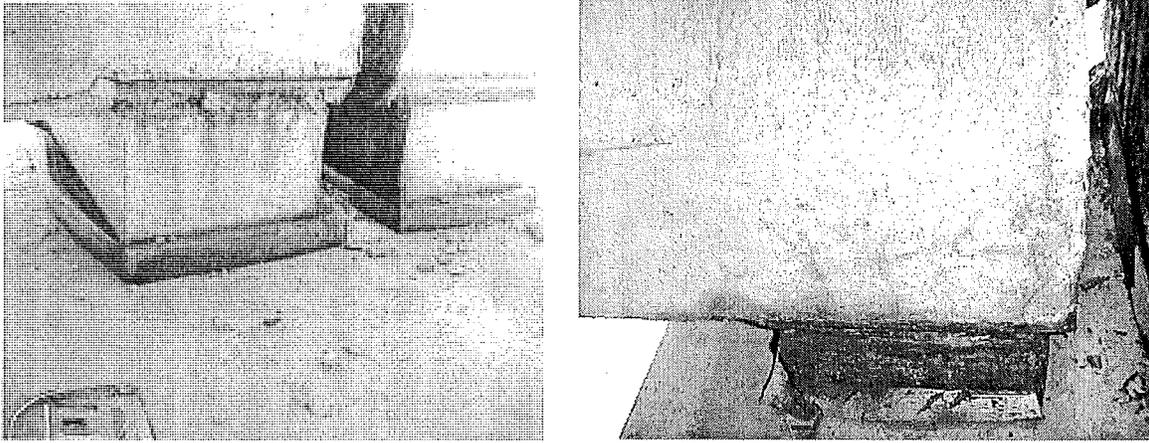
Additionally, if two or more of the conditions below are observed during inspection, the beam is considered as “highly vulnerable” to end deterioration (see Photo 4-3).

- Major cracks (> 0.01 inch) at the girder end,
- Leaking joint,
- Corroding sole plate, bearing plate
- Non-functional elastomeric bearing pad,
- Beam faces and pier caps are moist.

Photo 4-3. (Left) Sole plate corrosion and bulging at the sides of bearing pad, (Right) Sole plate corrosion and splitting, tearing and bulging at bearing pad

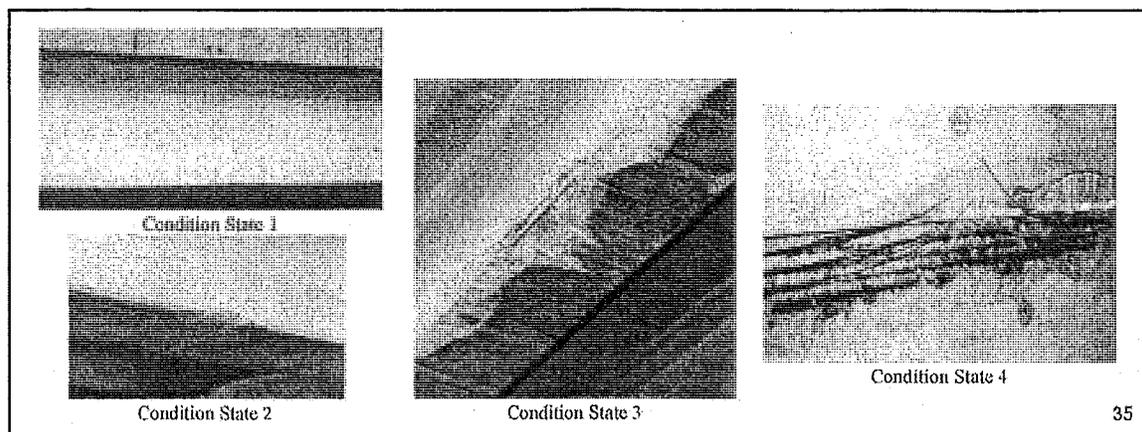
Certified bridge inspectors also assign a Pontis Condition State using the Pontis Bridge Inspection Manual (MDOT Lansing Maintenance Division, 1999). The manual illustrates four condition states for prestressed concrete I-beams; see Figure 6-1.

Figure 6-1. Pontis Bridge Inspection Condition State

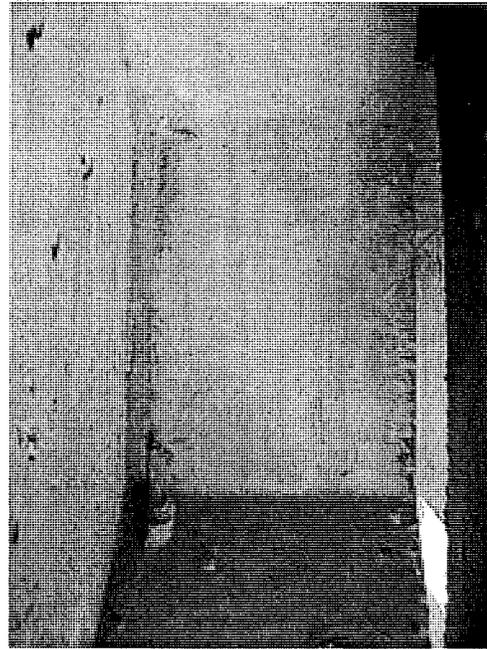
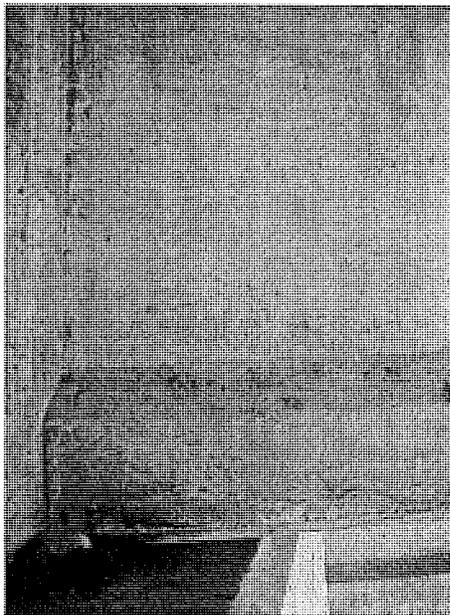
Photo 6-1. Condition State 1—No cracks observed, no staining (a) E1-S4-E-U from 25132 S34 and (b) S1-E2-N-E.2 from 06111 S04

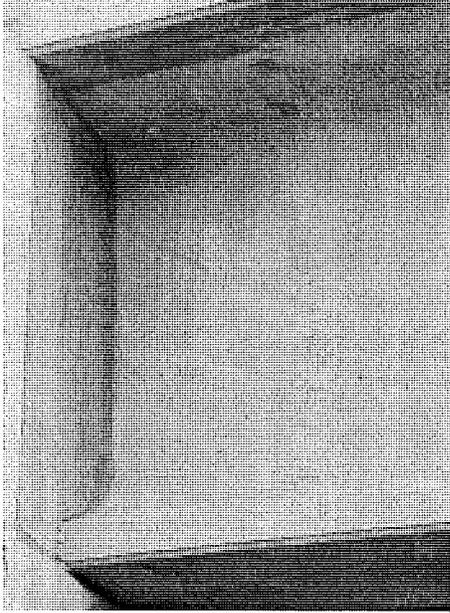
Photo 6-2. Condition State 2—Efflorescence, water-stains, and/or corrosion (a) E4-S5-W-B from 53034 S05 and (b) S1-E2-N-U from 67016 S09

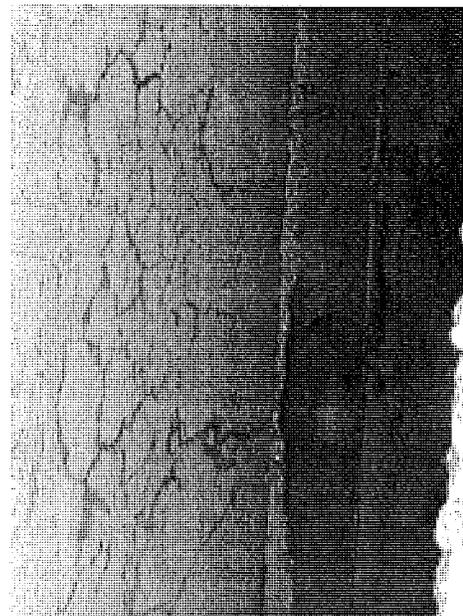
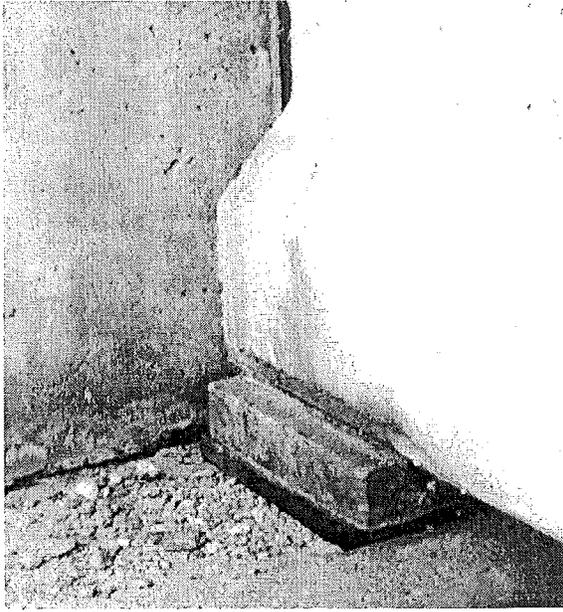
Photo 6-4. Condition State 4—Map Cracks (a) E2-S3-E-S from 25132 S34 and (b) E4-S1-E-R from 53034 S05

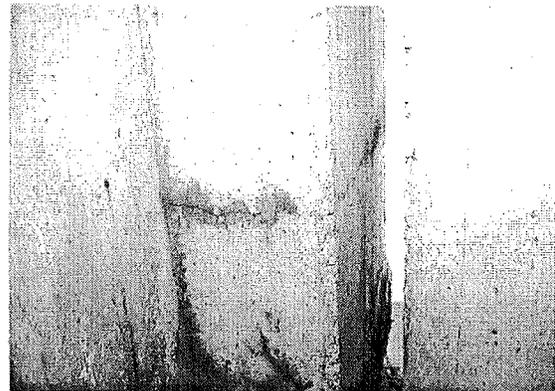
Photo 6-8. Condition State 8—Moderate Cracks with efflorescence, water-stains, and/or corrosion (a) E2-S3-E-B from 25132 S34 and (b) E2-S8-E-S.2 from 41029 S16-4

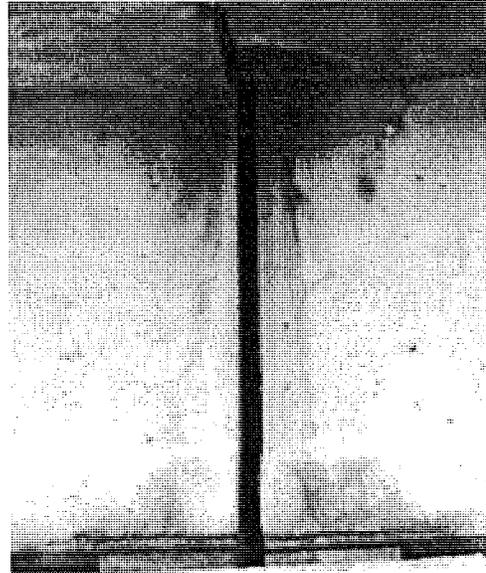
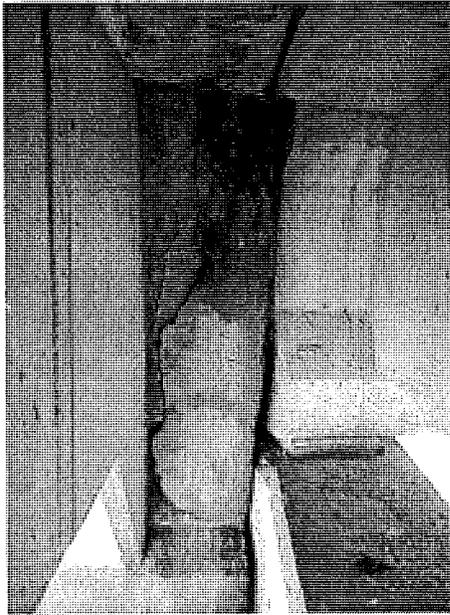
Photo 6-9. Condition State 9—Major Cracks with efflorescence, water-stains, and/or corrosion (a) S3-E9-N-W.2 from 29011 S03 and (b) S2-E9-N-W from 29011 S03

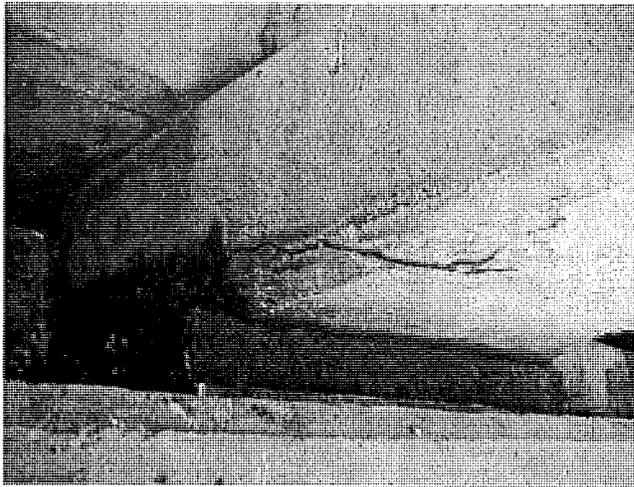
Photo 6-10. Condition State 10—Delamination with Moderate and/or Major Cracks (a) E2-S5-E-S.1 from 25132 S34 and (b) S2-E8-N-W from 29011 S03

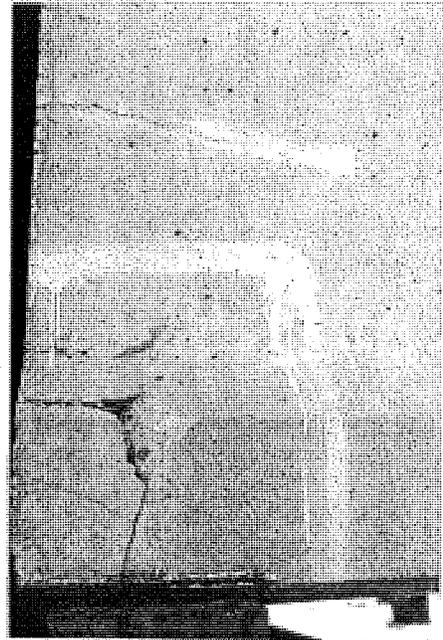
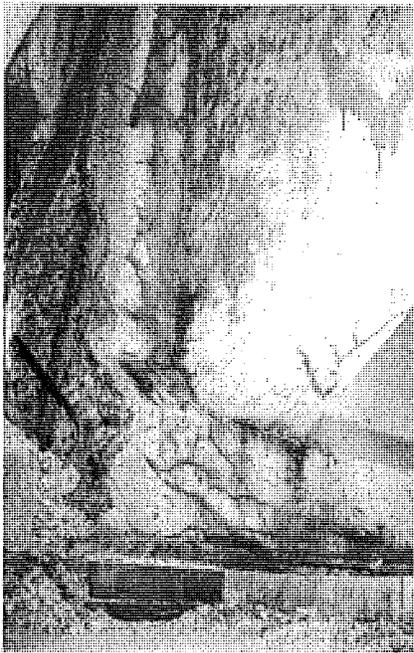
Photo 6-11. Condition State 11—Spall, Delamination, Corrosion, and Cracks (a) S2-E7-N-U from 29011 S03 and (b) E2-S8-E-N.6 from 41029 S16-4

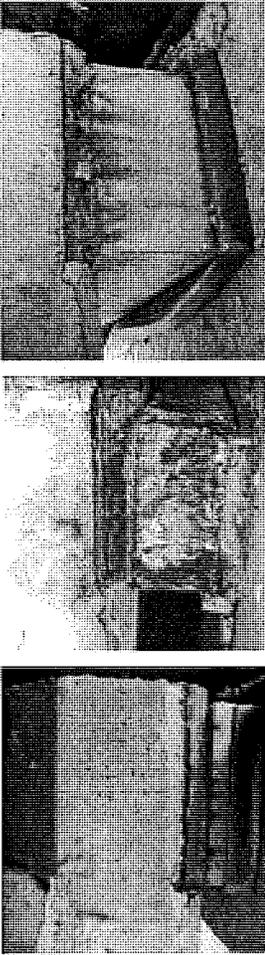
<p>5) Hairline Cracks with efflorescence, water-stains, and/or corrosion with a horizontal crack propagating from the sole plate</p>

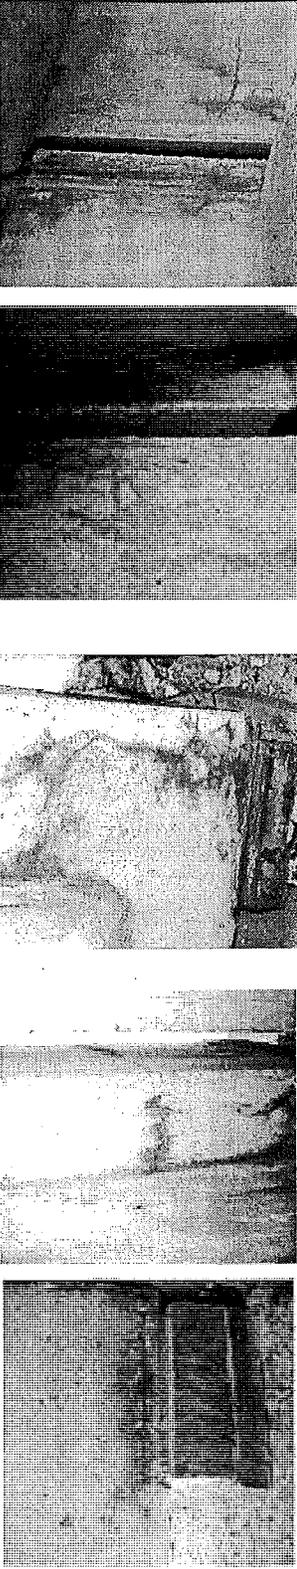
<p>7) Moderate Cracks</p>

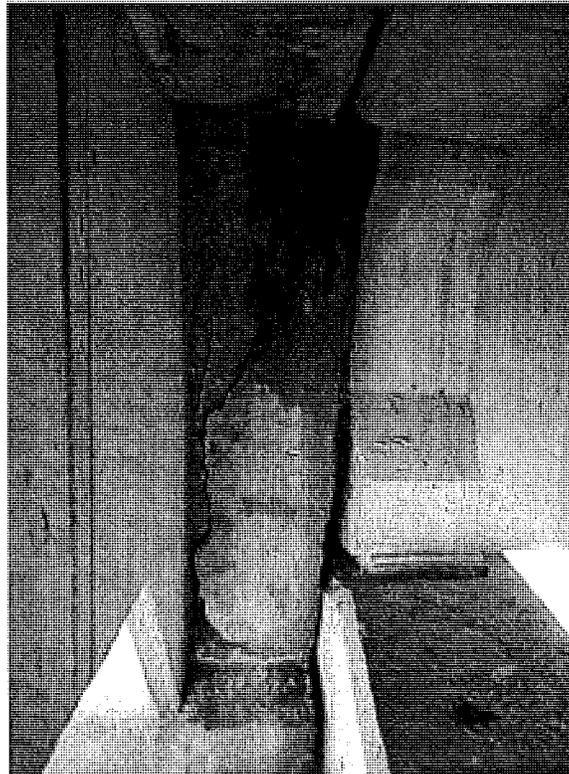
Photo 8-1. E2-S5-E-S.1 from 25125132000 S340

- Girder Photo: (span; S#, E#)-(girder; S#, E#)-(end; N,S,E,W)-(face; N,S,E,W,R,U,B,X,I). # in set
- Profile Photo: PRO-(face of bridge shown; N,S,E,W). # in set
- Abutment Photo: ABUT-(end; N,S,E,W)-(face N,S,E,W)-(nearest girder; S#, E#, GEN). # in set
- Pier Photo: PIER-(pier; S#, E#)-(column; S#, E#, GEN)-(face; N,S,E,W). # in set
- Deck Photo: DECK-(type; GEN, APP, JOINT, SPAN, UNDER)-(if GEN then looking direction; N,S,E,W / if APP then approach; N,S,E,W / if JOINT or SPAN then ; S#, E# / if UNDER then SPAN; S#, E#). # in set

For example access by bridge ID “25125132000S340” will display Figure 8-4. This is a schematic representation of this bridge’s primary elements to show the location of the pictures. The name of each picture will access display that particular picture. For example the name E2-S5-E-S.1 will access Photo 8-1. The name of the picture also denotes the location of that picture. The picture file convention was developed to give each picture a name that relates the contents of the picture to a position on the bridge (see Figure 8-5). A complete explanation of the picture file convention is provided in this sub-section.

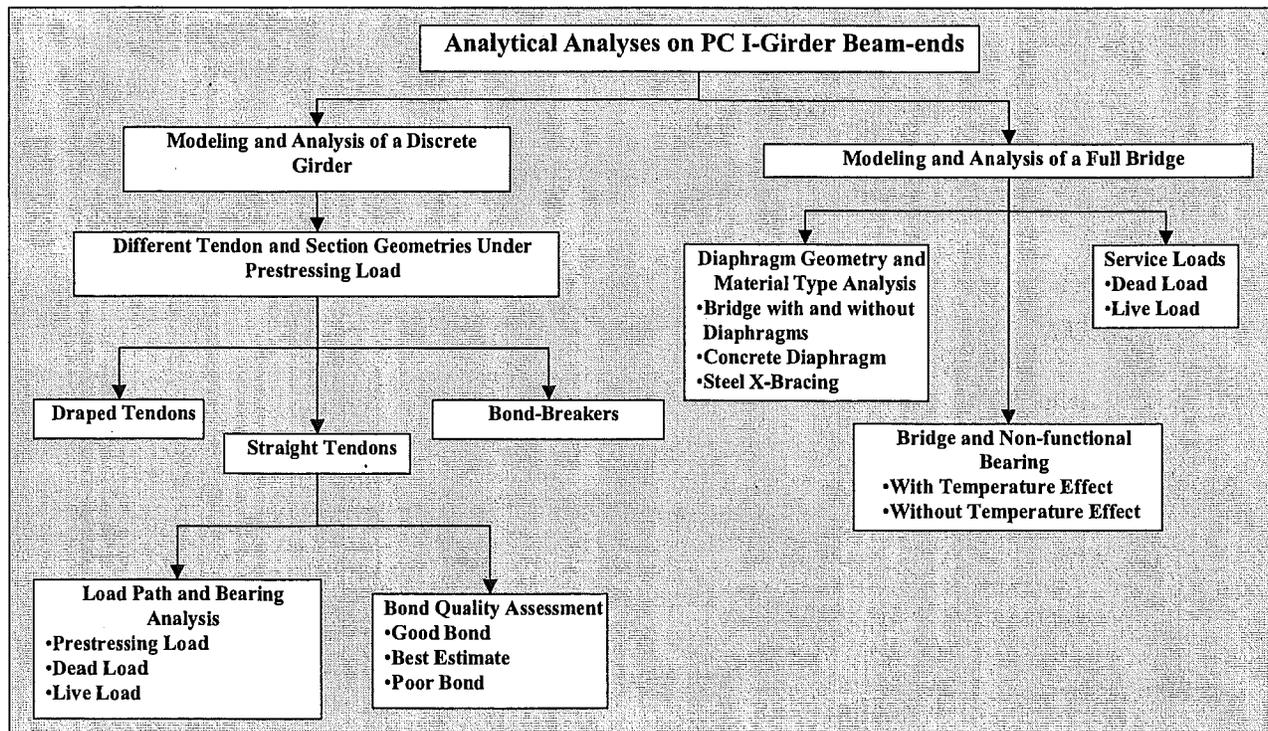
Analytical modeling steps are summarized in Figure 10-1.

Figure 10-1. Steps of Analytical Modeling

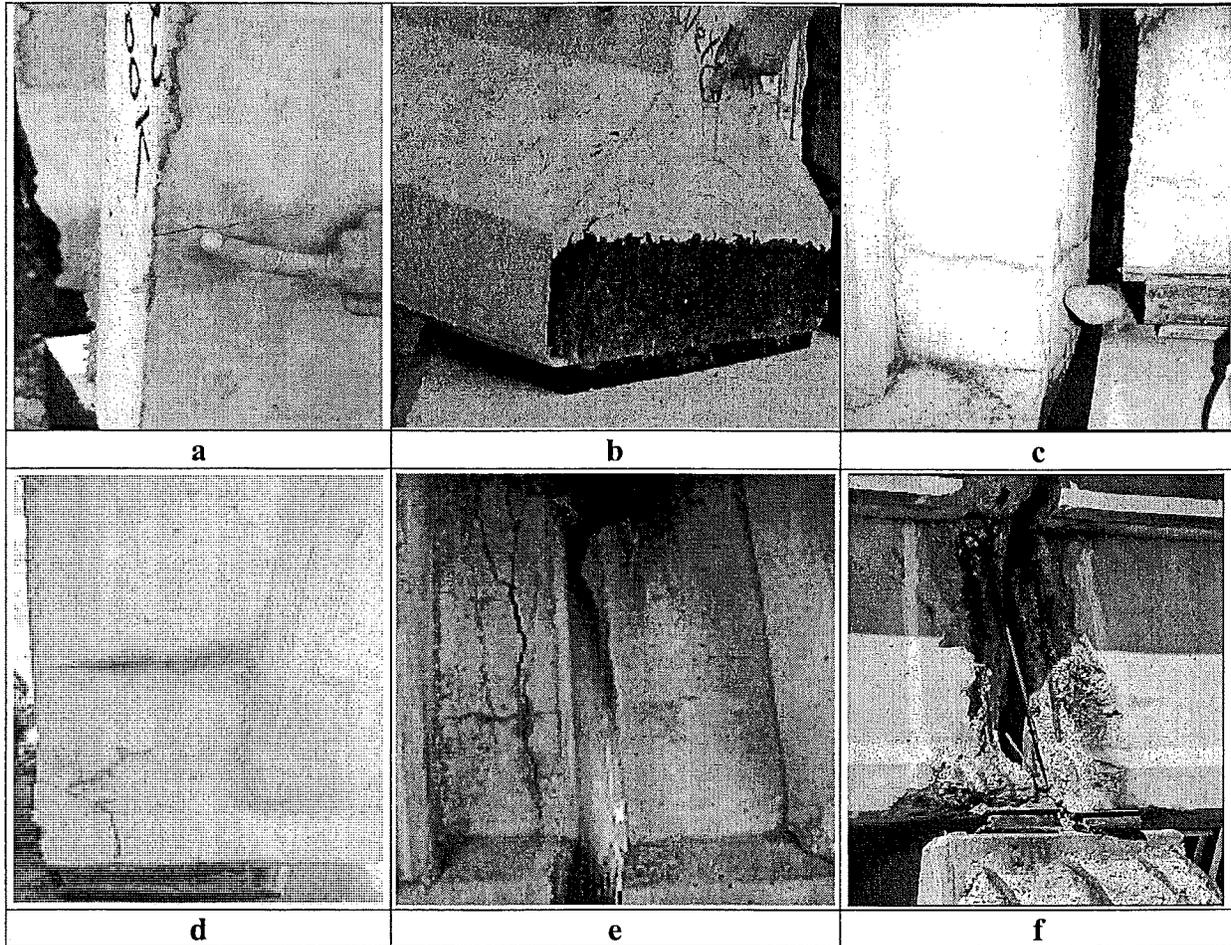
delamination, Figure 10-2-e, and spall of concrete cover, Figure 10-2-f, reducing the durability of the girder by a significant amount. Consequently, cracking prevention or reduction during manufacture, construction, and operation is the proper way to increase the durability and the lifetime of the PC I-beams.

Figure 10-2. (a) Cracking at the Web Zone at the Precast Plant; (b) Cracking within the Proximity of Bottom Flange of a Girder in a Bridge under Construction; (c) Cracking Observed on the Web and Around the Bottom Flange of Girders in-Service; (d) Moisture Presence Around Cracking on the Web; (e) Delamination and Spalling on a Girder; (f) Spalling of Cover Concrete and Exposed Rebar

The axial stress distributions in the z and y directions are shown in Figure 10-15-a and Figure 10-15-b, respectively. In Figure 10-15-a and Figure 10-15-b, the zones under tensile stress may initiate cracking. Level of tensile stress that is of significance is only seen in Figure 10-15-a within the web zone, around 390 psi. During field inspection and plant visit, web cracking at the same location was observed (see Figure 10-2-a, -b, -c, and -d).

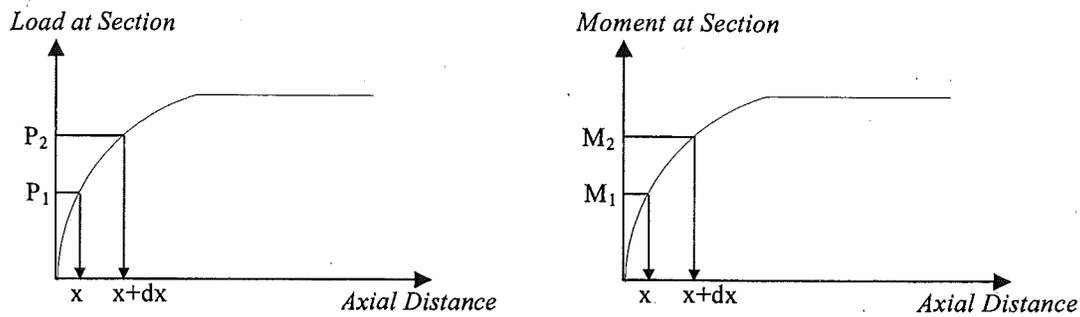
Considering an incremental element within the transfer length, the stress at each side of the element will be unequal (Russel et al, 1997). Thus, shear stress is generated. This change in nominal stresses near beam-end and equilibrium is described on an isolated incremental element as shown in Figure 10-8. Equation 10-2 describes the static equilibrium condition of the incremental element. Beyond the transfer length, the prestressing force remains constant. Therefore, the resultant shear stress shown in Figure 10-8 diminishes. The shear stress can also be explained by the Poisson's effect. By the changing uniaxial stresses, two incremental elements next to each other deform differently due to Poisson's effect. The preceding element lateral deformation is less than the succeeding element within the transfer length zone. Due to this difference in deformations between the elements, shear stresses are generated. Considering the shear stress generation within the transfer length, FE model of the PC I-girder is developed based on the description of force transfer from the tendon to the concrete medium.

Figure 10-7. Axial Stresses on an Incremental Element

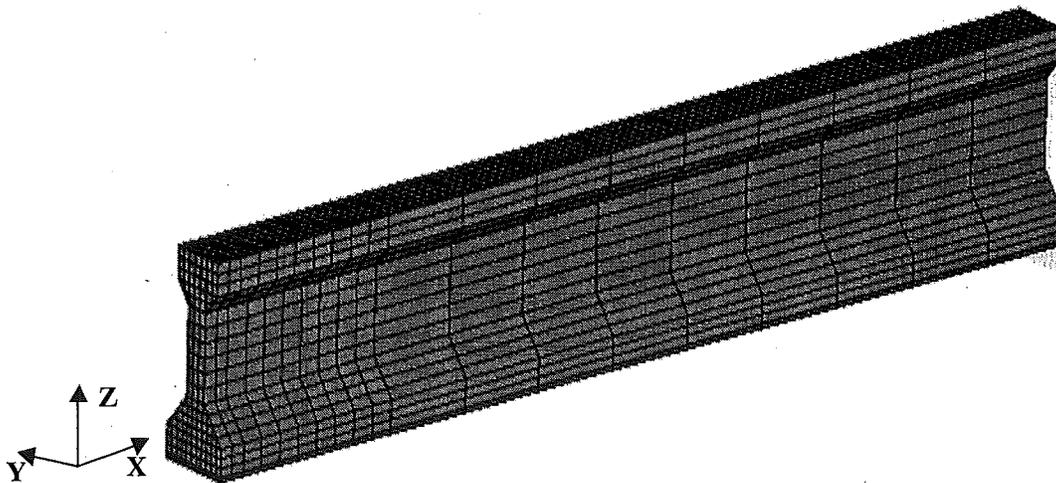
The geometry used in the model is identical to that of the real I-beam. The FE mesh is further refined near the beam-end. The length of the finite concrete elements is 4 inches at the beam-end for the first 8 inches, then 6.5 inches for the following 52 inches, and 26 inches for the remaining 234 inches, as shown in Figure 10-11.

Figure 10-11. The Girder with Straight Tendons

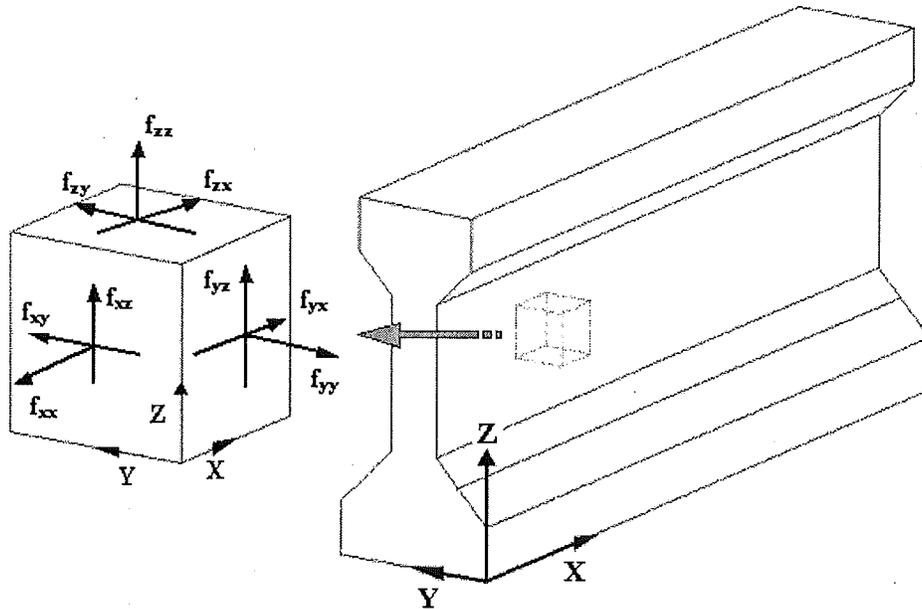
Figure 10-12. Stresses and Coordinate System used in the Model for the Infinitesimal Element

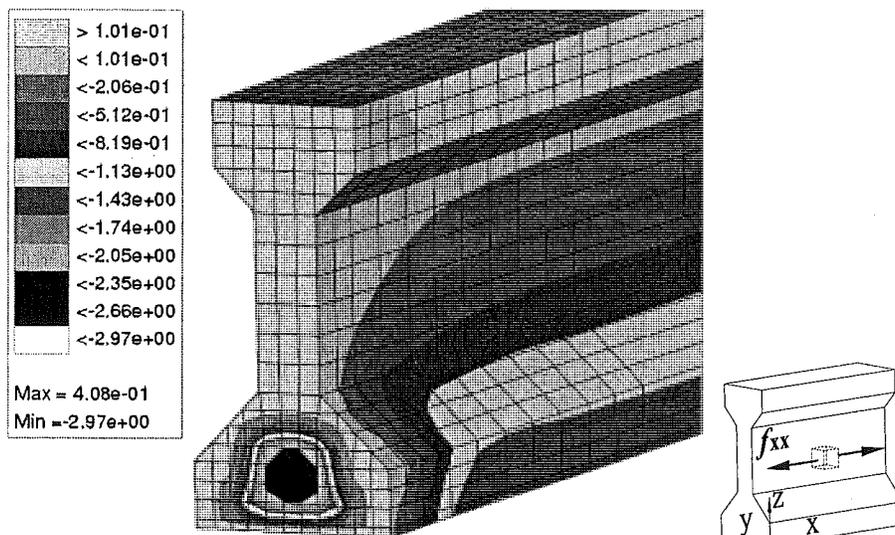
Figure 10-13. Axial Stress near the Beam-end (ksi), in X-Direction

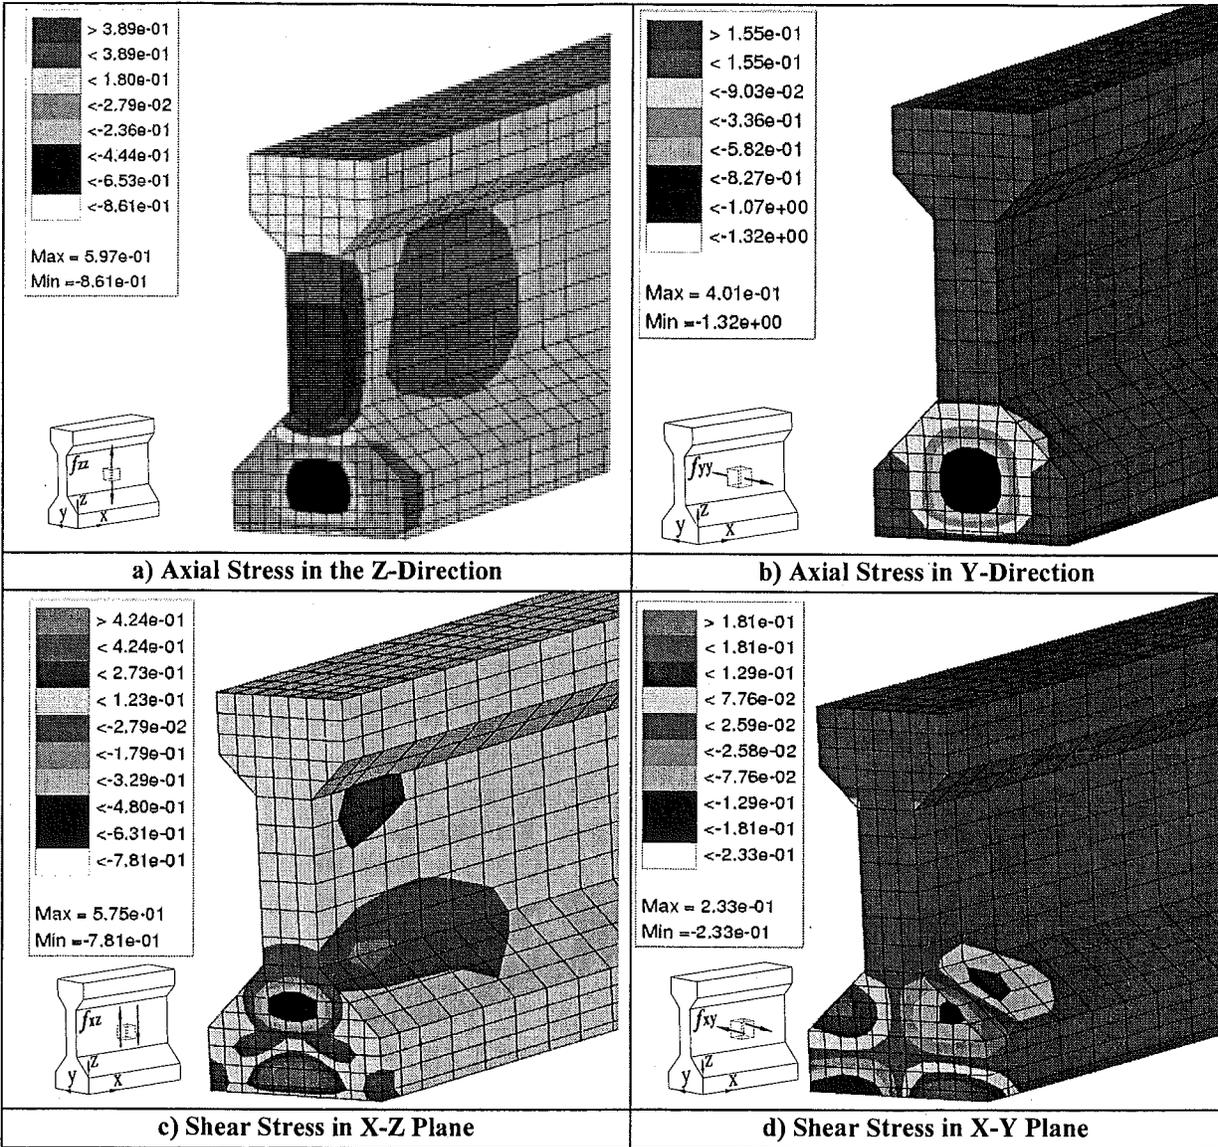
Figure 10-15. Stresses (ksi) Observed near the End of the Girder with Straight Tendons

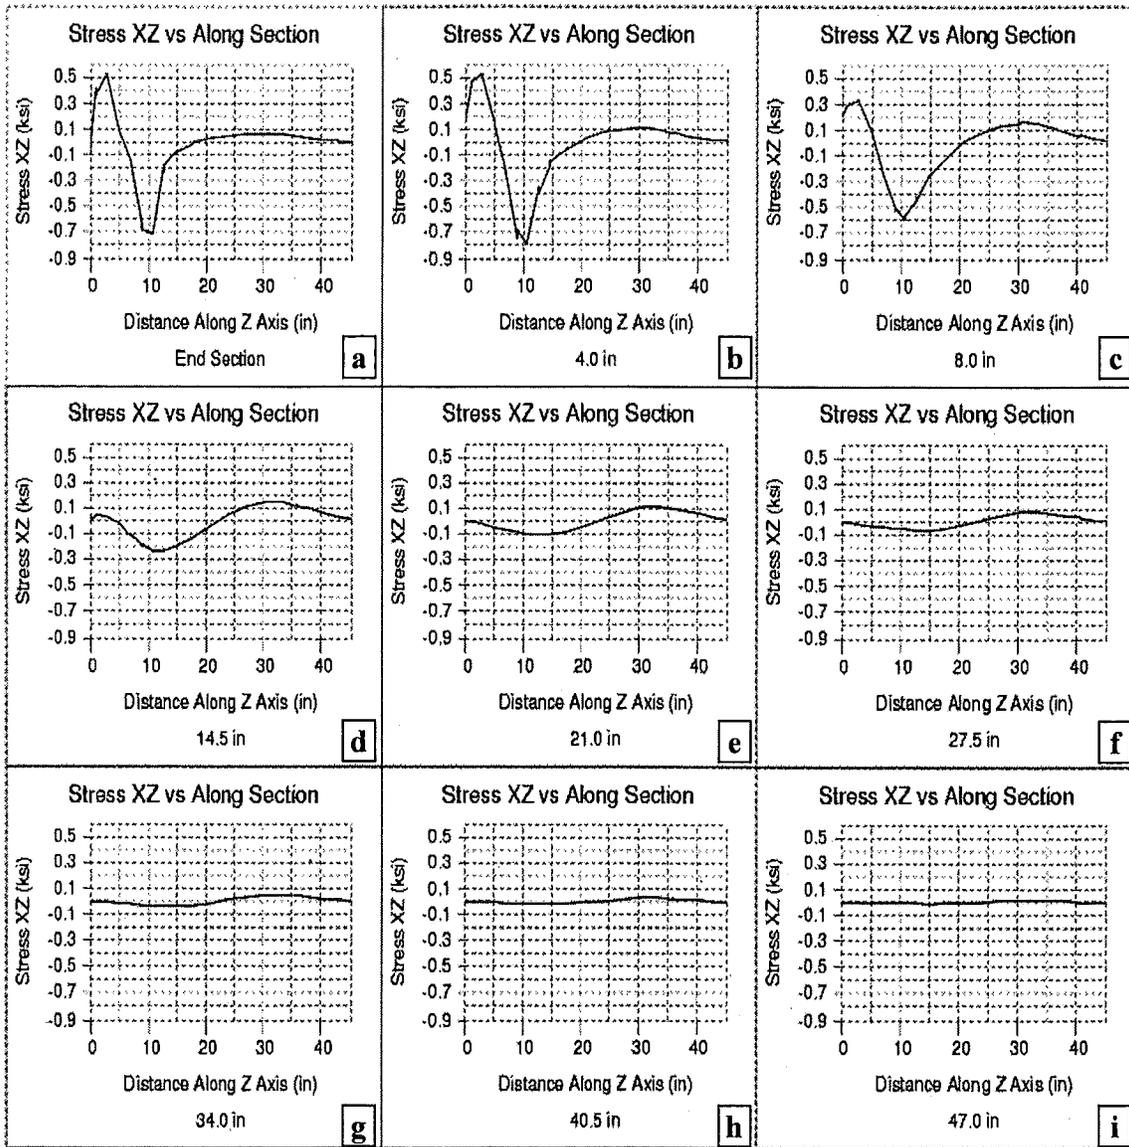
The shear stress development on x-z plane is also studied at selected sections along the beam axis as shown in Figure 10-16. In the figure, "Distance Along Z Axis" is along the depth of the beam. Figure 10-16-a to Figure 10-16-i shows the changes in shear stress distribution at sections along the beam starting from the beam-end. The section locations are also defined in the figures by the numerical value of "Distance Along Z Axis." In Figure 10-16, the distance from the beam-end to the location where the shear stress fully diminishes is 47 inches. A closer inspection shows that shear stress is insignificant starting at a distance from the beam-end just beyond 27.5 inches, which designates the point at which the prestressing forces in the tendons are fully developed. It is also important to specify the length at which shear stress remains in excess of allowable. The zones where the shear stress is in excess of $3.5 \cdot \sqrt{f'_c}$ or 247 psi will define the portions of the beam with high cracking potential by ACI (ACI, 2002). However, this does not mean that the zones with high shear stress crack. This information can be useful to define the critical zones. In Figure 10-16, shear stress is in excess of 500 psi on the section 8 inches from beam-end, which is significantly high. In Figure 10-17, the axial stress (flexural stress) variation in the x-direction shows non-uniformity similar to the shear stress distribution seen in Figure 10-16.

Figure 10-16. Shear Stress Distribution within the Web Projection at Selected Sections near the End Zone under Prestressing Loads

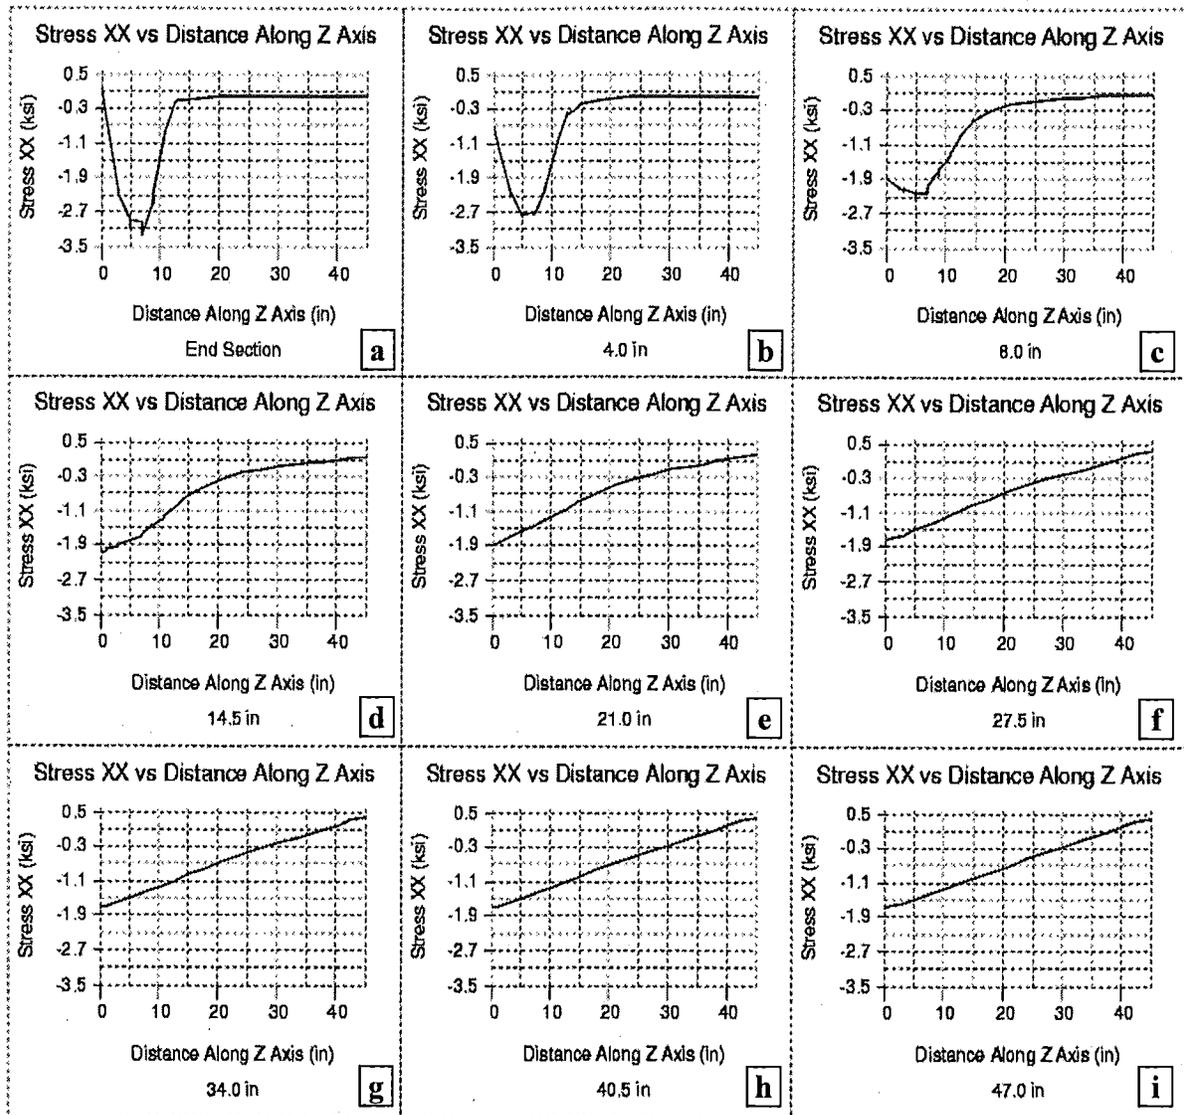
Figure 10-17. Axial Stress Distribution within the Web Projection at Selected Sections near the End Zone under Prestressing Loads

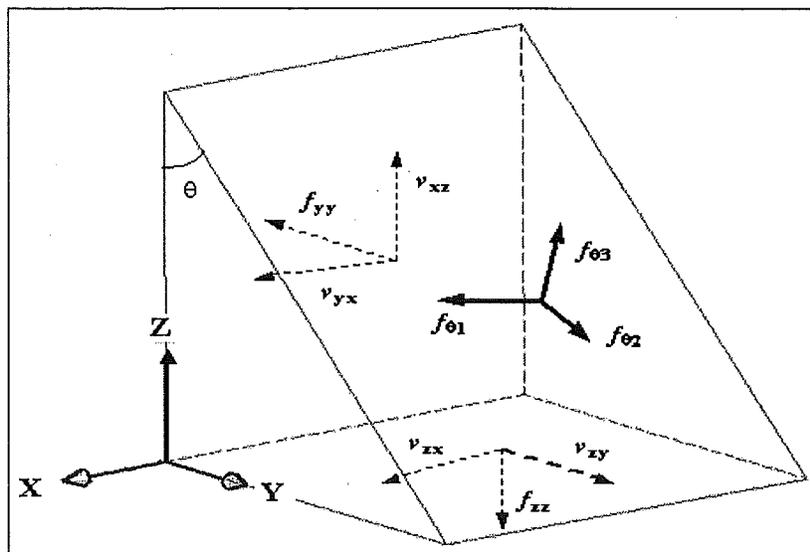
The cracking potential in the end zone is also described by using the principal stress contours. The principal stresses are calculated by rotating the x-y-z coordinates until the shear stress diminishes. In Figure 10-18, the principal stresses on the x-z plane are depicted by rotating the y-z coordinates through an angle " θ " about x-axis. The principal stresses of interest are noted by $f_{\theta 1}$ and $f_{\theta 3}$. $f_{\theta 1}$ and $f_{\theta 3}$ are the maximum and the minimum principal stresses, respectively. The principal stress $f_{\theta 2}$ is not significant for beam elements.

Figure 10-18. Principal Stresses on a Finite Element

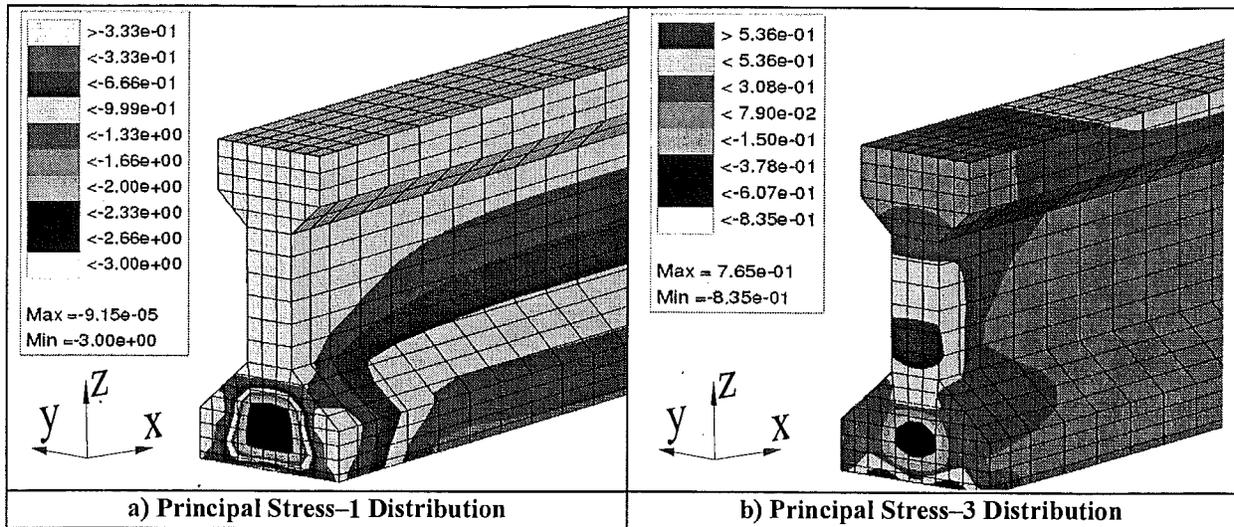
Figure 10-19. Principal Stresses (ksi) near the Girder-end under Prestressing Load

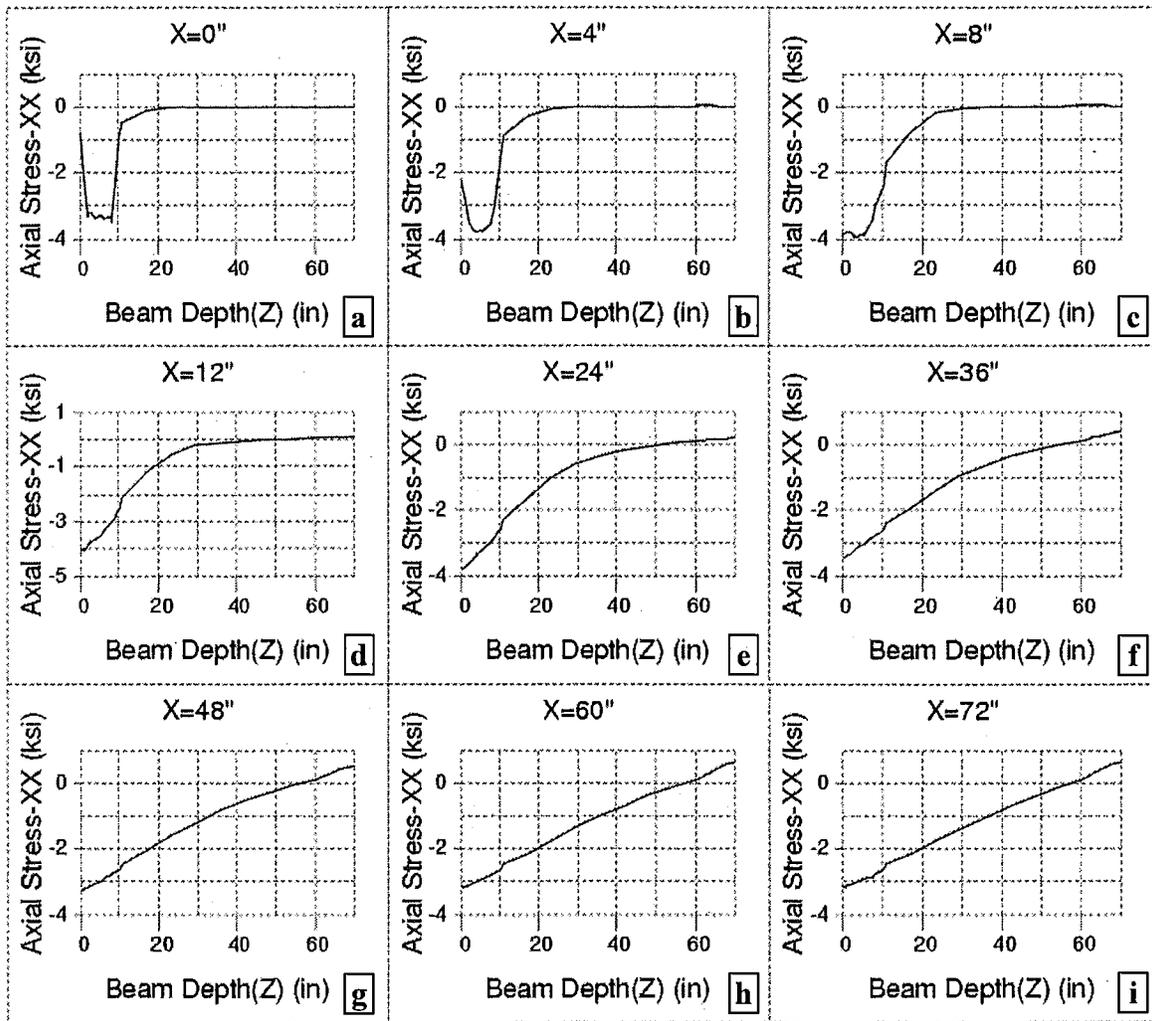
Figure 10-23. Axial Stress Distribution within the Web Projection at Selected Sections near the End Zone under Prestressing Loads on the Girder without Bond-Breakers
