4.0 Identification of Bridges Prone to Deterioration (Task 3)

4.1 Introduction

The objective of Task 3 was to identify bridges that are vulnerable to end distress. Bridge management in Michigan is performed using a relational database integrated under a software program called "Pontis." Pontis data that has been collected by MDOT bridge inspectors was analyzed along with the data collected from the research team's field investigation. A cursory inspection of recent I-girders as well as a visit to the precast plant showed that the girder ends are often cracked. The primary objective of the Pontis data analysis is to evaluate the impact of early age cracking on girders durability. The methodology and results of the analysis are described in this chapter.

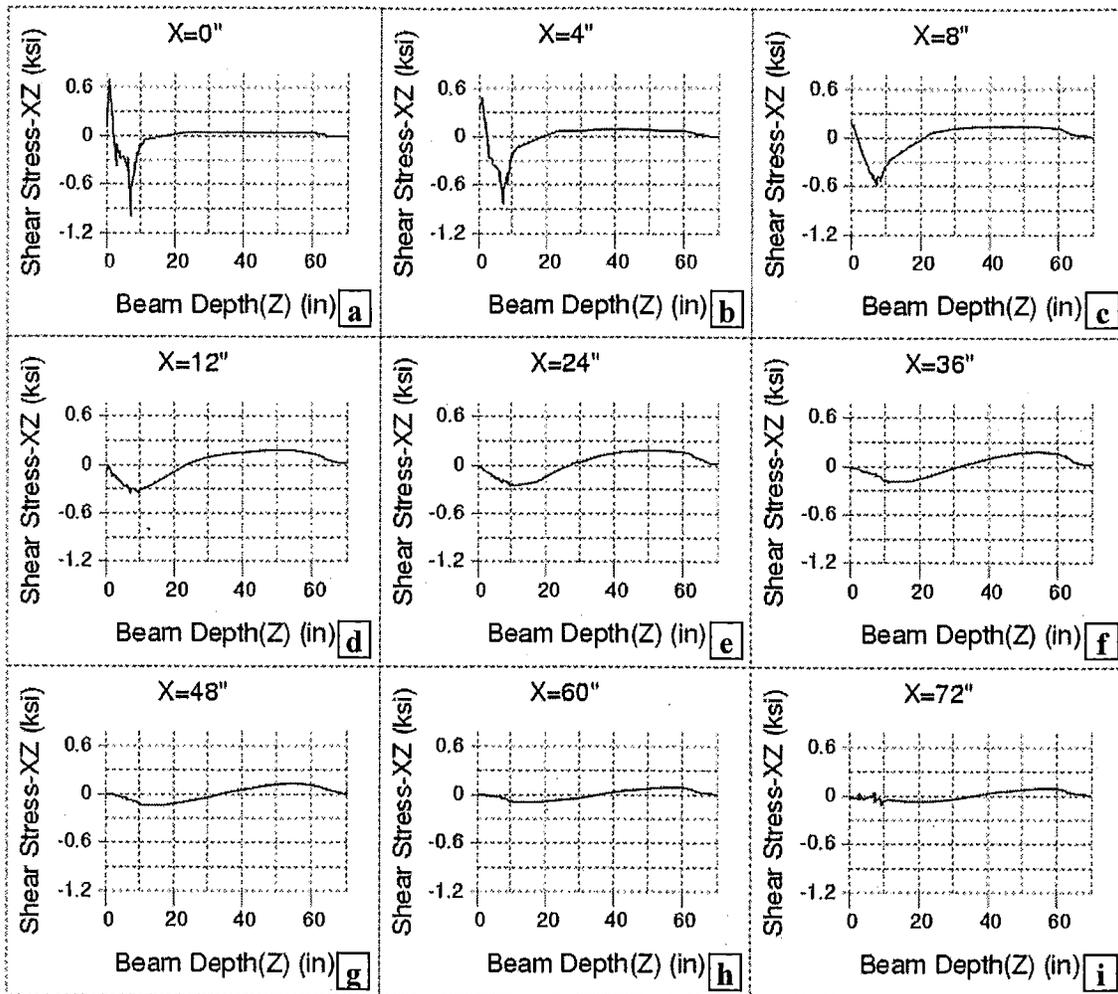
points. The shear stress magnitude, however, is approximately 30% lower in the girder with bond-breakers. The maximum shear stress on the web in the beam without bond-breakers is around 1.5 ksi, while in the beam with bond-breakers it's around 1.0 ksi (see Figure 10-24-a and Figure 10-26-a).

Figure 10-26. Shear Stress Distribution within the Web Projection at Selected Sections near the End Zone under Prestressing Loads on the Girder with Bond-Breakers

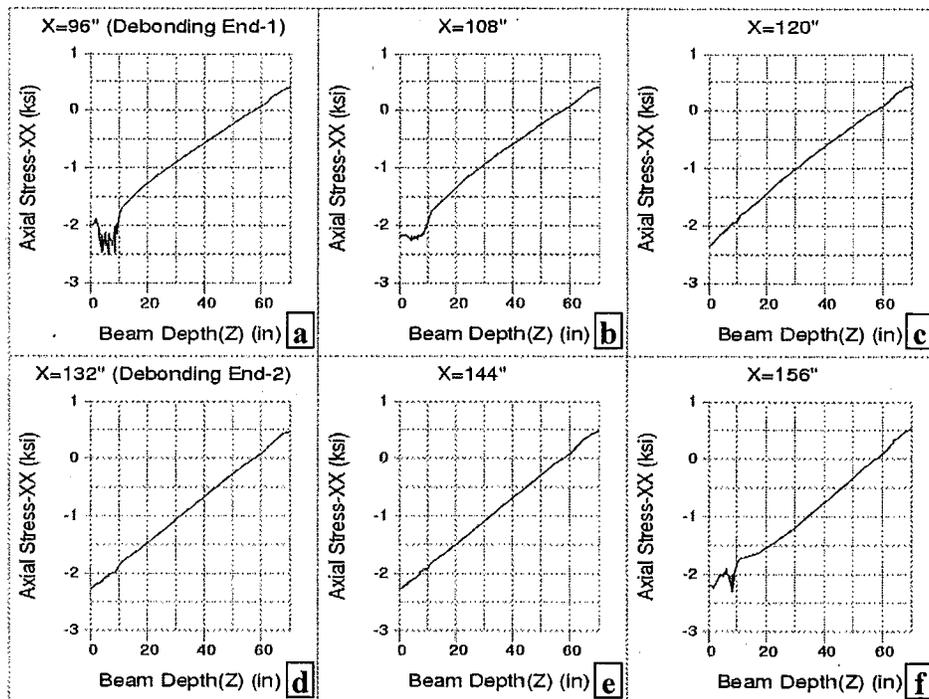
Figure 10-27. Axial Stress Distribution within the Web Projection at Selected Sections near the Release Points on the Girder with Bond-Breakers under Prestressing Loads

the girder within 24 inches, where debonding ends. The maximum shear stress is calculated as around 500 psi at the first release point as shown in Figure 10-28-a. Deviation of the axial stress between Figure 10-27-b and Figure 10-27-c is not significant.

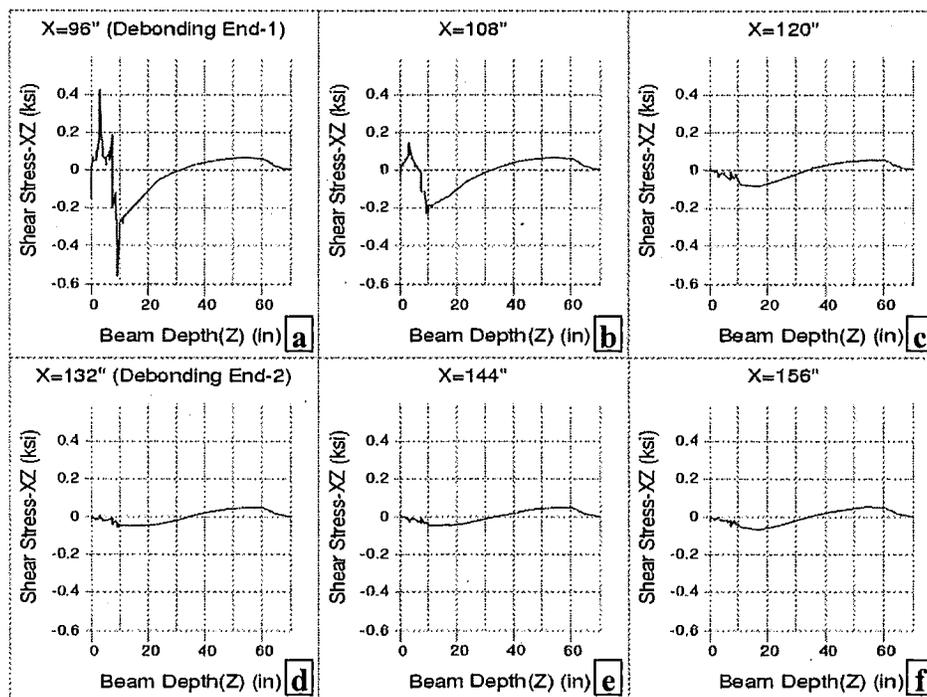
Figure 10-28. Shear Stress Distribution within the Web Projection at Selected Sections near the Release Points on the Girder with Bond-Breakers under Prestressing Loads

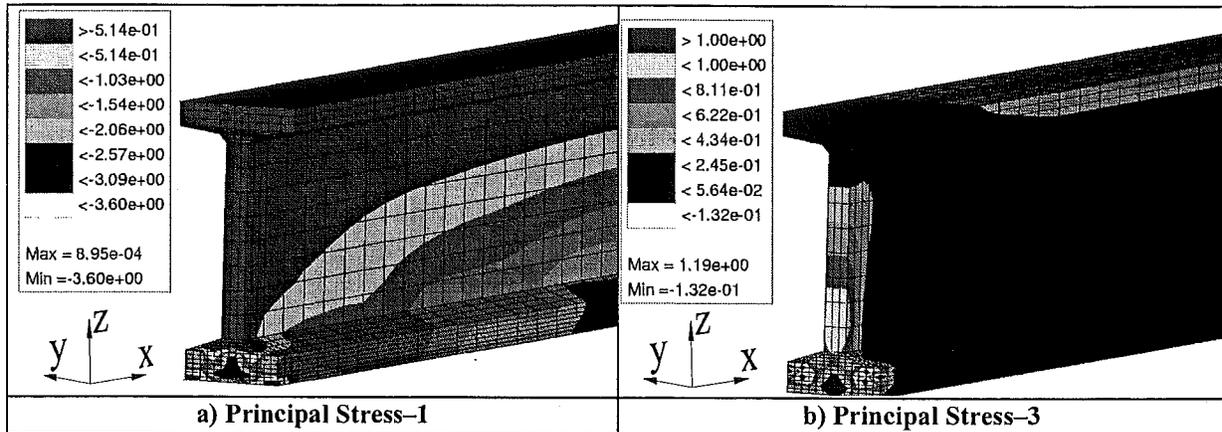
The shear stress cracking pattern may be described by the principal stresses. The maximum and minimum principal stresses for the beam with bond breakers are shown in Figure 29-a and -b. The maximum principle stress is 3.6 ksi around the tendons and the ends of debonding as shown in Figure 29-a. This stress is compressive and well below the compressive strength of concrete. The minimum principle stress, shown in Figure 29-b, is around 1.2 ksi. This tensile stress may be the main reason for the shear cracking. Because the stress value found exceeds the tensile strength of concrete, which is 424 psi. As it is seen in Figure 29-b, the web zone is prone to cracking due to excessive tensile stress.

Figure 29. Principal Stresses (ksi) near the Beam-end under Prestressing Load for the Beam with Bond-breakers

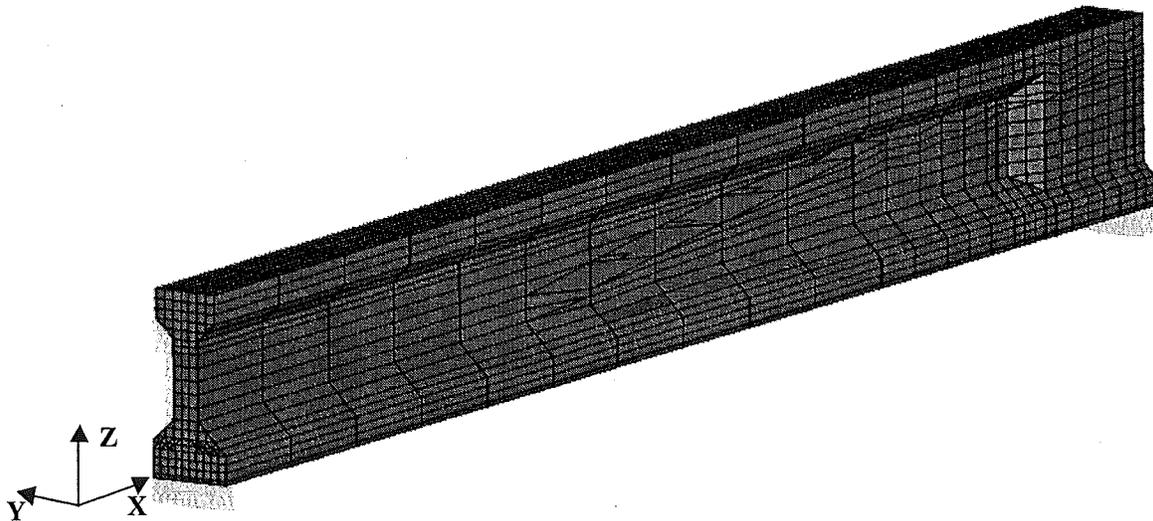
The FE model and mesh for the girder with draped strands shown in Figure 10-30 is significantly different than the other two tendon arrangements analyzed earlier. In this mesh, some of the elements are inclined in order to accommodate the inclined tendon and the end-block, where the web is gradually make thicker towards the beam-end.

Figure 10-30. One Half of a Beam with Draped Tendons and End Block

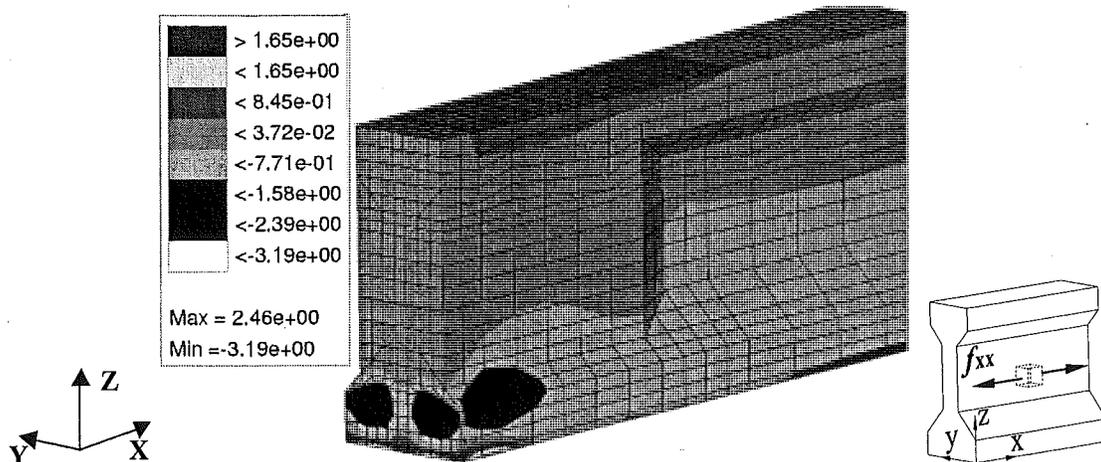
The axial stress distribution in x-axis is shown in Figure 10-31 and the shear stress distribution on the x-z plane is shown in Figure 10-32. As seen in Figure 10-32, the change in effective prestressing force within the transfer length results in shear stresses generated near the top flange within the end block and near the zone where the end block is gradually discontinued. The shears stress near the girder-end exceeding 600 psi shows the vulnerability of these girders to cracking. The shear strength of the concrete is around 247 psi, according to AASHTO (AASHTO, 1998)

Figure 10-31. Axial Stresses (ksi) in Beam Model with Draped Tendons

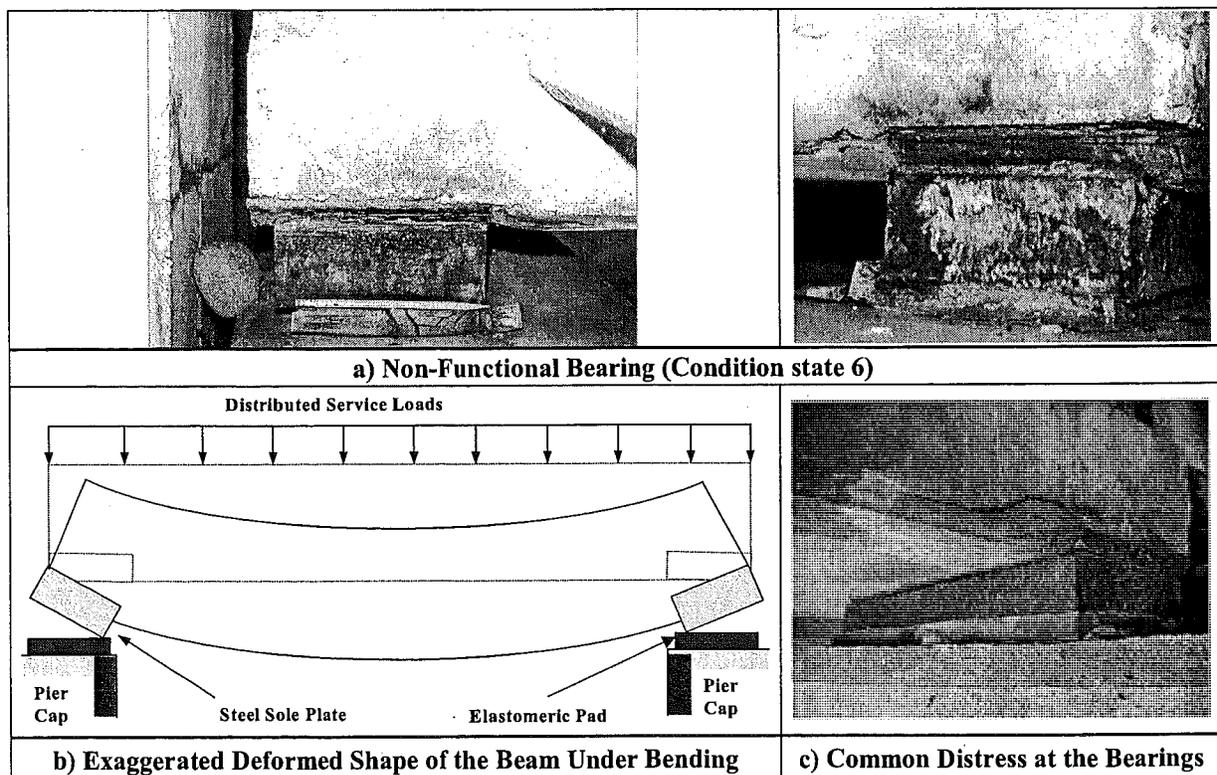
Influence of the bearing on the load path is an important parameter contributing to the stresses at the beam-end. The elastomeric bearing pad sits under a steel bearing plate. The concrete beam and the bearing plate are assumed in composite behavior, when the elastomeric bearing pads are deformable. However, when the elastomeric pad becomes non-functional, as shown in Figure 10-33-a, differential deformations between the bearing plate and the girder are observed. As the beam deforms under bending, the bearing without any deformability rocks on the pier cap. The effective support area is thus reduced. The exaggerated deformation is shown in Figure 10-33-b. Therefore, these differential deformations make the girder vulnerable to cracking, as shown in Figure 10-33-c.

Figure 10-33. a) Condition of the Elastomeric Bearing Pads; b) the Exaggerated Deformed Shape of a Girder under Flexural Bending; c) Common Distress Observed at the Bearings

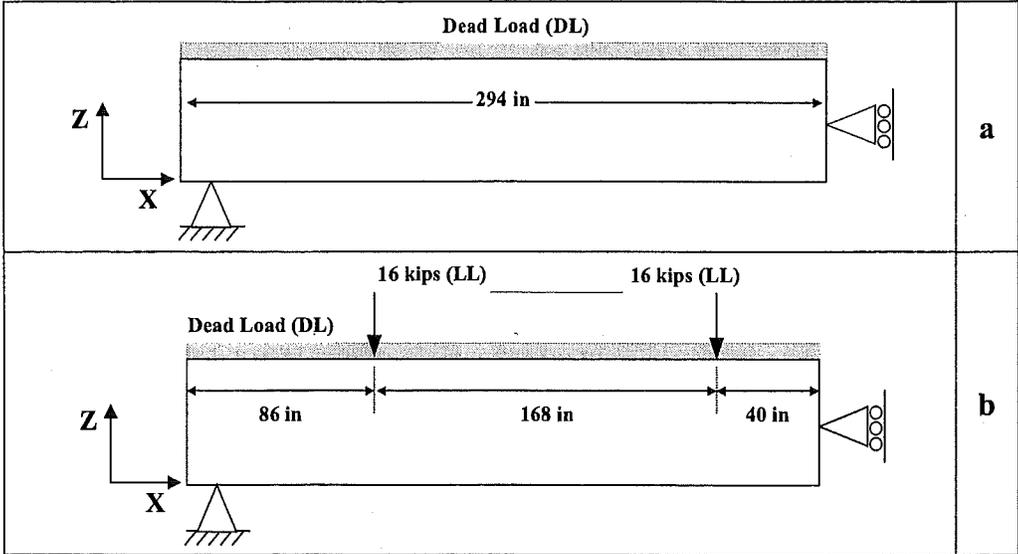
Figure 10-34. a) Beam FE Model and Loading under Dead Load; b) Live Load Distribution on the Girder

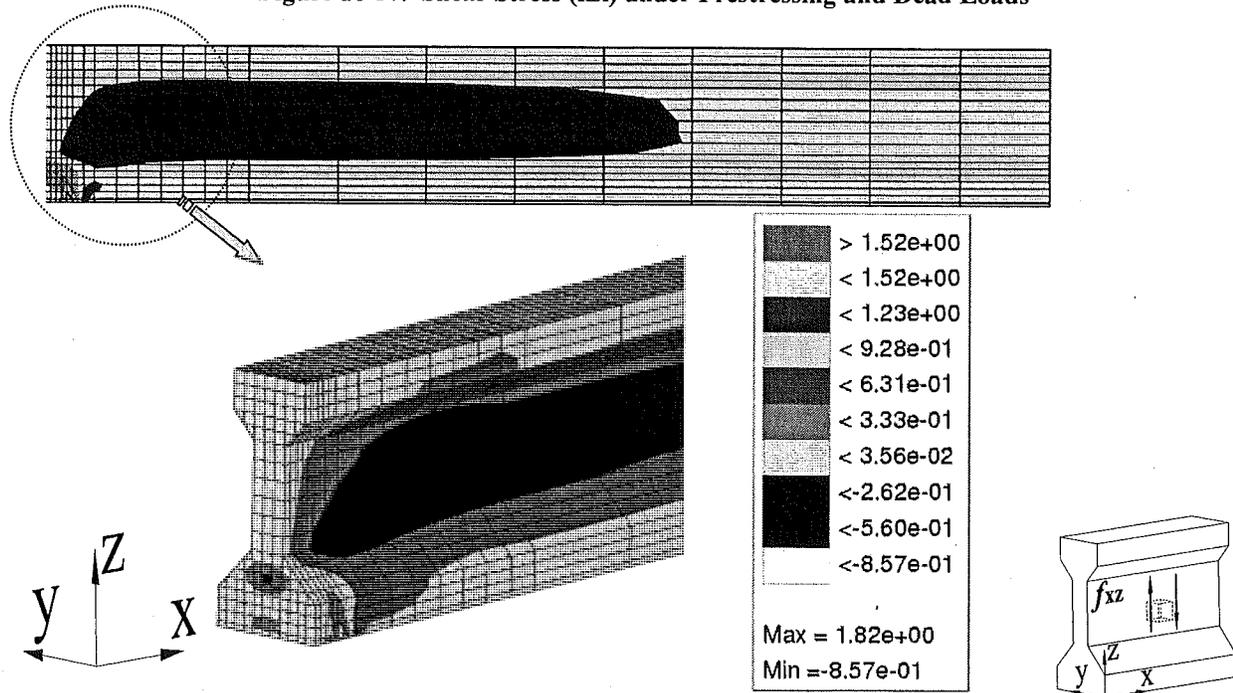
Figure 10-38. Shear Stress under Prestressing (ksi), Dead, and Live Loads

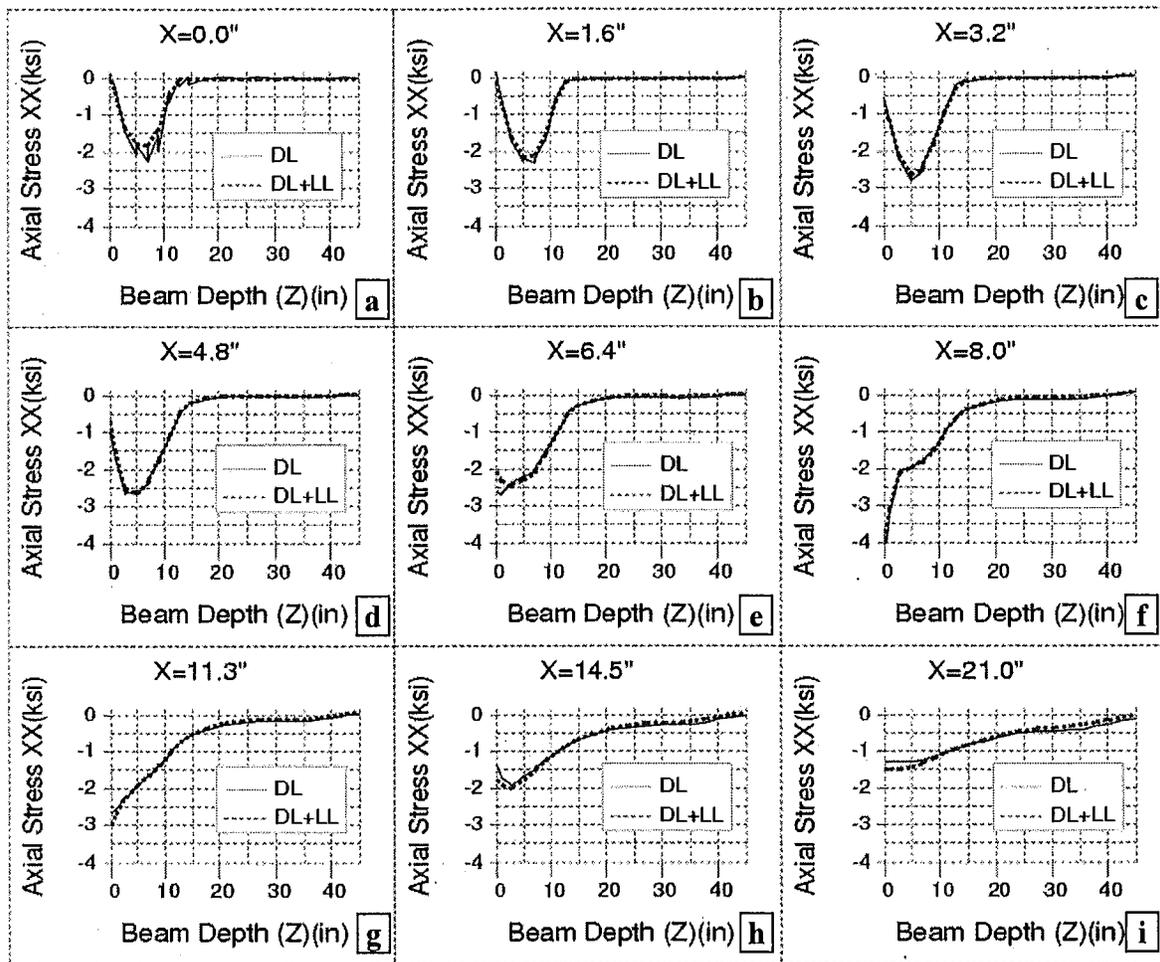
Figure 10-39. Axial Stress Distribution within the Web Projection at Selected Sections near the End Zone under Prestressing, Dead, and Live Loads

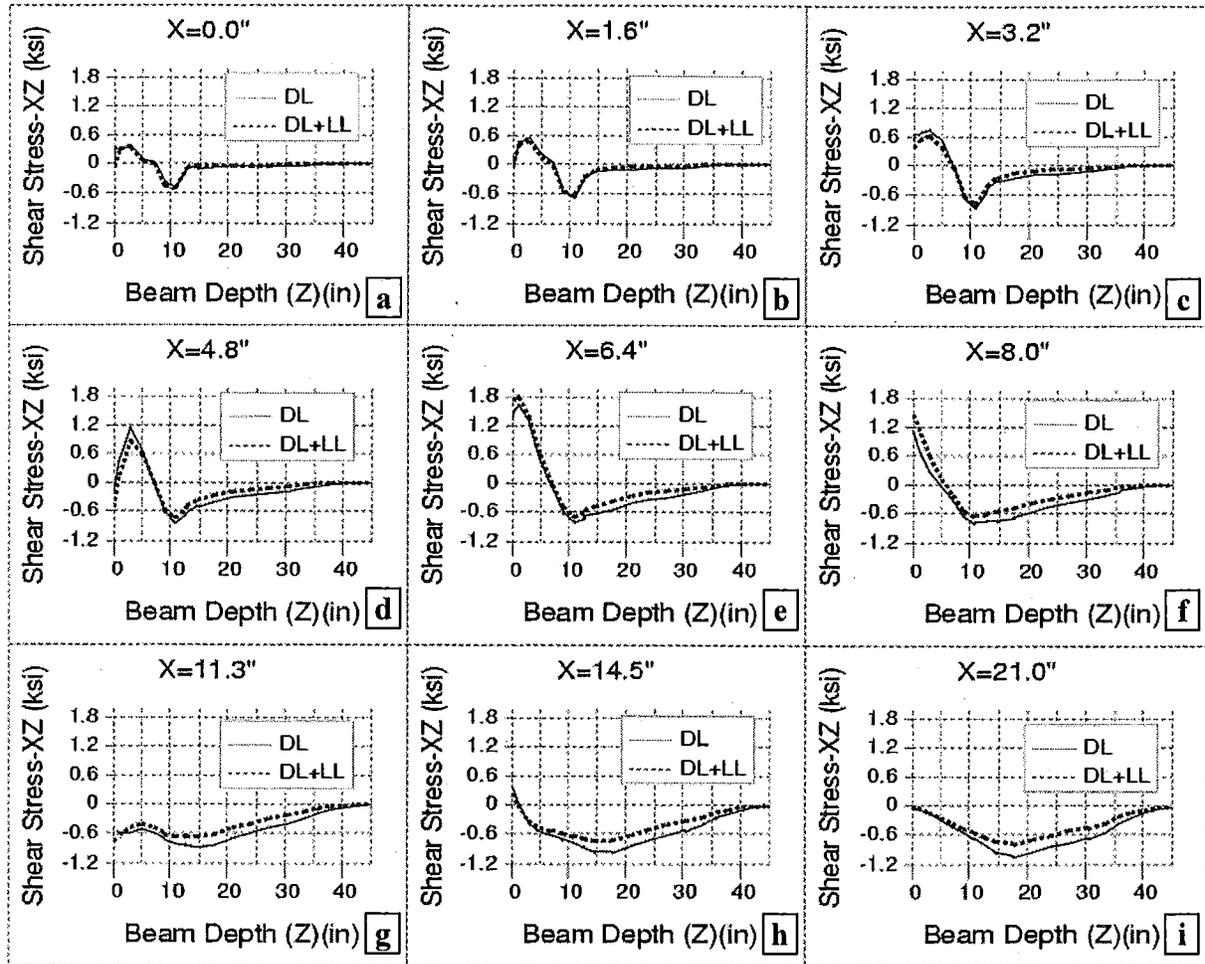
Figure 10-40. Shear Stress Distribution within the Web Projection at Selected Sections near the End Zone under Prestressing, Dead, and Live Loads

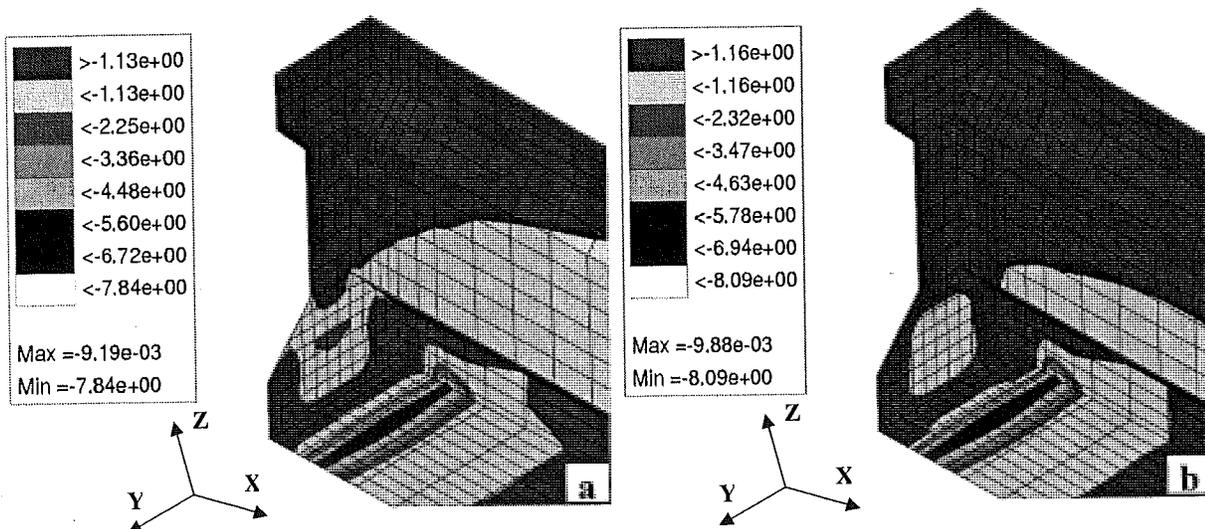
Figure 10-41. Principal Stress (Compressive), a) Under Dead Load (ksi); b) Under Dead and Live Loads (ksi)

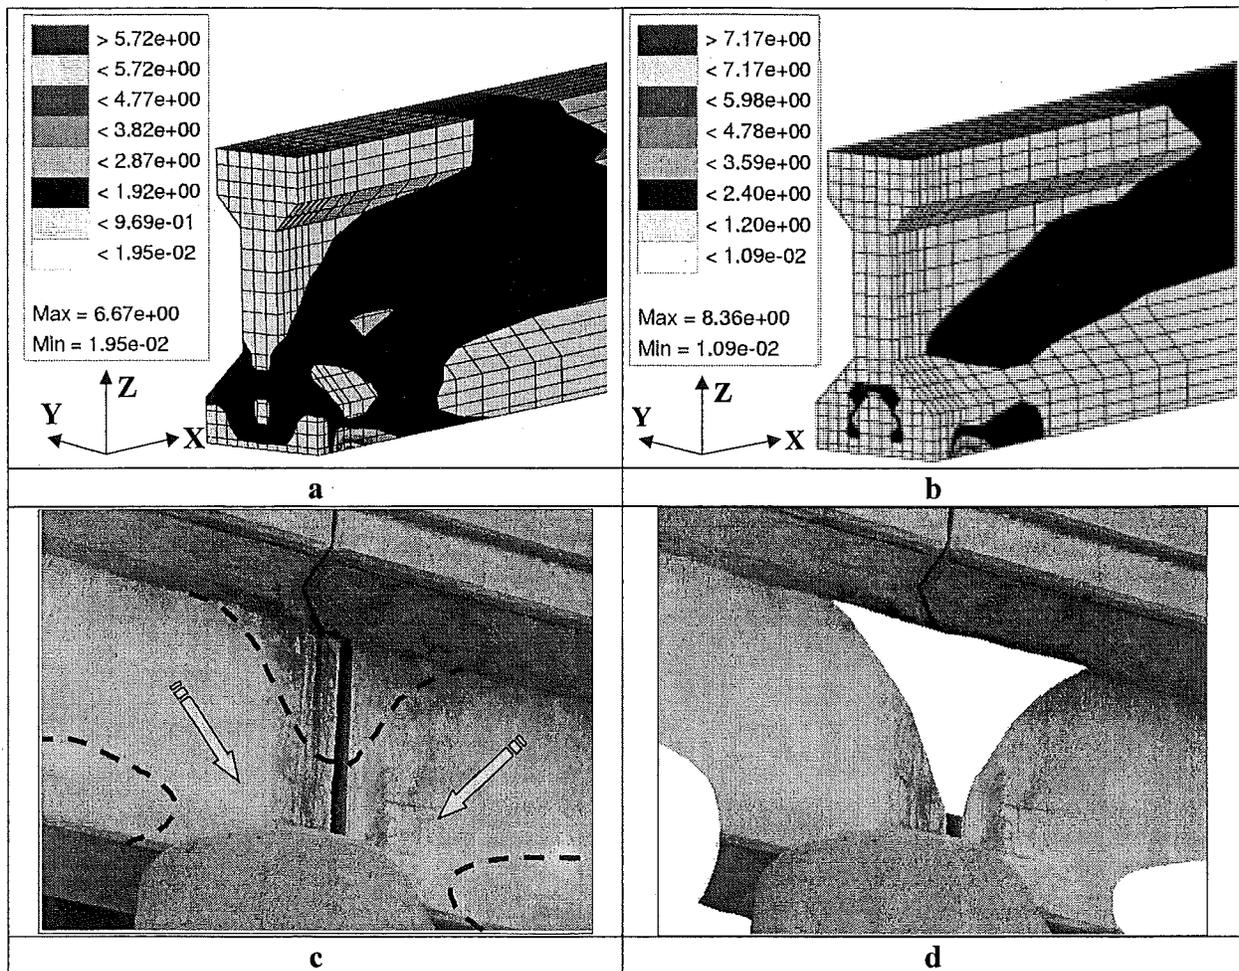
Figure 10-42. a) Von Mises Stress for Dead Load (ksi); b) Von Mises Stress for Dead and Live Loads (ksi); c) Load Path on a Girder; d) Critical Regions on Load Path

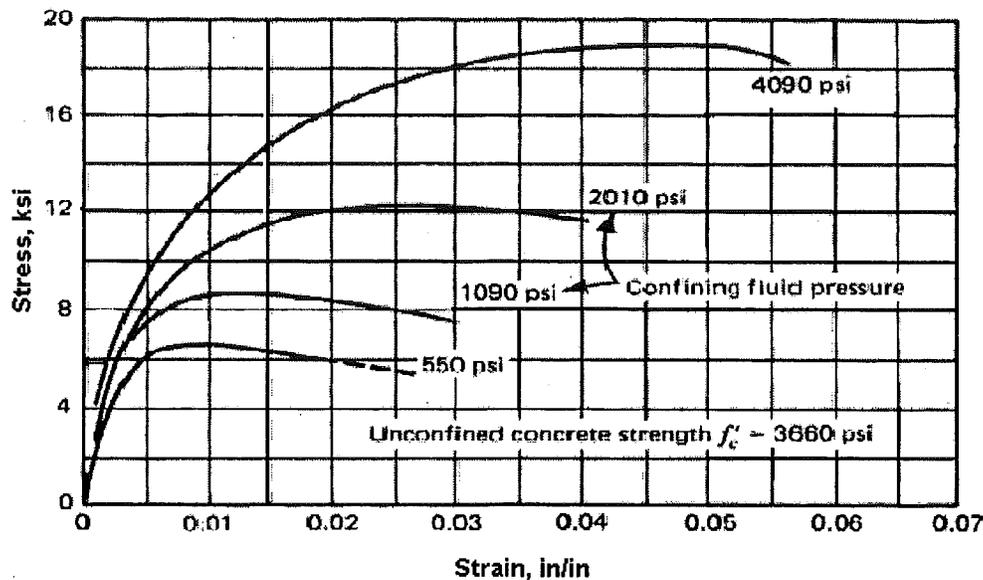
Figure 10-43. Axial Stress-Strain Curves from Triaxial Compression Tests on Concrete Cylinders (Park and Paulay, 1975)

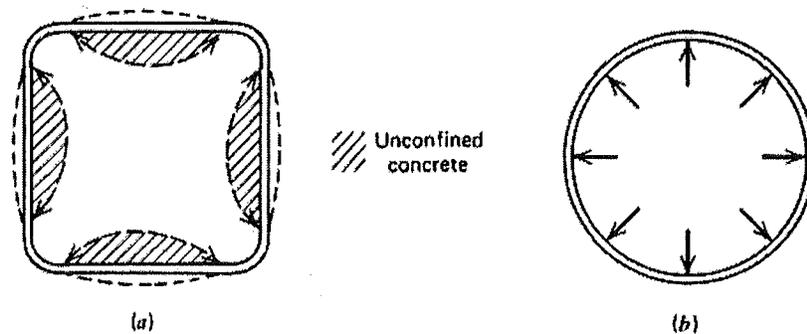
Figure 10-44. Confinement by a) Square Hoops and b) Spiral Hoops (Park and Paulay, 1975)

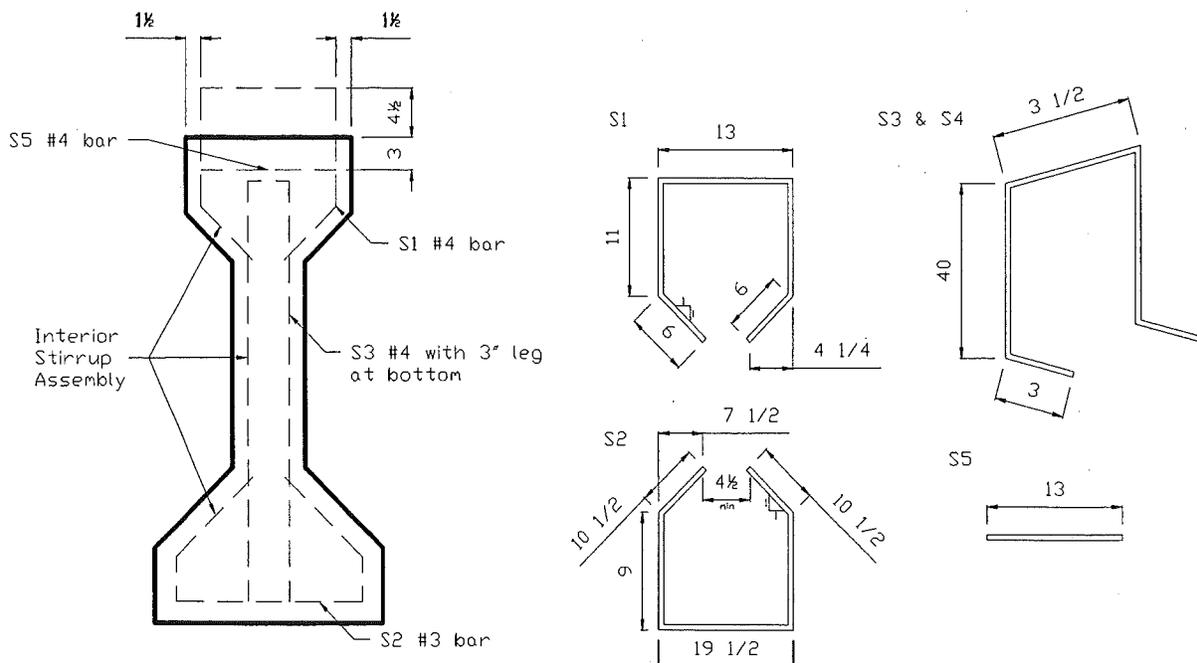
Figure 10-45. Shear Reinforcement used in the Girder Described in the Analytical Model (MDOT PC I-Beam Details)

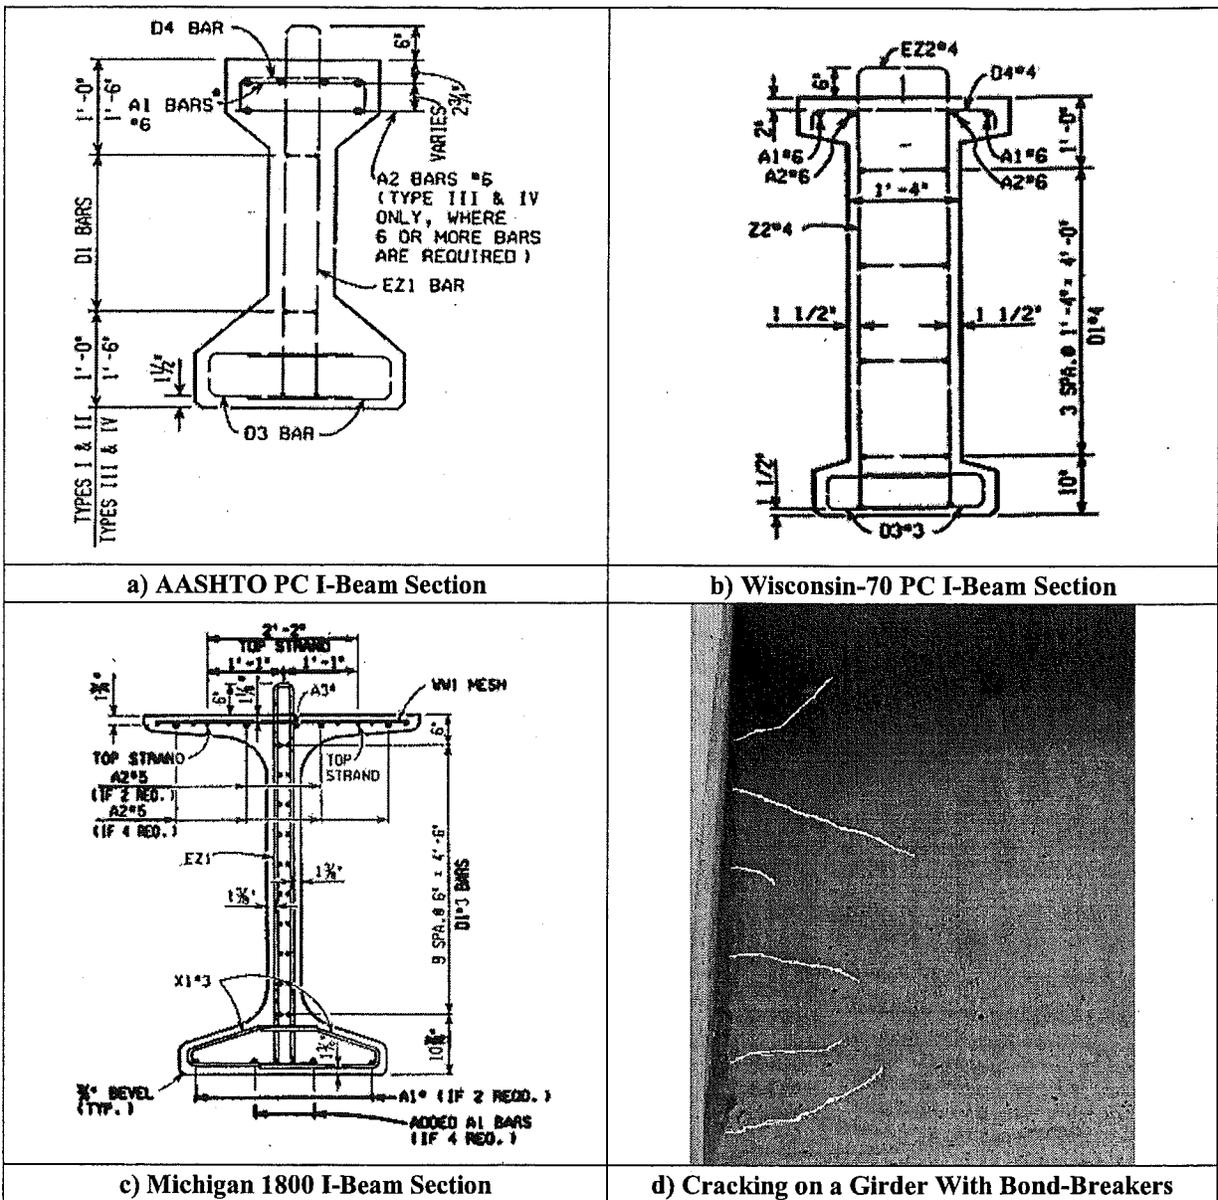
Figure 10-46. Shear Reinforcement used in Newly Manufactured Girders and Web Cracking Observed during Field Inspection on a PC I-Beam with Bond-Breakers

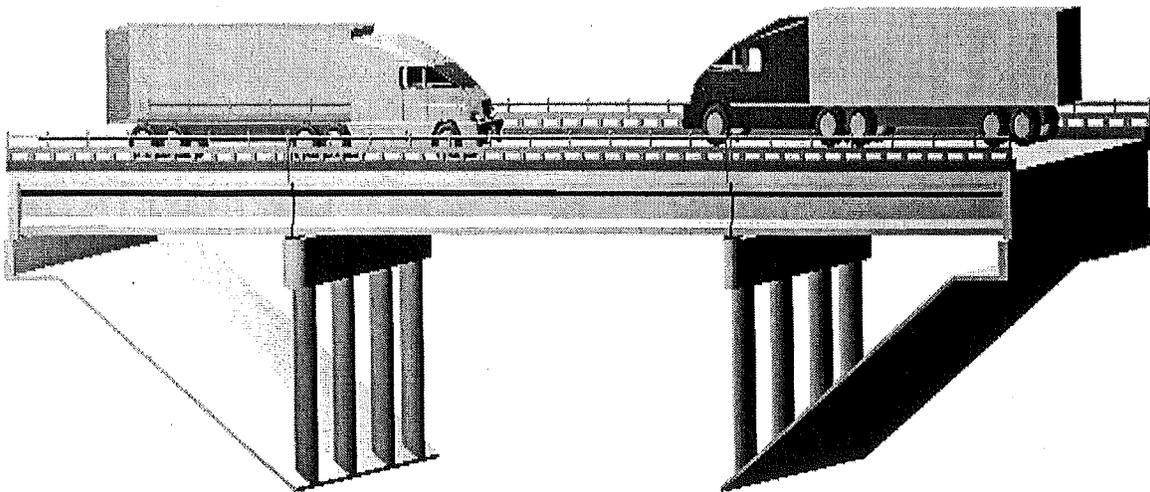
Figure 10-47. Drawing of the PC I-Beam Bridge Modeled

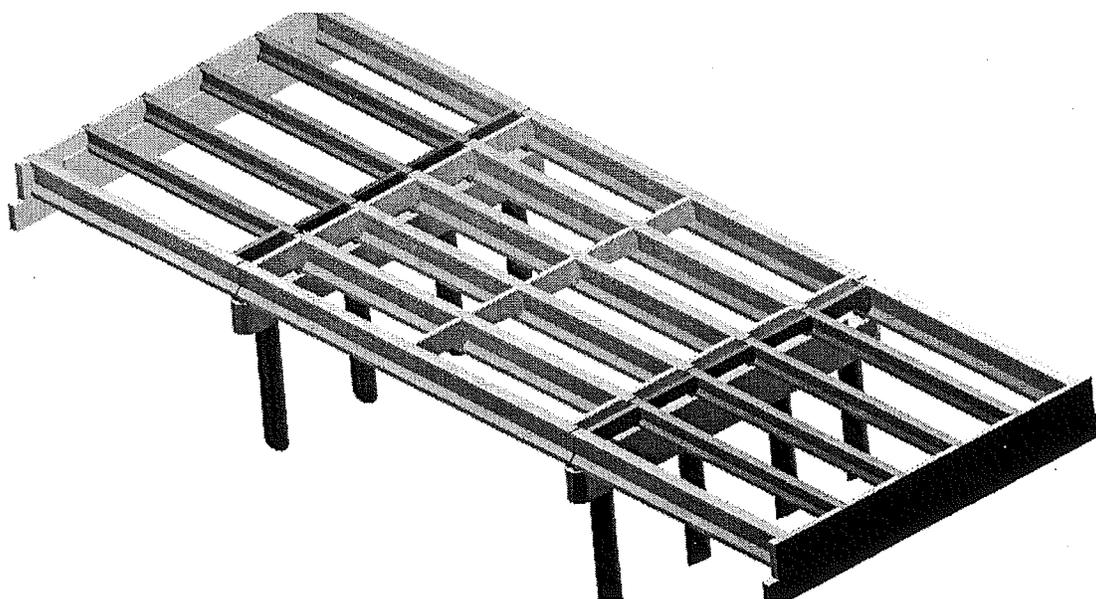
Figure 10-48. General View of the Diaphragm Arrangement in Early PC I-Beam Bridges

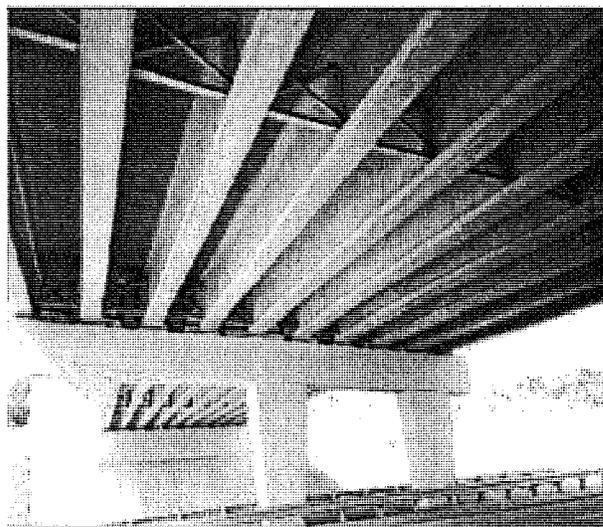
Figure 10-50. Steel Diaphragms between the Beams and the Cross-Section

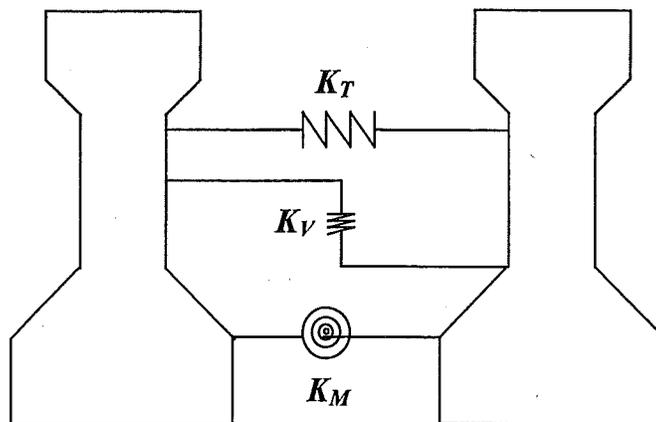
Figure 10-51. The Spring Representation of the Diaphragms

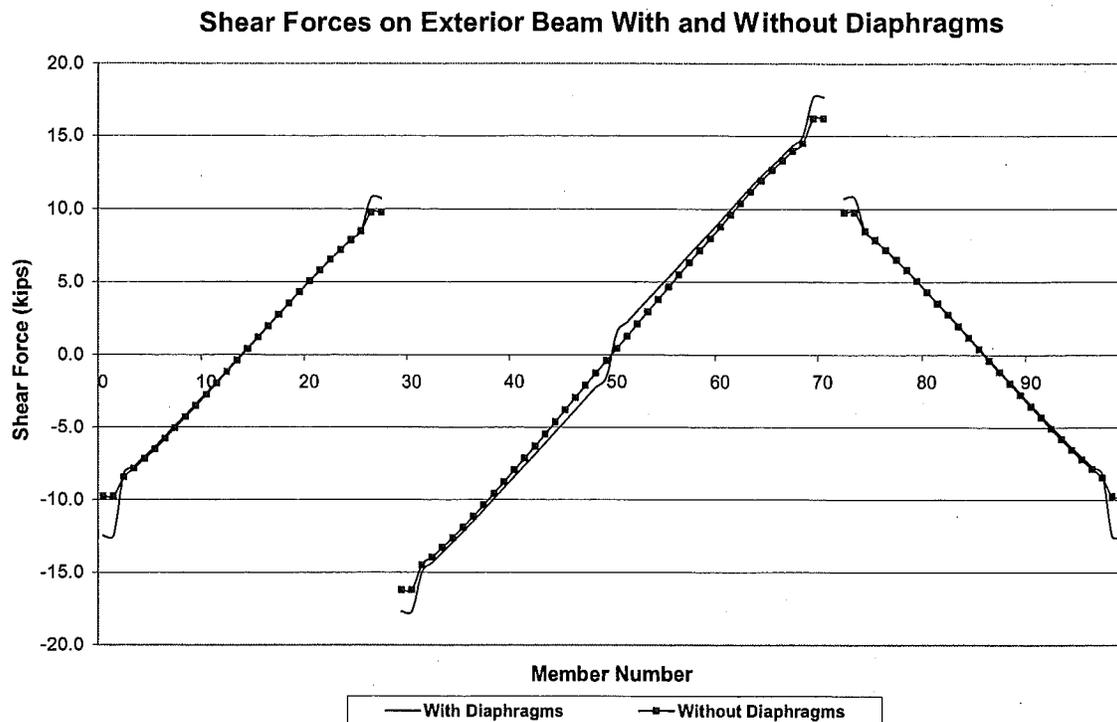
Figure 10-55. Shear Force Diagram of the Exterior Beams with and without Diaphragms

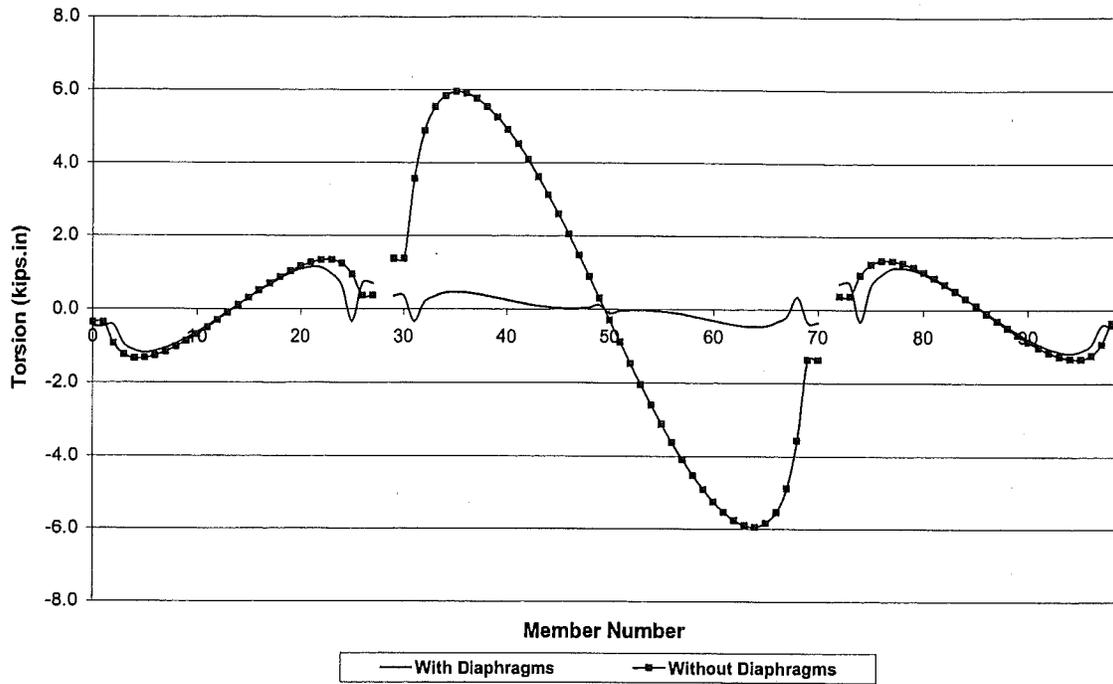
Figure 10-56. Torsion Diagram of the Interior Beams with and without Diaphragms

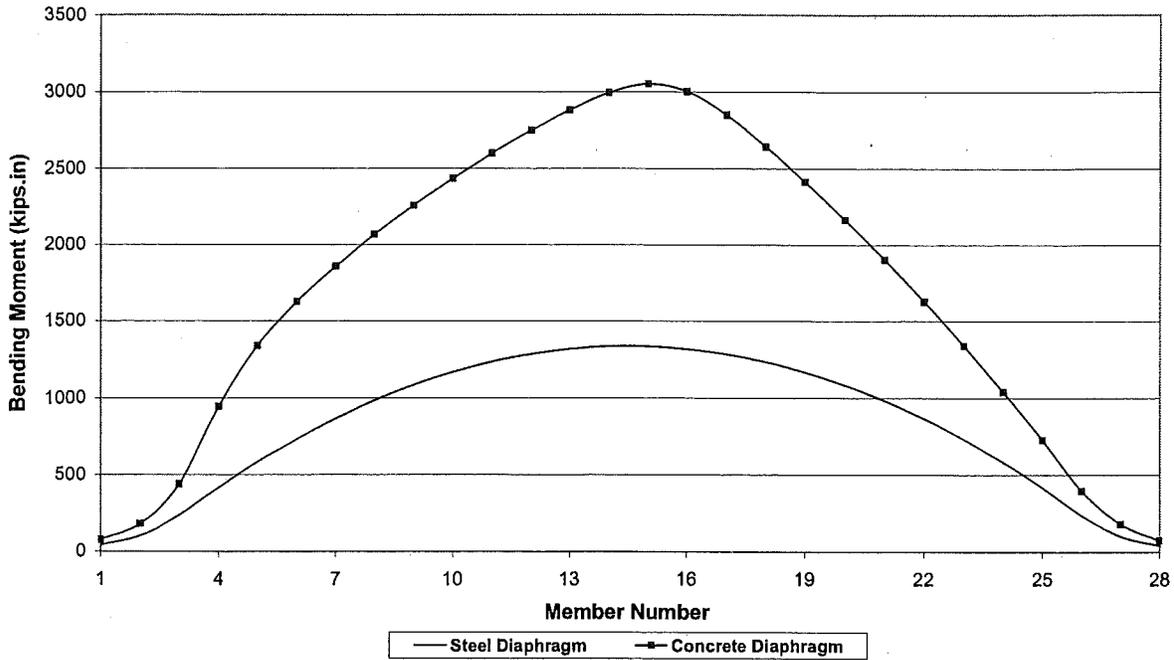
Figure 10-65. Starting from Abutment, Bending Moment on Interior Beam under Dead and Live Loads with Concrete and Steel Diaphragms

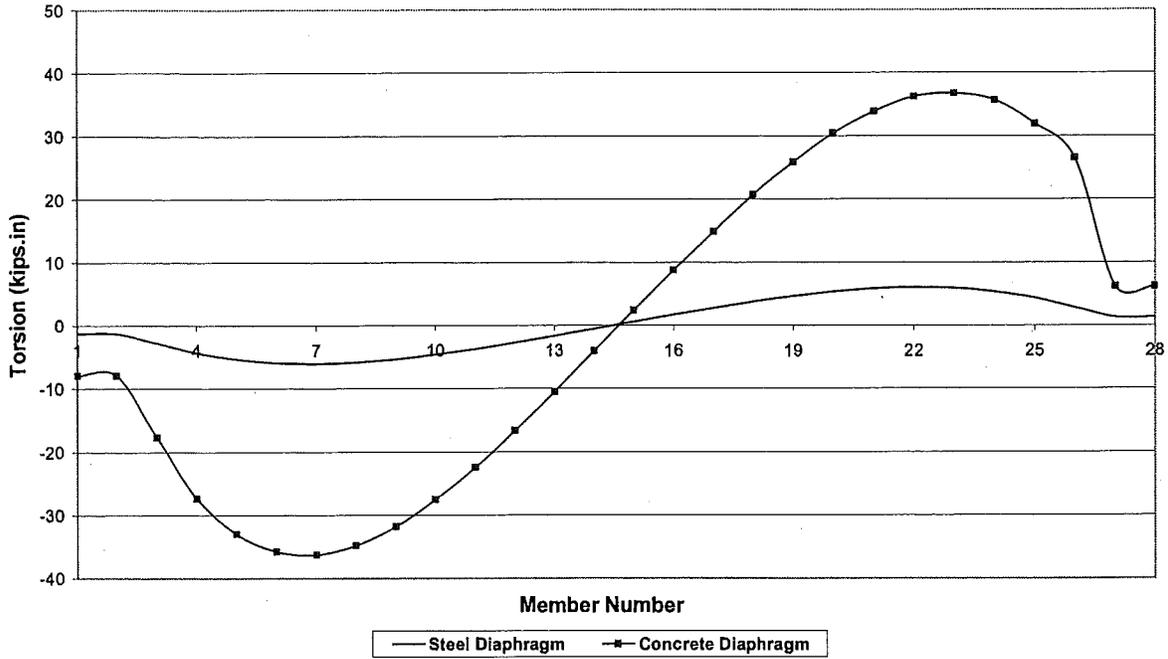
Figure 10-66. Starting from Abutment, Torsion on Exterior Beam under Dead and Live Loads with Concrete and Steel Diaphragms

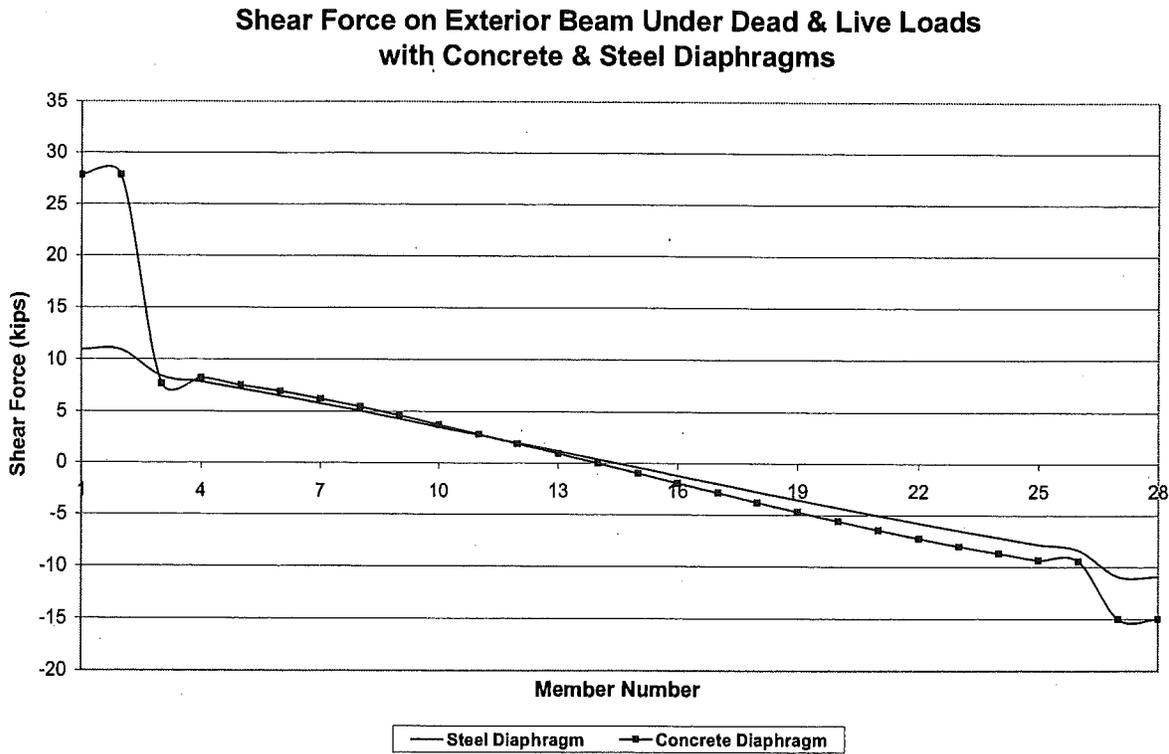
Figure 10-68. Starting from Abutment, Shear Force on Exterior Beam under Dead and Live Loads with Concrete and Steel Diaphragms
