MICHIGAN
DEPARTMENT OF STATE HIGHWAYS

June 27, 1973.

Subject: Failure of Preformed Guy-Grip Dead-Ends Used for Suspending
Steel Cable from Poles.
Research Project 73 TI-159. Research Report No. R-866.

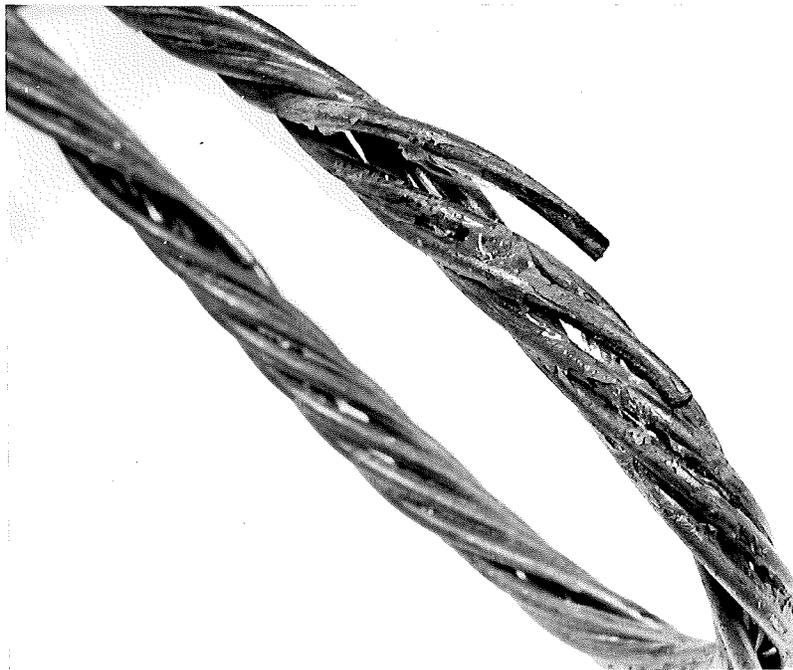
Figure 2. Two failed strands on the dead-end installed opposite the one in Figure 1.

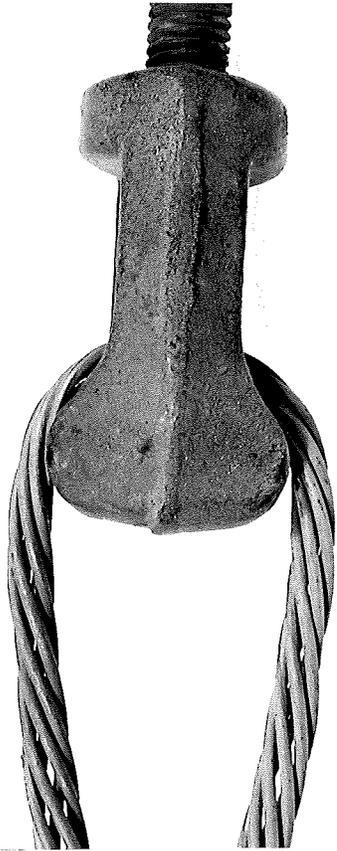
Figure 3. Loop holder currently employed in field installation of guy-grip dead-ends.

As to continued use of the guy-grip dead-ends, our own service record shows that they are economical and reliable as long as the materials used in their manufacture have the required strength and ductility properties. It is recommended that the currently used loop holder (Fig. 3) be discontinued and that the loop holder shown in Figure 7 be used exclusively. This arrangement will minimize the wear placed on the dead-end's strands themselves and greatly reduce the possibility of a recurrence of the problem at hand.

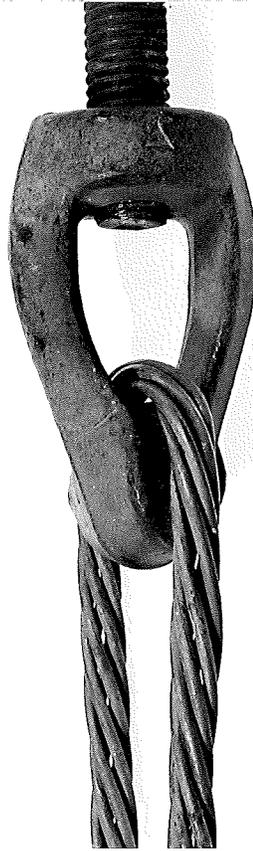
To check the validity of this theory, the Research Laboratory tested to failure a series of the guy-grip dead-end cable holders. These dead-end specimens were pulled in tension using the loop holder that is employed in a typical field installation (Fig. 4). The dead-ends were loaded to their ultimate load capacity and the nature of the fracture was observed in the wire strands. Six new dead-ends, taken from warehouse stock, were tested and the ultimate loads ranged from 17,500 to 17,900 lb with a mean of 17,670 lb. The fractures of the individual strands were due to ductility failure as can be seen by the "necking down" of the wire cross-section at the break

Figure 4. Tension test on guy-grip dead-end to measure ultimate load capacity.
