# Plastic Piping Information

**Harold Winnie**  
**Project Manager, Central Region**  
**PHMSA Office of Pipeline Safety**

# Plastic Pipe Construction Issues

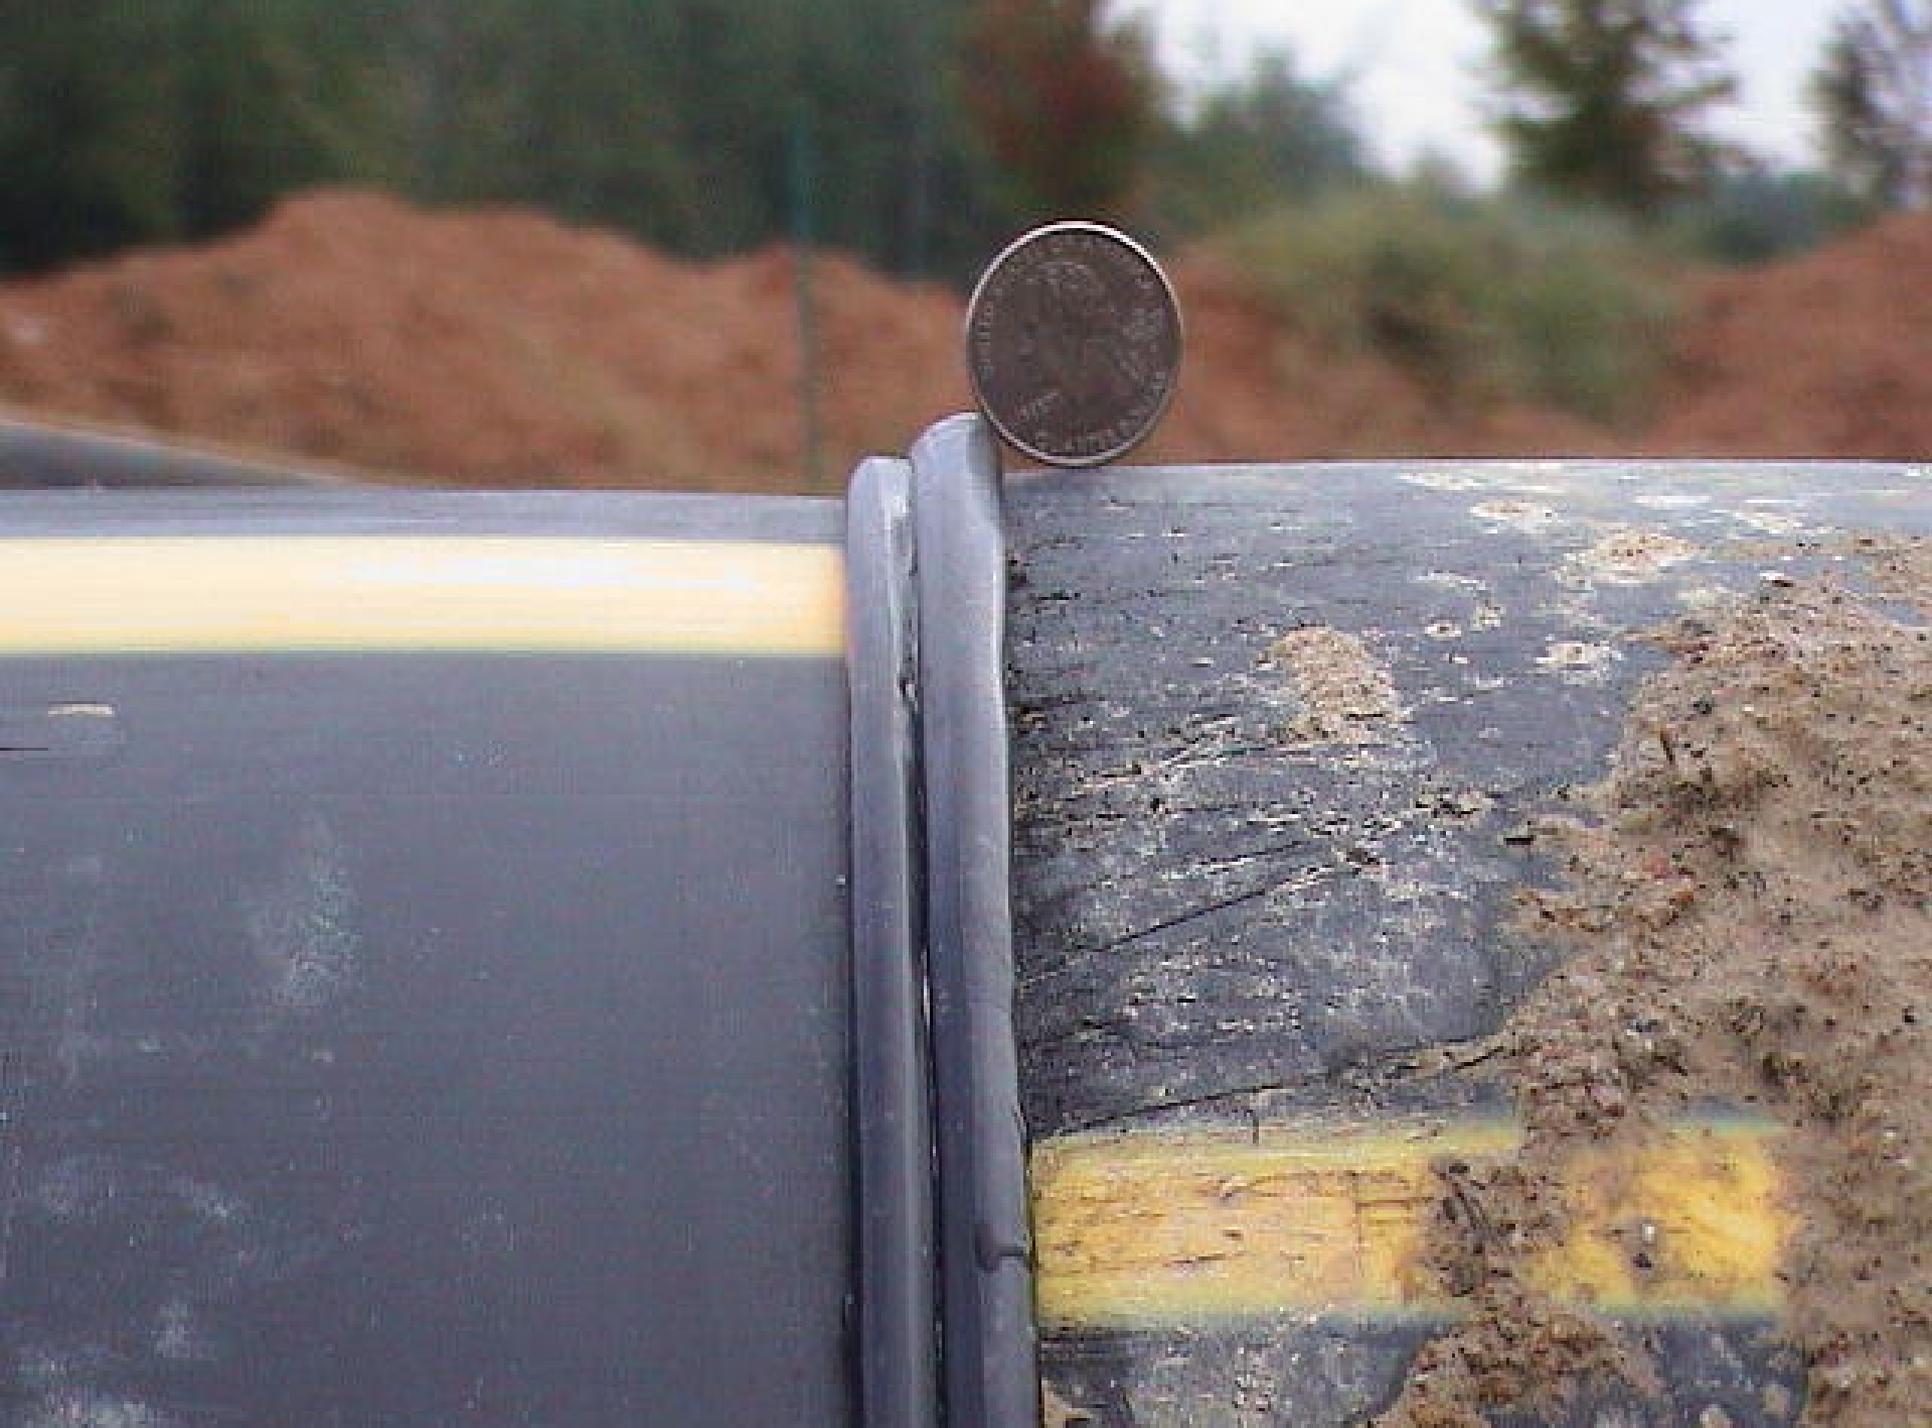
# Butt Fusion Procedures

## “COLD FUSION”

**Note the concave effect in the wall of the pipe. The melt has been pushed out of the fusion area. This will produce a bad joint.**

**UNACCEPTABLE**

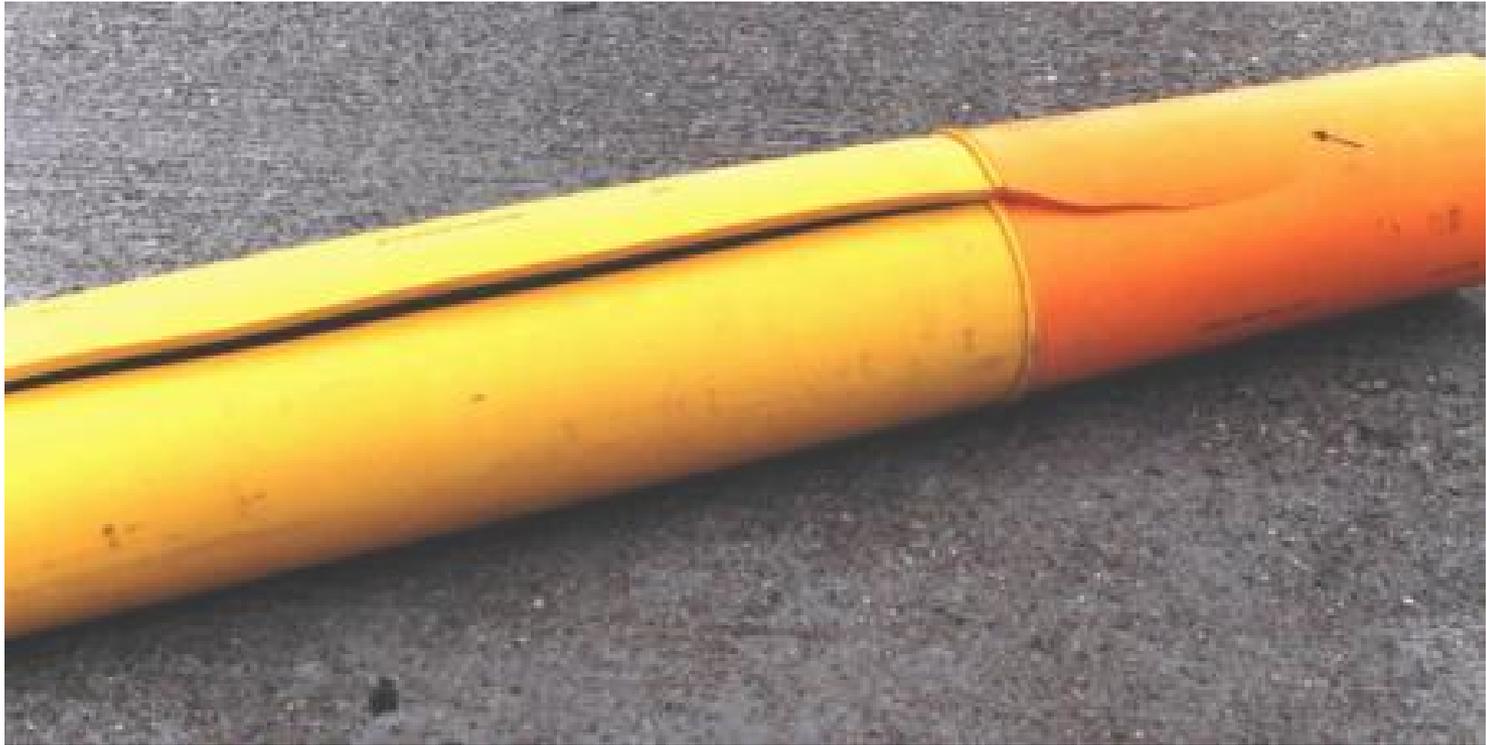
# Arrest of Rapid Crack Propagation

Crack arrest in ERGO pipe
