# Yellowstone River Crossings

**Harold Winnie**  
**Project Manager, Central Region**  
**PHMSA Office of Pipeline Safety**

# Silvertip Pipeline

# Another High Profile Accident in PHMSA's Western Region

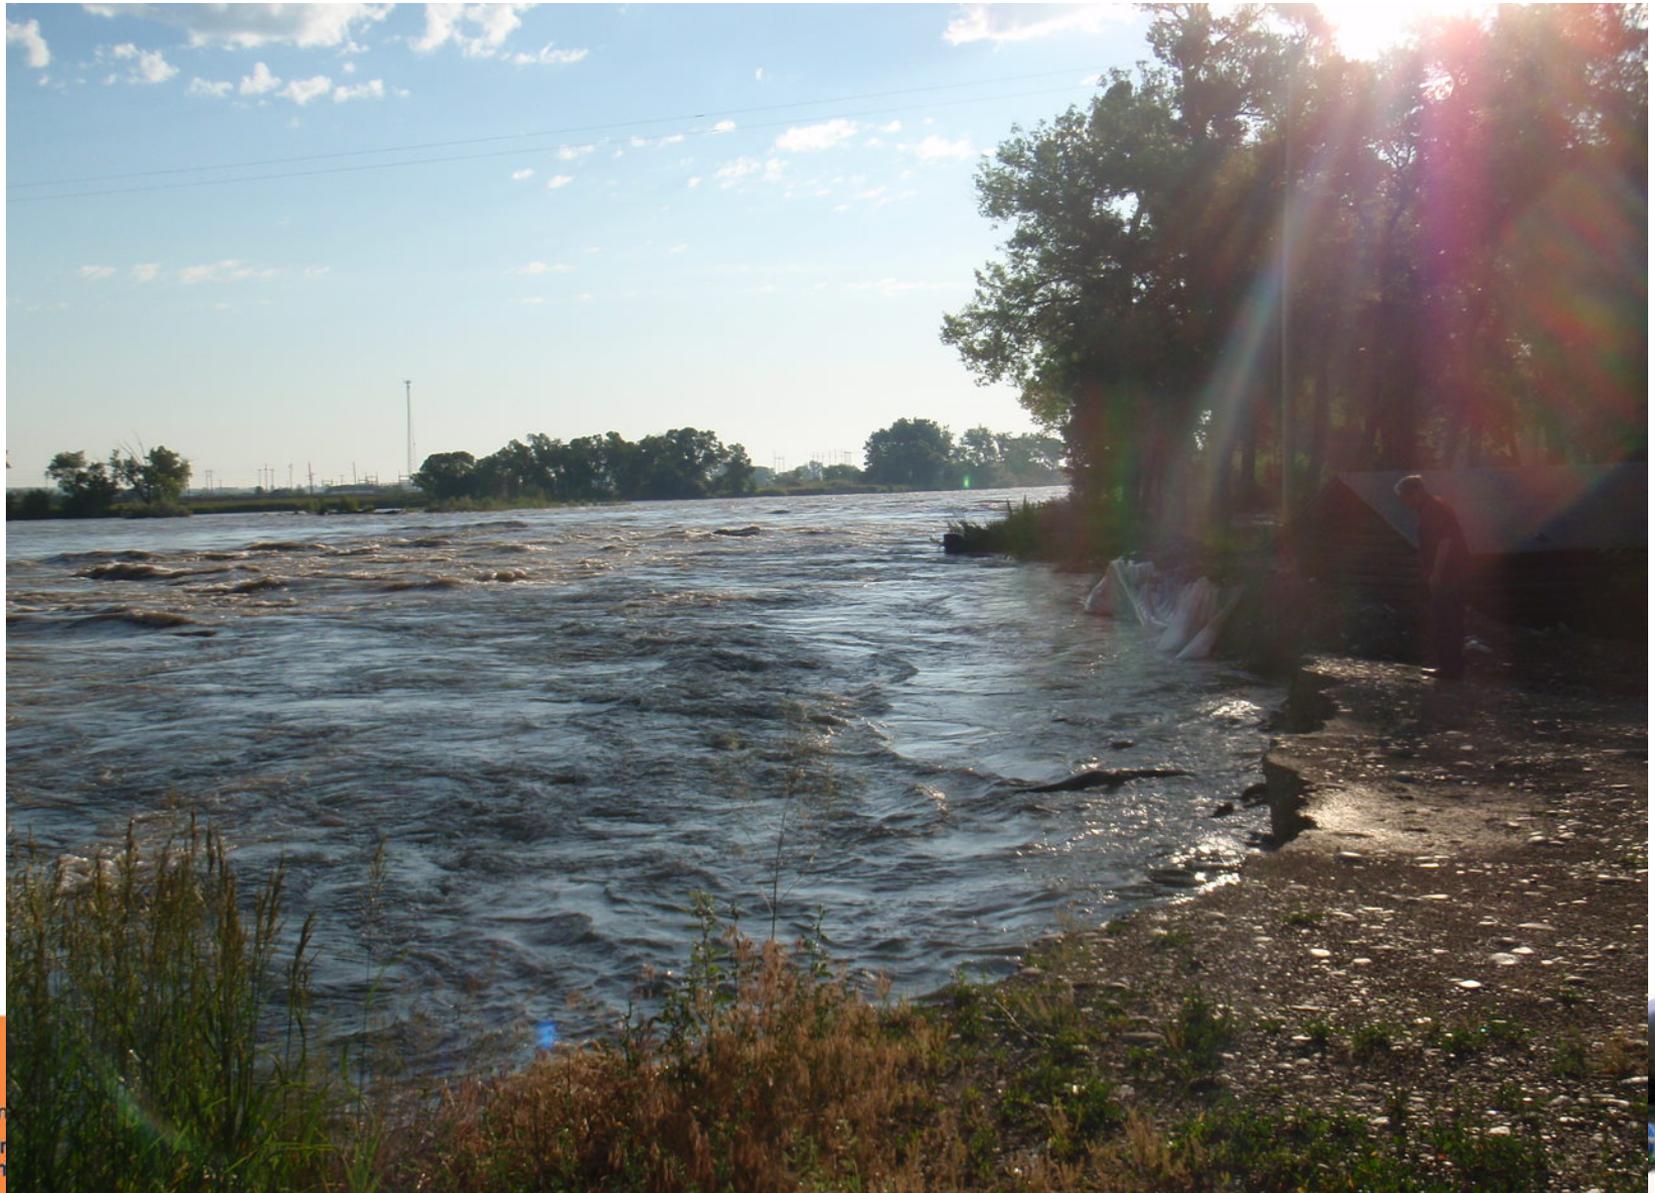
# Silvertip – July 2011

- Silvertip pipeline released an estimated 1000 barrels of crude oil into the Yellowstone River near Laurel, Montana; Est. \$42M damages
- River scour is cause of accident
- Operator was aware and monitored the flood conditions; had numerous remote actuated valves at rivers
- Controllers took 56 minutes after first alarm to close valve adjacent to river

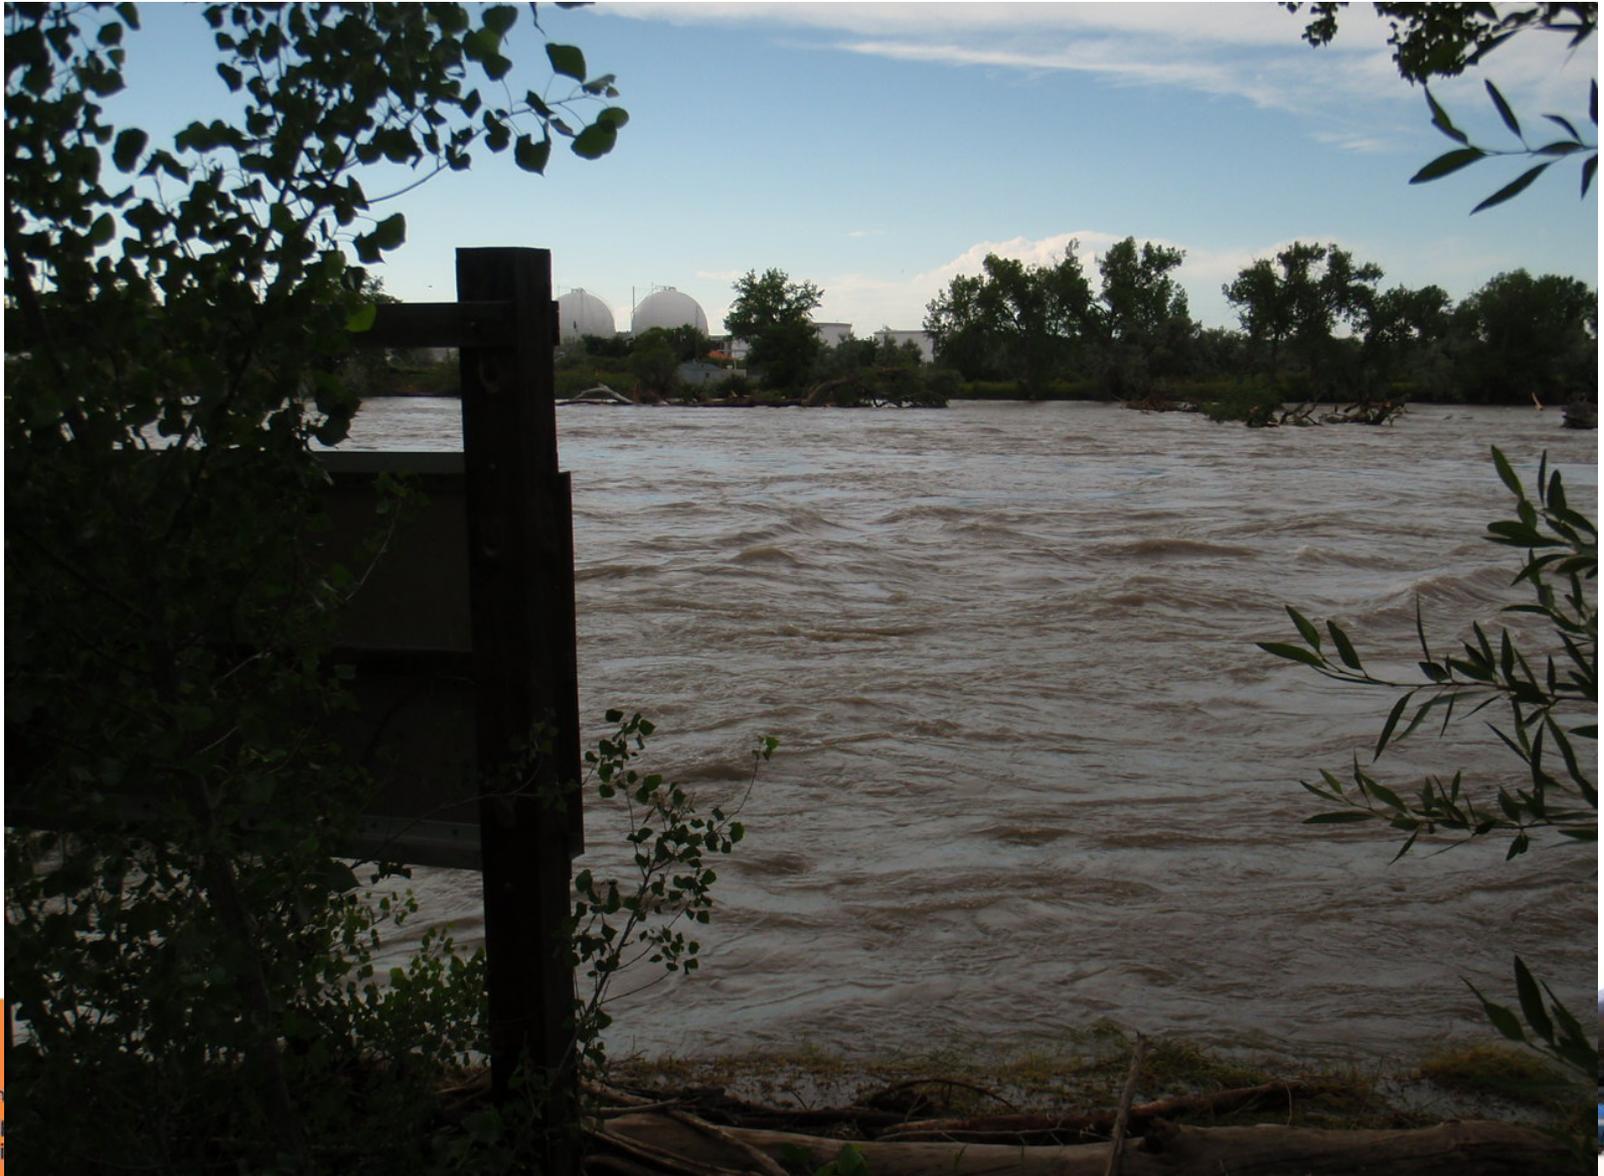
# Silvertip – July 2011

- Operator did not appear to explicitly integrate local river crossing information, particularly local stream information, into their IMP when determining their preventative and mitigative measures
- MT Governor's and PHMSA task force revealing few pipeline companies incorporate river and geotechnical risks when determining P&M measures

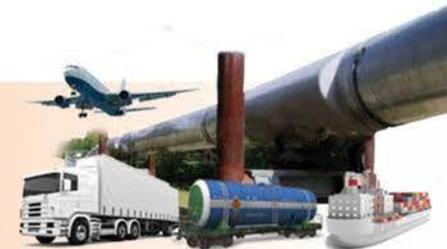
- The Poplar Pipeline ruptured on Saturday January 17, 2015, spilling approximately 30,000 gallons of crude oil into the Yellowstone River.
- Findings show that the pipe was exposed in the river following an ice dam event in 2014. This pipe exposure went undetected and the line failed due to water induced forces & vibrations.

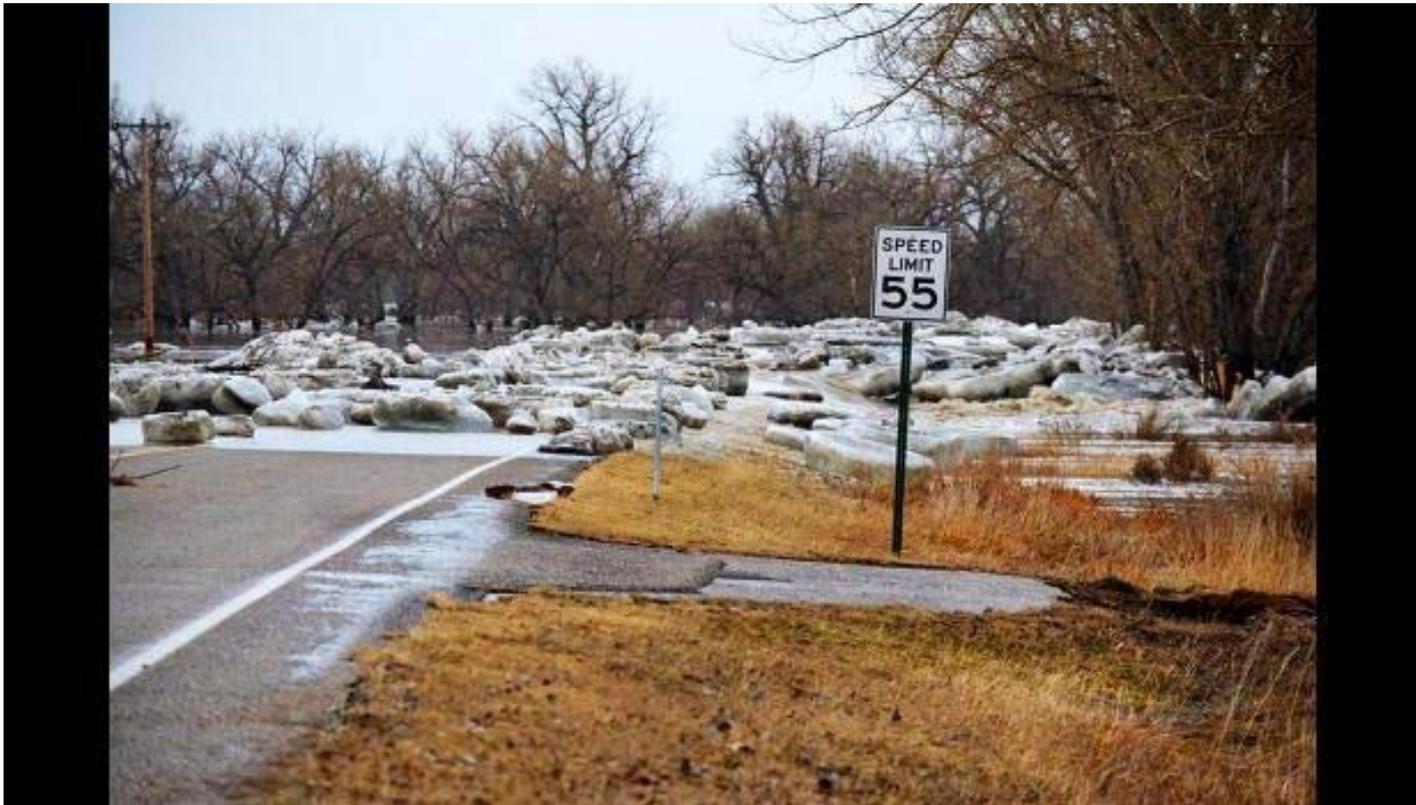
# Yellowstone River Near Glendive, MT

- 6800 feet between the North and South Block Valves with the river in between
- 2200 feet in this section is 12-inch, X52, .5-inch wall thickness, seamless pipe installed in 1967
- Crossing was inspected utilizing a depth of cover survey on September 17, 2011
- Maximum Operating Pressure (MOP) was 1200 psig

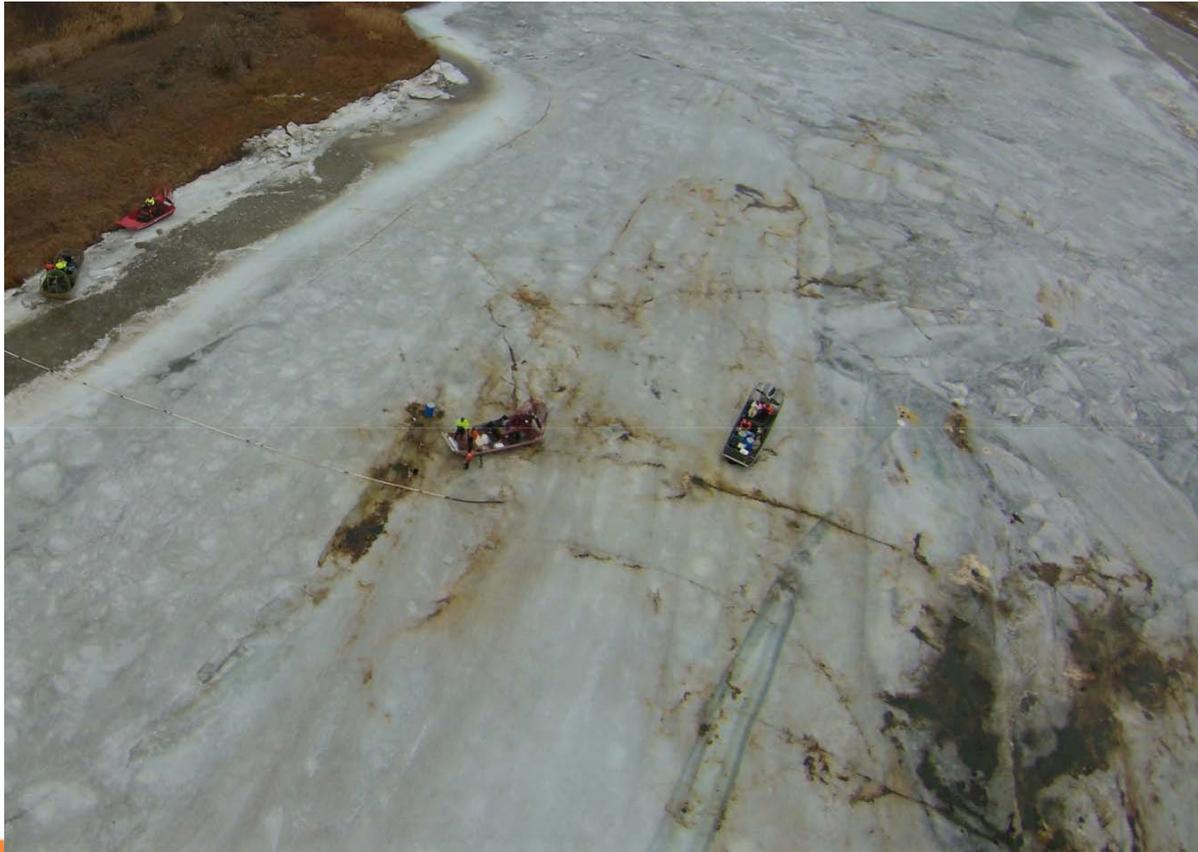
# Yellowstone River Response

Workers recovered a total of 1,722 gallons/41 BBLs of oil from the iced over river.
