HISTORICAL DATA REVIEW AND COMPILATION TECHNICAL MEMORANDUM

ABANDONED MINING WASTES – TORCH LAKE NON-SUPERFUND SITE
QUINCY MINING COMPANY MASON OPERATIONS AREA
HOUGHTON COUNTY, MICHIGAN
SITE ID# 31000098

FEBRUARY 2017

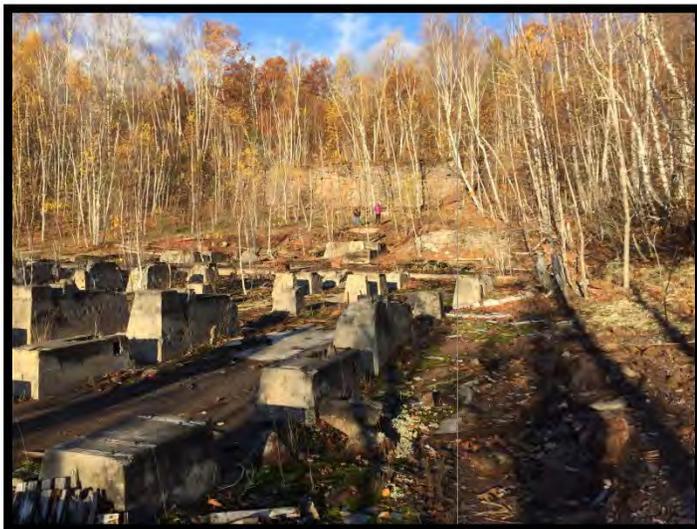
Photo 1: Current conditions at Quincy Stamp Mill No.1 (facing northwest)

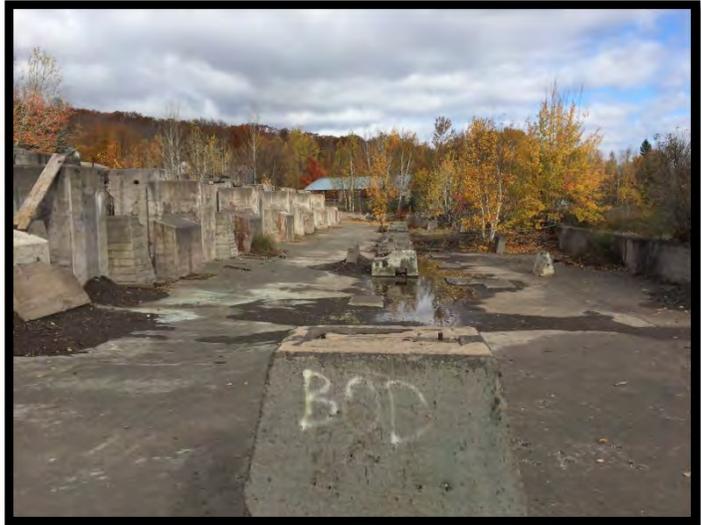
The Reclamation Plan shut down in 1967 and several years later a scrap metal company dismantled the Regrinding Plant, Shore Plant, and conveyor apparatus. Of the four major structures that were part of the facility, only the enclosed conveyor system that carried stamp sand from the Shore Plant to the regrinding plant is absent from the landscape. The Shore Plant's foundation and pilings still stand on the shore and in Torch Lake, respectively. The Regrinding Plant foundation is intact. Foundations of substation equipment remain in the northwest corner of the plant ruins, though the equipment itself is absent with the exception of a few power poles and insulators. The original dredge remains at the bottom of Torch Lake, marked by a red buoy. Quincy's second dredge rests on the bed of Torch Lake, close to shore and is mostly intact and visible above the water.

Photo 2: Current conditions at the former Quincy Reclamation Plant (facing north).

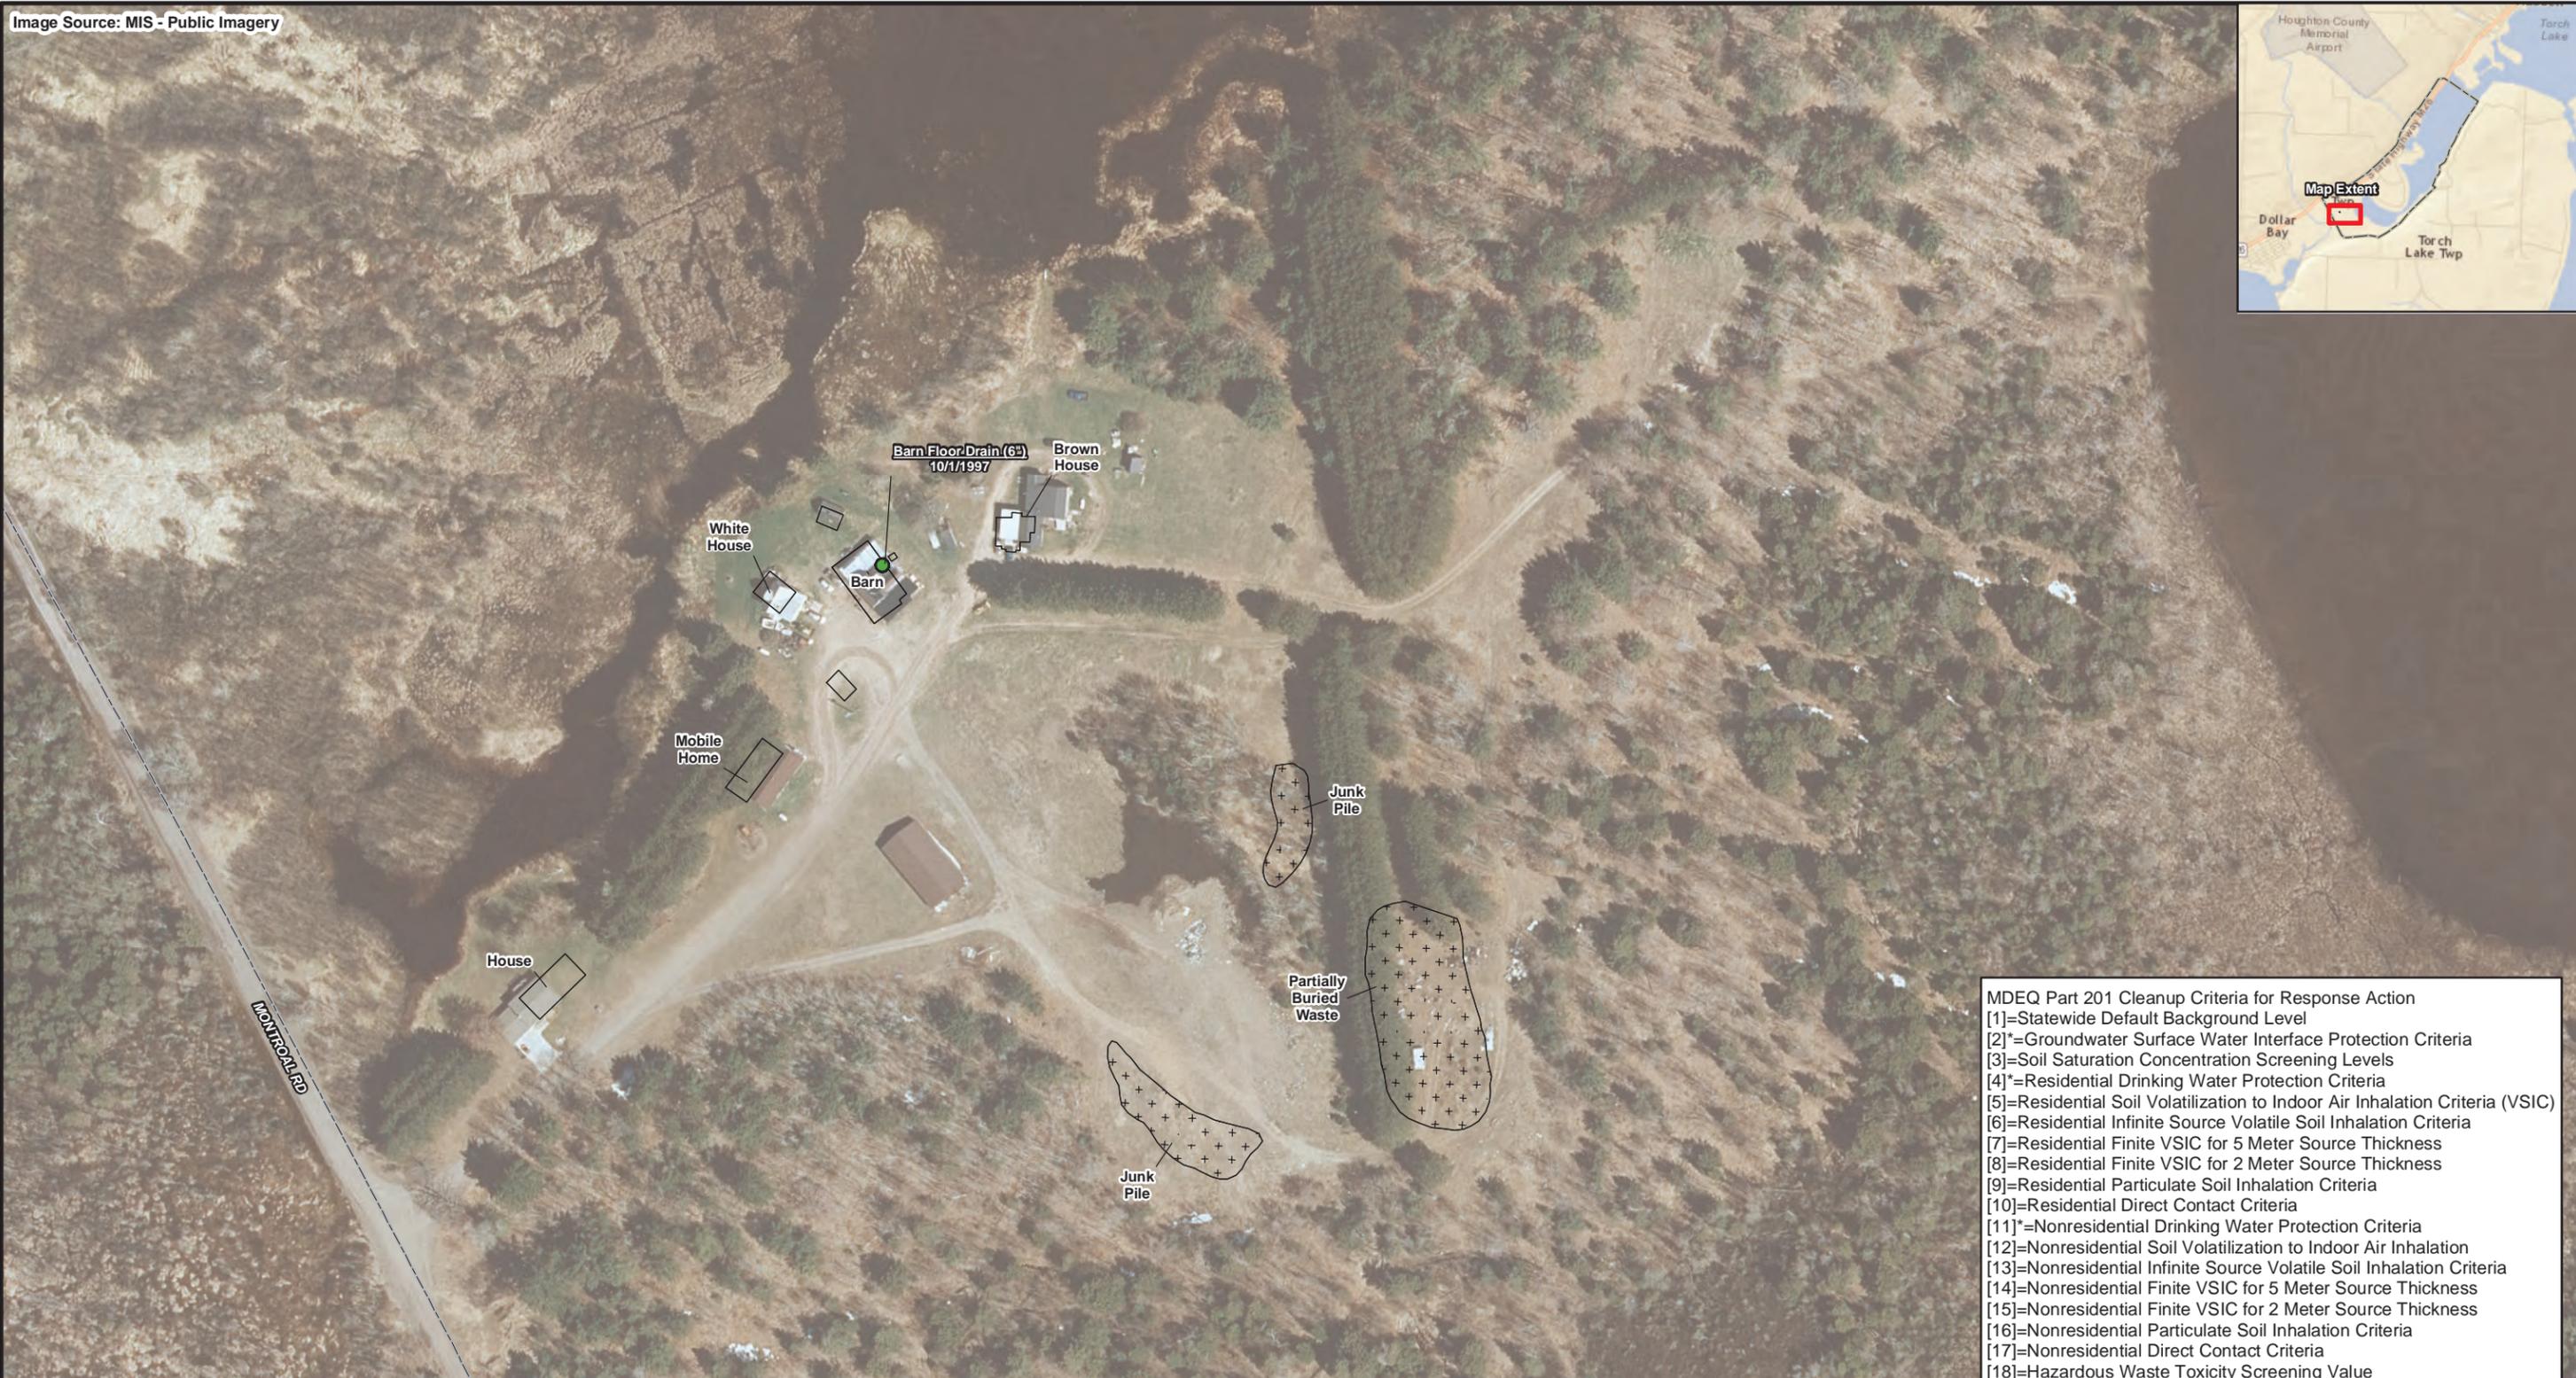
SS-01 9/10/2013
(0-10")
CYANIDE 0.26 J mg/kg [2]

SS-18 9/11/2013
(1-5")
TOTAL PCBs 6900 ug/kg [10, 17]

The SI findings will be incorporated into the sample design. Sample locations, screening locations, and contaminant concentrations are depicted on: *Figure 3a, Soil Sampling Location Map – Quincy Stamp Mills; Figure 3b, Soil Sampling Location Map – Quincy Reclamation Plant; Figure 4b, Soil Screening Results Map – QMCM North Central; Figure 4c, Soil Screening Results Map – QMCM South Central; Figure 5a, Groundwater Sampling Location Map – Quincy Stamp Mills and Reclamation Plant; Figure 6, Surface Water and Sediment Sample Location Map - QMCM; Soil Screening Results Map - QMCM; and, Figure 7, Asbestos and Waste Sample Location Map - QMCM* will be used to evaluate the presence of existing contamination and determine where data gaps may be present.

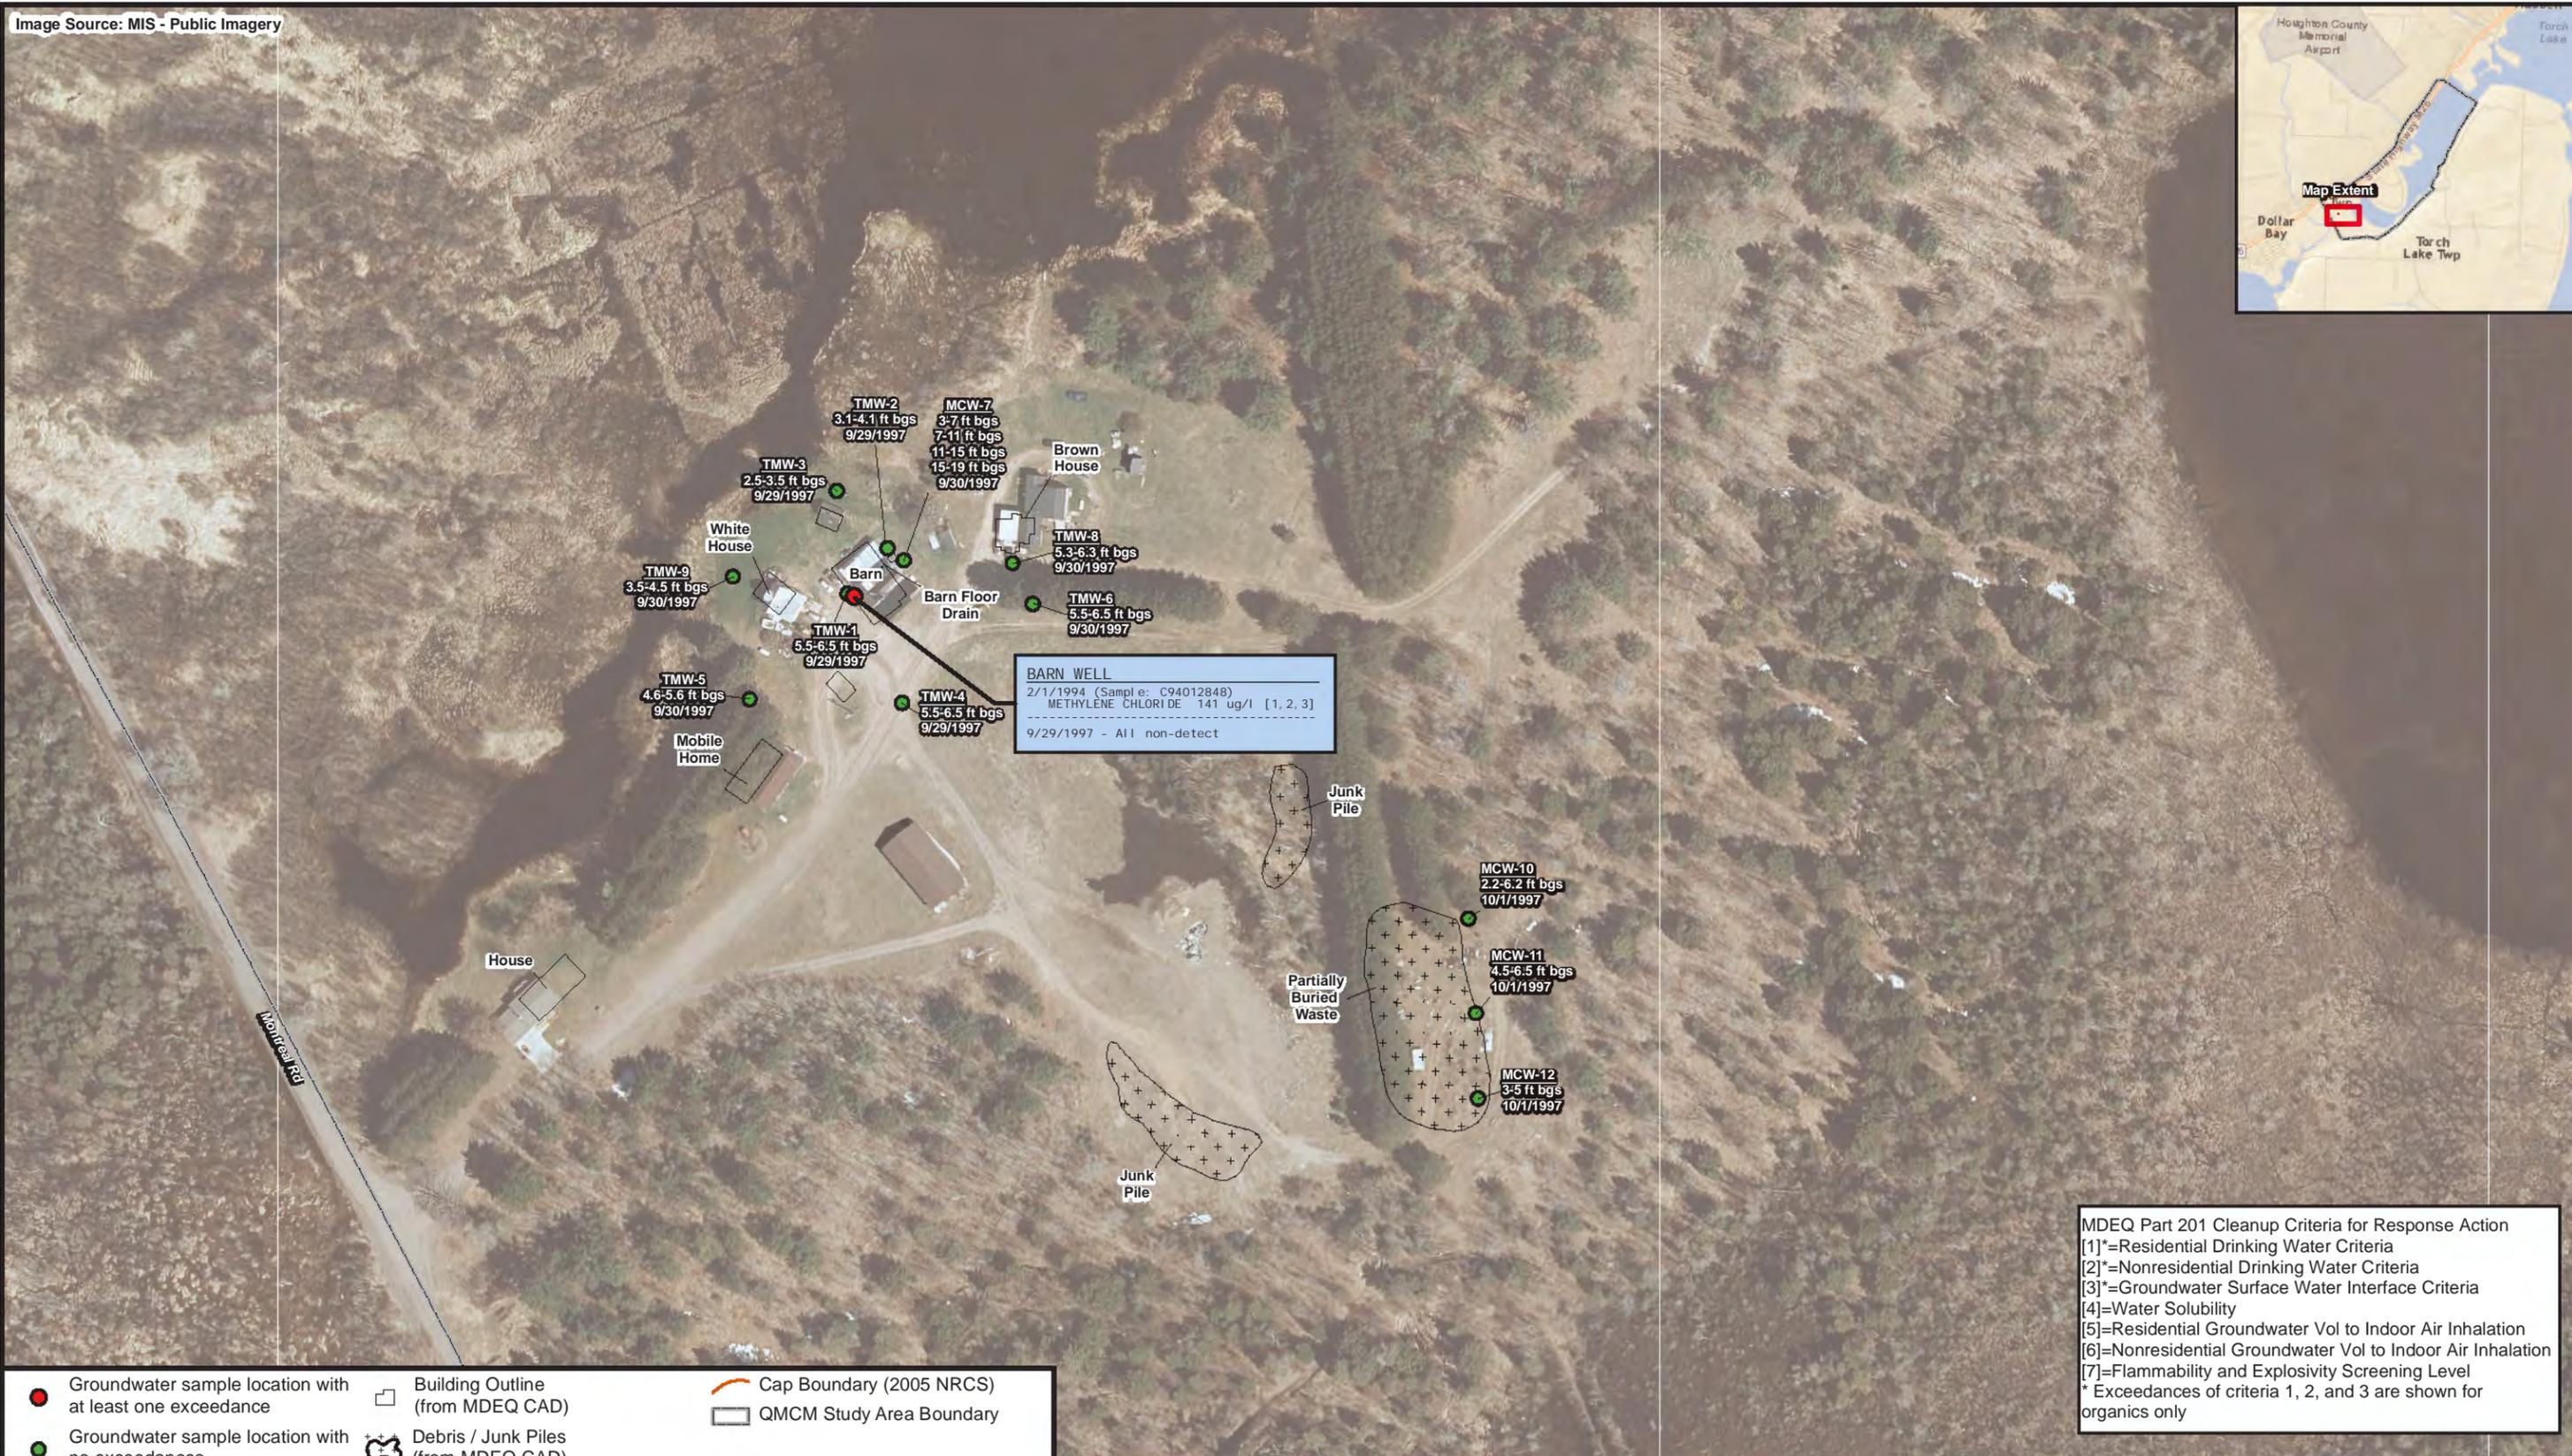
Figure 5a
Groundwater Sample Location Map - Quincy Stamp Mills and Reclamation Plant Quincy Mining Company Mason Operations Area Mason, Houghton County, Michigan

Groundwater sample location with at least one exceedance		Cap Boundary (2005 NRCS)
	Groundwater sample location with no exceedances		QCMC Study Area Boundary
	No Detections		Building Outline (from MDEQ CAD)
	At Least One Detection		Debris / Junk Piles (from MDEQ CAD)

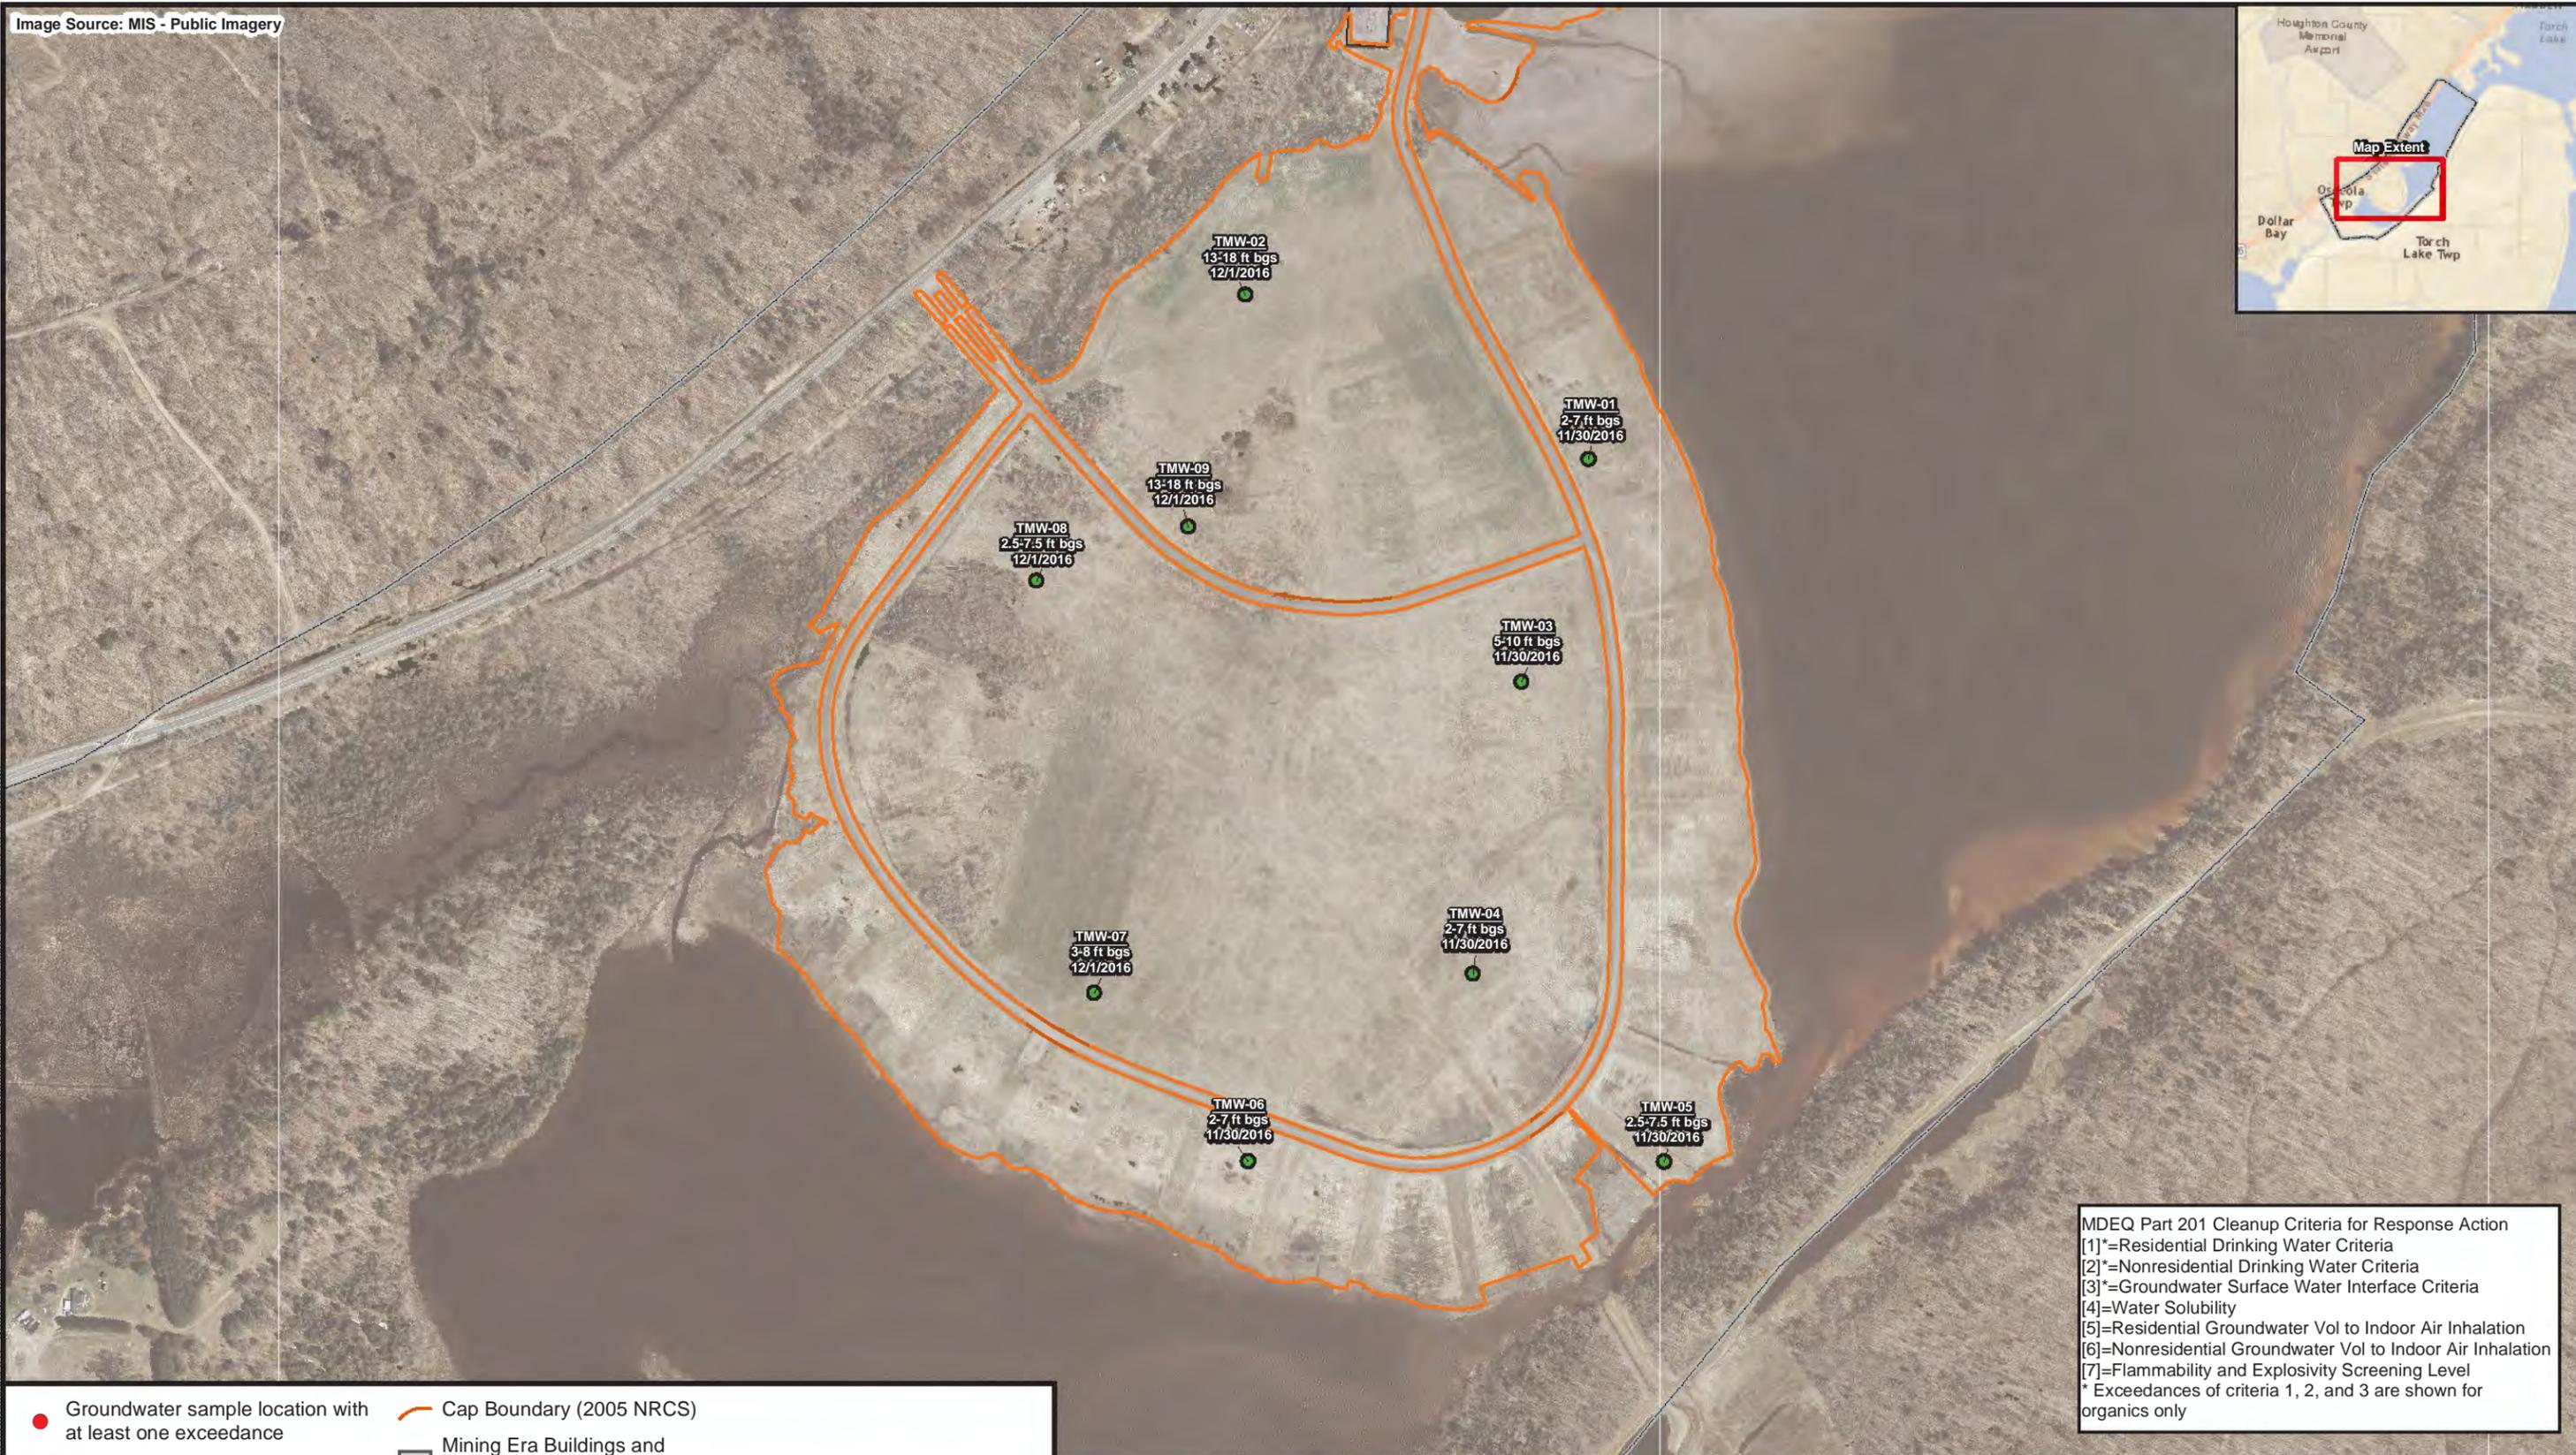
Figure 5b
 Groundwater Sample Location Map - Furniture Stripping Dollar Bay Site Quincy Mining Company Mason Operations Area Mason, Houghton County, Michigan

Groundwater sample location with at least one exceedance (Red dot)
Groundwater sample location with no exceedances (Green dot)

Coordinates associated with the Barn Well were not provided; therefore, the sample location was approximated based on the information provided in the MDEQ Limited Investigation Report. The well location and the associated analytical results are depicted on *Figure 5b, Groundwater Sample Location Map – Furniture Stripping Dollar Bay Site.*

Historical references, analytical results, and observations documented during the implementation of the Limited Investigation will be incorporated into the SAP. Coordinates associated with the sampling locations were not provided; therefore, were approximated based on the information provided in the MDEQ Limited Investigation Report. The soil and groundwater locations and the associated analytical results are depicted on *Figure 3c, Soil Sample Location Map – Furniture Stripping Dollar Bay Site* and *Figure 5b, Groundwater Sample Location Map - Furniture Stripping Dollar Bay Site*.

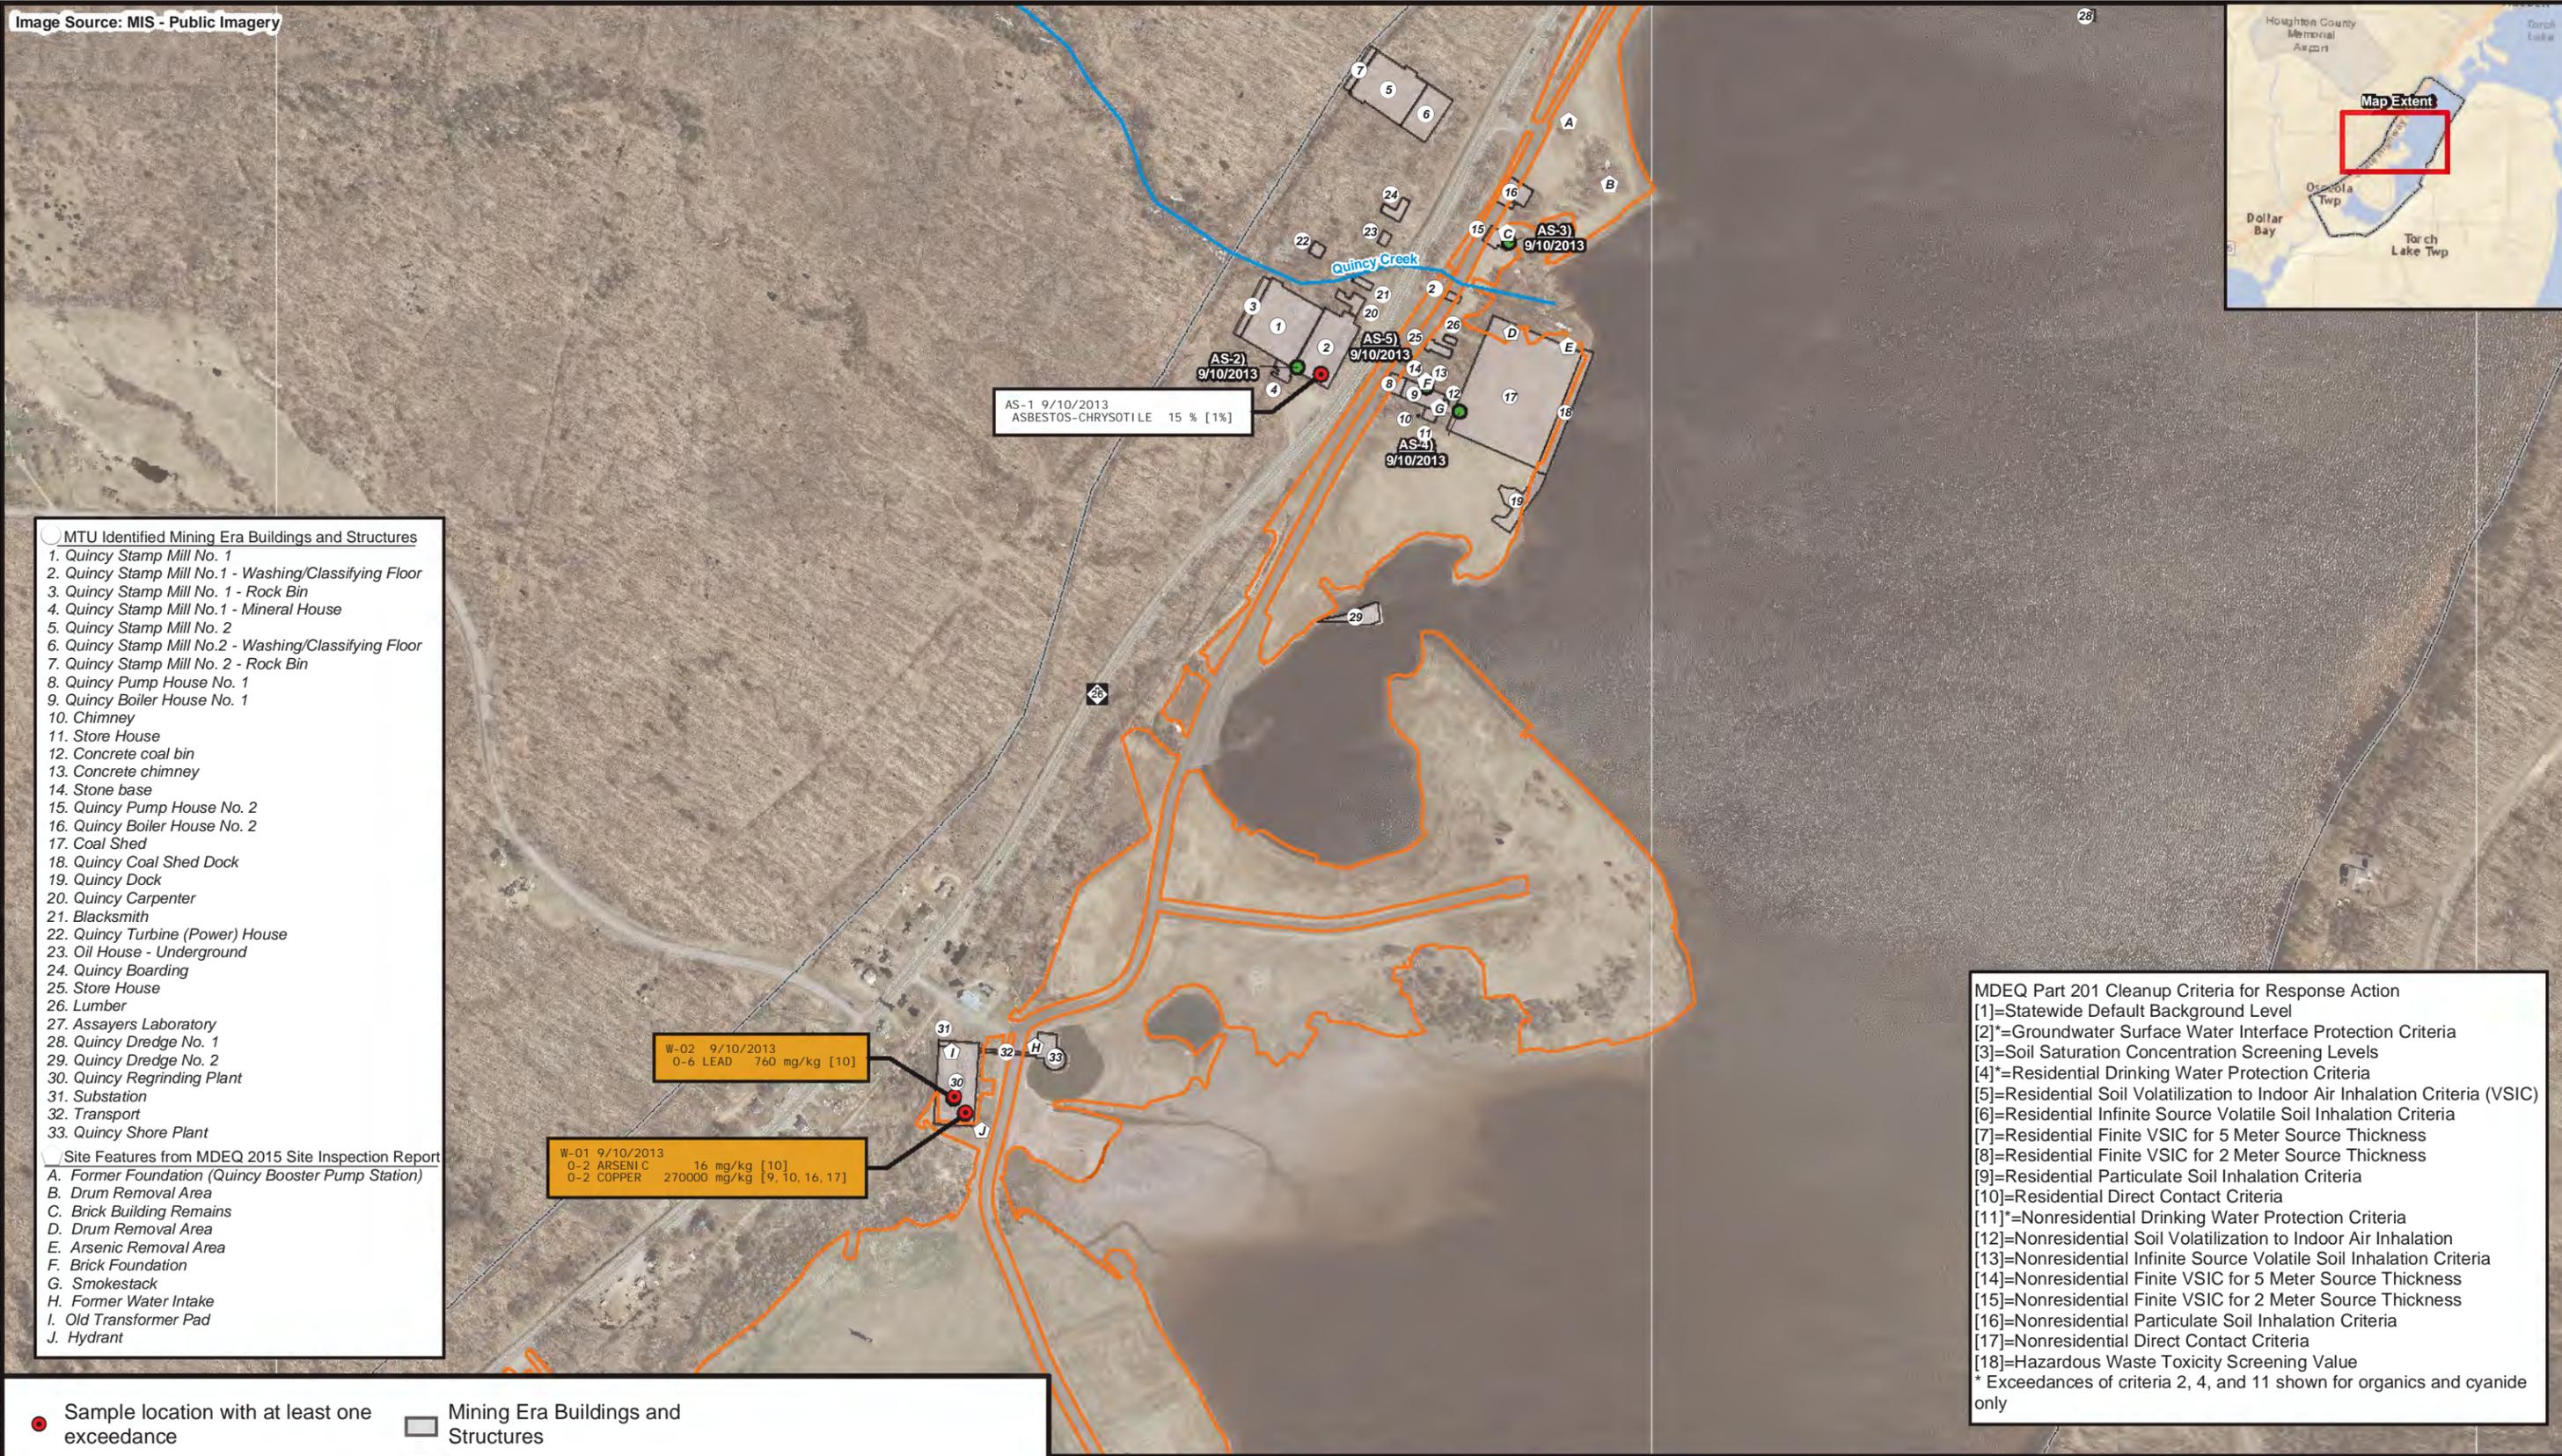
Figure 6
Surface Water and Sediment Sample Location Map
Quincy Mining Company Mason Operations Area
Mason, Houghton County, Michigan

- Sample location with at least one exceedance
- Sample location with no exceedances
- No Detections
- At Least One Detection
- Cap Boundary (2005 NRCS)

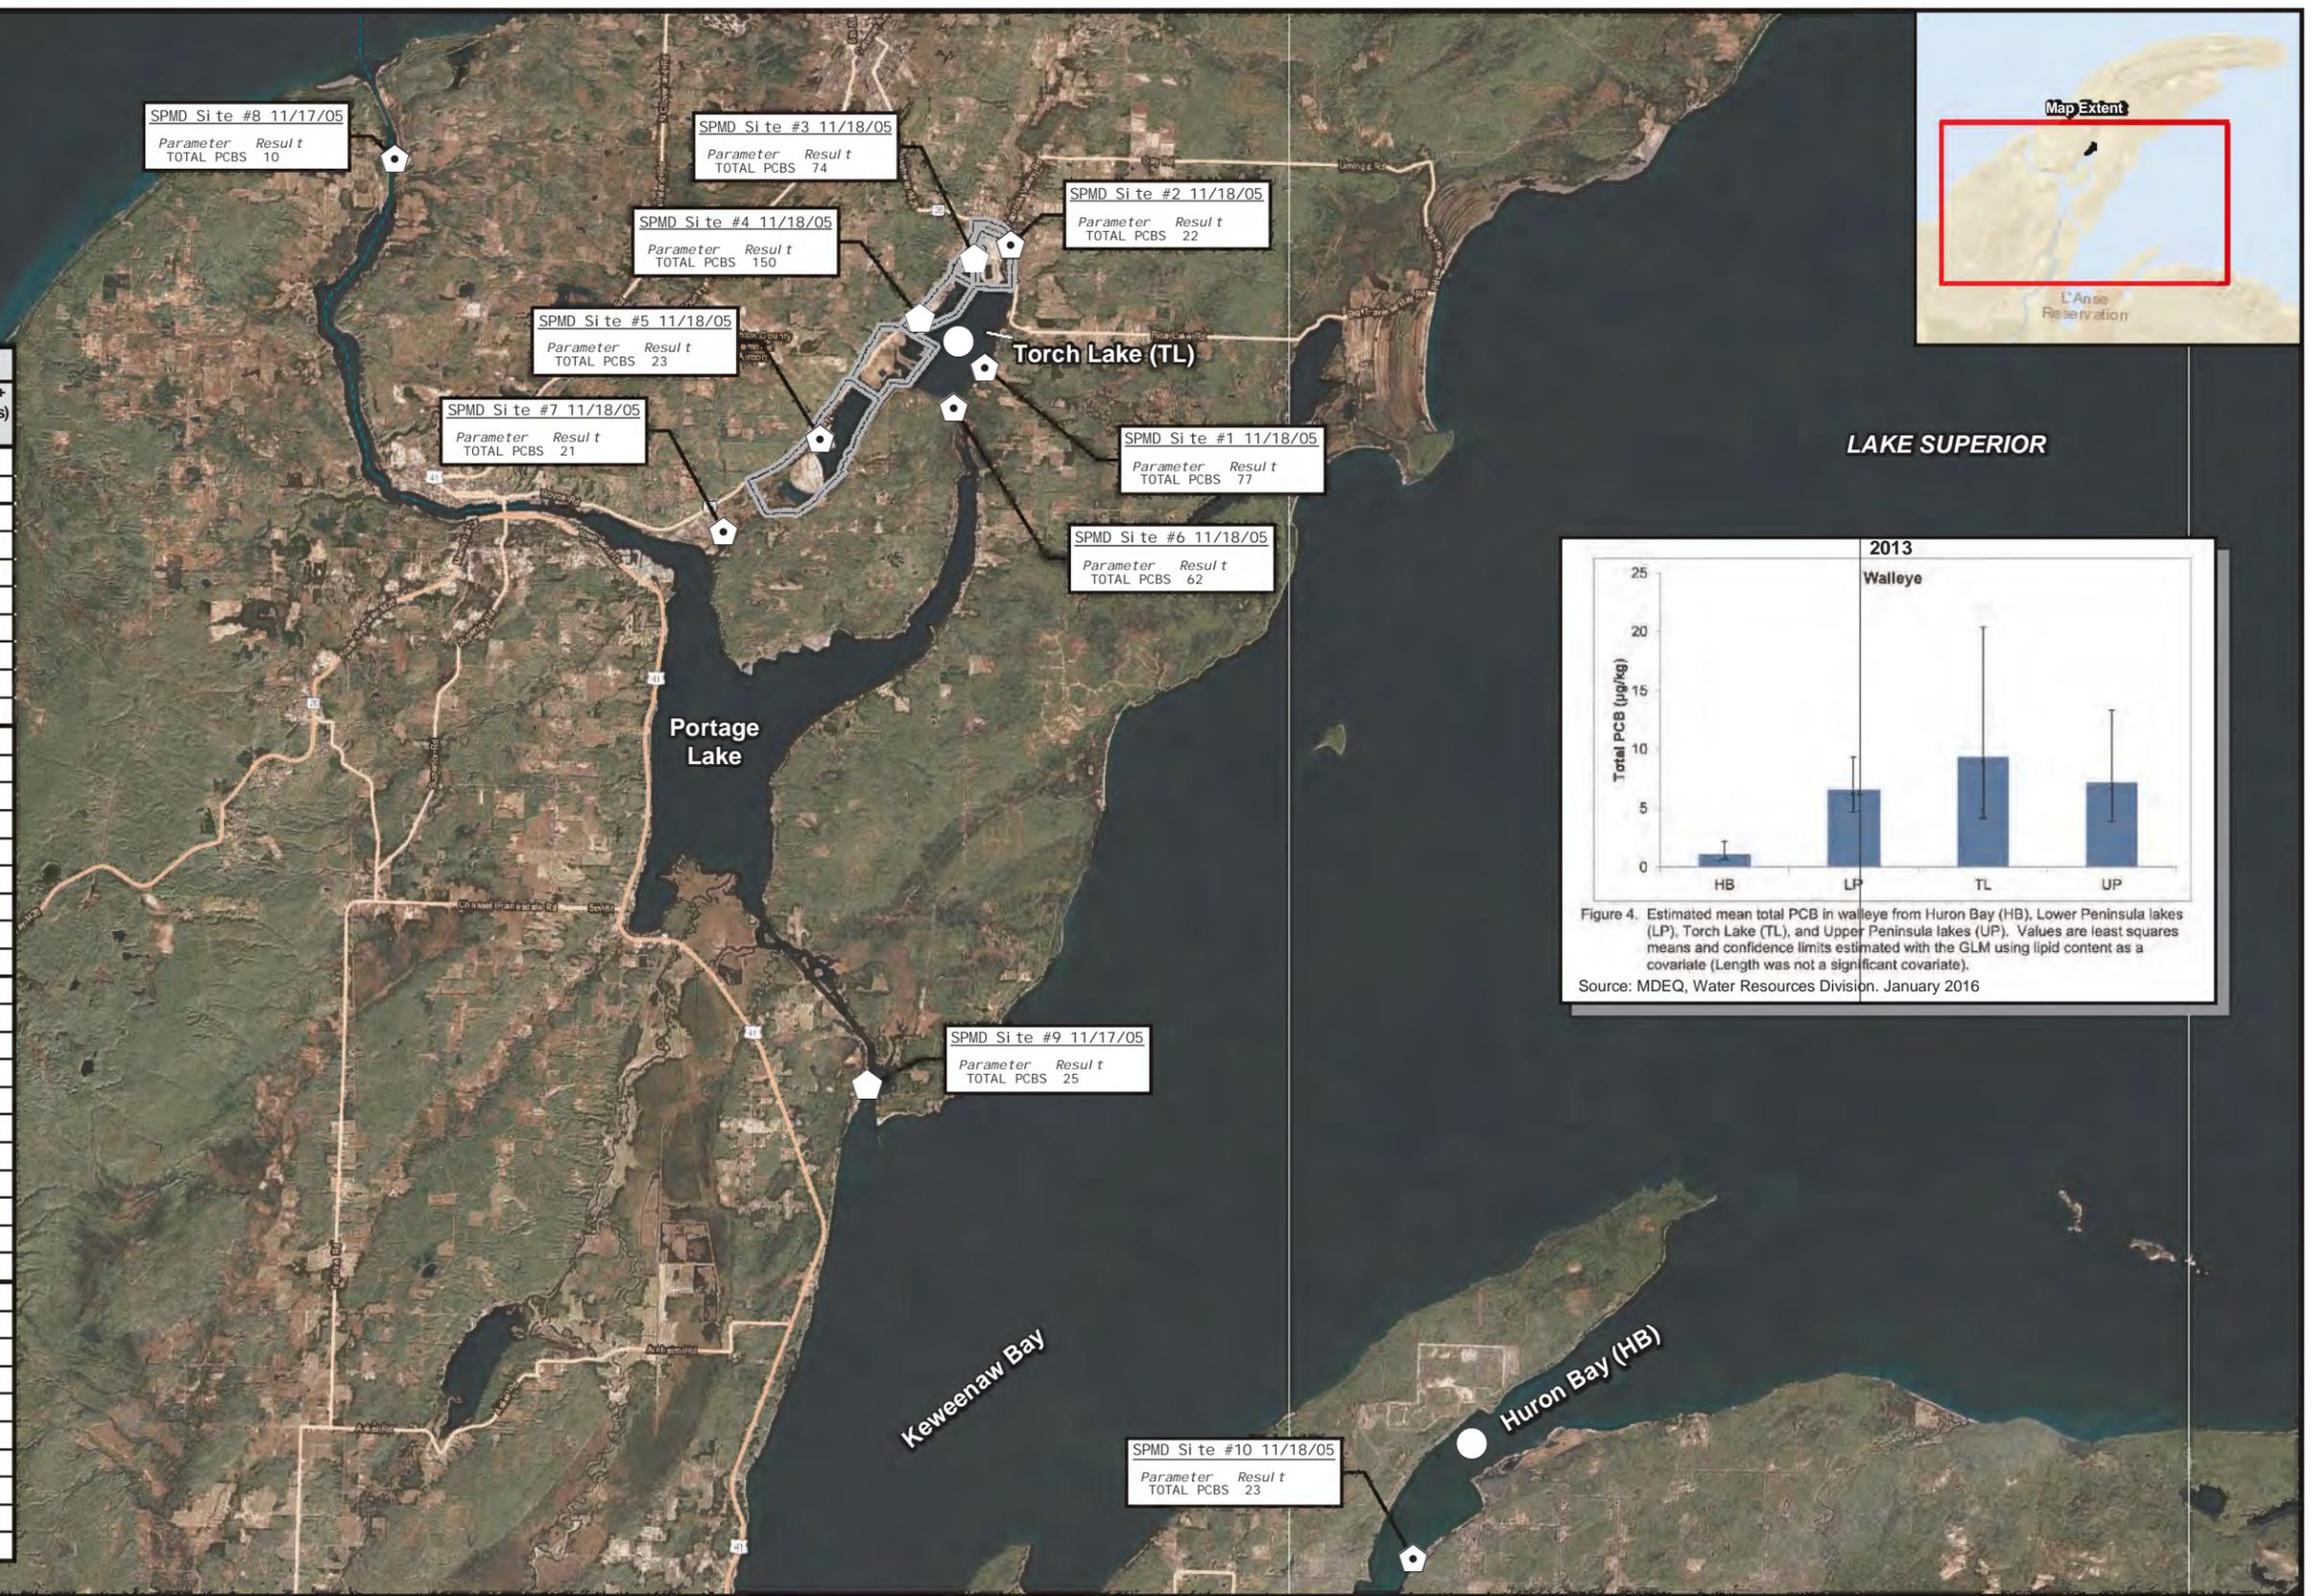
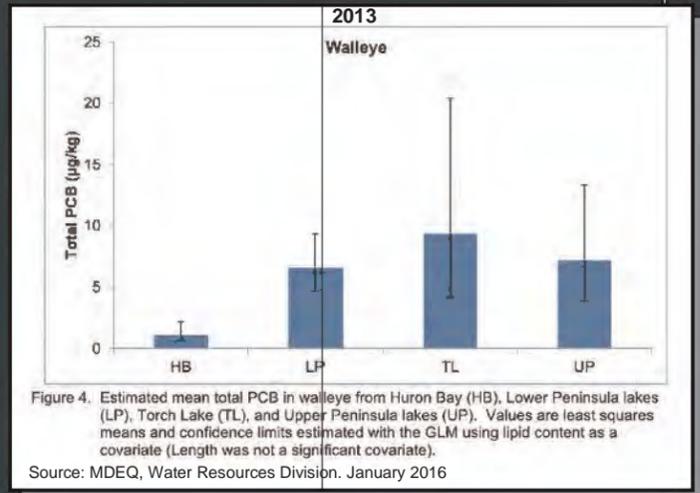
Figure 4. Estimated mean total PCB in walleye from Huron Bay (HB), Lower Peninsula lakes (LP), Torch Lake (TL), and Upper Peninsula lakes (UP). Values are least squares means and confidence limits estimated with the GLM using lipid content as a covariate (Length was not a significant covariate). Source: MDEQ, Water Resources Division, January 2016
