HISTORICAL DATA REVIEW AND COMPILATION TECHNICAL MEMORANDUM

ABANDONED MINING WASTES – TORCH LAKE NON-SUPERFUND SITE
QUINCY MINING COMPANY MASON OPERATIONS AREA
HOUGHTON COUNTY, MICHIGAN
SITE ID# 31000098

FEBRUARY 2017

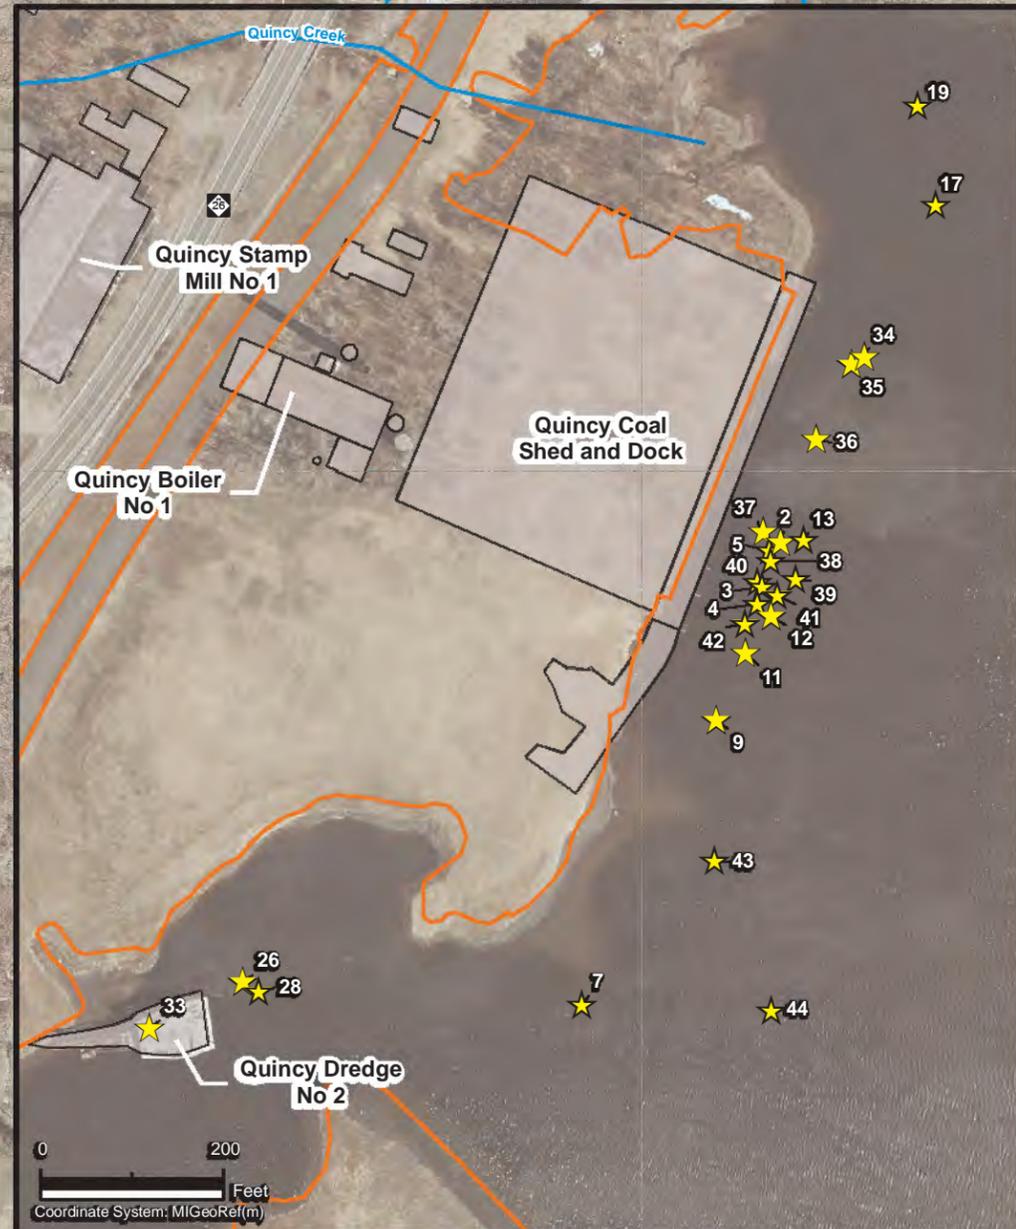
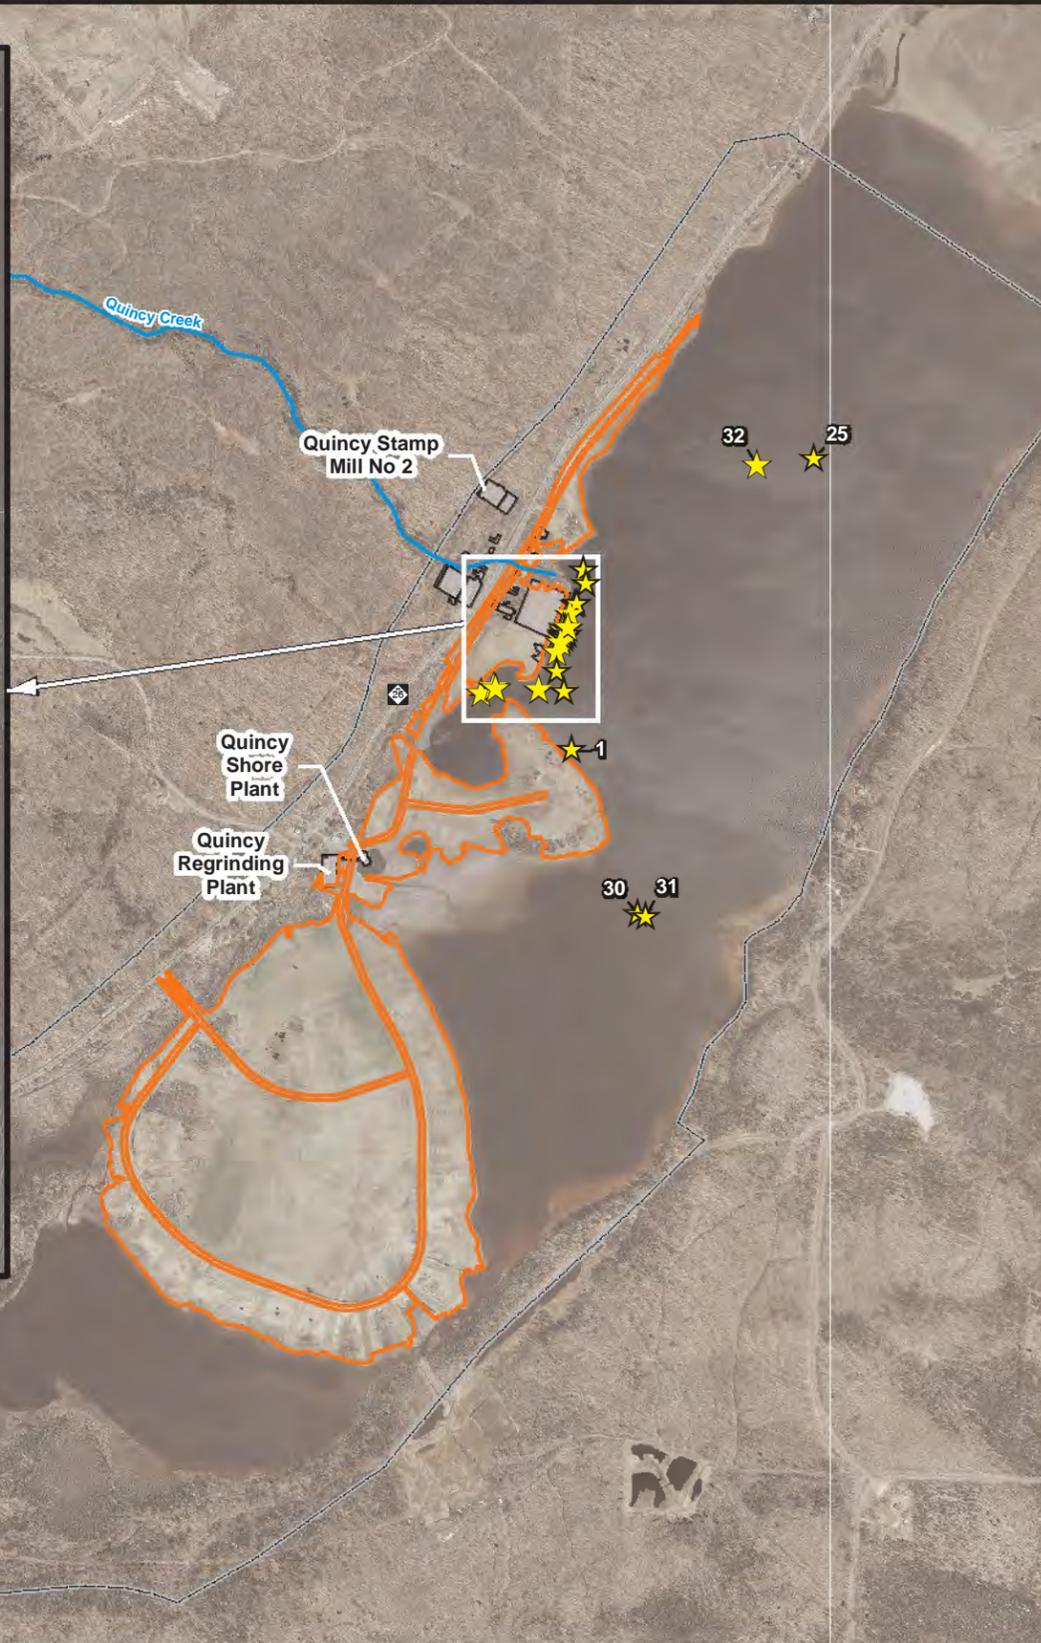
Figure 9
ROV Video Observation Location Map July 2016
Quincy Mining Company Mason Operations Area
Mason, Houghton County, Michigan

Locations of observed abandoned containers and/or waste deposits are depicted on *Figure 9, ROV Video Observation Location Map July 2016 - QMCM*.

Observation Number	Depth (ft below surface)	Observation	Notes
1	1.99	Pock-marked lake bottom	
2	22.65	Open ended barrel, possible contents	
3	16.42	1/2 drum, metal debris, near pilings, lumber & debris	Lots of wood debris along pilings where at least half of the video includes planks and timbers. Suggest random placed vibracore samples along pilings, if no biased spots indicated
4	15.54	Drum?	
5	15.44	Drum or cylinder @ angle out of sediments	
7	34.3	Strange surface appearance on sediments	Spotty GPS?
9	14.56	Concrete slabs w/ rectangular opening	
11	26.27	drum on side	
12	27.58	Drum	
13	25.85	Drum on side	
17	31.2	White drum?	
19	29.14	Tan pile of "sand?"	Lots of leaves on bottom 30'
25	54.18	Pock marked lake bottom	
26	18.8	Edge of something buried - contents of a former drum or a timber?	
28	22.46	Pock marks/pitting	
30	20.56	Lake bottom has white appearance	Lens of ROV hit it and it took a lot of fast movement thru water column to clean it off

31	19.91	Lake bottom has white appearance	Rolling bathymetry
32	various	Quincy Dredge No. 1 - sunken in Torch Lake	Collect multiple sediment samples around perimeter of sunken dredge
33	various	Quincy Dredge No. 2 - partially sunken near shoreline	Collect multiple sediment samples around perimeter of dredge
34	--	Possible drum carcass?	
35	--	Possible drum carcass?	
36	--	Possible Drum?	
37	--	Debris with possible drum carcass	
38	--	Drum	
39	--	Drum	
40	--	Drum(?) with unknown contents	
41	--	Drum.	
42	--	Wood debris and drum	
43	--	Unknown debris	
44	--	Unknown debris-possible drums

ROV video findings will be incorporated into the SAP by positioning the offshore sampling program to evaluate environmental conditions along the lake bottom and shoreline of Torch Lake to determine whether contributing sources of PCB contamination may be present because of observed abandoned containers and/or waste deposits.

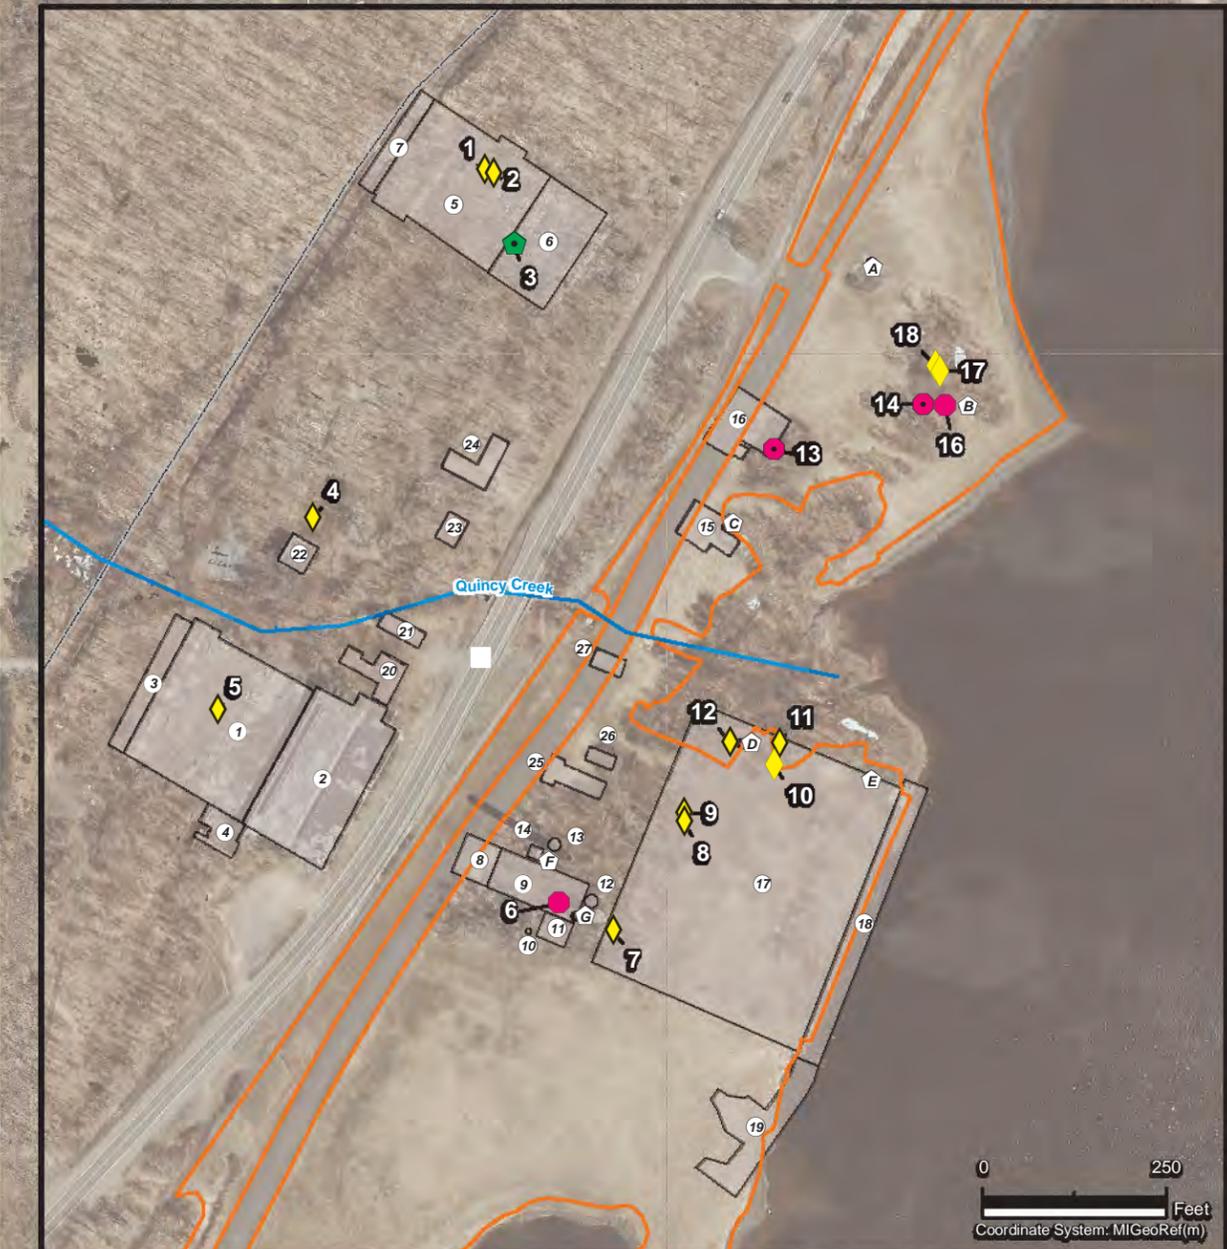
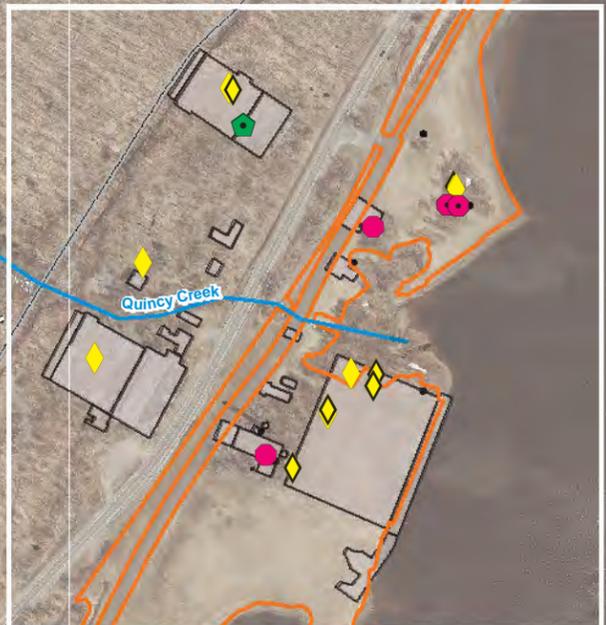
Figure 10
Preliminary Reconnaissance Observations October 2016
Quincy Mining Company Mason Operations Area
Mason, Houghton County, Michigan

QMCM – Preliminary Reconnaissance Summary	
Potential Chemical or Physical Hazards	Recorded Observations
Suspect Asbestos Containing Material (SACM)	Suspect thermal insulation was observed on steam piping in a vault adjacent to the east side of Quincy Stamp Mill No. 1 and the ground at Quincy Stamp Mill No. 2. Asphaltic roofing material was observed at several locations including on the east side of the concrete coal bin at Quincy Boiler House No. 1 and on remnant wood structures and on the ground near the former Coal Shed. Other SACM was observed mixed in with household debris near the Drum Removal Area. Near the former Turbine (Power) House, a piece of countertop was also SACM.
Residual Process Materials	At Quincy Stamp Mill No. 1, residual process materials in the form of suspect tailings and stamp sand were observed to be widespread across the footprint. At the Quincy Stamp Mill No. 2 location, residual process materials in the form of suspect tailings were observed within the building footprint.

Potentially Abandoned Containers	Several mining era containers were observed during the inspection of the properties including crushed or otherwise compromised drums on the hillside south of Quincy Stamp Mill No 1, at Quincy Boiler House No. 1, Quincy Boiler House No. 2, and near the Drum Removal Area. More modern-era containers were also observed near the Drum Removal Area including an empty 5-gallon can and numerous paint cans.
Soil Staining/Stressed Vegetation	No barren or stressed areas of the ground surface were documented on the inspected properties except for the eroding railroad embankment constructed of mine rock and stamp sand between Quincy Stamp Mill No. 1 and the Turbine (Power) House.
Potential Polychlorinated Biphenyl (PCB) or Mercury Containing Equipment	No potential PCB or mercury containing equipment was observed on the inspected properties.
Other: Household Waste and Debris	Bottles, cans, and similar household debris were observed on the ground surface near the Drum Removal Area in what appeared to be a former small dumping area.

Numerous significant hazards were identified in the QMC during the preliminary reconnaissance activities. The inventoried hazards will be qualitatively assessed for potential human health and environmental risks to determine if analytical sampling should be incorporated into the SAP. The properties contain remnants of abandoned mining-era structures. The majority of the property east of Highway M-26 has been capped during previous remedial activities, including both capped and vegetated areas out to the shoreline as well as a graded strip with gravel cover to provide a roadway that parallels M-26 inside the perimeter fence line. The property west of Highway M-26, however, has not been improved since the mining era and features widespread disposition of tailings and stamp sand within and proximal to the stamp mill ruins and widespread debris. Other items of concern include abandoned drums, most of which appeared to be rusting carcasses, that are present in a number of areas across the properties. In particular, a number of abandoned containers were observed near the former Drum Removal area adjacent to what appeared to be a small former dumping area for household debris. Quincy Creek flows through the ruins, discharging to Torch Lake, and erosion channels to the creek were observed from Quincy Stamp Mill No. 1 and the neighboring eroding railroad embankment constructed of mine rock and stamp sand. In addition, several locations feature structural voids in foundations and floors at or above grade in mining era building footprints, including a vault on the east side of Quincy Stamp Mill No. 1 containing SACM wrapped piping inside a tunnel leading beneath Highway M-26. The above ground casing of Mason Well No. 2 was observed near the Quincy Reclamation Plant ruins. According to DEQ's Wellogic the well is a Type I public well that is owned by the Village of Mason. Wellogic also indicates that Mason Well No. 1 is located near the Quincy Reclamation Plant ruins but it was not observed during the preliminary reconnaissance. It is unknown if these wells are currently in service.
