MICHIGAN DEPARTMENT OF ENVIRONMENT, GREAT LAKES, AND ENERGY
WATER RESOURCES DIVISION
JUNE 2021

STAFF REPORT

Bacterial Monitoring Results for Michigan Rivers and Streams: 2020

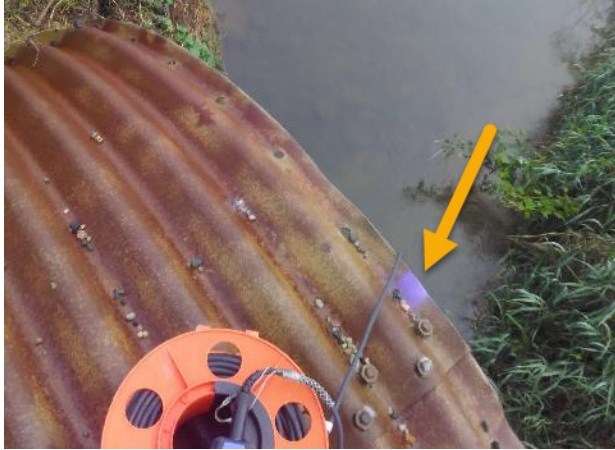
Figure 2. Mark on culvert for determining the relative water level. Measurements are from this point to the water's surface and were recorded on each sampling visit.

Precipitation data for the 24 hours and 48 hours prior to each sampling event are recorded in Appendix 2, and graphed in Appendix 5, and were obtained from nearby weather stations (Michigan State University (MSU) Extension, 2021). Where possible, the relative water level was determined at each sampling event by measuring the distance in centimeters from a set point on the bridge or culvert to the surface of the river using a weighted metal tape (Appendices 4 and 5) (Figure 2).
