### 6.0 ELECTRICAL SYSTEMS ASSESSMENT

Overall the condition of the Belle Isle Boat Club electrical system is **Poor**.

# Belle Isle Boathouse & Site Work Renonovations/Restorations

# **Cost Model Estimates**

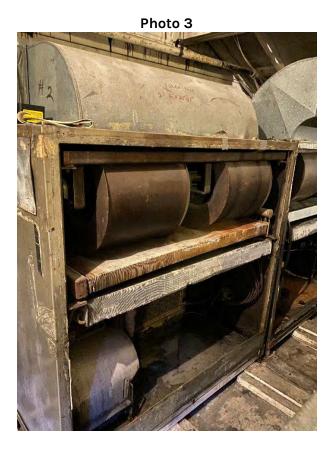
Photo 4

- Incoming overhead service and outdoor meters [Photos 1, 2].
- Sections of abandoned service equipment [Photos 3, 4].

- Remove and trash all existing switchboards and panelboards throughout.
- Remove and trash all existing lighting fixtures, except the historic fixtures described above.
- Remove all raceways, wiring and other ancillary electrical work.

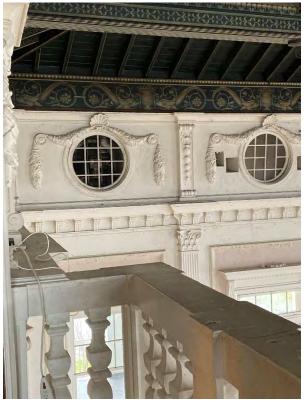
Photo 5

Only Section E is in operation to serve the lights and receptacle, but in a location that is not Code compliant; the others have been abandoned in place. However, all the main switchboard sections are extremely old, in great disrepair and not fit for continued use. All other panelboards in the building are also in poor condition and need replacement. Most have been de-energized, although some are operational such as on the third floor near the Presidential Room.

- Distribution Panelboards [Photos 5, 6].
- Branch Circuit Panelboards [Photos 7, 8].

- Provide a new 2,000 Amp, 208/120 volt, 3-phase, 4-wire switchboard. This would be contingent on DTE replacing the planned 300 KVA 240/120-volt transformer with a new 500 KVA 208/120-volt transformer.
- Provide new feeders and power panels in the Kitchen for food service equipment.
- Provide new feeders and lighting/receptacle panelboards throughout the building. These panels could be located where existing panels are currently located to facilitate running the new feeders, but other design factors and security issues may dictate housing these panels in electrical closets.
- Provide new wiring devices, disconnect switches, etc. throughout.

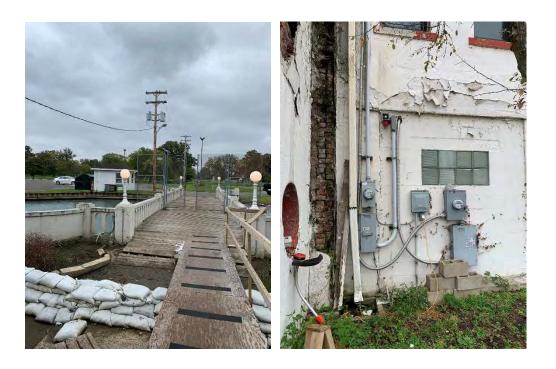
Photo 1

Subsequent to the fire, two "temporary" overhead service lines were brought to the building, via a pole-mounted transformer. One service is rated 120/240 single phase (for lights and receptacles); the other 240-volt three-phase (mainly for the elevator). Both services are rated for approximately 200 Amps, which is probably well below what is needed for a building as a whole, but sufficient for its current reduced use.

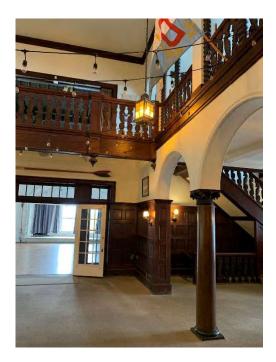
Photo 9

There are four suspended fixtures and several wall sconces on the first floor which are original fixtures dating back to when the Boat Club was first opened. These should be restored and refurbished to their original condition.

- Historic/Original hanging light fixture [Photo 9].
- Historic/Original wall sconce light fixture [Photo 10].

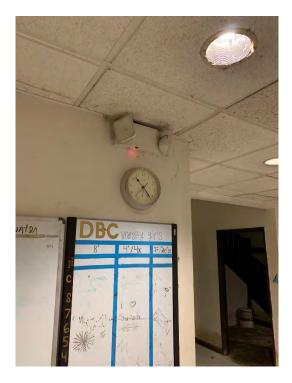
Photo 11

Emergency lighting is provided via wall-mounted battery-pack units in a few areas of the building; some are operational, others are not. Regardless, the emergency lighting is inadequate for the spaces that are in use and it does not meet current code requirements.

• Wall-mounted emergency lighting battery pack [Photo 11].

• Provide a 10 KVA central battery system for life safety lighting and exit signs throughout.
