Upper River, Tahquamenon River
Luce County
Tahquamenon River Watershed, last surveyed 2009

Jim Waybrant

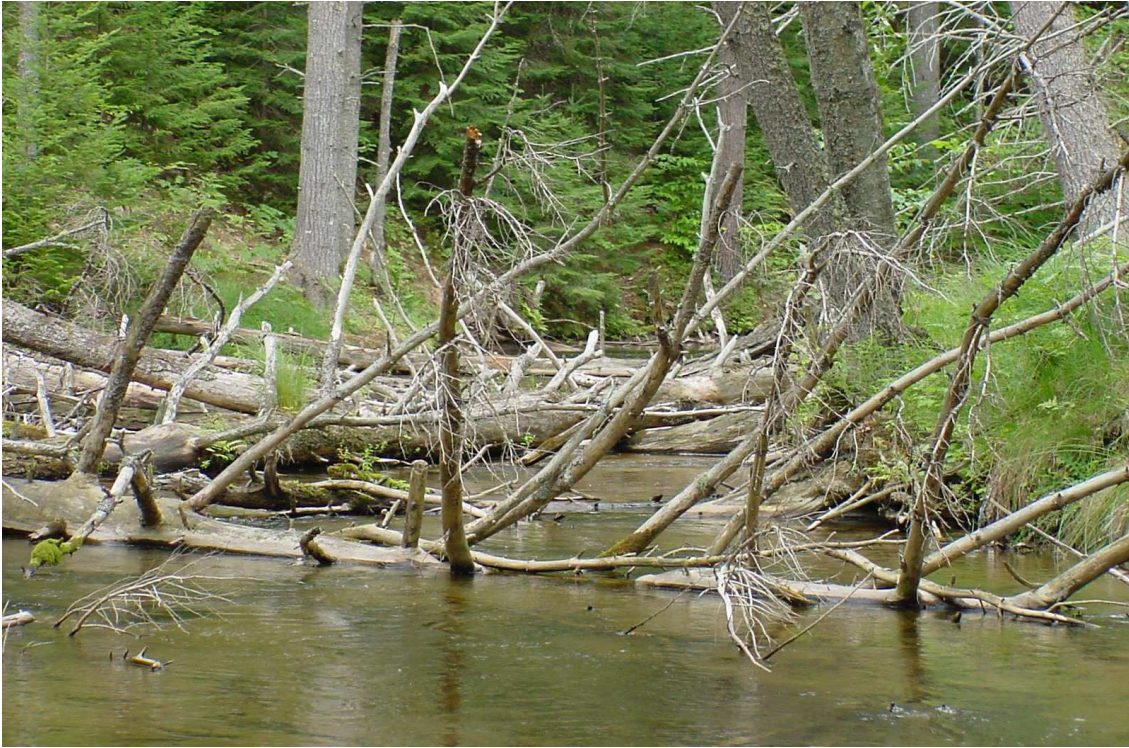
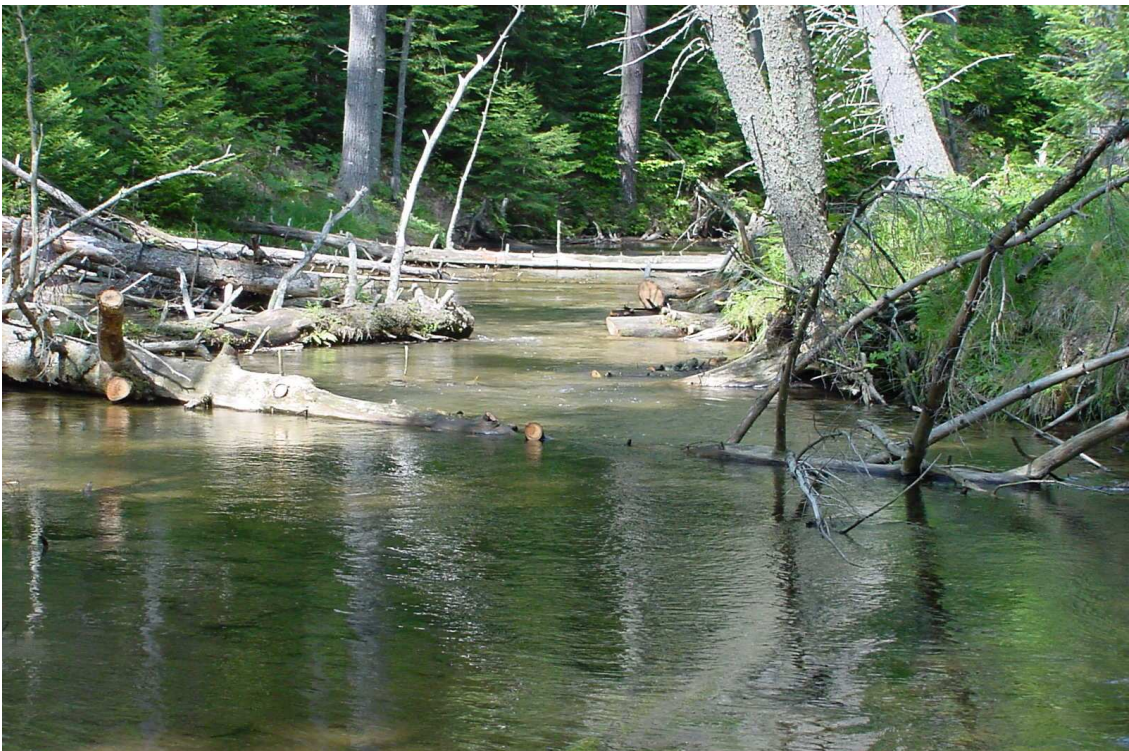
Figure 2. Before and after examples of stream work completed in the Upper River, Tahquamenon River, Luce County, 1999-2001.

Before stream work

After stream work

A multi-year habitat enhancement effort took place from 1999-2001 encompassing about 6 mi of this section. The effort was almost entirely directed at in-stream woody structure, with some minor removals and much placement modification (Figures 2, 3). Visual surveys during and following the work showed some surprisingly rapid habitat changes. In some instances, removal of one downed tree resulted in new flows scouring a channel more than two ft depth within one hour. In other instances, banks that had been actively eroding were isolated from the new stream channel by the next morning. Modifying placement of in-stream materials to narrow the existing channel several times exposed gravel substrate within 24 hours. In addition, scoured sand was re-deposited by water currents into backwater areas, effectively narrowing and deepening the channel. Judicious removal or modification of large woody debris allowed scouring of deep holding water underneath that structure and increased habitat diversity in the channel. Above all else, the effort was designed to be as natural-looking as possible.

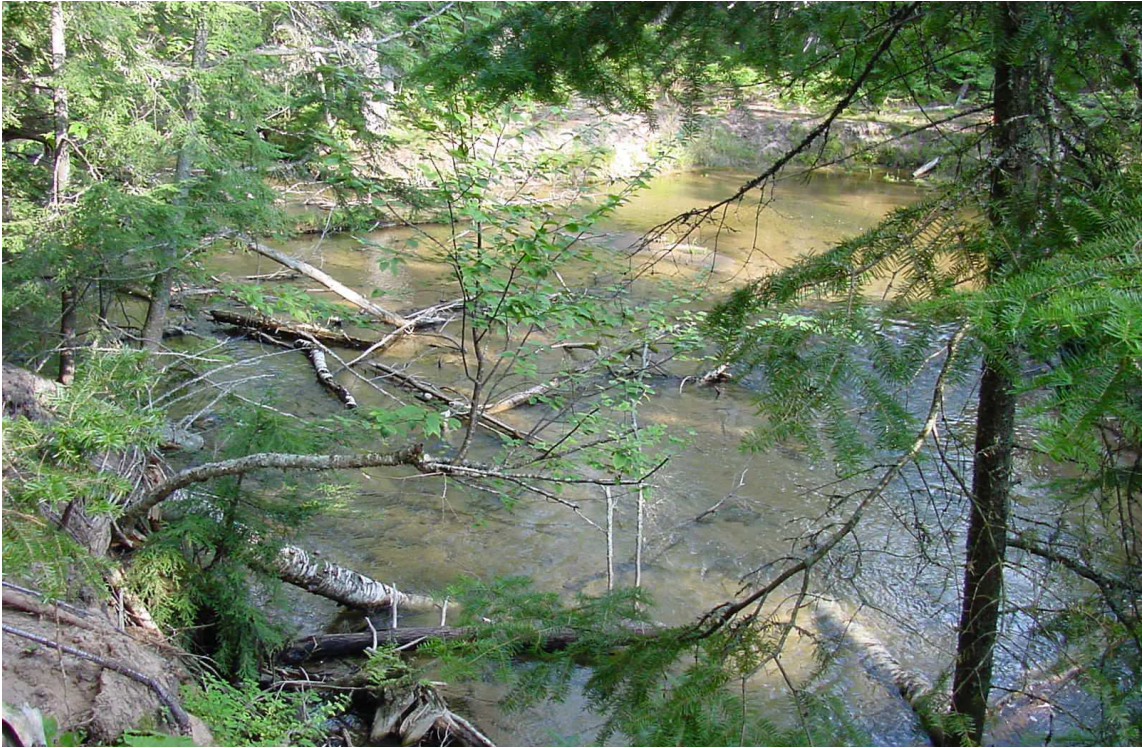
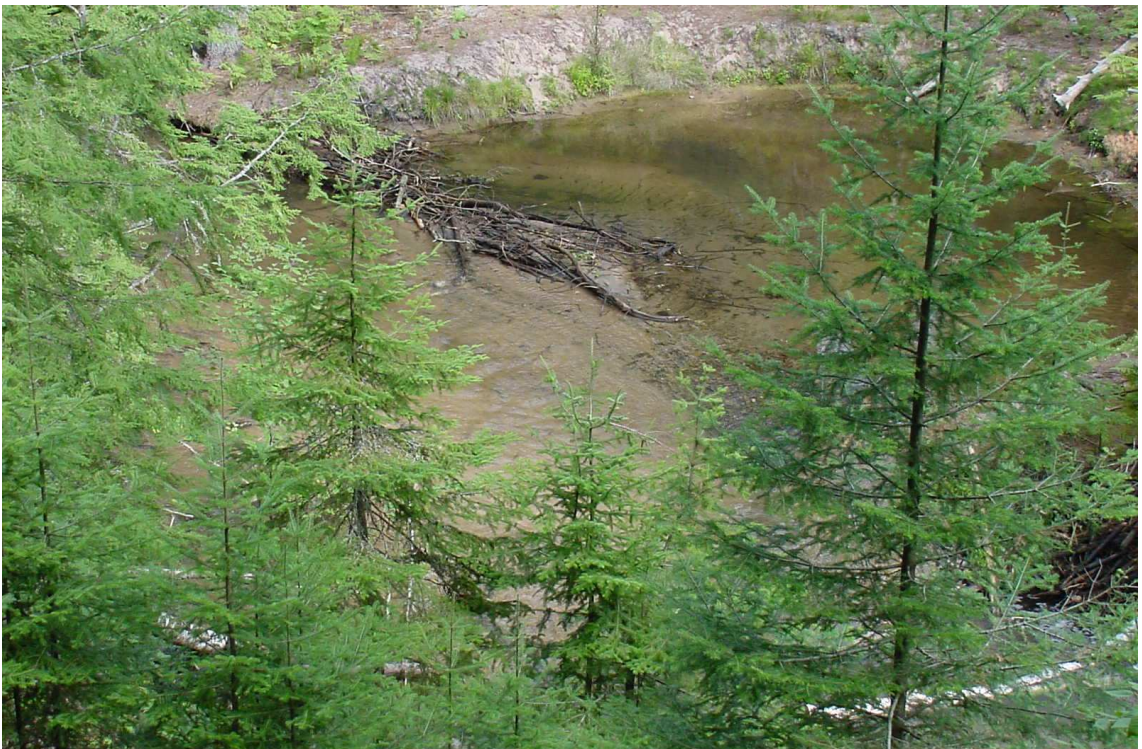
Figure 3. Before and after examples of stream work completed in the Upper River, Tahquamenon River, Luce County, 1999-2001.

Before stream work

After stream work

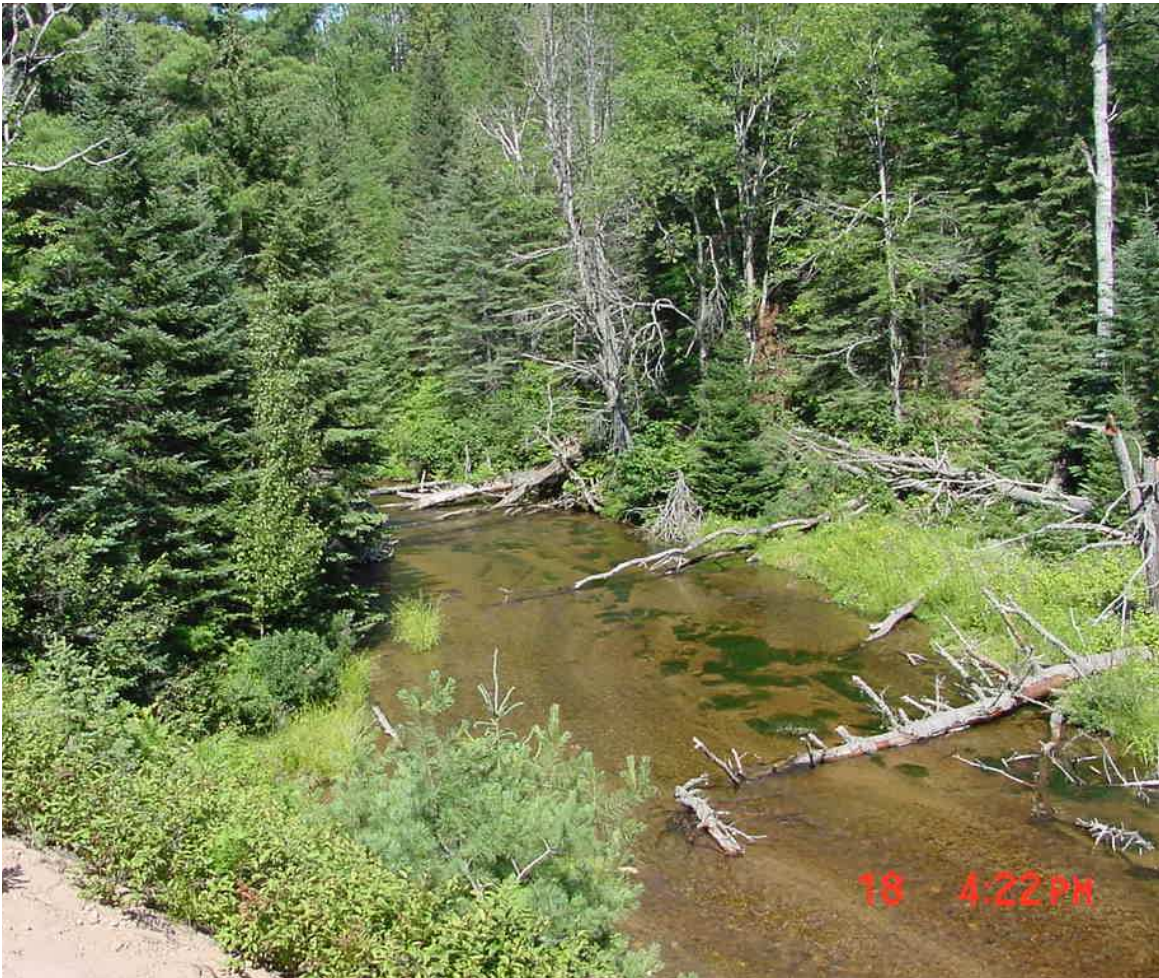
Figure 10. The sand bank at the parking site for the State of Michigan owned access site, designated as the standard survey site for status and trends sampling, Upper River, Tahquamenon River, Luce County, T47N, R12W, Section 34.

Angler access is another source of bank erosion. The State of Michigan-owned access site for the 2009 electrofishing survey features a level parking area with a steep 15-20 ft sand bank to the river's edge (Figure 4) and a vegetated two-step drop 100 ft downstream. There, a narrow, flat floodplain collects loosened sediment before it reaches the river. Despite the more environmentally sound alternative immediately downstream, anglers continue to slide down the sand bank, causing increased erosion into the river. A possible bank protection project will entail a log fence barrier along the top of the sand bank, and a sign pointing to the path at the two-step drop.
