M-69: Paint River Bridge Rehabilitation

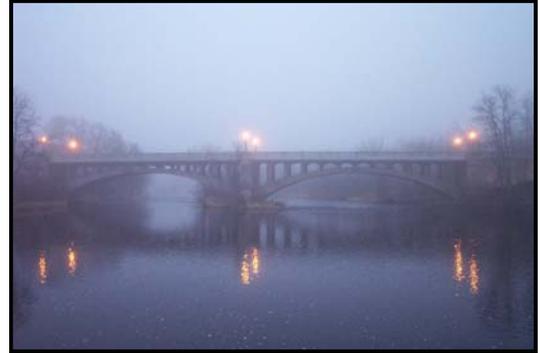
Built in 1924, the structure is the only non-redundant open spandrel concrete arch bridge in Michigan. The project purpose was to maintain safe traffic flow over the river. Rehabilitation efforts included deck replacement, replacement of the spandrel columns, substructure repair, approach work, and sidewalk replacement on both sides.

The bridge was designed, with critical modifications, following the essence of the historical design, including the spandrel columns, superstructure, railing, lighting columns, and lamps. Staging construction on one span at a time minimized potential disruption to the structural equilibrium of the bridge and virtually eliminated environmental impacts. Drainage problems were addressed and new lighting, based on the original design, added to the safety and ambiance of the rehabilitated bridge. MDOT responded to the issue of some motorists feeling crowded when sharing the bridge with trucks carrying wide loads. Although the existing deck was essentially wide enough, MDOT widened the superstructure by six inches and each sidewalk was reduced by six inches without impacting non-motorized and snowmobile users and without increasing dead load. MDOT also addressed the community's concerns about the impact of the detour on downtown businesses as well as controlling speed on the detour route, which went through a residential area. The department provided signs on the detour route to indicate that the downtown business district was open. MDOT also funded dedicated work zone law enforcement for the detour route, which was in effect for five months.

Returned to service in 2002, the bridge is both a gateway into Crystal Falls and a focal point for a non-motorized path along the Paint River. As viewed from the adjacent park, the bridge fits well with its surroundings lending an element of charm to the landscape.
