FREEMAN ELEMENTARY SCHOOL

Outlet Sampling and Plumbing Assessment Recommendations

4001 Ogema Avenue, Flint, MI 48507

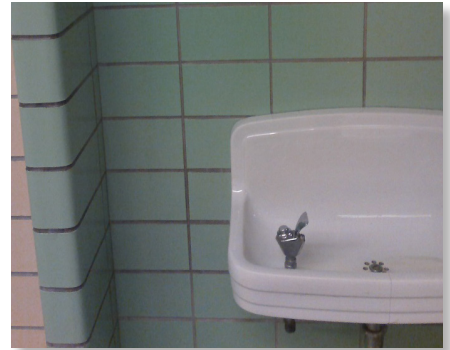
Outlet: Bubbler Drinking Fountain, Left (DW001)

Location: Hallway outside Janitorial Room

Results: P1=40 parts per billion, P2=6 parts per billion
F1=4 parts per billion, F2=1 part per billion

These results suggest the highest contribution of lead may be from the bubbler itself. This bubbler fixture is believed to have a brass valve. The connection underneath the sink also appears to have some brass components, including the valve at the wall.

Replacement of this bubbler tap and its connection plumbing with lead-free materials will significantly reduce lead exposure at this location.

If replacement is not currently feasible, sample results indicate that flushing this tap for 3 minutes following periods of stagnation is likely to reduce lead concentrations and lead exposure.

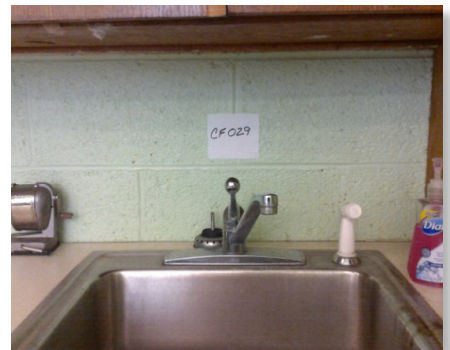
Outlet: Sink Faucet (CF029)

Location: DHHS Office, west wall

Results: P1=17 parts per billion, P2=12 parts per billion
F1=2 parts per billion, F2=non-detect

These results suggest the highest contribution of lead may be from the faucet and its connecting plumbing. The faucet is a Delta 400. This model faucet valve has brass components. This style faucet also has a mixing valve that may allow mixing of hot and cold water. Connecting plumbing in the cabinet under the sink may also contain brass components.

This faucet also has an aerator at the outlet. The aerator should be removed, inspected for particulate accumulations, scrubbed clean, and reinstalled. If particulates are found, the aerator should be periodically checked and cleaned.

Replacement of this faucet and its connection plumbing with lead-free materials will significantly reduce lead exposure at this location. If replacement is not currently feasible, sample results indicate that flushing this tap for 3 minutes following periods of stagnation is likely to reduce lead concentrations and lead exposure.

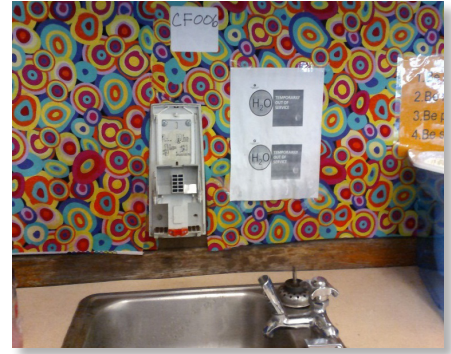
Outlet: Integrated faucet and bubbler fountain (CF006)

Location: Classroom 2, south wall

Results: P1=16 parts per billion, P2=3 parts per billion
F1=1 part per billion, F2=1 part per billion

These results were collected from the faucet portion of the fixture and suggest the highest contribution of lead may be from the fixture itself. The make and model of this fixture is unknown, but appears to be made of chrome plated brass and may be connected on the underside of the sink using a brass nipple.

Replacement of this fixture and its connection plumbing with lead-free materials will significantly reduce lead exposure at this location. If replacement is not currently feasible, sample results indicate that flushing this tap for 3 minutes following periods of stagnation is likely to reduce lead concentrations and lead exposure.

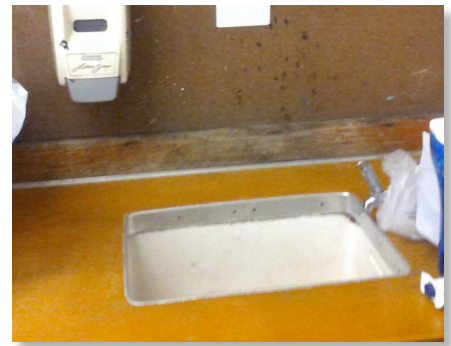
Outlet: Integrated faucet and bubbler fountain (CF014)

Location: Classroom 10, north wall

Results: P1=27 parts per billion, P2=7 parts per billion
F1=4 parts per billion, F2=3 parts per billion

These results were collected from the faucet portion of the fixture and suggest the highest contribution of lead may be from the fixture itself and its connecting plumbing. The make and model of this fixture is unknown, but appears to be made of chrome plated brass and may be connected on the underside of the sink using a brass nipple. Connecting plumbing in the cabinet under the sink may also contain brass components.

Replacement of this fixture and its connection plumbing with lead-free materials will significantly reduce lead exposure at this location. If replacement is not currently feasible, sample results indicate that flushing this tap for 3 minutes following periods of stagnation is likely to reduce lead concentrations and lead exposure.

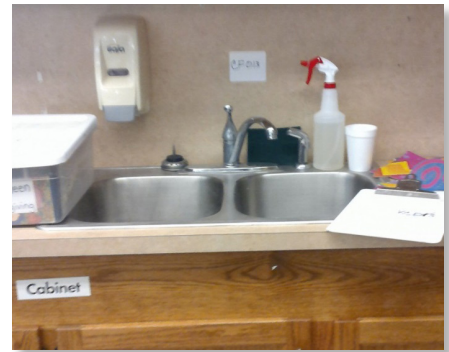
Outlet: Sink Faucet (CF013)

Location: Classroom 10, north wall

Results: P1=9 parts per billion, P2=18 parts per billion
F1=3 parts per billion, F2=3 parts per billion

These results suggest the highest contribution of lead may be from the connecting plumbing with some contribution from the faucet itself. The faucet appears to be a Delta 500 series. This model faucet may have some brass components. This style faucet also has a mixing valve that may allow mixing of hot and cold water. Connecting plumbing in the cabinet under the sink should be checked for brass components, including brass valves.

This faucet also has an aerator at the outlet. The aerator should be removed, inspected for particulate accumulations, scrubbed clean, and reinstalled. If particulates are found, the aerator should be periodically checked and cleaned.

Replacement of this faucet and its connection plumbing with lead-free materials will significantly reduce lead exposure at this location. If replacement is not currently feasible, sample results indicate that flushing this tap for 3 minutes following periods of stagnation is likely to reduce lead concentrations and lead exposure.

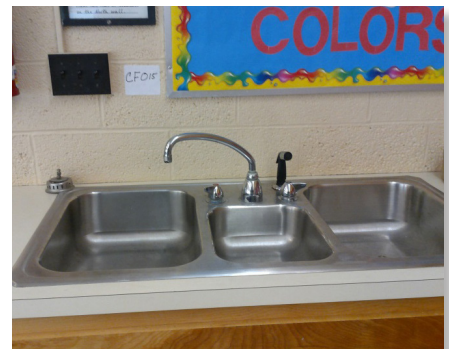
Outlet: Sink Faucet (CF015)

Location: Classroom 11, northeast corner

Results: P1=102 parts per billion, P2=326 parts per billion
F1=14 parts per billion, F2=11 parts per billion

These results suggest the highest contribution of lead may be from the connecting plumbing and from the faucet itself. The faucet is an older design that uses a brass tube approximately 8 inches in length between the hot and cold water valves and connects to the outlet under the sink. This brass tube may be the primary source of lead, explaining the higher second (P2) sample result. The faucet and valves may also contain brass components. Connecting plumbing in the cabinet under the sink should be checked for additional brass components, including brass valves.

The continued presence of lead in samples collected at Classroom 11 (CF015) may be a result of lead particulates caught in the aerator/screen installed on the faucet outlet or may be from a source of lead further back in the plumbing system. However, the non-detect results from consecutive samples collected in Proposed Pre-K Room (CF030) and Classroom 21 (CF027) suggest any additional source of lead associated with Classroom 11 (CF015) is localized to the plumbing branch serving this faucet. The faucet aerator/screen in Classroom 11 (CF015) should be removed and inspected before completing a more in-depth plumbing analysis. Consecutive sampling results at Classroom 11 (CF015) support the water use restrictions specified for this outlet.

This faucet also has an aerator at the outlet. The aerator should be removed, inspected for particulate accumulations, scrubbed clean, and reinstalled. If particulates are found, the aerator should be periodically checked and cleaned.

Replacement of this faucet and its connection plumbing with lead-free materials will significantly reduce lead exposure at this location and needs to be completed. If replacement is not currently feasible, **DO NOT USE THIS FAUCET FOR DRINKING OR COOKING.**

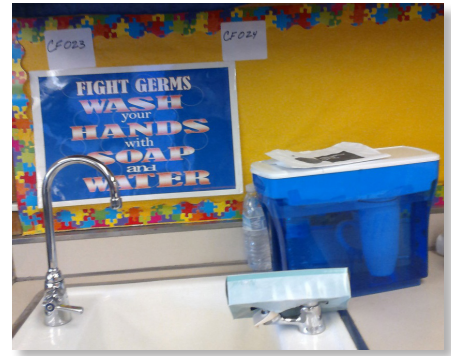
Outlet: Integrated faucet and bubbler fountain (CF024)

Location: Classroom 19, east wall

Results: P1=23 parts per billion, P2=3 parts per billion
F1=4 part per billion, F2=3 parts per billion

These results were collected from the faucet portion of the fixture and suggest the highest contribution of lead may be from the fixture itself. The make and model of this fixture is unknown, but appears to be made of chrome plated brass and may be connected on the underside of the sink using a brass nipple.

Replacement of this fixture and its connection plumbing with lead-free materials will significantly reduce lead exposure at this location. If replacement is not currently feasible, sample results indicate that flushing this tap for 3 minutes following periods of stagnation is likely to reduce lead concentrations and lead exposure.

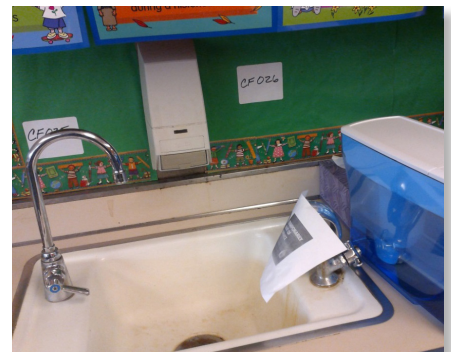
Outlet: Bubbler fountain (CF026)

Location: Classroom 14, west wall

Results: P1=36 parts per billion, P2=30 parts per billion
F1=17 parts per billion, F2=4 parts per billion

These results suggest the highest contribution of lead may be from the bubbler itself. This bubbler fixture appears to be made of chrome plated brass. This style bubbler typically has a 4-5-inch brass fitting that connects to a 3-inch brass nipple on the underside of the sink. This would explain the higher concentrations in the first two sample results. The connection underneath the sink may also have some brass components and should be checked, including the valve.

Replacement of this bubbler tap and its connection plumbing with lead-free materials will significantly reduce lead exposure at this location and should be completed. If replacement is not currently feasible, sample results indicate that flushing this tap for 3 minutes prior to each use and for at least 4 minutes following periods of stagnation is likely to reduce lead concentrations and lead exposure. **In general, use of this fountain for drinking water should be discouraged.**
