Abandoned Mining Wastes (including PCBs) Project -- Torch Lake

Torch Lake Investigation Update – What We Did in 2014

Figure 1
 C&H Lake Linden
 Operations Area Map
 Lake Linden, Houghton County,
 Michigan

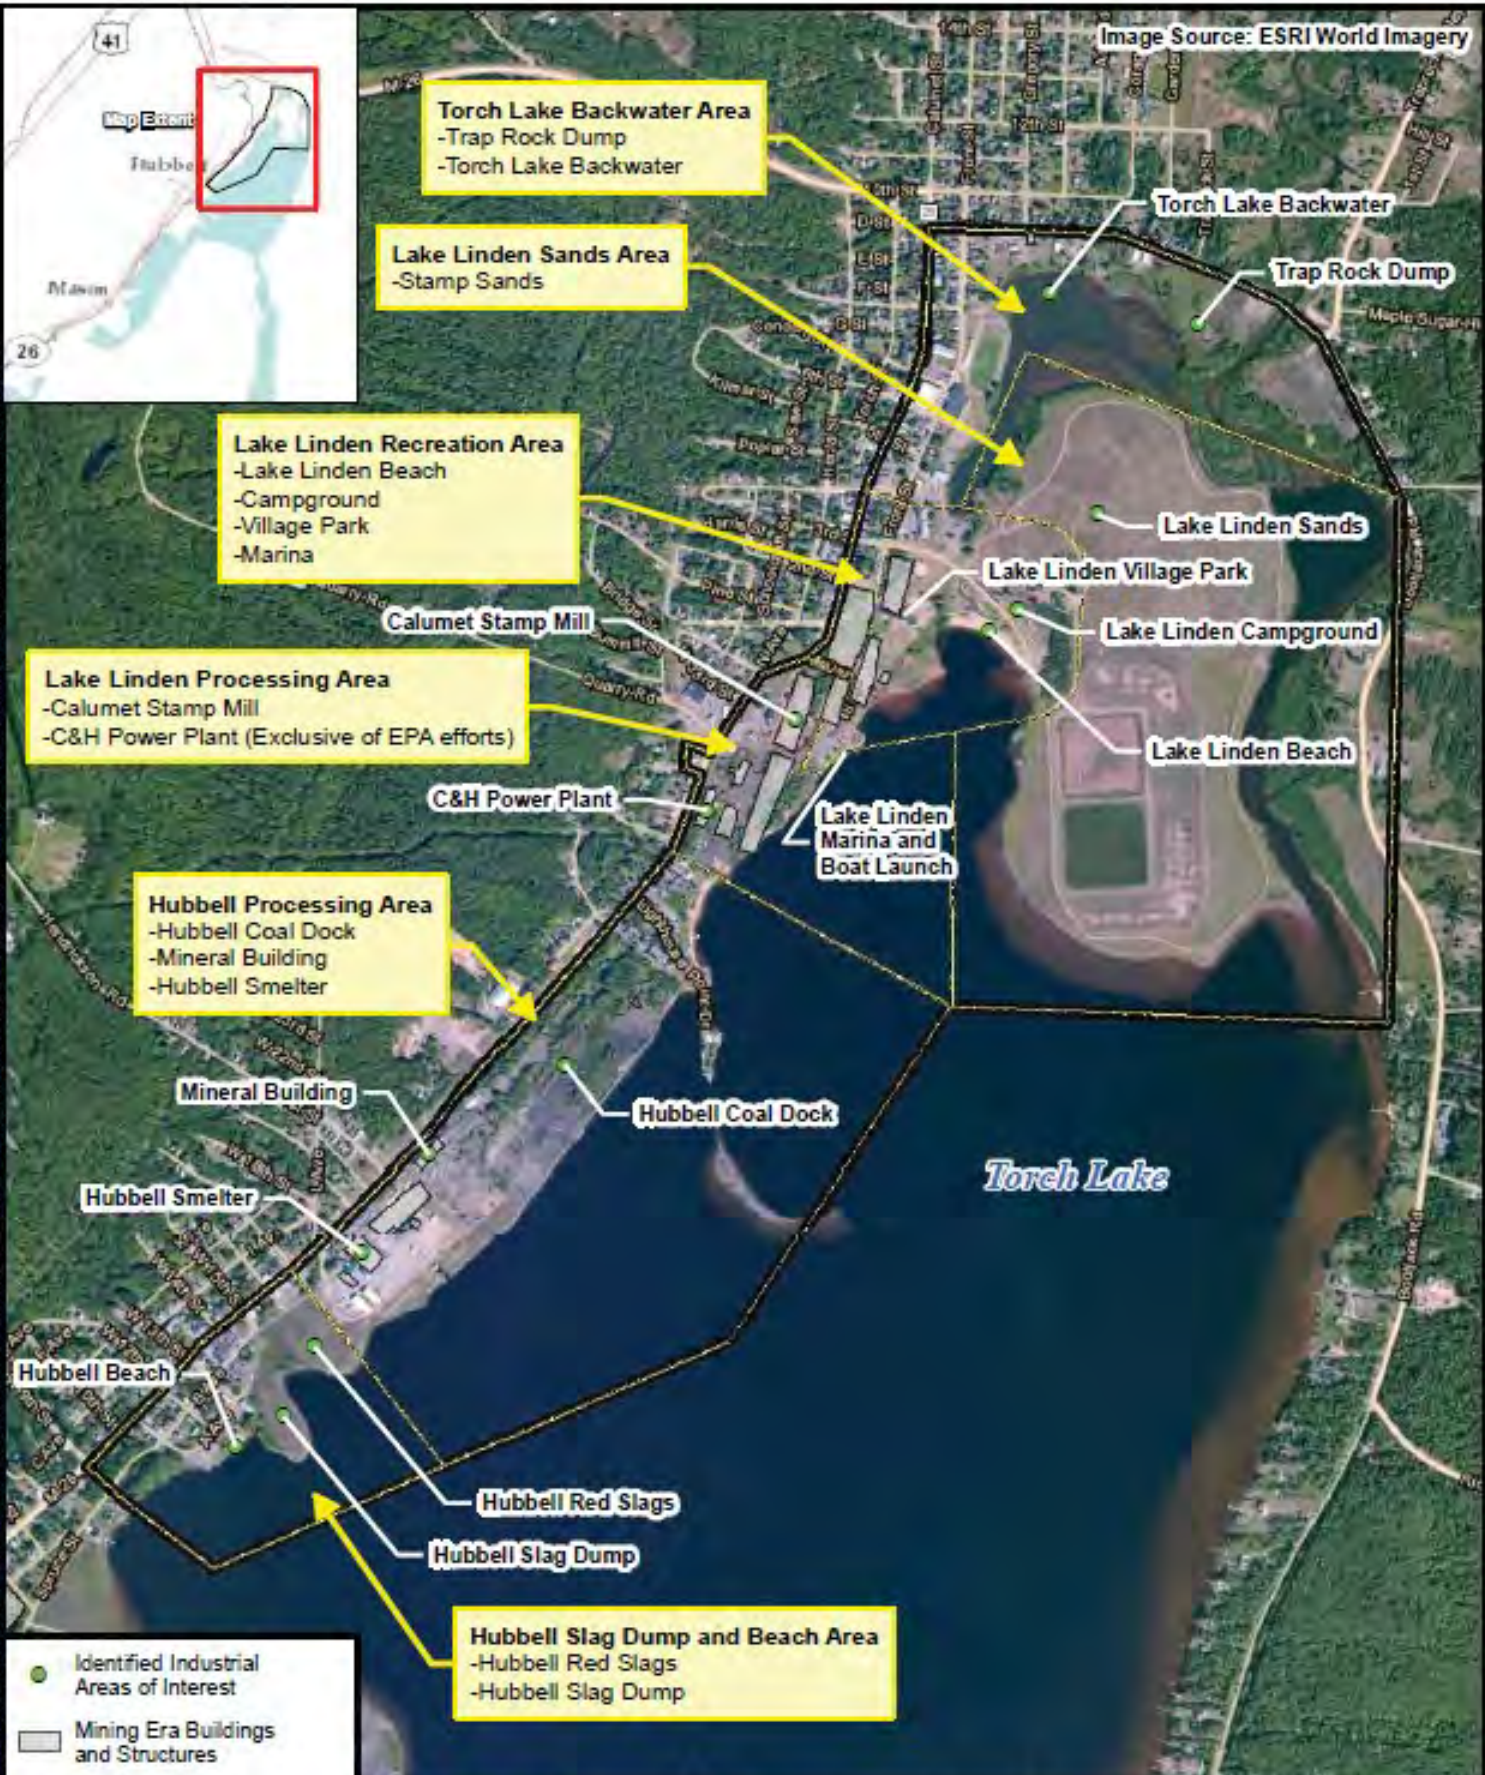
Since the time of the last newsletter (May 2014) we have been conducting field work, preparing our report, and gearing up for the next phase of work, which will start within the next couple of weeks. This investigation is an evaluation of the former industrial areas in the area we call the C&H Lake Linden Operations Area (“C&H” referring to the Calumet & Hecla Mining Company). **Figure 1** depicts the study area and sub-areas of the Lake Linden Operations Area.

Torch Lake Backwater Area
 -Trap Rock Dump
 -Torch Lake Backwater

Lake Linden Sands Area
 -Stamp Sands

Lake Linden Recreation Area
 -Lake Linden Beach
 -Campground
 -Village Park
 -Marina

Lake Linden Processing Area
 -Calumet Stamp Mill
 -C&H Power Plant (Exclusive of EPA efforts)

Hubbell Processing Area
 -Hubbell Coal Dock
 -Mineral Building
 -Hubbell Smelter

Hubbell Slag Dump and Beach Area
 -Hubbell Red Slags
 -Hubbell Slag Dump

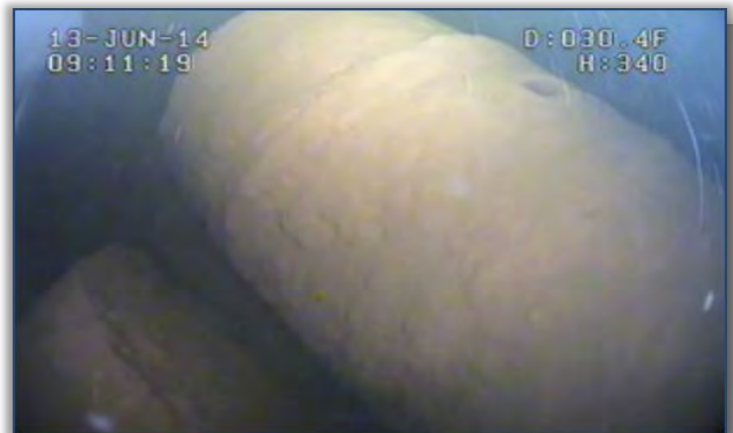
The photo to the right was taken by the DEQ ROV underwater camera on June 13, 2014 in 30' of water. As you can see, multiple drums are present on top of each other. From our studies, we were able to verify the presence of the significant drum deposits offshore of the former Hubbell Smelter complex.

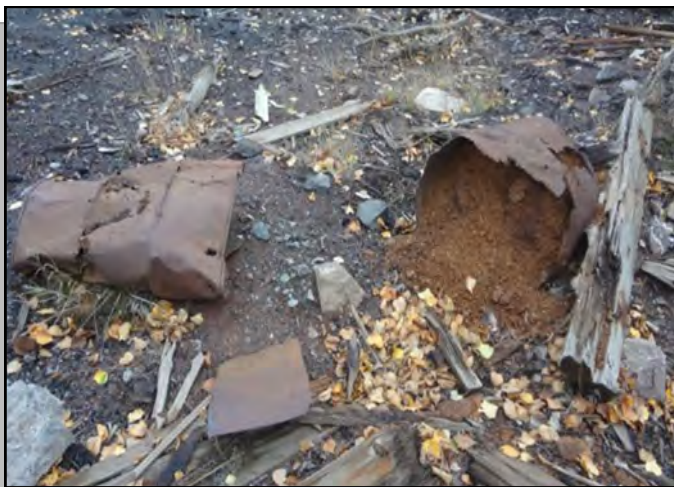
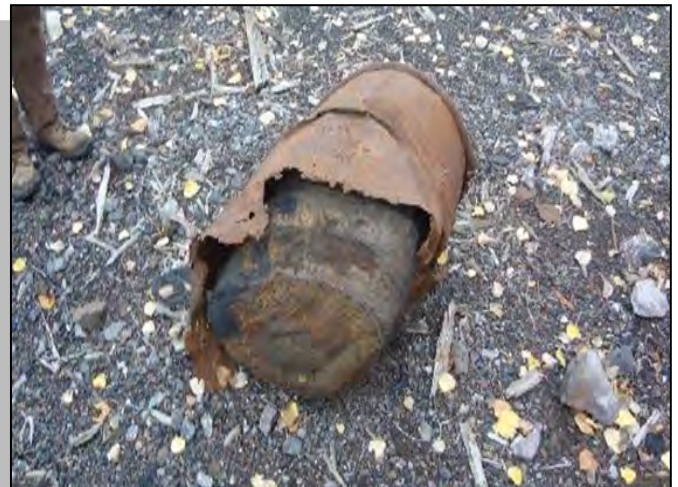
The photos below are of drums found in the Hubbell area at former industrial properties.

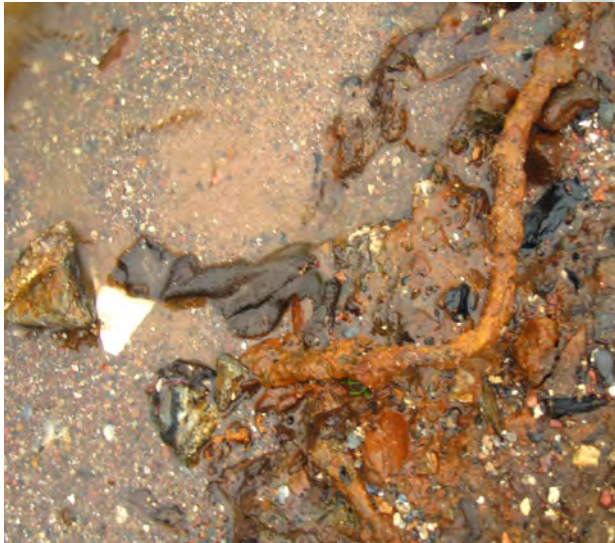
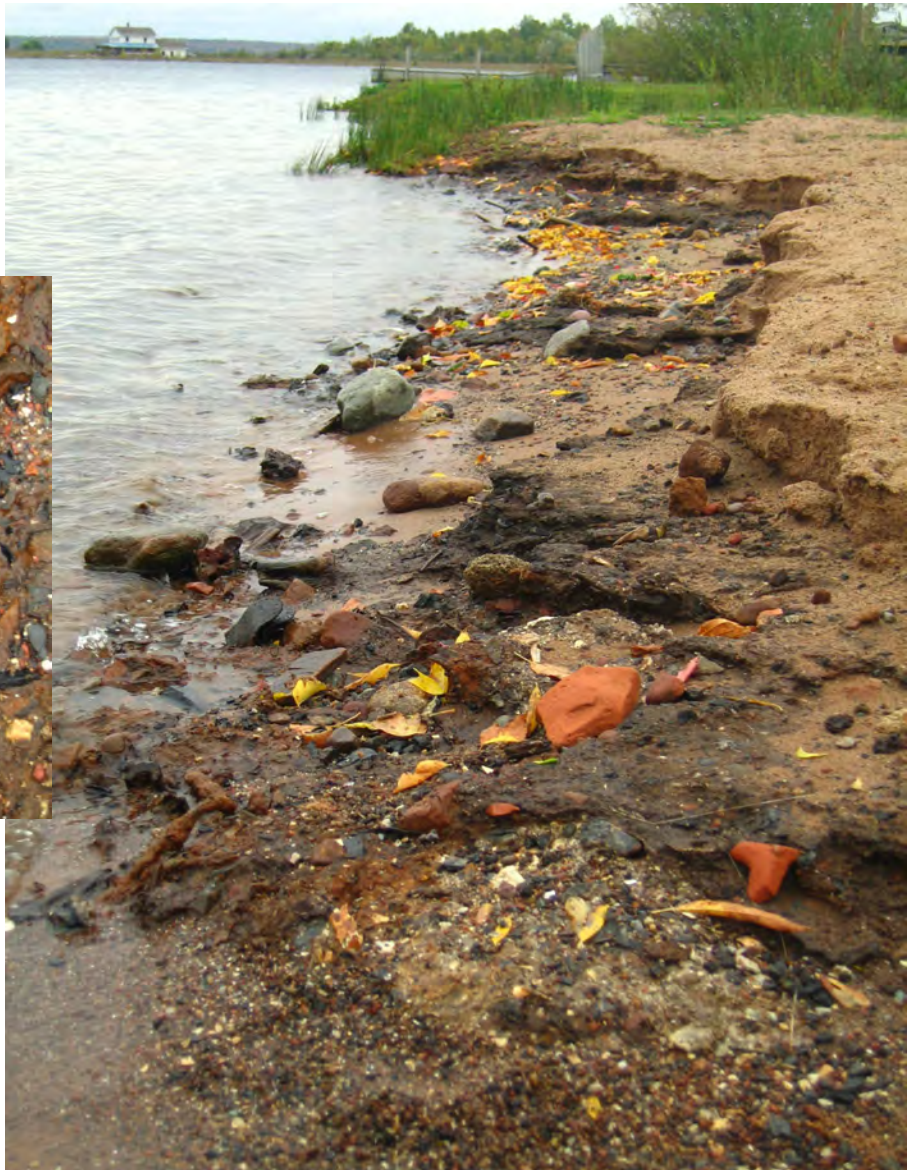
In addition to the presence of organic and inorganic contamination, there are physical hazards such as metal and porcelain-like debris at the Hubbell Beach near the old town dump. These wastes can be seen in the shallow water near the swimming area. The DEQ has provided the analytical data from the C&H Lake Linden Operations Area investigation including the Hubbell Slag Dump and Beach Area and the Lake Linden Recreation Area to the Michigan Department of Community Health (MDCH) for further evaluation to supplement their *Public Health Assessment, Evaluation of Recreational Uses at Beach Areas at Lake Linden and Along Torch Lake, Houghton County, Michigan* (MDCH, September 2014). You may recall that the MDCH gave a presentation of their draft reports in May 2013 at the school. Those reports have since been finalized and shared with the community. You can find them at the local library or on the internet at http://www.michigan.gov/mdch/0,4612,7-132-54783_54784_56159-278958--00.html.

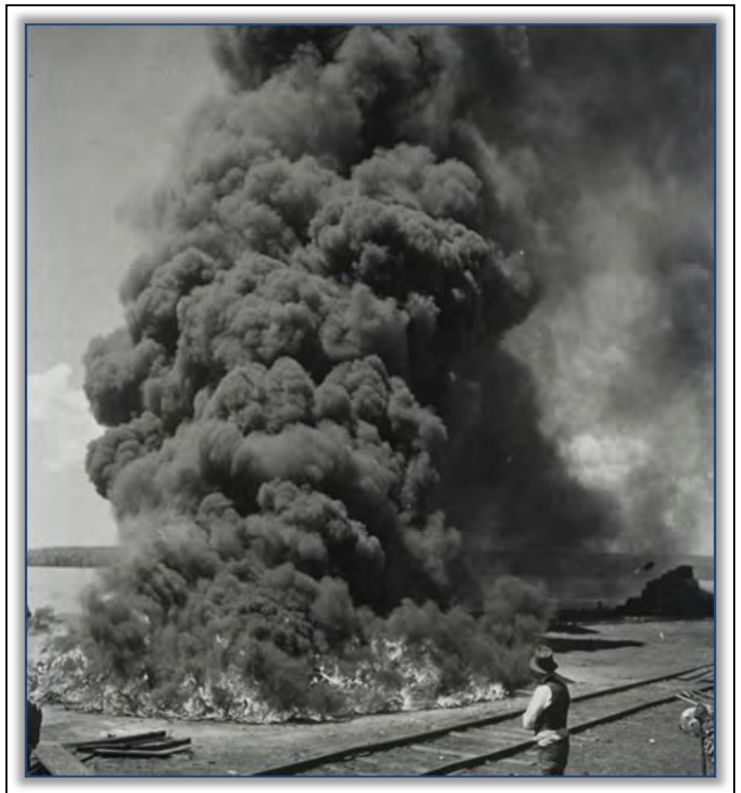
Above is a photo provided by the NPS. Old *C&H News n' Views* newsletters described how scrap, brought in from all over the country for reclamation of copper during the war-effort, was often encased in plastic or other materials. The plastic coatings on wire would be stripped and/or burned off in piles such as depicted above. It has been determined that the coatings on some of the cables that were brought in contained PCBs.
