**DETAILED FINDINGS REPORT
TAMARACK SANDS AREA**

7. DETAILED FINDINGS REPORT – TAMARACK SANDS AREA

Figure 7-1
Sampling Location Map
Tamarack Sands Area
Tamarack City, Houghton County, Michigan

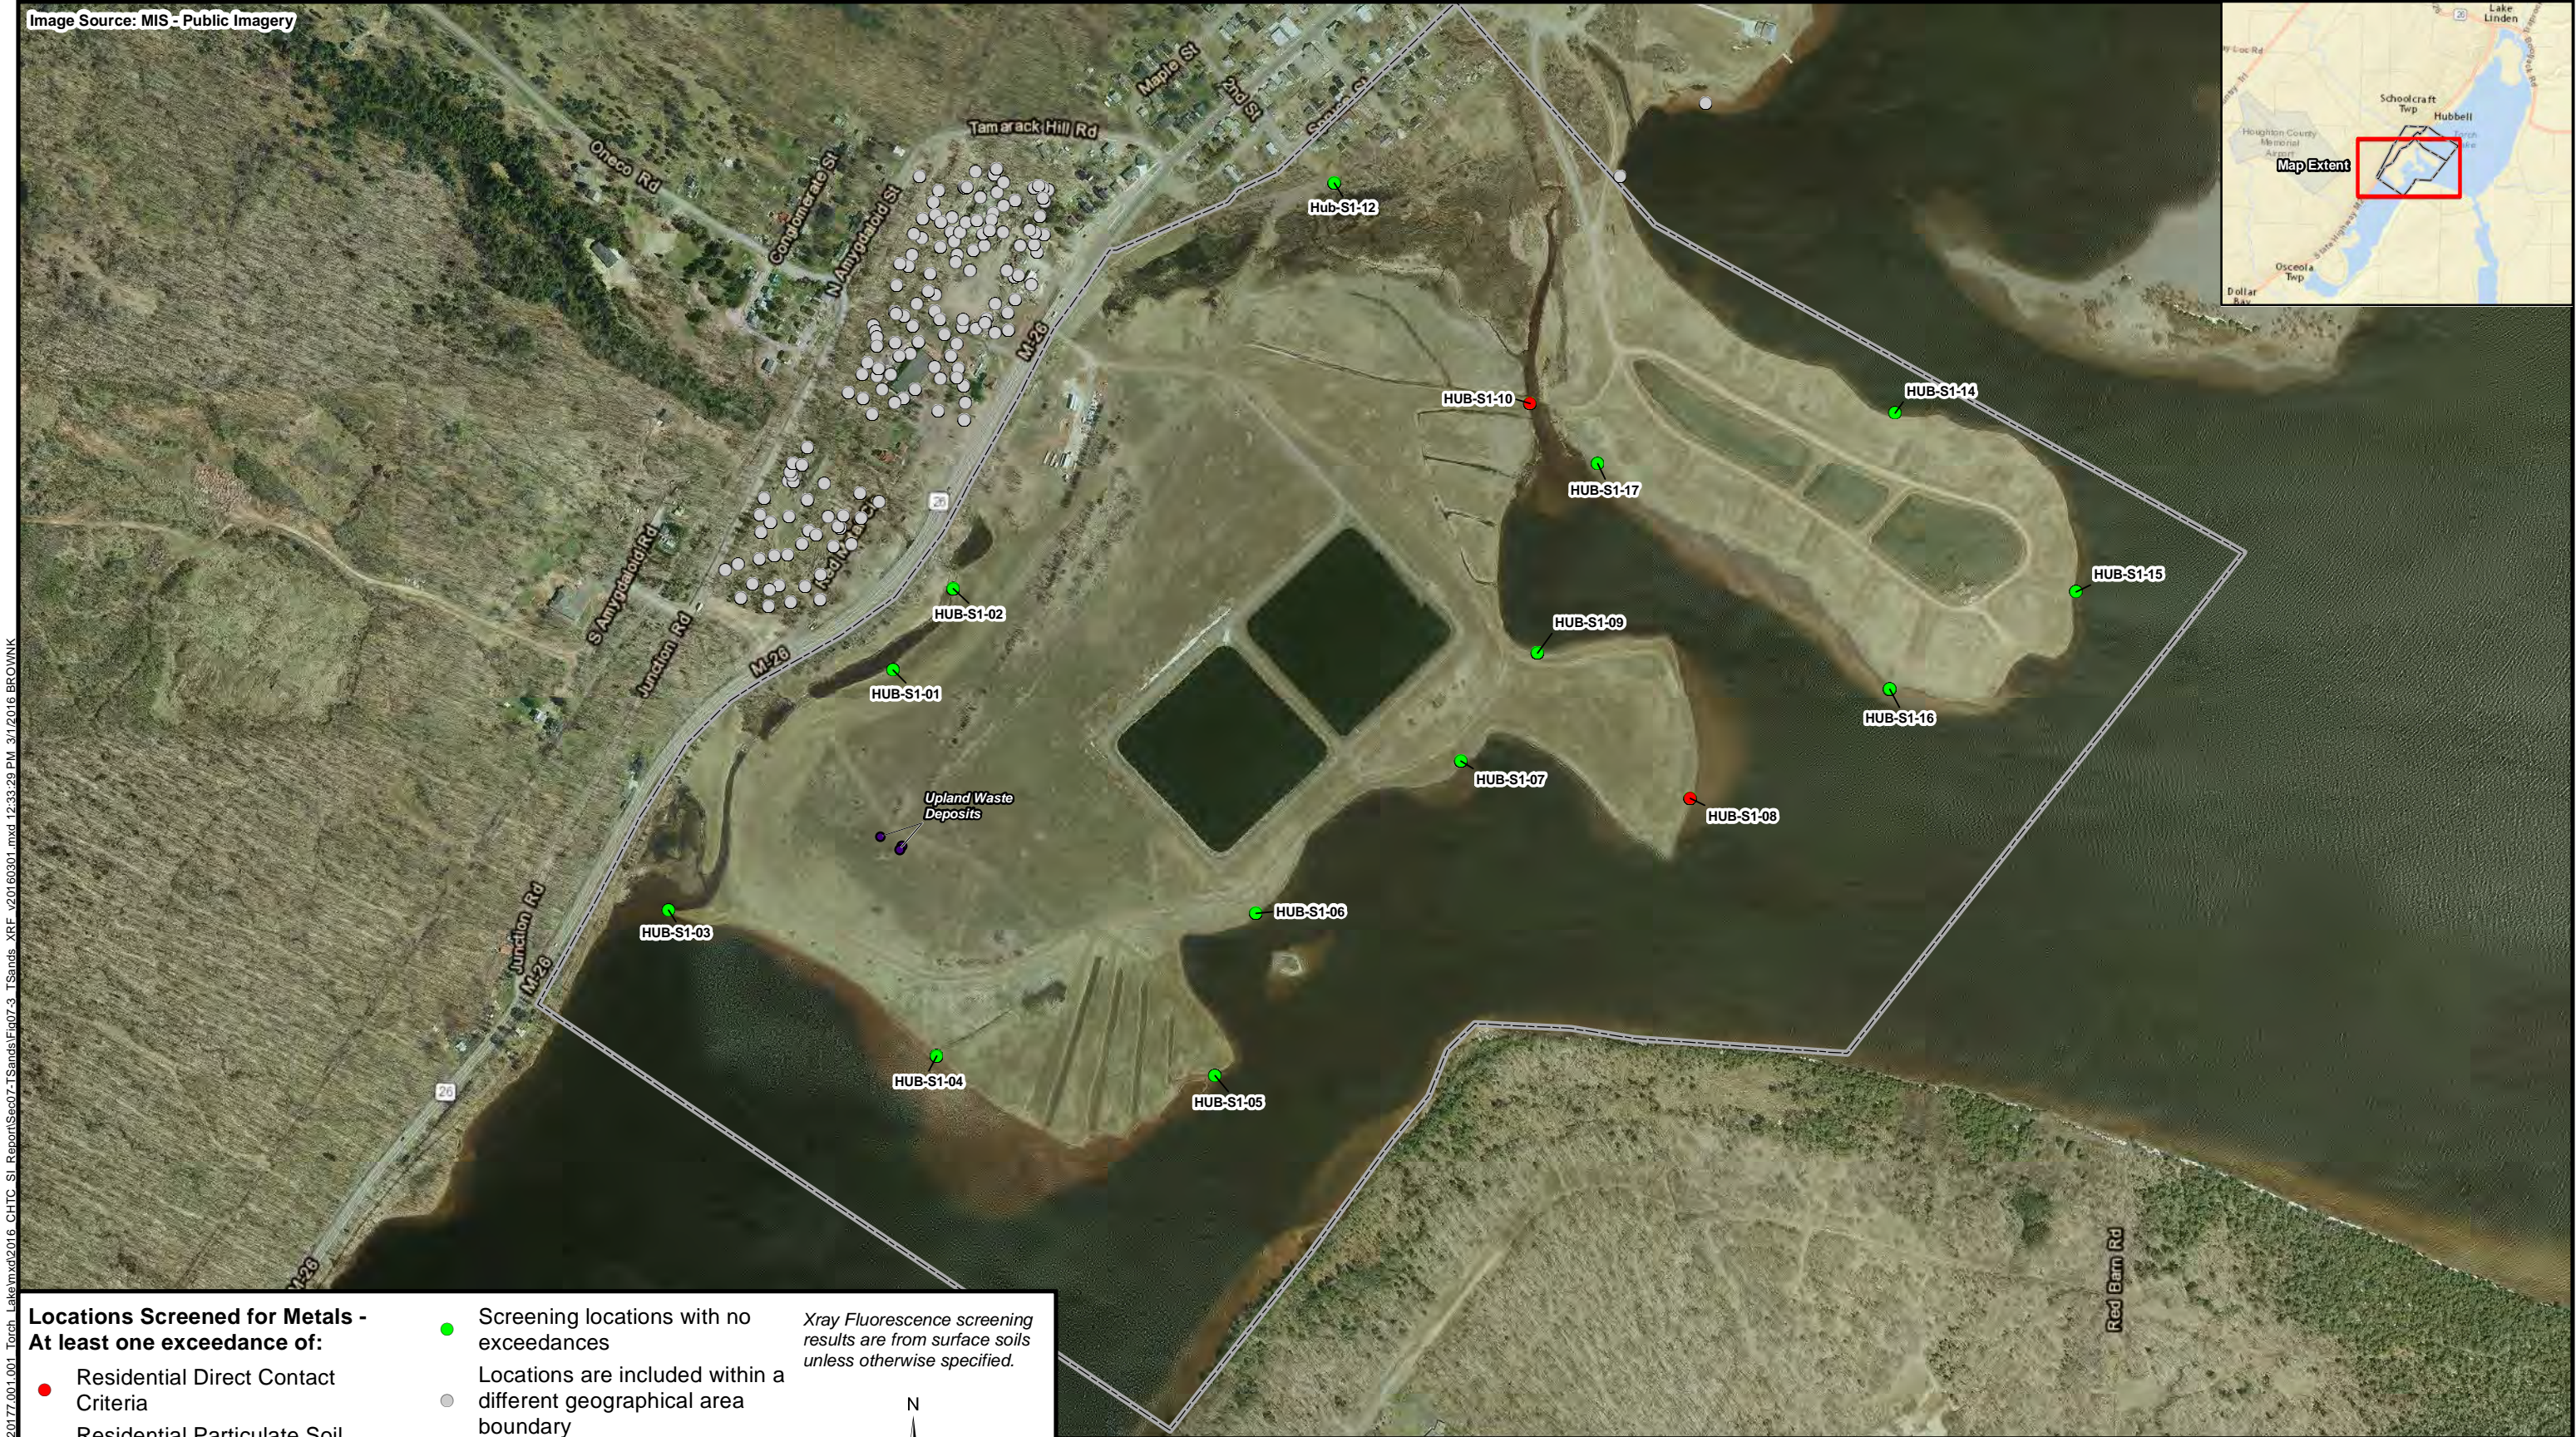
Figure 7-3
Soil Screening Results Map - Soil
Tamarack Sands Area
Tamarack City, Houghton County, Michigan

**Locations Screened for Metals -
At least one exceedance of:**

- Residential Direct Contact Criteria
- Residential Particulate Soil Inhalation Criteria
- Non Residential Direct Contact Criteria
- Non Residential Particulate Soil Inhalation Criteria

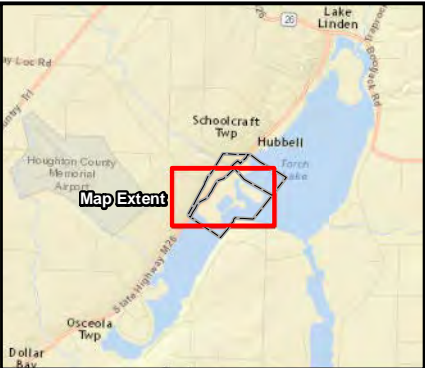
A detailed summary of soil analytical results collected from the Tamarack Sands Area are provided in [Table 7-2](#). XRF soil screening results from the Tamarack Sands Area are depicted on [Figure 7-3](#). Soil analytical results from the Tamarack Sands Area are depicted on [Figure 7-4](#). Soil boring logs are included in **Appendix G** of this SI Report.
