INTERIM RESPONSE CONSTRUCTION SUMMARY REPORT FOR TRAIL CAPPING

ABANDONED MINING WASTES – TORCH LAKE NON-SUPERFUND SITE
CHTC TAMARACK SANDS AREA
HOUGHTON COUNTY, MICHIGAN
SITE ID# 31000098

JANUARY 2017

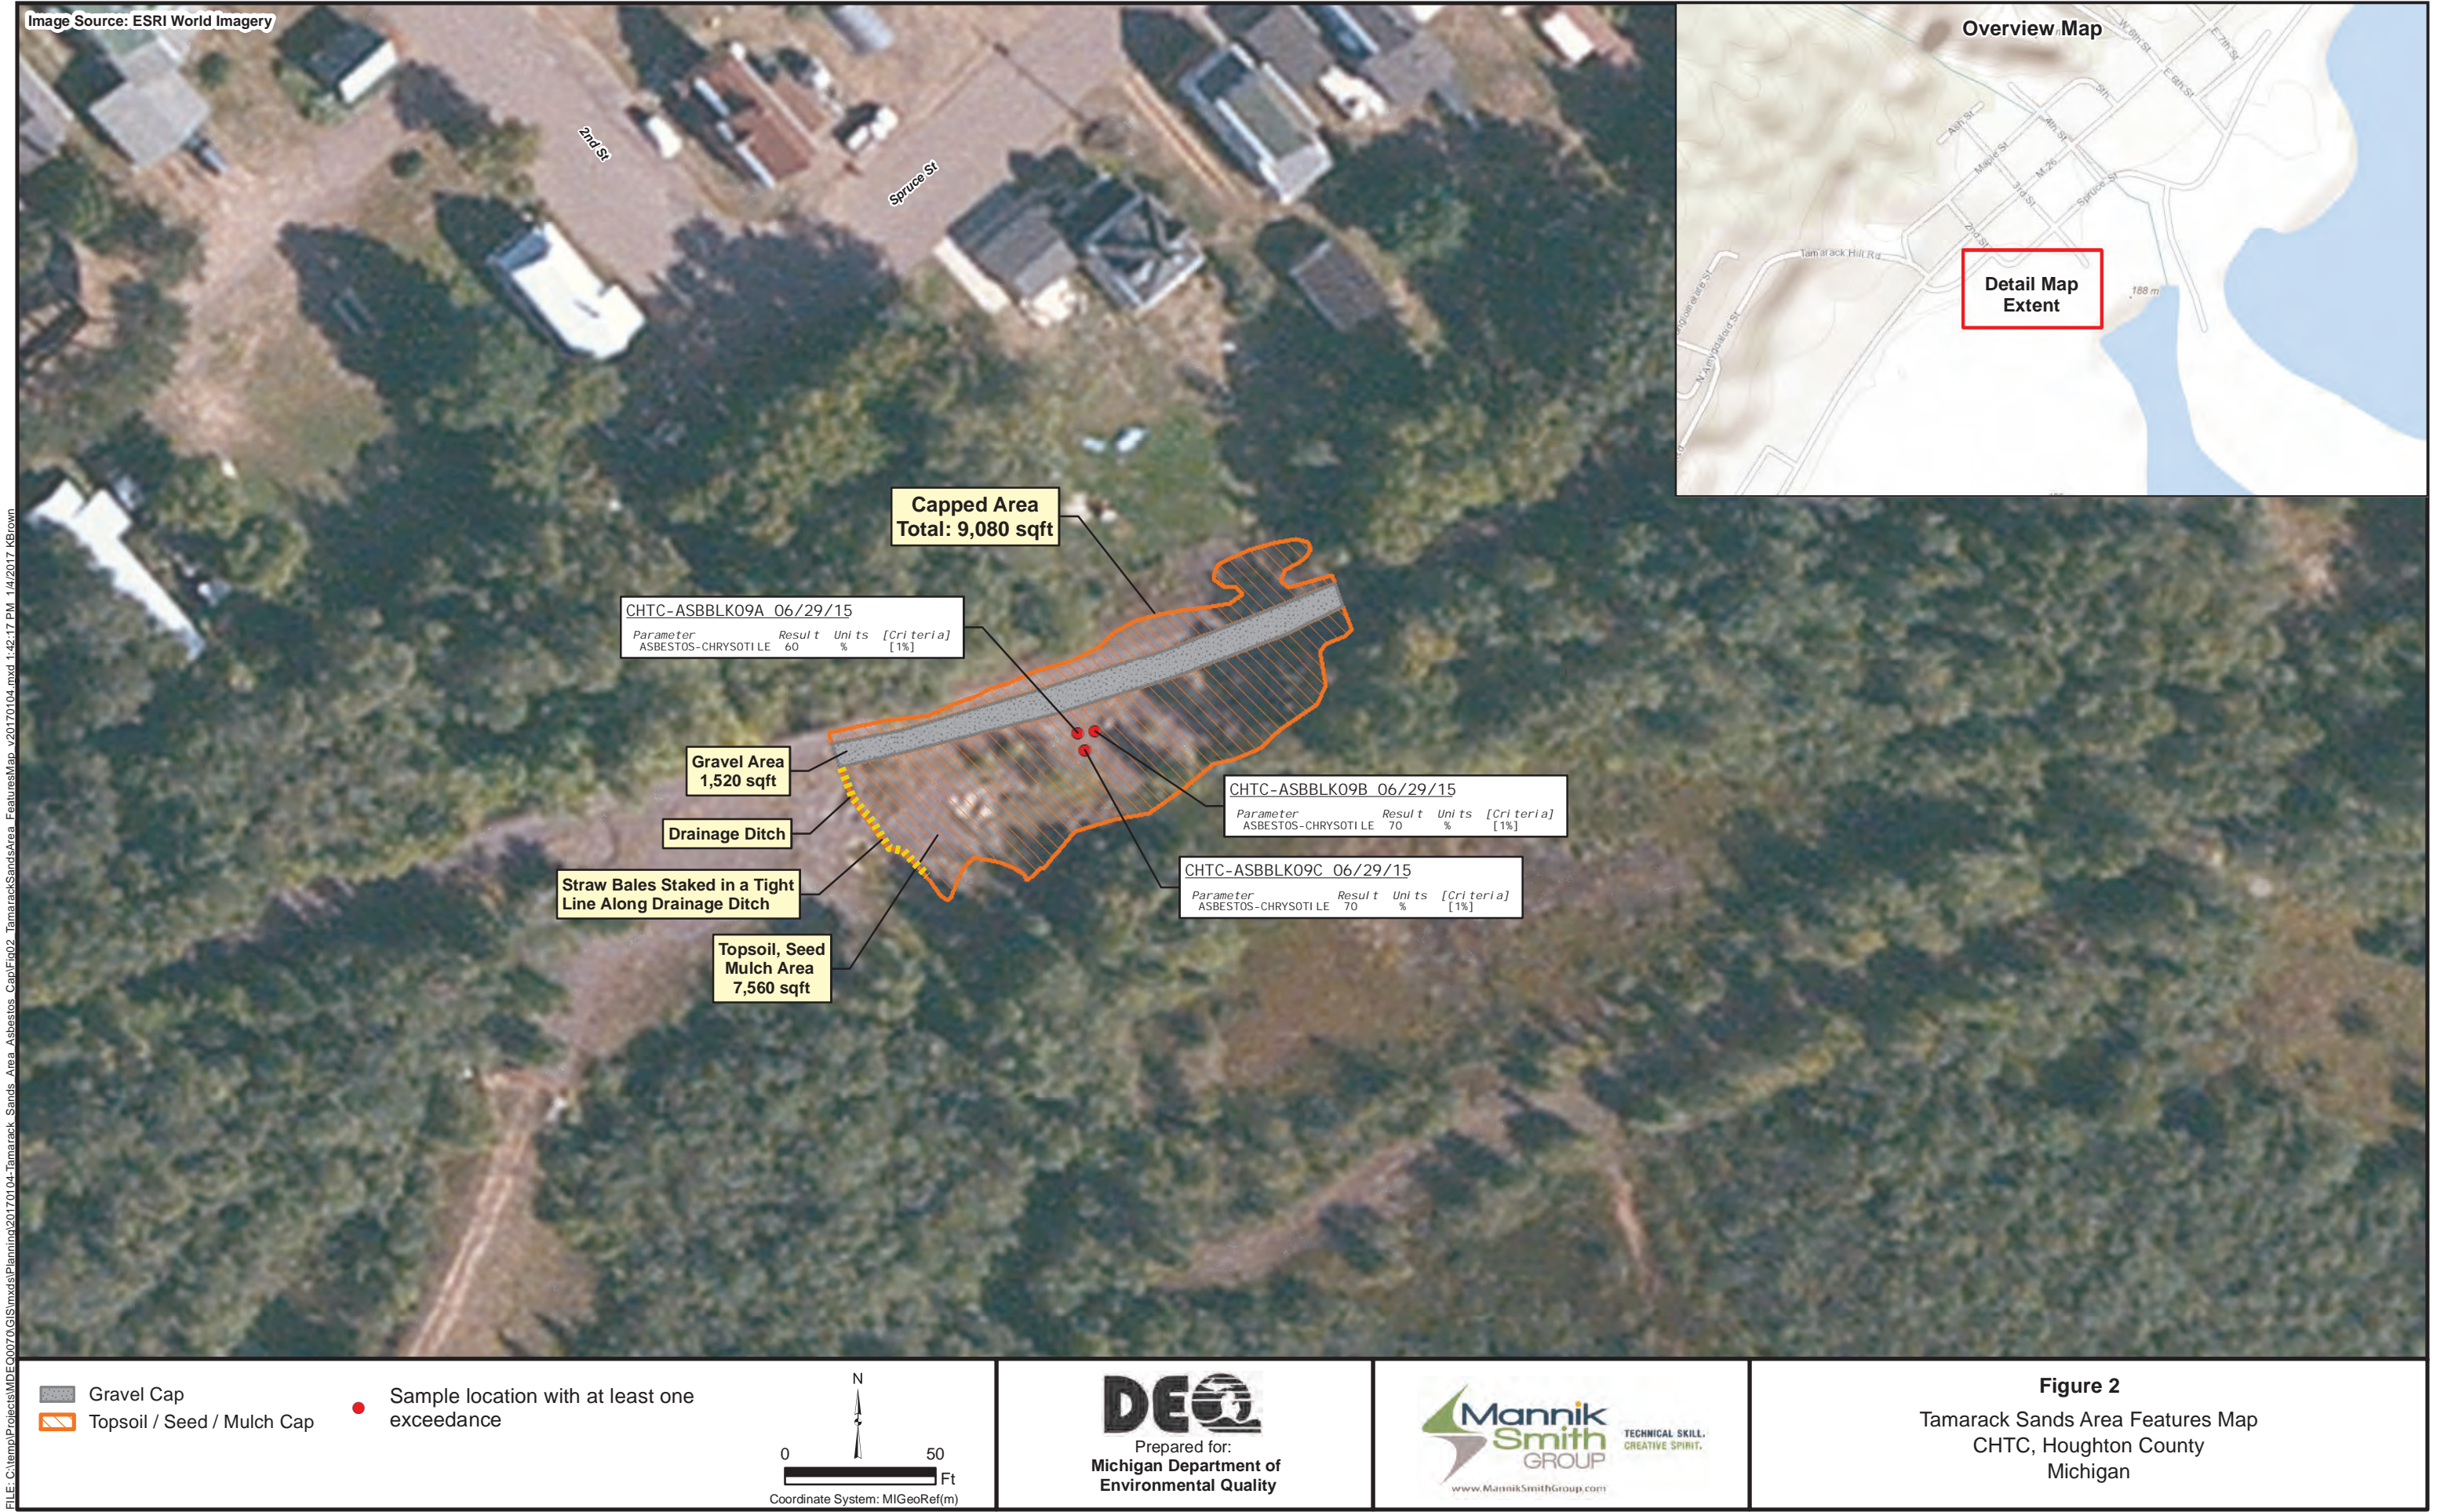
The CHTC Tamarack Sands Area is located in Tamarack City along the southeast side of Highway M-26 and Spruce Street, and generally characterized as an in-lake stamp sand deposit associated with the industrial operations in the Ahmeek Mill and Tamarack Processing Areas. Residential (single-family residences) and industrial (capped stamp sands) properties, and Torch Lake border the Tamarack Sands Area. The IR for trail capping focused on capping of ACBM residual on and along a section of an informal trail that is a former railroad grade right of way owned by the Michigan Department of Transportation (MDOT). *Figure 2, Tamarack Sands Area Features Map*, depicts the area encompassing the Tamarack Sands Area in addition to site features and the trail area capped.

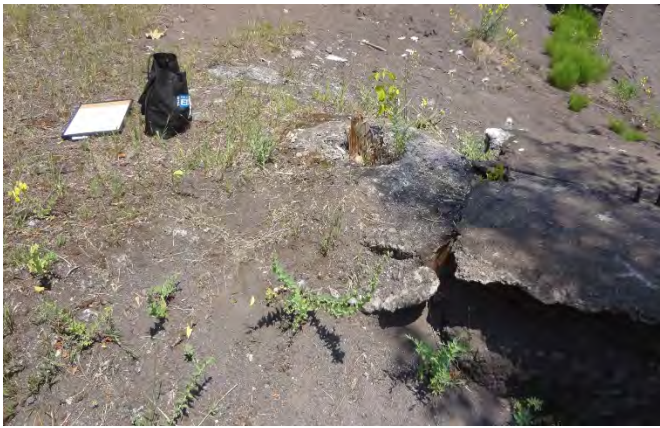
As part of the AMW CHTC Ops project, during a site walkover, asbestos was observed and confirmed via sampling at a former RR grade which is located immediately adjacent to a residential area where children use the grade as their main play area; riding bikes and building forts on it. Though bulk asbestos has been removed, residual is visible on surficial soils on the grade intermittently over an area ~ 150'X40'.

Photo 1: Asbestos containing building material (ACBM) on and along trail prior to capping. Photo taken on 6/29/15.

- Capped approximately 9,080 square feet of trail surface, shoulder, and adjacent areas through placement of a geotextile separator fabric (demarcation layer), a 1-foot thick layer of gravel over the trail surface, 6-inches of top soil and straw mulch blankets on the trail shoulder and adjacent areas, and installation of soil erosion and sediment control best management practices.

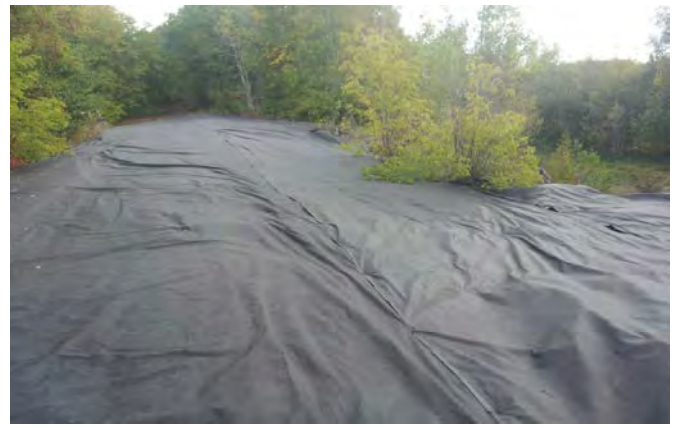
Photo 2: Placement of geotextile separator fabric (demarcation layer) over area. Photo taken on 9/25/15.

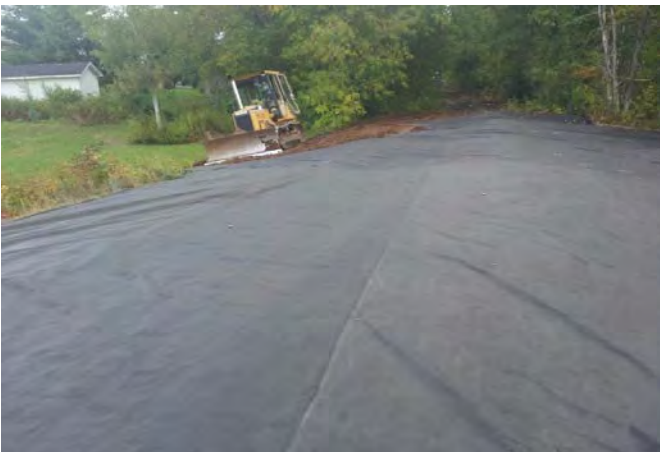
Photo 3: Placement of 6-inch layer of top soil over the trail shoulder and adjacent areas. Photo taken on 9/25/15.

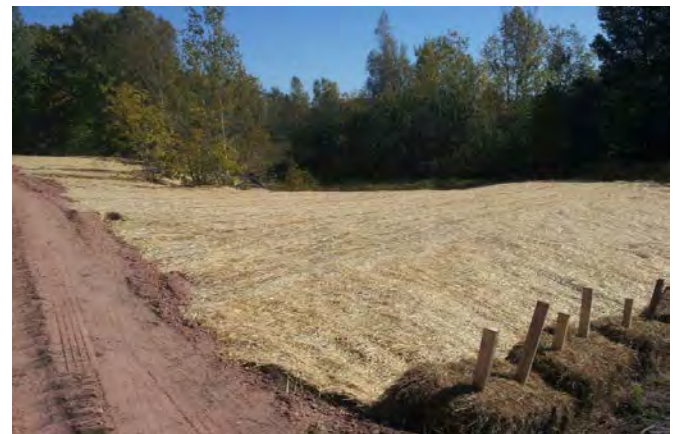
Photo 4: Placement of seed, straw mulch blankets, and SESC BMPs installation. Photo taken on 9/27/15.

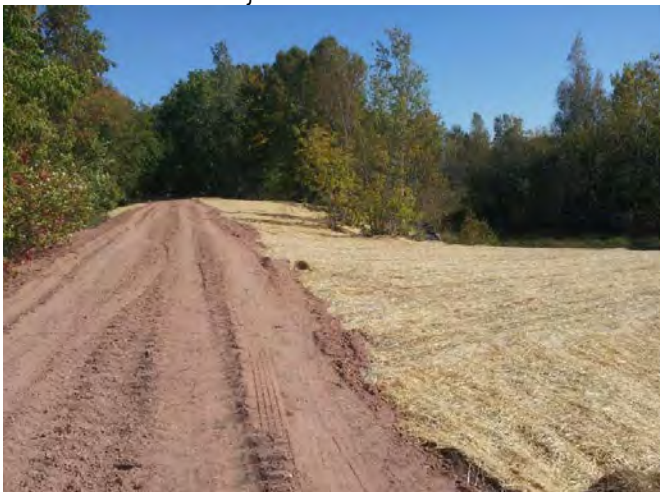
Photo 5: Placement of 1-foot thick layer of gravel over the trail surface. Photo taken on 9/27/2015.

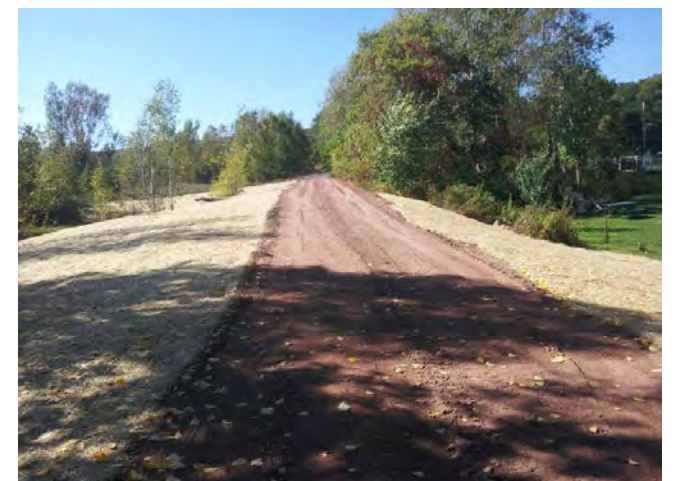
Photo 6: Completed trail capping. Photo taken on 9/27/15.

- Periodic monitoring and maintenance as required of the capped area to maintain the IR's effectiveness.
