Notes from the desk of Amy Keranen

Fall-
Winter
2015
-
2016

Abandoned Mining Wastes (including PCBs) Project -- Torch Lake

Abandoned Mining Wastes Project Update – What We Did in 2015

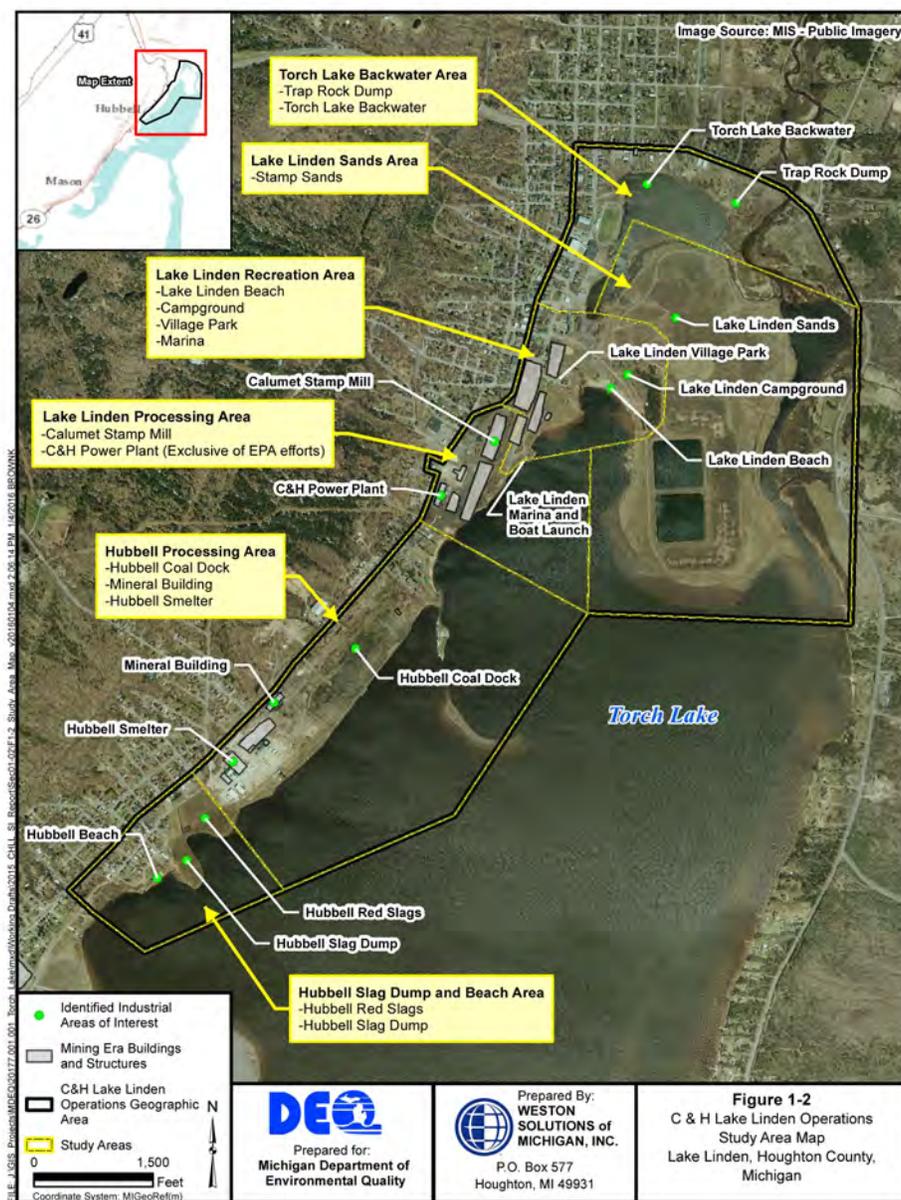
This figure is of the CHLL project area, where our studies were focused in 2014 with follow-up in 2015.

The key issues are with asbestos at the former Calumet Stampmill; PCBs, asbestos and metals in the former Hubbell Smelter area; a small area of asbestos in a dump in Tamarack City; and, PCBs in sediments in the lake at Lake Linden and Hubbell.

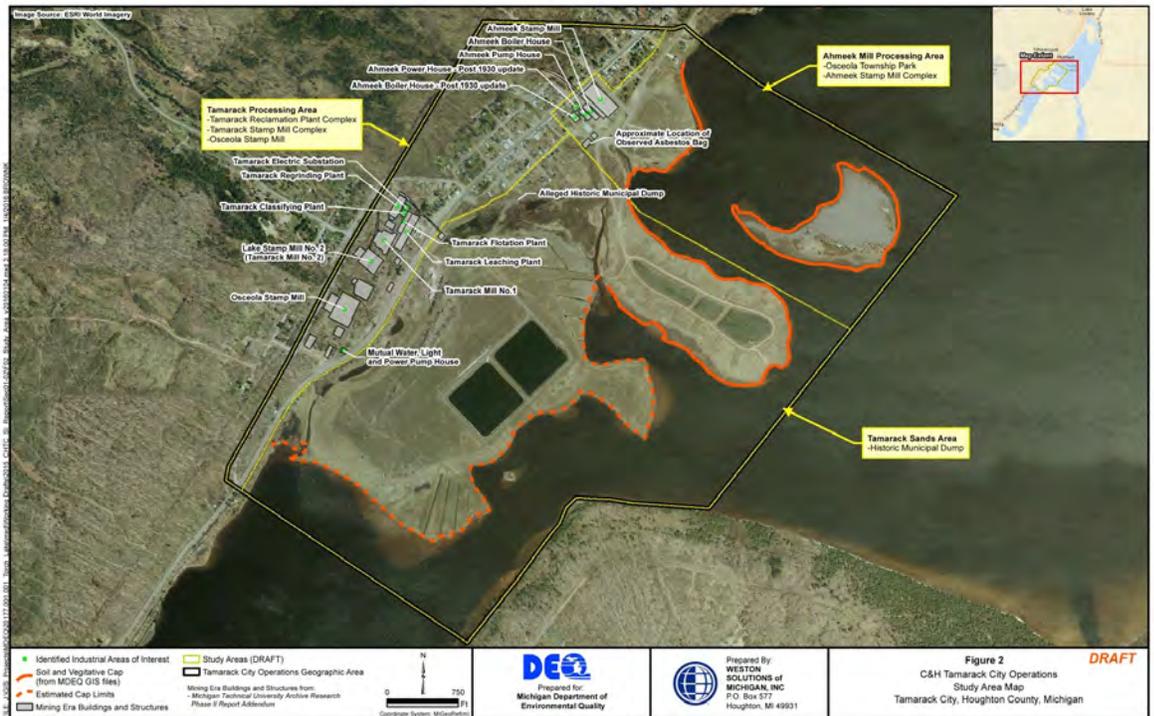
At the right is a map of the CHTC area. It includes the properties of four former stampmills: Ahmeek, Tamarack, Lake, and Osceola.

A lot of the 2015 work occurred at the hillside ruins of three of the old mills and out on the large stamp sands area. PCBs had been detected at a couple locations around the mills in the past, but our 2015 sampling did not find widespread PCBs.

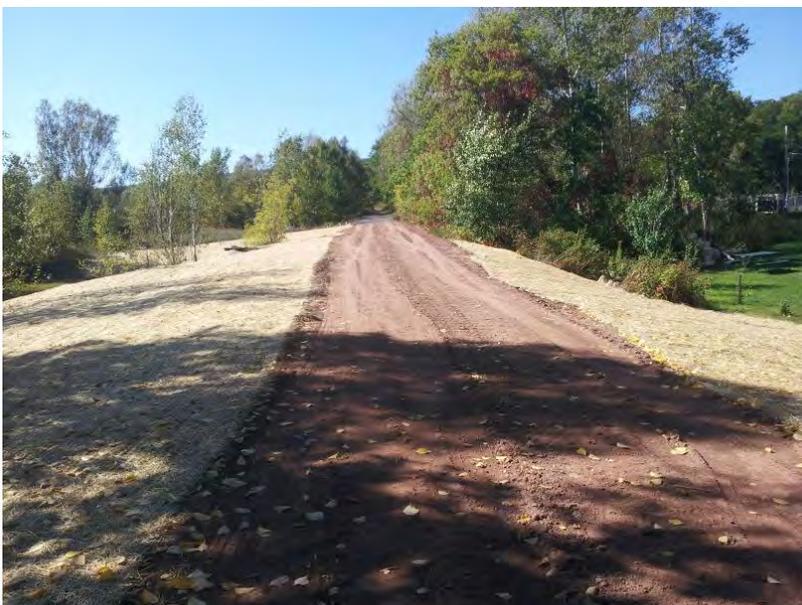
Tamarack City Trail Asbestos

The photo to the left shows an area where asbestos from an old steam pipe was left behind after the pipe was removed and the mines shut down. As part of addressing the asbestos, the DEQ capped the former railroad grade and brought in soil and grass seed. We did this work in late September and thanks to a beautiful fall, it appears the grass started growing before winter.

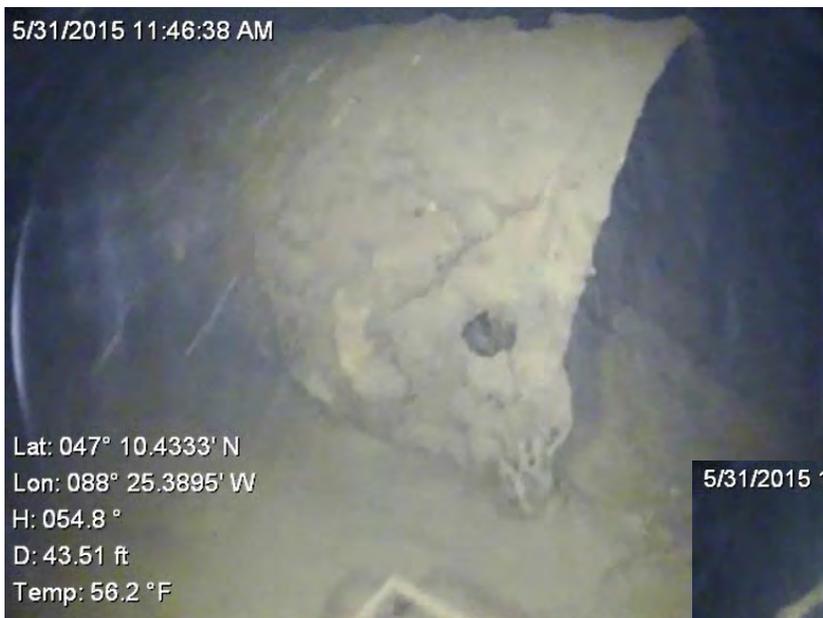
In 2015 we upgraded our underwater camera to one that is able to determine and display the GPS coordinates of whatever we are looking at, so that we can return to an exact location to collect samples. We were able to confirm that the areas where lots of drums had been located are also areas with elevated PCB concentrations in sediment samples. We were able to directly sample a drum at the shoreline that contained elevated concentrations of PCBs.

The original underwater camera was useful in identifying debris on the lake bottom; additional steps only allowed us to identify the general location of drums. The upgraded equipment provides detailed information in a much more straightforward manner.

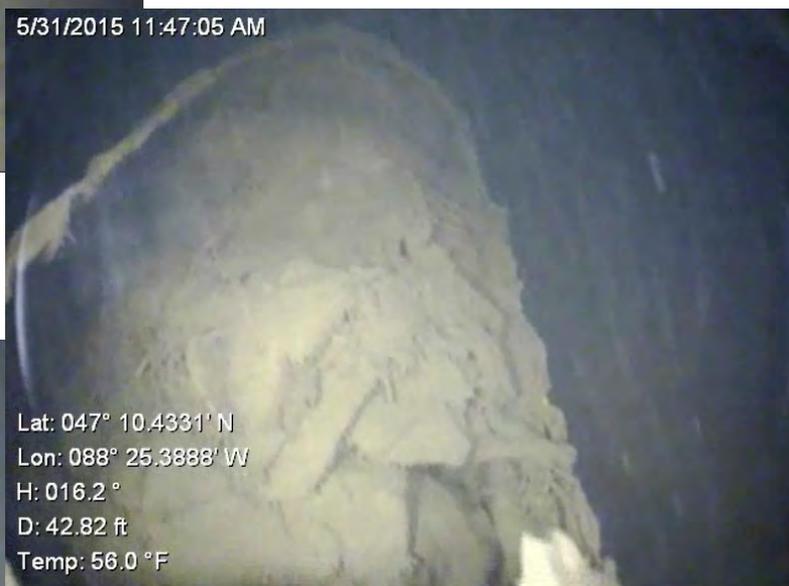
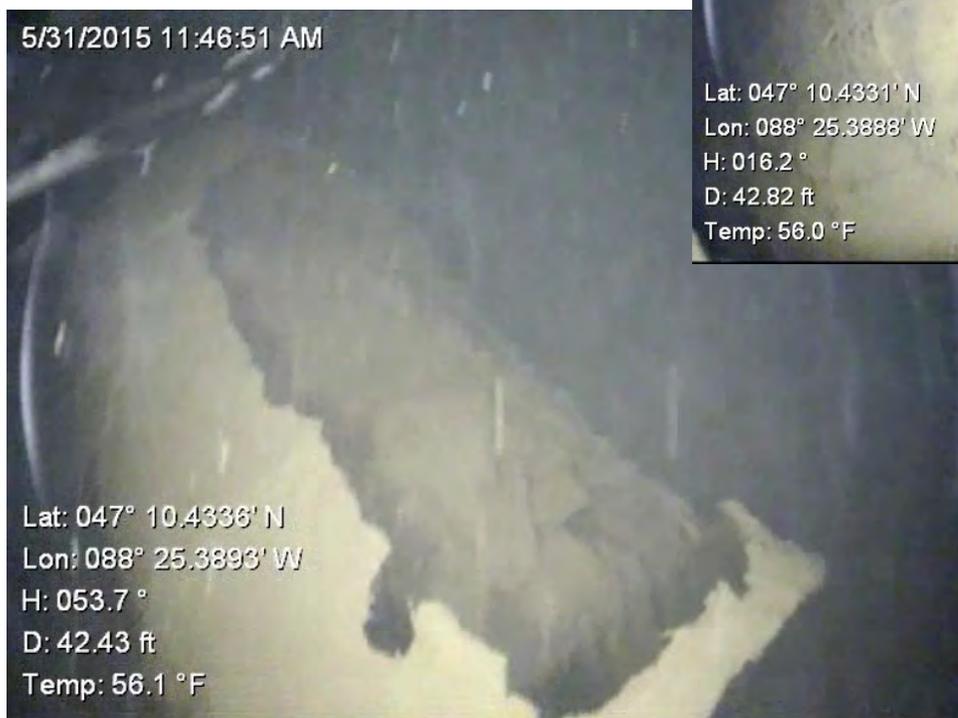
These are photos of some drums in an area where many drums have been found. The information on the screen shows their precise locations in about 43 feet of water. None of the drums we have seen so far are intact – all have some sort of hole.

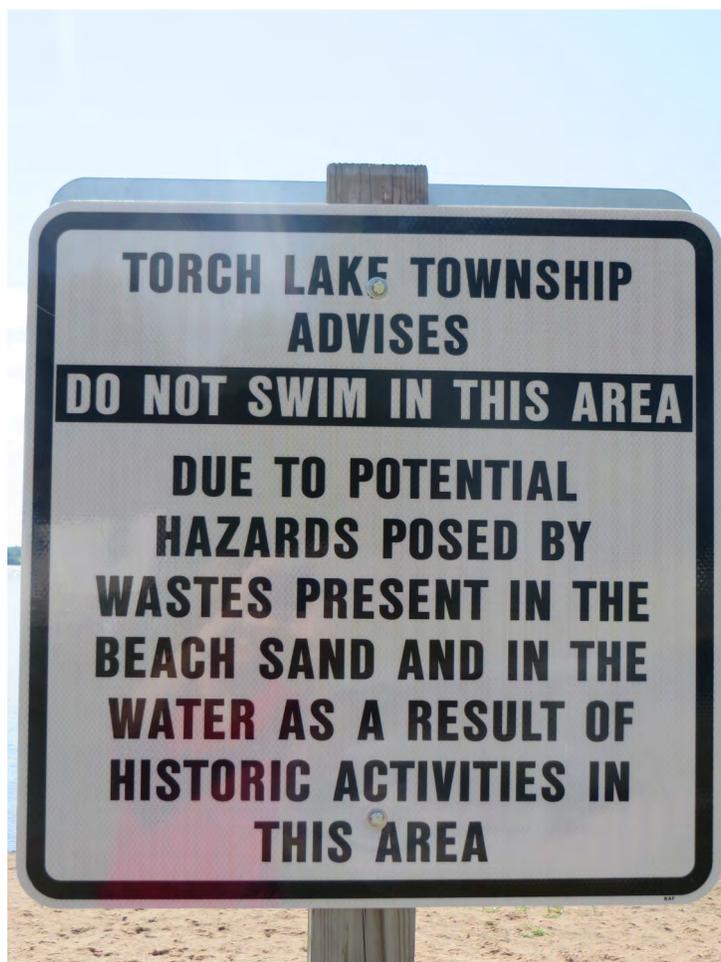
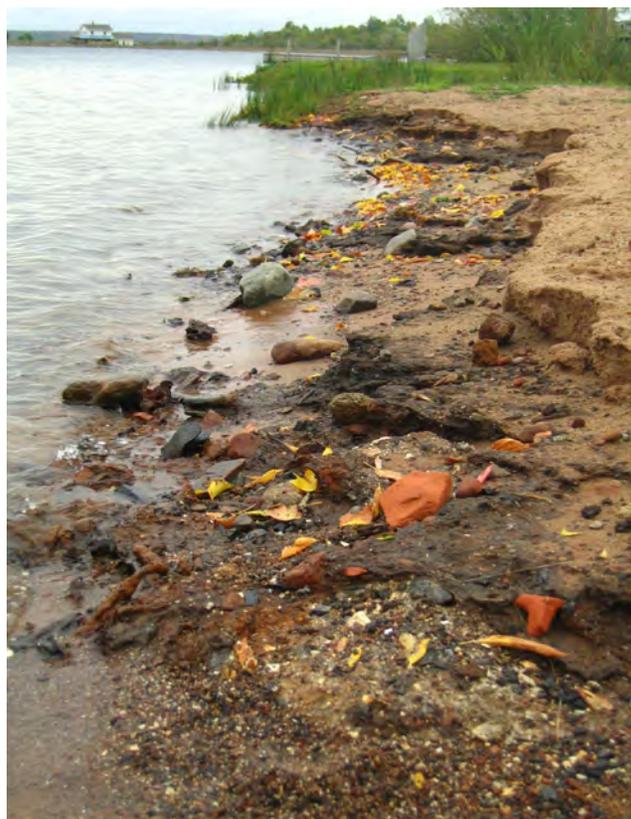
Physical hazards such as metal and porcelain-like debris continue to be an issue at the Hubbell Beach near the old town dump. These wastes can be seen in the shallow water near the swimming area. In June 2015, the Torch Lake Township board determined that it was in the public's interest to close the beach to swimming due to the debris on the lake bottom and the beach.

This sign was designed and posted by the Torch Lake Township board to advise visitors of the hazards at the beach. The photo to the right shows debris present at the beach area.

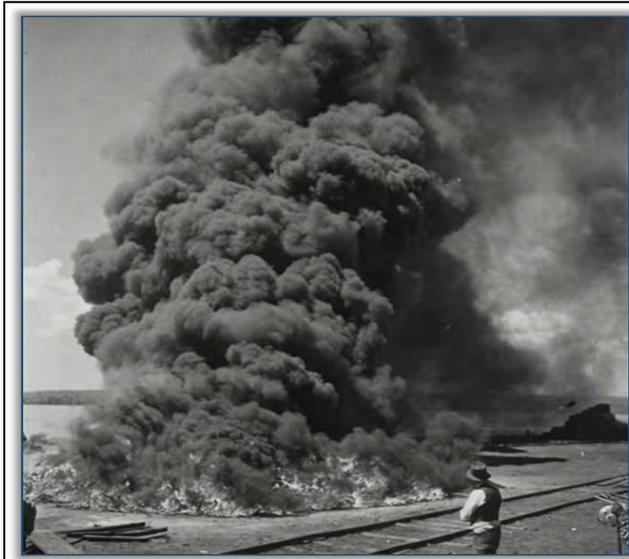
Above is a photo provided by the NPS from old C&H News n' Views newsletters. These newsletters described how scrap was brought in from all over the country for reclamation of copper during the war effort.
